Character-Defining Features of Contributing Buildings and Structures in the Fort Gordon, Georgia, Signal School Campus Historic District

Sunny E. Adams and Adam D. Smith

July 2016

Final report

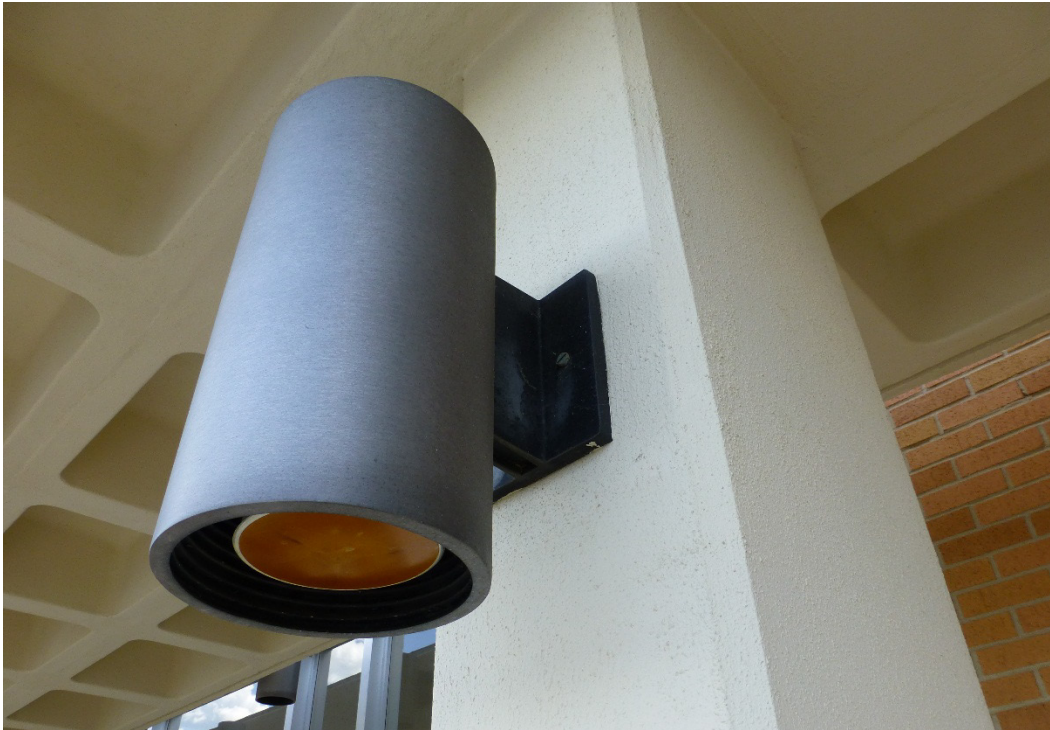
Figure 79. In-kind replacement cylinder—bronze wall-mounted light fixture—located near the main entry on the south elevation of Building 25810, Brant Hall (ERDC-CERL, 2015).

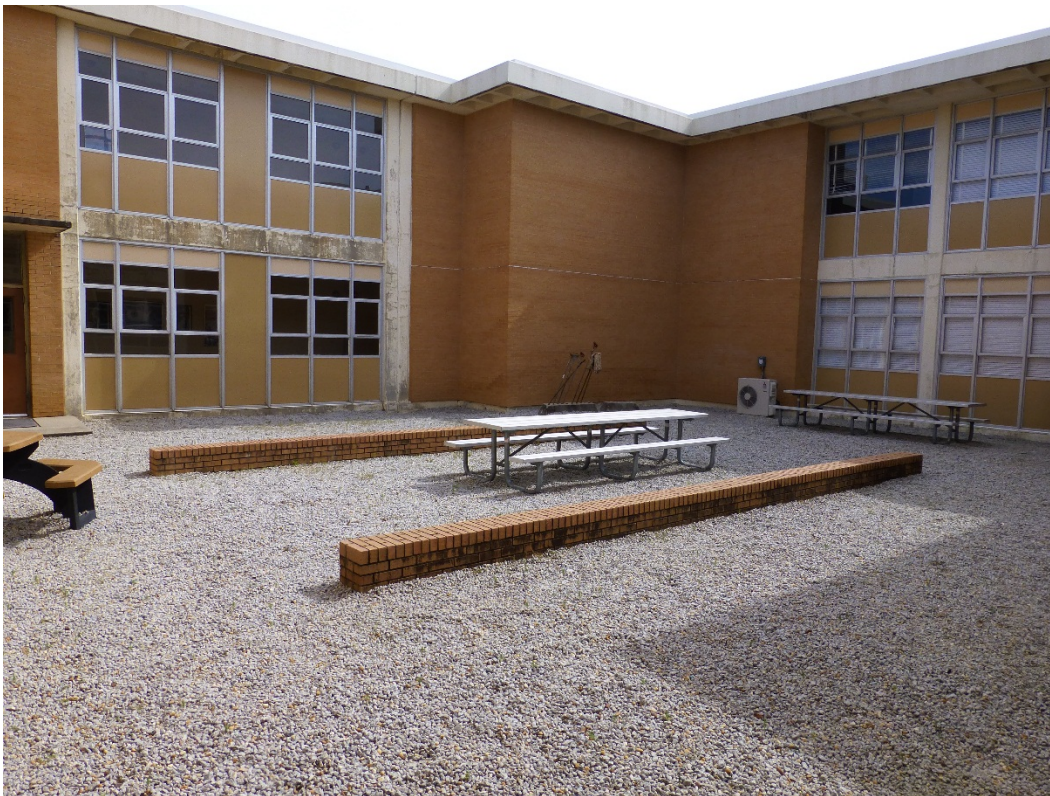
Figure 92. Interior view of the west courtyard in Building 29813, Allen Hall, showing the window bays and parallel brick sitting walls. Note the absence of vegetation that has been removed and replaced with gravel infill (ERDC-CERL, 2015).

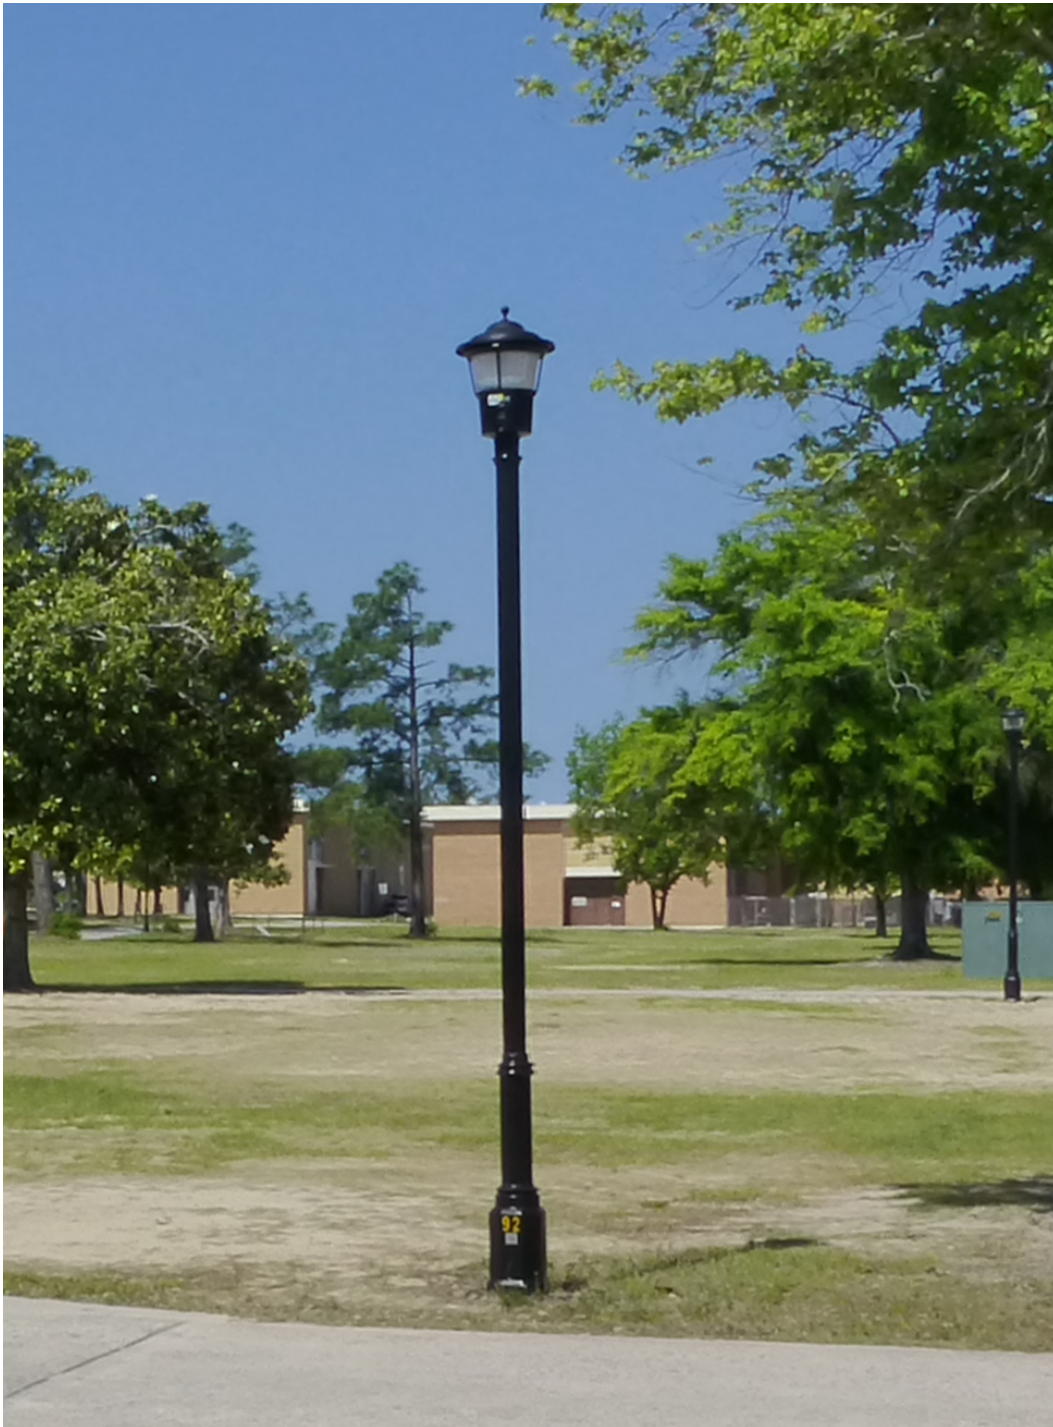
Figure 120. An example of one type of the replacement sidewalk lights (ERDC-CERL, 2015).

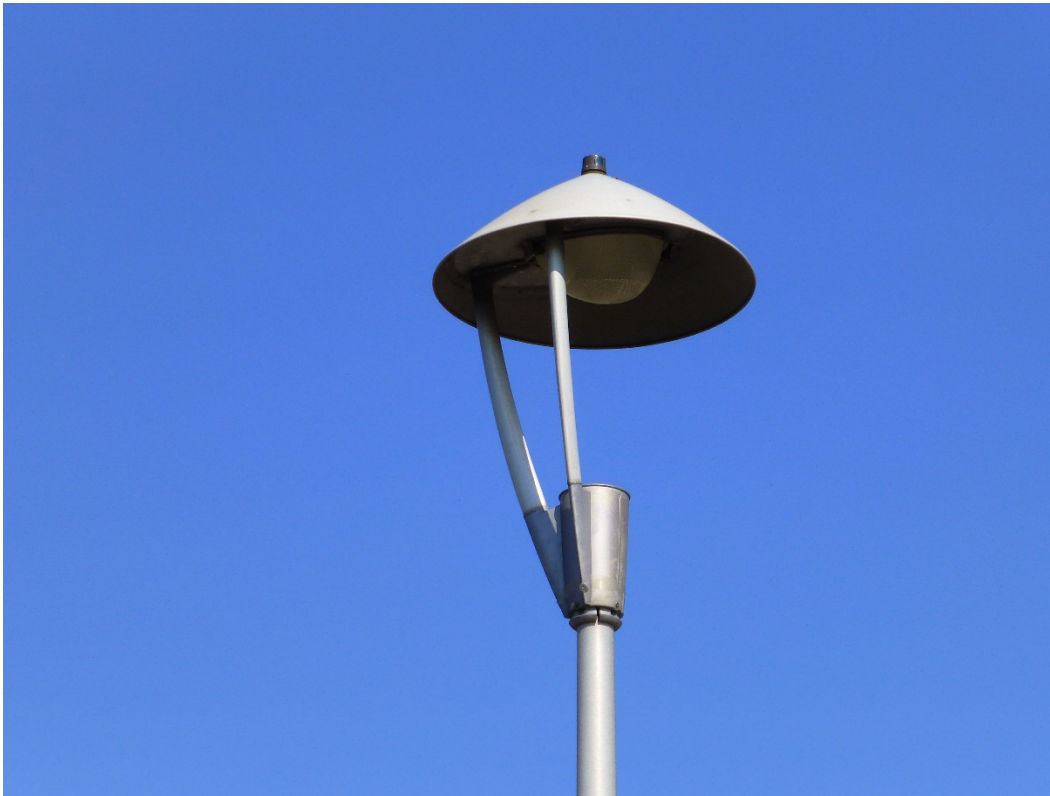
Figure 121. An example of one type of the replacement sidewalk lights (ERDC-CERL, 2015).

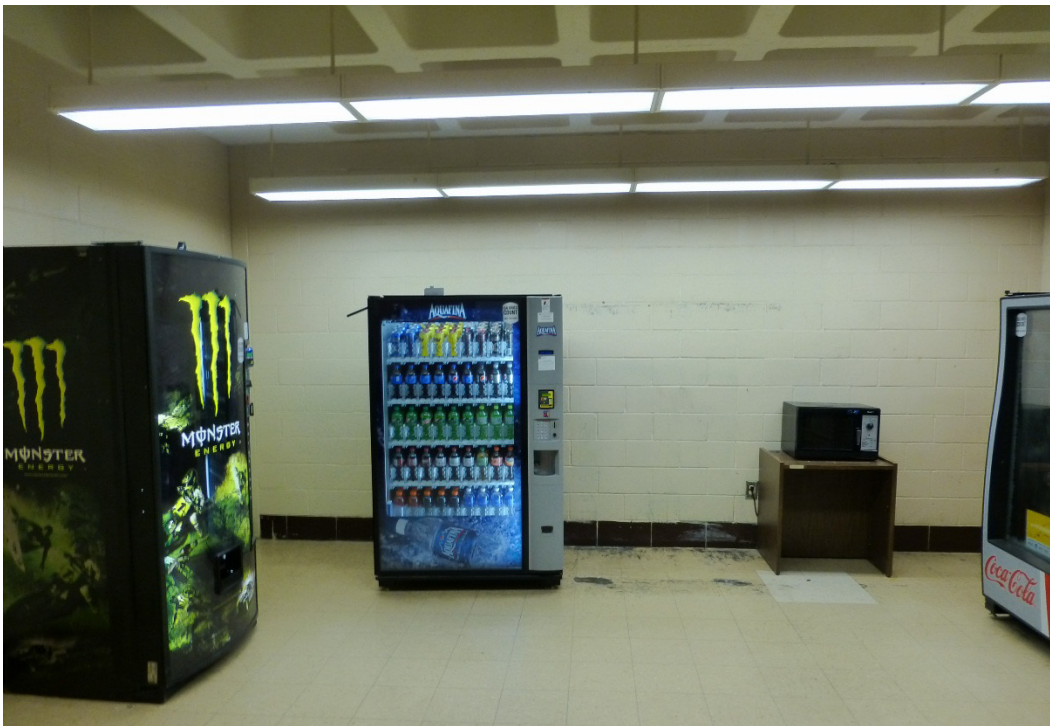
Figure 163. Example of a modified open vending area (ERDC-CERL, 2015).

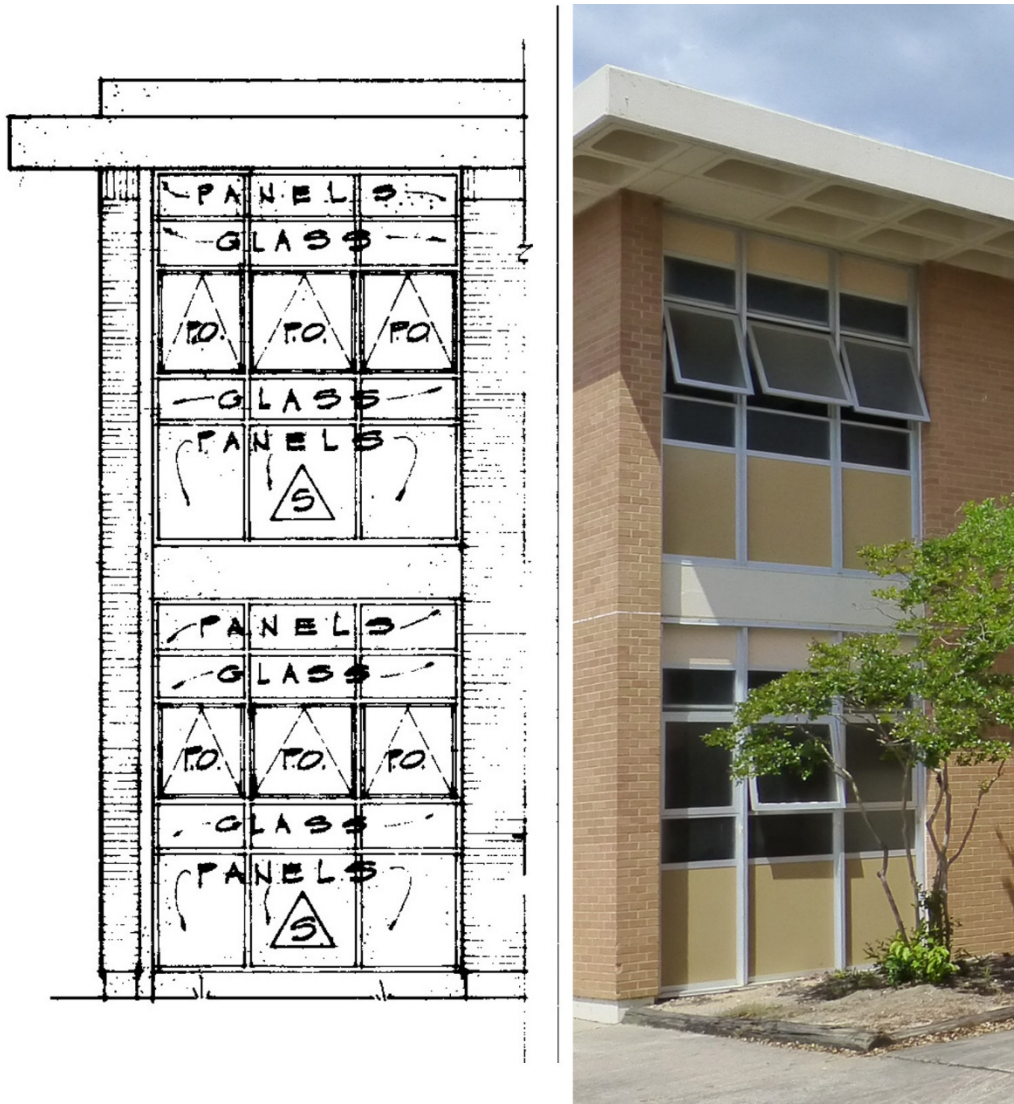
Figure 222. Window bay - comparison of the original drawing detail from 1966 [left] to the current condition of the replacement bright-aluminum windows [right] (ERDC-CERL, 2015).
