# **Demonstration and Validation of a High-Performance Floor-Sealant System to Reduce Concrete Degradation**

Final Report on Project F10-AR02

Clint A. Wilson and Susan A. Drozd

May 2015

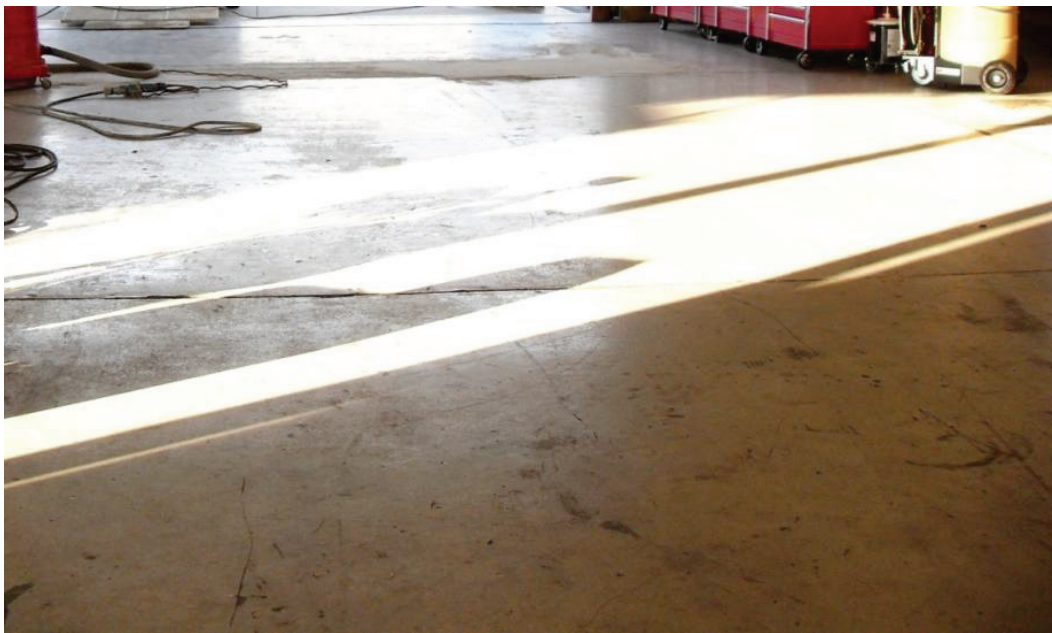
The previous paint on the maintenance bay floors was an epoxy-based coating that was deteriorating. The appearance of the floor was poor due to peeling, chipping, and staining. Because of the light color of the floor, frequent cleaning was necessary. In addition to the maintenance bays (Figure 1 and Figure 2), a tool room (Figure 3), office (Figure 4), training room (Figure 5), and hallways (Figure 6) were also included in this demonstration. The training room and hallways were covered with two layers of vinyl tile that had to be removed.

Figure 2. Condition of epoxy-coated maintenance bay floors before project.

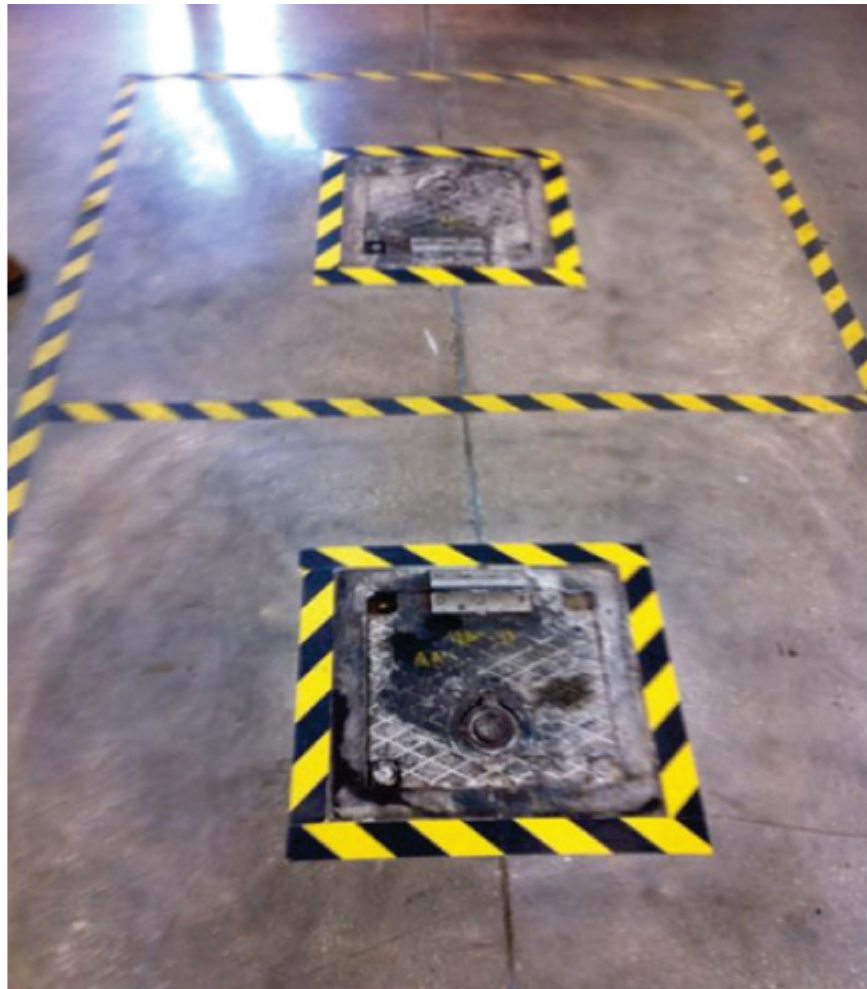
This inspection was performed in conjunction with a site visit scheduled by project team personnel to apply safety striping tape to vehicle bay floors. Stripes are needed around electrical junction boxes, which are installed in raised sections of the vehicle bay floor (Figure 22). Safety striping is normally painted on concrete floors, but tape was used because striping paint would not adhere to the sealed surfaces. At this same time, the treated floor surfaces were assessed, and no sealant deficiencies were noted.

Figure 22. Safety striping tape marking junction boxes on floor.

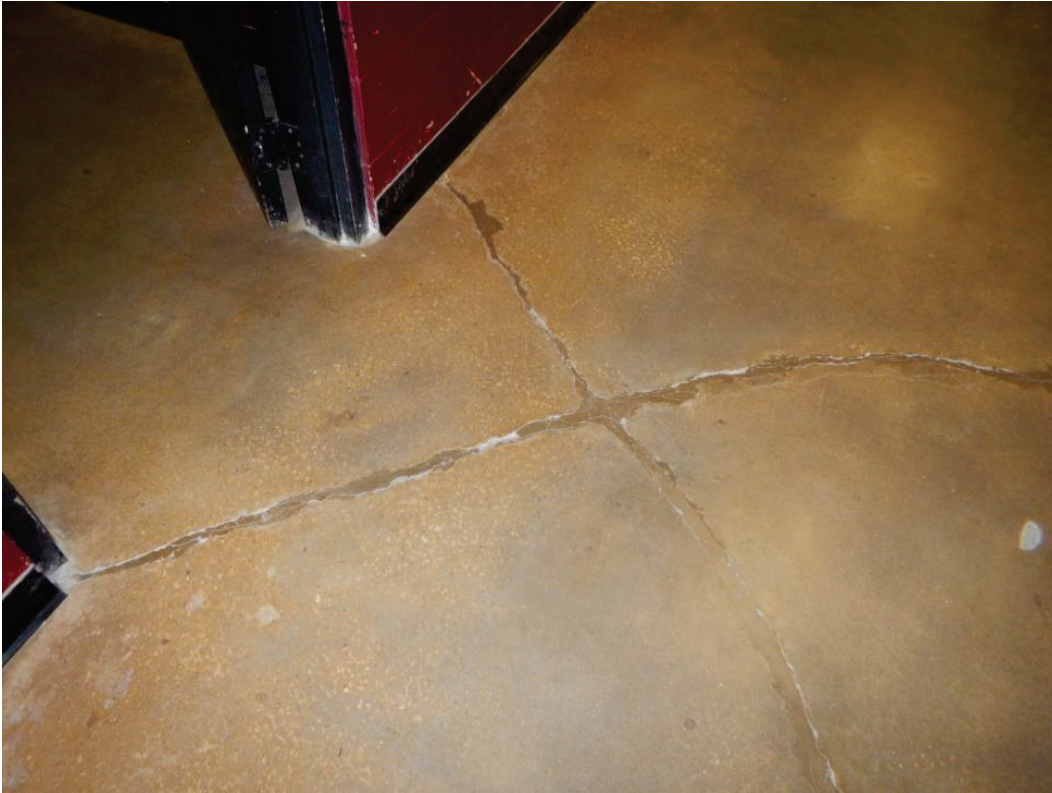
There was, however, an issue with concrete-repair materials that had been applied to some large cracks before sealant application. The concrete repair material showed signs of minor deterioration along some edges, but it was not related to the sealant application. The floors in the vehicle-maintenance bays were in excellent condition and only showed tire marks. Facility personnel reported that spills of vehicle-maintenance fluids on the floor were easy to clean and did not leave any penetrating stains.

Figure 24. Repaired cracks, showing lighter areas of repair-material deterioration.

As with joint sealers, crack repairs must be made with attention to detail. The edges of crack repairs did not hold up under use. The sealant system did not prevent these materials from chipping at the edges, but it should be noted that no floor sealant would be expected to prevent that sort of damage in a similar situation. The deterioration of the floor-crack repairs in the hallway were considered by the building users to be the main negative aspect of the project.

Continued deterioration of floor crack repairs was noted through the twelve-month inspection (section 3.2.4), and this is considered by the building users to be the biggest issue with the demonstration project results.

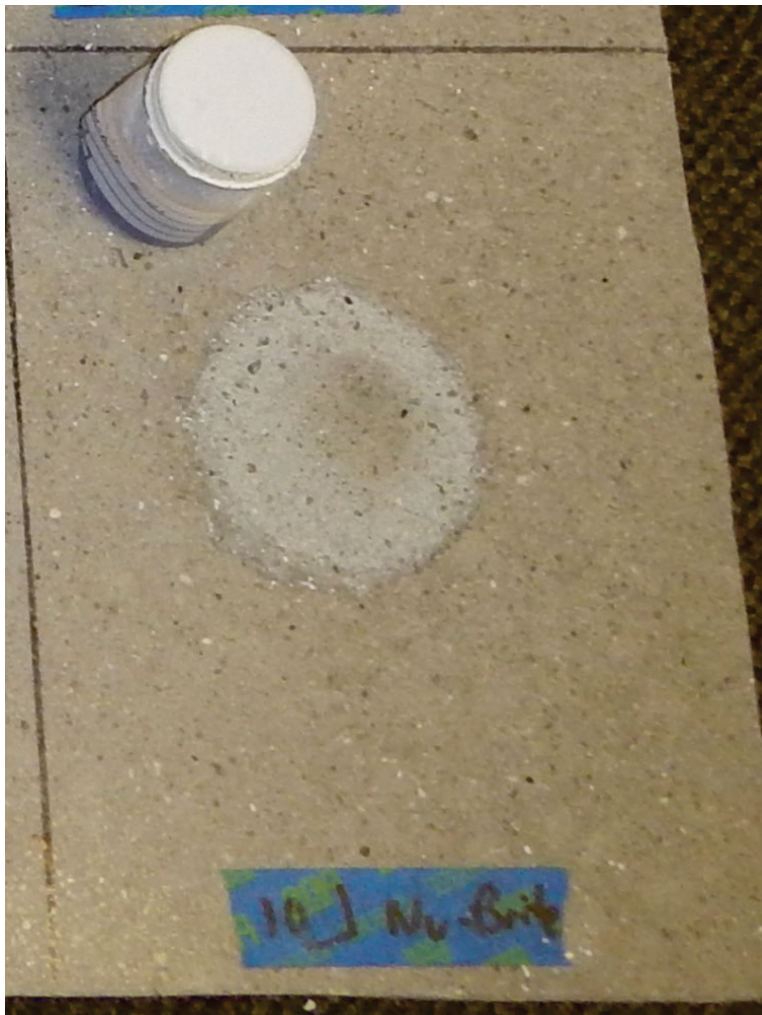
Figure D24. Test 10—Nu-Brite alkaline coil cleaner.

Only one material—Nu-Brite Alkaline Coil Cleaner—had any damaging effect on the Pentra-Sil® 244+ and Pentra Guard® (HP) surface sealant system. This caustic chemical defeated the sealant system and physically etched the polished concrete surface.
