Demonstration and Validation of Materials for Corrosion-Resistant Fencing and Guard Railings in Aggressive Climates

Final Report on Project F09-AR02

October 2015

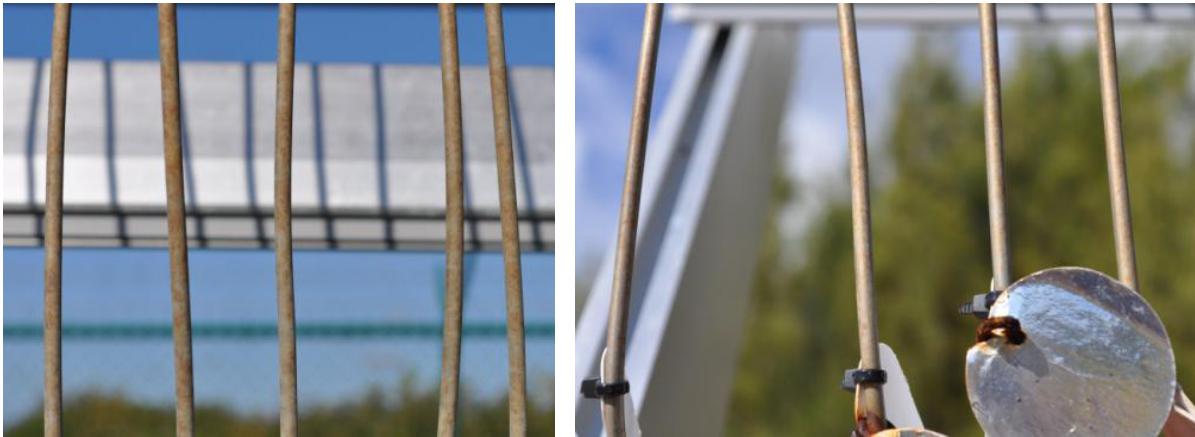
Figure 20. Stainless steel wire coupon at FRF (left) and KTA (right) after 6 months of exposure.

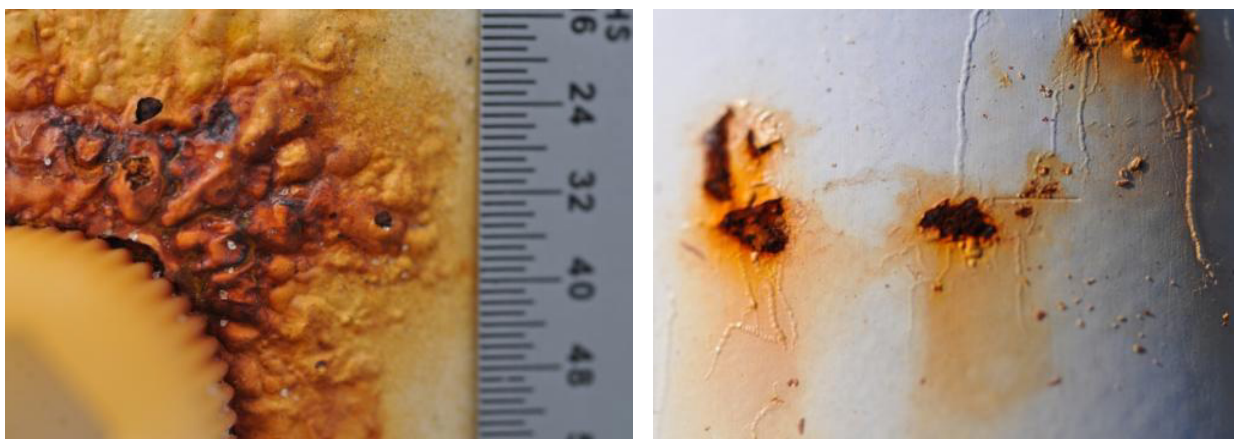
Figure 34. Coated steel railing coupon at FRF (left) and KTA (right) after 12 months of exposure.

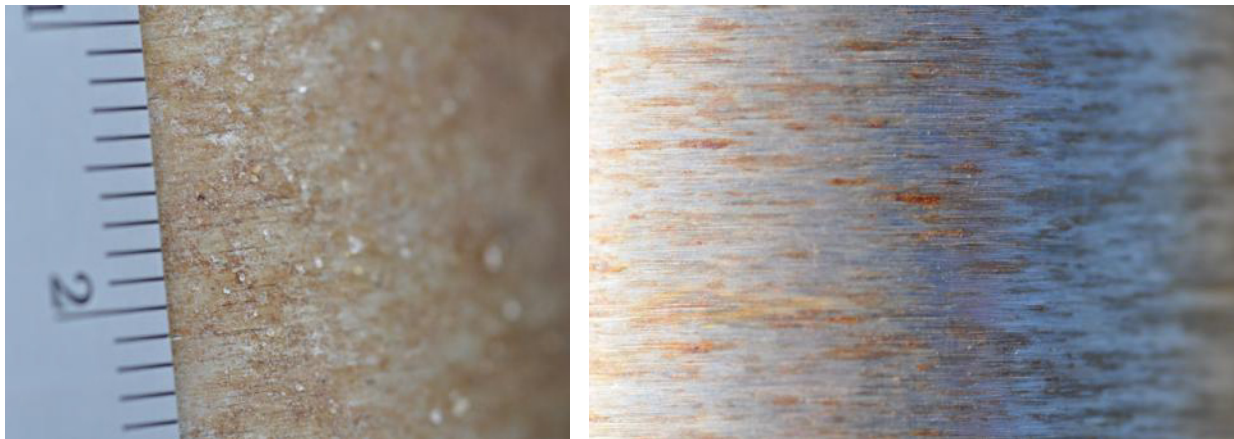
Figure 35. Stainless steel railing coupon at FRF (left) and KTA (right) after 12 months of exposure.

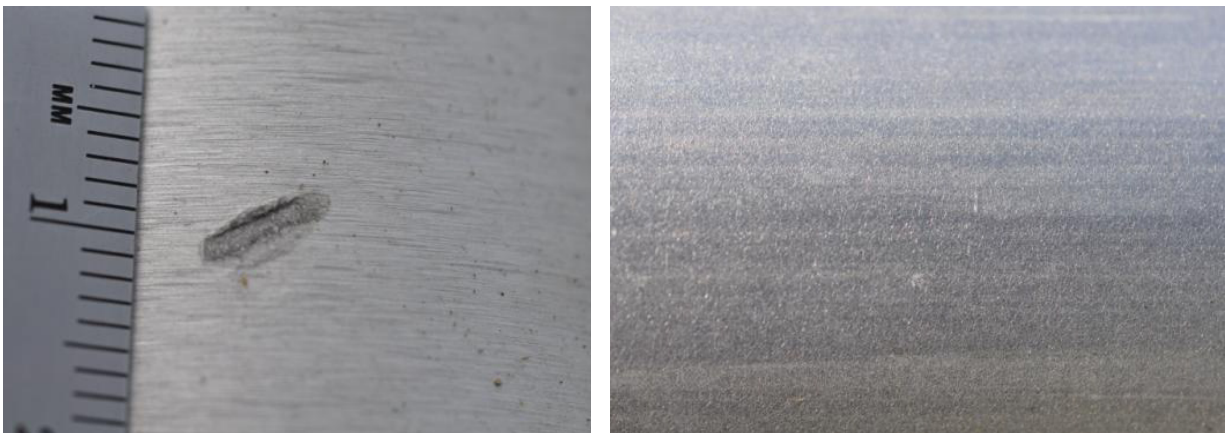
Figure 36. Aluminum railing coupon at FRF (left) and KTA (right) after 12 months of exposure.

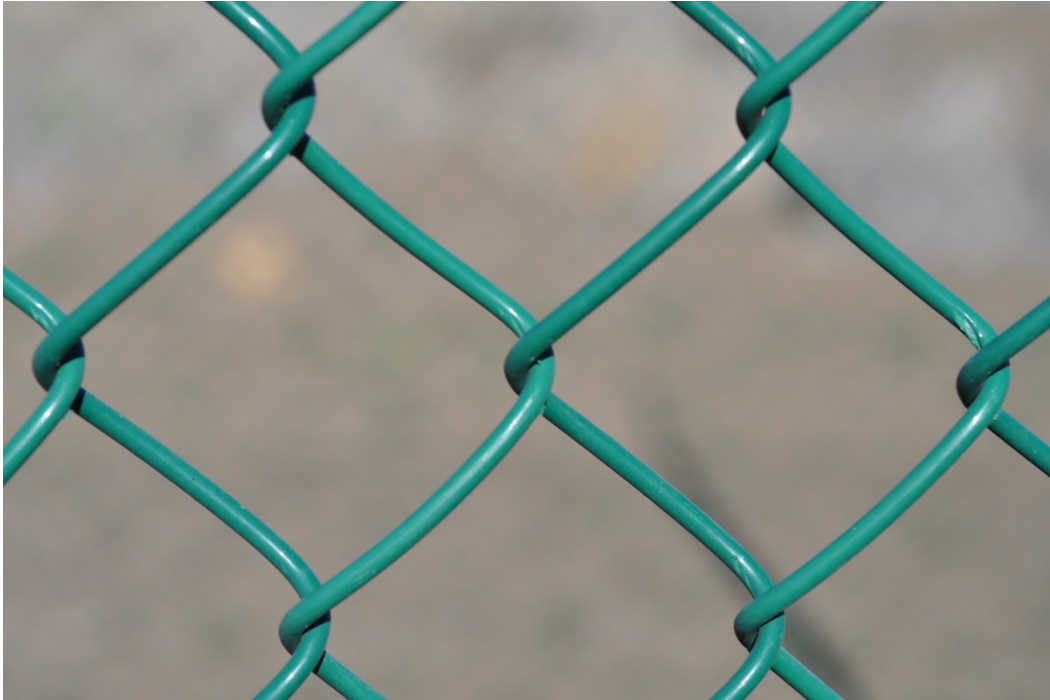
Figure A7. Fuse-bonded PVC after 6 months exposure.

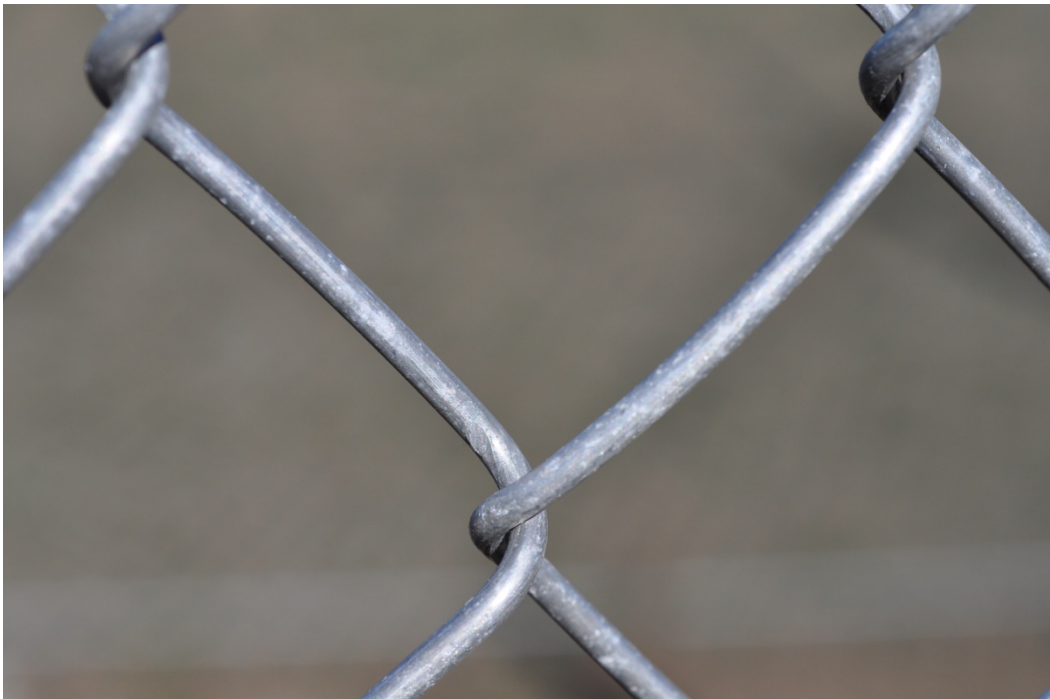
Figure A8. Stainless steel after 6 months exposure.

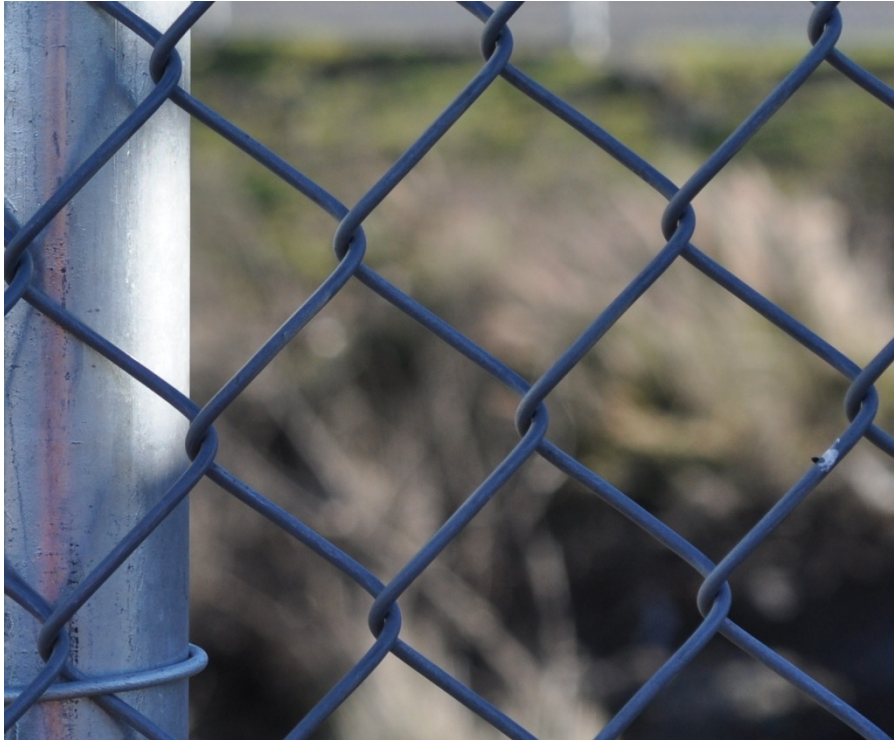
Figure A13. Galvan PVC after 6 months exposure.

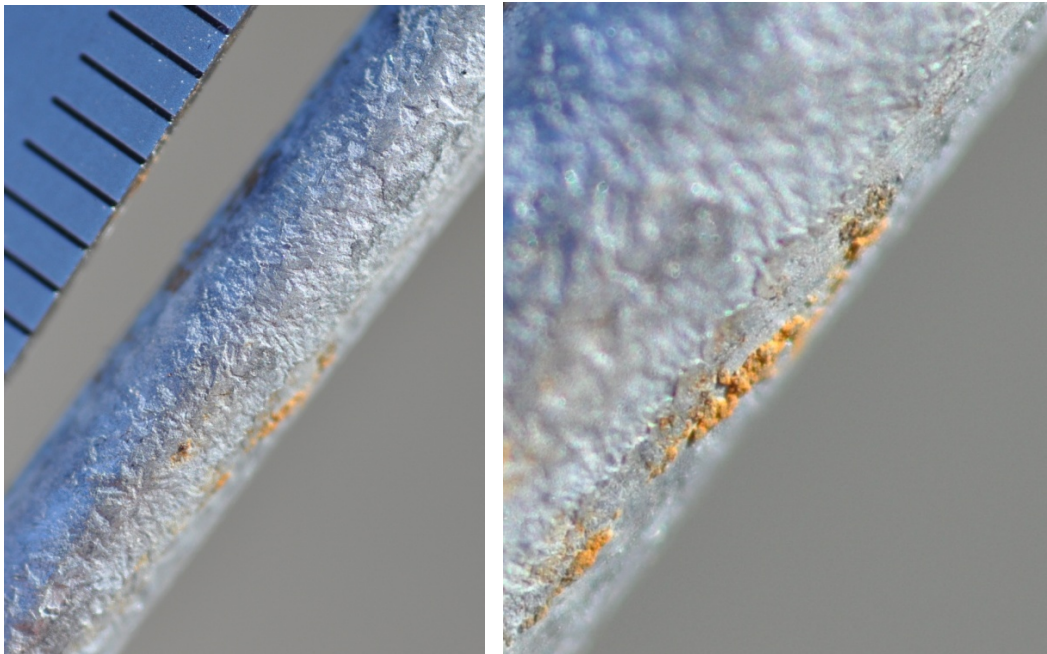
Figure A14. Aluminized after 12 months exposure showing corrosion on less than 5% of the total surface area.

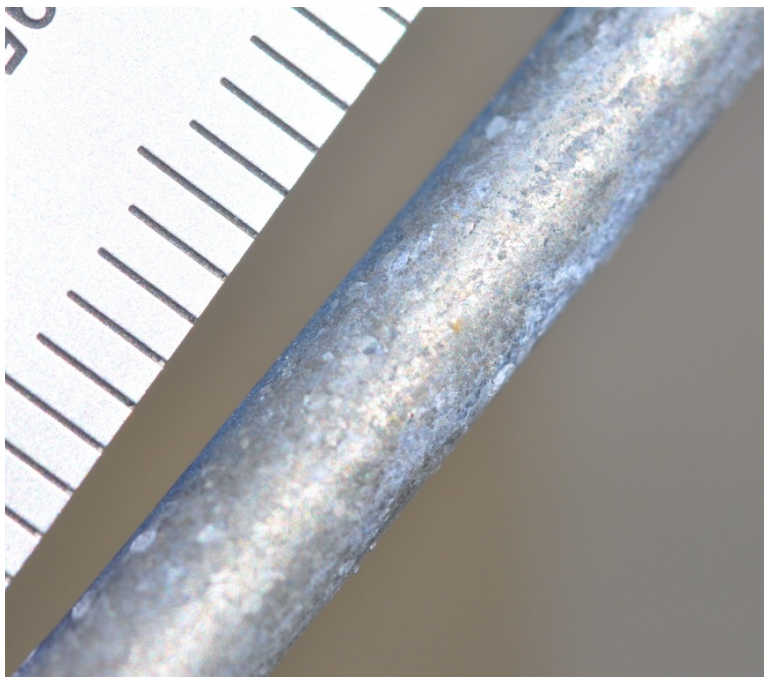
Figure A19. Galvanized after 12 months exposure.

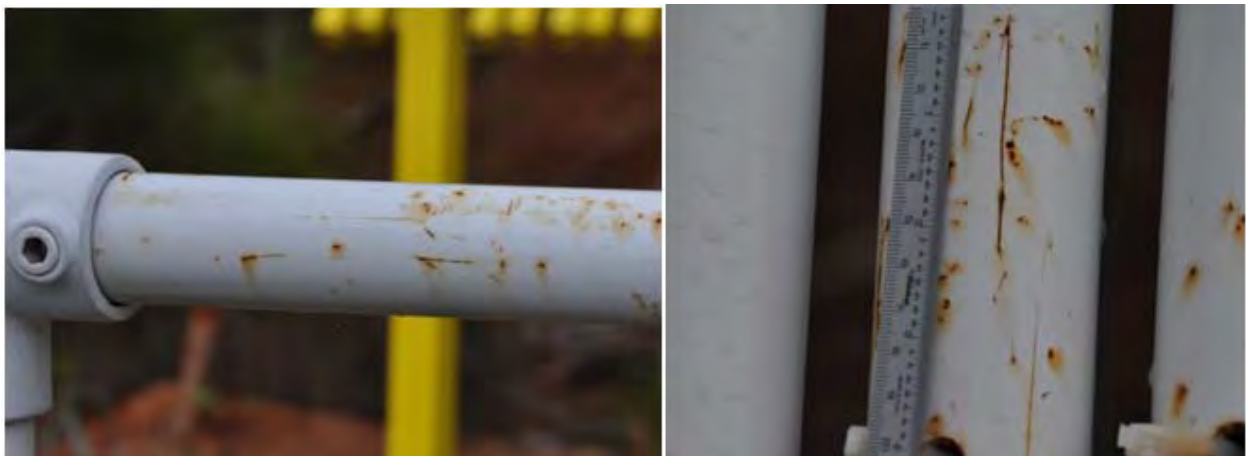
Figure B66. (Left) Stainless steel coupons facing away from the ocean; (Right) stainless steel coupons facing the Ocean.

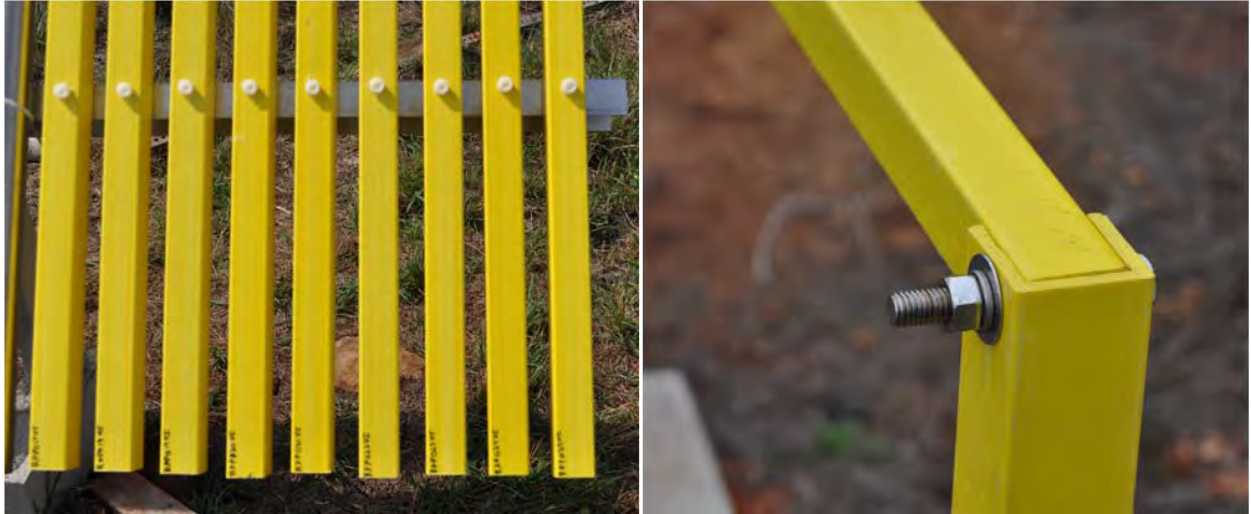
Figure B67. (Left) Painted carbon steel railing coating failure. (Right) Painted carbon steel coupon coating failure.

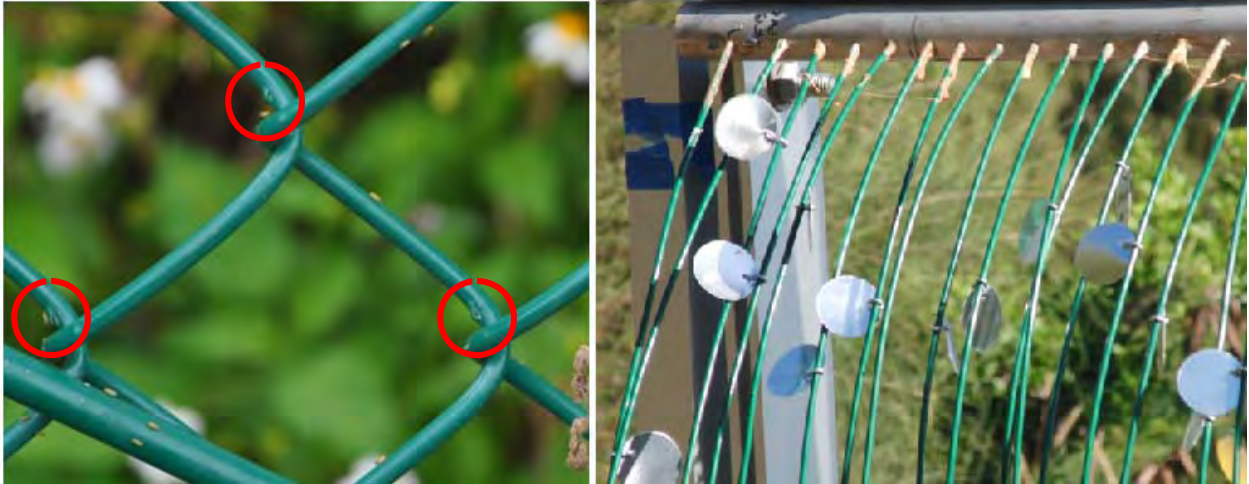
Figure B70. (Left) Stainless steel fence after 3 months exposure.
(Right)Stainless steel wire coupons after 3 months exposure.

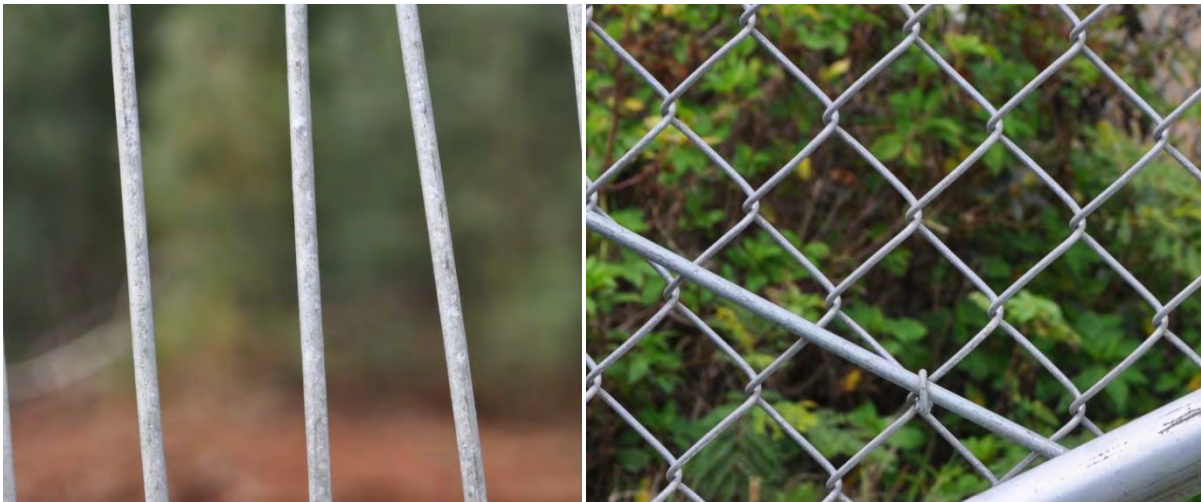
Figure B71. (Left) Fused bonded PVC coated galvanized steel formation damage. (Right) PVC coated galvanized steel wire coupons
