Demonstration of Reactive Vitreous Coatings on Reinforcement Steel to Prevent Corrosion and Concrete Failure

Final Report on Project F08-AR01

September 2016

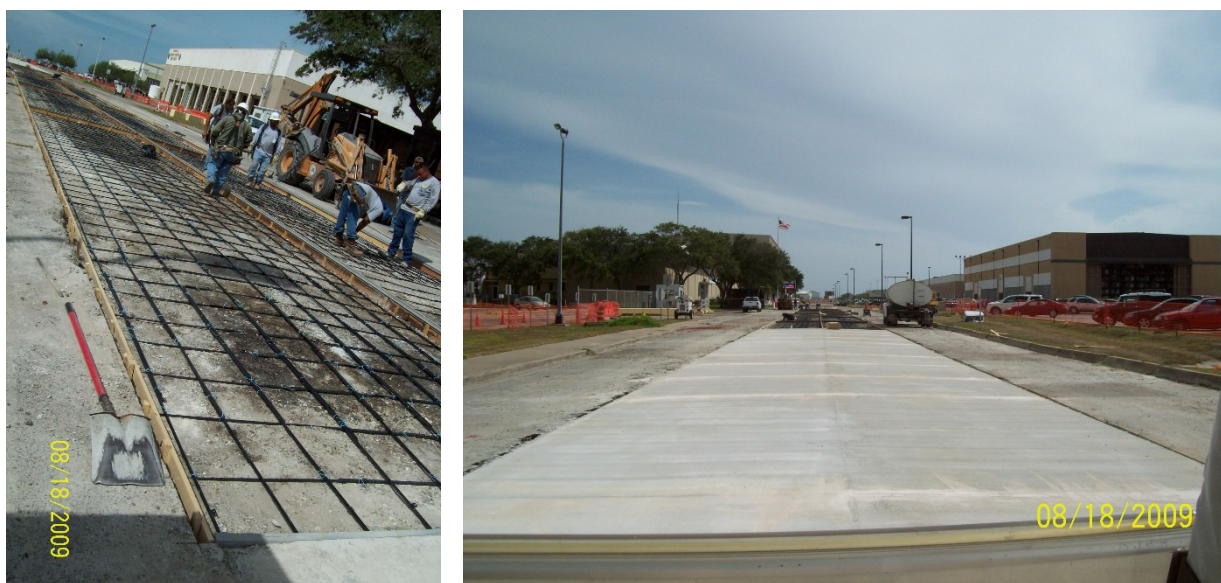
Figure 1. Vitreous rebar in place before and after Crecy Street concrete pour.

Although many flakes of vitreous coating were seen in the rebar shipping containers, the coating on the bars appeared to be reasonably durable during placement. Concrete was placed for Crecy Street on 14 and 19 August 2009. The concrete mix design (cubic yard basis) and quality control data are as follows:

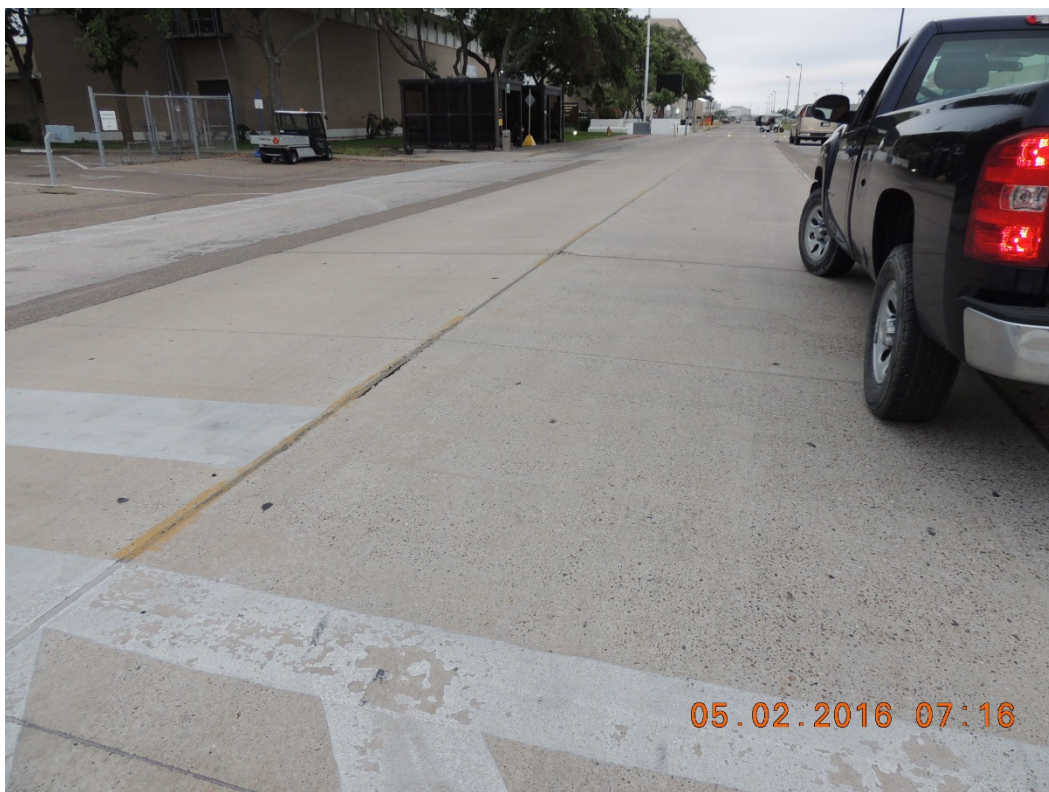
As of May 2016, the overall condition of the pavement was reported to be sound (see Figure 7). Some minor D-cracking (less than 4 in. radius) was observed by DPW personnel at some corners of the installed pavement (see Figure 8).

Figure 7. Crecy Street pavement condition as of May 2016.

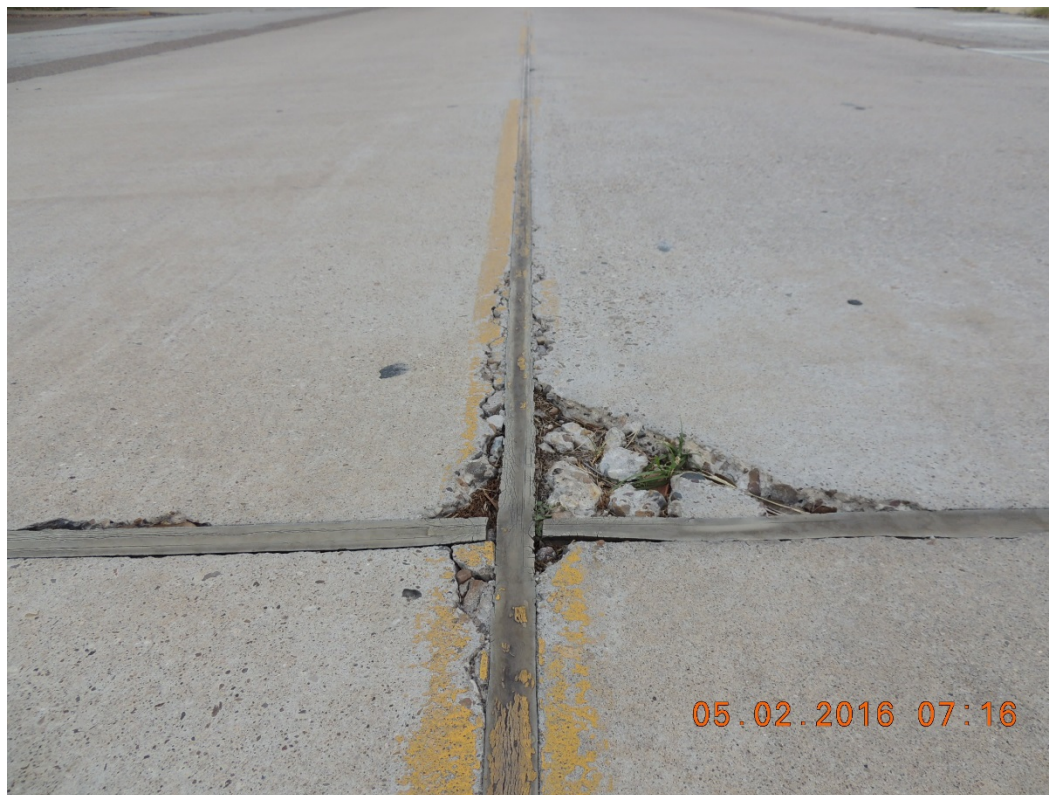
Figure 8. Observed D-cracking unrelated to vitreous rebar performance.

D-cracking is a deterioration mechanism in concrete in which fine cracks run parallel to joints and cuts and propagate radially around slab corners. This crack pattern is most consistent with moisture-aggravated deterioration. It is unlikely that these cracks are related to the reinforcing bars, which are installed in a grid pattern covering the entire roadbed and not localized to slab corners.

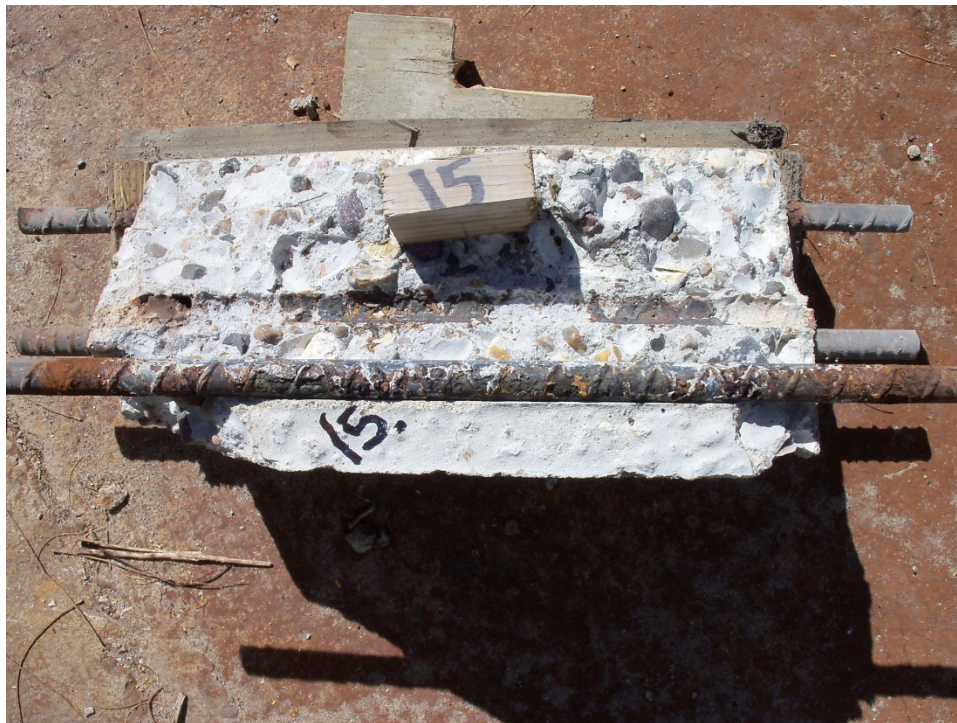
Figure A1. Rebar trace of uncoated bar in Test Block 15.

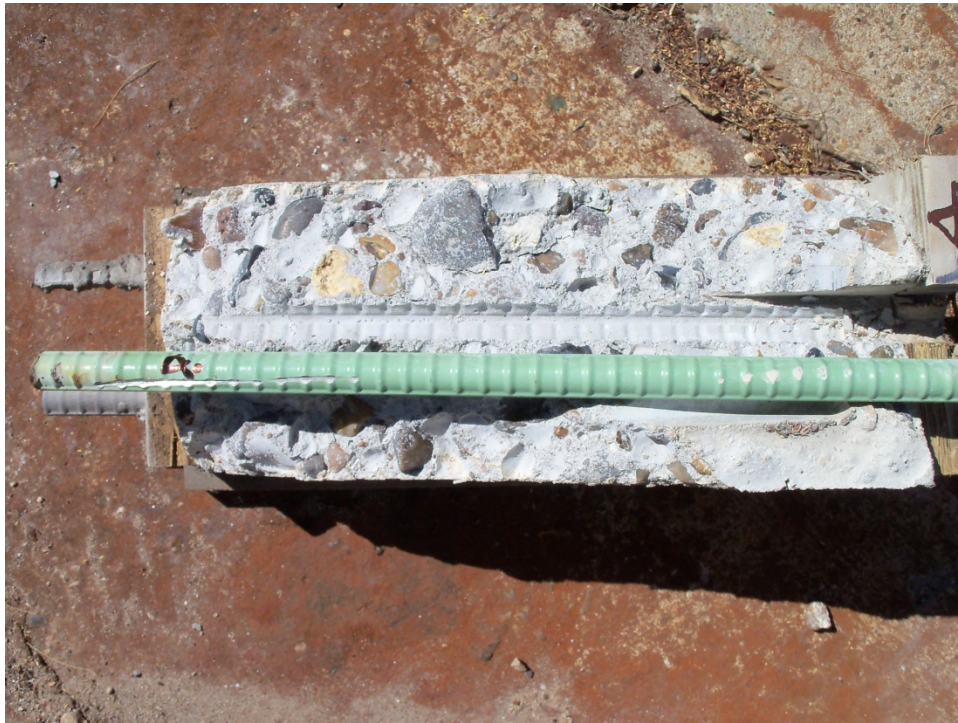
Figure A2. Rebar trace of epoxy-coated bar in Test Block 4.

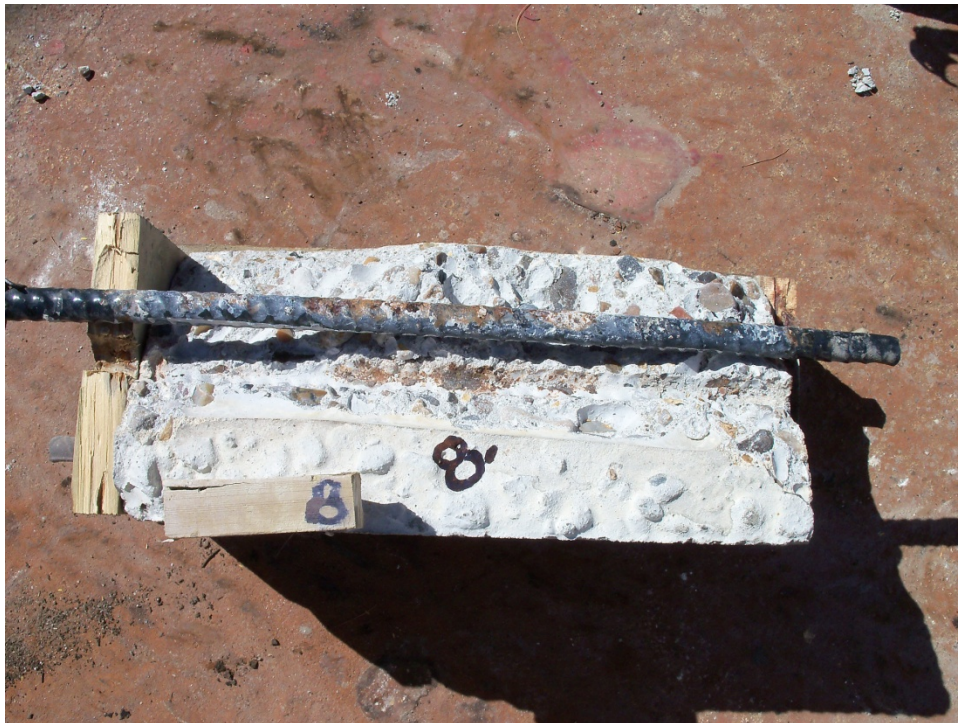
Figure A3. Rebar trace of vitreous-coated bar in Test Block 8.

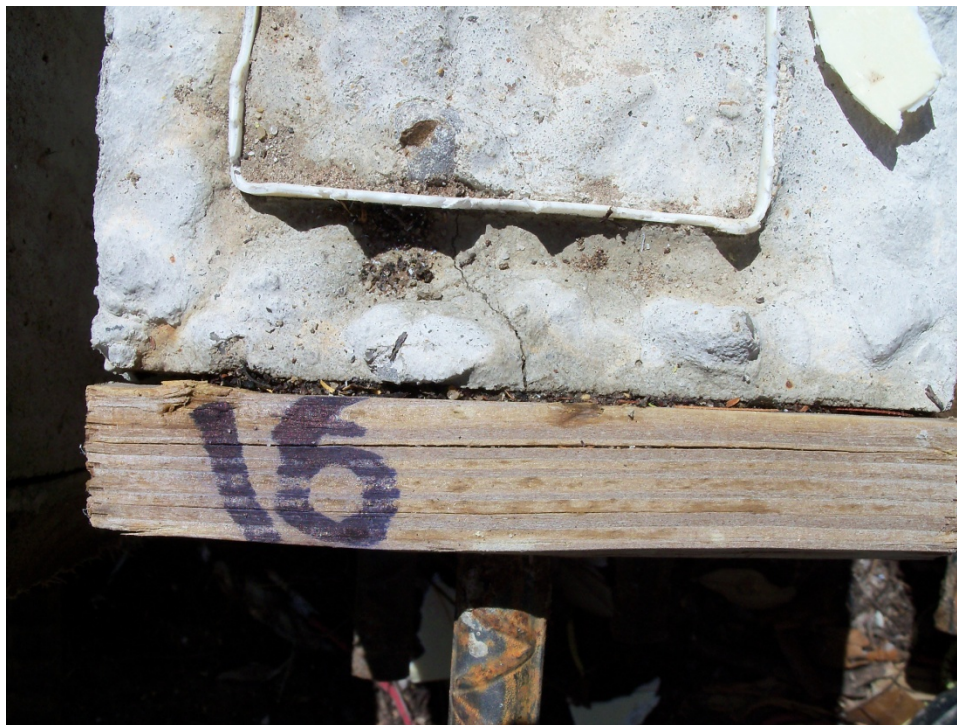
In addition, test blocks containing uncoated bars had small corrosion cracks above the reinforcing bars near the ends of the blocks at the conclusion of the test. These cracks were caused by expansion of the bars from an

accumulation of corrosion products. An example of these corrosion cracks is shown in Figure A4. None of the other test blocks was cracked at the conclusion of the demonstration.

Figure A4. Corrosion crack above uncoated bar on Test Block 16.
