Post-tensioned Multistrand Anchorage Capacity Deterioration Due To Corrosion: John Day Lock Project

by Robert Ebeling, Richard Haskins, David Scofield, John Hite, and Ralph Strom

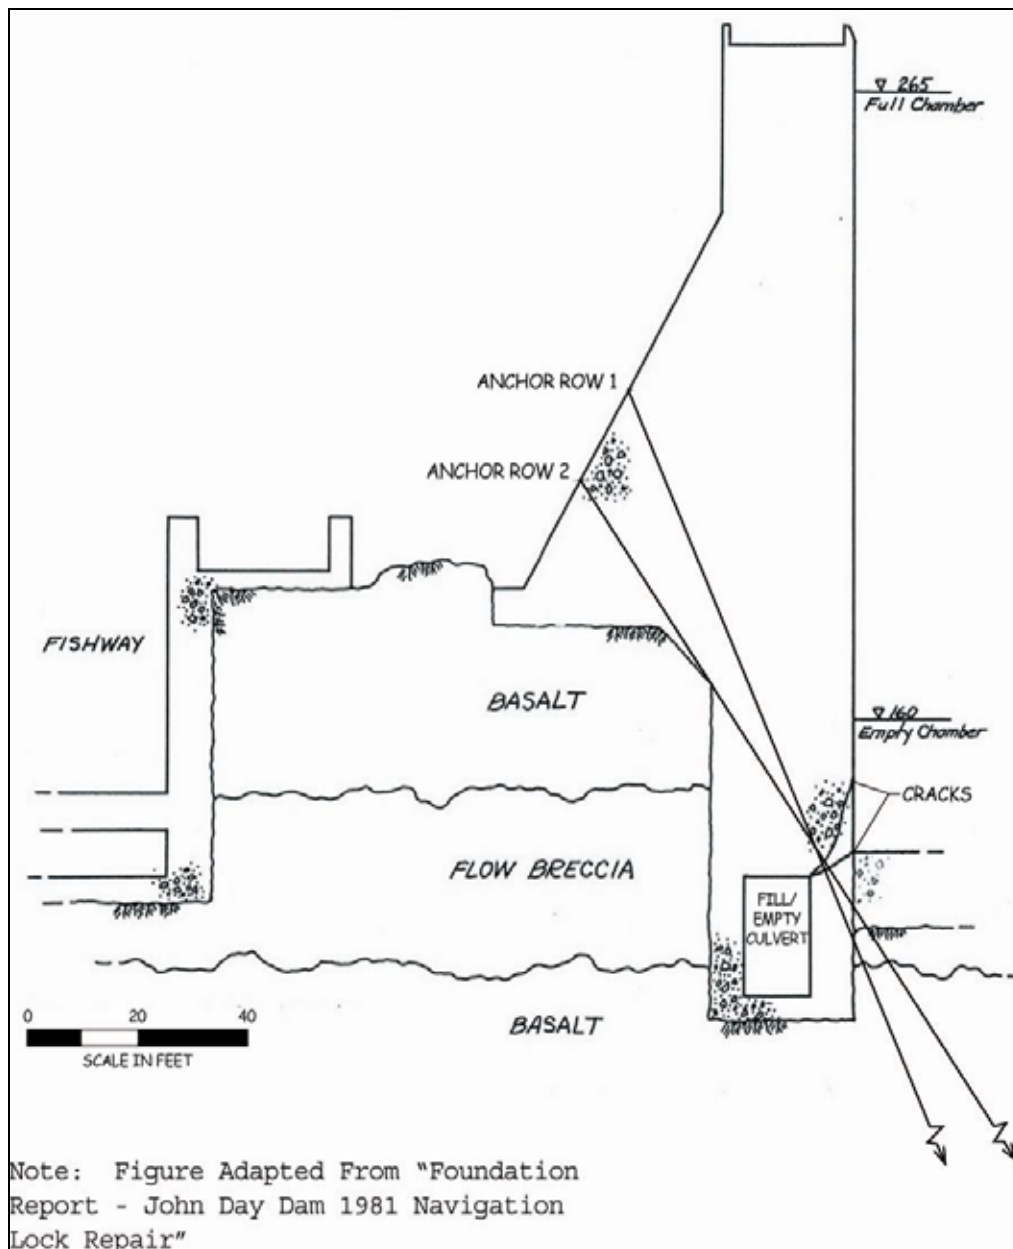
John Day Lock. The John Day Lock and Dam Project is 216 miles upriver from the mouth of the Columbia River near the city of Rufus, OR. The authorized primary project purposes are navigation and power generation. The project consists of a navigation lock, spillway, powerhouse, and fish passage facilities. John Day Lock was designed and constructed in the 1950's and 1960's simultaneously with the four Snake River locks and dams. The lock is 650 ft long by 86 ft wide and possesses the highest single lift (113 ft) in the Corps of Engineers. The project design was based on the Snake River locks with about 100 ft lifts and scaled to the John Day project conditions. Construction of John Day Lock and Dam was completed in 1971. Structural cracks in the south filling/emptying culvert were first noticed in 1975 and continued to

grow. No significant reinforcement steel was included within the concrete that formed the culvert, and the culvert wall between the lock and culvert is only 7-ft thick. The monoliths were observed to move with each lockage.

Figure 1. Schematic of John Day Lock crack repair using multistrand anchors.

Multistrand Anchors at John Day Lock. An investigation was performed in 1979 which led to the installation of 73 post-tensioned anchors in 1981. Each anchor contained 37, 7-strand (0.6 in. diameter) wires and was oriented to pass through a window (about 7 ft) between the emptying/filling culvert and the lock chamber. Spacing and inclination was varied to pass between laterals in the chamber. Figure 1 shows a schematic section view of the anchors. Load transfer takes place at the ends of the post-tensioned anchorage; at the top of an anchor head and at the other end, along the bonded zone contained within the basalt below the base of the lock.

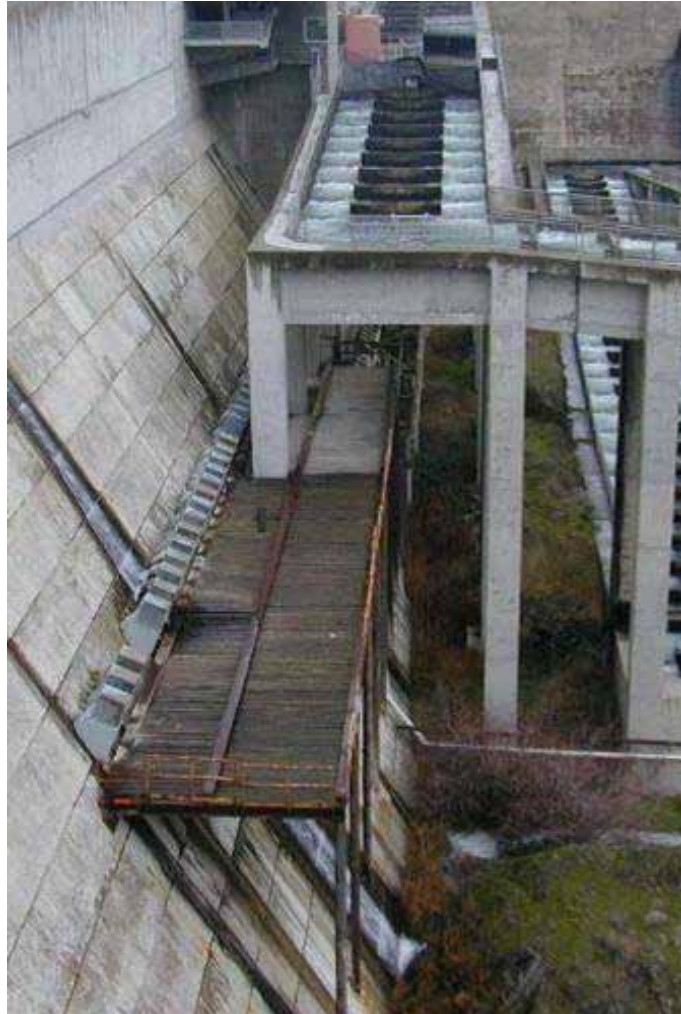
Pat Hunter from the John Day Project led the tour on 31 August. Figure 3 shows the anchor pedestals (i.e., reinforced concrete reaction blocks) and anchor head protective covers protruding from the outside face of the south lock wall. These are some of the upper anchors shown in Figure 1. Figure 4 shows the original anchor head installed in 1981. This anchor head was specially manufactured for this project with a threaded head (refer to Figure 4). This special provision facilitates the connection of a specially manufactured “coupler” to the jacking equipment used for lift-off testing. This feature is unique to the John Day anchorage.

Figure 3. Anchor head pedestals and protective covers along the south lock wall access deck.

- f. Water on the Columbia is characteristically soft which further contributes to corrosiveness.
- g. It was noted that there are extreme seasonal temperatures and the pedestals containing the anchor heads (Figure 3) are exposed to these conditions.

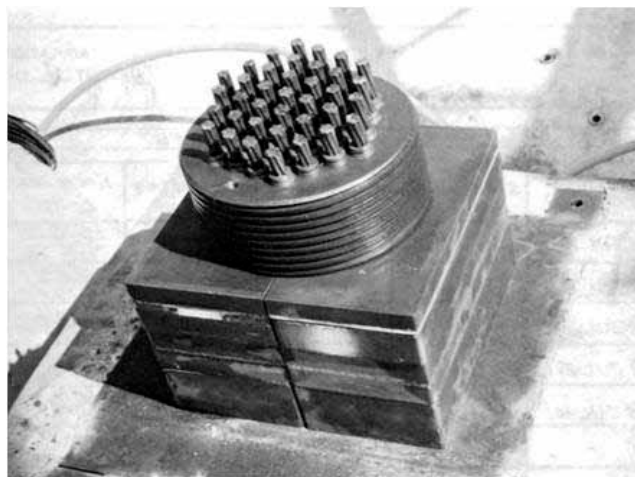
Figure 4. Original 1981 threaded anchor head with spacers and wedges resting on the anchor pedestal.

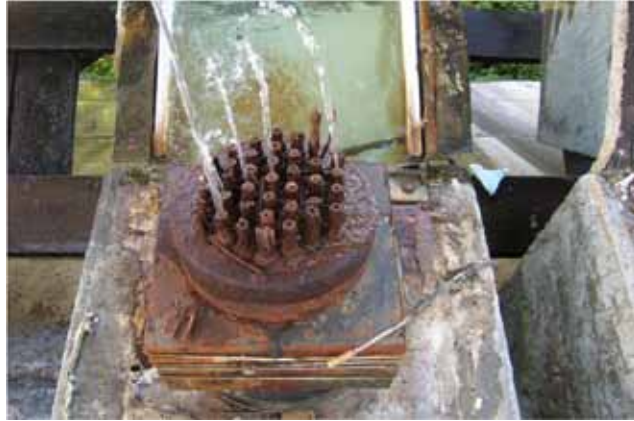
FIELD OBSERVATIONS: A significant number of anchor failures seem to initiate with the failure of the center wire known as the "king" or "core" wire. The center wire has a larger diameter than the outer wires to assure the outer wires bear on the center wire and grip it as there is no other means of keeping tension in the center wire. This failed wire has been observed either retracting into the seven-strand grouping or protruding outwards (and above the tops of the seven-strand wire groups). For those wires protruding, the length has been on the order of six to eight inches. This length likely corresponds to the distance between the tip of the gripping wedge and the top of the wire above the anchor head. Retraction of the center wire could indicate a loss of section due to corrosion where the diameter has reduced enough to prevent the outer wires from bearing on it. Protrusion of the center wire may indicate a corrosion failure. Figure 5 shows flow of water through the anchor from the lock operation, and the loss of the center wires can also be seen. Potential contributing factors to strand failure near the anchor head are listed below:

- a. Temperature,
- b. Wetting and drying action leading to a concentration of dissolved oxygen near the anchor head
- c. Corrosion stress, stress concentration, or loss of cross section at the gripping wedge,
- d. Increased corrosion potentials (electrical potentials).

Figure 5. 2008 inspection (and lift-off testing) of multi-strand tendons showing loss of center wire and flow of water through several of the 7-stand wires.
