TECHNICAL REPORT S-74-8

COMPARATIVE PERFORMANCE OF STRUCTURAL LAYERS IN PAVEMENT SYSTEMS

DESIGN, CONSTRUCTION, AND BEHAVIOR UNDER TRAFFIC OF PAVEMENT TEST SECTIONS

U. S. Army Engineer Waterways Experiment Station

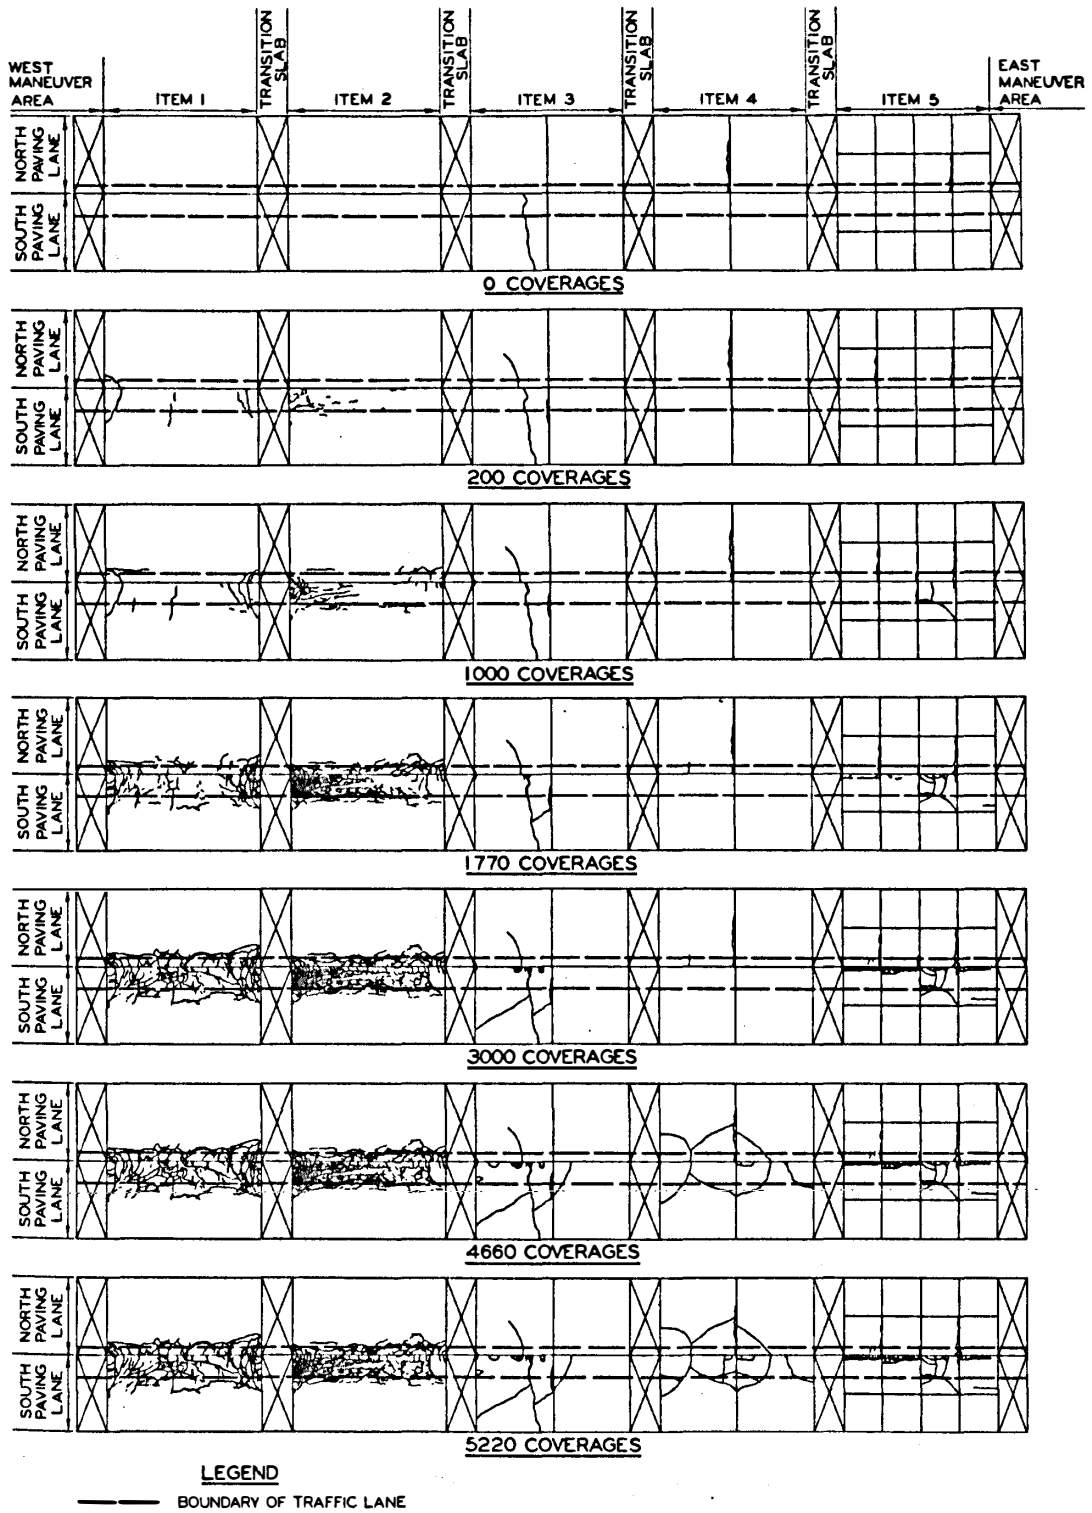
Figure A5. Crack development in lane 1, rigid pavement test section

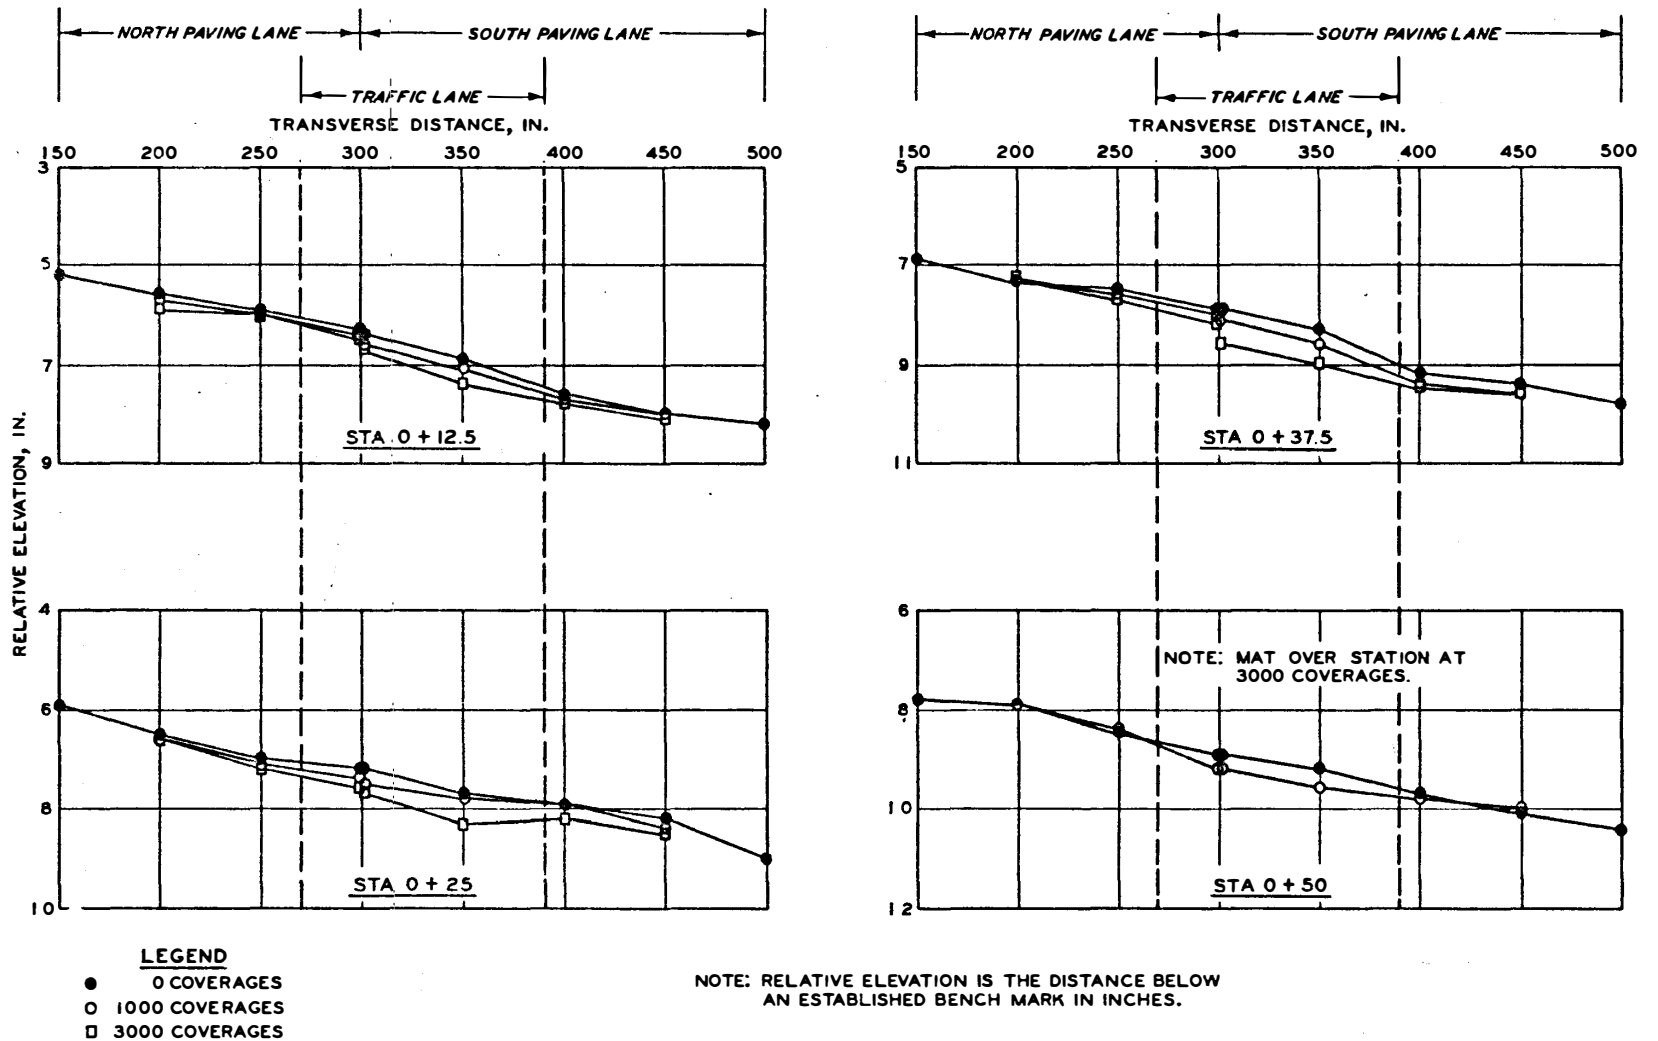
Figure A6. Surface deformation in item 1, lane 1, rigid pavement test section

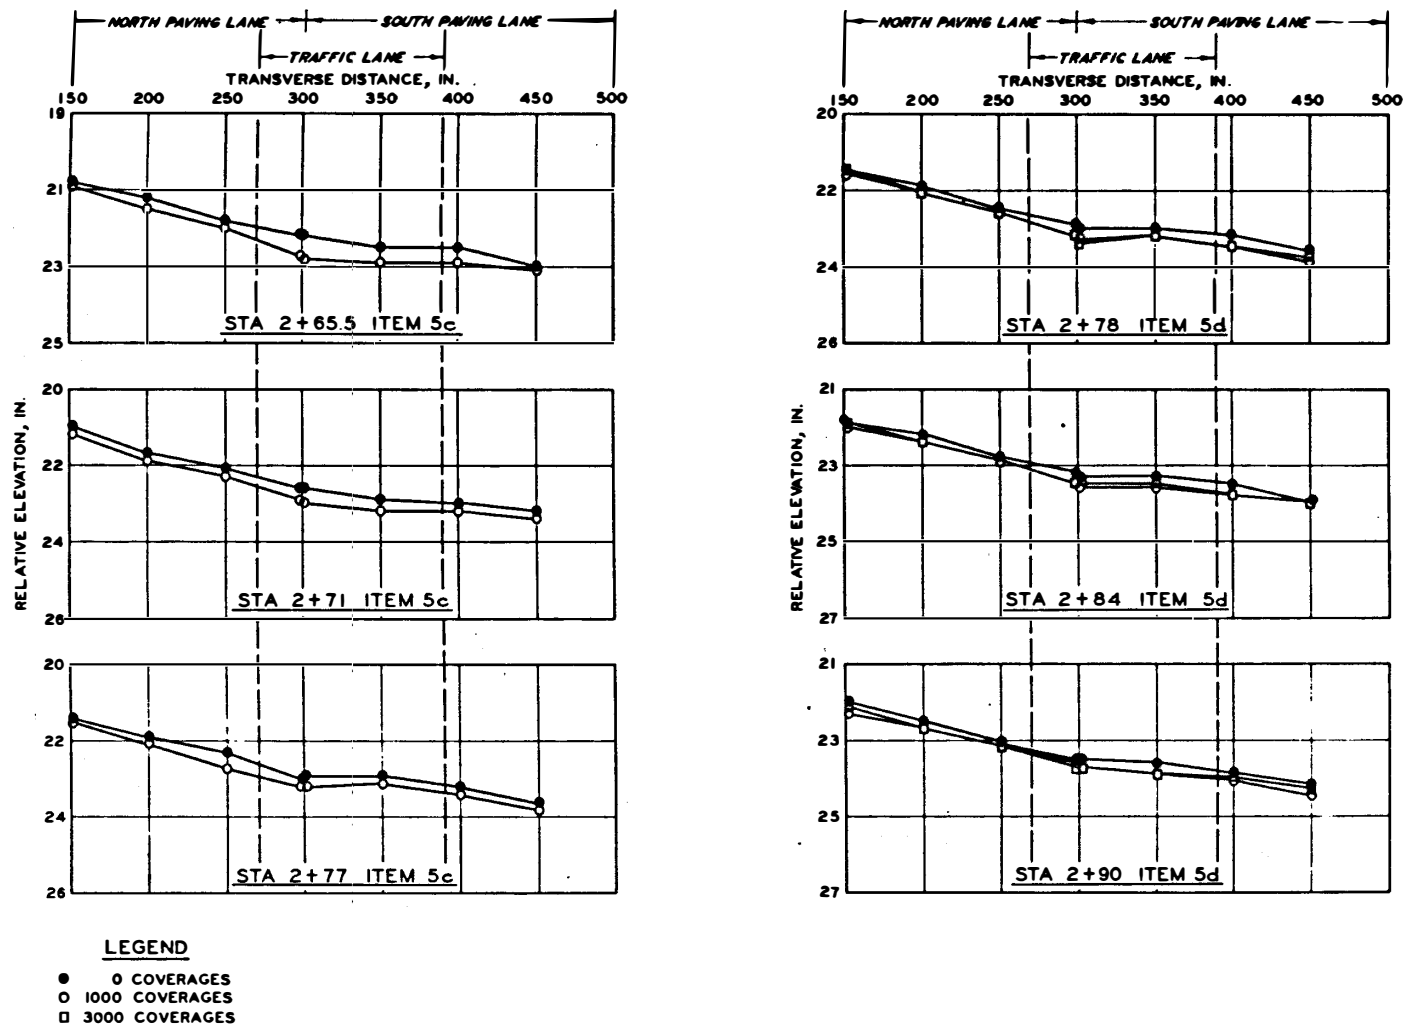
Figure A29. Surface deformation in subitems 5c and d, lane 1, rigid pavement test section

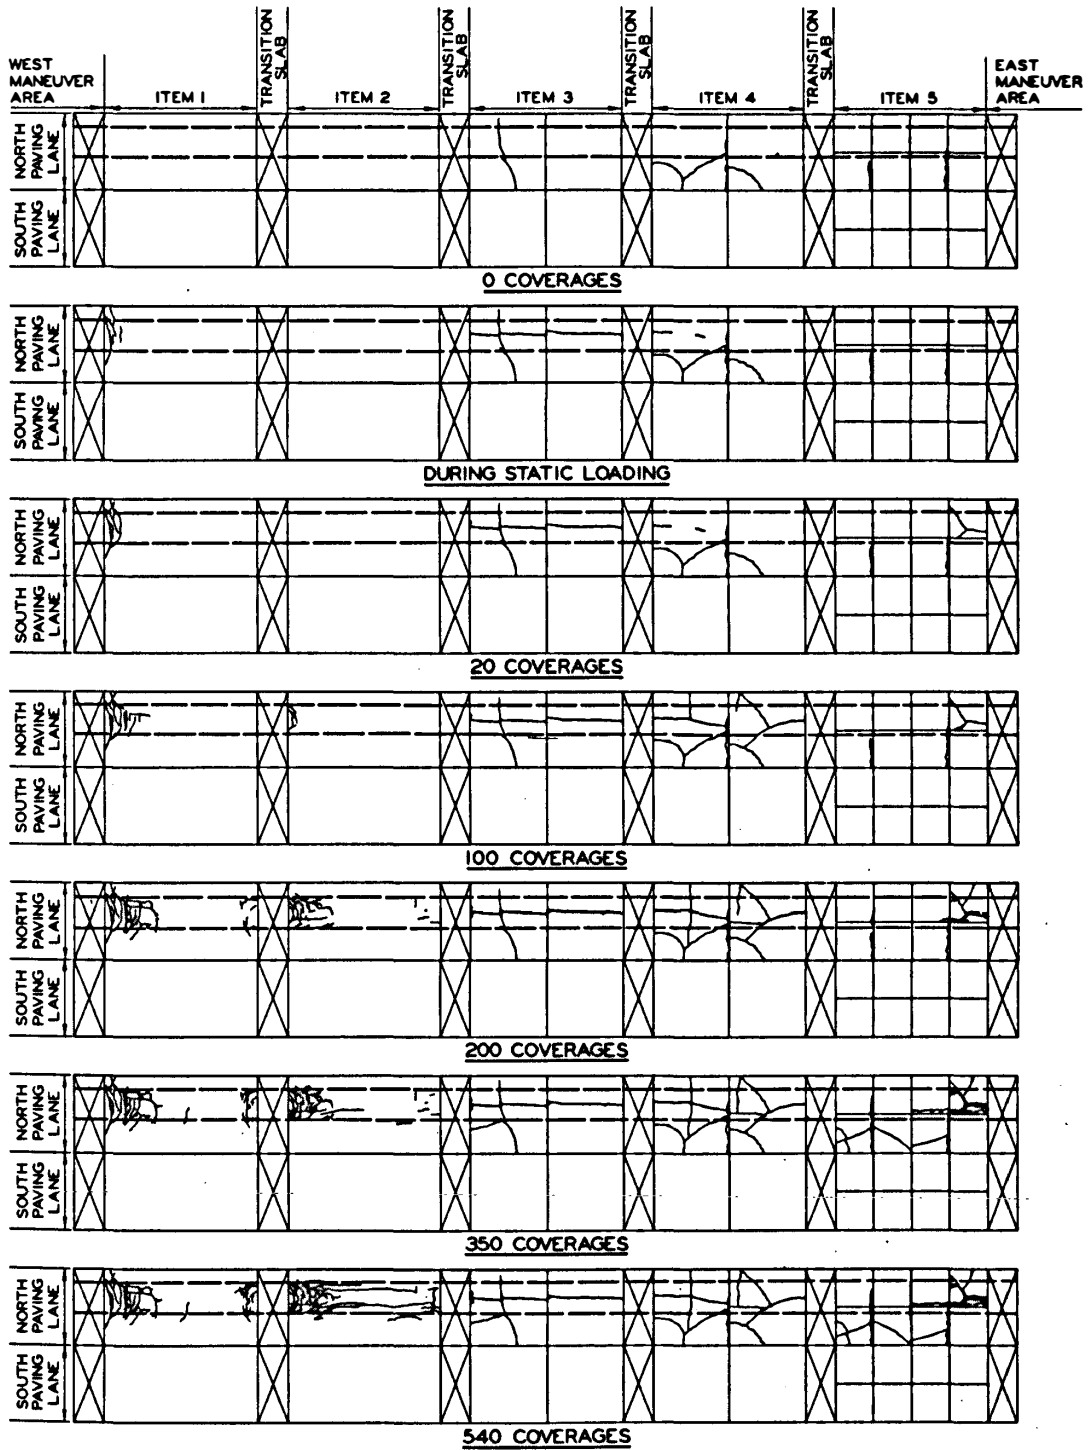
Figure A32. Crack development in lane 2, rigid pavement test section

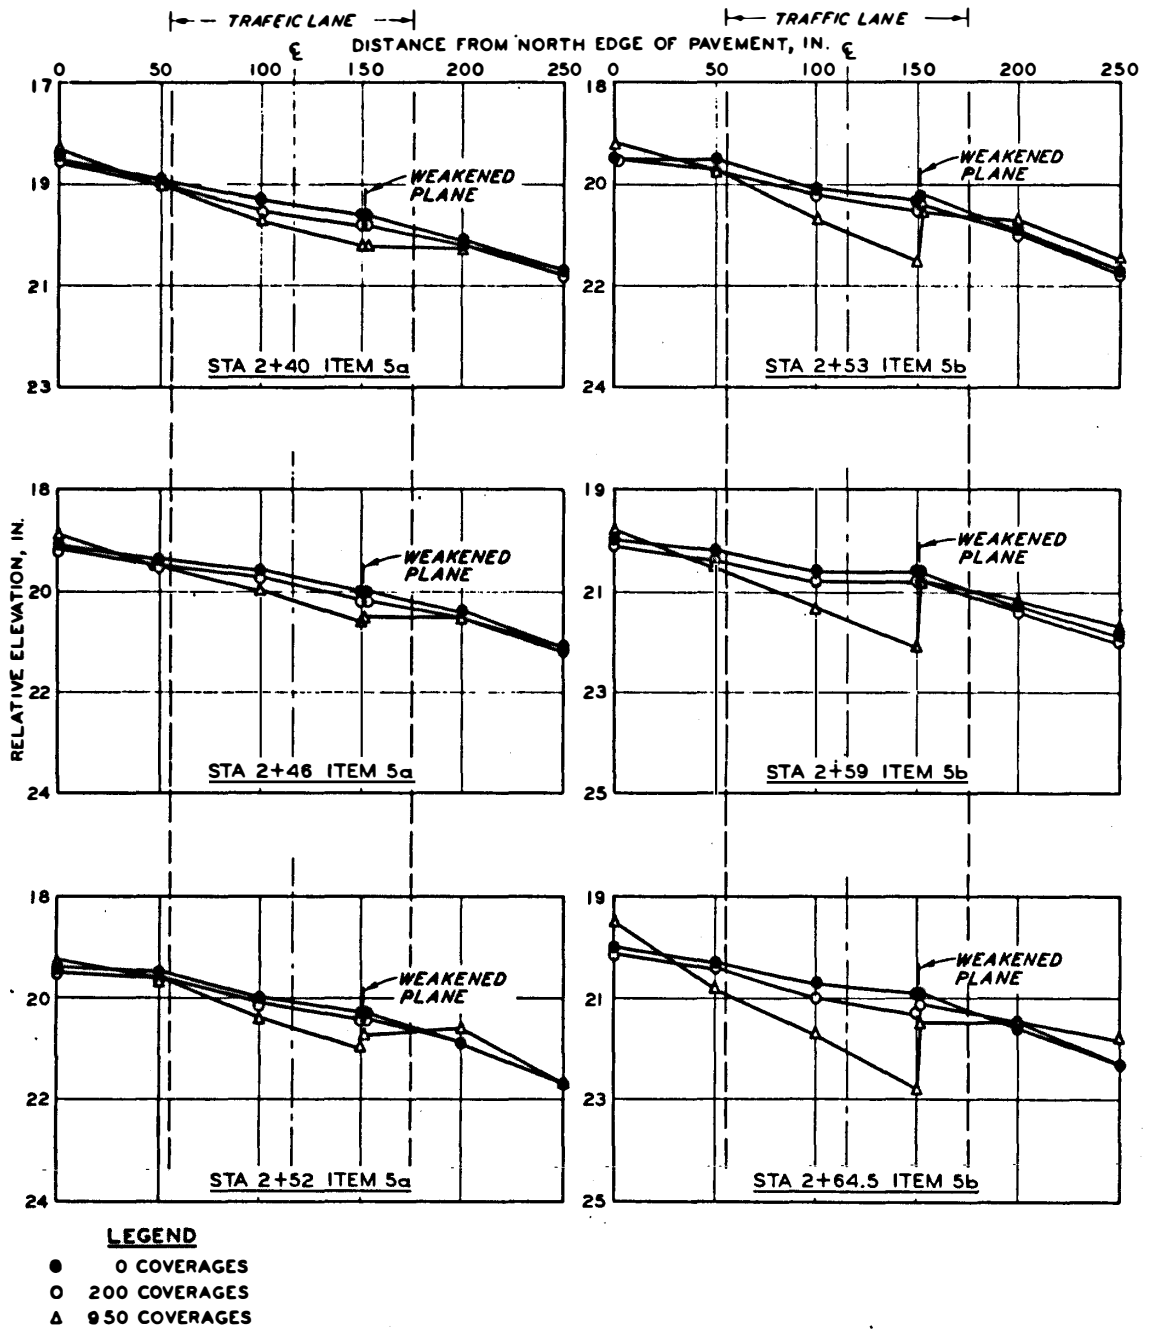
Figure A50. Surface deformation in subitems 5a and b, lane 2, rigid pavement test section

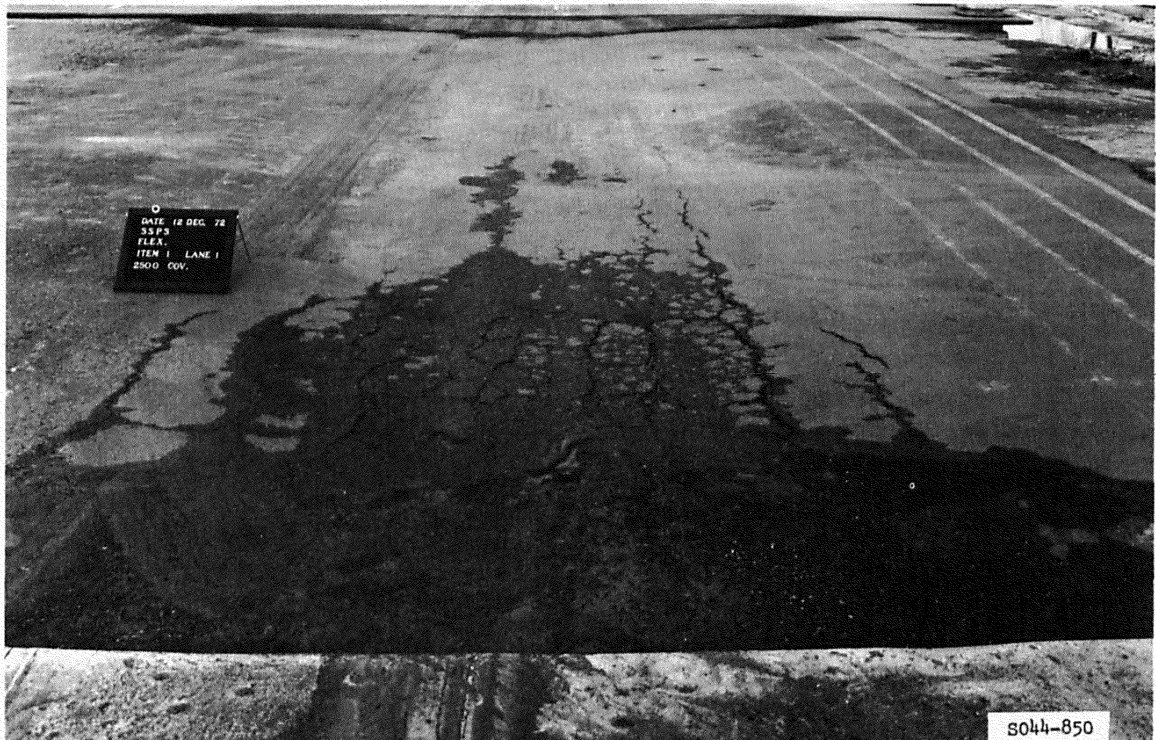
Figure B2. Cracking in western quarter of item 1, lane 1, flexible pavement test section, at 2500 coverages of 200-kip twin-tandem assembly

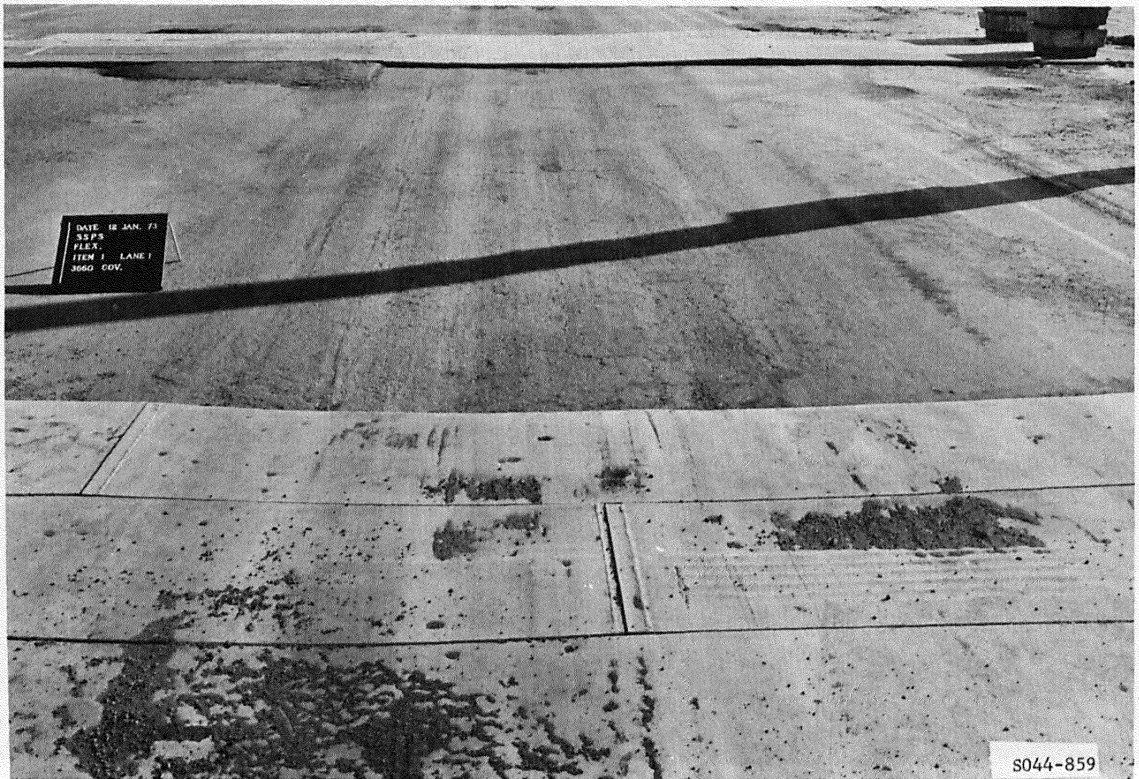
Figure B3. Cracking in eastern three-fourths of item 1, lane 1, flexible pavement test section, at 3660 coverages of 200-kip twin-tandem assembly

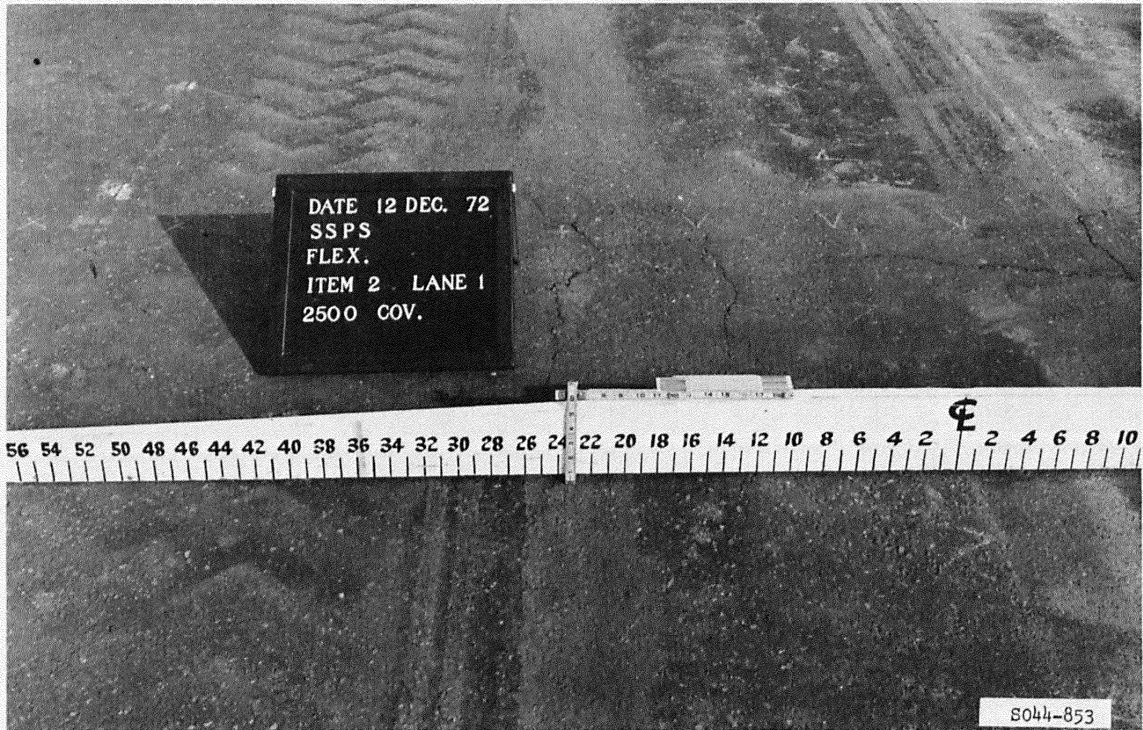
Figure B5. Cracking at instrumentation grid in item 2, lane 1, flexible pavement test section, at 2500 coverages of 200-kip twin-tandem assembly

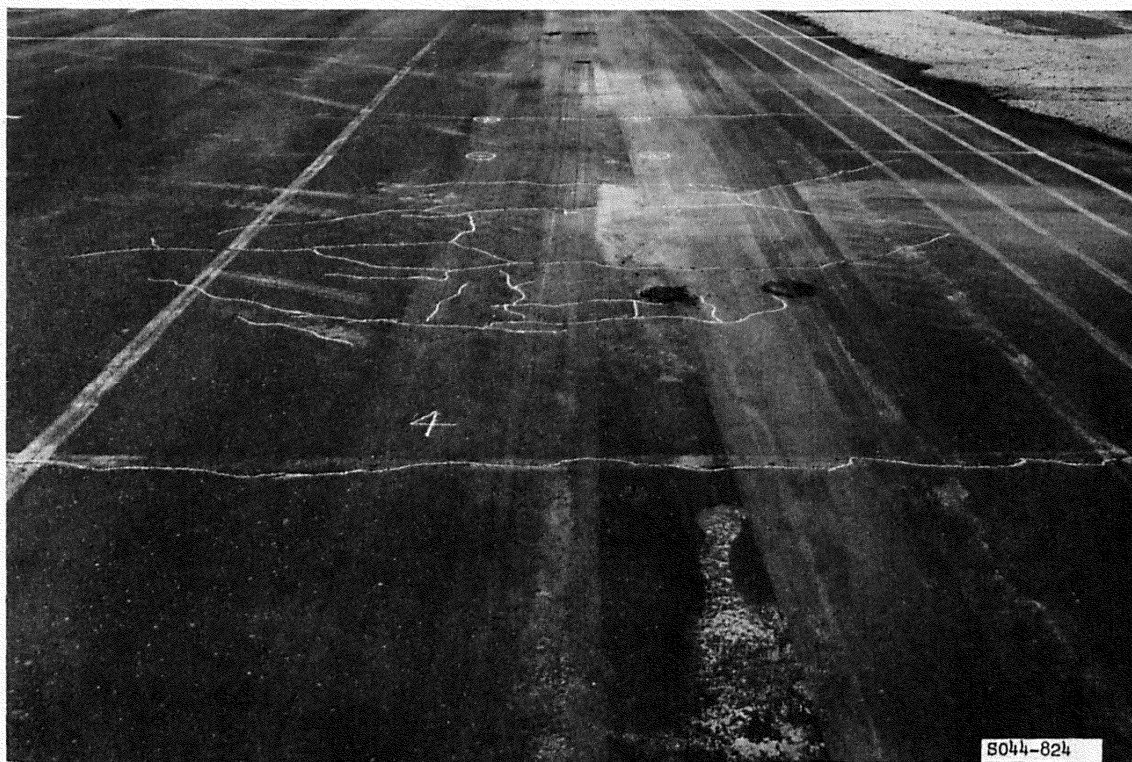
Figure B10. Cracking in item 4, lane 1, flexible pavement test section, after 1200 coverages of 200-kip twin-tandem assembly

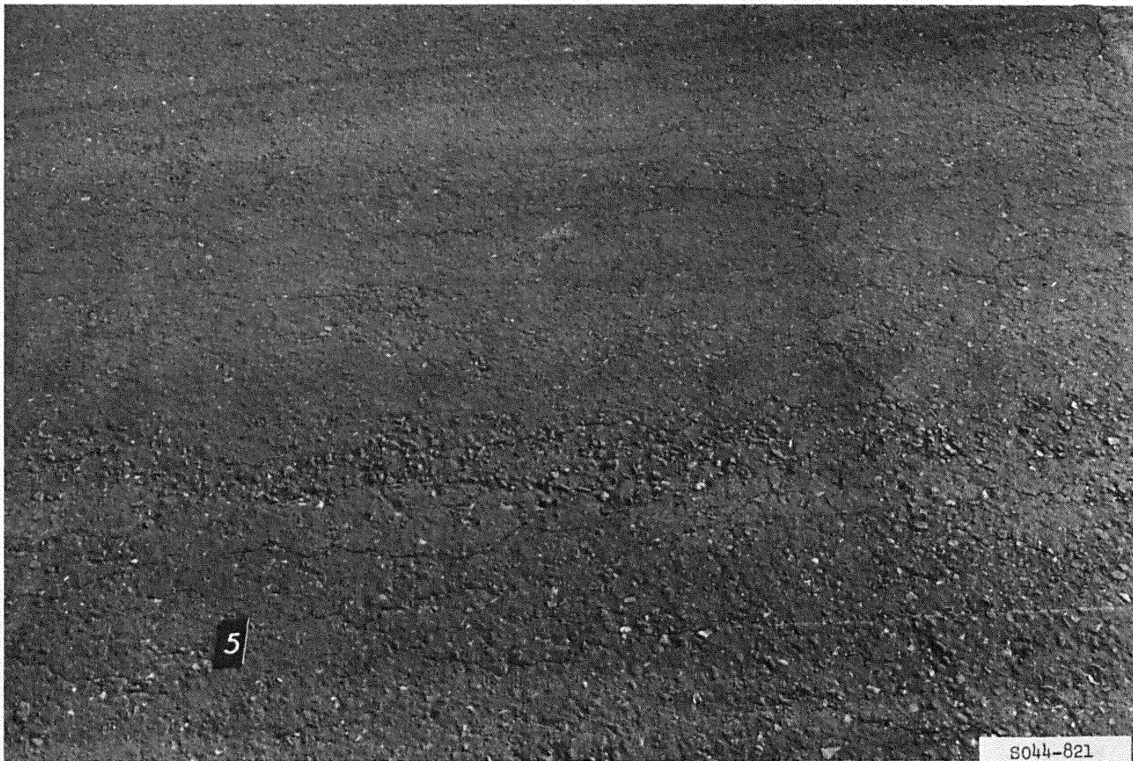
Figure B13. Cracking in item 5, lane 1, flexible pavement test section, after 1200 coverages of 200-kip twin-tandem assembly

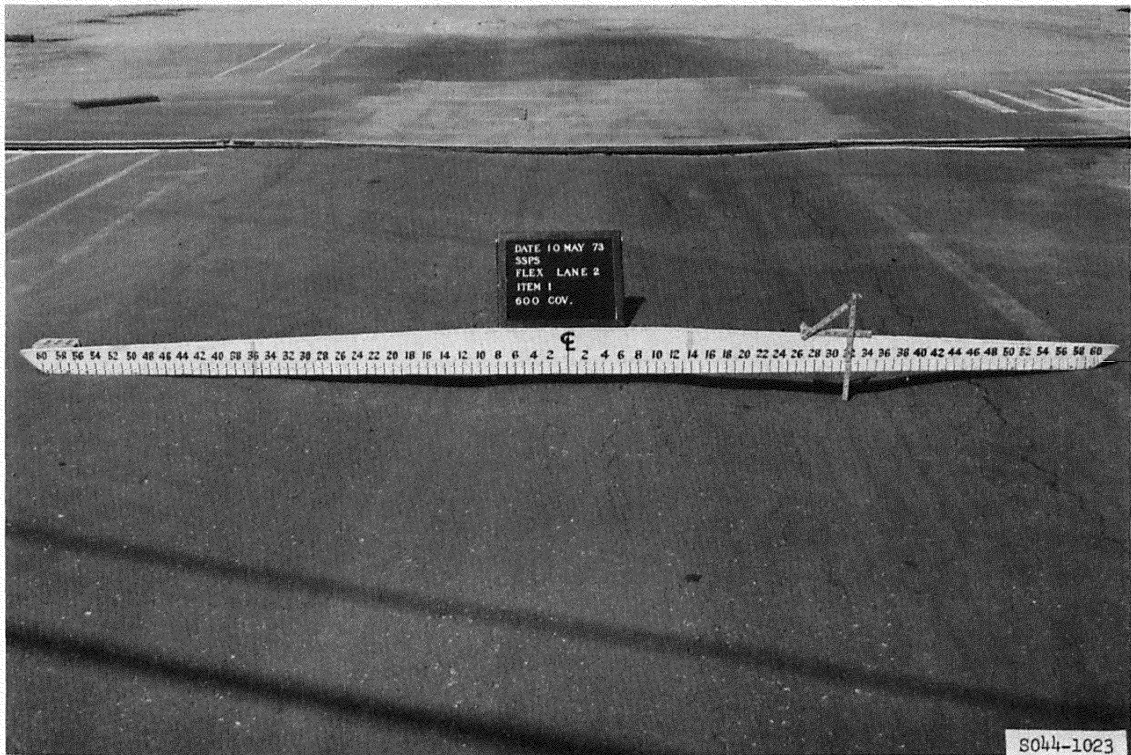
Figure B29. Cracking and deformation in item 1, lane 2, flexible pavement test section, after 600 coverages of 240-kip twin-tandem assembly

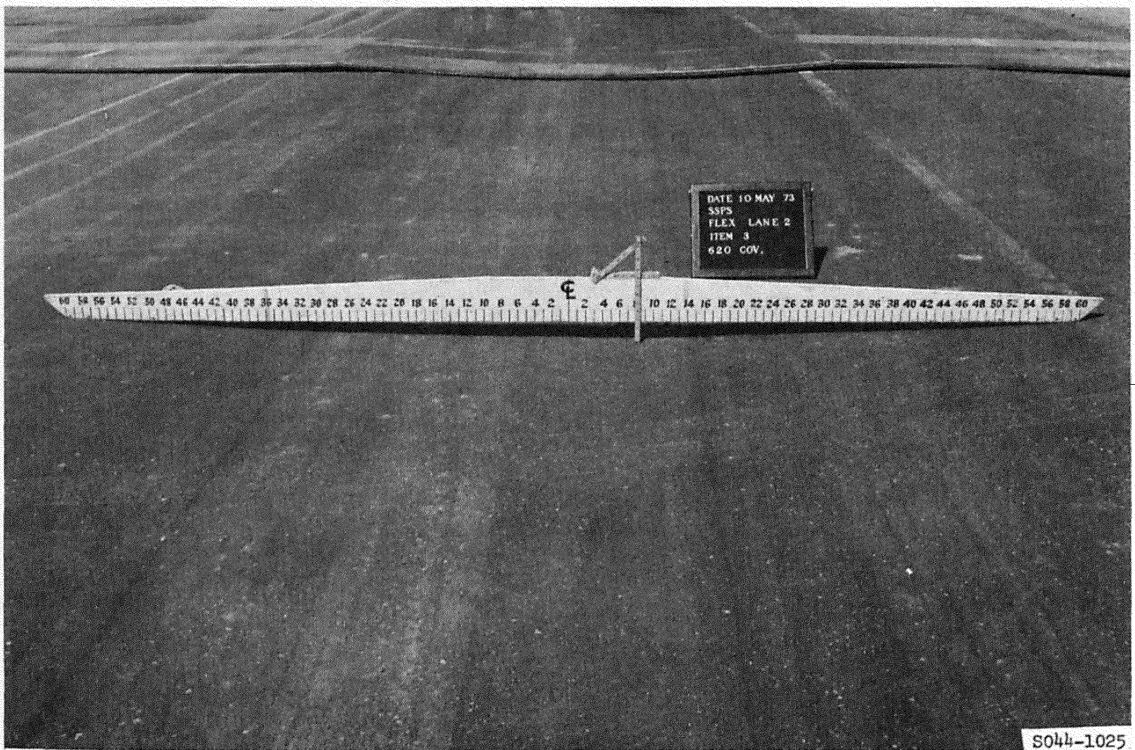
Figure B33. Deformation in item 3, lane 2, flexible pavement test section, at failure after 620 coverages of 240-kip twin-tandem assembly

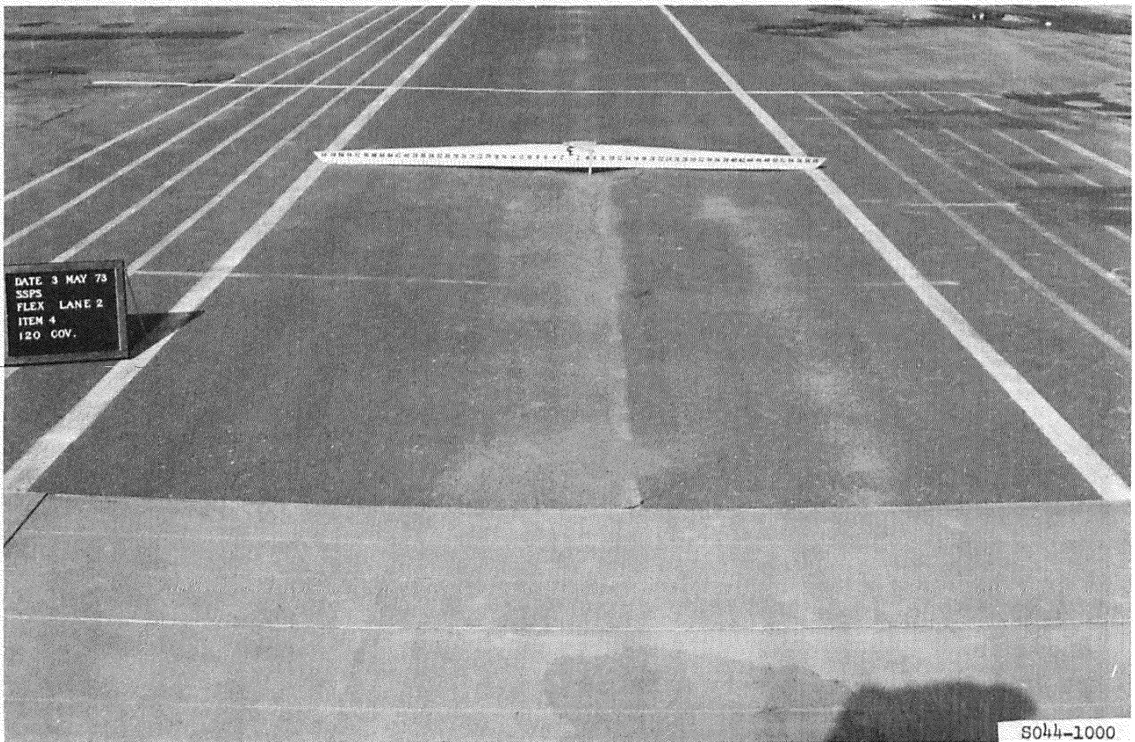
Figure B35. Cracking and deformation in item 4, lane 2, flexible pavement test section, at failure after 120 coverages of 240-kip twin-tandem assembly

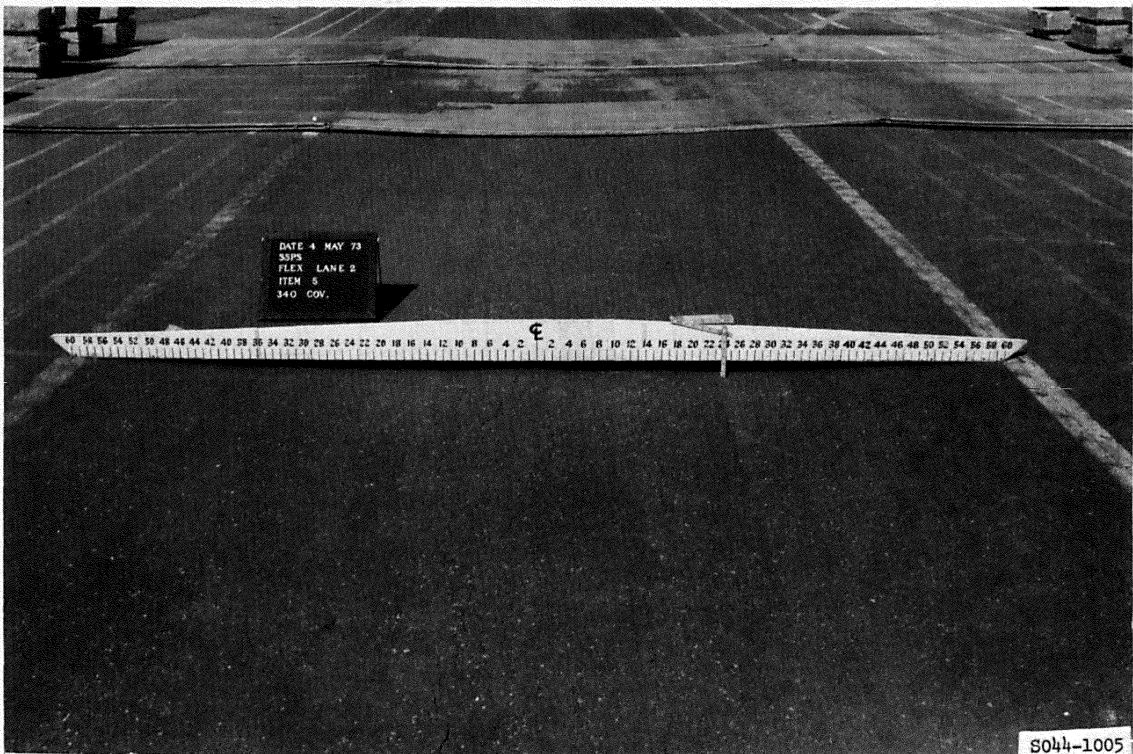
Figure B37. Cracking and deformation in item 5, lane 2, flexible pavement test section, at failure after 340 coverages of 240-kip twin-tandem assembly

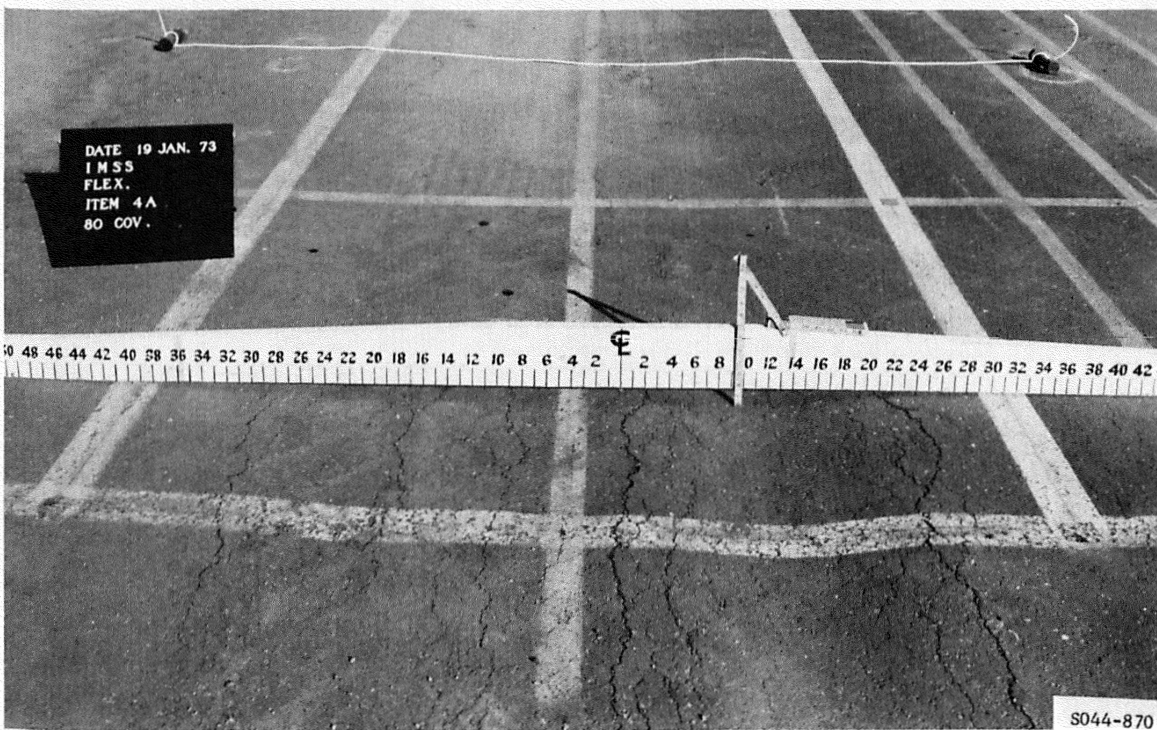
Figure B52. Cracking in subitem 4a, lane 3, flexible pavement test section, after 80 coverages of 50-kip single-wheel assembly

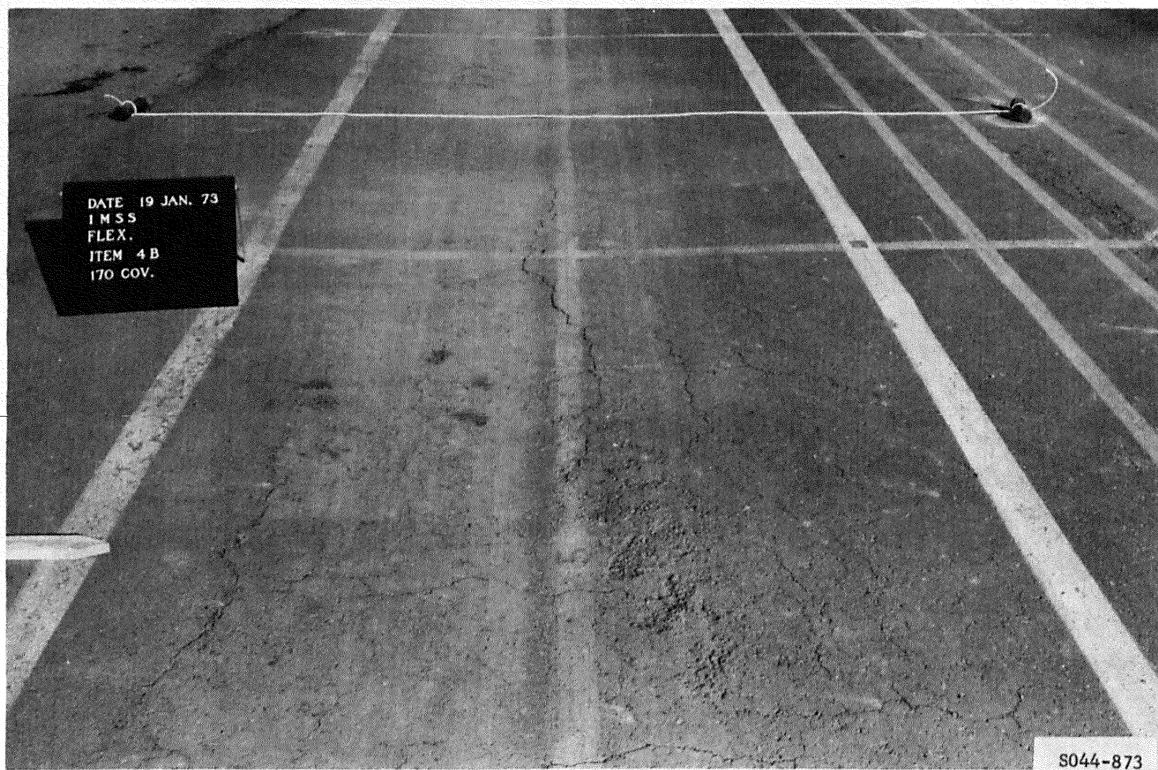
Figure B54. Cracking and deformation in subitem 4b, lane 3, flexible pavement test section, at failure after 170 coverages of 50-kip single-wheel assembly

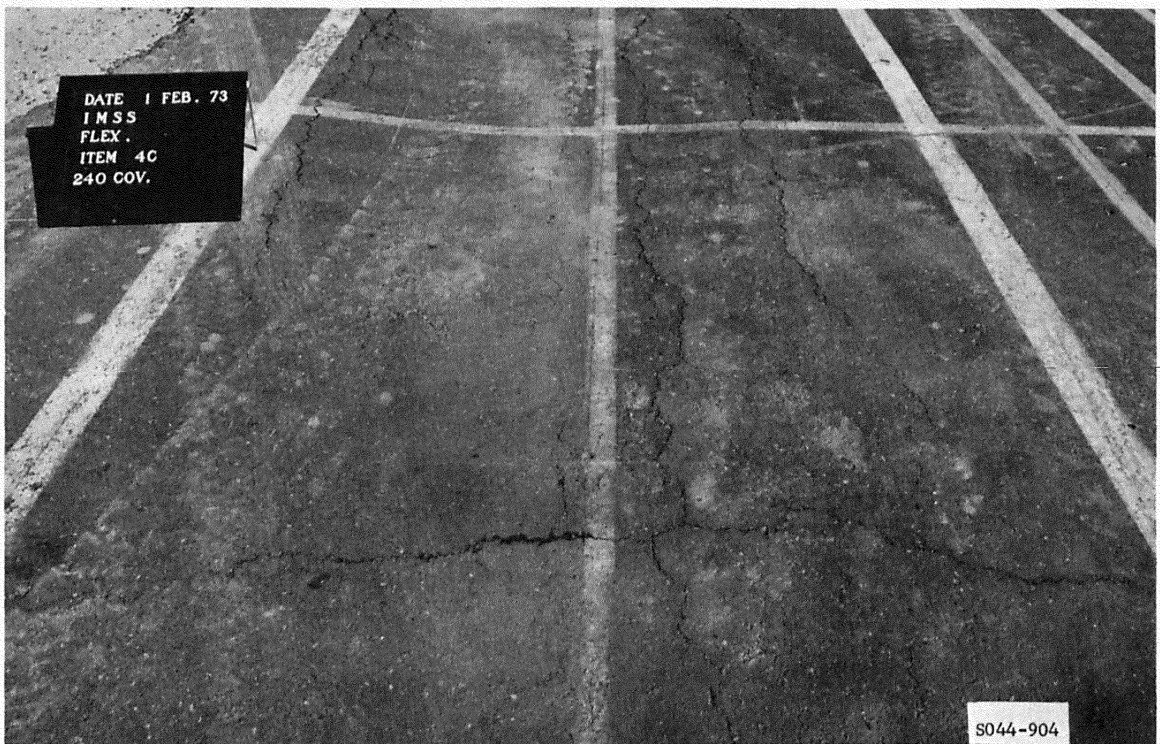
Figure B56. Cracking in subitem 4c, lane 3, flexible pavement test section, at failure after 240 coverages of 50-kip single-wheel assembly

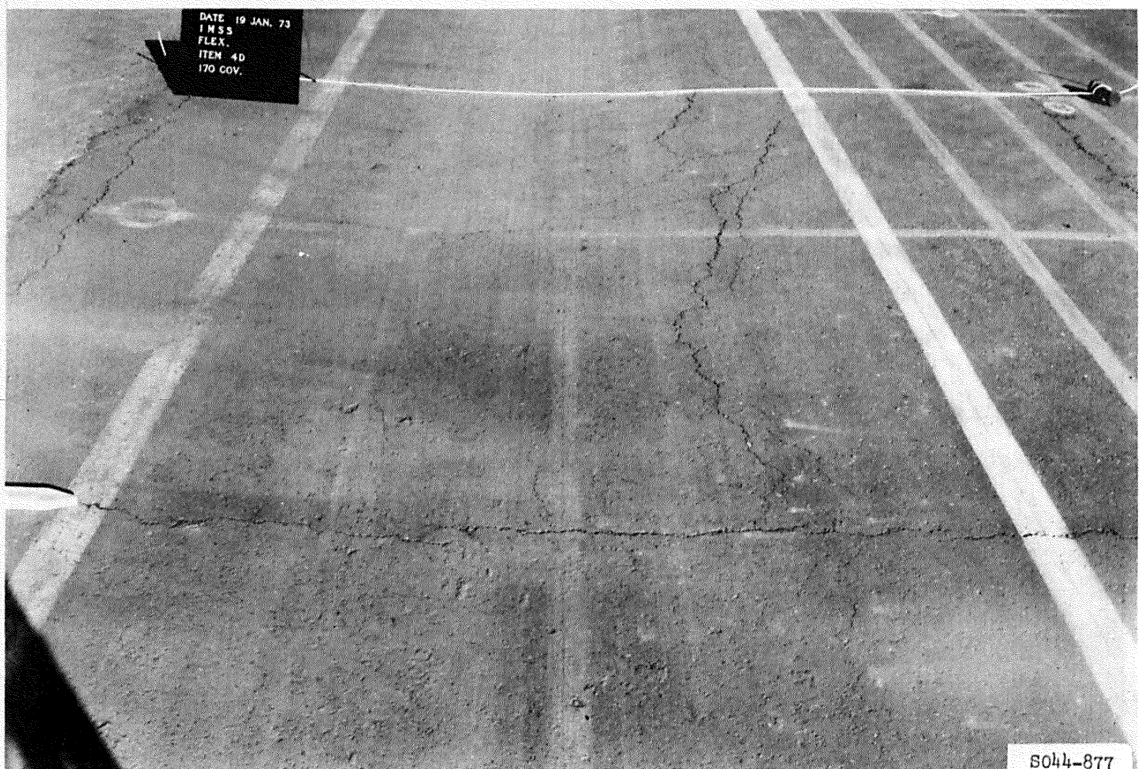
Figure B58. Cracking in subitem 4d, lane 3, flexible pavement test section, at 170 coverages of 50-kip single-wheel assembly

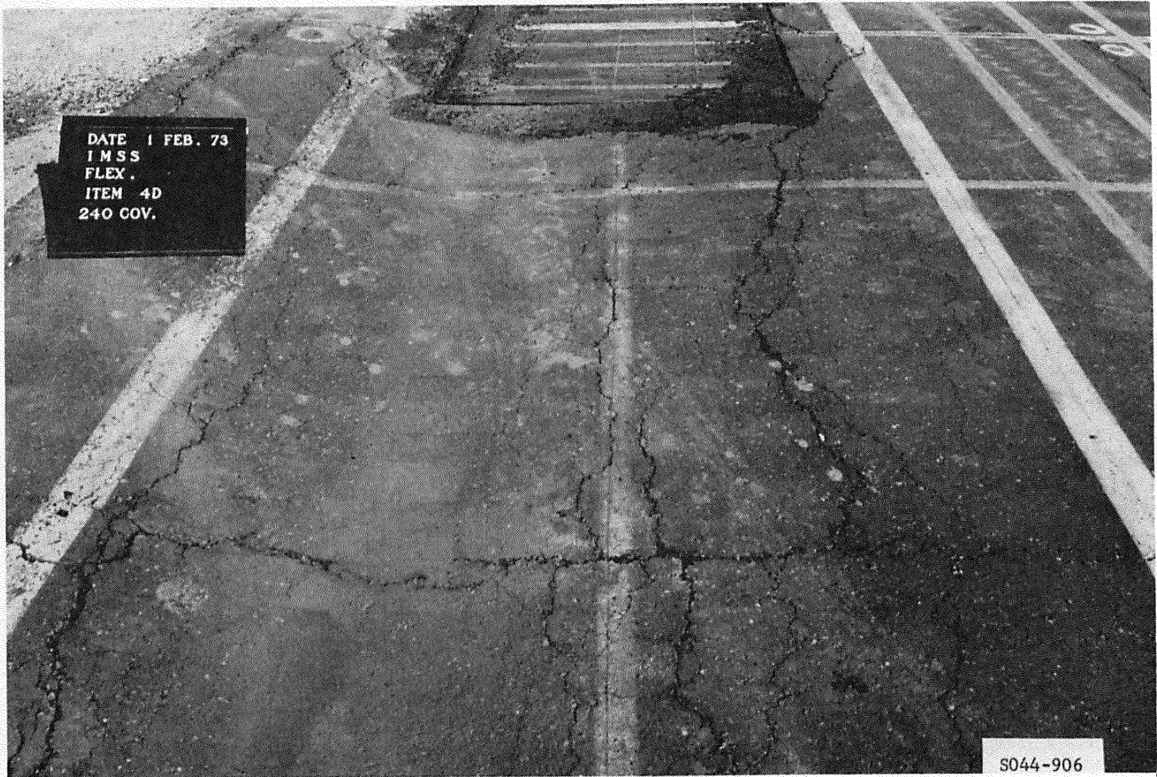
Figure B59. Cracking in subitem 4d, lane 3, flexible pavement test section, at failure after 240 coverages of 50-kip single-wheel assembly

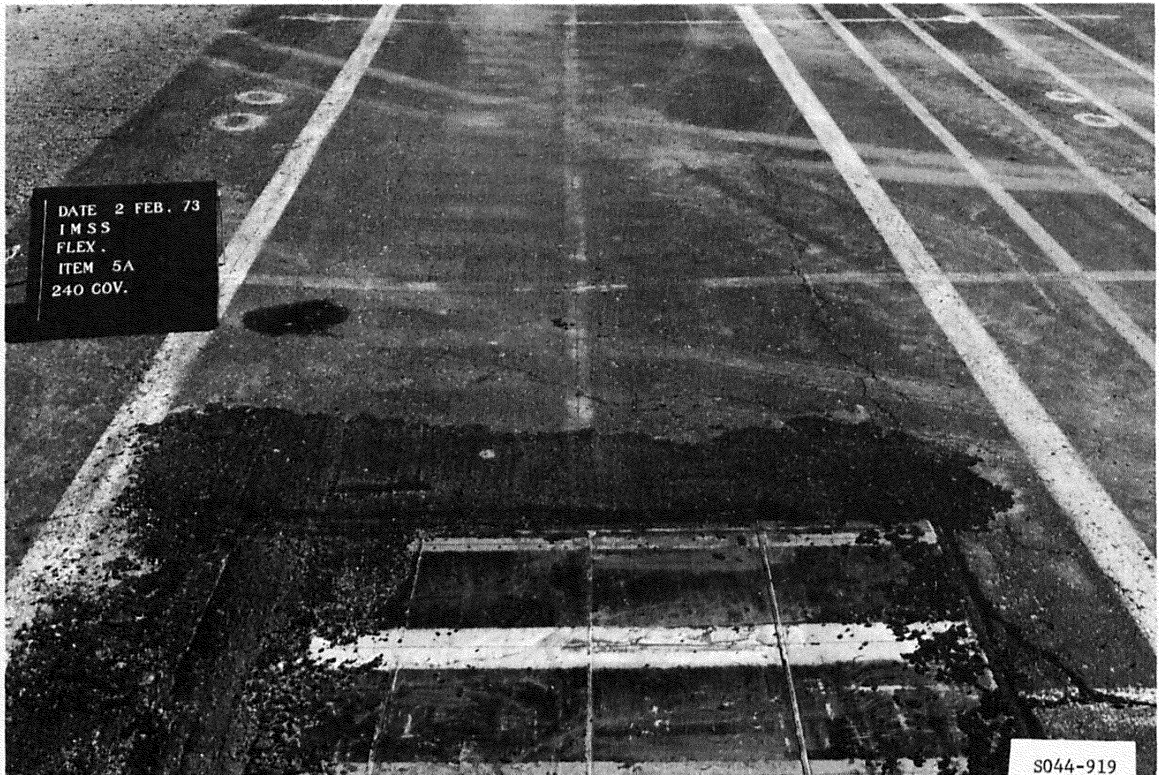
Figure B61. Cracking in subitem 5a, lane 3, flexible pavement test section, at failure after 240 coverages of 50-kip single-wheel assembly

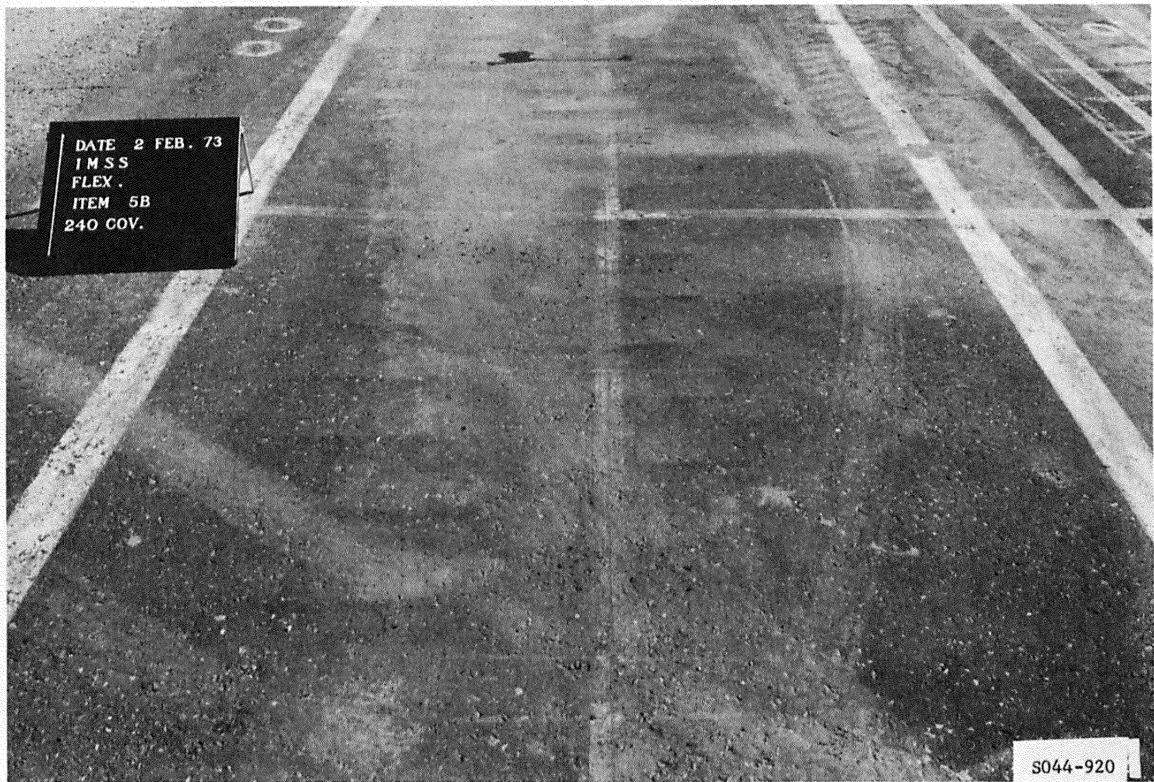
Figure B63. Subitem 5b, lane 3, flexible pavement test section, at failure after 240 coverages of 50-kip single-wheel assembly
