TECHNICAL REPORT S-74-8

COMPARATIVE PERFORMANCE OF STRUCTURAL LAYERS IN PAVEMENT SYSTEMS

DESIGN, CONSTRUCTION, AND BEHAVIOR UNDER TRAFFIC OF PAVEMENT TEST SECTIONS

U. S. Army Engineer Waterways Experiment Station

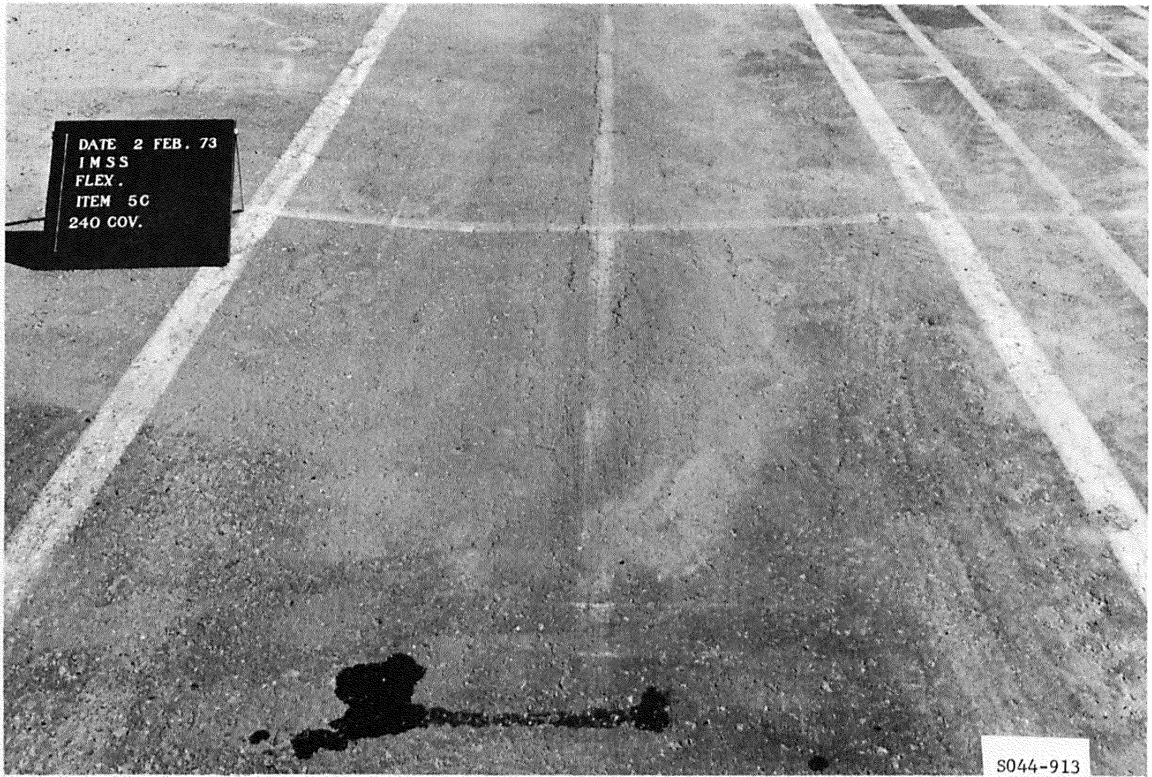
Figure B65. Cracking in subitem 5c, lane 3, flexible pavement test section, at failure after 240 coverages of 50-kip single-wheel assembly

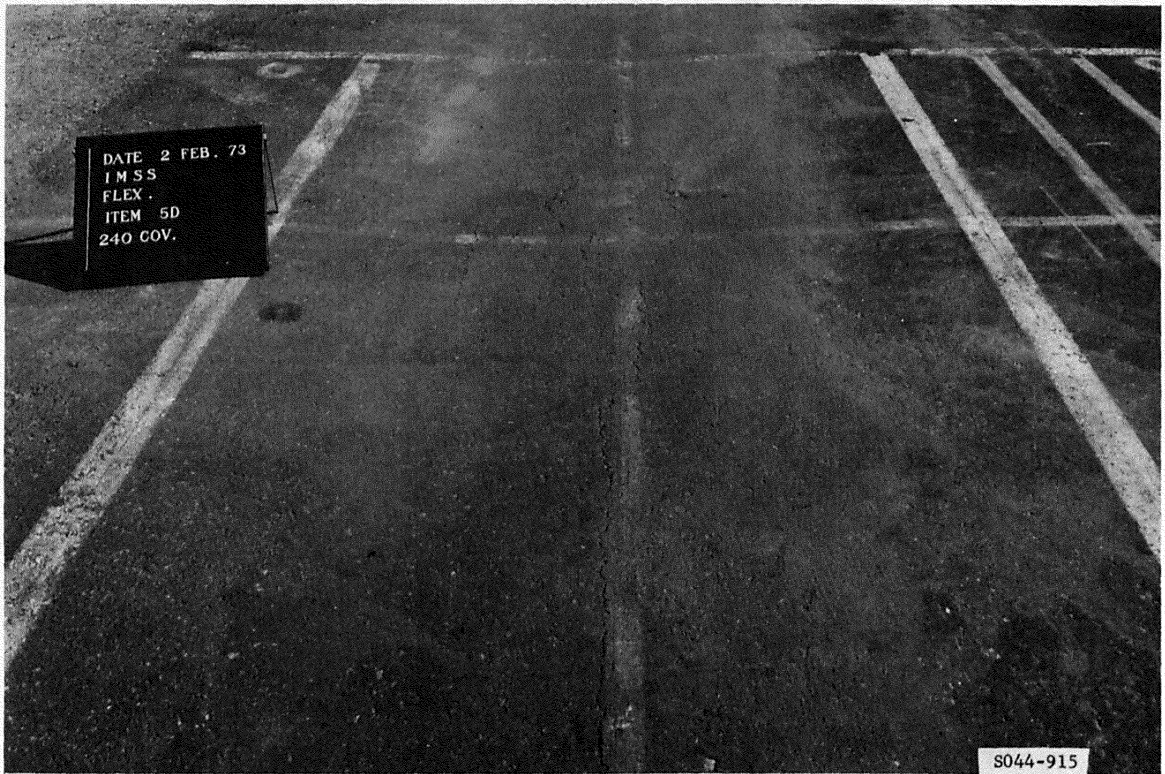
Figure B67. Cracking in subitem 5d, lane 3, flexible pavement test section, at failure after 240 coverages

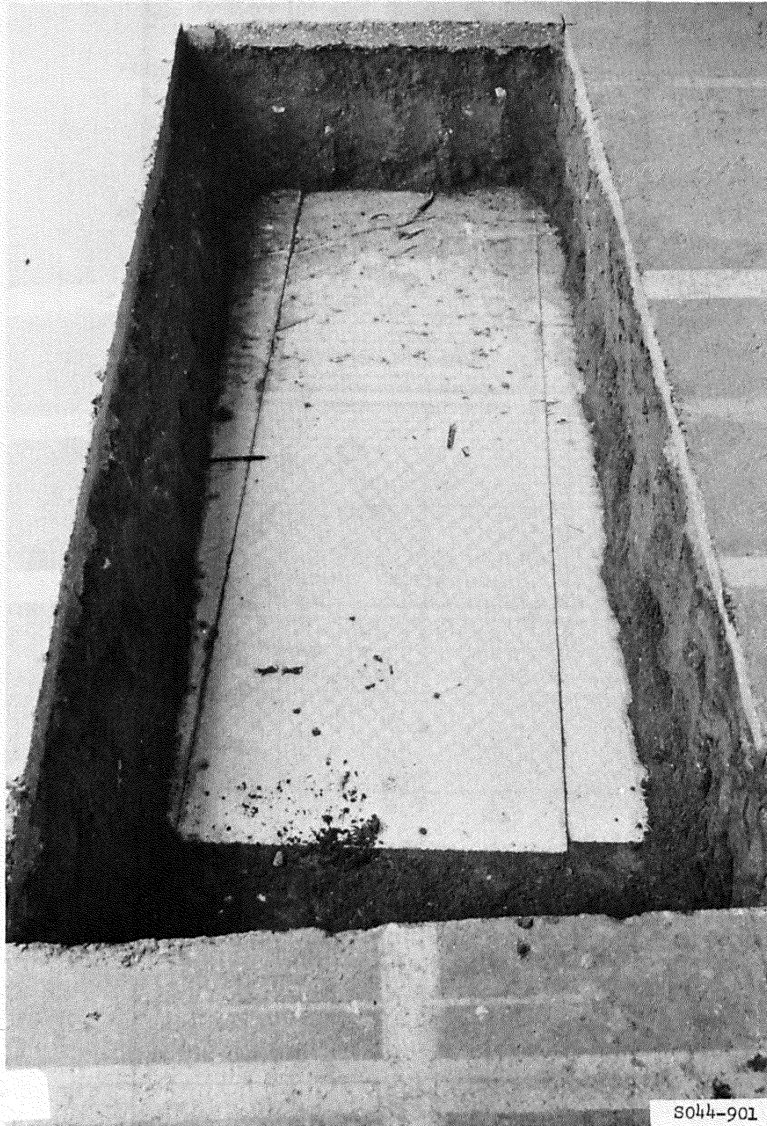
Figure B78. Cracks in polystyrene panels in subitem 4a, lane 3, flexible pavement test section, after traffic

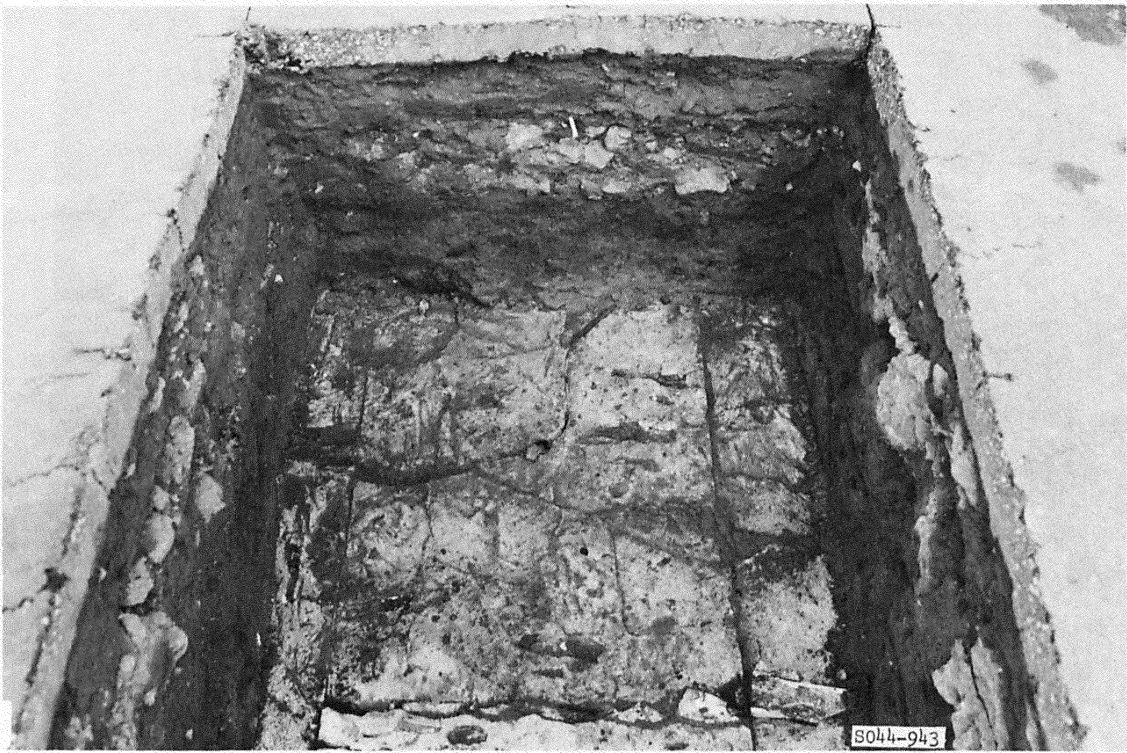
Figure B79. Cracks in polystyrene panels in subitem 4b, lane 3, flexible pavement test section, after traffic

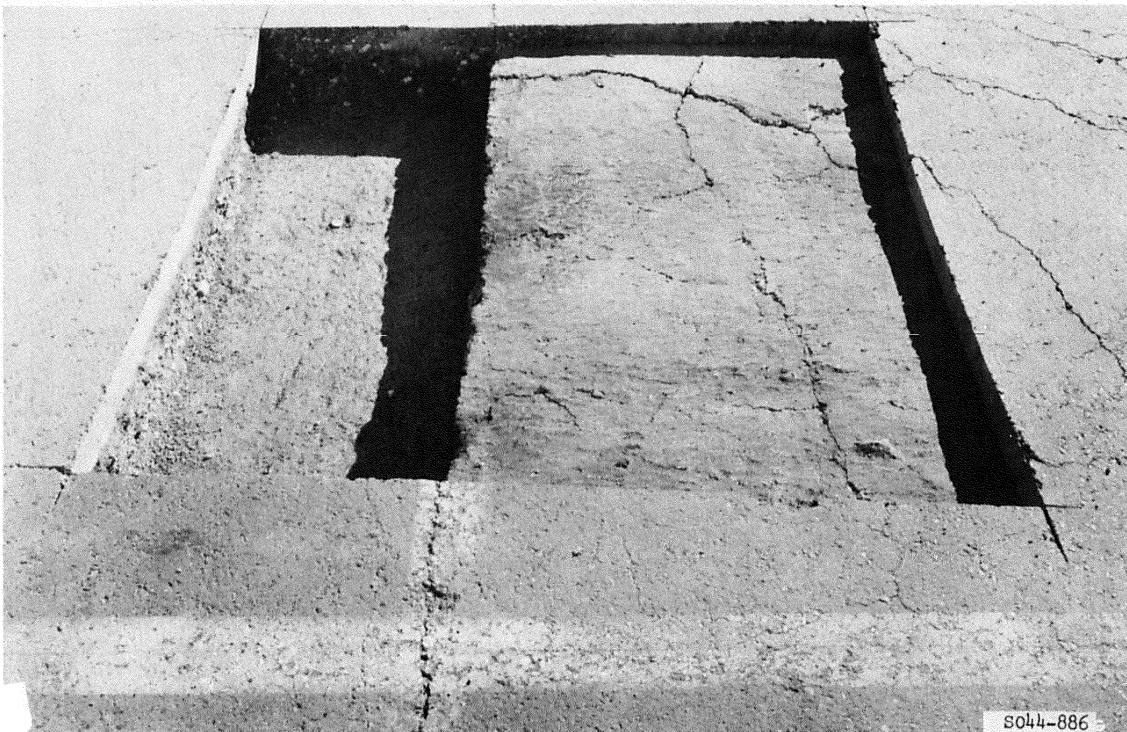
Figure B80. Cracks in lightweight concrete in subitems 4d and 5a, lane 3, flexible pavement test section, after 170 coverages of 50-kip load
