MISCELLANEOUS PAPER S-68-22

A STUDY OF THE CONDITION OF PIEZOMETERS IN THE 1949 INSTALLATION AT REID-BEDFORD, LOUISIANA

November 1968

U. S. Army Engineer Waterways Experiment Station
CORPS OF ENGINEERS
Vicksburg, Mississippi

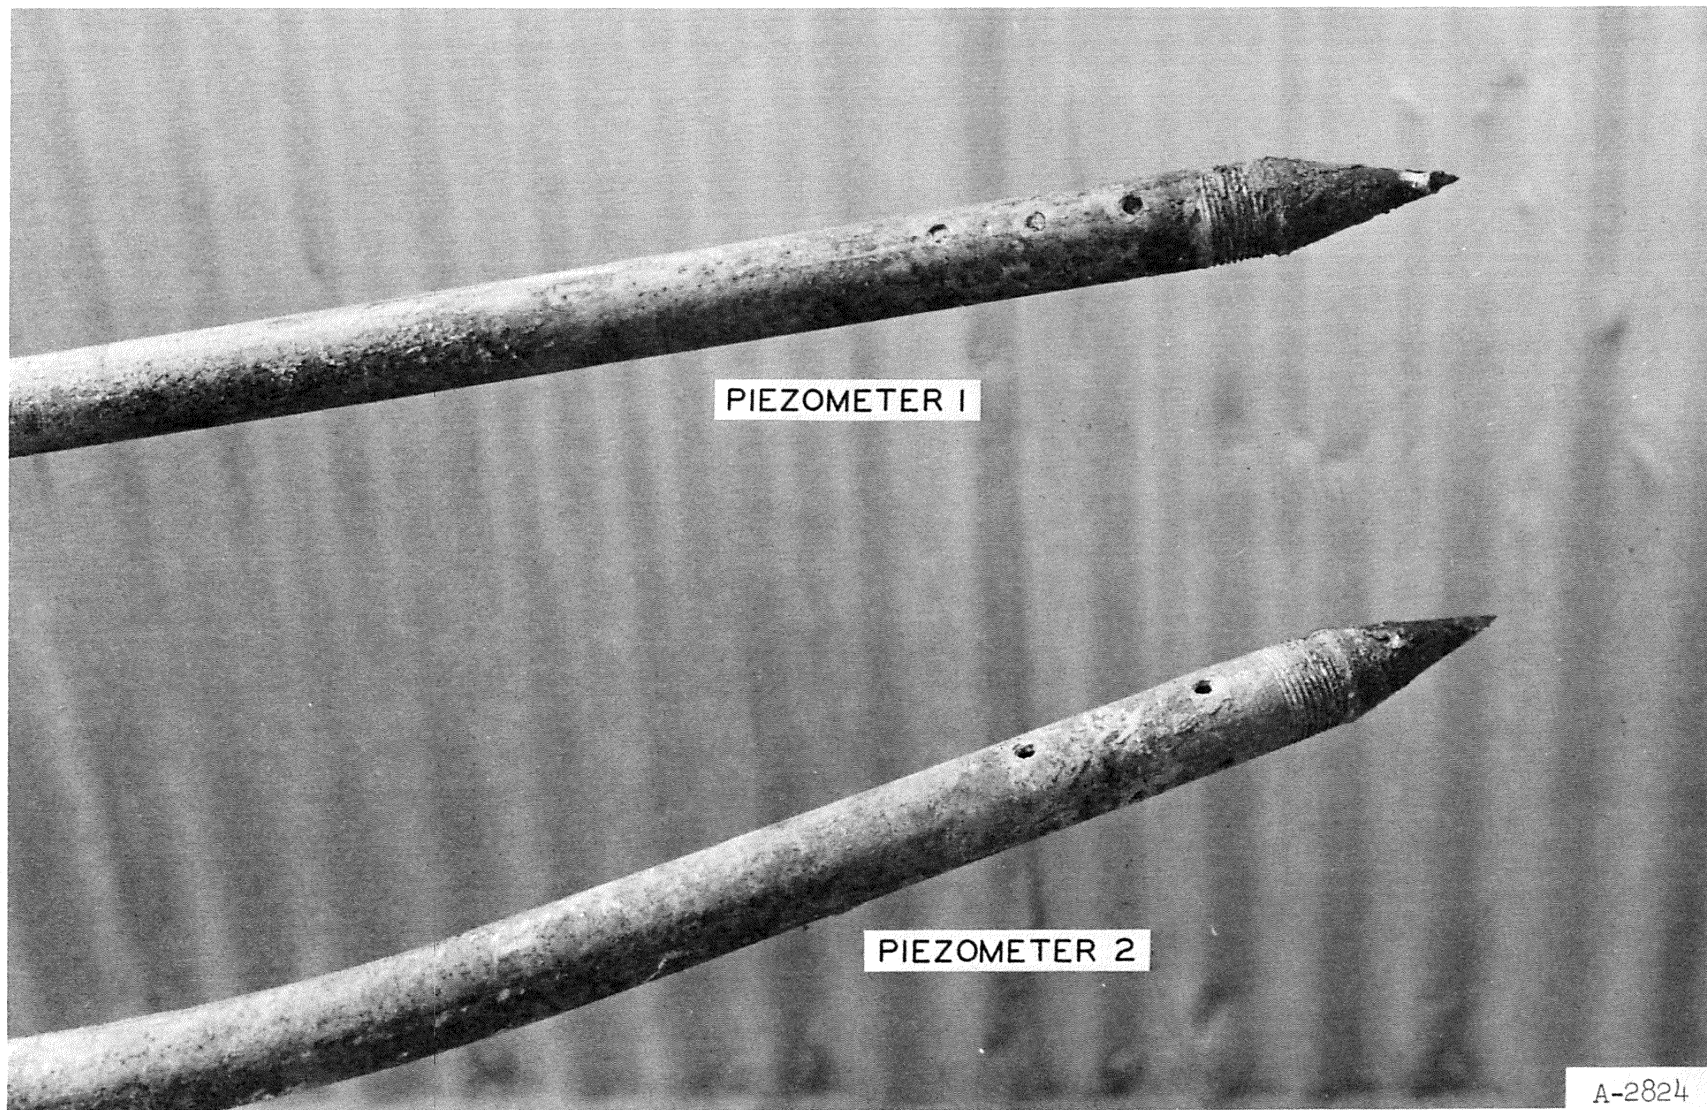
20. Drive point piezometers 1 and 2 were found to be completely clogged. In the 1949 study these two piezometers were operated as closed systems and consistently showed pressures indicating water elevations at or above the natural ground surface (approximately el 82). At the time, the high readings were attributed to an accumulation of gas in the piezometers. It is probable that these piezometers became clogged during driving and have never functioned properly. The other two drive point piezometers, 14 and 15, were found to be partially clogged, although piezometer 15 gave readings only slightly higher than the piezometers considered to be still giving satisfactory data. It was noted in the 1949 study that piezometers 14 and 15 were very slow in reacting to changes in hydrostatic pressure as compared to the reactions of the other open-system piezometers. It is probable that these piezometers have also been clogged to some extent ever since installation.

Photograph 1. U. S. Bureau of Reclamation drive point piezometers 1 and 2

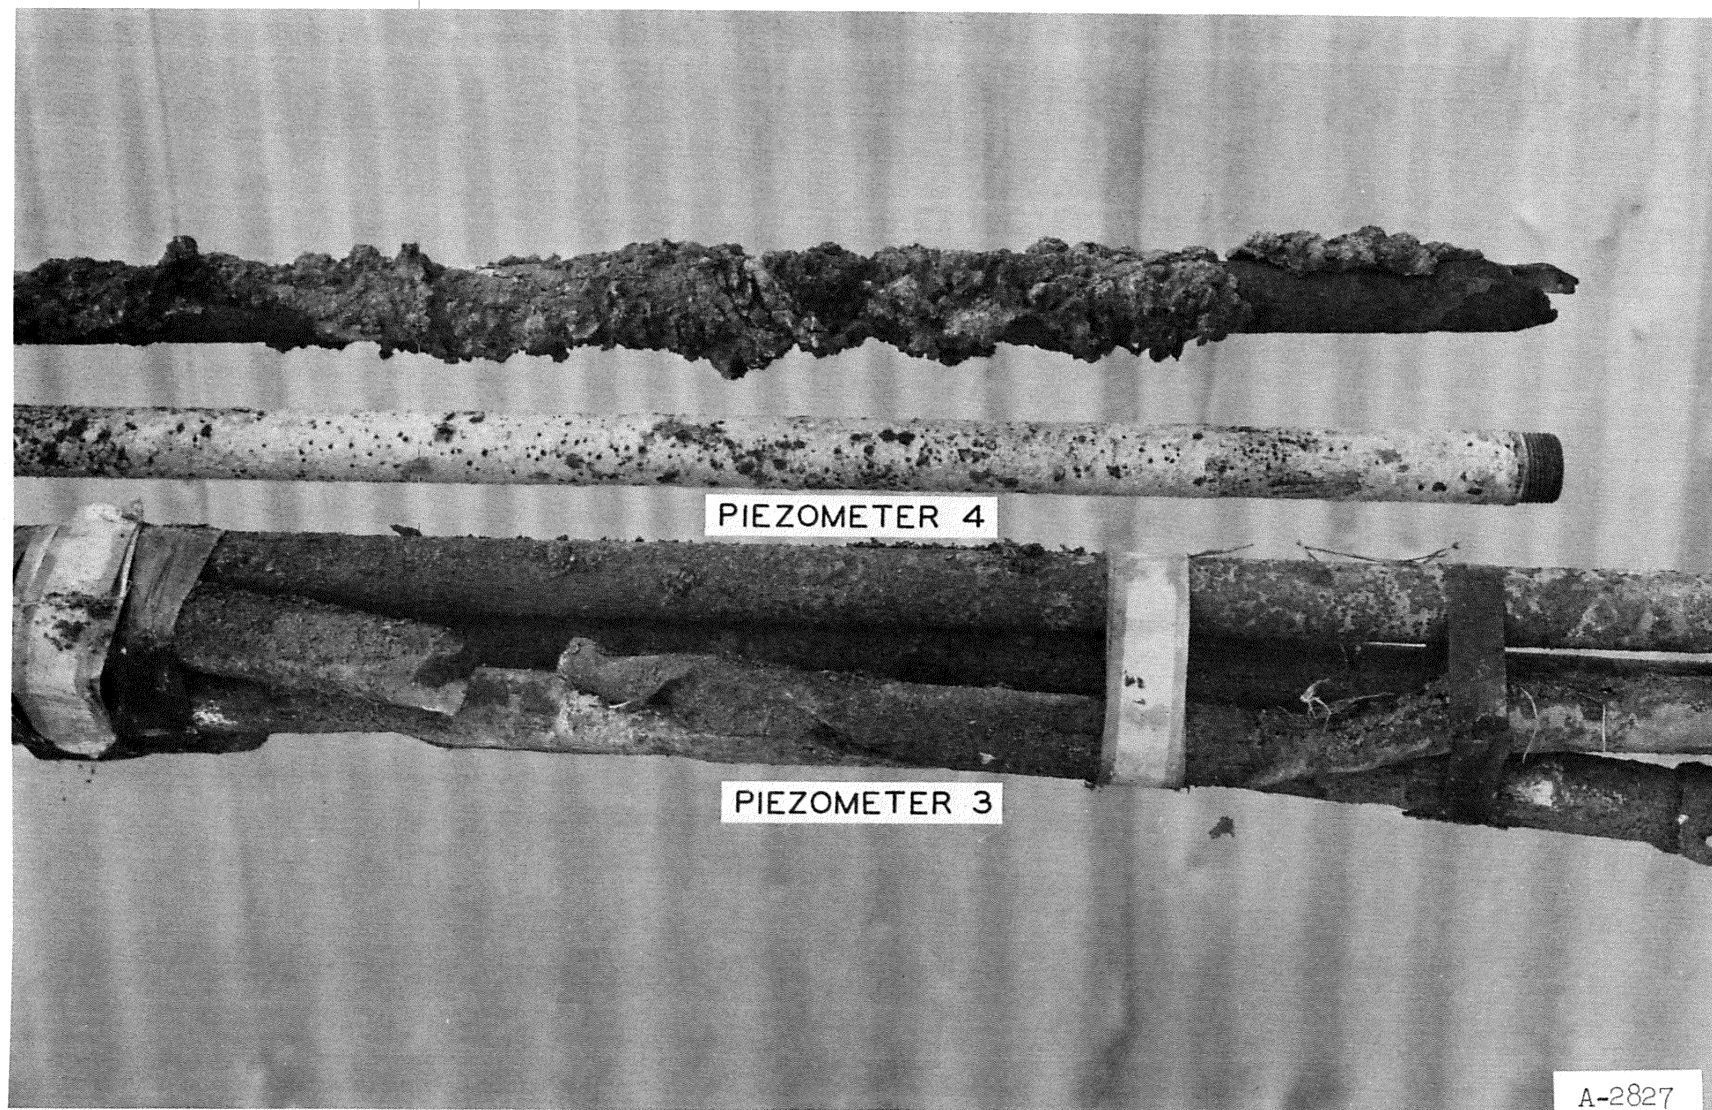
Photograph 2. Standpipes from Cherry Creek piezometers 3 and 4

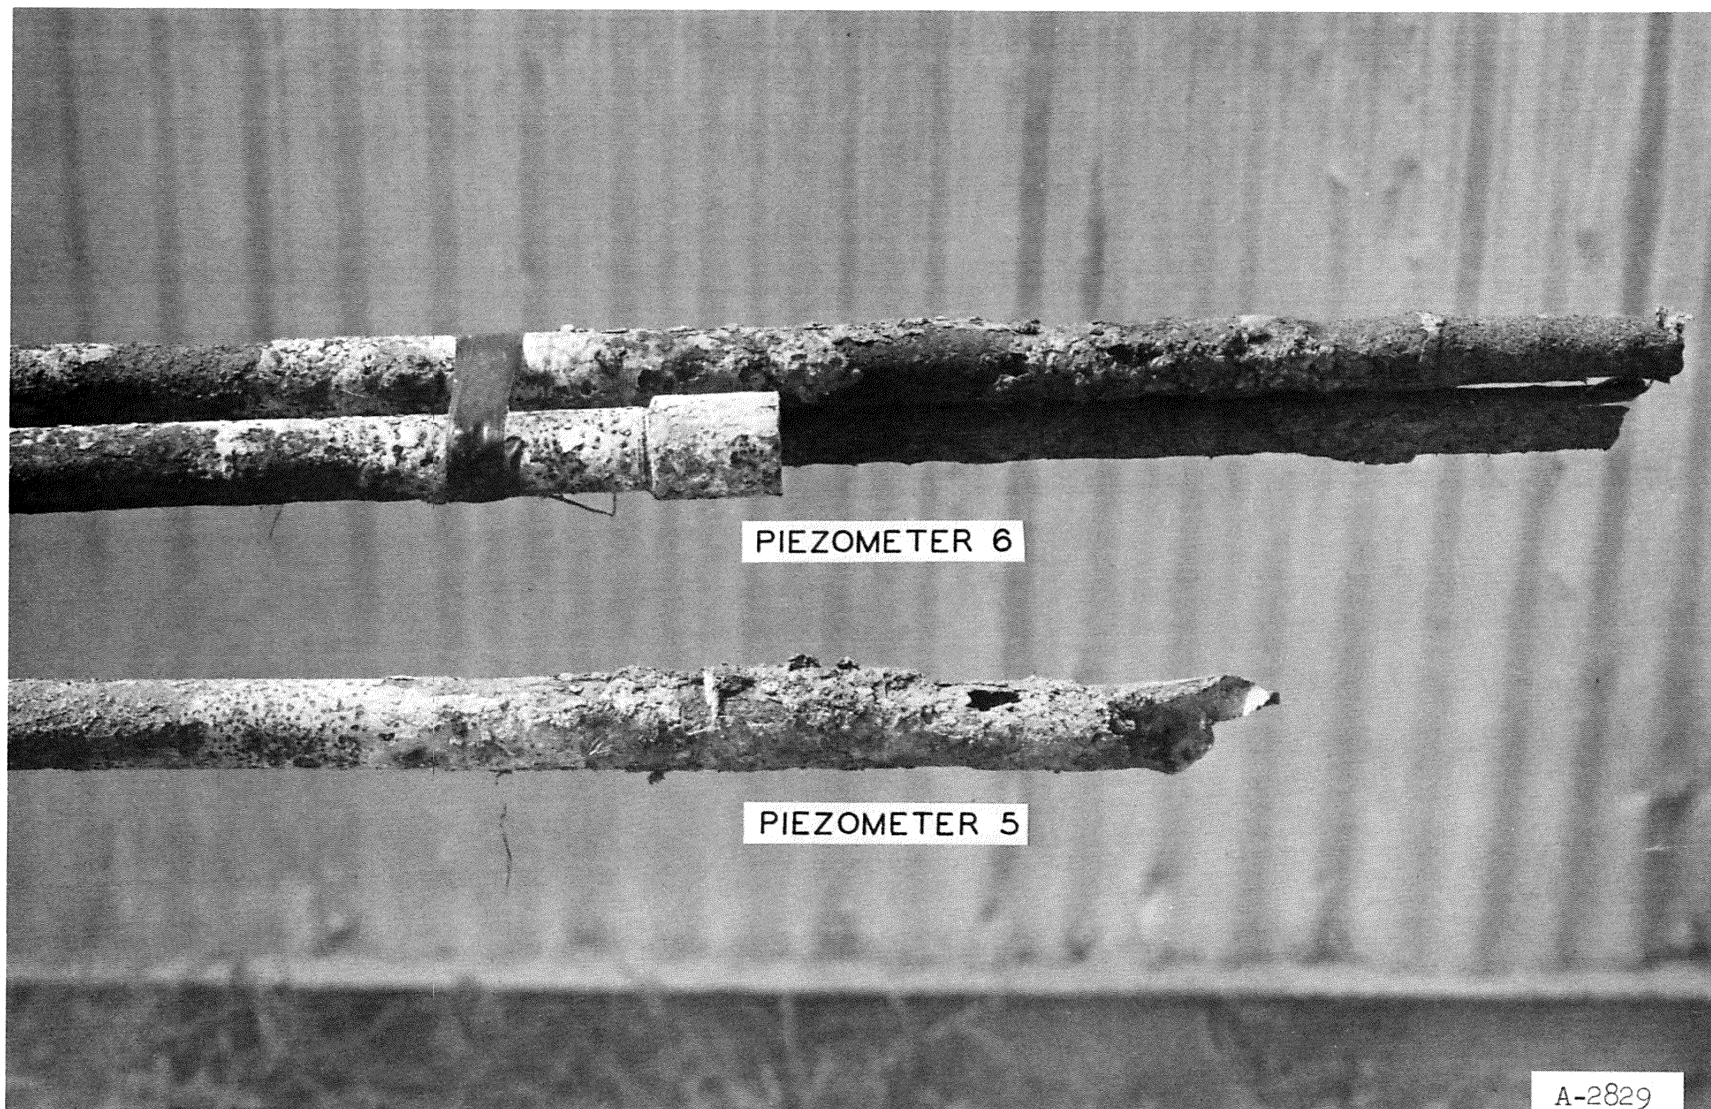
14. The total installed lengths of the standpipes of piezometers 1, 2, 6, 10, 14, and 15 were recovered. The standpipes of piezometers 6 and 10 were badly corroded, while the standpipes of piezometers 1, 2, 14, and 15 showed little or no evidence of corrosion. The lower ends of standpipes of piezometers 14 and 15, which had been in contact with the drive point, showed some brooming as a result of driving during the installation. The standpipes of piezometers 3, 4, 5, and 1A were so badly corroded that only portions of the standpipes were recovered. The total lengths of the protective iron pipes encasing the Saran tubing standpipes for Casagrande piezometers 7 and 8 were recovered and showed evidence of considerable corrosion. The Saran tubing standpipes for the Casagrande piezometers showed no signs of deterioration from age and appeared to be intact; however, mechanical damage occurred during the recovery attempt. The lower 5 ft of the standpipes for piezometers 1 and 2 were seen to be bent in a spiral when recovered; it is presumed that the standpipes were bent during the recovery operation.

Photograph 3. Standpipes from Cherry Creek piezometers 5 and 6

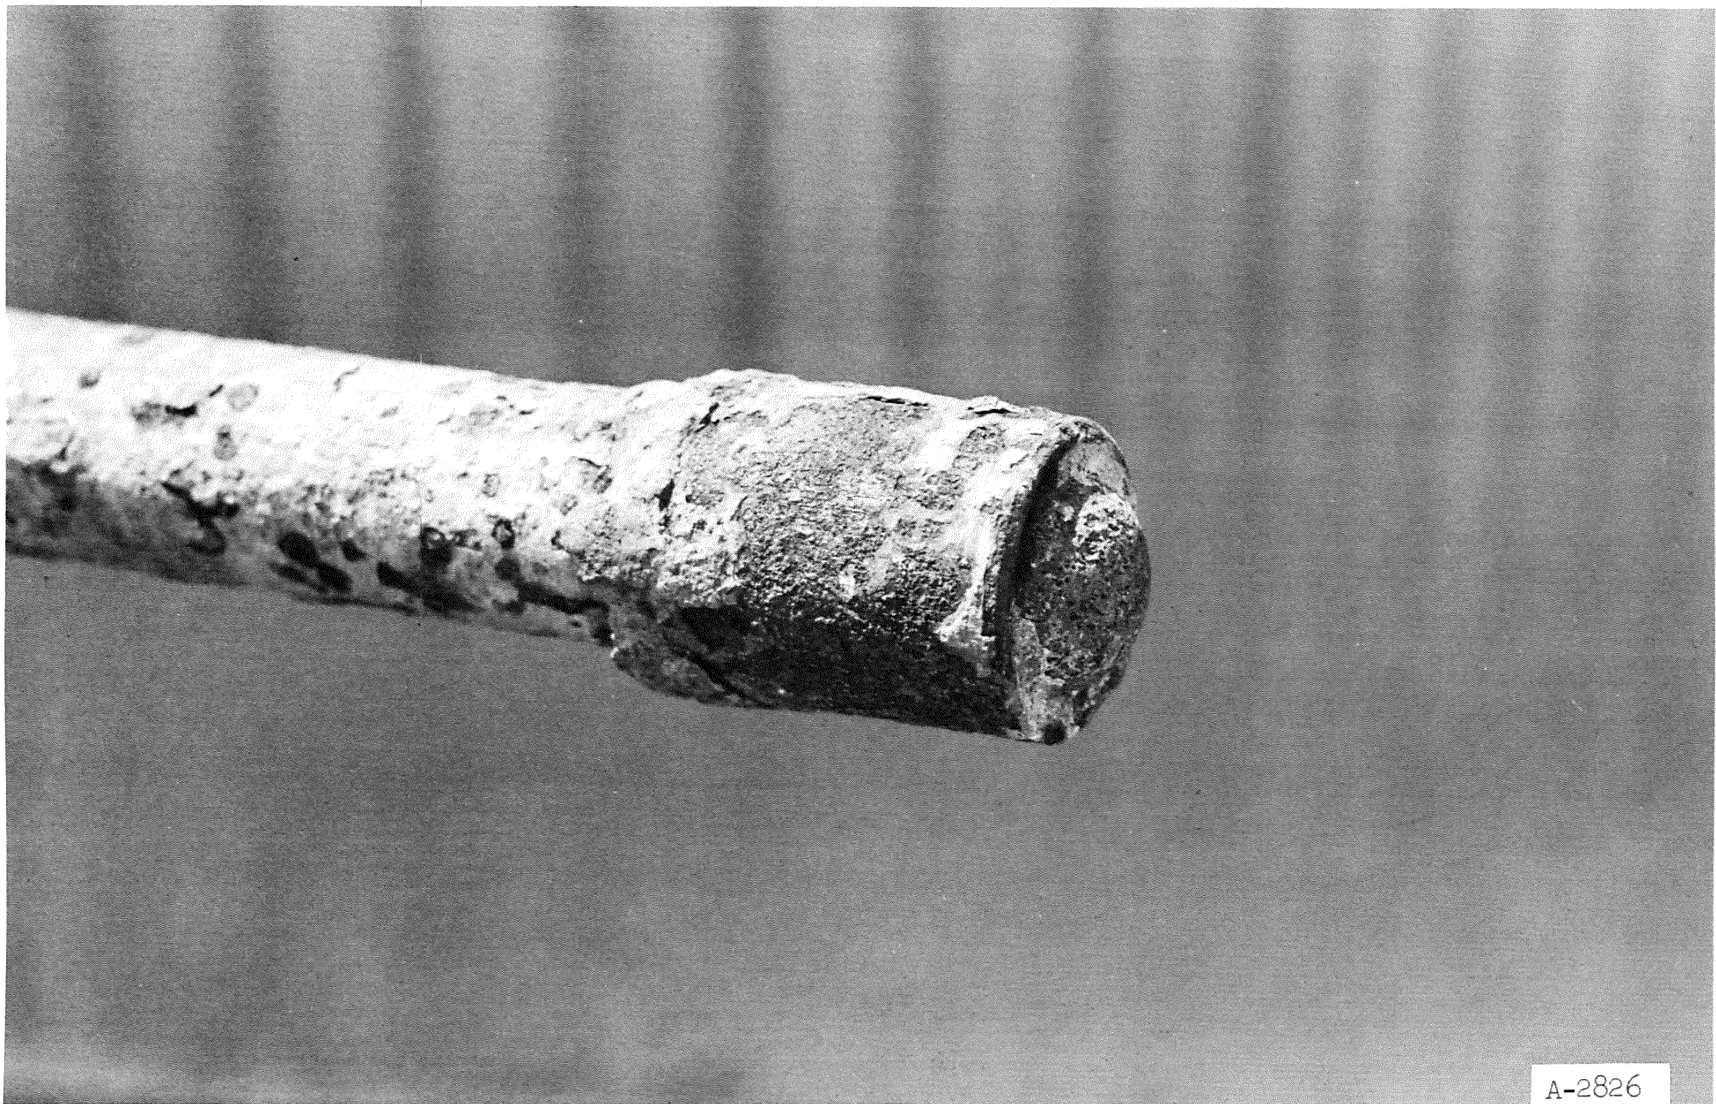
Photograph 4. Hemispherical tip of Cherry Creek piezometer 6

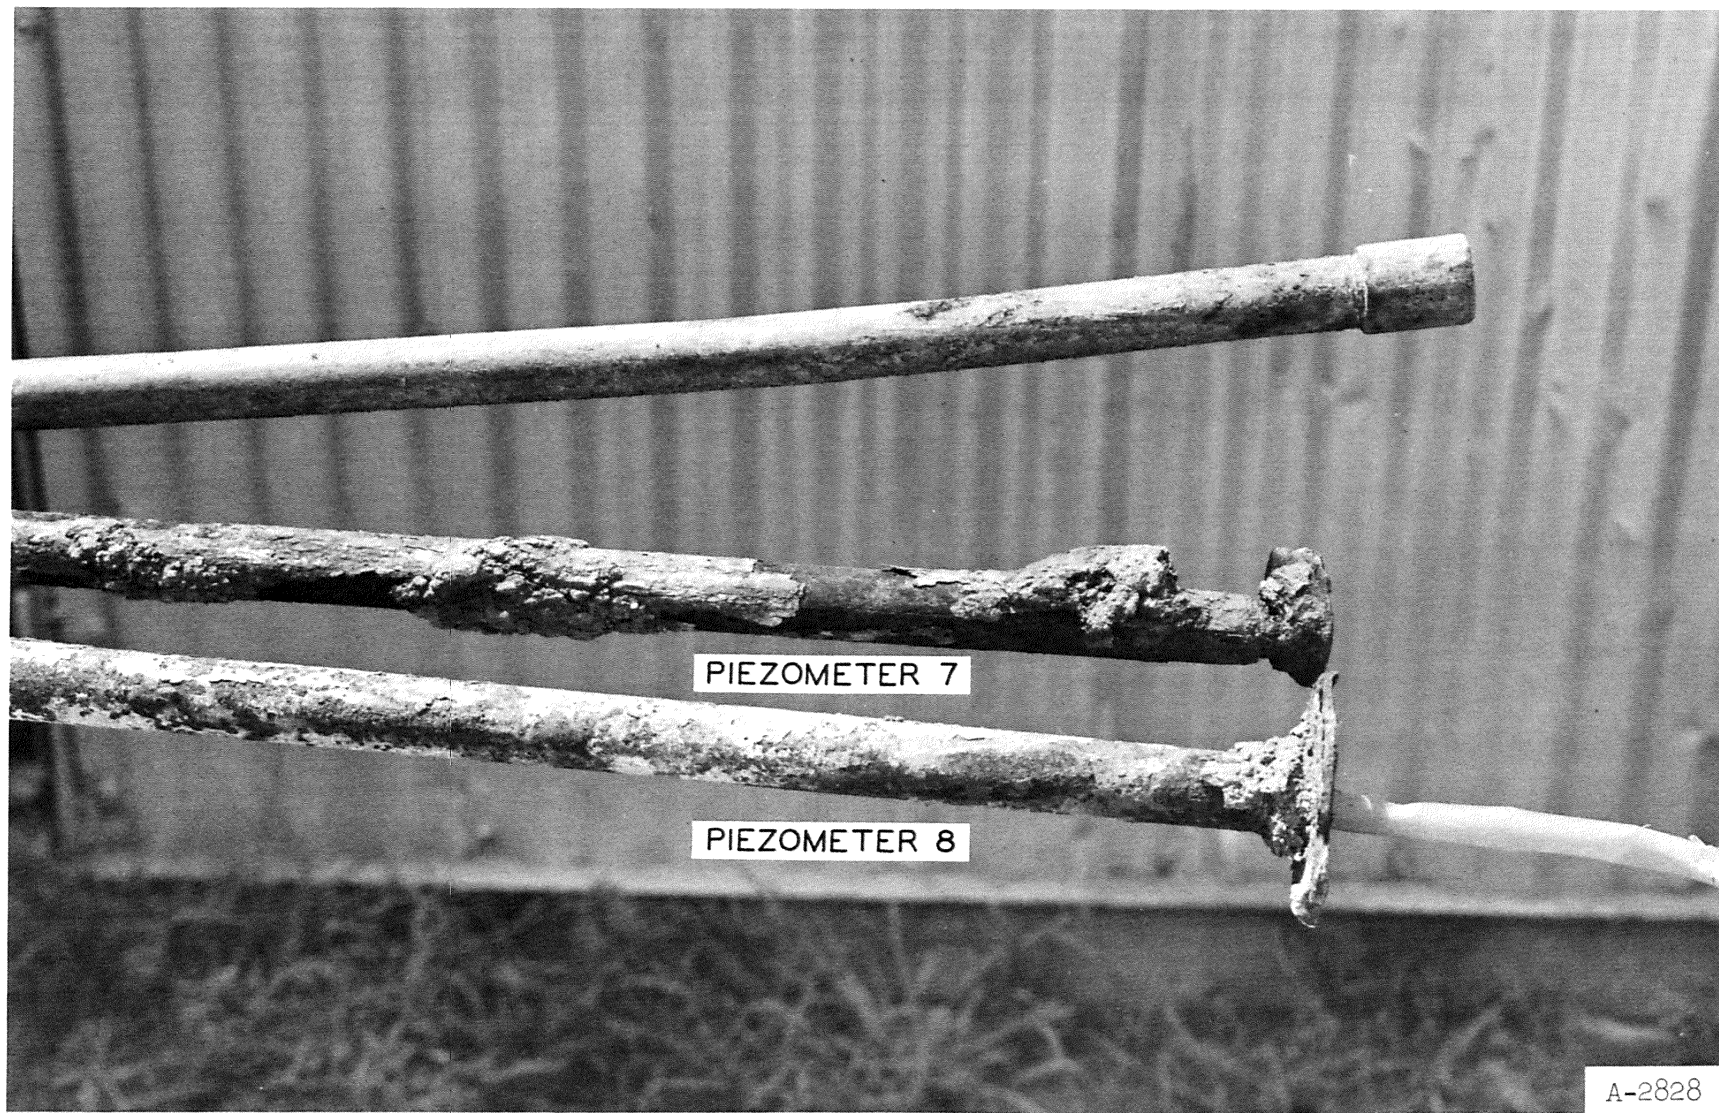
Photograph 5. Standpipes from Casagrande piezometers 7 and 8 with Saran tubing attached to 8

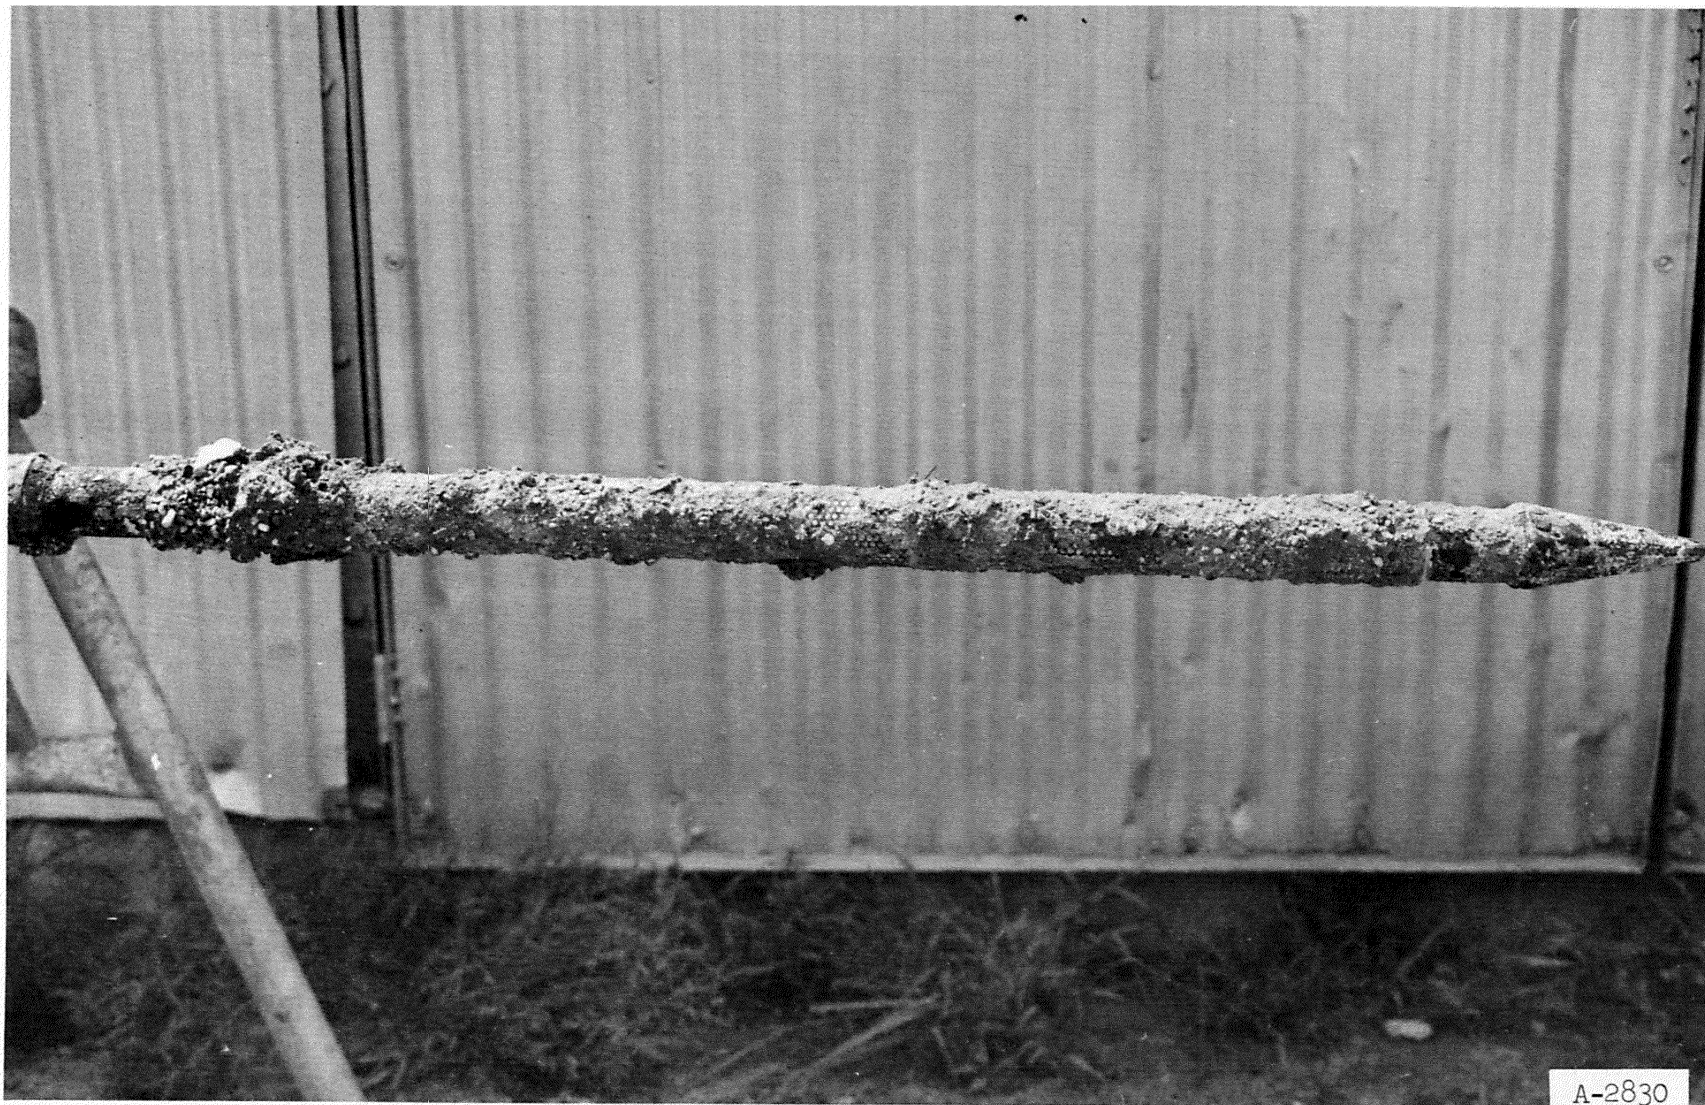
Photograph 6. Encrustation and clogging of screen of wellpoint piezometer 10

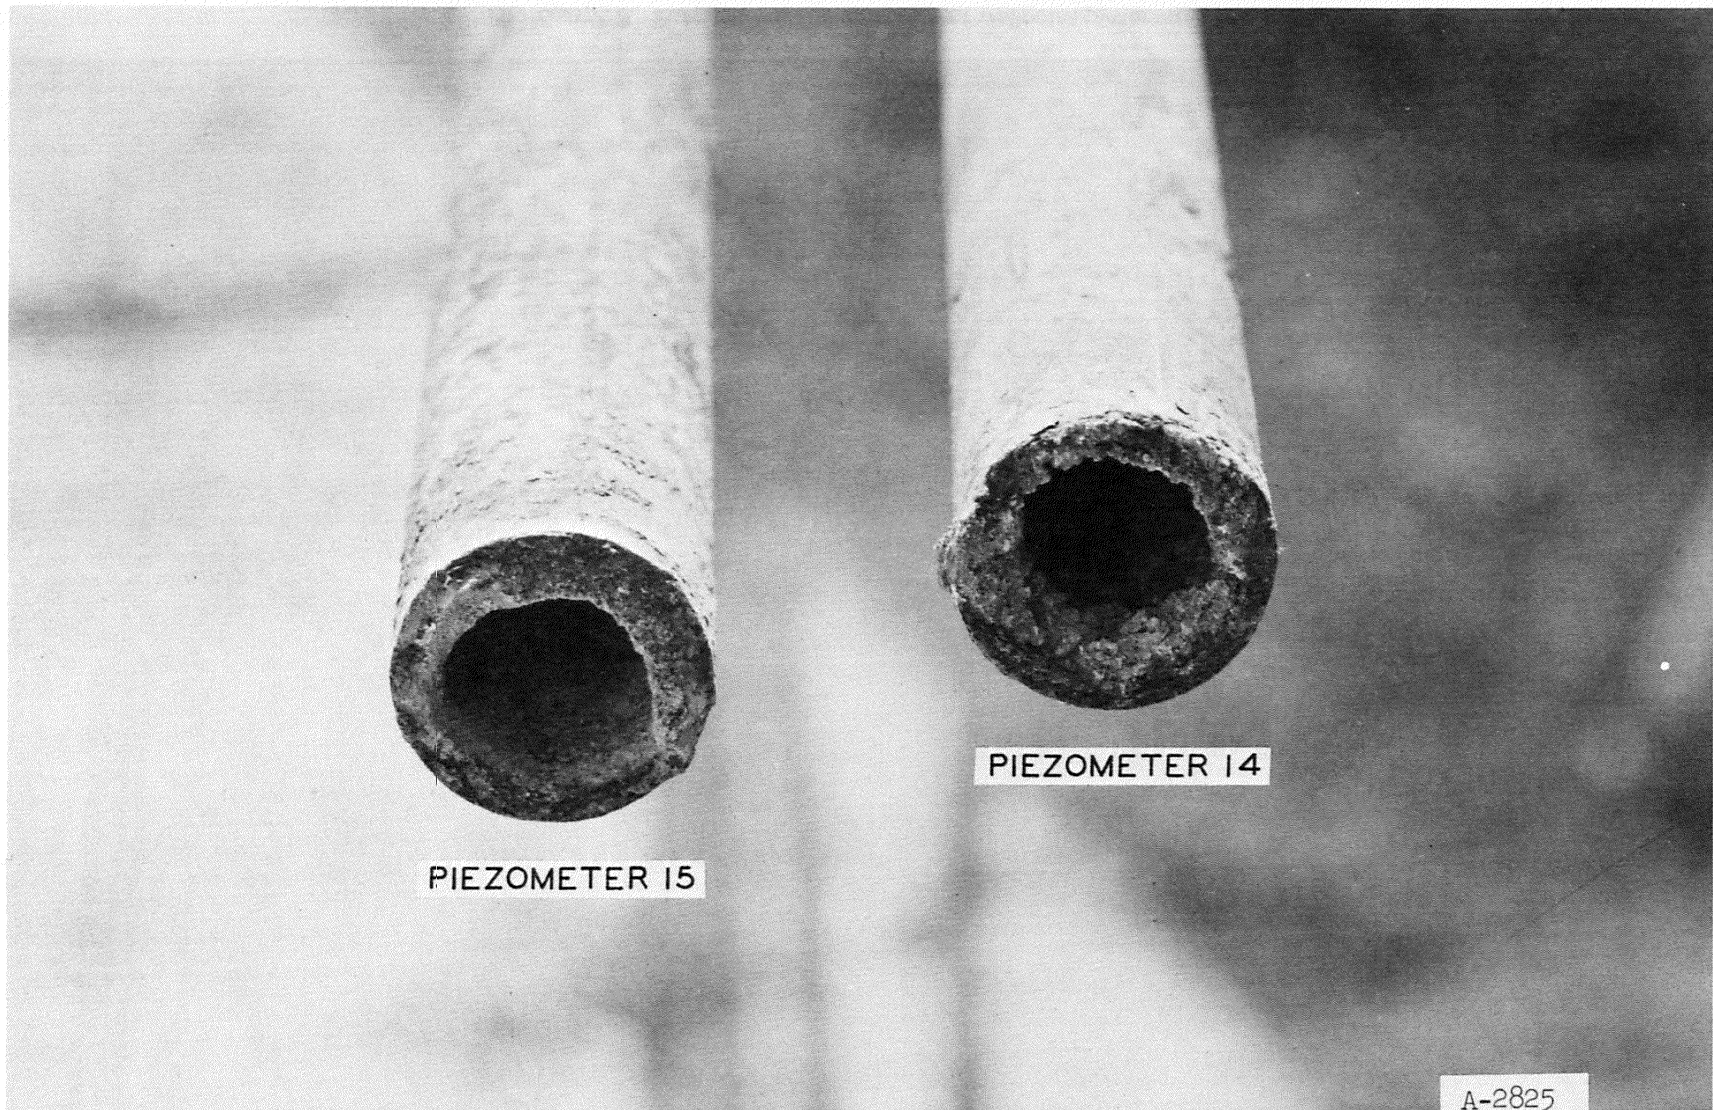
Photograph 7. Drive point piezometers 14 and 15

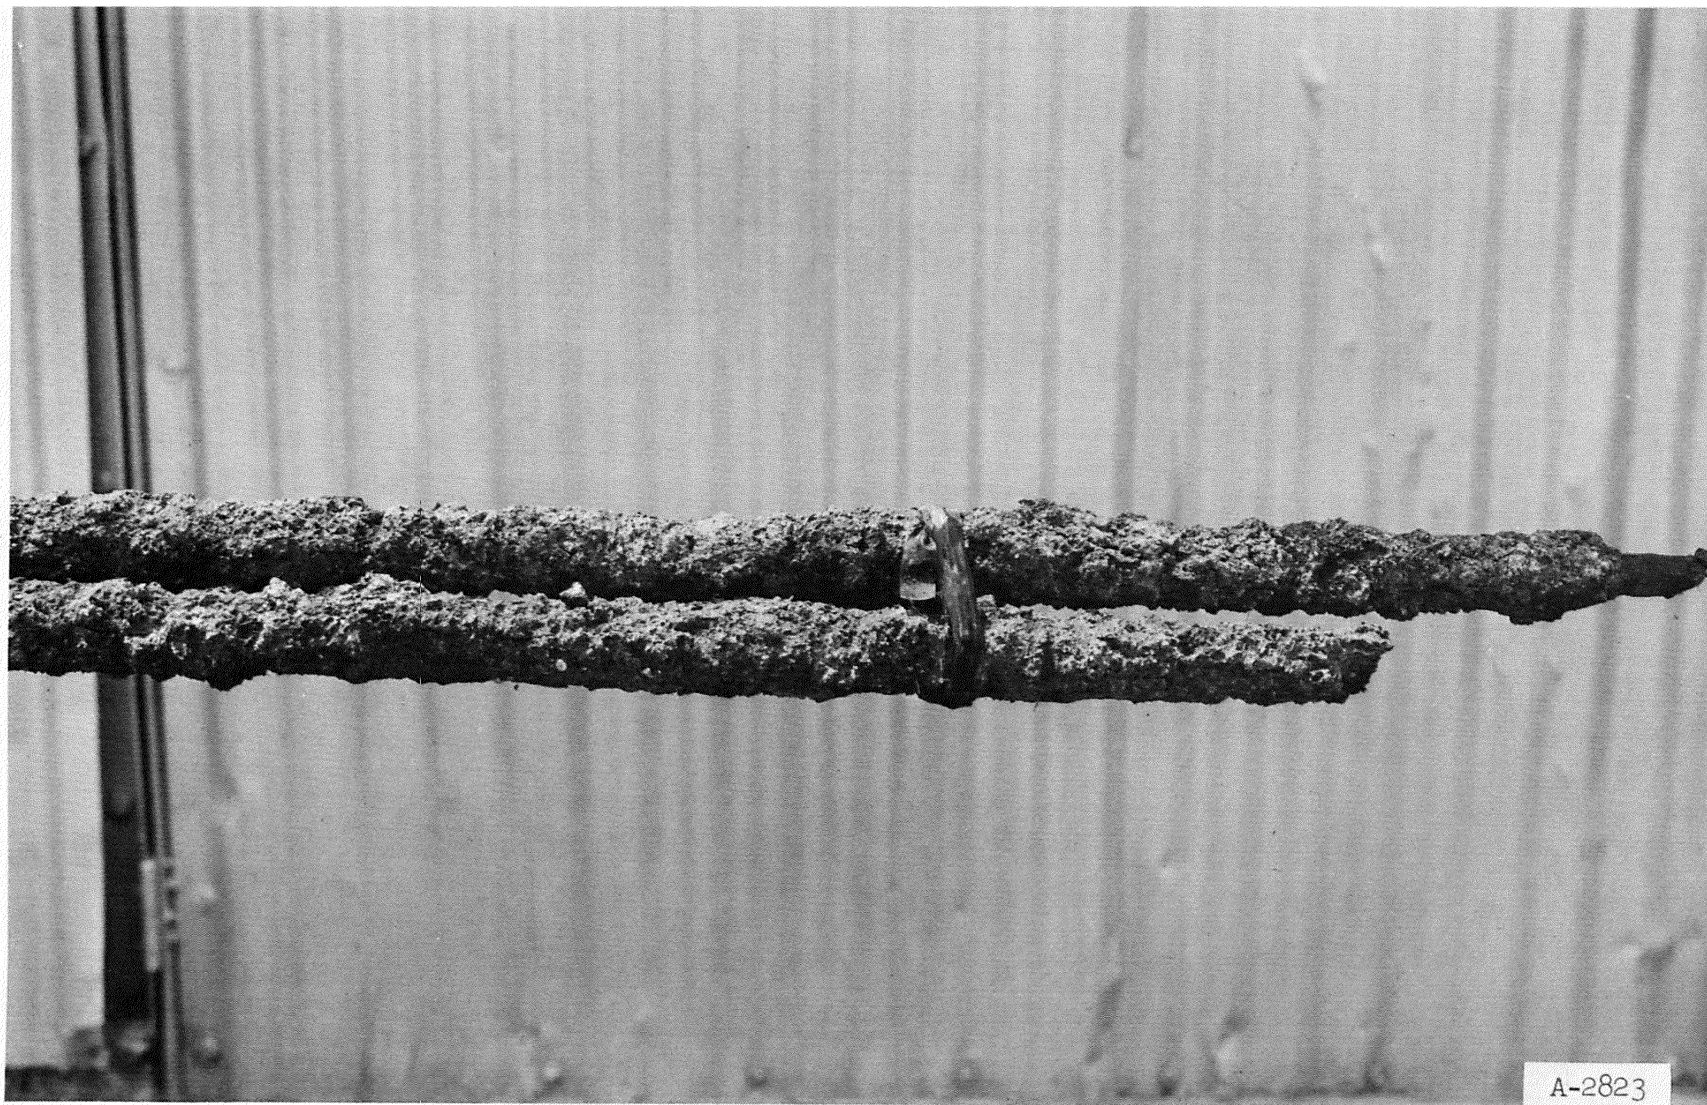
piezometer 4 can be attributed to contamination of the soil by products of the corrosion process. The standpipes for all piezometers were made of galvanized iron pipe. Because zinc is anodic with respect to iron, the corrosive attack would first deplete all of the zinc, at least in the zone of attack, before acting on the iron. This was the case with those standpipes found corroded. The zinc coating on noncorroded standpipes was intact. The standpipes for wellpoint piezometers 10 and 15, which had brass parts in the points, were corroded, but not as badly as the four standpipes for the Cherry Creek piezometers which had nonmetallic hemispherical filter tips. In view of the foregoing, it is believed that the basic cause of the extensive corrosion was the acidic condition of the soil surrounding the standpipes.

Photograph 8. Encrustation and corrosion of wellpoint piezometer 1A

- c. The pH value of the soil should be determined before selecting the type of piezometer tip and standpipe to be used in an installation. When acidic soils are present, consideration should be given to the use of nonmetallic materials for both the tip and the standpipe.
