MISCELLANEOUS PAPER S-73-47

CONDITION SURVEY, FT. DEVENS ARMY AIRFIELD, FT. DEVENS, MASSACHUSETTS

June 1973

Conducted by **U. S. Army Engineer Waterways Experiment Station
Soils and Pavements Laboratory
Vicksburg, Mississippi**

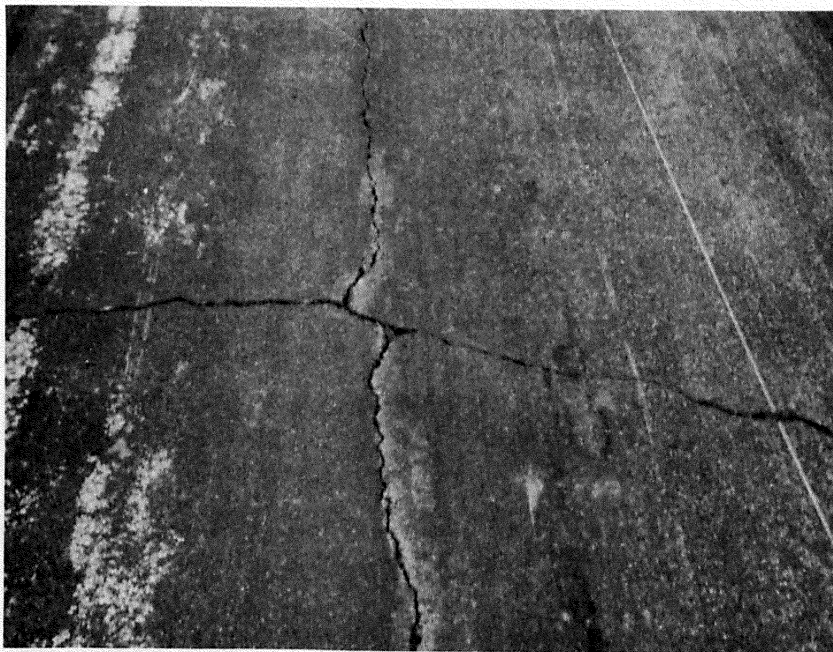
9. In August 1972, the conditions of the pavement surfaces ranged from good to excellent. The NW-SE runway had a 1-in. leveling and a 1-in. surface course applied in 1961. In 1969, a bituminous slurry seal was applied to the surface in an effort to seal the cracks that had reflected through the 2-in. overlay from the underlying soil cement. Photo 1 shows both longitudinal and transverse cracks in this runway. Most of the cracks were in the transverse direction and were spaced at 25- to 50-ft intervals. None of the cracks showed evidence of movement; however, the material on each side of some of the cracks was slightly higher than the surrounding area (photo 2). This runway was considered to be in good condition (photo 3). The N-S runway is used primarily as a taxiway and was in excellent condition (photo 4). This runway was overlaid with 1 in. of bituminous concrete in 1969. The overlay for taxiway D was specified as a nominal 2 in.; however, subsequent investigation by the New England Division indicated the overlay was actually 2.5 in. thick. Taxiways B and C have been overlaid twice since they were constructed. The first overlay was 1.5 in. of bituminous concrete and the second was 2 in. Taxiway A was overlaid in 1969 with 1 in. of bituminous concrete. The taxiways were in good to excellent condition. All of the apron areas were overlaid in 1969 with 1 to 3.5 in. of bituminous concrete. The apron areas were considered to be in excellent condition.

Photo 1. Longitudinal and transverse
cracks in NW-SE runway

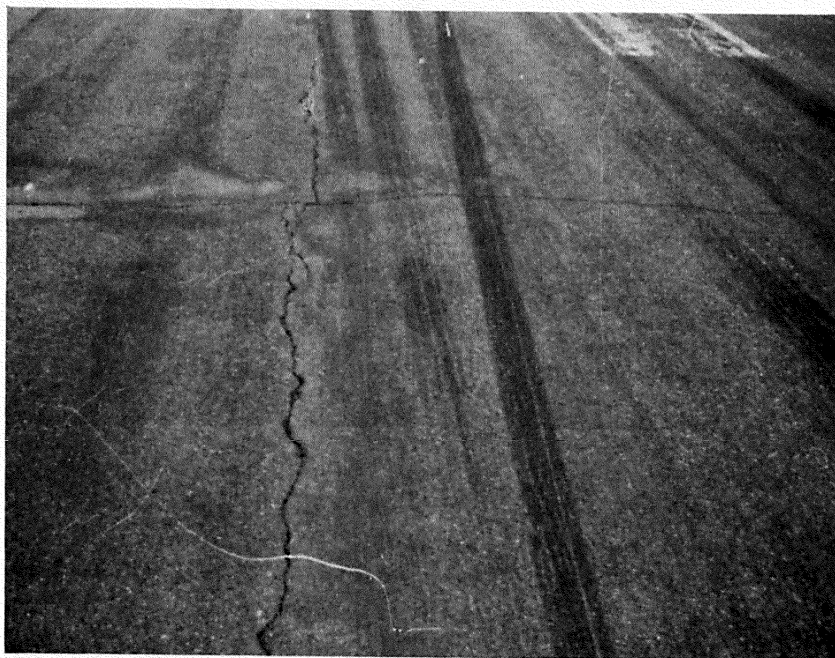
Photo 2. Cracks with slightly raised
edges on NW-SE runway

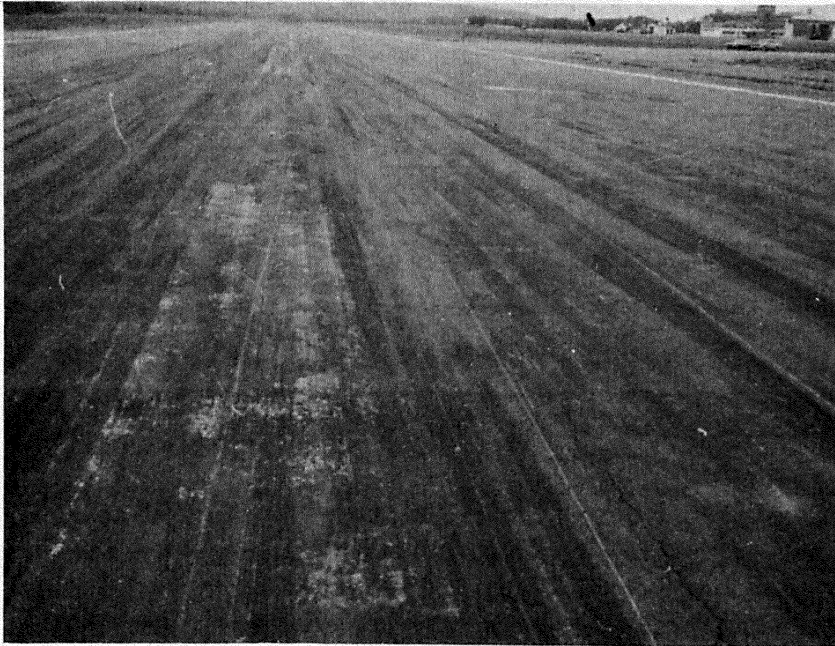
Photo 3. General view of NW-SE runway

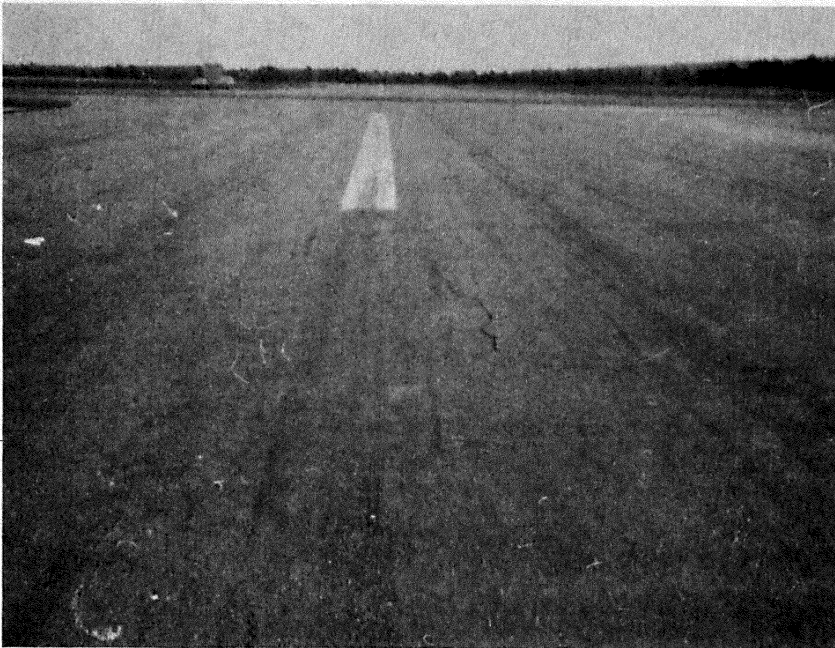
Photo 4. General view of N-S runway
