# CONDITION SURVEY, DYESS AIR FORCE BASE, TEXAS

R. D. Jackson

June 1973

Conducted by **U. S. Army Engineer Waterways Experiment Station  
Soils and Pavements Laboratory  
Vicksburg, Mississippi**

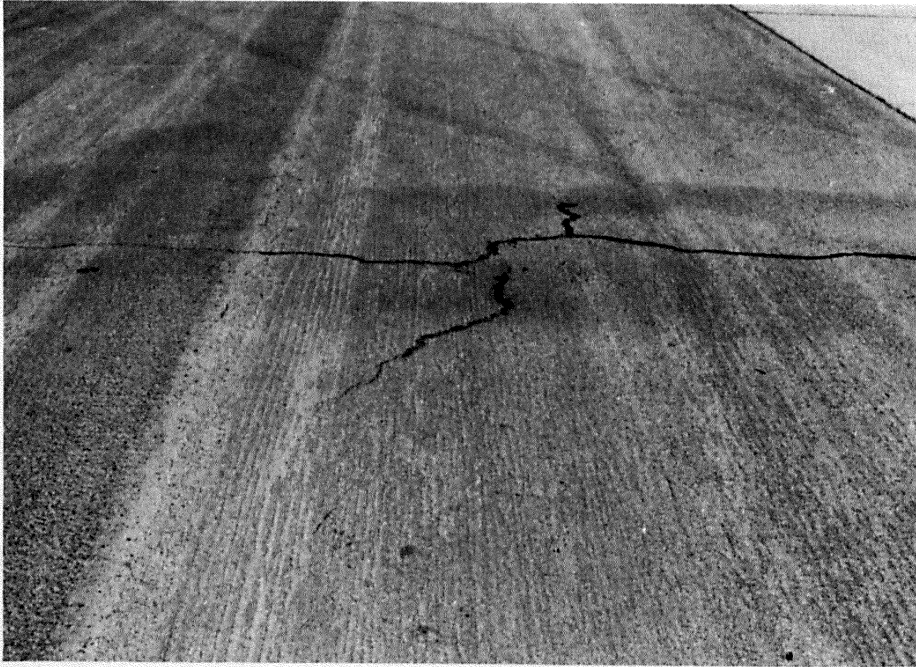
Photo 1. AC portion of runway near north end, east side

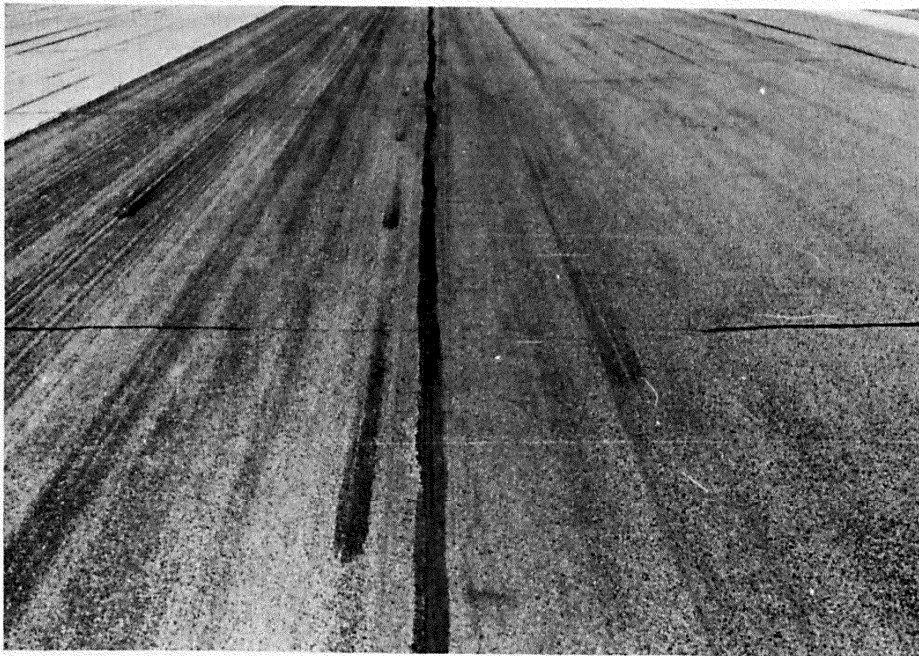
Photo 2. AC portion of runway, 5000 ft from north end,  
west side

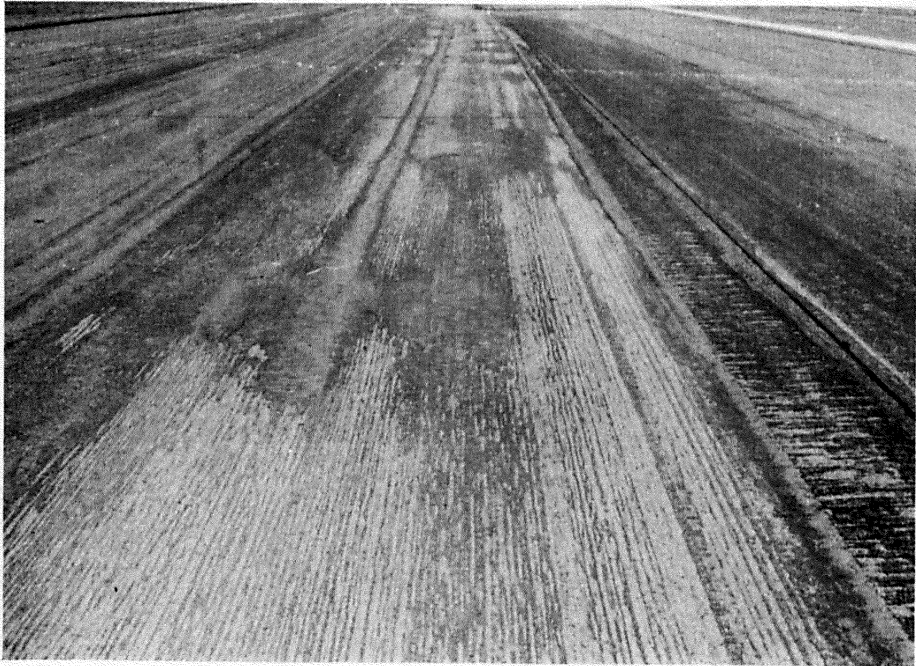
Photo 3. AC portion of runway, 5000 ft from north end,  
east side

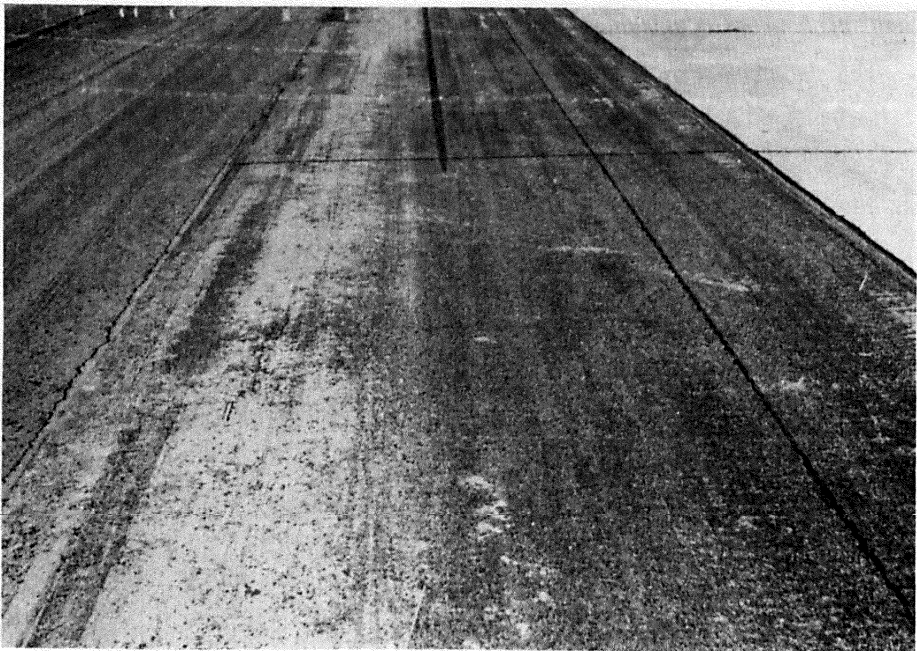
Photo 4. AC portion of runway, 6000 ft from south end,  
east side

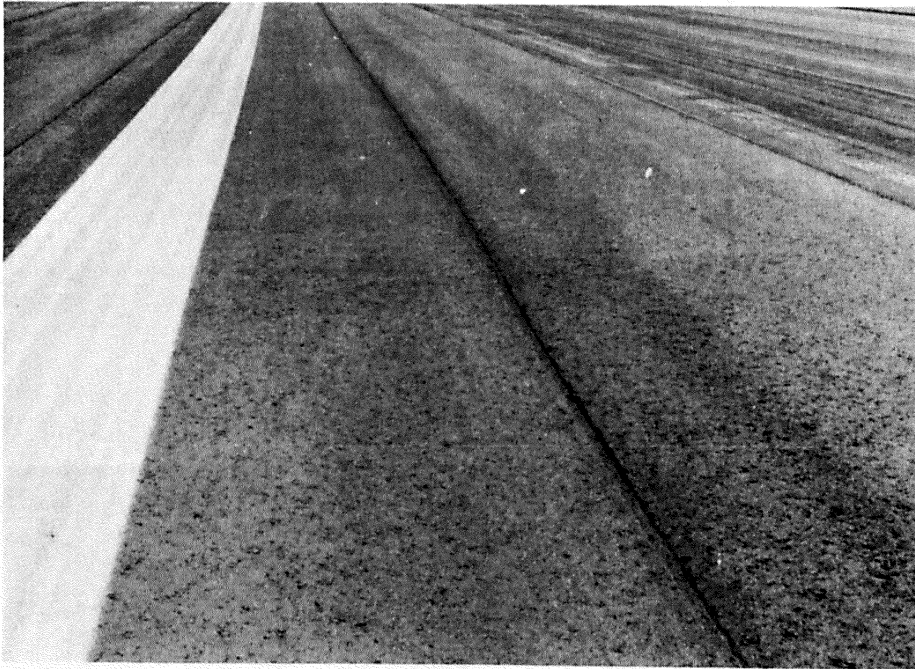
13. The PCC pavement features of the runway were in good to excellent condition based on the percentages of slabs containing no major defects. The predominate major defects on the runway were longitudinal cracks. The asphaltic concrete (AC) outside edges of the runway interior were in fair to good condition (see photos 1-5).

Photo 5. AC portion of runway, 4000 ft from south end,  
west side

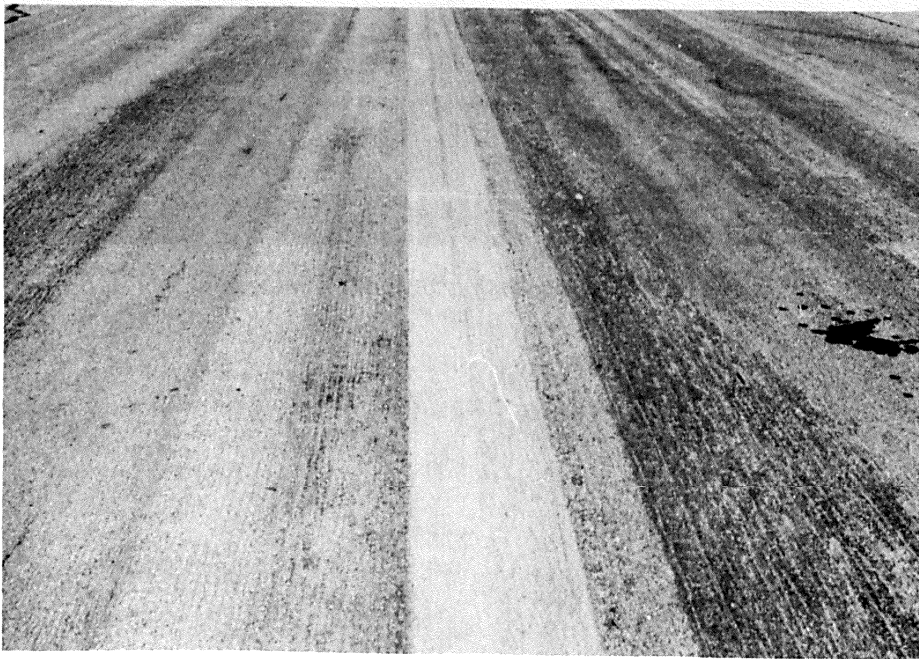
14. The primary taxiways, 1, 5, and 7 (features T1A, T2A, T3B, T7A, T8A, T10B, and T11B), were in conditions ranging from good to excellent based on the percentages of the slabs containing major defects. The taxi lane on taxiway 7 had been moved and a 26-in. inlay constructed at the present location of the taxi lane. Using only the 75 ft at the present location for the condition rating of this feature would have resulted in a rating of very good to excellent; however, using the 150-ft width resulted in a condition rating of good. Taxiway 2, which is 16- and 18-in. PCC, was in very good condition. Taxiways 3 and 4, which are AC, were in only fair condition (see photos 6 and 7).

Photo 6. General view of taxiway 3

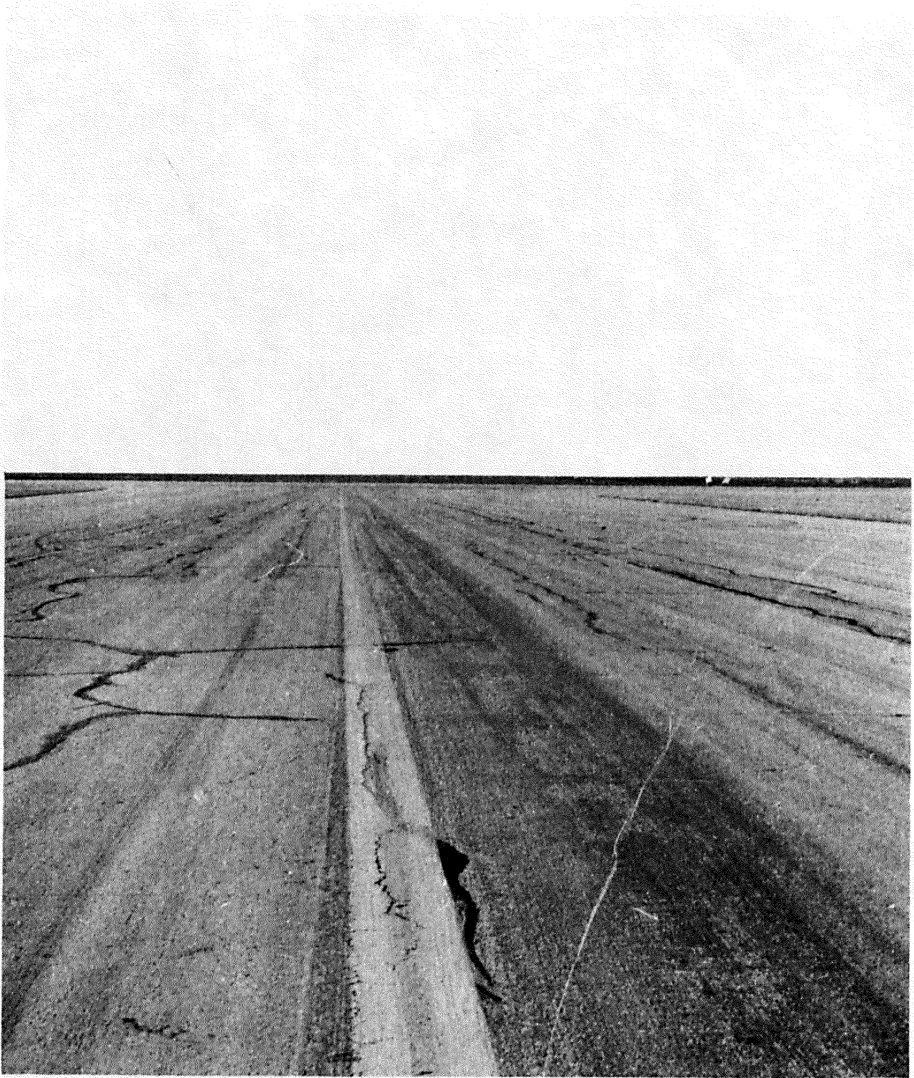
Photo 7. General view of taxiway 4
