MISCELLANEOUS PAPER S-73-51

# CONDITION SURVEY, LORING AIR FORCE BASE, MAINE

June 1973

Conducted by U. S. Army Engineer Waterways Experiment Station  
Soils and Pavements Laboratory  
Vicksburg, Mississippi

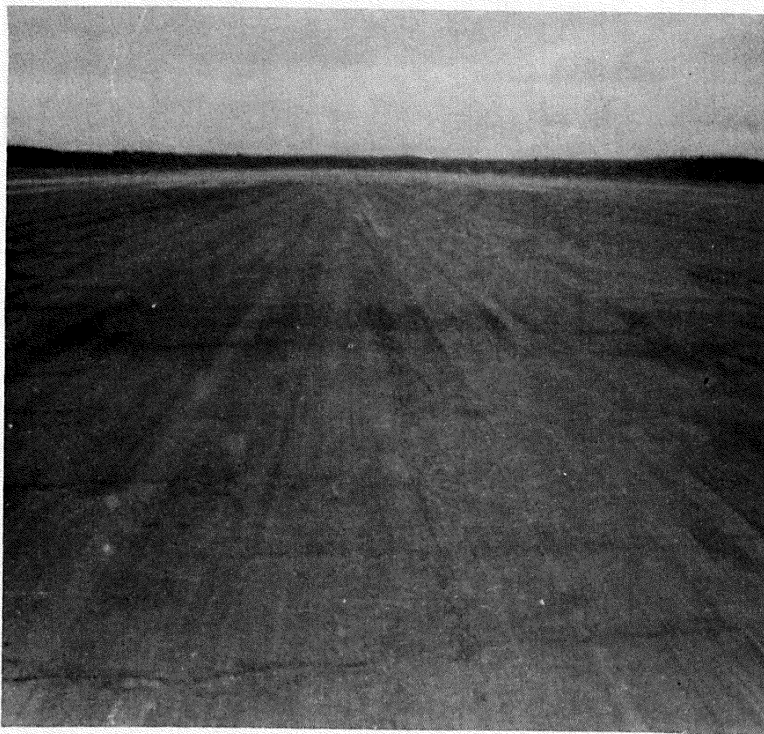
Photo 1. Crack on AC portion of N-S runway  
near north end

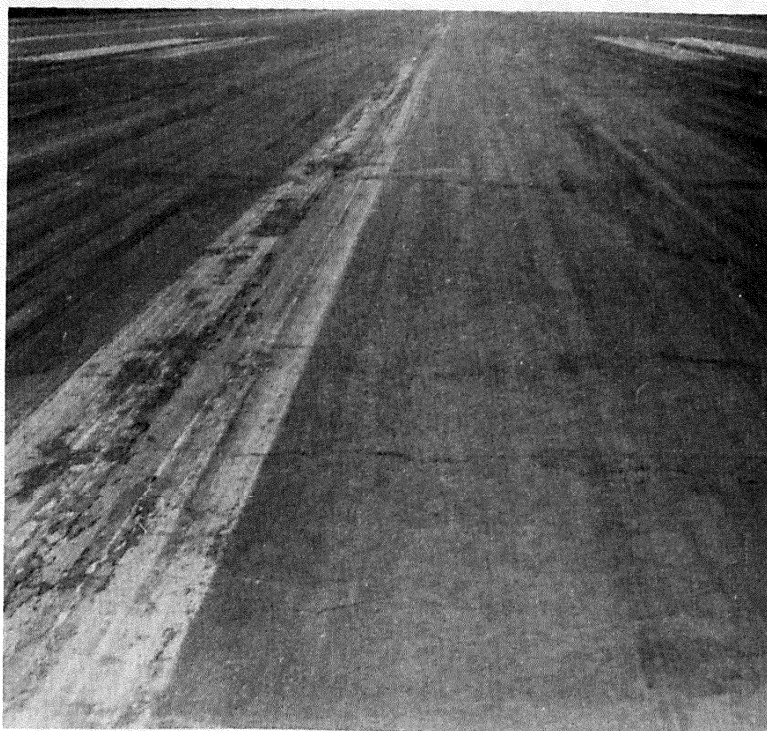
Photo 2. Cracking on N-S runway near  
north end of AC pavement

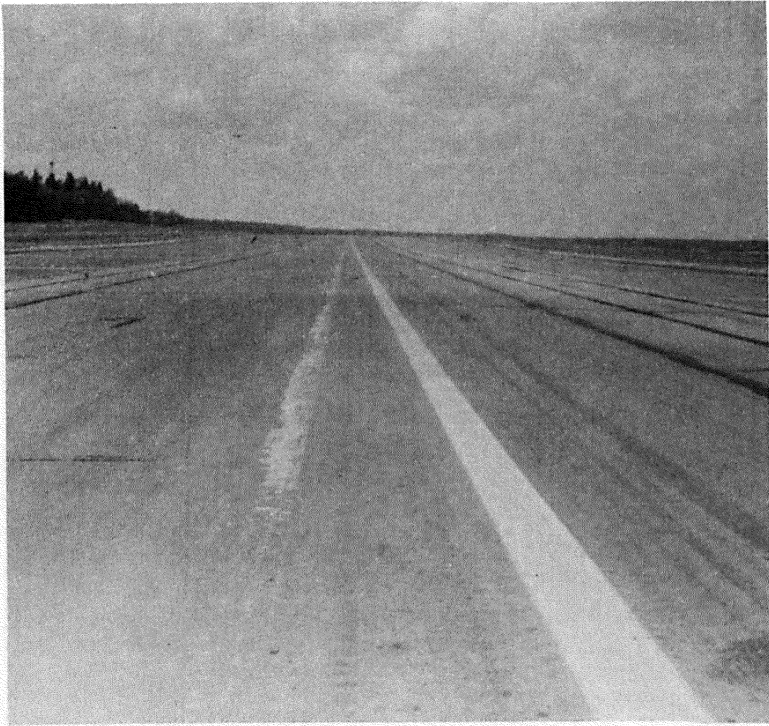
11. Taxiway A from taxiway B to the dogleg (see plate 1) was in good condition, since a chip seal was applied during the time of the survey. The extension to taxiway A was in good condition (photo 3). The PCC portions of taxiways D, E, and F and taxiway G were in conditions ranging from poor to very good (photos 4 and 5). The predominate defects in these taxiways were longitudinal cracks, and more than 50 percent of the cracks were in the center lane. Taxiways B and C were in good condition. The AC portion of taxiway D was in excellent condition; it had recently been overlaid. The north connecting taxiway, which contained 111 major defects, was in a poor to failed condition; however, the facility was still serviceable since little or no movement was observed at the locations of the major defects. Photo 6 shows some of

Photo 3. Extension to taxiway A

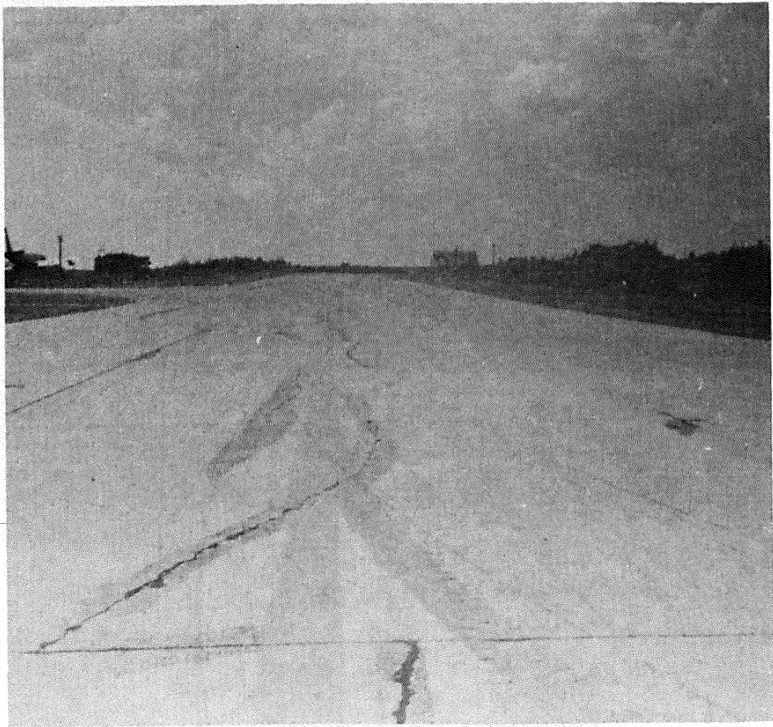
Photo 4. Cracks in taxiway E west of  
intersection with taxiway G

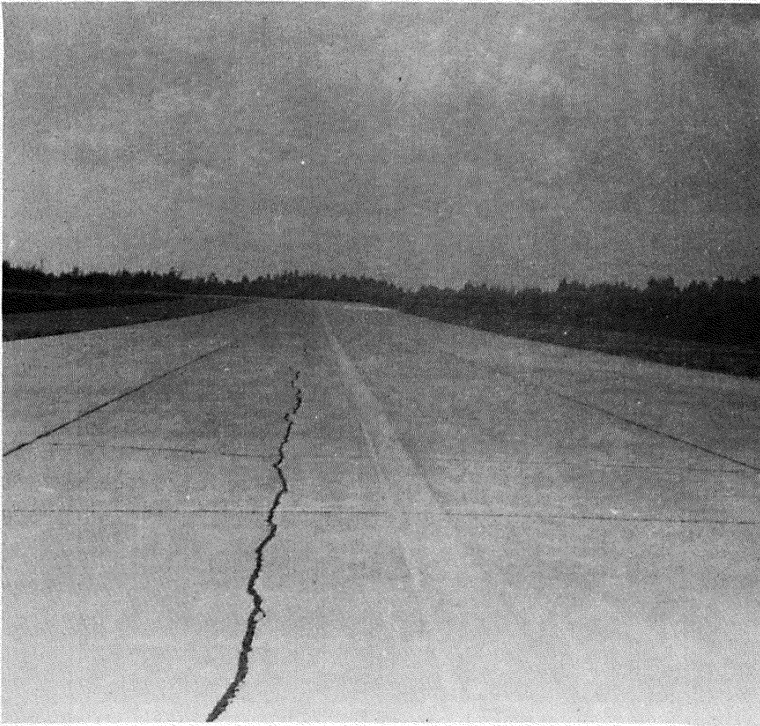
Photo 5. Cracks in taxiway G

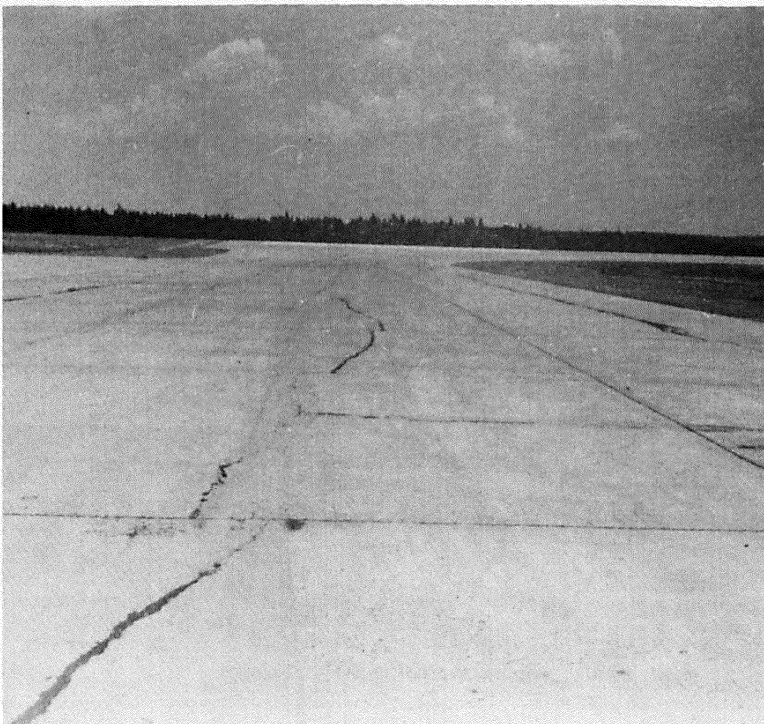
Photo 6. Cracks in north connecting taxiway

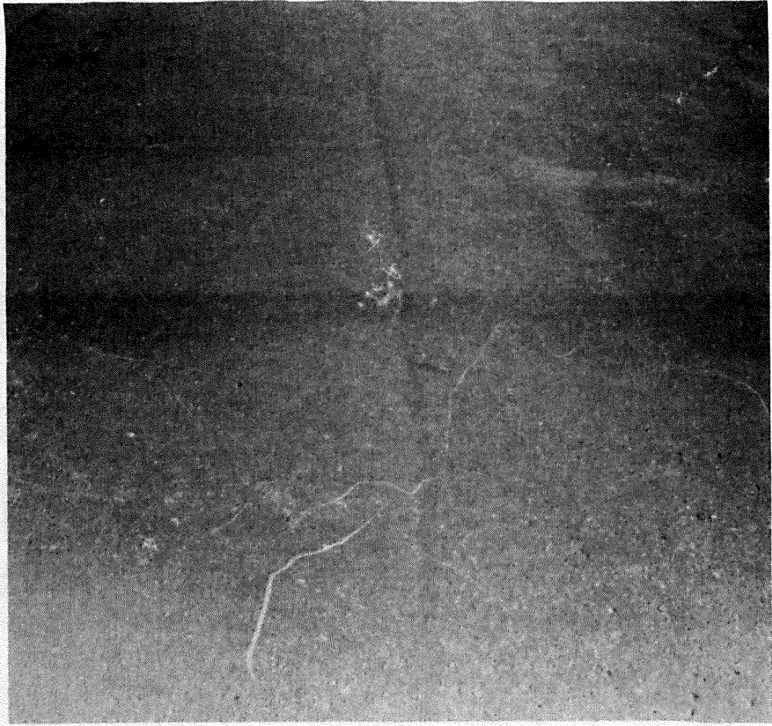
12. The parking and maintenance apron west of the apron taxiway was in good condition. A tar rejuvenator that sealed the smaller cracks and partially filled the larger cracks was applied to this area in 1971 (photos 7 and 8). The area of the parking and maintenance apron east of the apron taxiway was in only fair condition; the tar rubber surface contained many cracks. The north warm-up apron (feature ALB) was in a poor to failed condition. A total of 179 major defects were observed in this feature, of which 120 were longitudinal cracks. Parking apron 1, which is essentially a taxiway with parking stubs, was in fair to good condition. The taxiway portion between taxiways D and F had a chip seal coat applied during the time of this survey. Photo 9 shows the relatively good condition of stub 8. All of the stubs of parking apron 1 had a tar rejuvenator applied in 1971. Parking apron 2 is the same type of facility as parking apron 1. The south portion of taxiing area had a chip seal coat applied during the time of this survey. The PCC taxiway portion of apron 2 was in poor condition structurally. The bituminous concrete parking stubs of this apron were in fair condition. Photo 10 shows the condition of stub 23, which was typical of the flexible pavement stubs in this apron. The PCC stubs were in poor to fair condition. The stubs of parking apron 3 were in fair to good condition, as were those of parking apron 4. The taxiway portion of parking apron 5 was in fair condition, and the stubs were in conditions ranging from poor to very good.

Photo 7. Close-up of parking and maintenance apron. Tar rejuvenator was applied in 1971

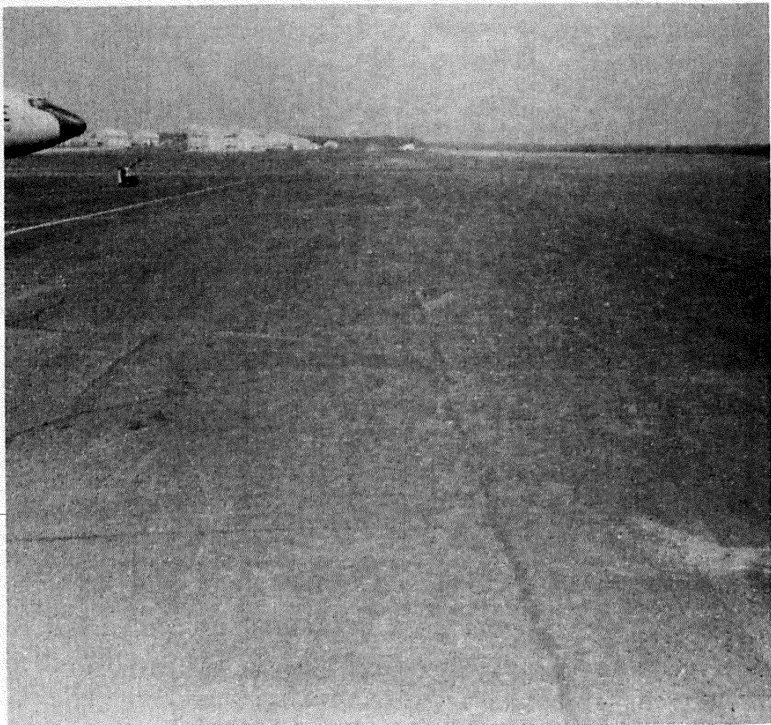
Photo 8. General view of parking and maintenance apron

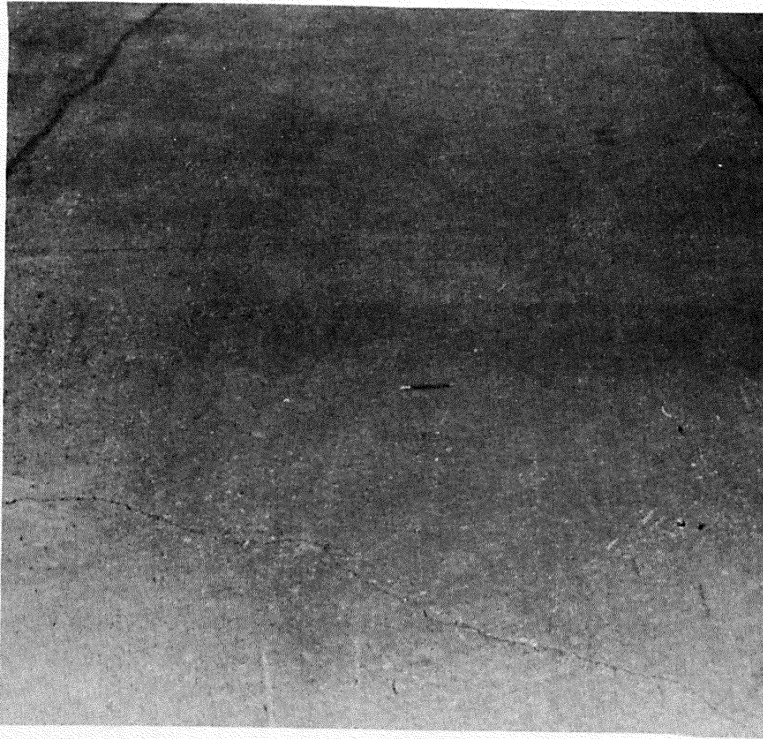
Photo 9. View of parking stub 8. Tar rejuvenator was applied in 1971

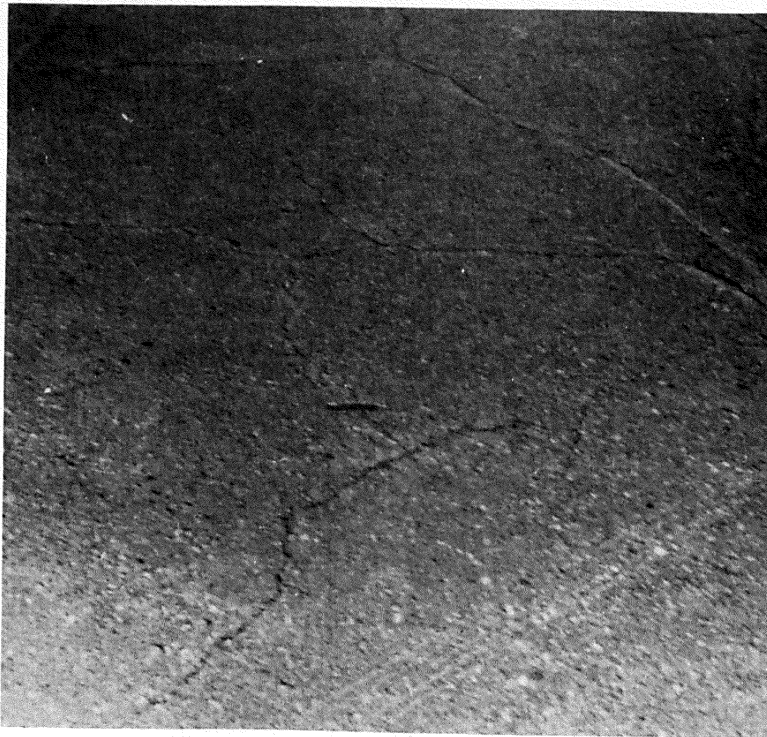
Photo 10. View of stub 23 (typical of AC stubs)
