MISCELLANEOUS PAPER S-72-14

ENGINEER DESIGN TESTS OF DUST-CONTROL MATERIALS AND EMPLACEMENT EQUIPMENT

M. M. Culpepper, W. A. Wilvert

LIBRARY BRANCH
TECHNICAL INFORMATION CENTER
US ARMY ENGINEER WATERWAYS EXPERIMENT STATION
VICKSBURG, MISSISSIPPI
June 1972

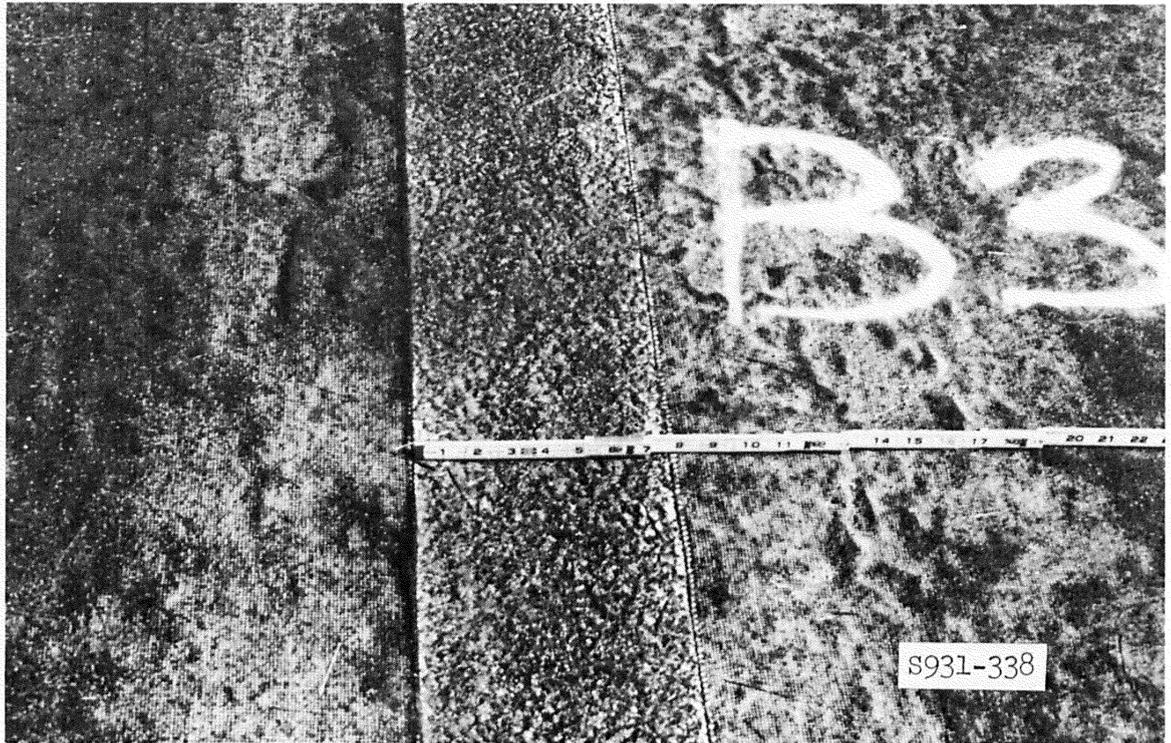
Photo 1. Area where scrim did not overlap, leaving 8-in. nonreinforced strip

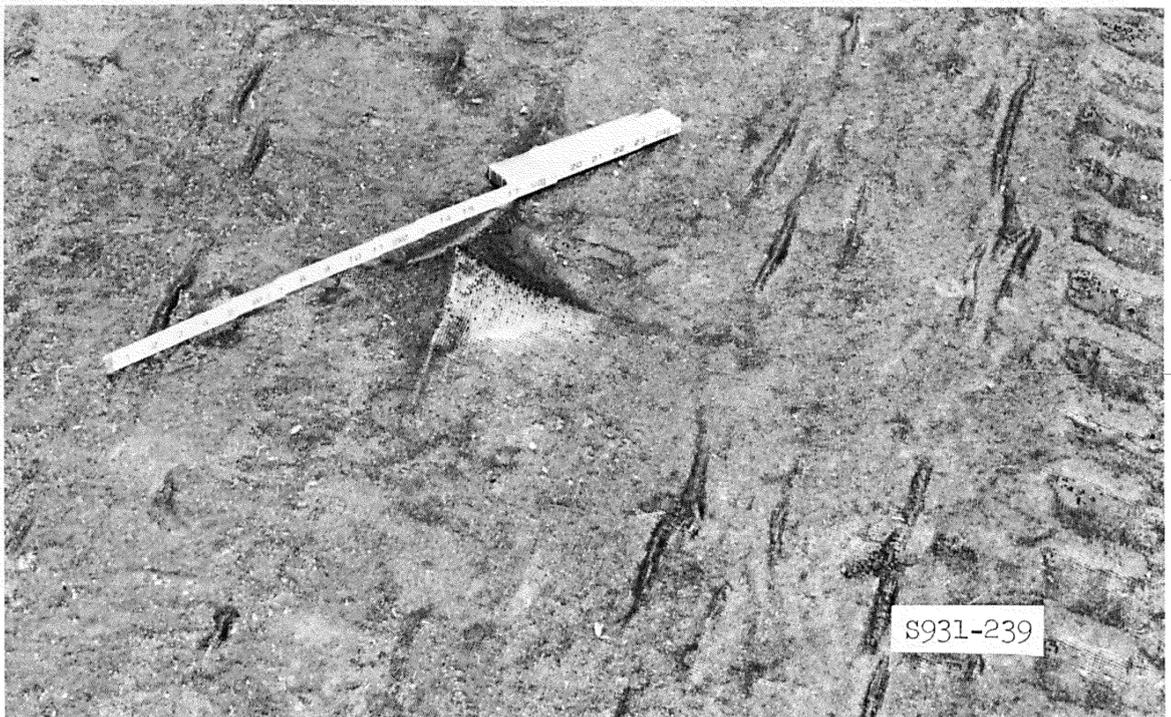
Photo 2. Tentlike area where fiberglass scrim was placed over roots or debris

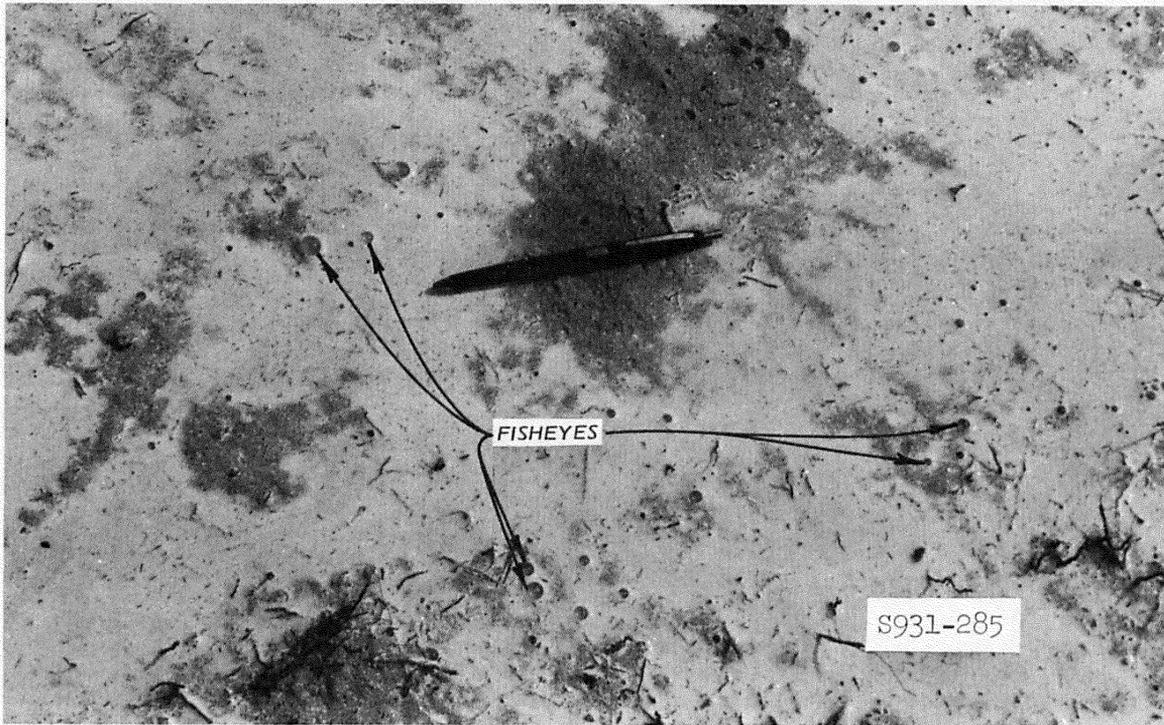
* "Fisheyes" are small holes ranging in size from 1/4 to 1-1/2 in. in diameter that are formed in the dust-control emulsion almost instantaneously after application. Initially, complete soil coverage is obtained, but surface tension of the soil causes the emulsion not to adhere to the soil, thus causing the small random holes. The holes allow moisture to enter the soil and airblast to get under the dust-control film.

Photo 3. Fisheyes in material A

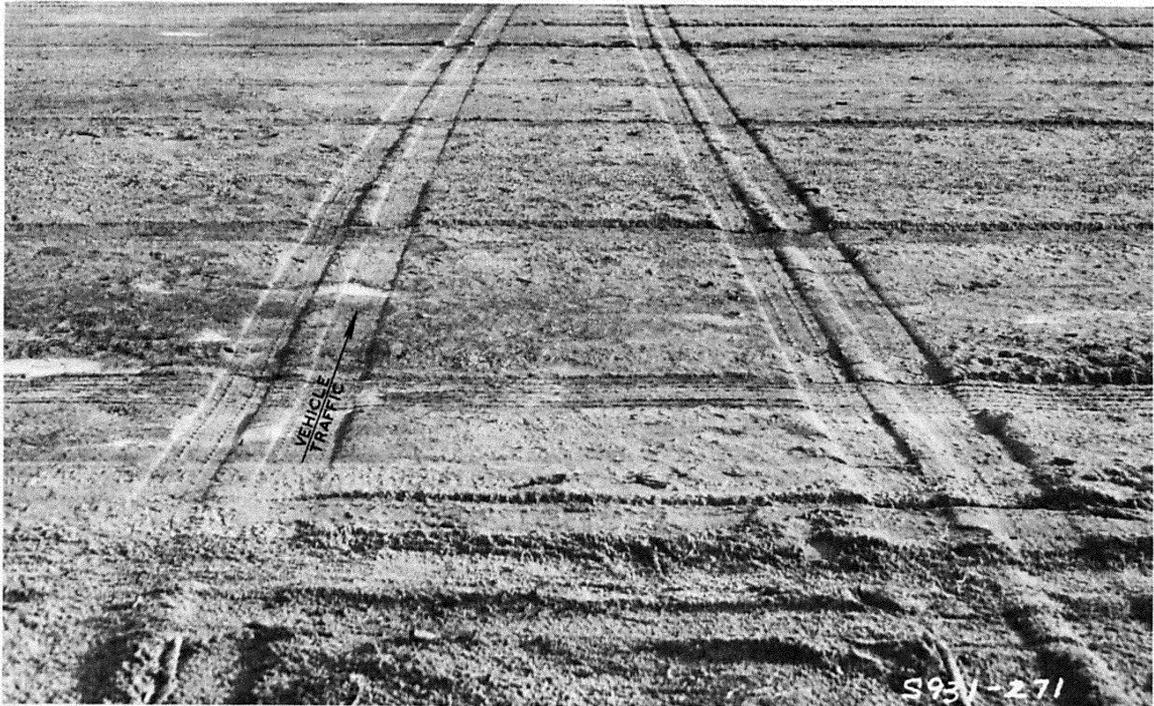
59. Vehicular traffic. All test sections were damaged by traffic, mainly where the vehicles crossed ruts created by distributor operation (photo 5). Traffic test results are given in table 1.

68. Vehicular traffic. All test sections were damaged by traffic, mainly where the vehicles crossed ruts created by distributor operation (see photo 5). Traffic test results are given in table 1.

Photo 5. Damage caused by 2-1/2-ton truck traffic across ruts left by distributor traffic

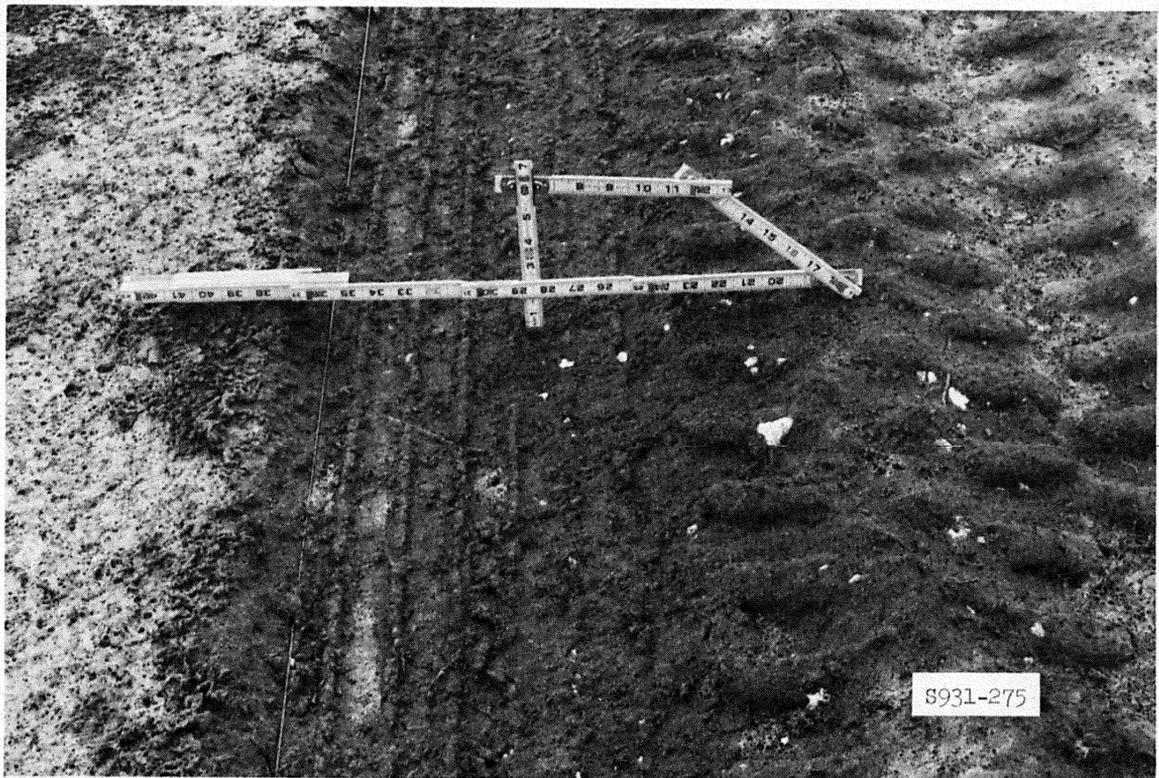
64. Material B. Following the application of prewetting water, material B was placed by the pneumatic distributor. Except for fisheying (photo 6), acceptable application rates and uniform coverage were obtained. The fisheyes were large and numerous enough to require that the atomizing prewetting water nozzles be replaced with larger capacity V-jet nozzles. Although this change helped, it did not eliminate all fisheyes. Material B hit the ground with enough force and at such an angle that it disturbed the prewetted soil. Material B cured in 4 hr but remained tacky (photo 7) until enough dust or sand covered the surface to blot the tacky material. Application on the transition joints was the same as that described for material A (see paragraph 55).

Photo 6. Fisheyes in material B. Note ruts caused by operation of the pneumatic distributor

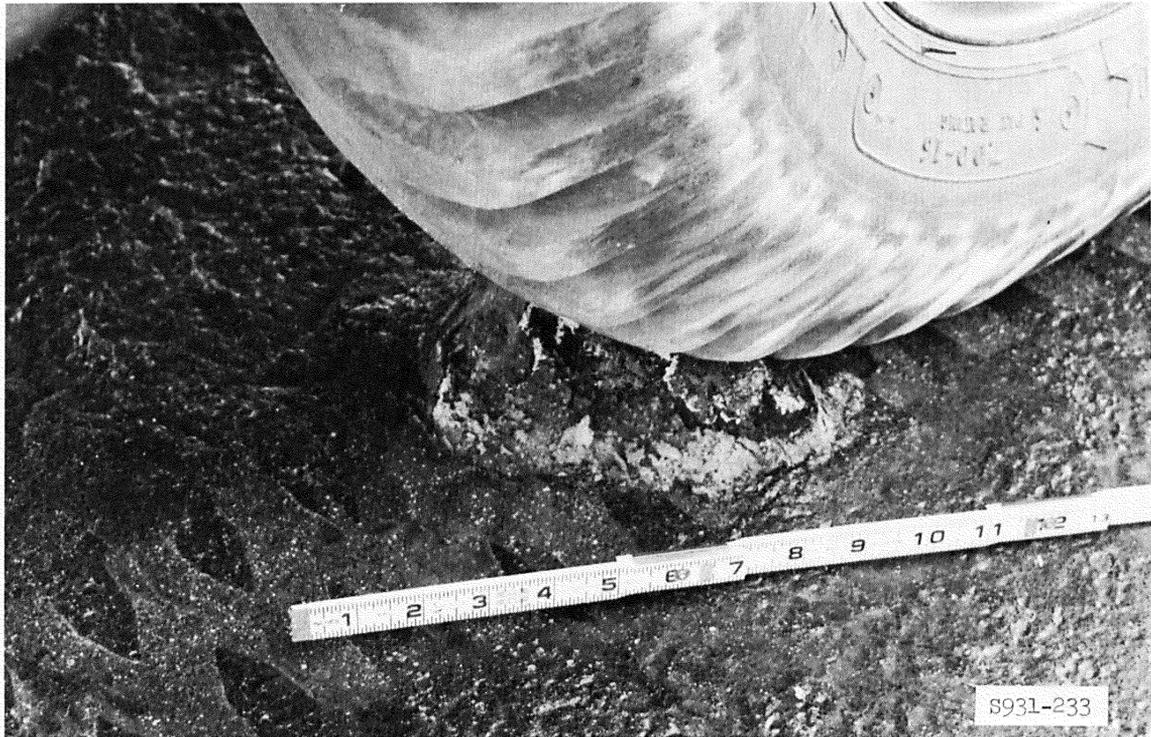
Photo 7. Tacky material B being picked up from surface by tire of test vehicle

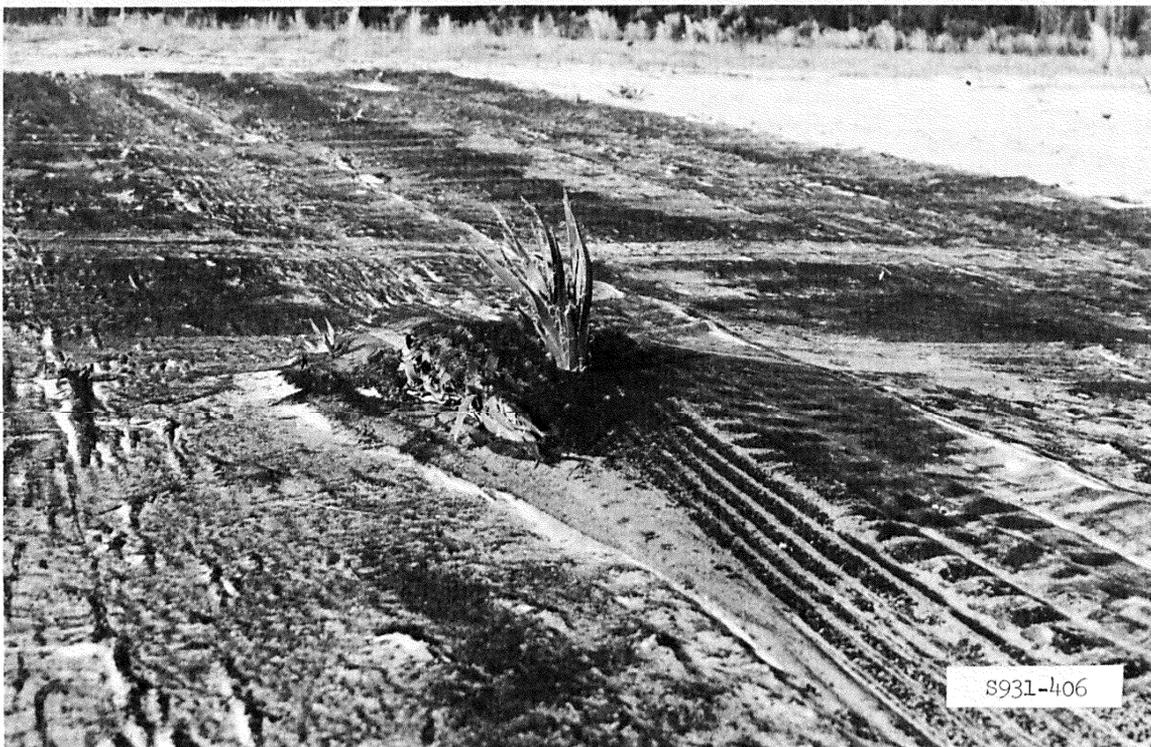
91. Retest results indicated that materials A and B had increased in strength during the 90-day period between tests. Blasts from the C-130 and helicopter air-impingment simulators produced no failures. The materials supported wheeled traffic with fewer failures than occurred during the initial tests. However, in places, vegetation had grown and lifted up the fiberglass-scrim reinforcement sections from materials A and B (photo 8).

Photo 8. Vegetation pushing up fiberglass scrim at Eglin AFB, Fla., 90 days after application (scrim cut for photo)
