MISCELLANEOUS PAPER S-69-5

# EVALUATION OF MO - MAT GROUND COVER FOR USE IN ARMY DEPOT OPEN-STORAGE AREAS

January 1969

U. S. Army Engineer Waterways Experiment Station  
CORPS OF ENGINEERS  
Vicksburg, Mississippi

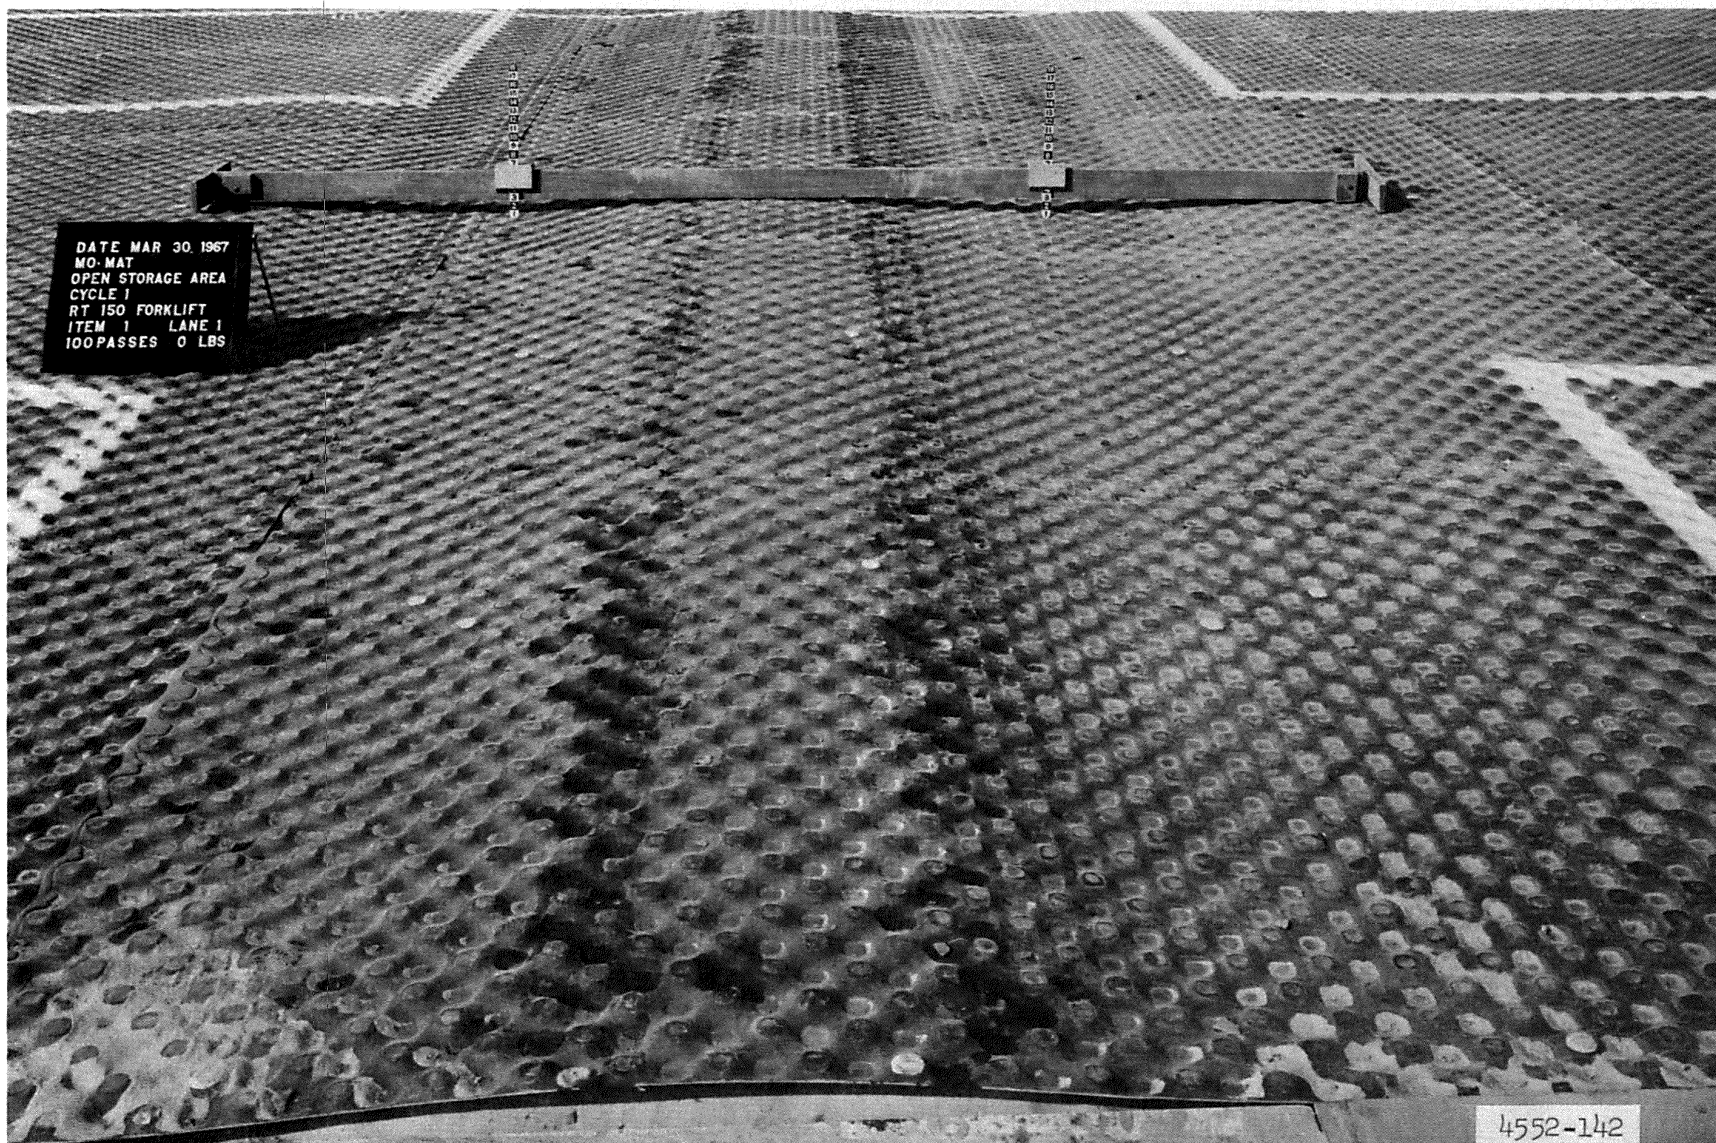
Photograph 15. Item 1, lane 1, after 100 passes of the RT-150 forklift with no payload  
in test series I, cycle 1

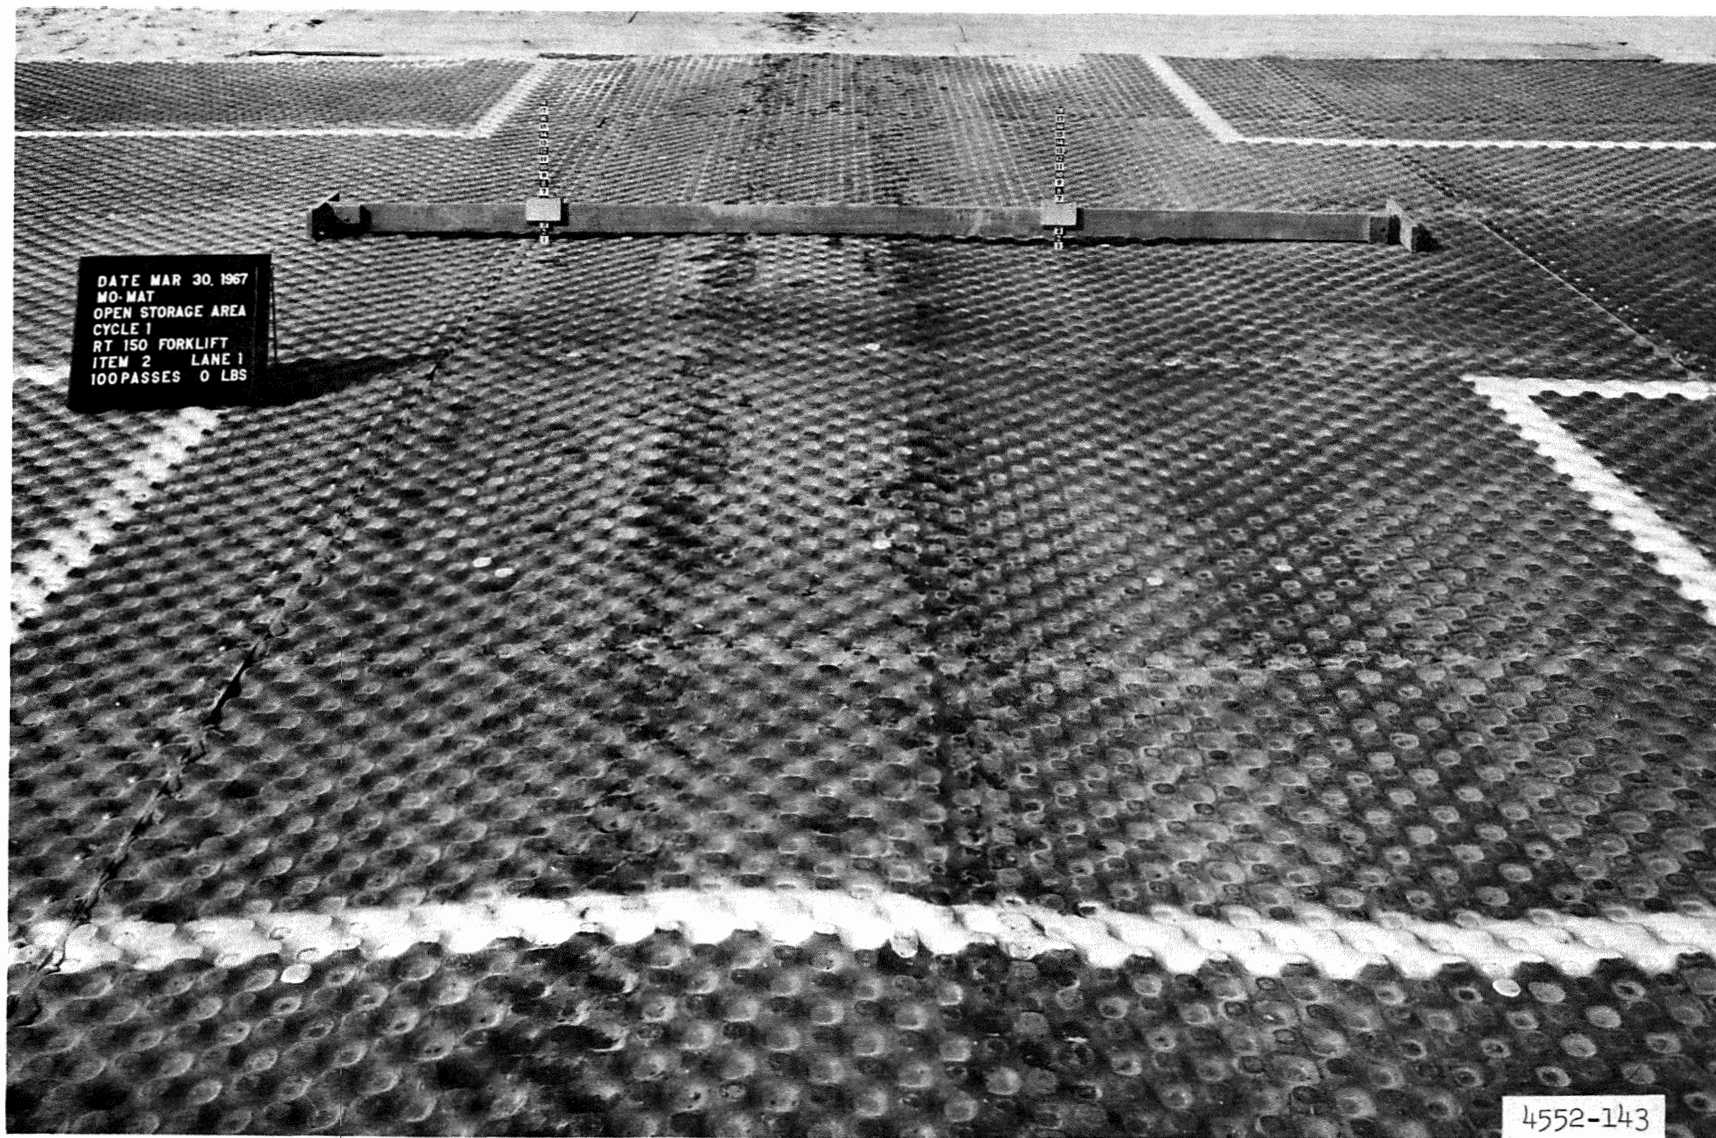
Photograph 16. Item 2, lane 1, after 100 passes of the RT-150 forklift with no payload in test series I, cycle 1

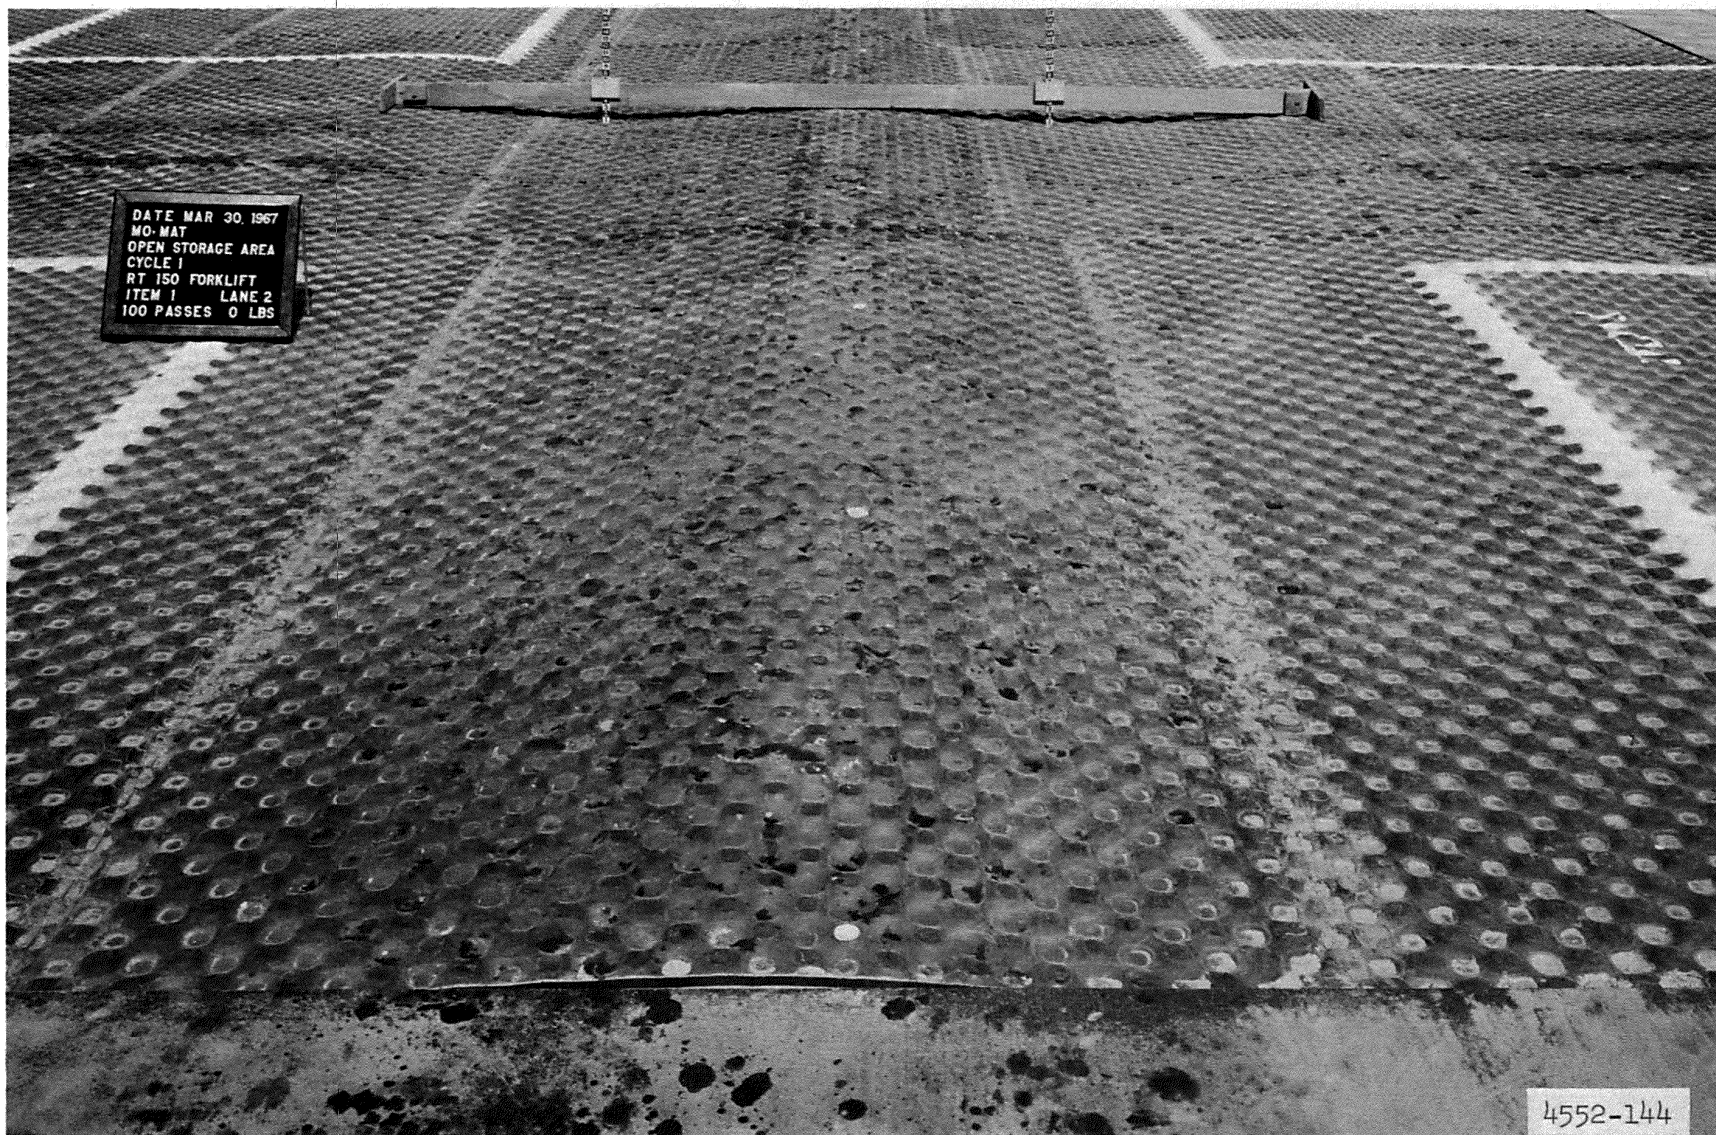
Photograph 17. Item 1, lane 2, after 100 passes of the RT-150 forklift with no payload in test series I, cycle 1

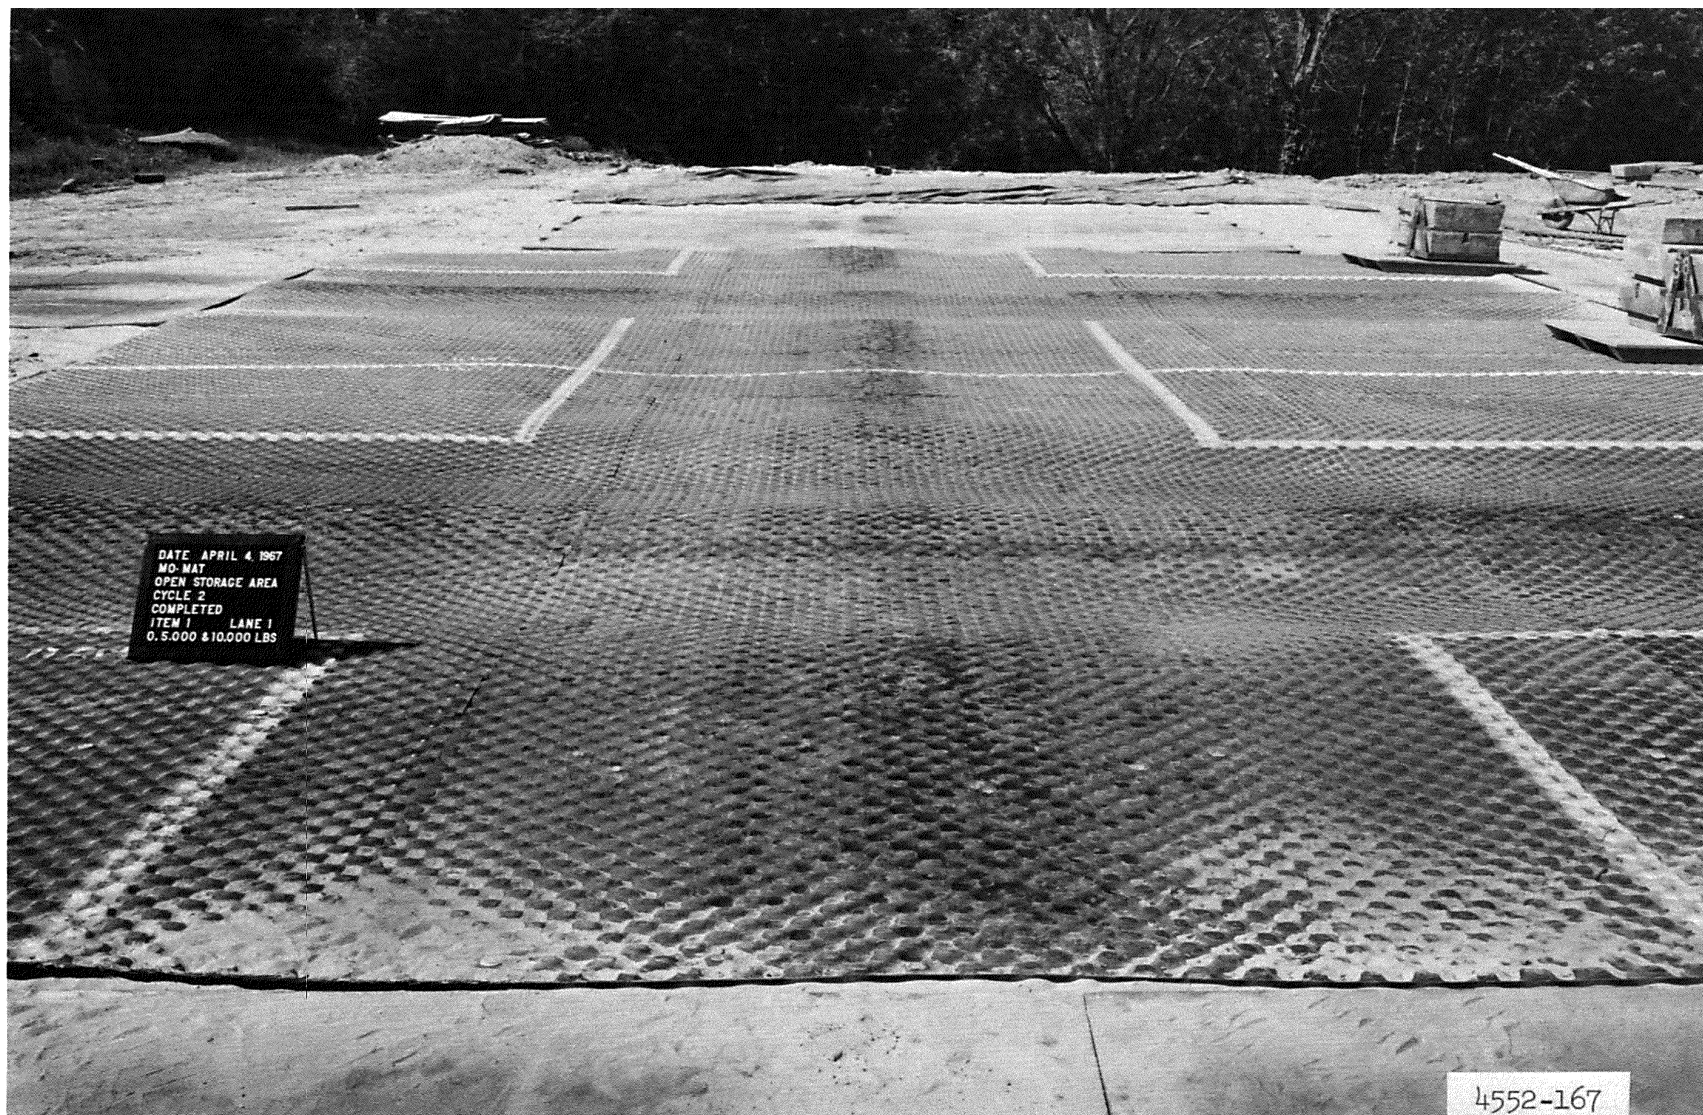
15. As traffic was continued through cycle 4 (photographs 19-22), the mat was not visibly damaged. Rutting occurred and increased gradually in depth until a maximum of approximately 5 in. was reached. Rutting was more extensive in item 1 than in item 2. No damage appeared to be caused by traffic of the cargo trucks.

Photograph 20. Item 1, lane 1, after the completion of cycle 2

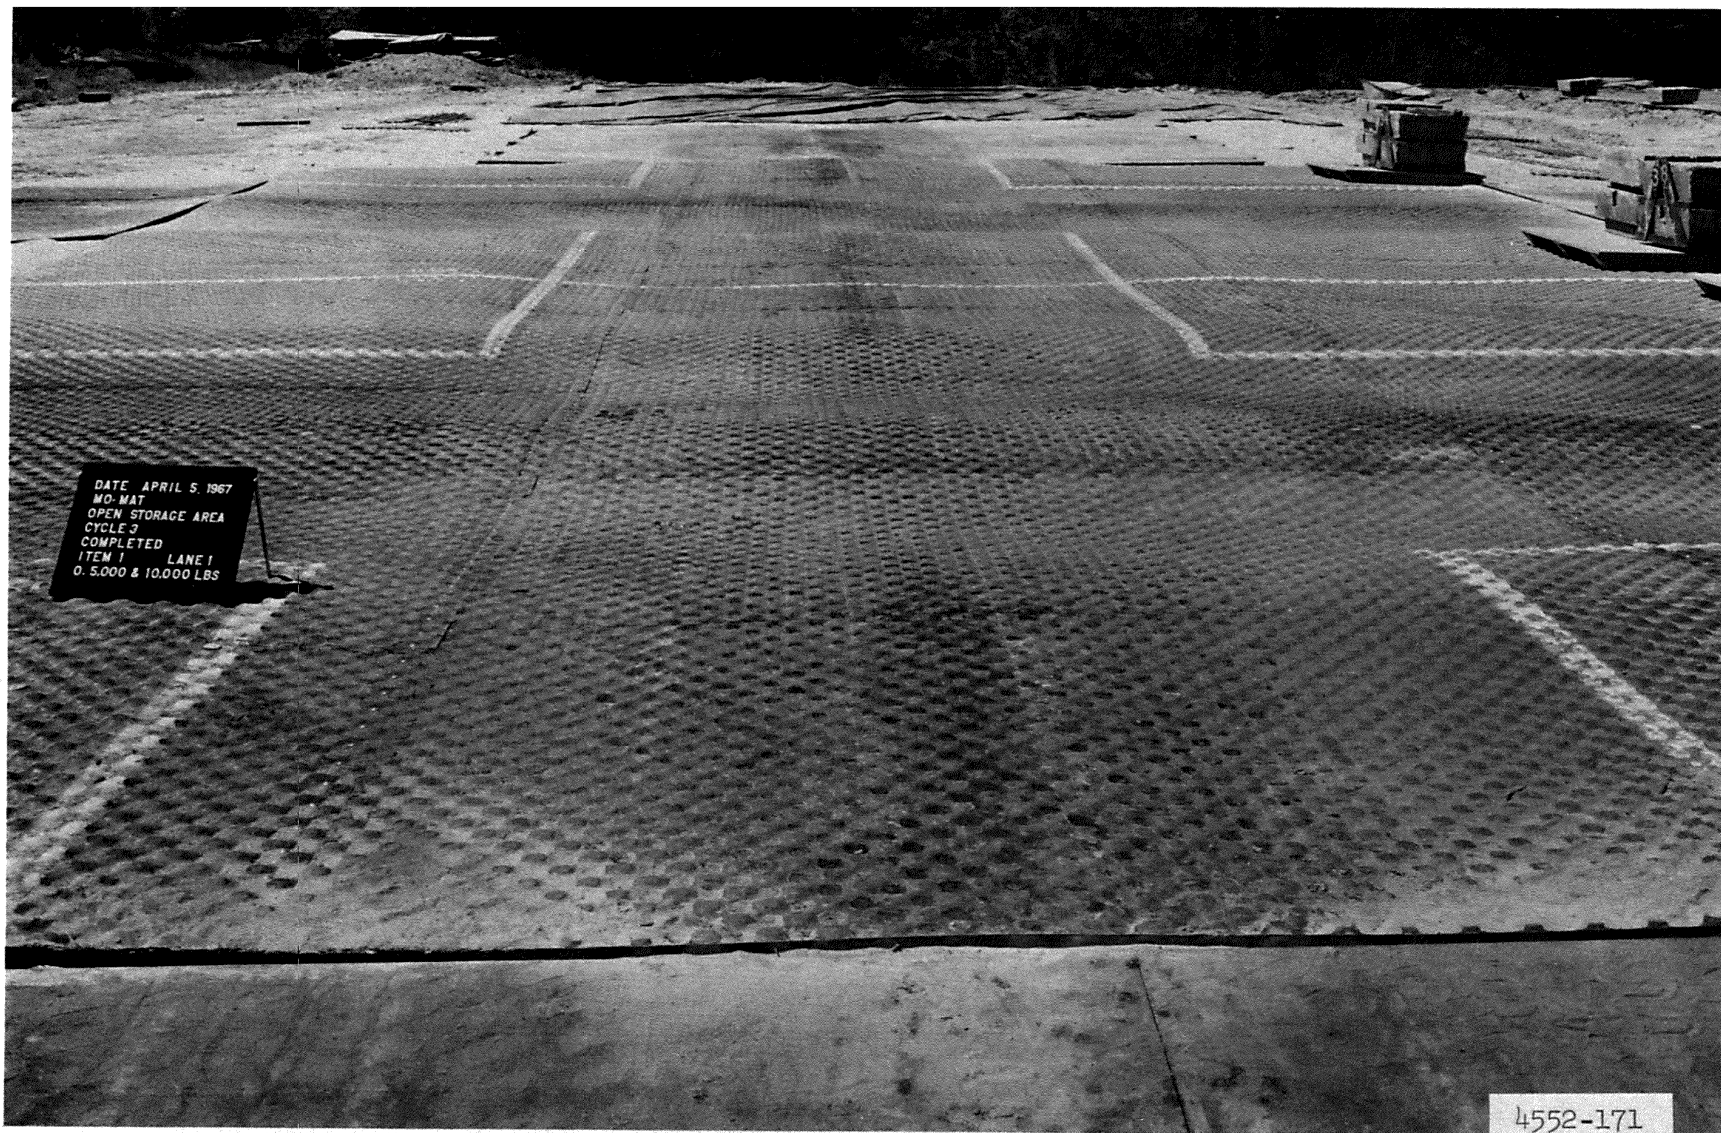
Photograph 21. Item 1, lane 1, after the completion of cycle 3

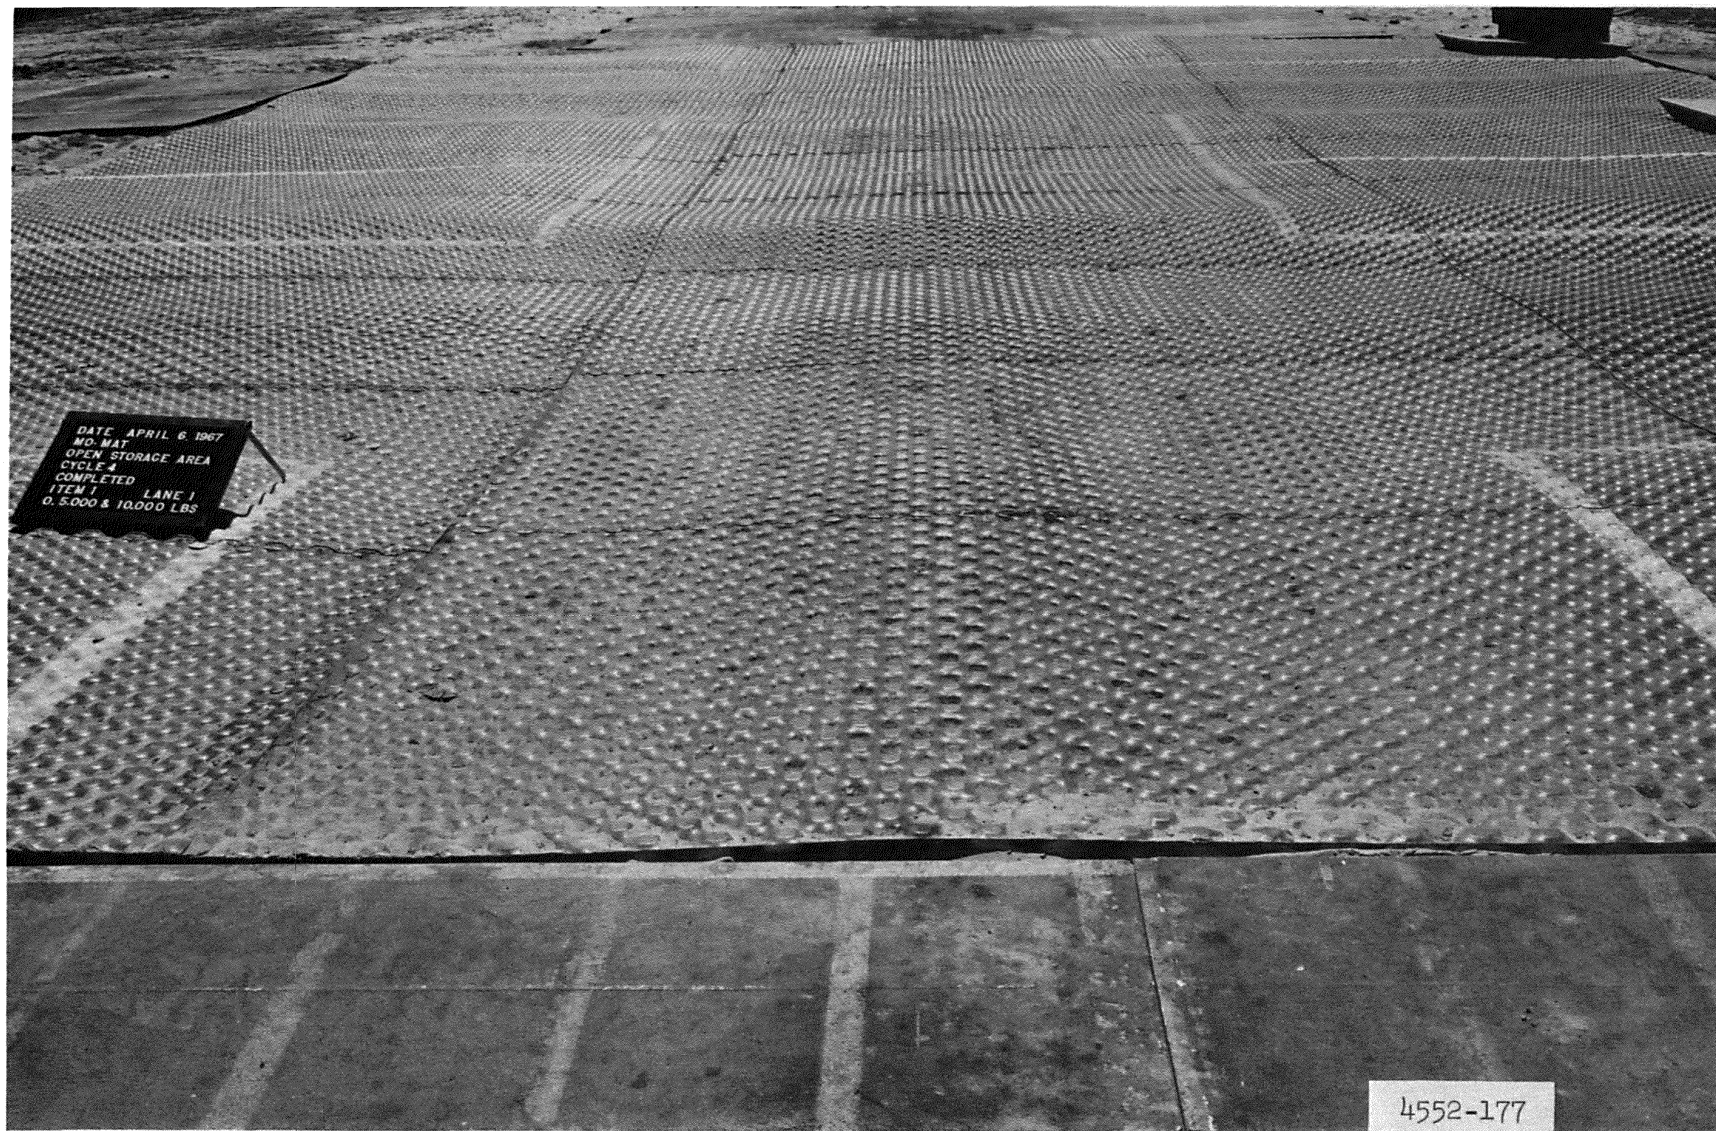
Photograph 22. Item 1, lane 1, after the completion of cycle 4

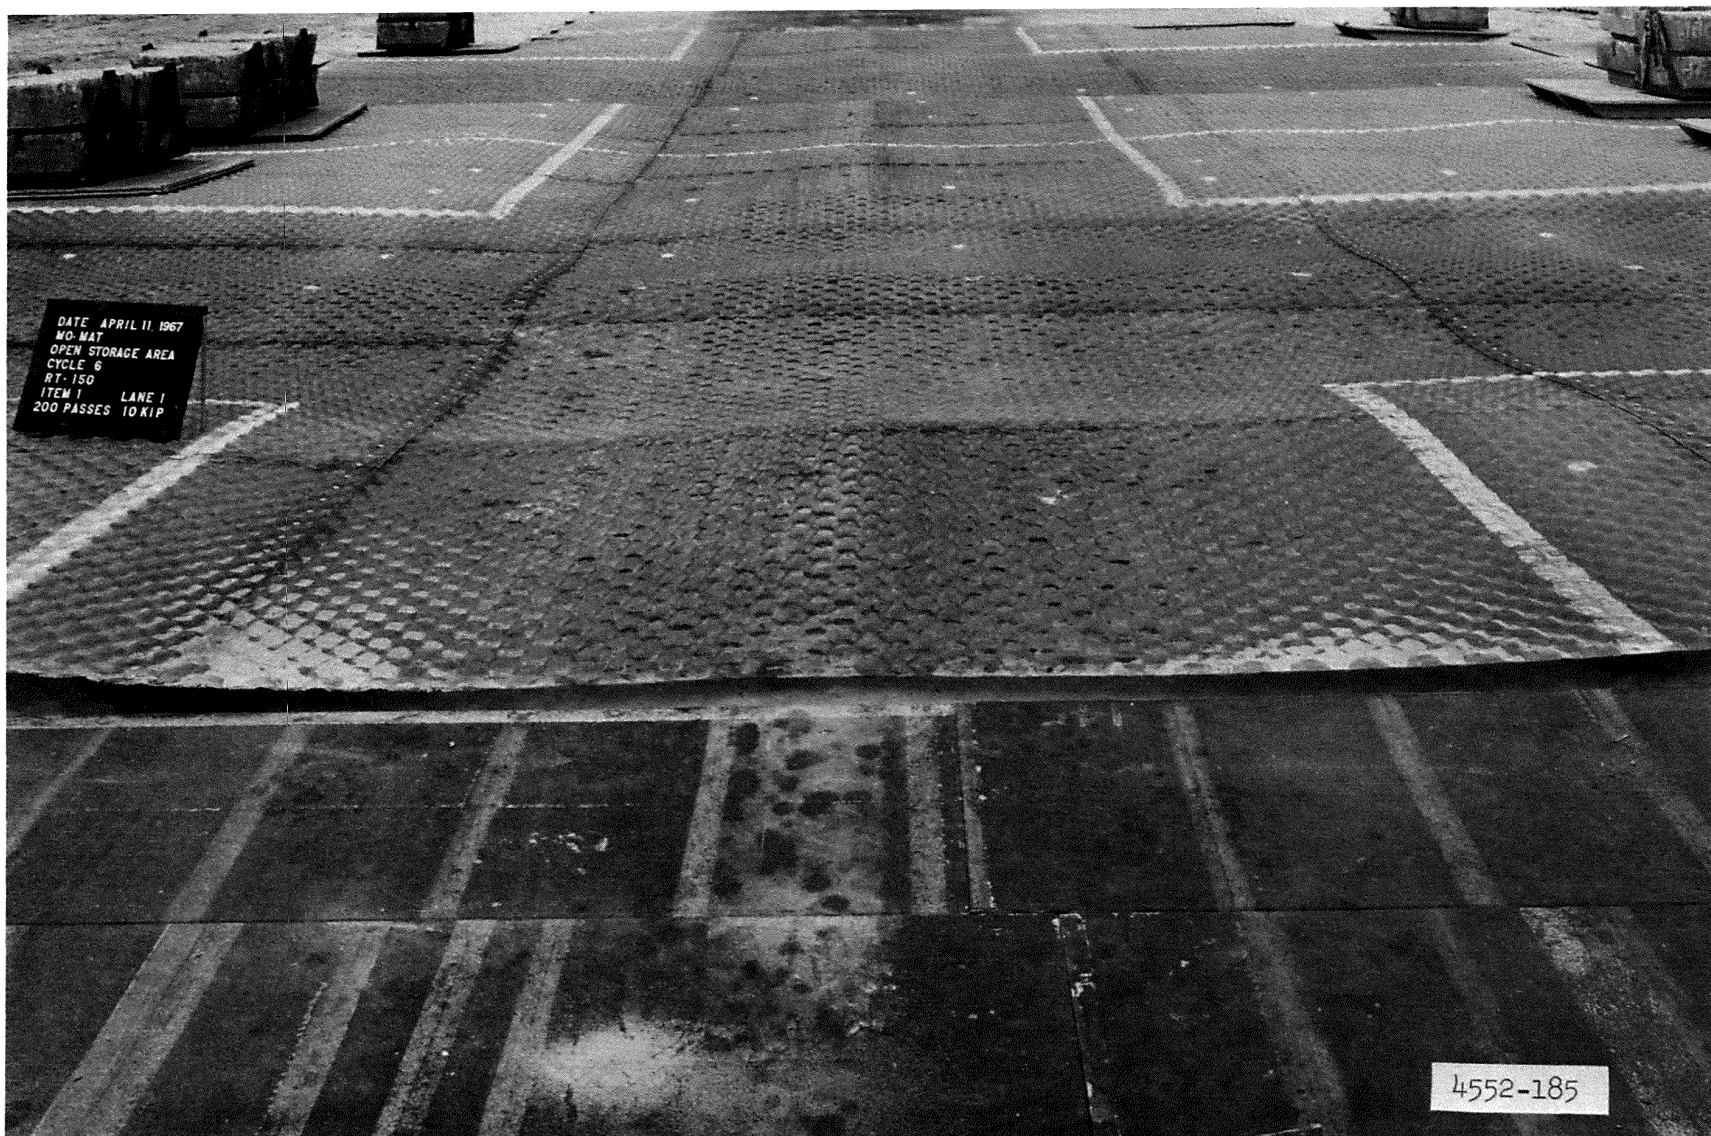
17. Prior to the start of cycle 6, several variations were made in the test plan. Pallets loaded to 8000 lb were placed on the south edge of the mat to further evaluate the effects of the pallet loading. Because the cargo truck traffic caused no apparent damage to the mat during previous cycles, the truck traffic was stopped. The testing was accelerated by placing 200 passes on each lane with the RT-150 with a 10,000-lb payload. After trafficking with this load, fairly deep ruts were present in all traffic lanes (photograph 23). The unconfined east and west ends of the mat had a tendency to curl.

Photograph 23. Item 1, lane 1, after 200 passes of the RT-150 forklift with a 10,000-lb payload (cycle 6)

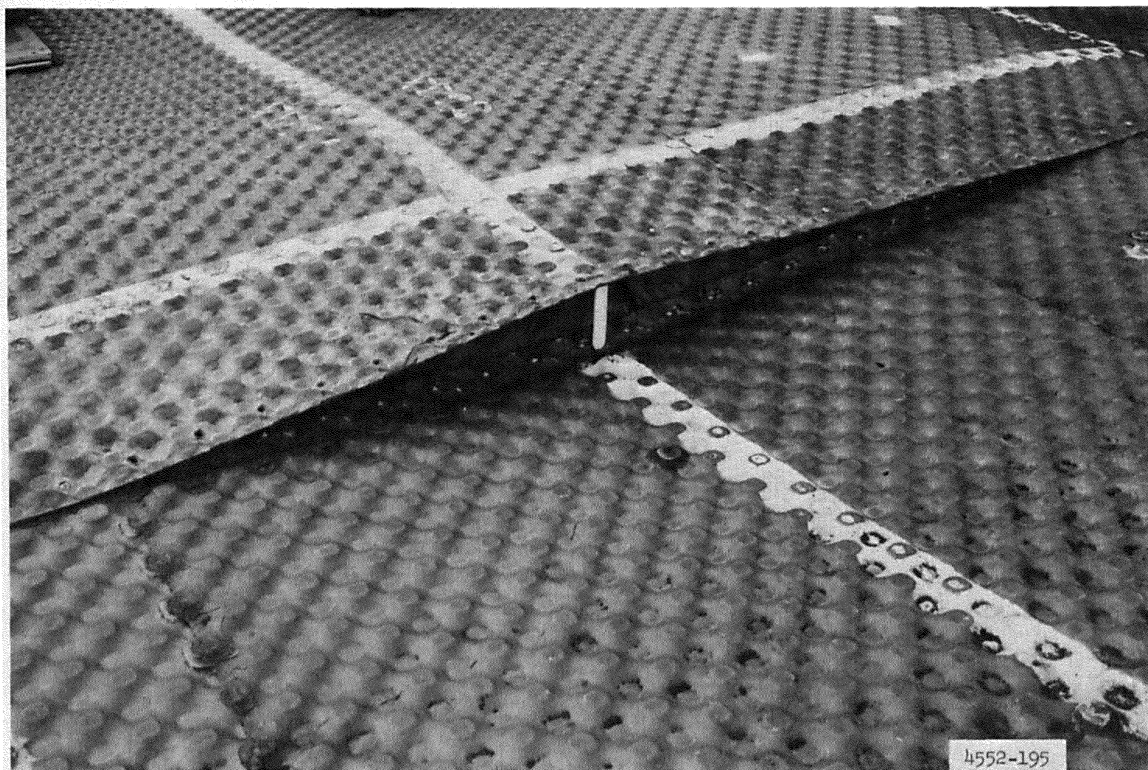
16. During cycle 5, the adhesive on the overlap joint (3.5 ft left of the center line in lane 1, item 1) lost its bond to the upper mat. At the completion of cycle 5, the length of the tear was approximately 17 ft.

- f. Prolonged traffic had no detrimental effect on the reinforced material from which MO-MAT is molded.
- g. The adhesive recommended by the manufacturer for constructing joints did not perform as desired.

Photograph 24. The failure of the longitudinal joint in lane 1 after 8 cycles of traffic

- a. Factory-fabricated joints should be staggered when constructing field joints with the mat.
- b. An adhesive stronger than the one supplied by the manufacturer for constructing the overlap joints should be provided.
- c. Vehicles with solid rubber tires should not be used on the mat.
- d. Small pieces of mat to be used for repairs should be included in bundle shipments.

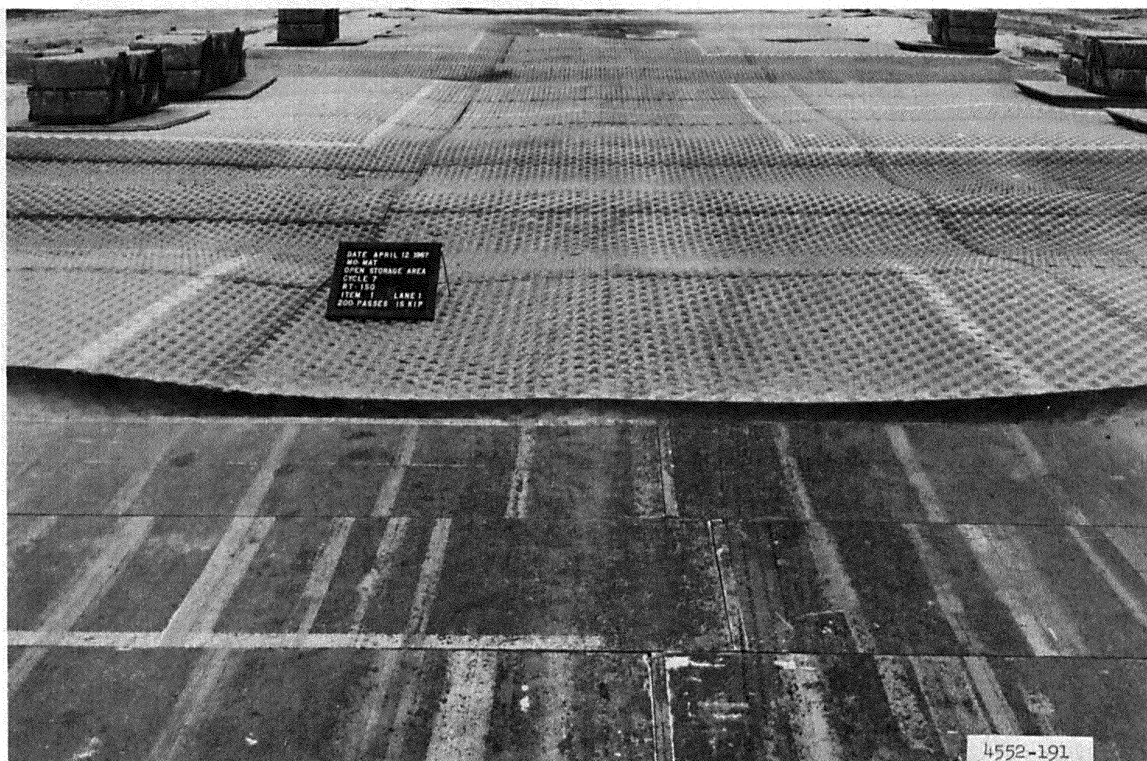
18. Cycle 7 consisted of 200 passes of the RT-150 forklift loaded to the maximum payload of 15,000 lb. The effect of this increased loading was evident as the traffic progressed. In lane 1 after 150 passes, two rivets had pulled through the mat, and at 170 passes, the overlap joint had completely failed for approximately 10 ft. After completion of this cycle, 25 rivets had pulled through the mat (photograph 24). Deep rutting developed in all traffic lanes (photograph 25). Cycle 8 consisted of 20 passes per lane of the RT-150 forklift with the 15,000-lb payload. No additional damage was done to the mat. The test section was considered failed when the testing was stopped; however, the adhesive joint was actually the only part of the mat to fail structurally during the investigation. Profiles and cross sections are shown in plates 7 and 8.

Photograph 25. Item 1, lane 1, after 200 passes with the RT-150 forklift with a 15,000-lb payload (cycle 7)

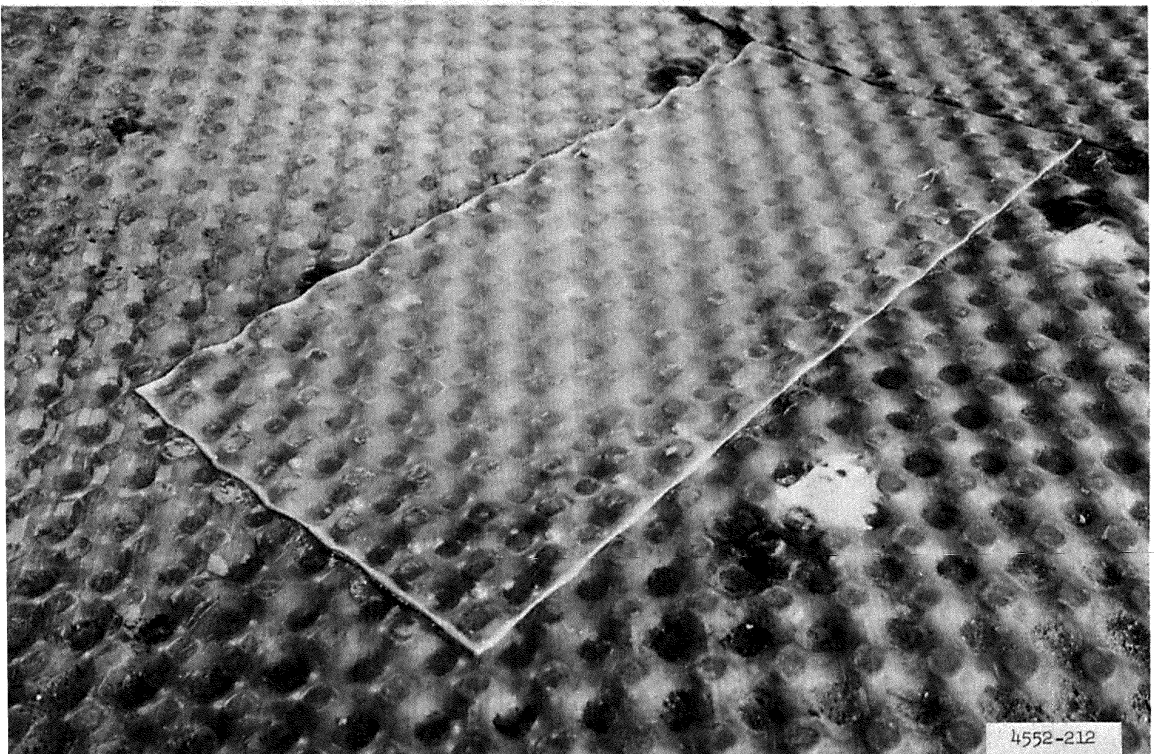
Photograph 29. A 2- by 4-ft patch used to repair joint

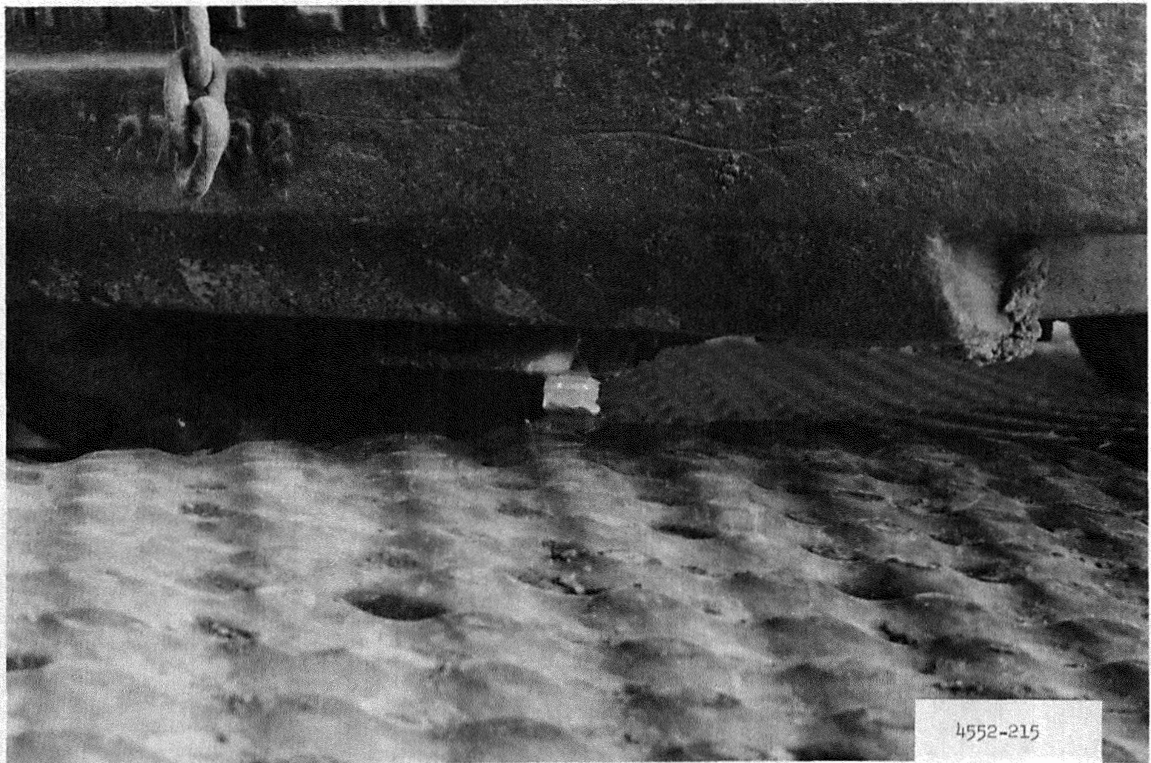
25. Rutting became more apparent in item 1 during cycle 2. After 10 passes of the RT-150 forklift with a payload of 5000 lb, the undercarriage of the test vehicle began to scrape the surface of the mat (photograph 30). The result of the scraping action is shown in photograph 31. At the end of 30 passes with a 15,000-lb payload, rutting had become so severe that item 1 was considered failed. A total of 790 passes had been applied to item 1. Traffic was continued for eight cycles in lanes 1 and 3 on item 2. At the completion of cycle 8, no additional damage to the mat in item 2 had occurred. Only slight rutting had developed due to concentrated traffic (photograph 32). Profiles and cross sections are shown in plates 10 through 13.

Photograph 30. Low clearance between undercarriage of RT-150 forklift  
and mat surface

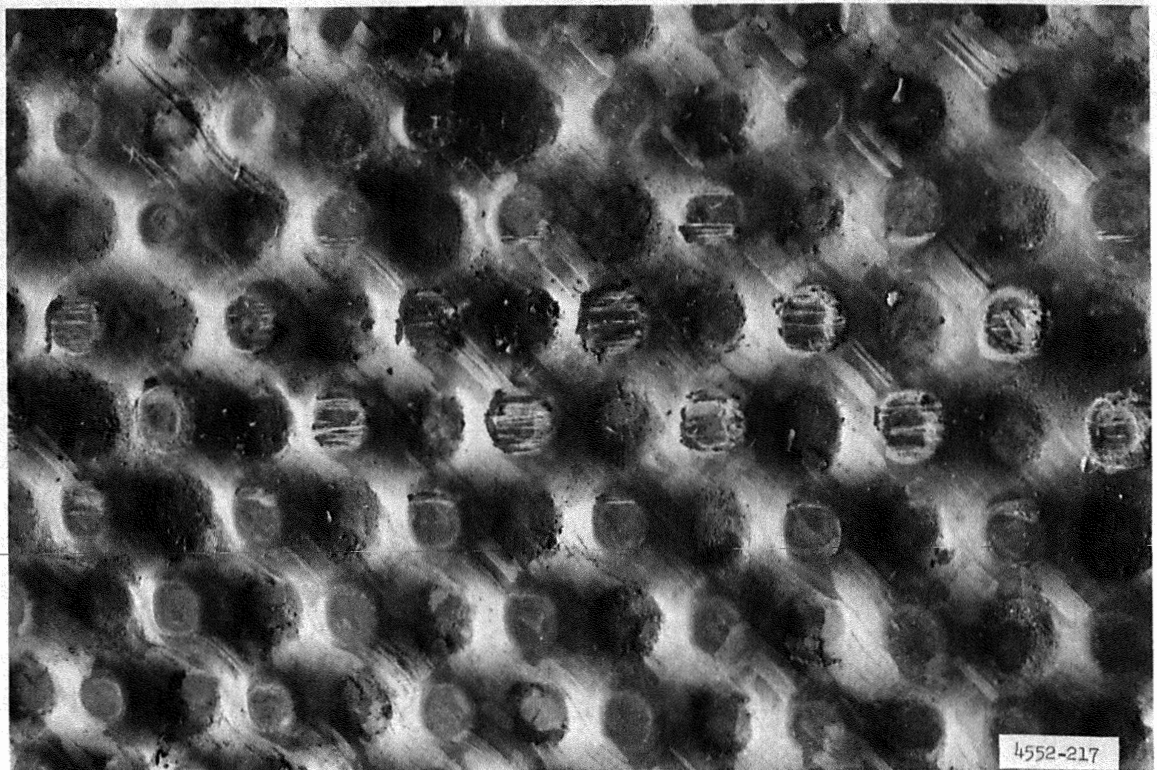
Photograph 31. Damage resulting from Hyster undercarriage's dragging  
surface of mat

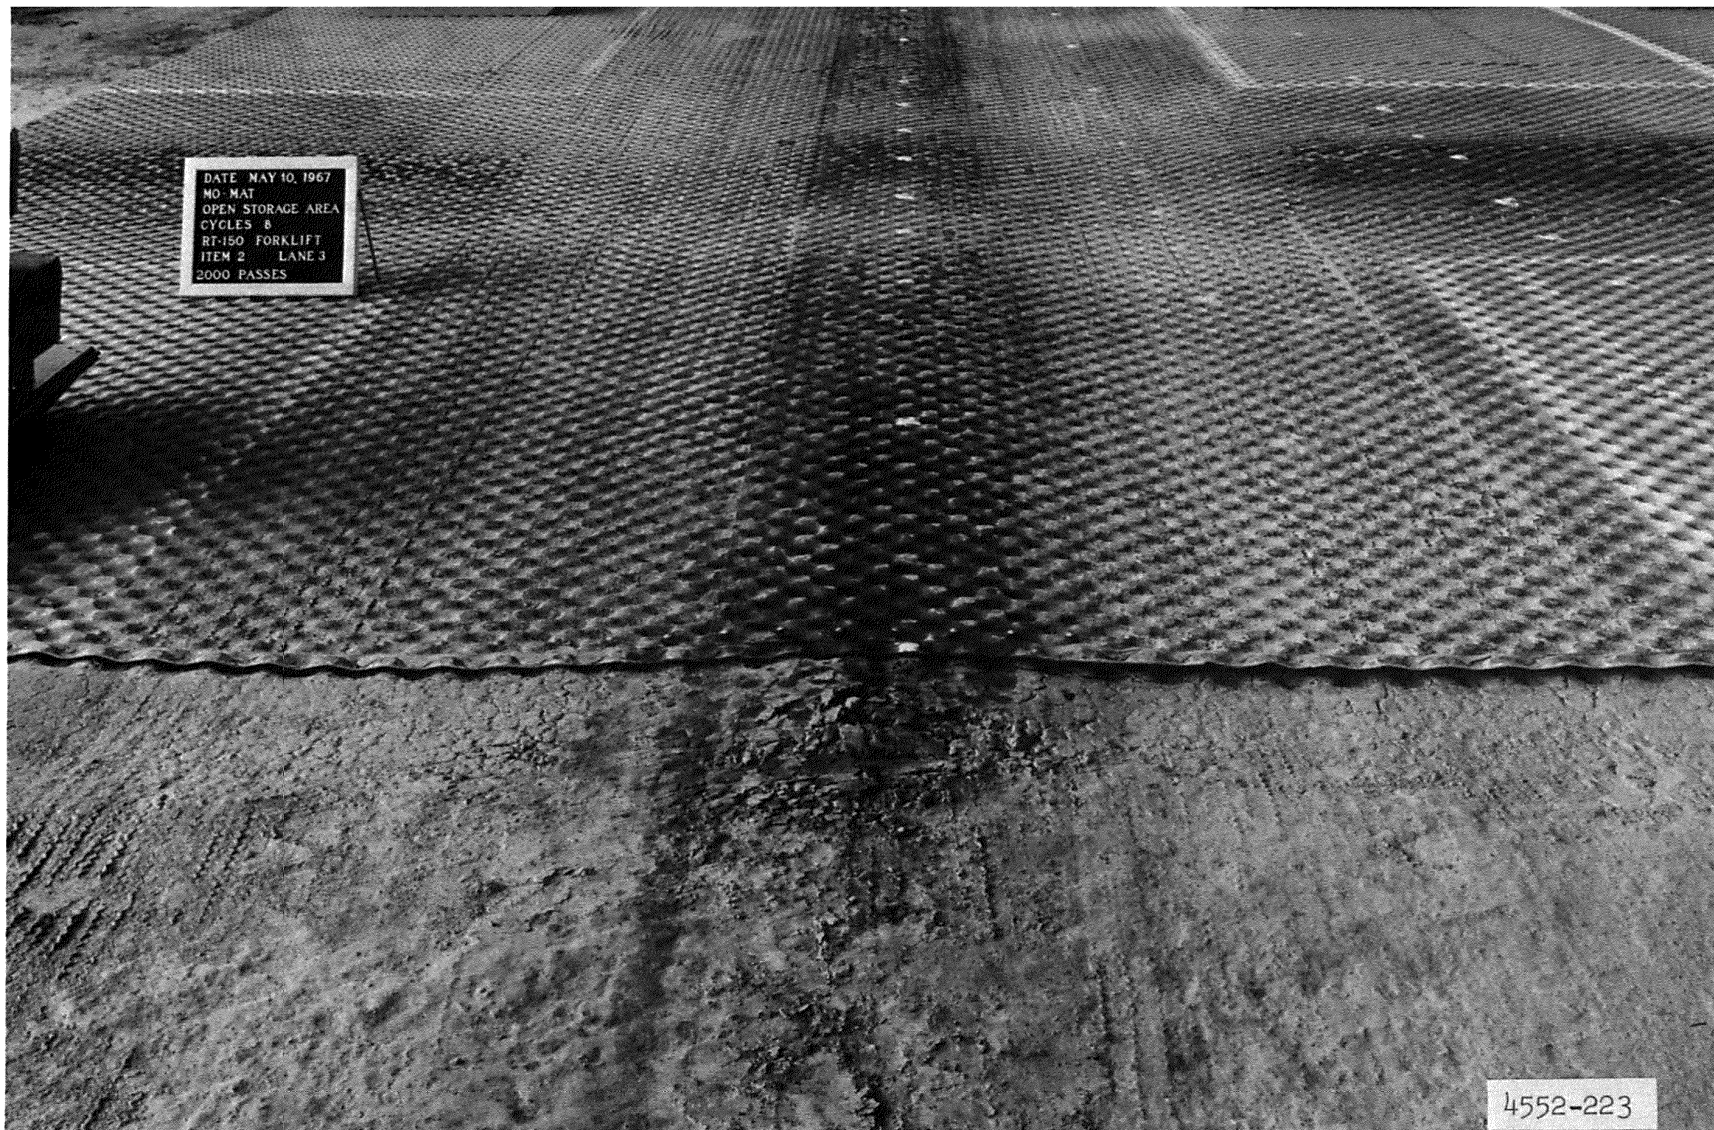
Photograph 32. Item 2, lane 3, after 2000 passes of the RT-150 forklift

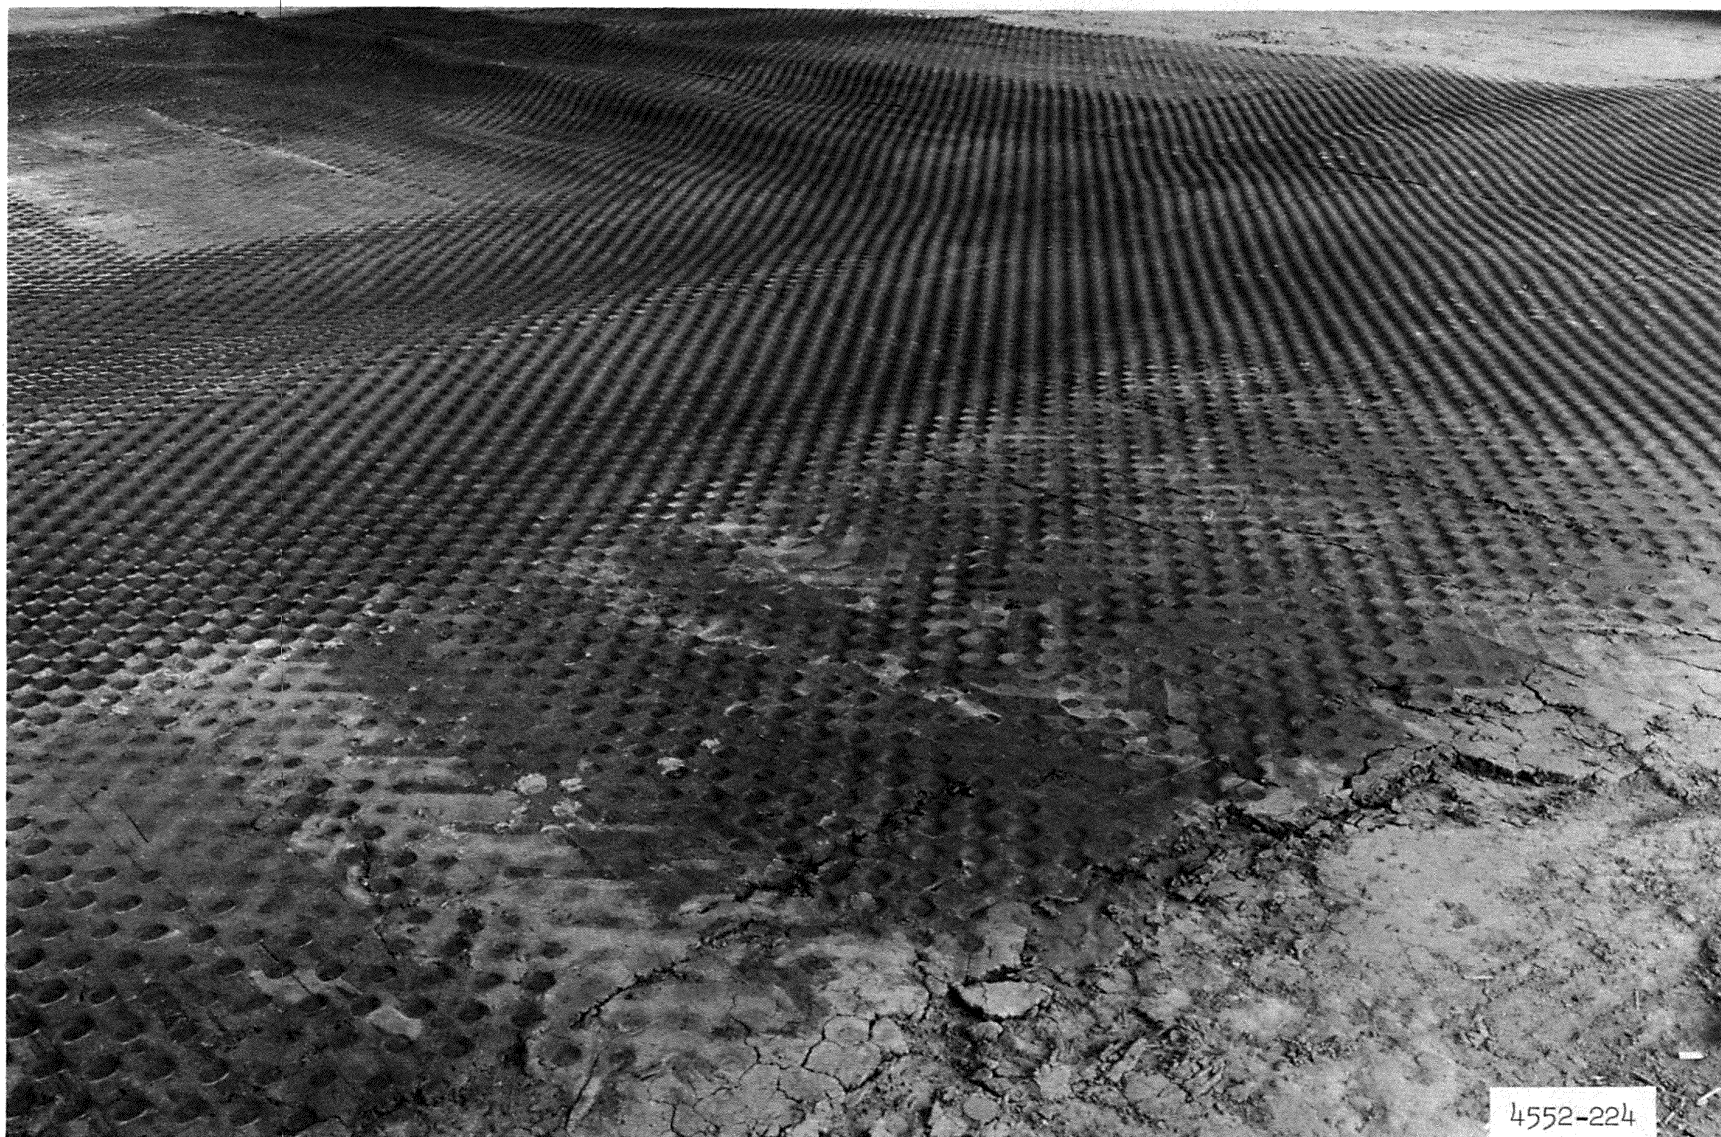
Photograph 33. Subgrades of items 1 and 2 at the completion of mat testing. Picture was taken before the additional traffic was run on the unsurfaced subgrade
