MISCELLANEOUS PAPER S-72-23

CONDITION SURVEY, REDSTONE ARMY AIRFIELD, HUNTSVILLE, ALABAMA

June 1972

Conducted by U. S. Army Engineer Waterways Experiment Station
Soils and Pavements Laboratory
Vicksburg, Mississippi

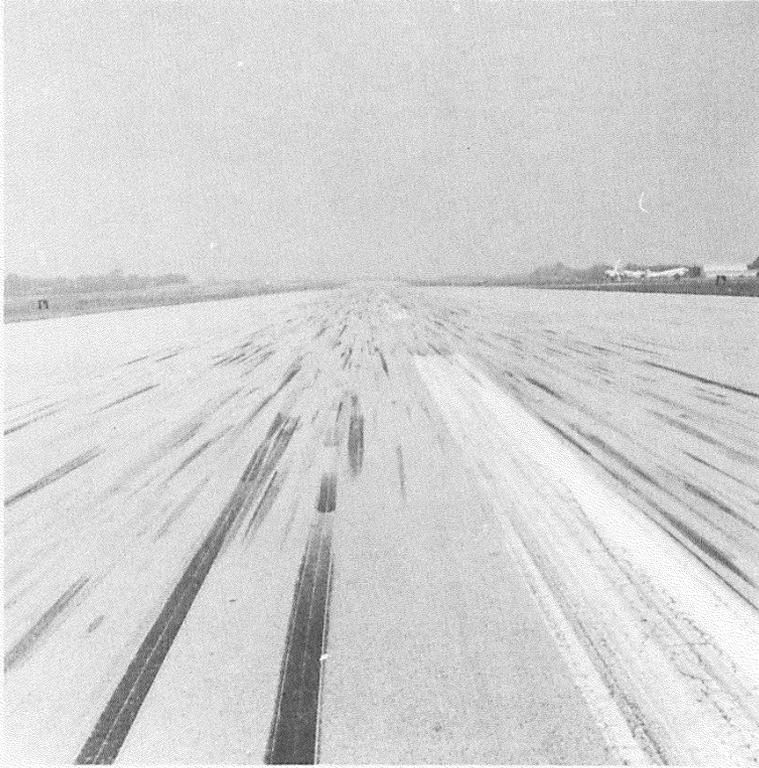
13. A visual inspection of the pavements in April 1971 indicated the pavement condition to range from poor to very good. The surface on the runway and two connecting taxiways was in very good condition with some evidence of crack opening at longitudinal joints (photographs 1-3). The taxiway to the NASA apron showed distress in the form of rutting (photograph 4) from the wheel load of the Guppy aircraft. A localized weak area probably exists in the taxiway as there is no evidence of any distress from operation of this aircraft on the NASA apron. The portland cement concrete apron is in poor condition as a result of numerous spall areas that are occurring on the surface (photographs 5-8). These spalls appear to be the result of D-line cracking that occurs in the slab surface. This type cracking may extend for the full depth of the slab, but it appears only the top 1-2 in. at the surface are affected. Some spalled areas along the joints have been repaired in the past with an epoxy grout, and in some cases, the cracking continues next to the patched area (photograph 8). A crack survey of the parking apron indicates that approximately 6 percent of the slabs contain major structural defects, such as longitudinal, transverse, or diagonal breaks.

Photograph 1. View along N-S runway (south to north)

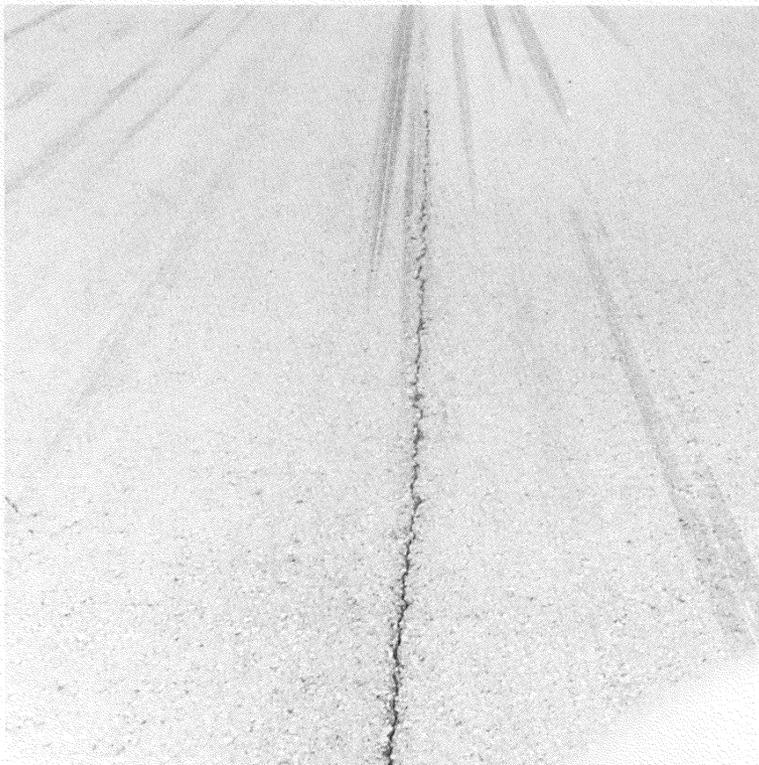
Photograph 2. Cracking in longitudinal construction joint in runway

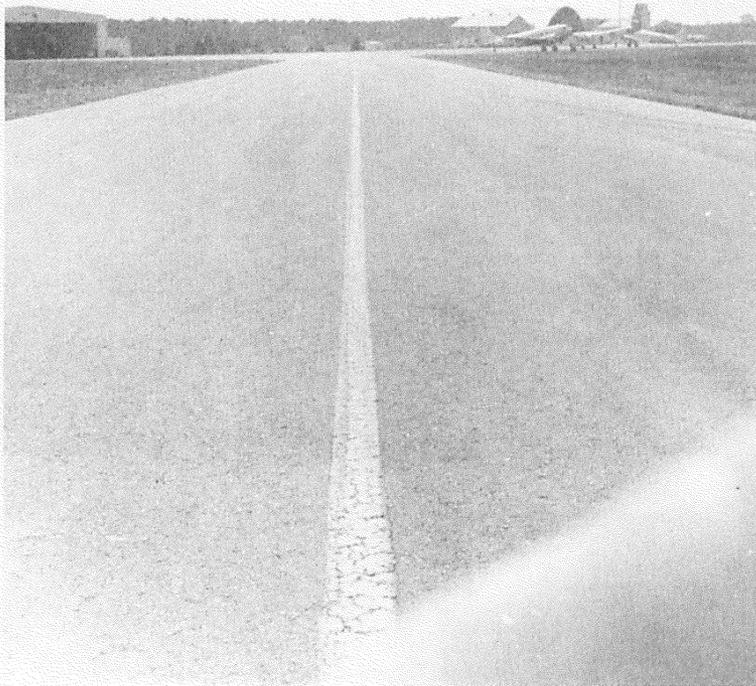
Photograph 3. Condition of connecting taxiway

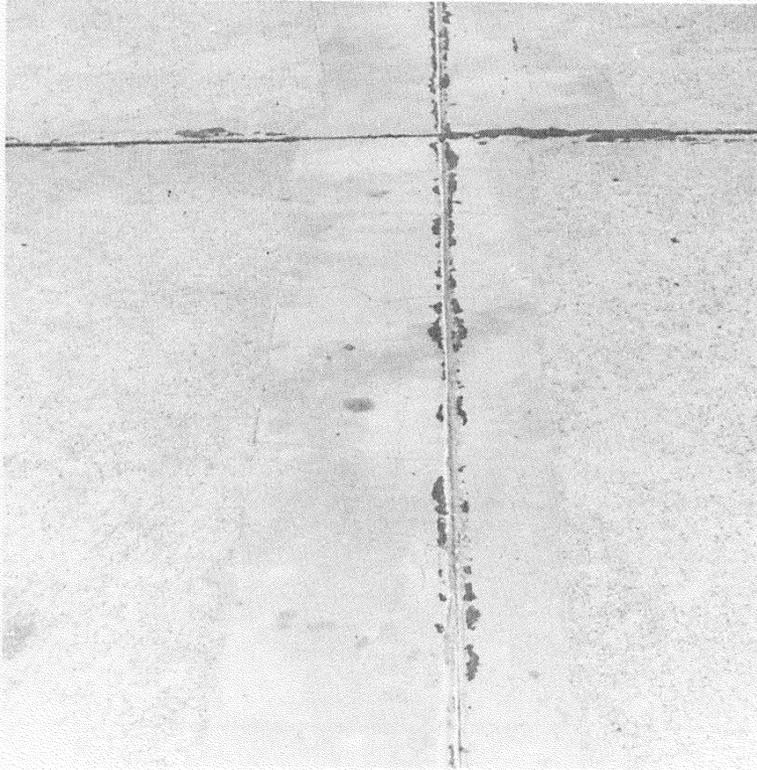
12. Maintenance has consisted of sealing cracks and repairing spalled areas in the portland cement concrete on the parking apron. The spalled areas, caused by D-line cracking in the slab and occurring mostly along the joints, have been repaired using an epoxy grout. About 132 slabs on the northwest corner of the apron were replaced due to structural failures. An extensive maintenance program is needed at the present time to repair the many spalled areas in the parking apron.

Photograph 5. Spall on longitudinal joint in apron area that has been repaired with epoxy grout

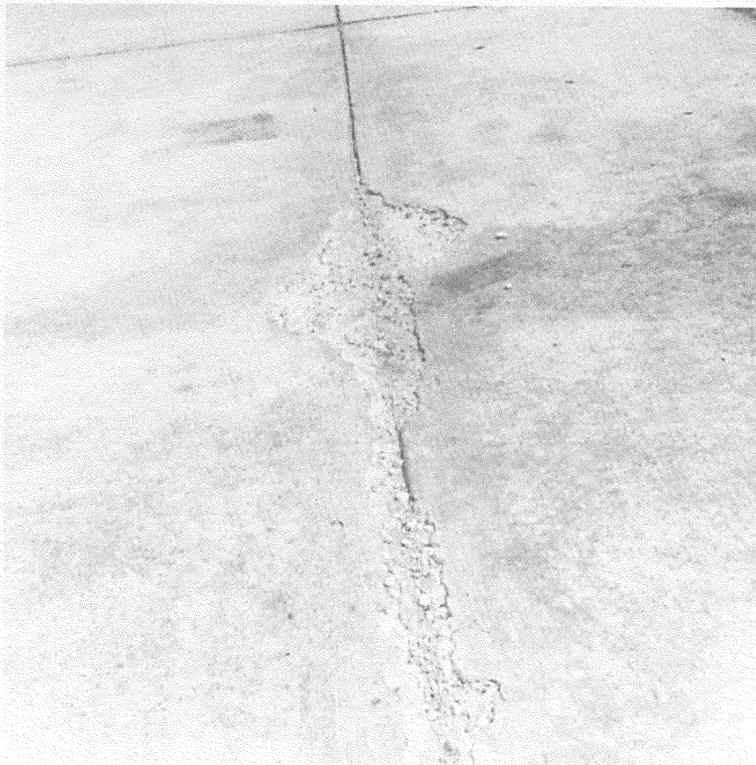
Photograph 6. Spalling along longitudinal joints in apron area

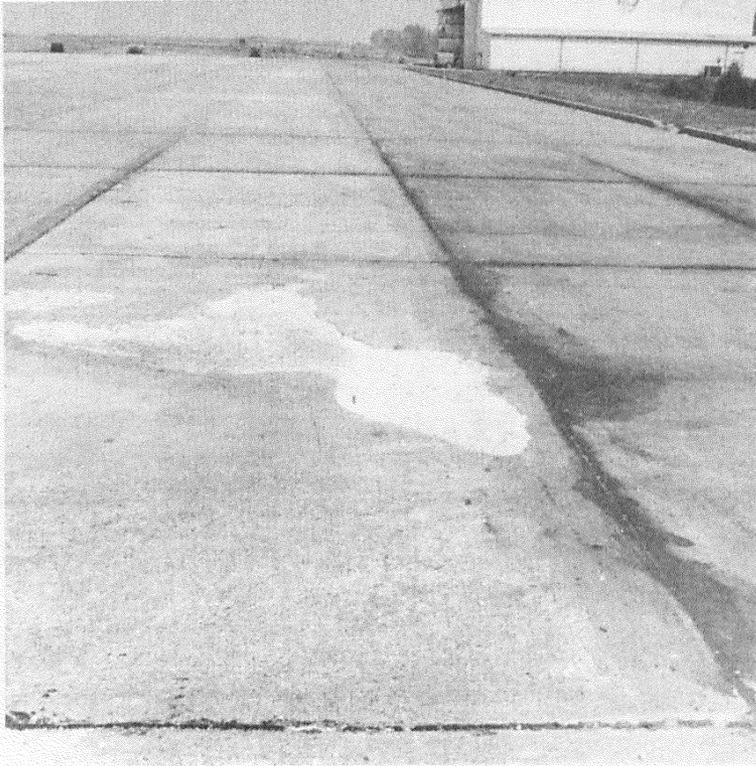
Photograph 7. Spalled area covering most of slab

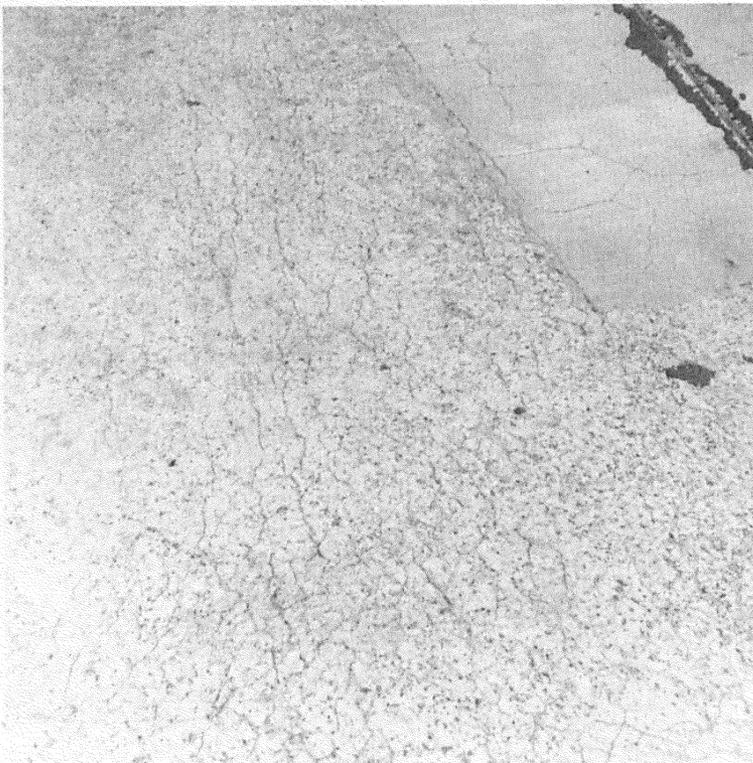
Photograph 8. D-line cracking that is causing spalling
