MISCELLANEOUS PAPER S-72-22

CONDITION SURVEY, FORNEY ARMY AIRFIELD FORT LEONARD WOOD, MISSOURI

June 1972

Conducted by **U. S. Army Engineer Waterways Experiment Station**
Soils and Pavements Laboratory
Vicksburg, Mississippi

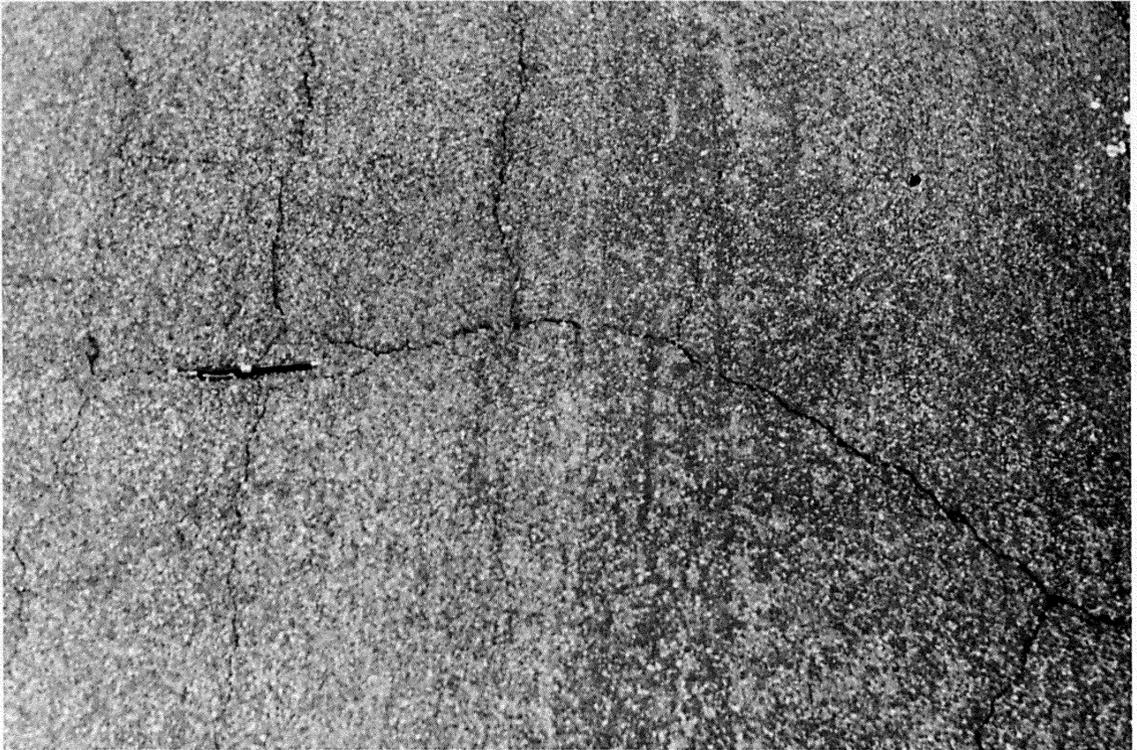
8. A visual inspection of the pavements in April 1971 indicated the airfield pavement to be generally in fair condition. The runway contained numerous cracks; however, the major portion appeared to be adequately supporting the aircraft using the pavement. The typical condition of the major portion of the runway pavement is shown in photograph 1. Photograph 2 shows the condition of an area about 25 ft wide, located east of the center line and extending from the vicinity of runway sta 34+60 to 40+60; this area is showing considerable distress. Another area, approximately 25 by 100 ft and located near runway sta 65+00, showed some distress

Photograph 1. Typical condition of runway pavement

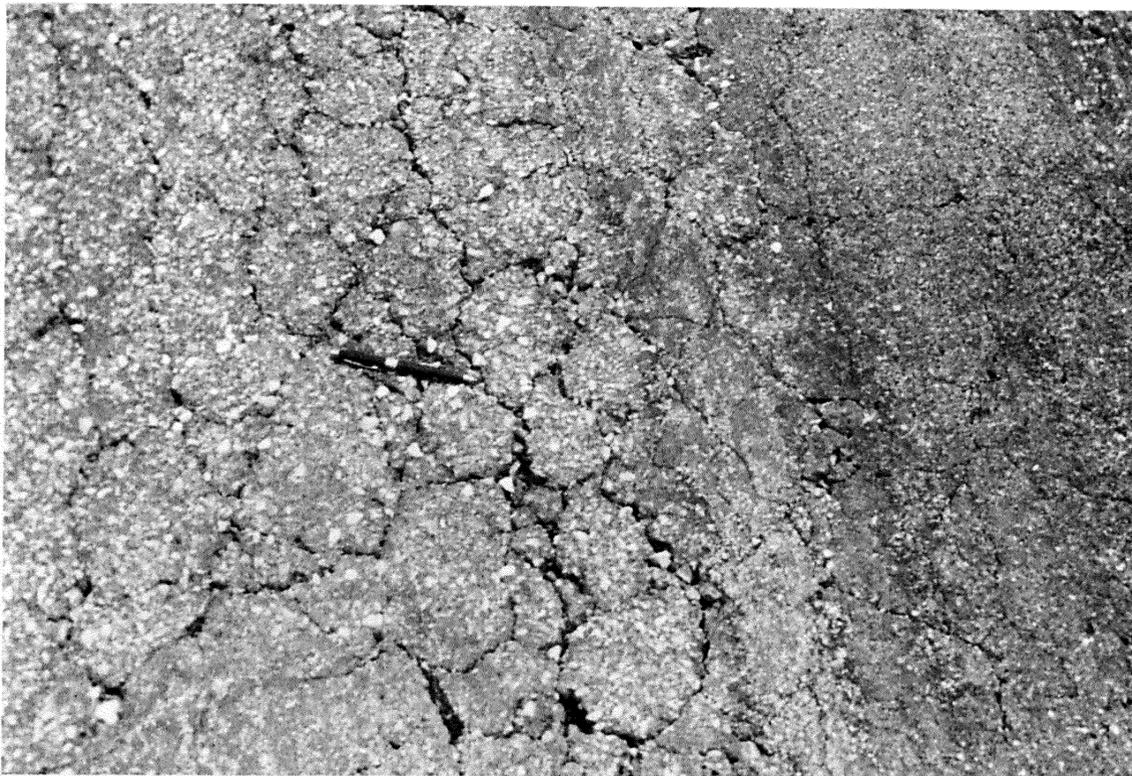
Photograph 2. Distressed area near middle of runway

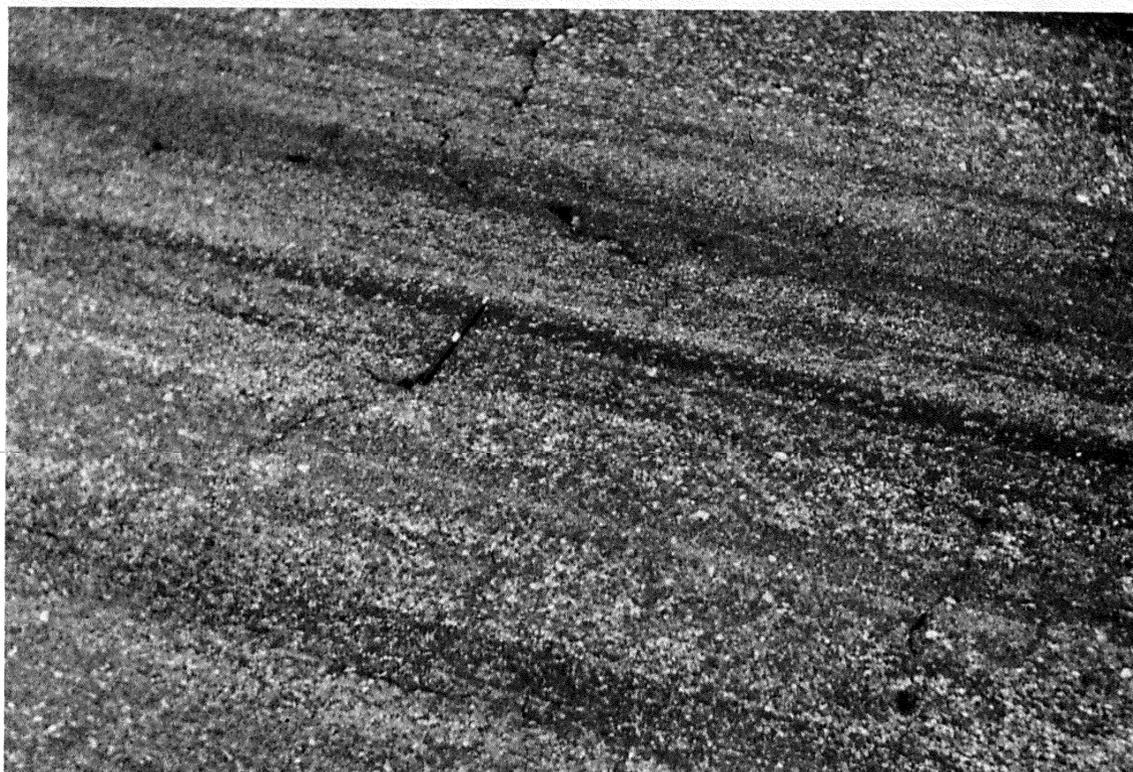
(photograph 3); however, distress in this area was not as severe as that in the area near the middle of the runway.

Photograph 3. Distressed area near north end of runway

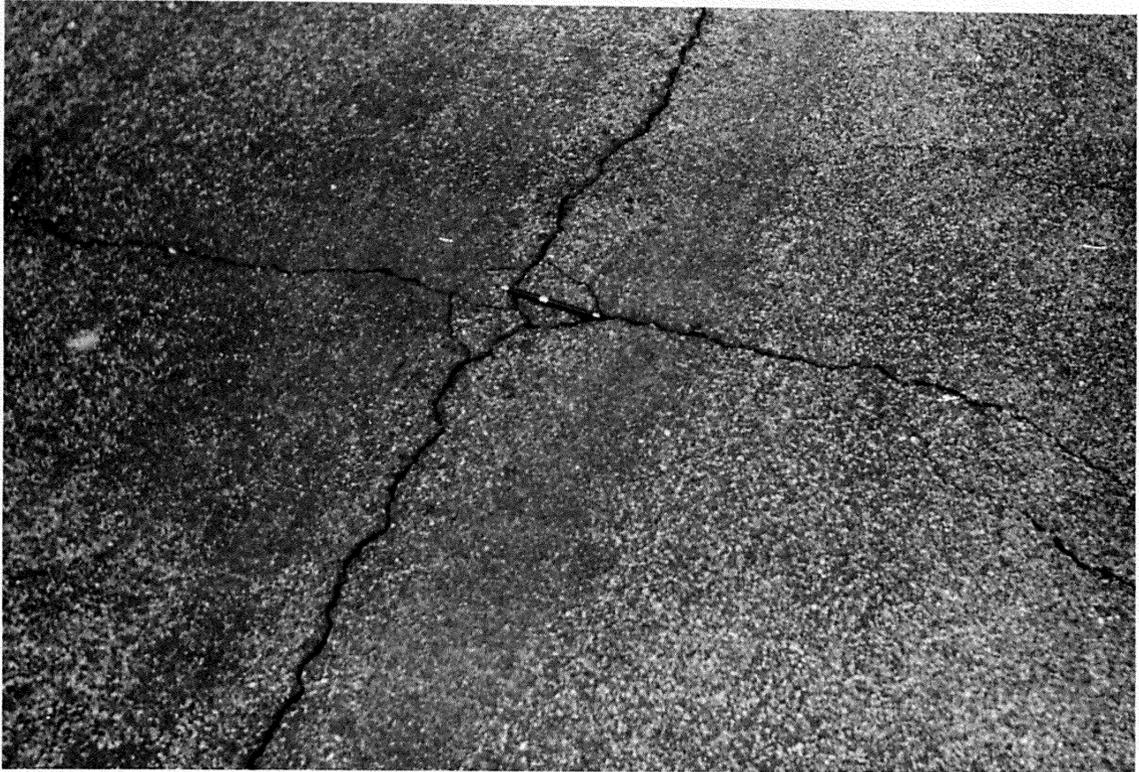
9. The taxiway and apron contained numerous cracks. Views of typical pavements of the taxiway and apron are shown in photographs 4 and 5, respectively. The cracks in the taxiway were approximately 25 ft apart in each direction and appeared to be contraction cracks. Neither the taxiway nor the apron showed any structural distress.

Photograph 4. Typical condition of taxiway pavement

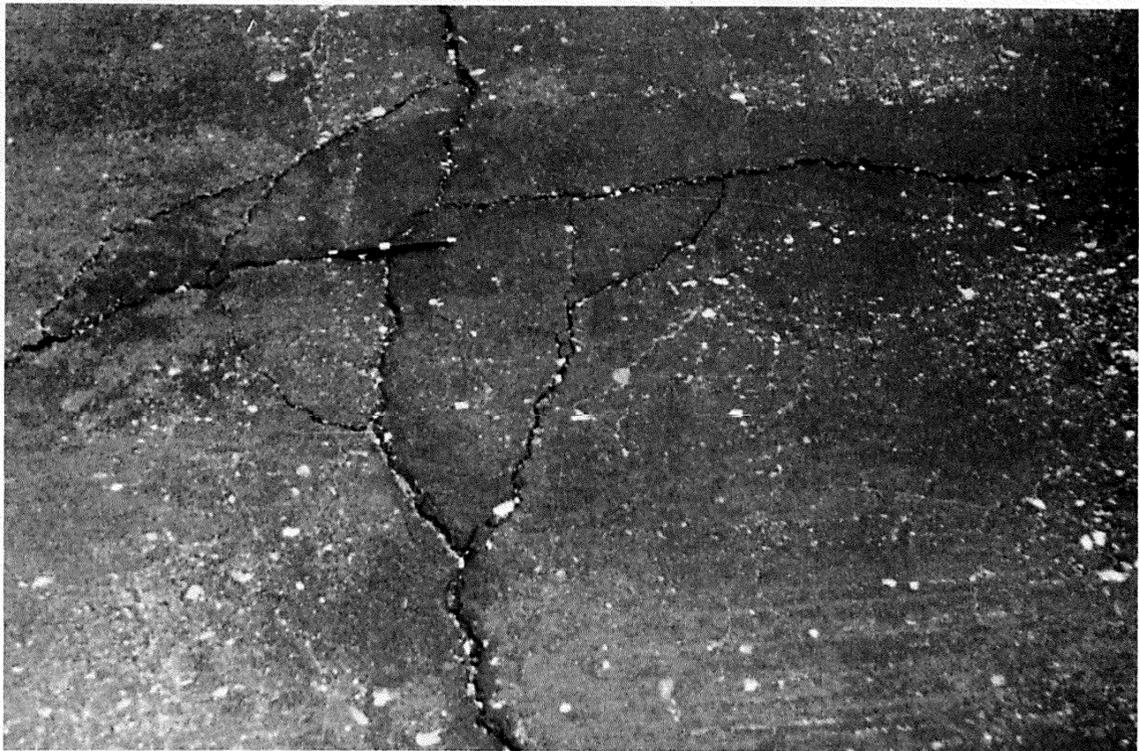
Photograph 5. Typical condition of apron area
