MISCELLANEOUS PAPER S-69-47

CONDITION SURVEY SIMMONS ARMY AIRFIELD FT. BRAGG, NORTH CAROLINA

P. J. Vedros
W. B. Abbott, Jr.

October 1969

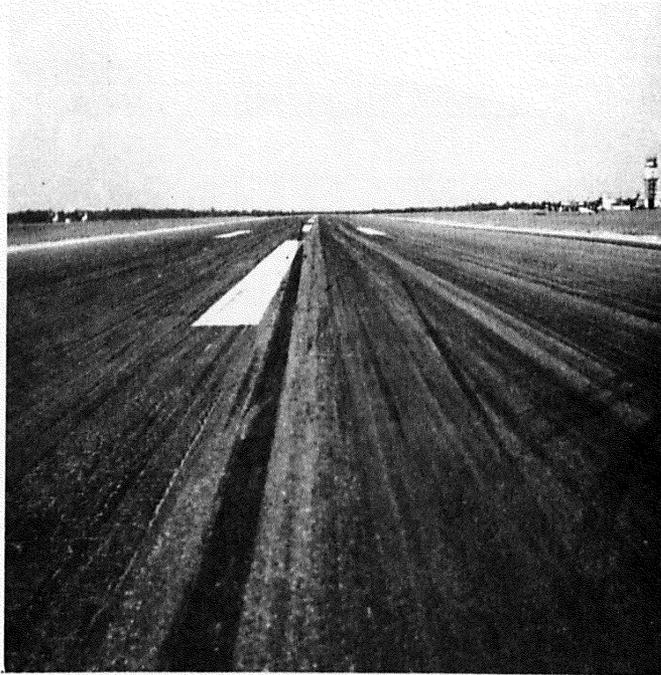
12. A visual inspection in February 1969 indicated that the airfield pavements were generally in good condition. The surface of the 3600-ft-long asphalt concrete fixed-wing runway was slightly weathered, with unsealed longitudinal shrinkage cracks appearing on the surface at a few locations (photographs 1 and 2). The asphaltic concrete parking apron 1 and adjacent taxiways had recently been slurry-sealed (photograph 3). These areas are performing well, and little or no signs of deterioration were noted. The asphaltic concrete shoulder areas bordering the portland cement concrete heliport facilities had also been slurry-sealed. These areas showed little or no signs of deterioration (photograph 4). The joints between the asphalt and concrete pavements were generally well sealed.

Photograph 1. General condition of the asphaltic concrete-fixed-wing runway

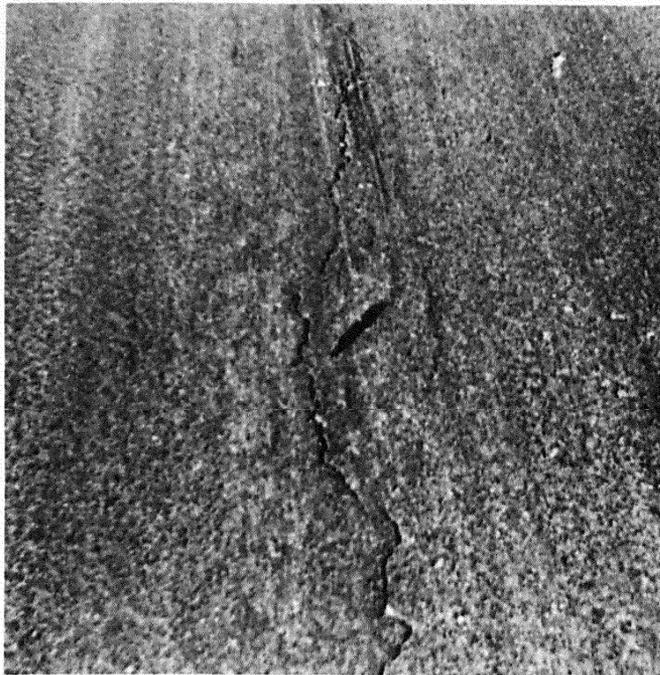
Photograph 2. Unsealed crack in pavement of fixed-wing runway

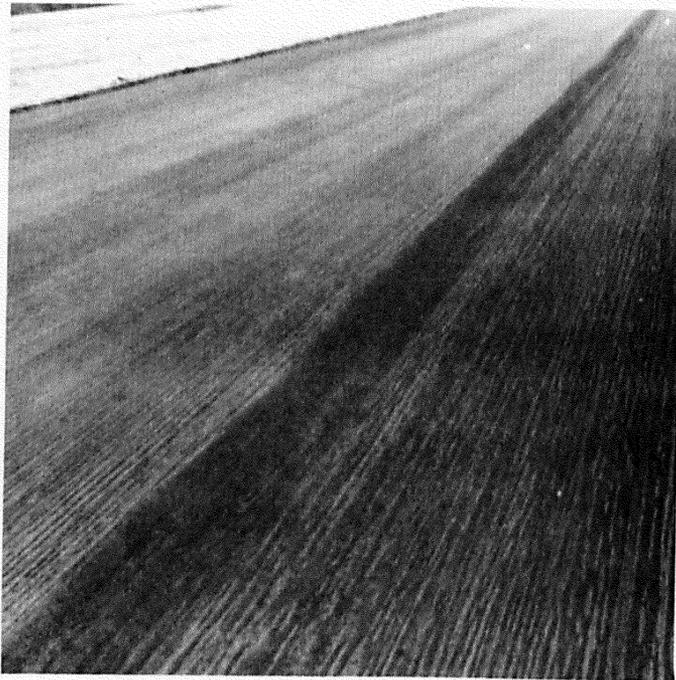
Photograph 3. General condition typical
of the slurry-sealed taxiways

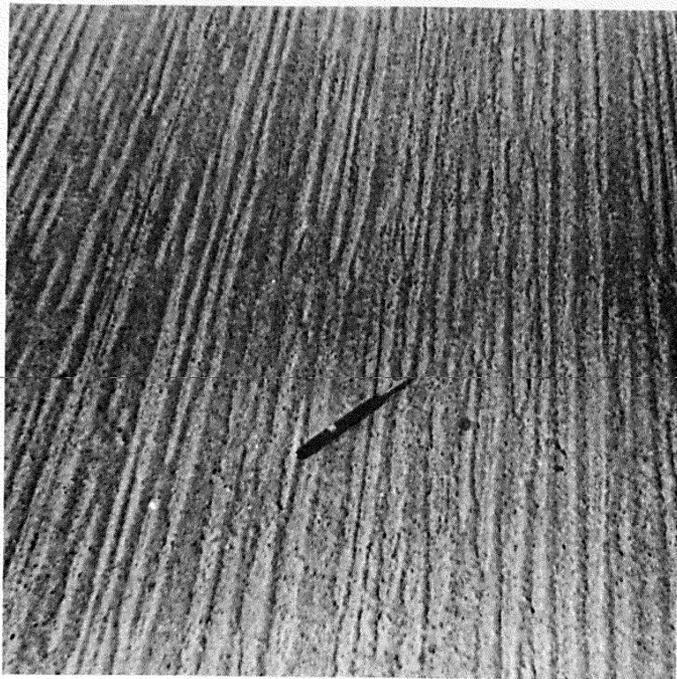
Photograph 4. Typical view of the
slurry-sealed shoulder area

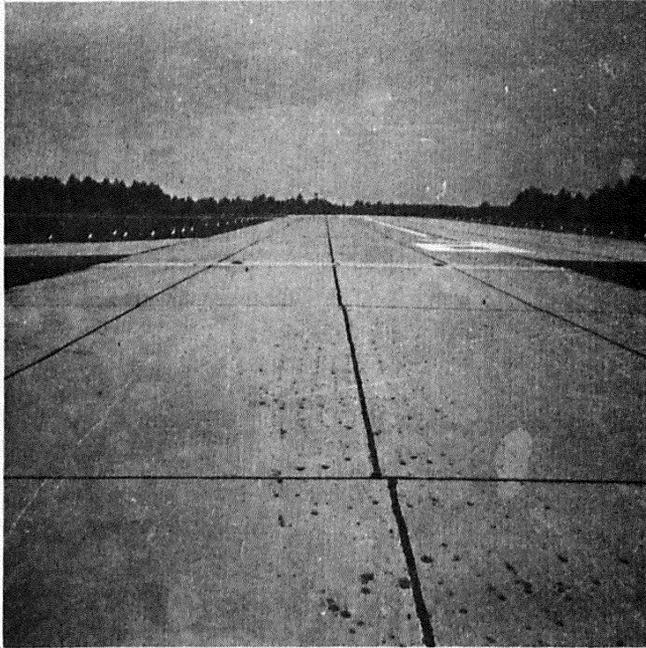
13. A brief inspection was made of the portland cement concrete portions of the airfield. The concrete slabs appeared to be in good condition with only a minimum of cracking. The joints seemed to be adequately sealed and performing well (photograph 5).

Photograph 5. View of concrete rotary-wing
runway (6-24)
