MISCELLANEOUS PAPER S-69-27

LANDING MAT OVERLAY ON DETERIORATED PAVEMENT

BARE BASE SUPPORT

June 1969

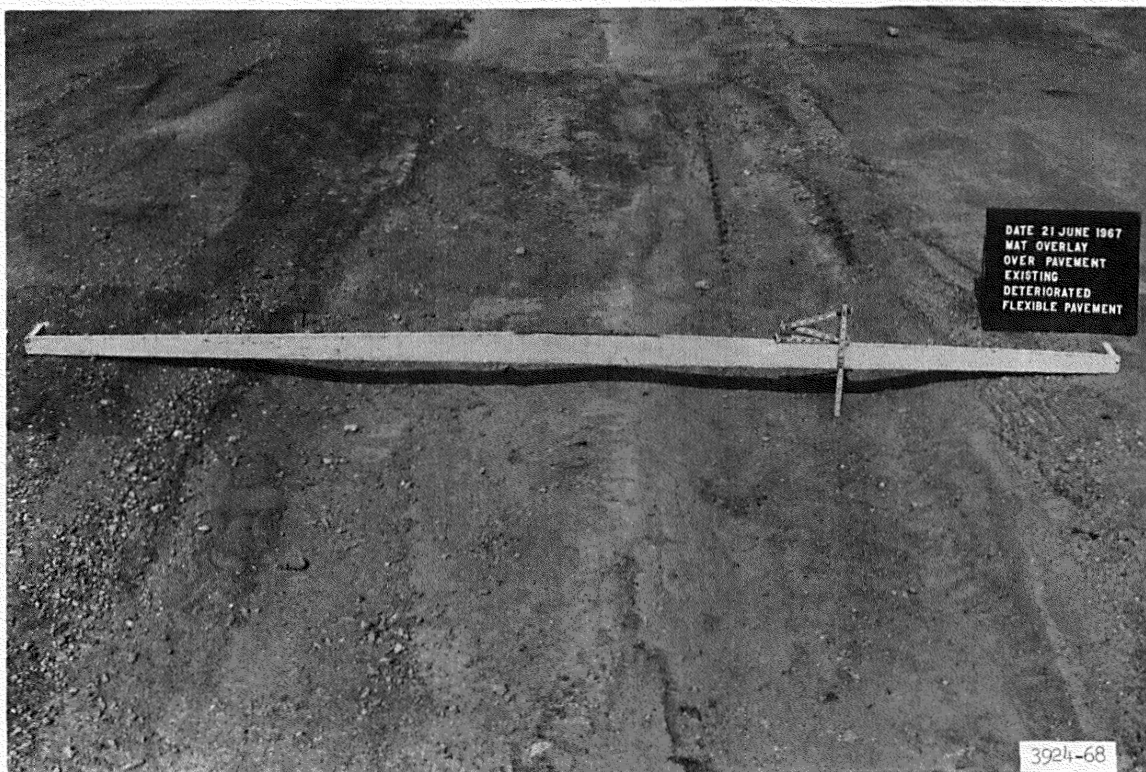
20. A general view of the deteriorated pavement prior to construction of the overlay test section is shown in photograph 3. The area had a continuous slope of about 1.1 percent from south to north (plate 5). A section measuring 180 ft long and 36 ft wide was laid out on the deteriorated pavement and was divided into six test items, each 30 ft long and 36 ft wide. The entire soil overlay was constructed prior to placement of the landing mat.

Photograph 3. Deteriorated asphaltic concrete pavement used for test section

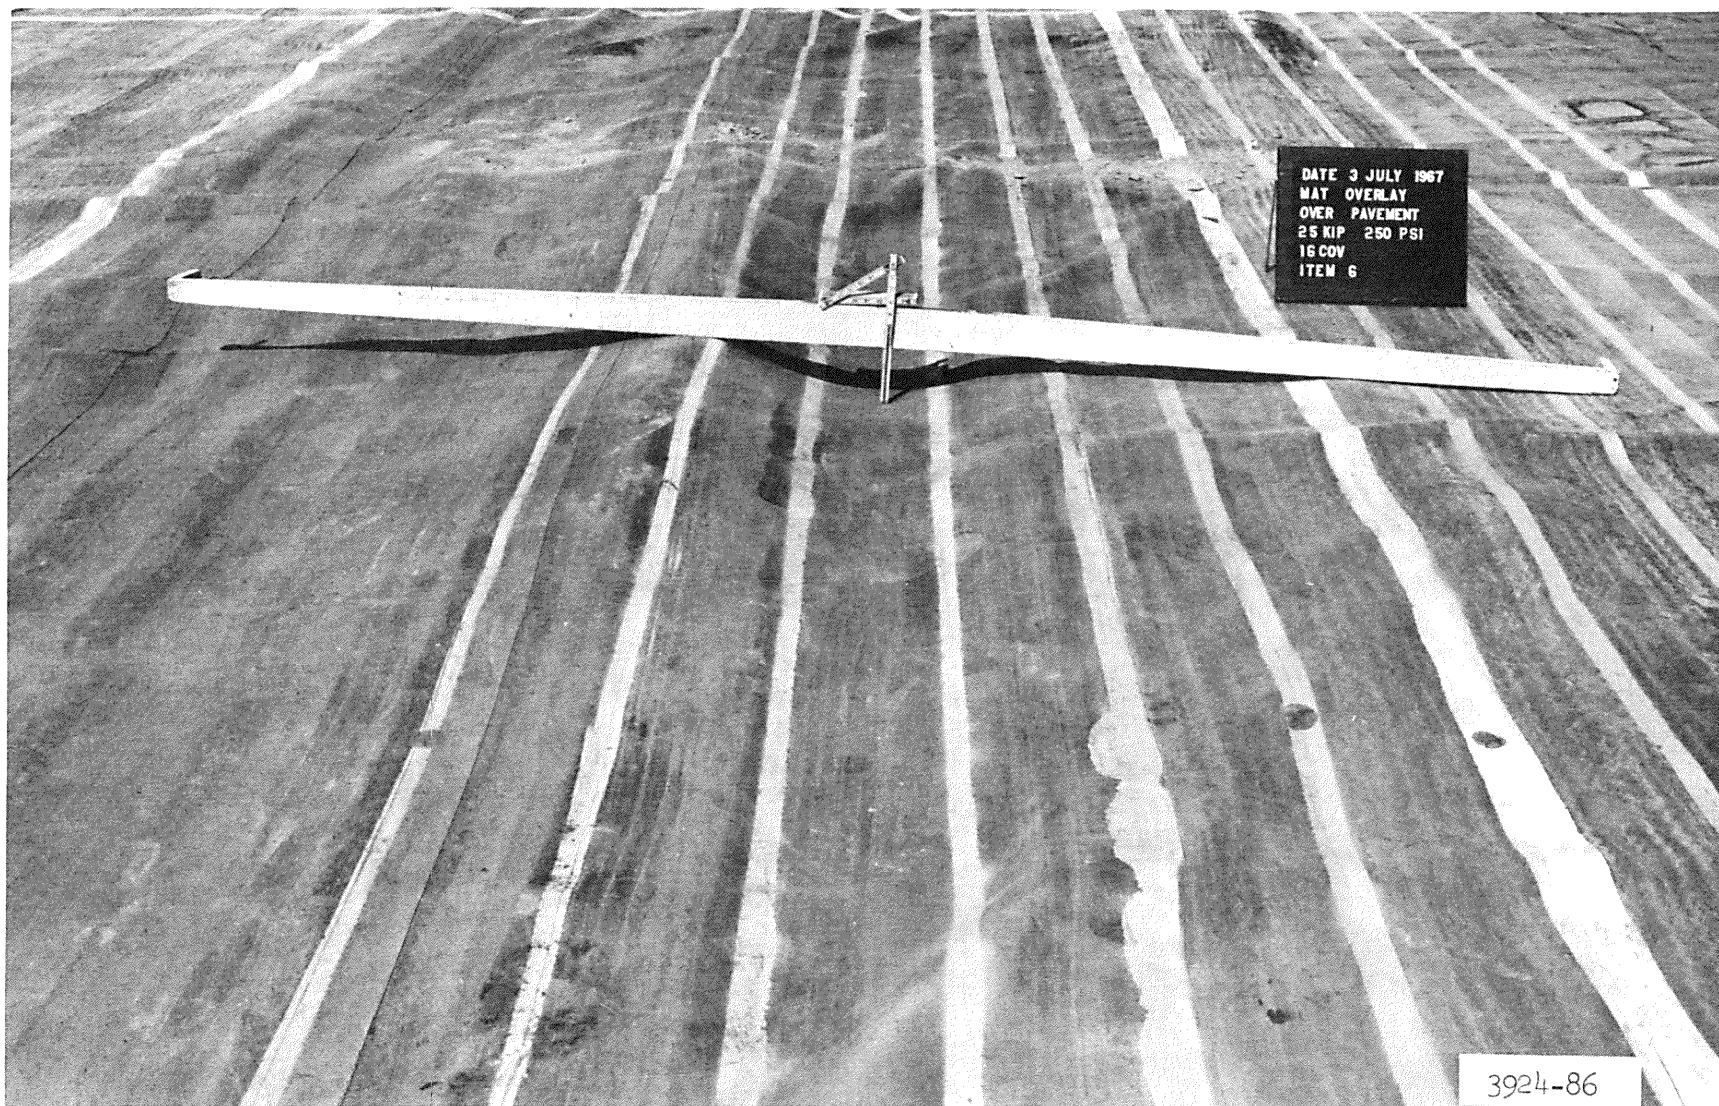
31. Test traffic was begun on 30 June 1967. General views of items 1 through 6 prior to traffic are shown in photographs 10 through 15. Rutting began to develop in item 6 at about 10 coverages. By 16 coverages there was an average rut depth of approximately 2.5 in. as shown in photograph 16. Investigation of the lean clay leveling material revealed that the in-place moisture content was approximately 16.5 percent, which was too high for the compaction effort being exerted by the simulated F-4C test

load. The high soil moisture resulted in the development of pore pressure in the soil under the high-pressure tire traffic with a resultant loss in strength. Therefore, at this stage of the test, it was necessary to remove the WX18 membrane from item 6 and to dry the lean clay soil to a lower water content. The soil was dried back to about 11.5 percent moisture and compacted with 16 coverages of the 50,000-lb roller described in paragraph 23. The compacted clay overlay was then proofrolled with four coverages of the test load vehicle, after which an average surface CBR of 44 was indicated. The compacted clay was then fine bladed with a road grader, the WX18 membrane was replaced on the item and anchored, and the traffic test was resumed.

Photograph 16. Item 6 after failure at 16 coverages

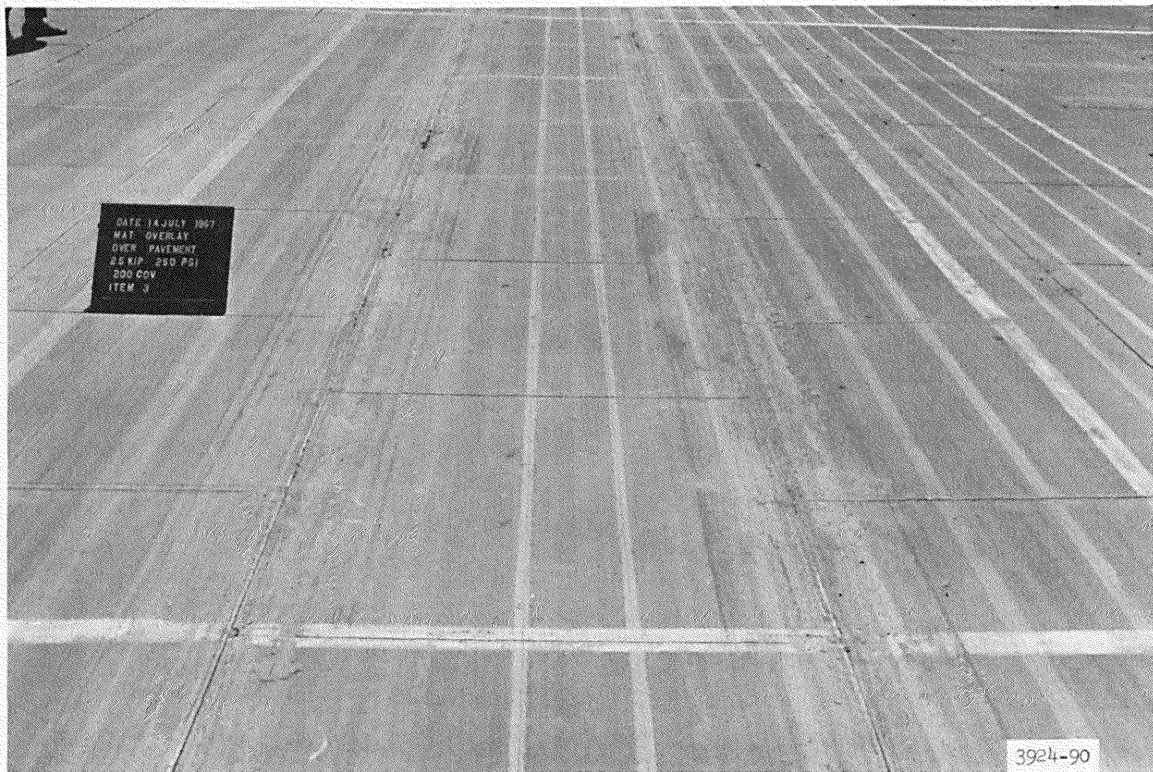
32. On 12 July, 64 coverages of traffic were applied to the test section for a total of 80 coverages. During these 64 coverages, there was a light rainfall in the test area, and it was observed that a slight amount of soil (i.e. the fines in the clay gravel) was pumping up through the mat joints in item 3. The pumping was minor, however, and did not affect the serviceability of the item. The remainder of the test section indicated no signs of soil pumping and was quite serviceable at this time.

Photograph 19. Item 3 after 120 coverages applied during light rainfall (200 coverages total). Note soil pumped onto mat surface

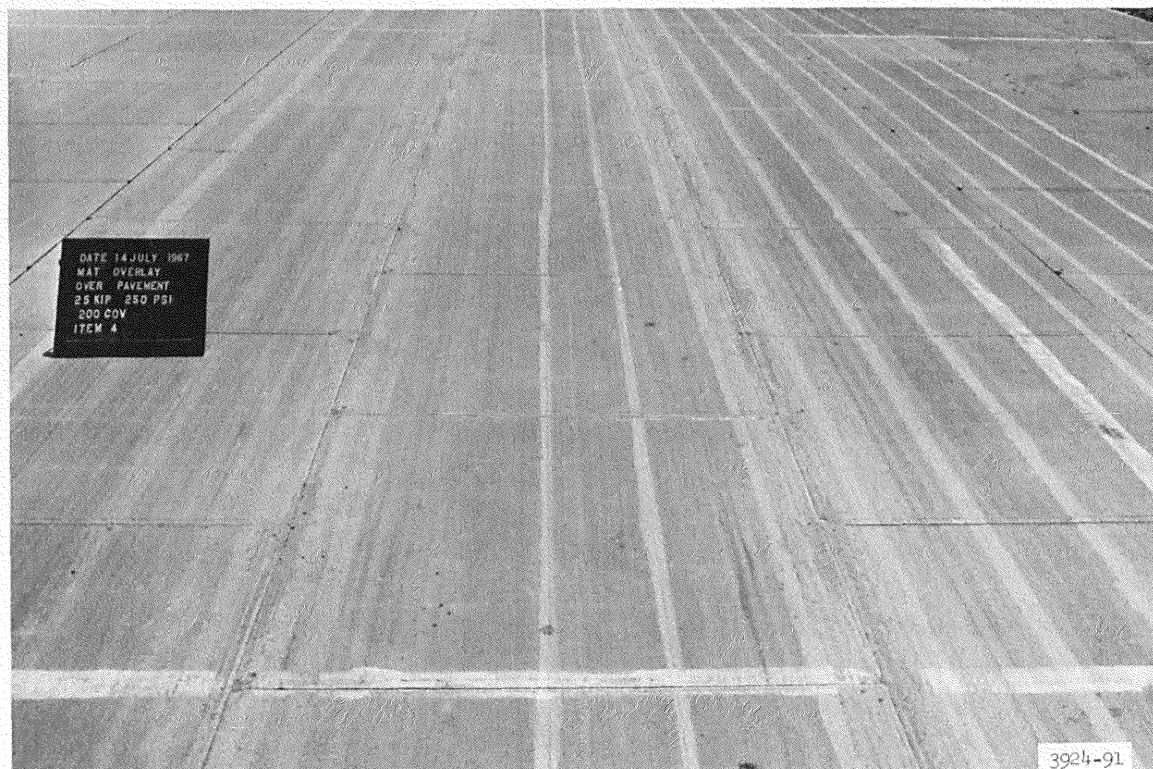
Photograph 20. Item 4 after 120 coverages applied during light rainfall (200 coverages total). Note soil pumped onto mat surface

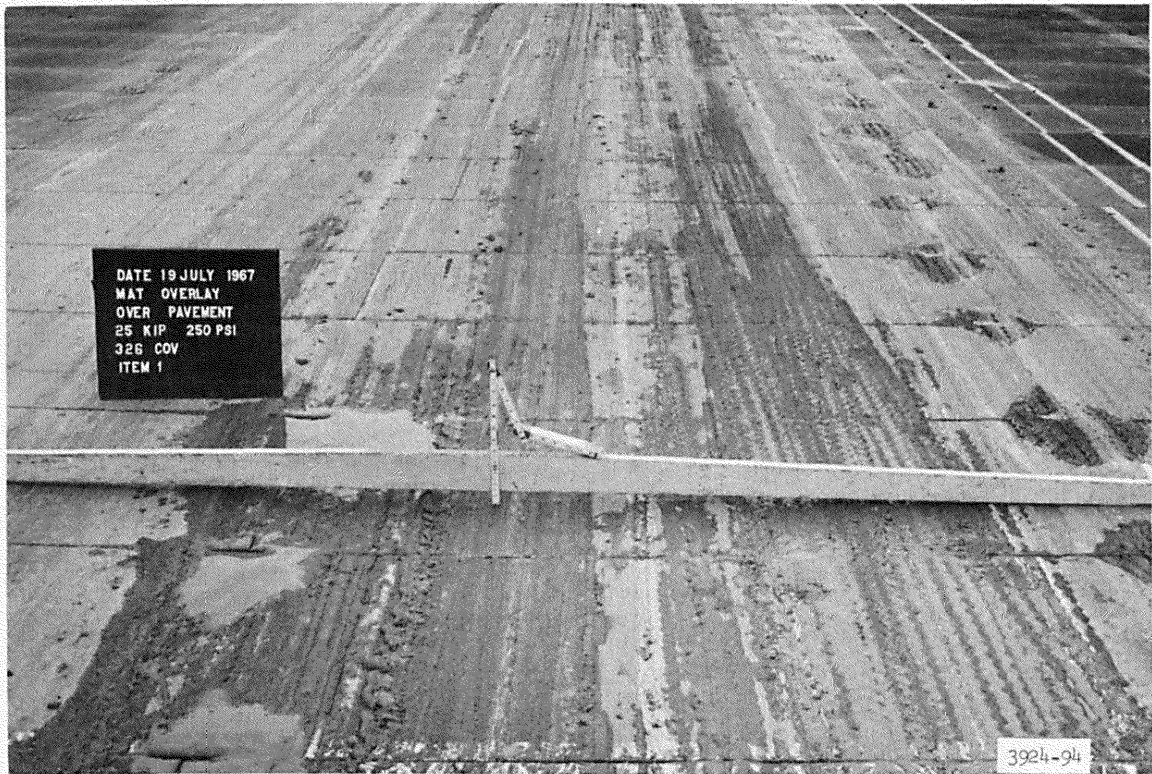
34. From 14 to 18 July, the test section received 100 coverages (total 300) and no difficulties were experienced. On 19 July, 26 coverages were applied during a heavy rainstorm. Severe pumping of the sand in items 1 and 2 and of the clay gravel fines in items 3 and 4 occurred. No soil pumping was observed in items 5 and 6. Views of items 1 through 6 at 326 coverages are shown in photographs 23 to 28, respectively. A close-up of sand pumped through the mat joints between items 1 and 2 is shown in

Photograph 23. Item 1 after 26 coverages applied during heavy rainfall caused severe pumping (326 coverages total)

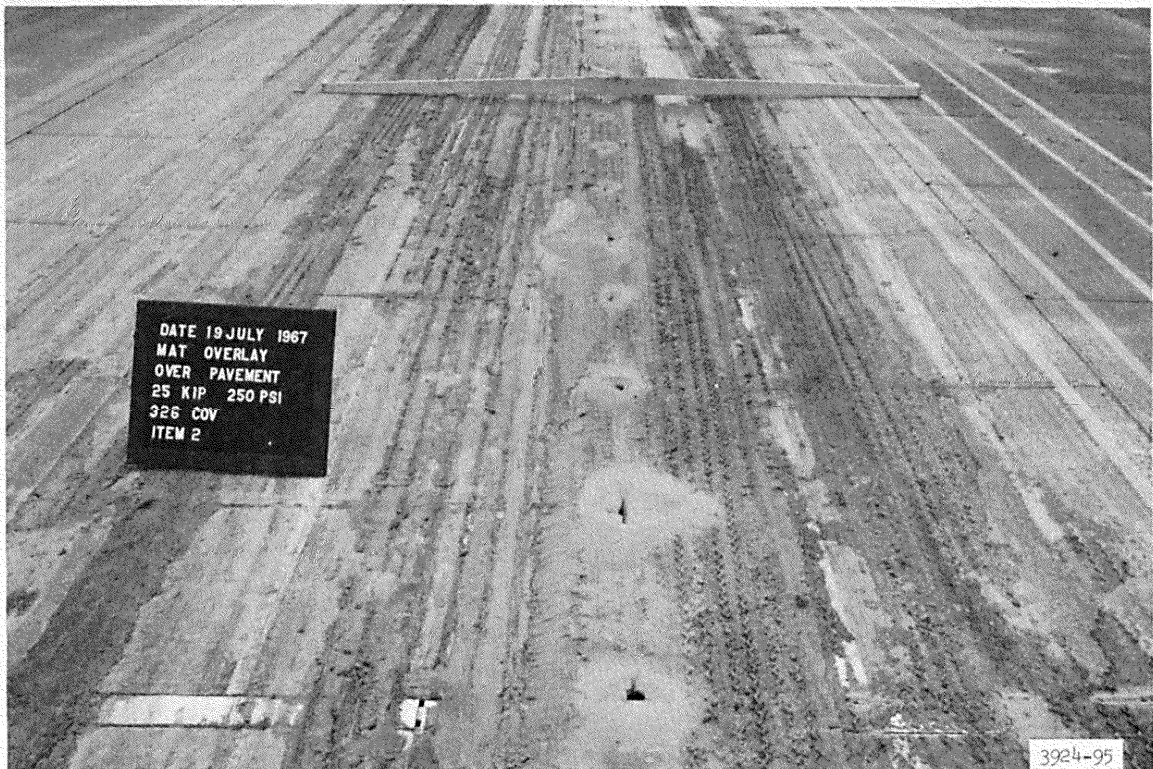
Photograph 24. Item 2 after 26 coverages applied during heavy rainfall caused severe pumping (326 coverages total)

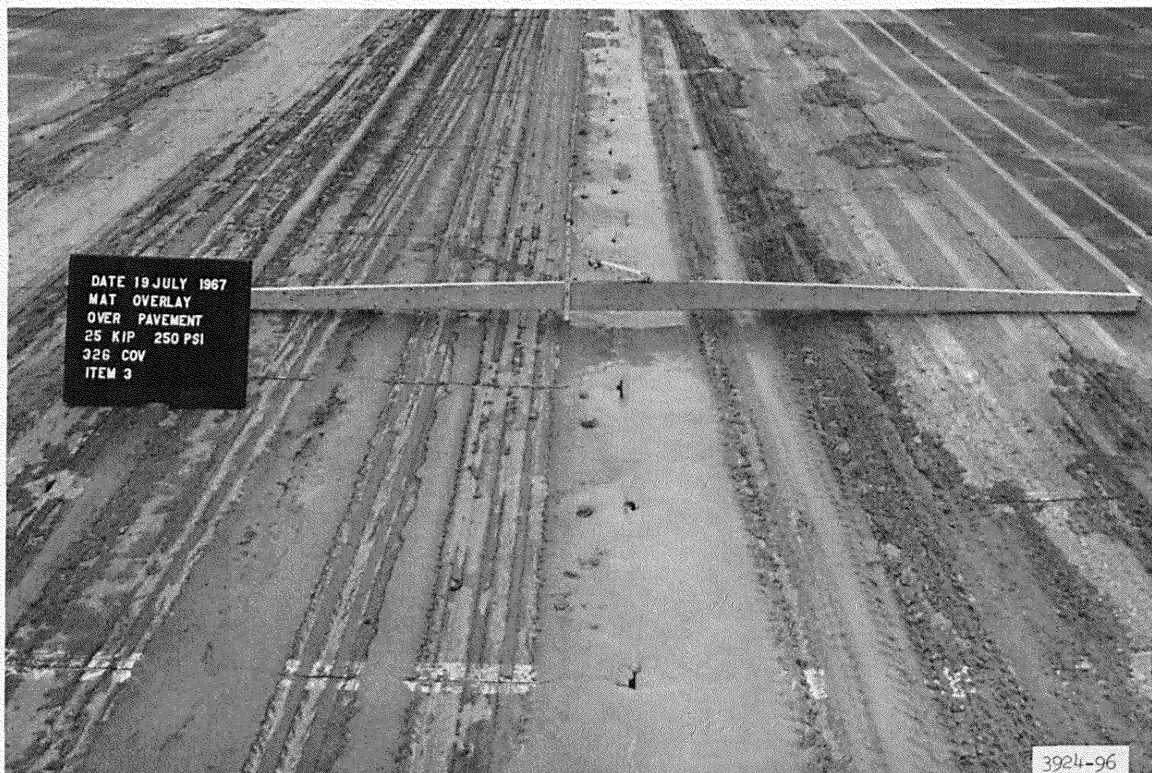
Photograph 25. Item 3 after 26 coverages applied during heavy rainfall caused severe pumping (326 coverages total)

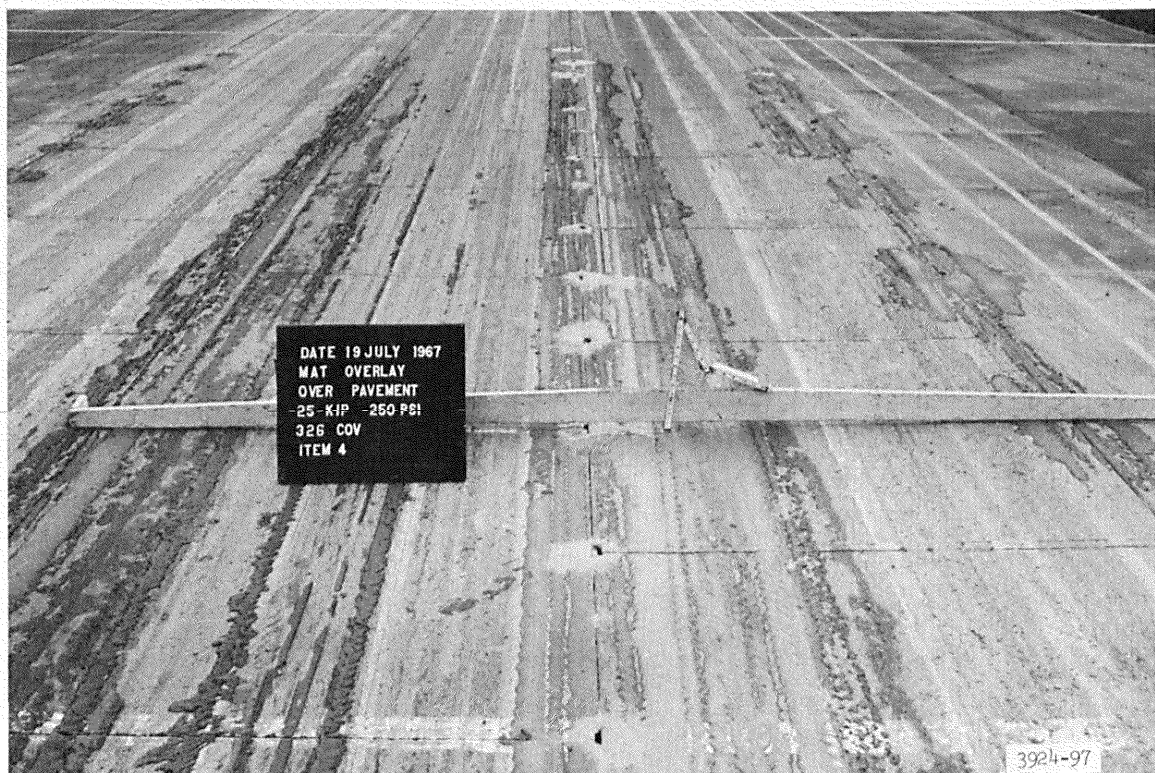
Photograph 26. Item 4 after 26 coverages applied during heavy rainfall caused severe pumping (326 coverages total)

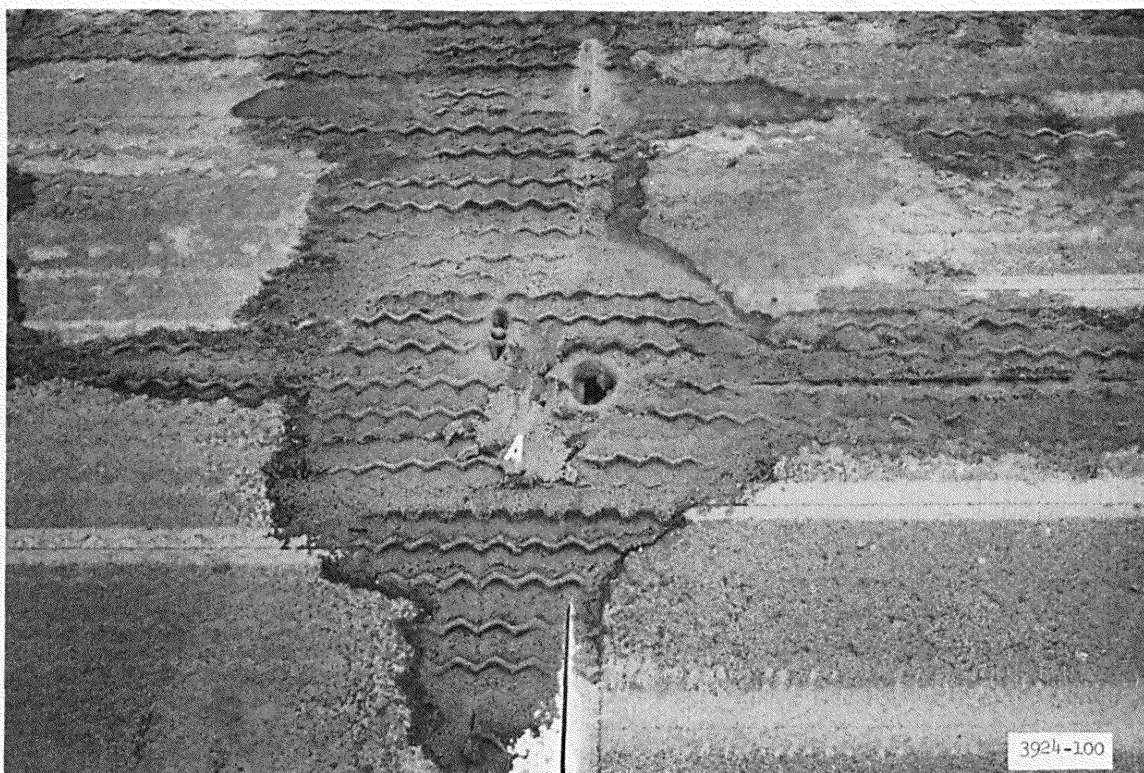
photograph 29. After 330 coverages, it was decided that major maintenance would be required to prevent further deterioration of items 1 through 4; therefore, test traffic was suspended.

Photograph 29. Sand that pumped through the mat joints between items 1 and 2 when section was trafficked during heavy rainfall

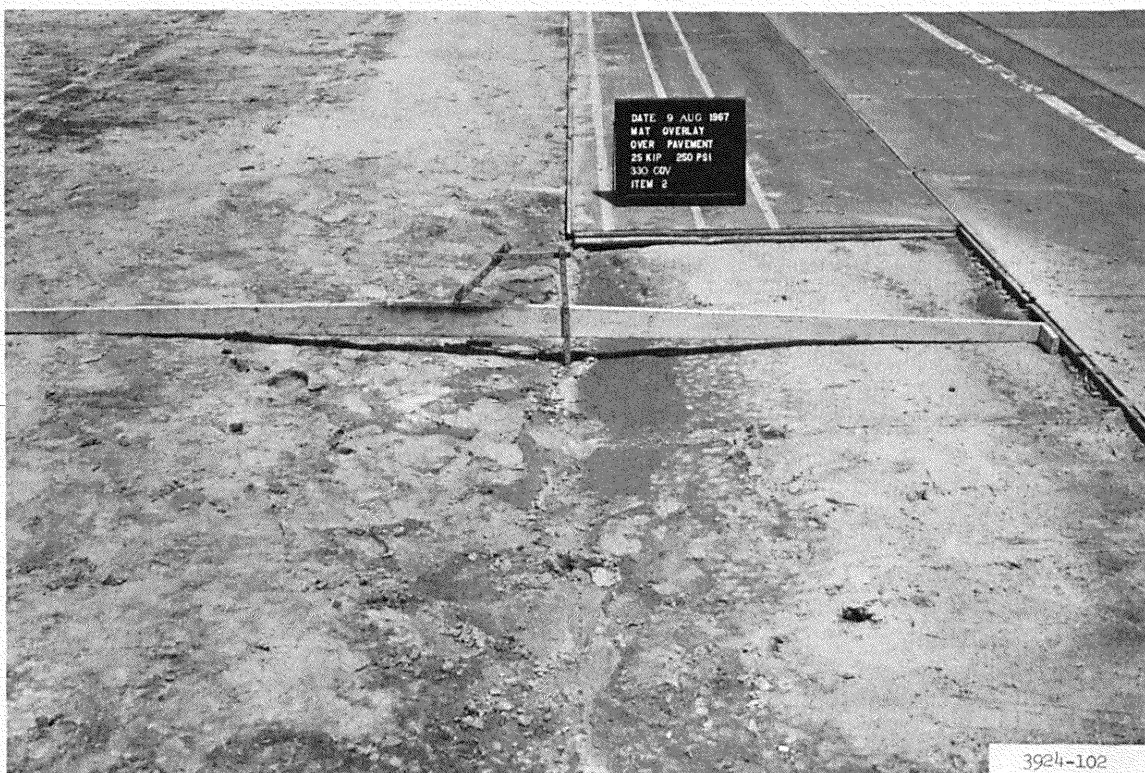
Photograph 30. Condition of sand overlay after 330 coverages

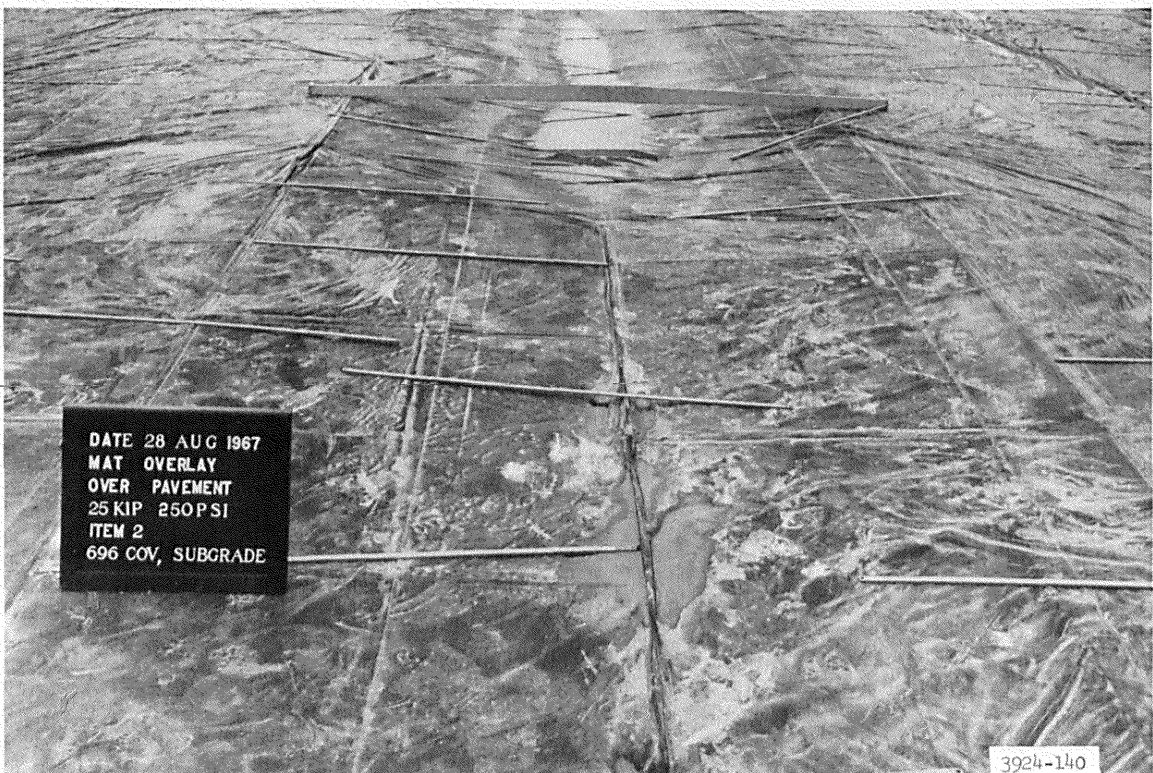
Photograph 42. T16 membrane in item 2 after mat was removed after 696 coverages (rods are XML9 connector bars)

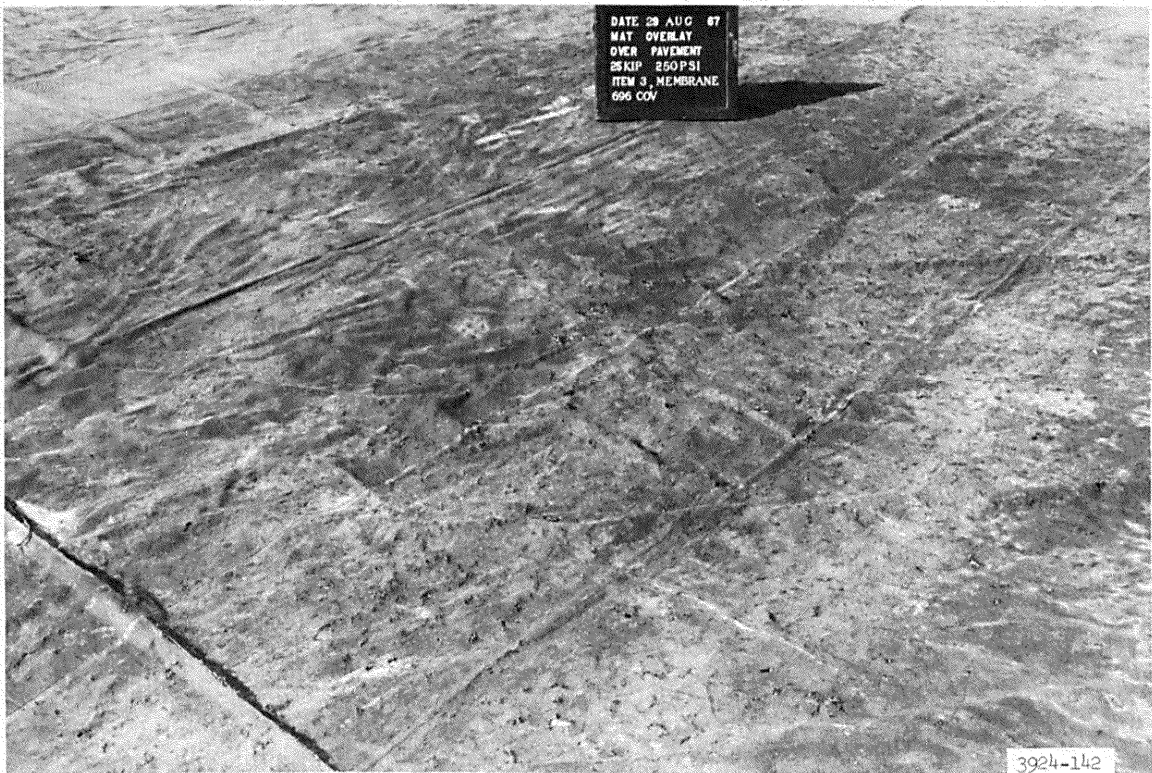
Photograph 44. Numerous holes worn in T16 membrane on item 3 during 366 coverages (696 total coverages on section)

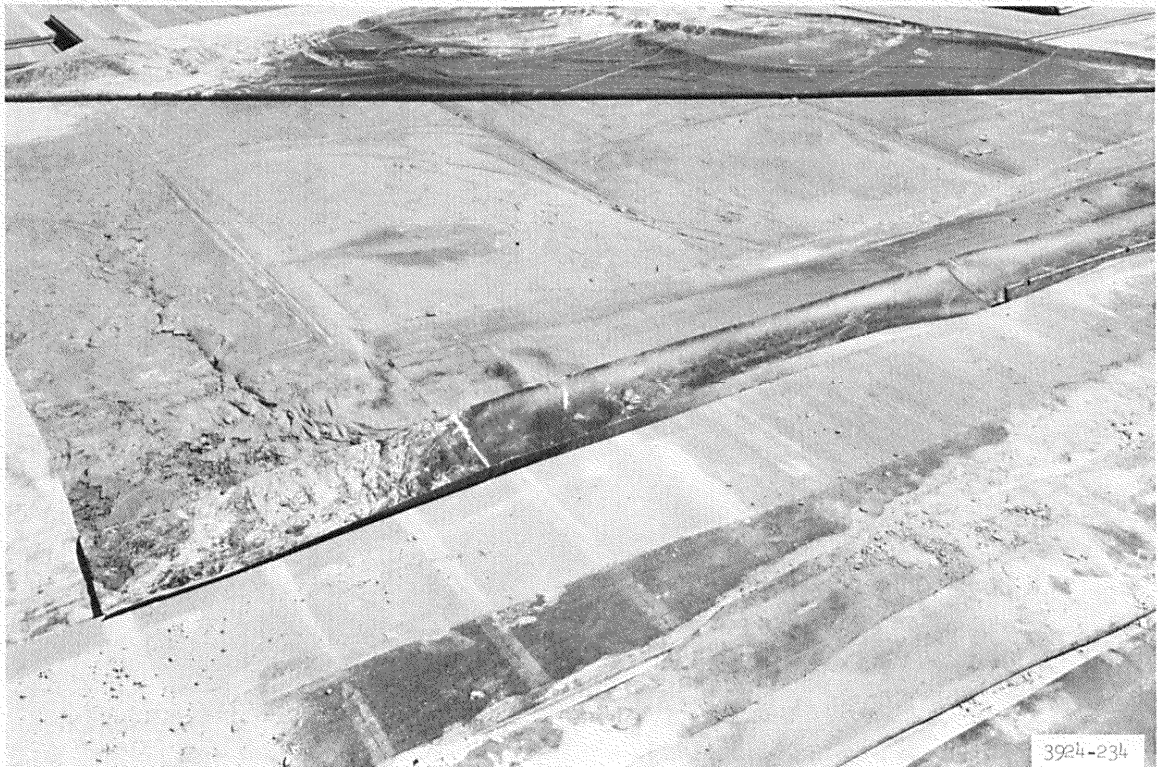
46. From 28 September to 11 October, an additional 502 coverages were applied for a total of 1790. During this period, several panels of XM19 mat appeared to be developing core damage; however, no difficulties were experienced with the overlay soil courses. On 12 October, 60 coverages were applied for a total of 1850. At this time, it was observed that a panel of XM19 located at the northwest corner of item 5 had developed core failure. The failed panel and several adjacent panels were removed. An inspection of the underlying membrane revealed that several holes had been abraded in the T16 membrane, which during previous showers had resulted in leakage to the soil immediately under the failed panel (photograph 51). The wet soil was removed and replaced with soil cement, the membrane was replaced, the holes were patched with waterproof tape, and the landing mat was relaid. The failed panel was replaced with a new XM19 panel. Test traffic was resumed on 18 October. By 24 October, 2149 coverages (total) had been applied to the test section. No damage to or pumping of the overlay soils was observed; however, several panels of XM19 began to indicate signs of fatigue.

Photograph 51. Condition of soil under failed panel of XM19 (1850 coverages)

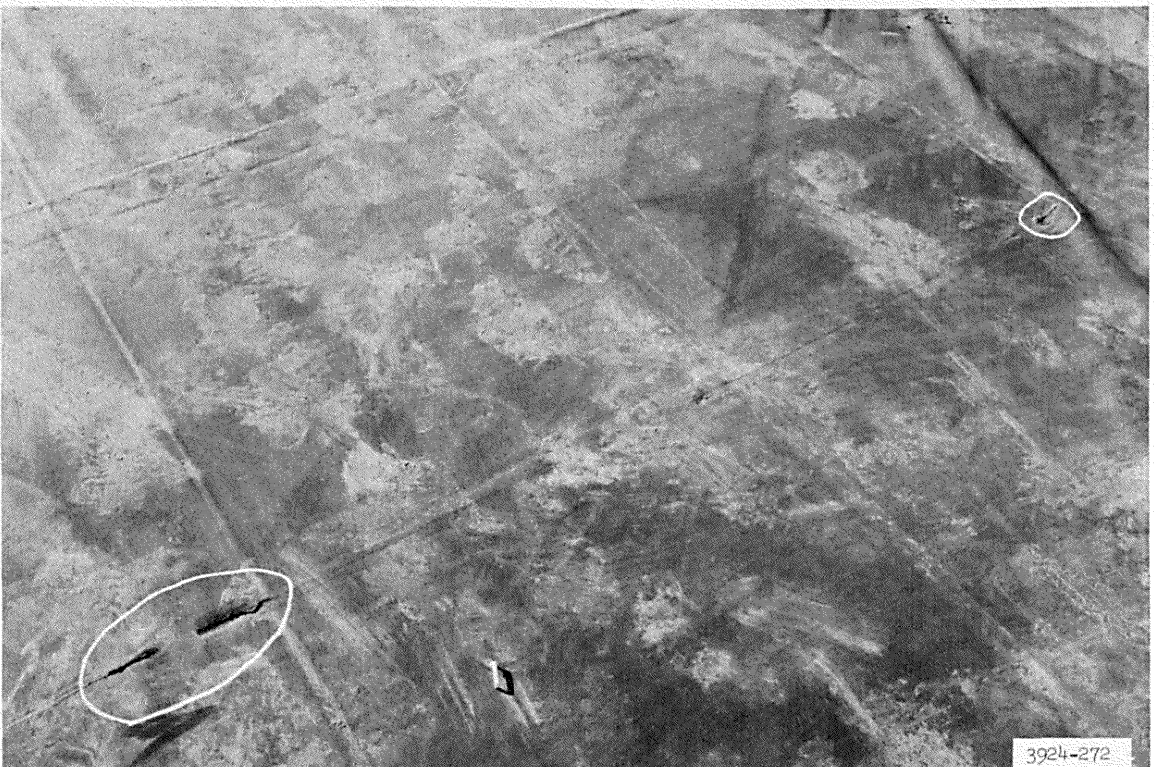
48. All mat was removed from the test section. Inspection of the test section revealed that the continual movement of the individual mat planks during trafficking had caused a pinching action on the Tl6 membrane directly below the mat joints in items 1 and 2. The pinching had cut the membrane in several locations, which allowed water to enter the sand and cause subsequent pumping. Closeup views of the result of the pinching action of the mat in items 1 and 2 are shown in photographs 57 and 58, respectively. The soil pumping had not been particularly severe, and as shown in photographs 59 and 60, the underlying sand was still relatively smooth and stable. An examination of the WX18 membrane in item 3 revealed that the WX18 fared little better than the Tl6 membrane when exposed to the abrasive action of the mat and clay gravel. Photograph 61 shows that numerous holes were worn in the WX18 membrane.

58. The service life of the Tl6 membrane when used between a sand overlay and landing mat appears to be about 2000 coverages. When traffic was stopped at 2170 coverages, it was found that several holes had been worn in the Tl6 by the pinching action of the mat joint flexure during traffic. Since no evidence of pumping of either dry powdery material during dry weather or wet sand during wet weather was found prior to this

Photograph 57. Membrane cut by pinching action of mat in item 1

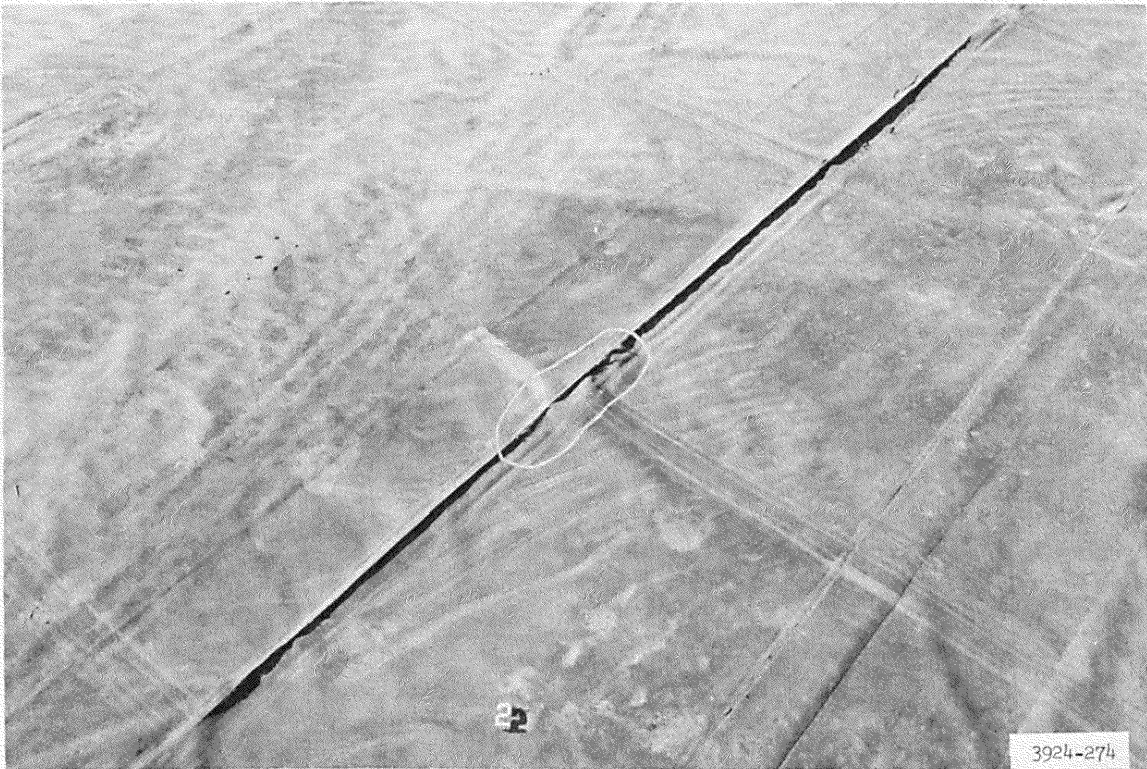
Photograph 58. Membrane cut by pinching action of mat in item 2

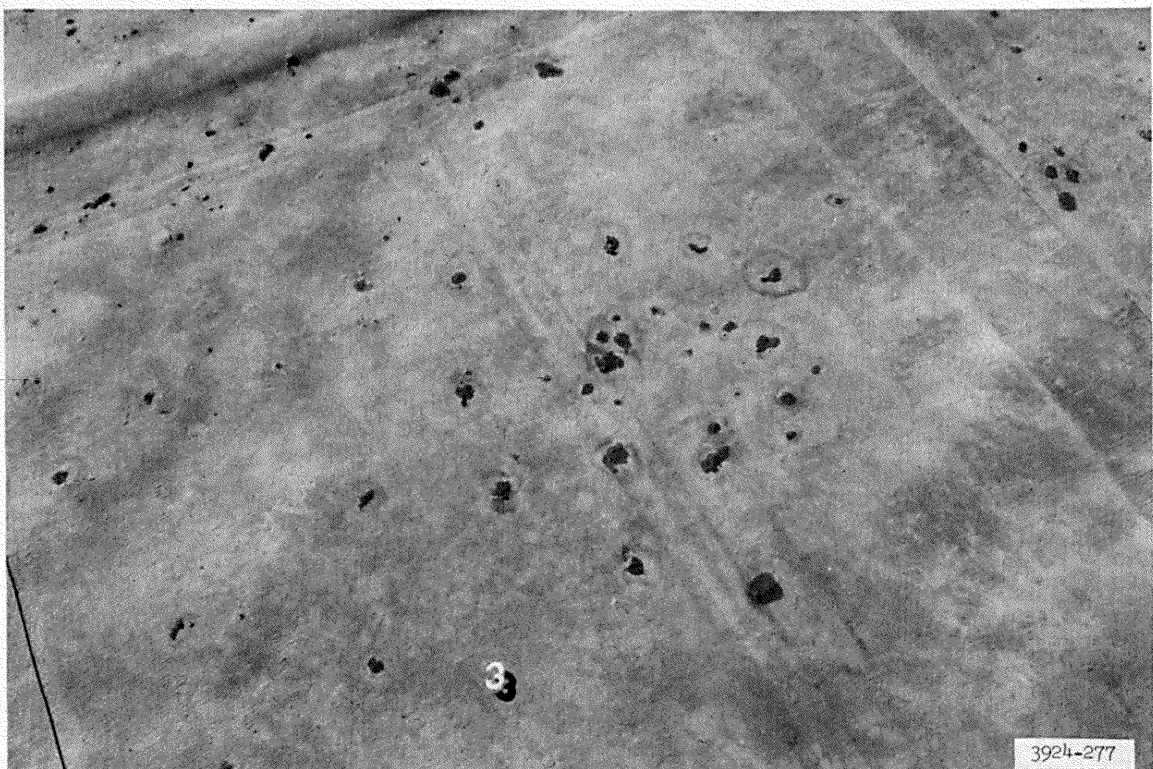
Photograph 61. Holes worn in WX18 by abrasive action of mat and clay gravel

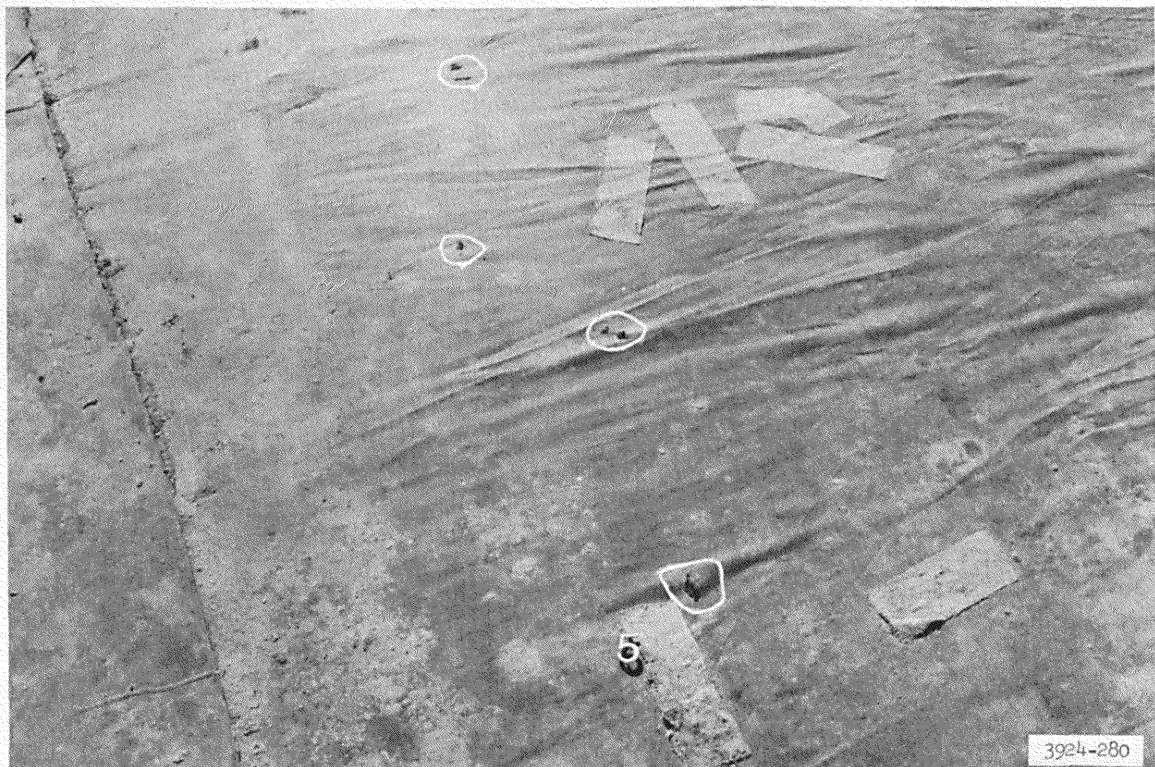
50. Examination of the Tl6 in item 5 after removal of the mat revealed that, generally, the membrane had remained intact throughout the test. In a small area near the transition to item 4, it was found that several small holes had been cut in the membrane due to point abrasion of the membrane on pebbles and small rocks between the membrane and hard soil surface during traffic (see photograph 63). The exposed lean clay in the area directly below the location of the holes in the Tl6 is shown in photograph 64. It can be seen from the heel prints on the soil that the lean clay had become wet in this particular area. Soil tests in this area indicated an average surface strength of about 3.2 CBR.

Photograph 63. Small holes cut in T16 membrane in item 5

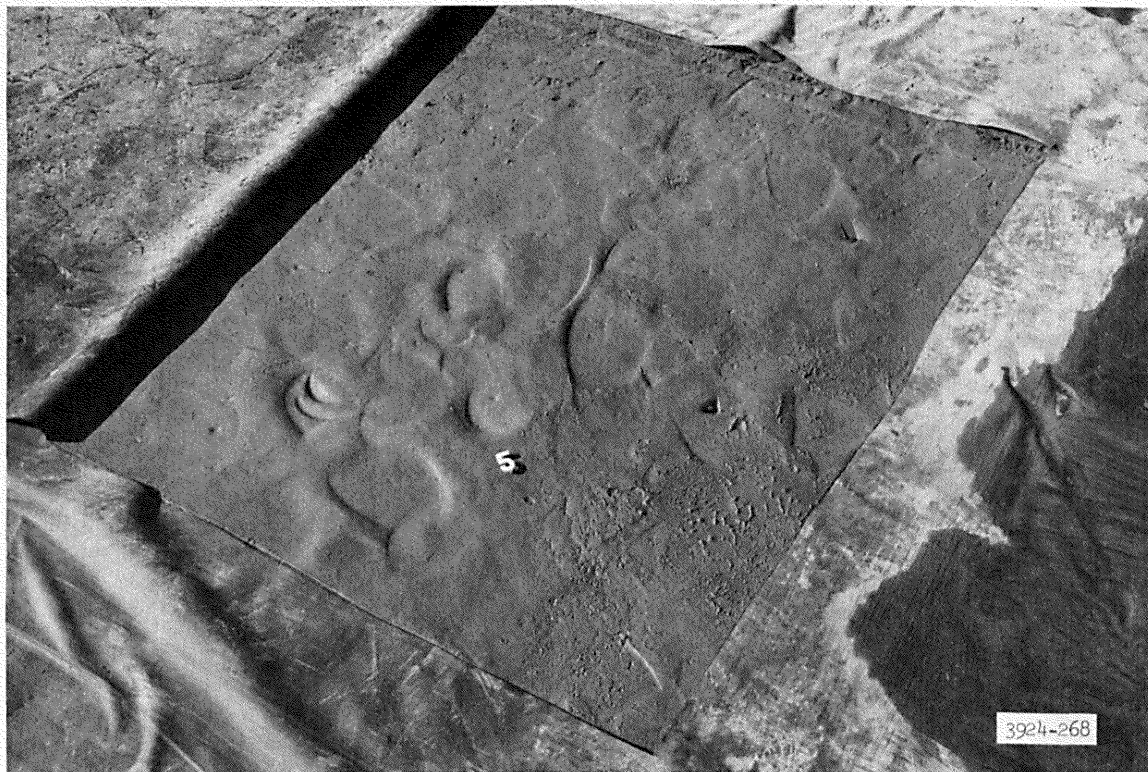
Photograph 64. Lean clay directly under holes shown in photograph 63

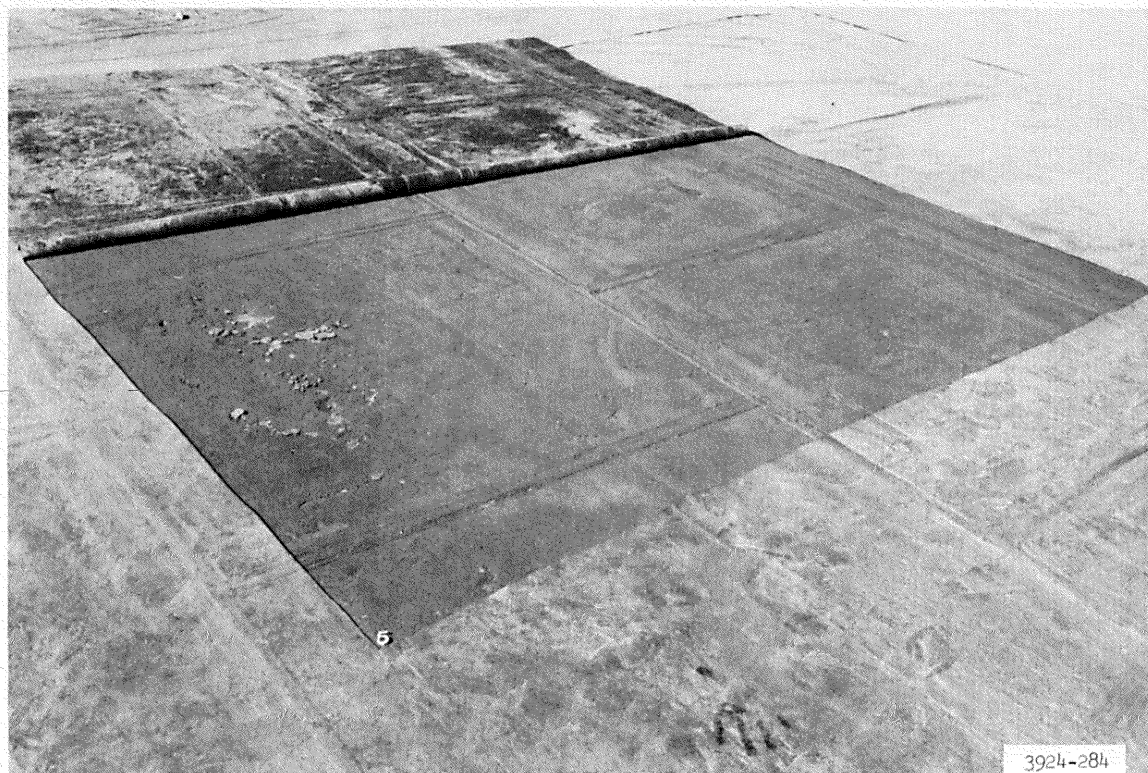
exposed area of the lean clay considered to be typical of the item is shown in photograph 65. The top $1/8$ to $1/4$ in. of soil was moist due to condensation under the membrane; however, the underlying material was quite dry and hard. Soil tests in this area indicated soil strength below the moist zone to be about 49 CBR.

Photograph 65. Stable condition of lean clay considered typical of item 5

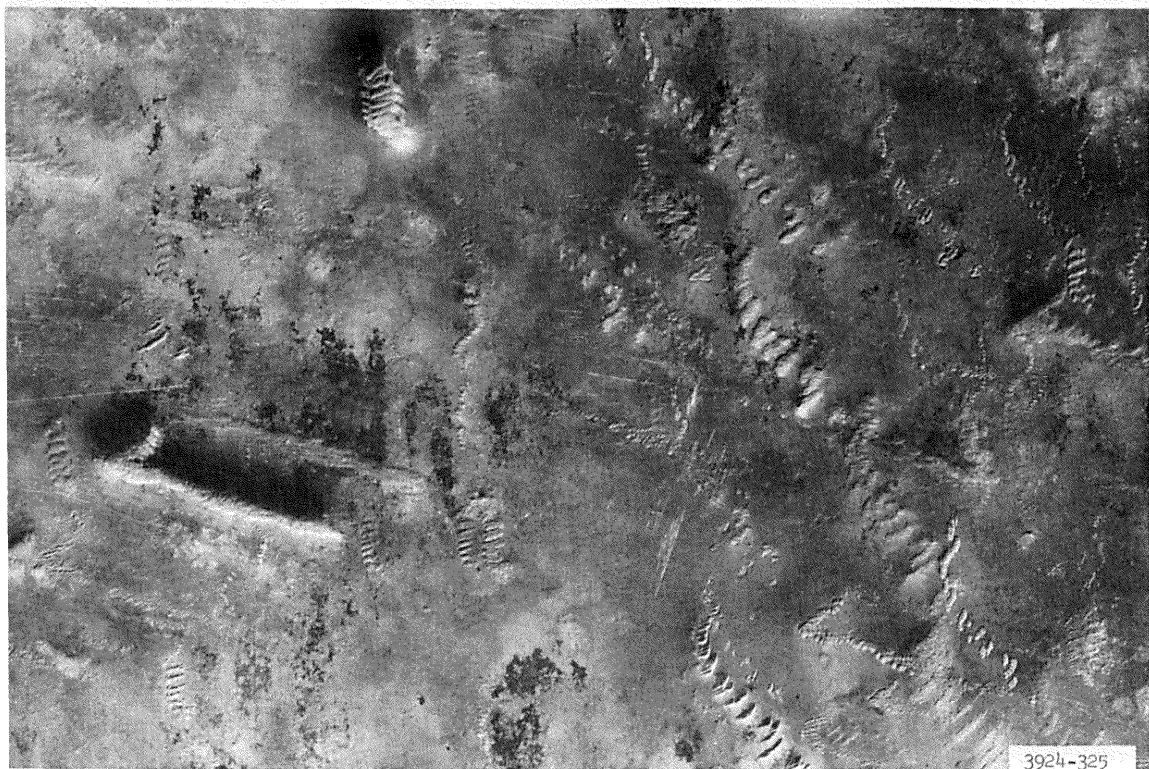
61. One point that should be emphasized at this time is the performance of the XM19 mat on the clay gravel. During the latter part of the test, it was observed that a number of panels in items 3 and 4 had developed shallow depressions 4 to 8 in. in diameter in the upper surface, which indicated that core failure was developing in these areas. Upon removal of the mat after testing was completed, it was found that the panels had been subjected to point loading in areas of contact between the mat and the larger aggregate in the clay gravel. This was evident from the numerous indentations found on the underside of the panels after their removal from the clay gravel items (see photograph 67). The results of this point loading were localized failures of the mat core that progressed to form large depressed areas. Photograph 68 shows a cut section of mat in an area where a surface depression had

Photograph 67. Indentations on underside of mat that had been placed on clay gravel

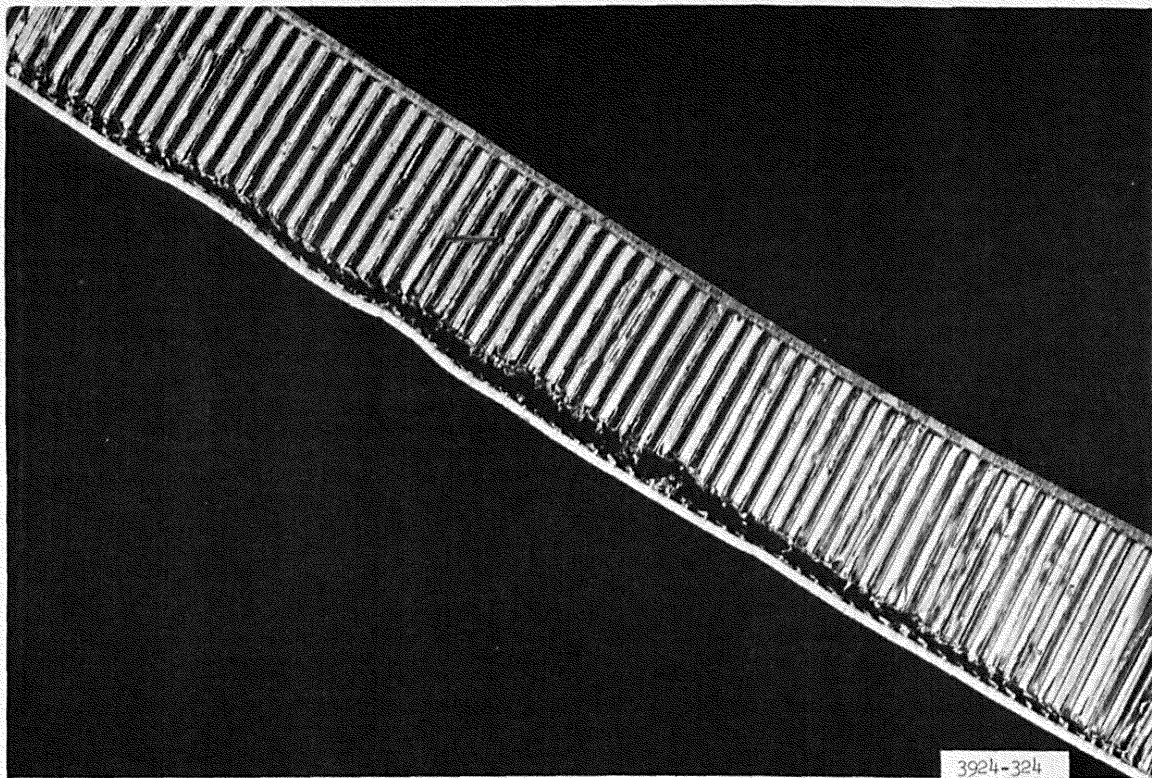
developed. It can be seen that the lower part of the internal core had failed and separated from the panel skin.

Photograph 68. Internal failure of XM19 mat
