EMERGENCY GATE PERFORMANCE MC ALPINE LOCK, OHIO RIVER, KENTUCKY

Hydraulic Prototype Tests

MISCELLANEOUS PAPER NO. 2-622

February 1964

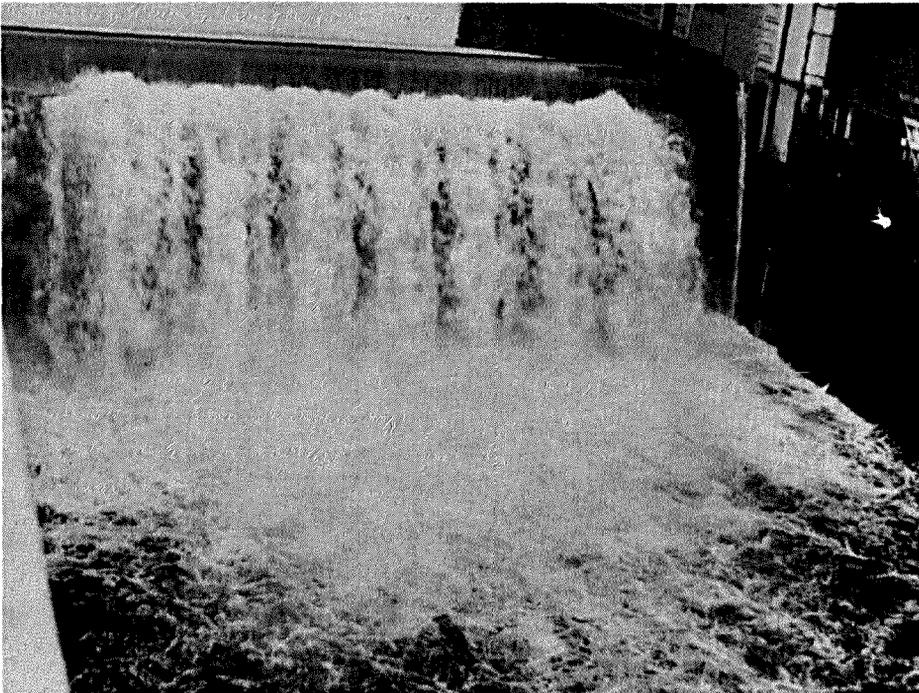
Fig. 6. Flow over gate during gate lowering. Gate crest about 16 ft above sill. Maximum downpull occurred at this condition

girder drain holes were probably not sufficient to drain all of the overflow. As the gate was further lowered and the overflow increased, the overflow nappe began to clear the girder top, progressing from the ends, where the girder is tapered, toward the gate center. When the gate crest was about 13 ft above the sill, the overflow nappe appeared to have cleared the downstream edge of the top girder flange. The overflow at this stage

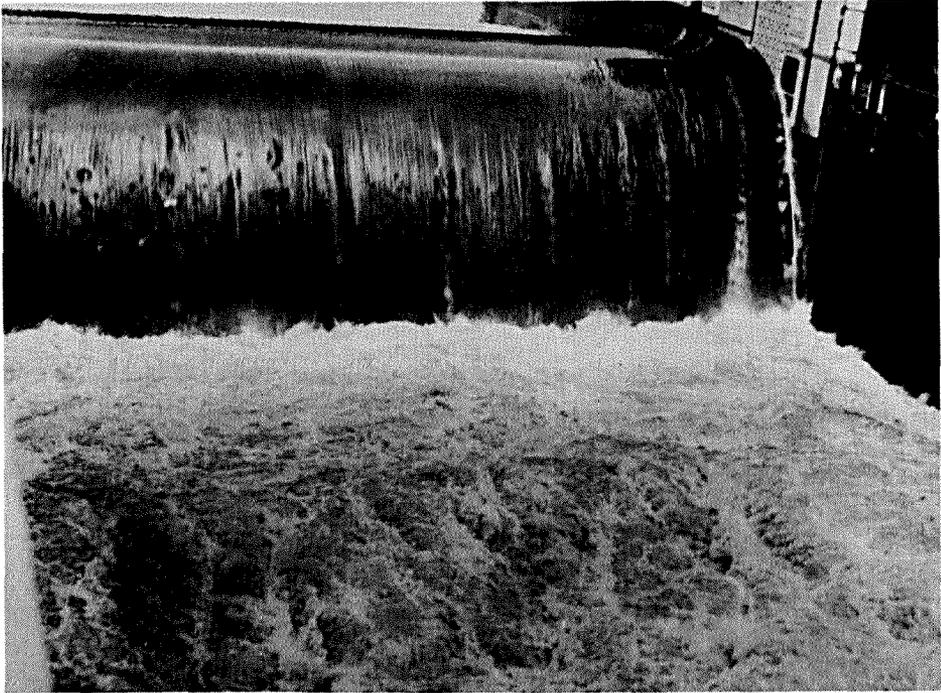
Fig. 7. Flow over gate during gate lowering. Gate crest about 12 ft above sill

is shown in fig. 7. As the gate was lowered further, the overflow nappe was less discernible as the lock water surface rose.

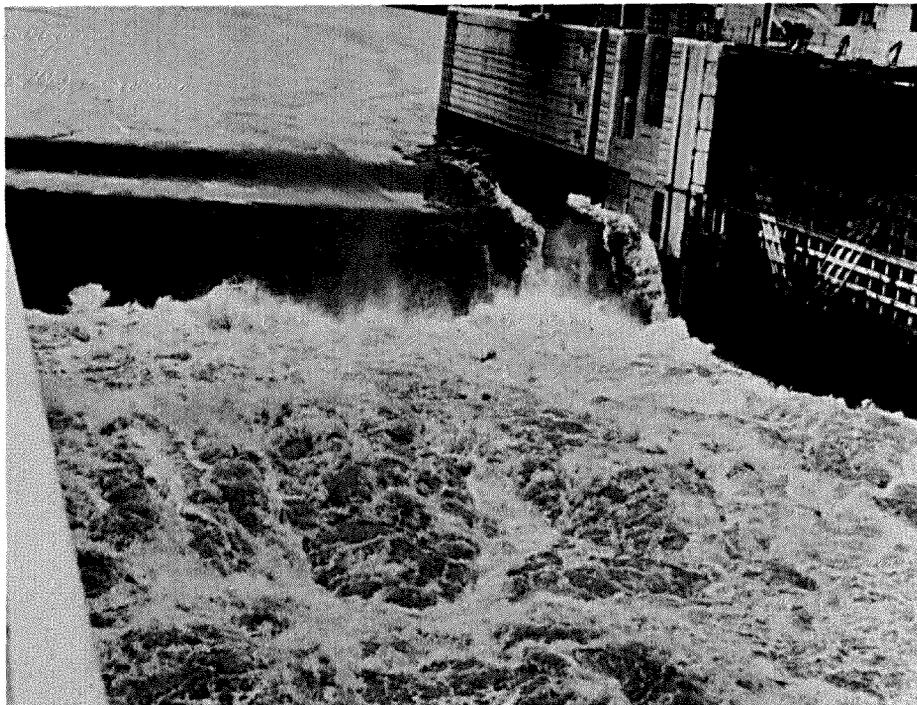
Fig. 8. Flow over gate during gate lowering. Gate crest about 3-1/2 ft above sill. Maximum uplift occurred at this condition. Note separation along guide wall at right

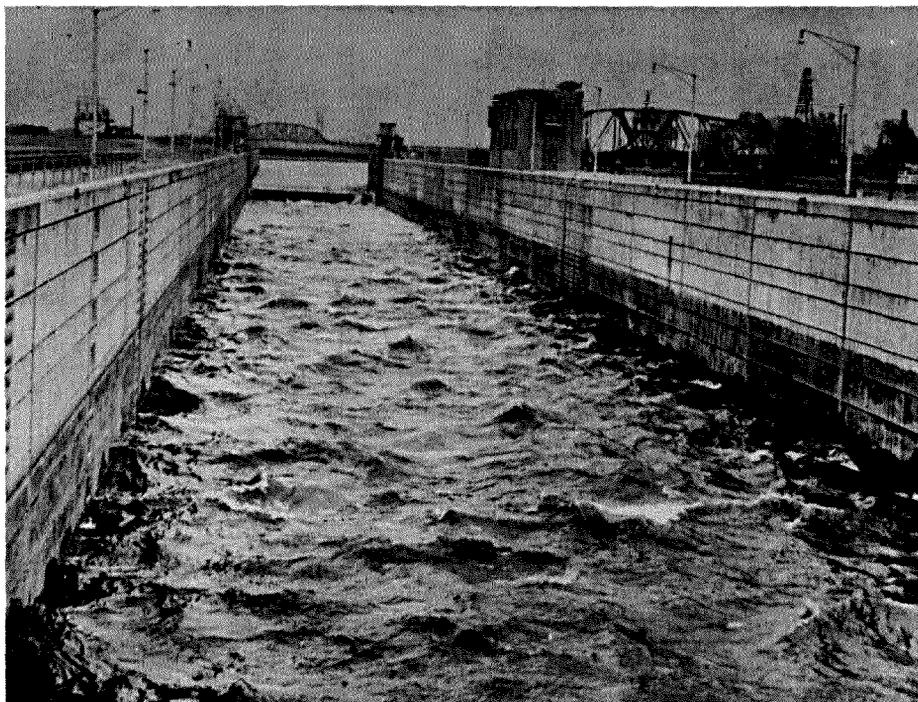
Fig. 9. Flow in lock chamber while gate was being lowered. Gate crest about 3 ft above sill. Wave heights up to about 5 ft

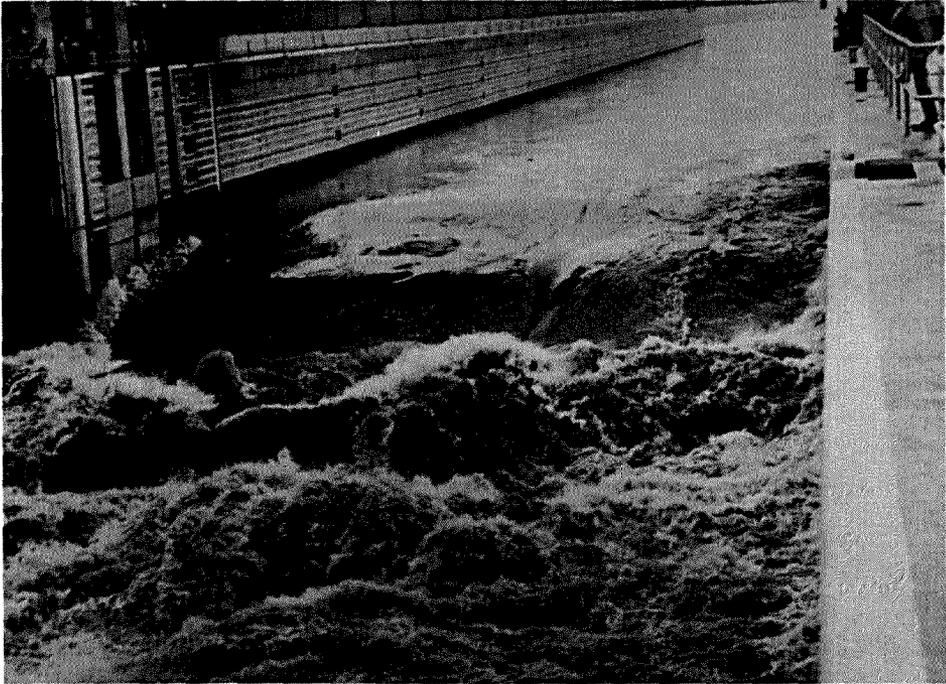
Fig. 10. Flow over gate at full-down position. Gate crest at sill. Note separation along guide wall at right

the gate was further lowered. When the gate reached full-down position (crest at elevation 402), a wavy type of surface disturbance was observed. This undular type of hydraulic jump maintained a relatively steady position downstream of the gate. Fig. 10 shows flow conditions with the gate at full-down position.

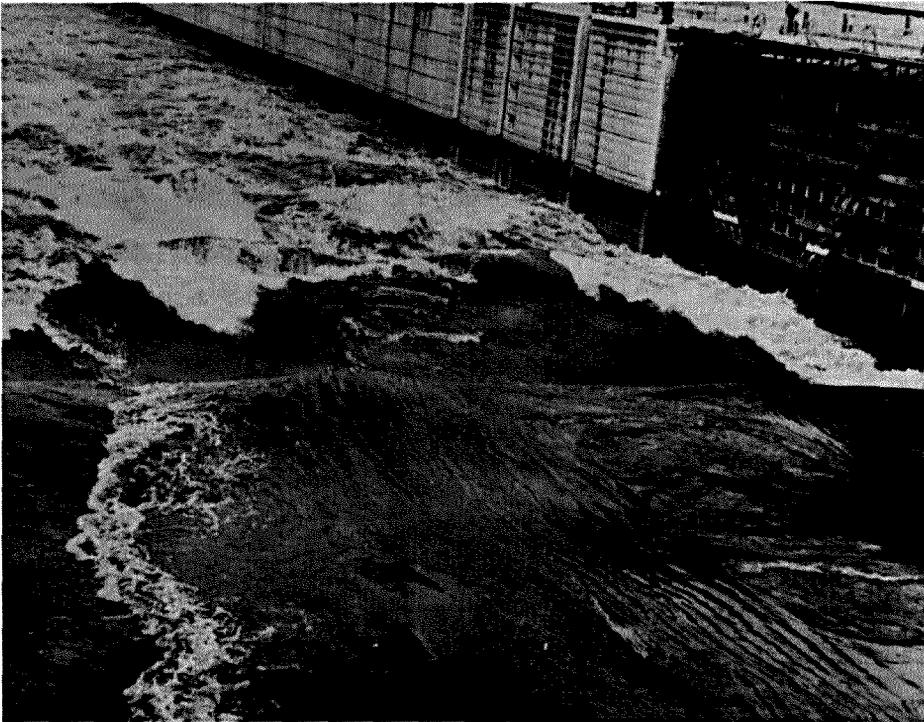
46. Flow conditions appeared to be smoother for gate raising than for gate lowering, especially for gate positions of 8 ft and less (compare figs. 8 and 11). This was probably due to the lock water surface being several feet higher during the gate raising as compared to gate lowering at equal gate positions. As the lock water level decreased, flow conditions appeared similar to gate lowering conditions.

Fig. 11. Flow over gate during gate raising. Gate crest about 2-1/2 ft above sill
