TESTS ON METHODS OF EMPLOYING  
PIERCED PLANK LANDING MAT WITH  
PREFABRICATED BITUMINOUS SURFACING

TECHNICAL MEMORANDUM NO. 211-4

U. S. WATERWAYS EXPERIMENT STATION  
VICKSBURG, MISSISSIPPI

5 OCTOBER 1945

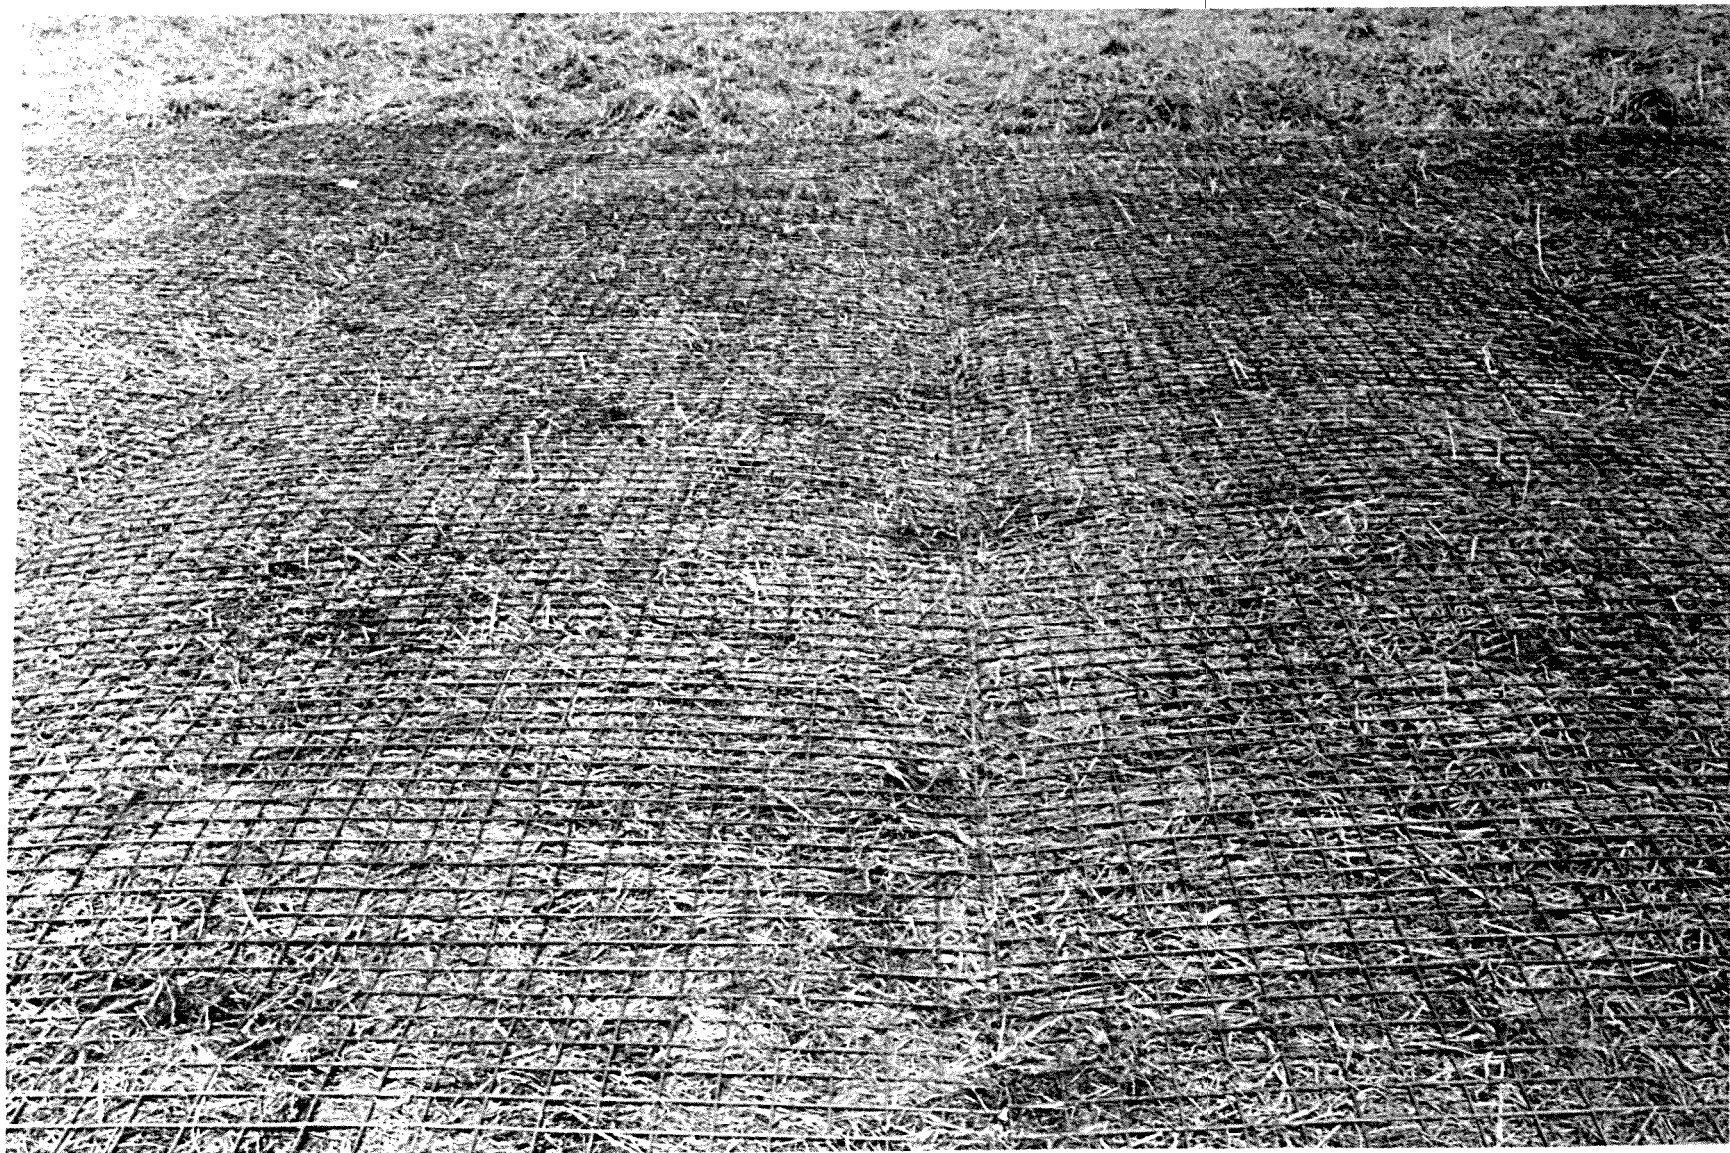
STRAW MULCH WITH WIRE MESH, READY FOR COVERING WITH PIERCED PLANK MAT

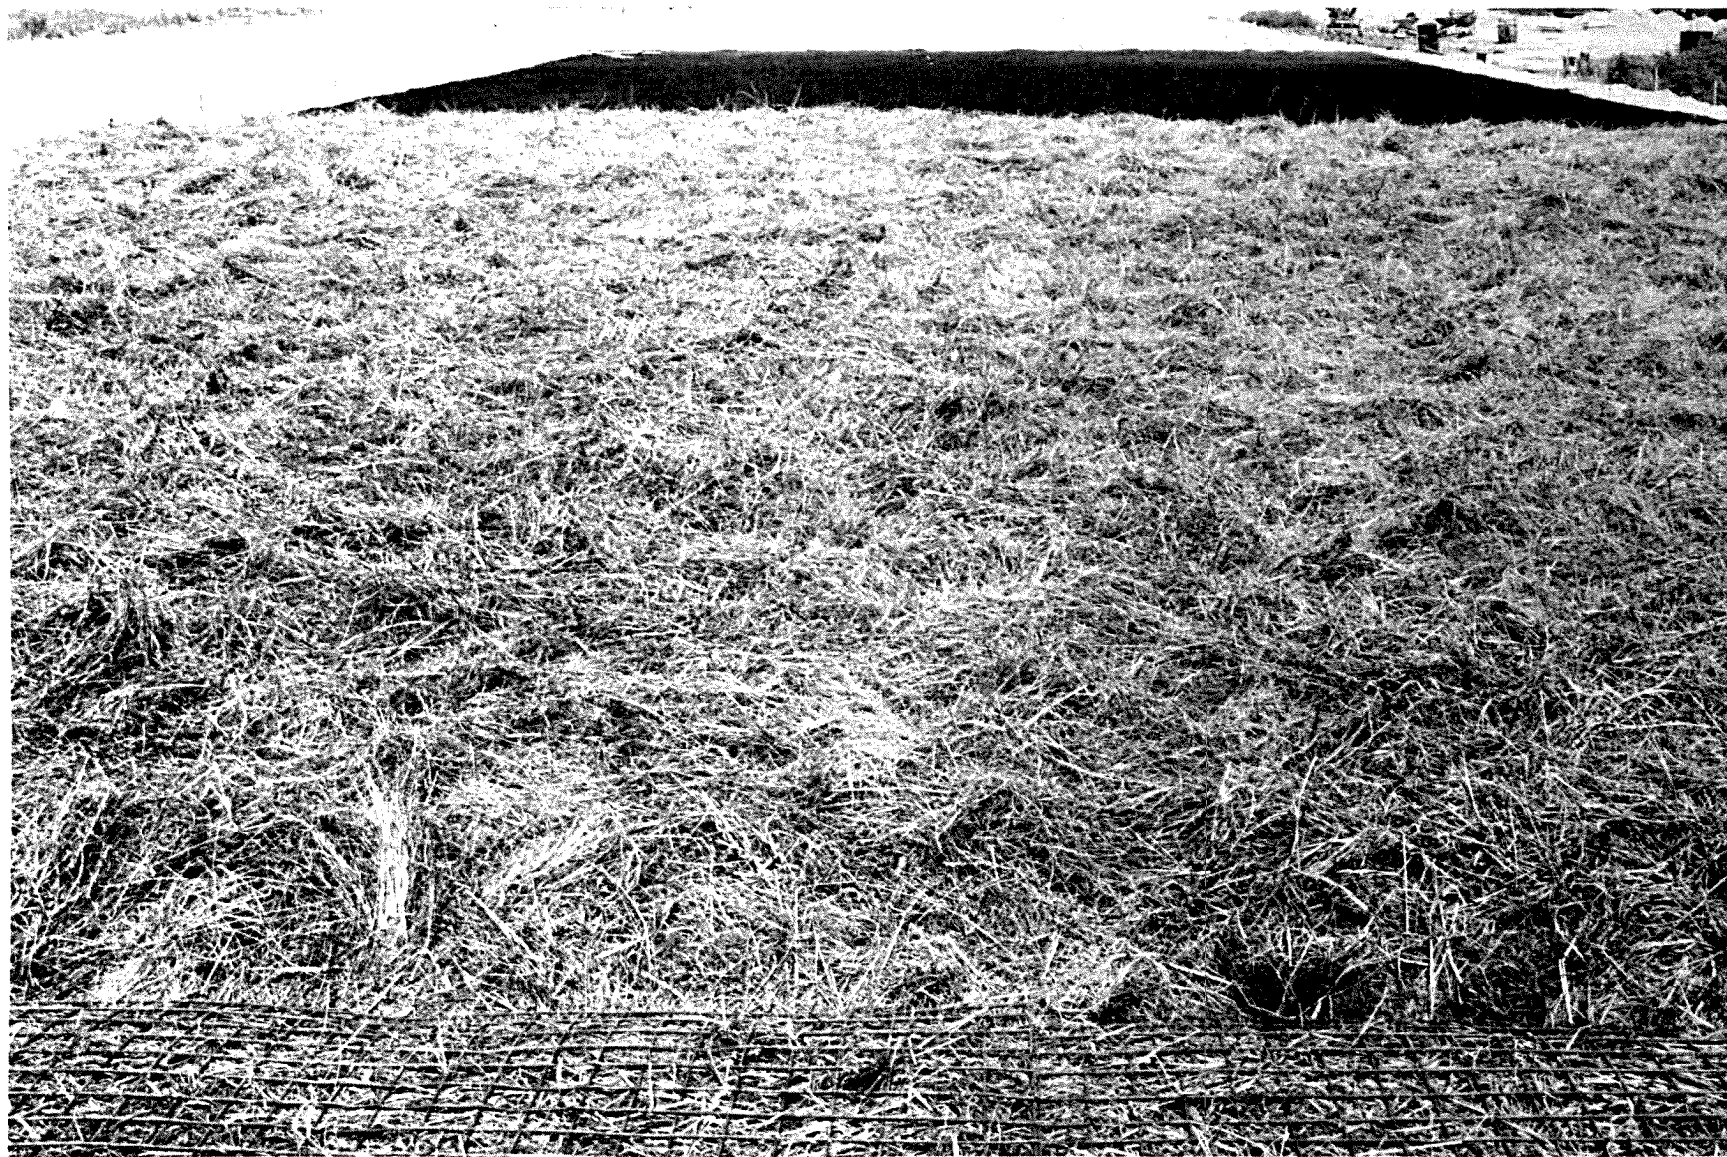
STRAW MULCH, JUST PRIOR TO PLACEMENT OF PIERCED PLANK MAT

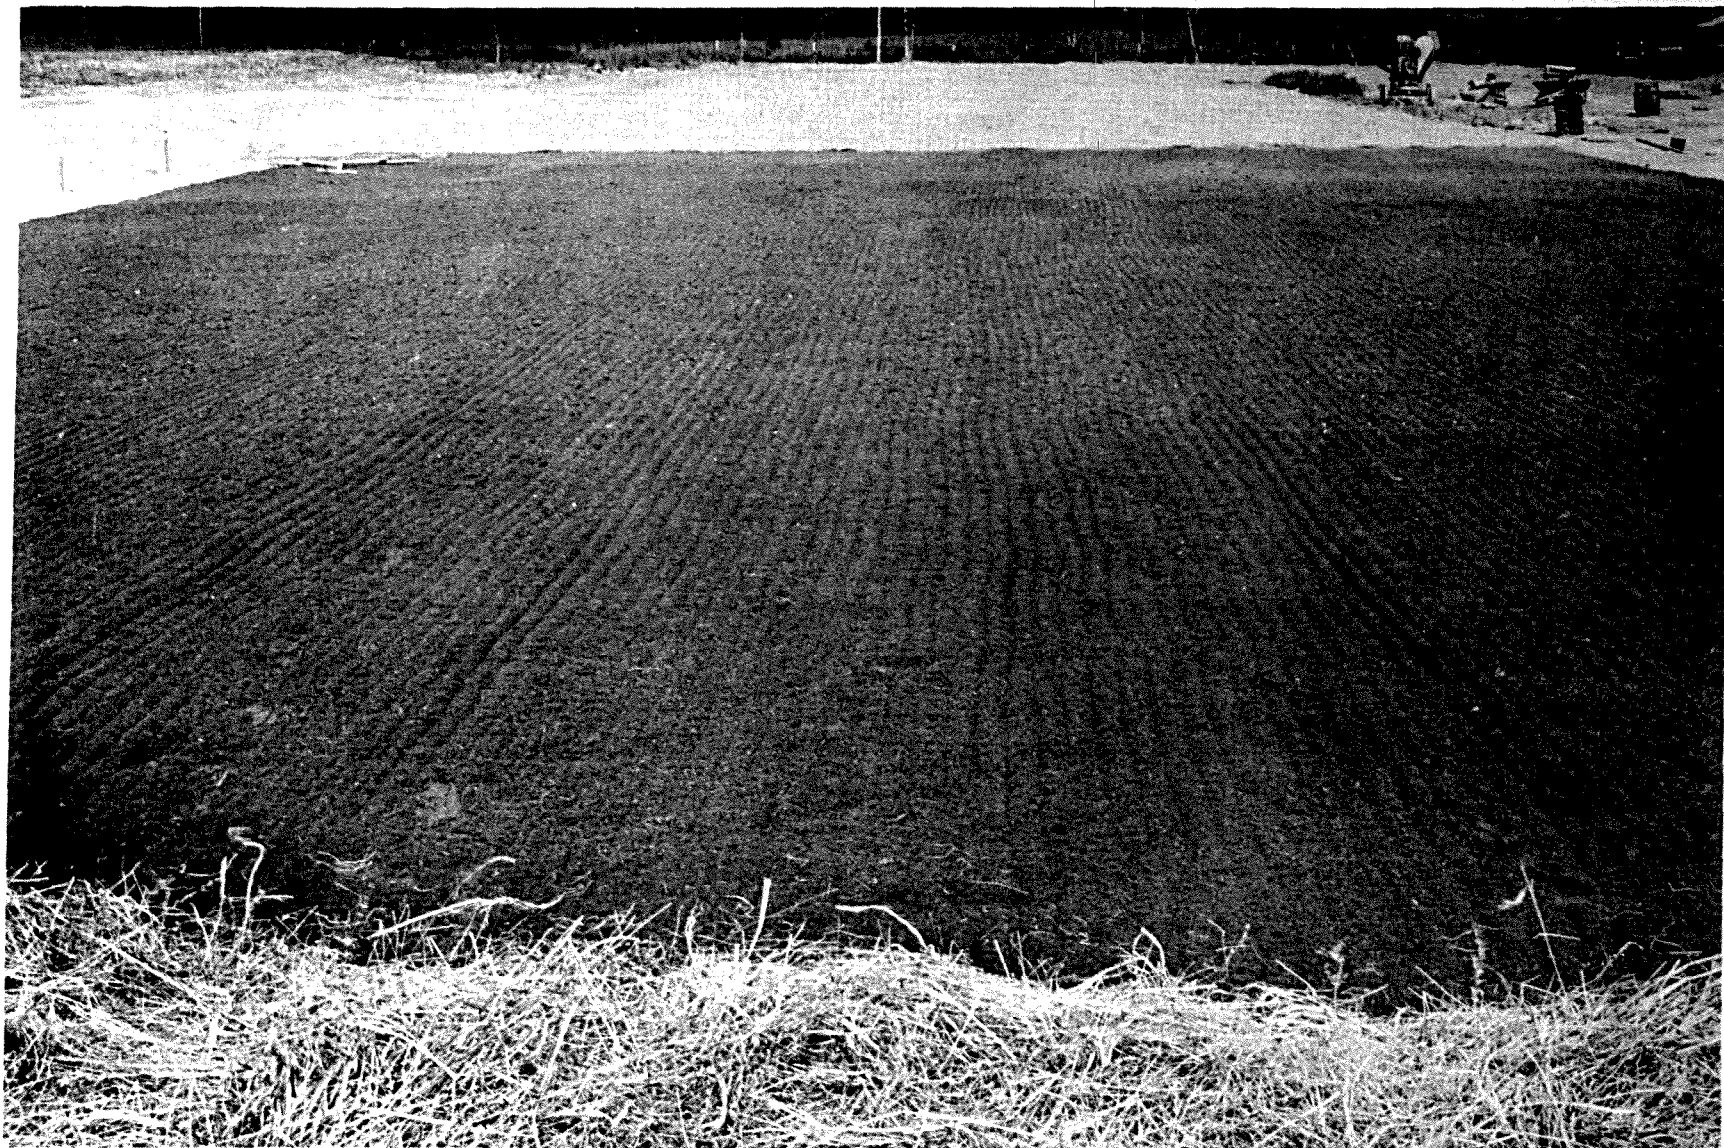
SAND - AND SOIL - ASPHALT CUSHIONS READY FOR COMPACTION

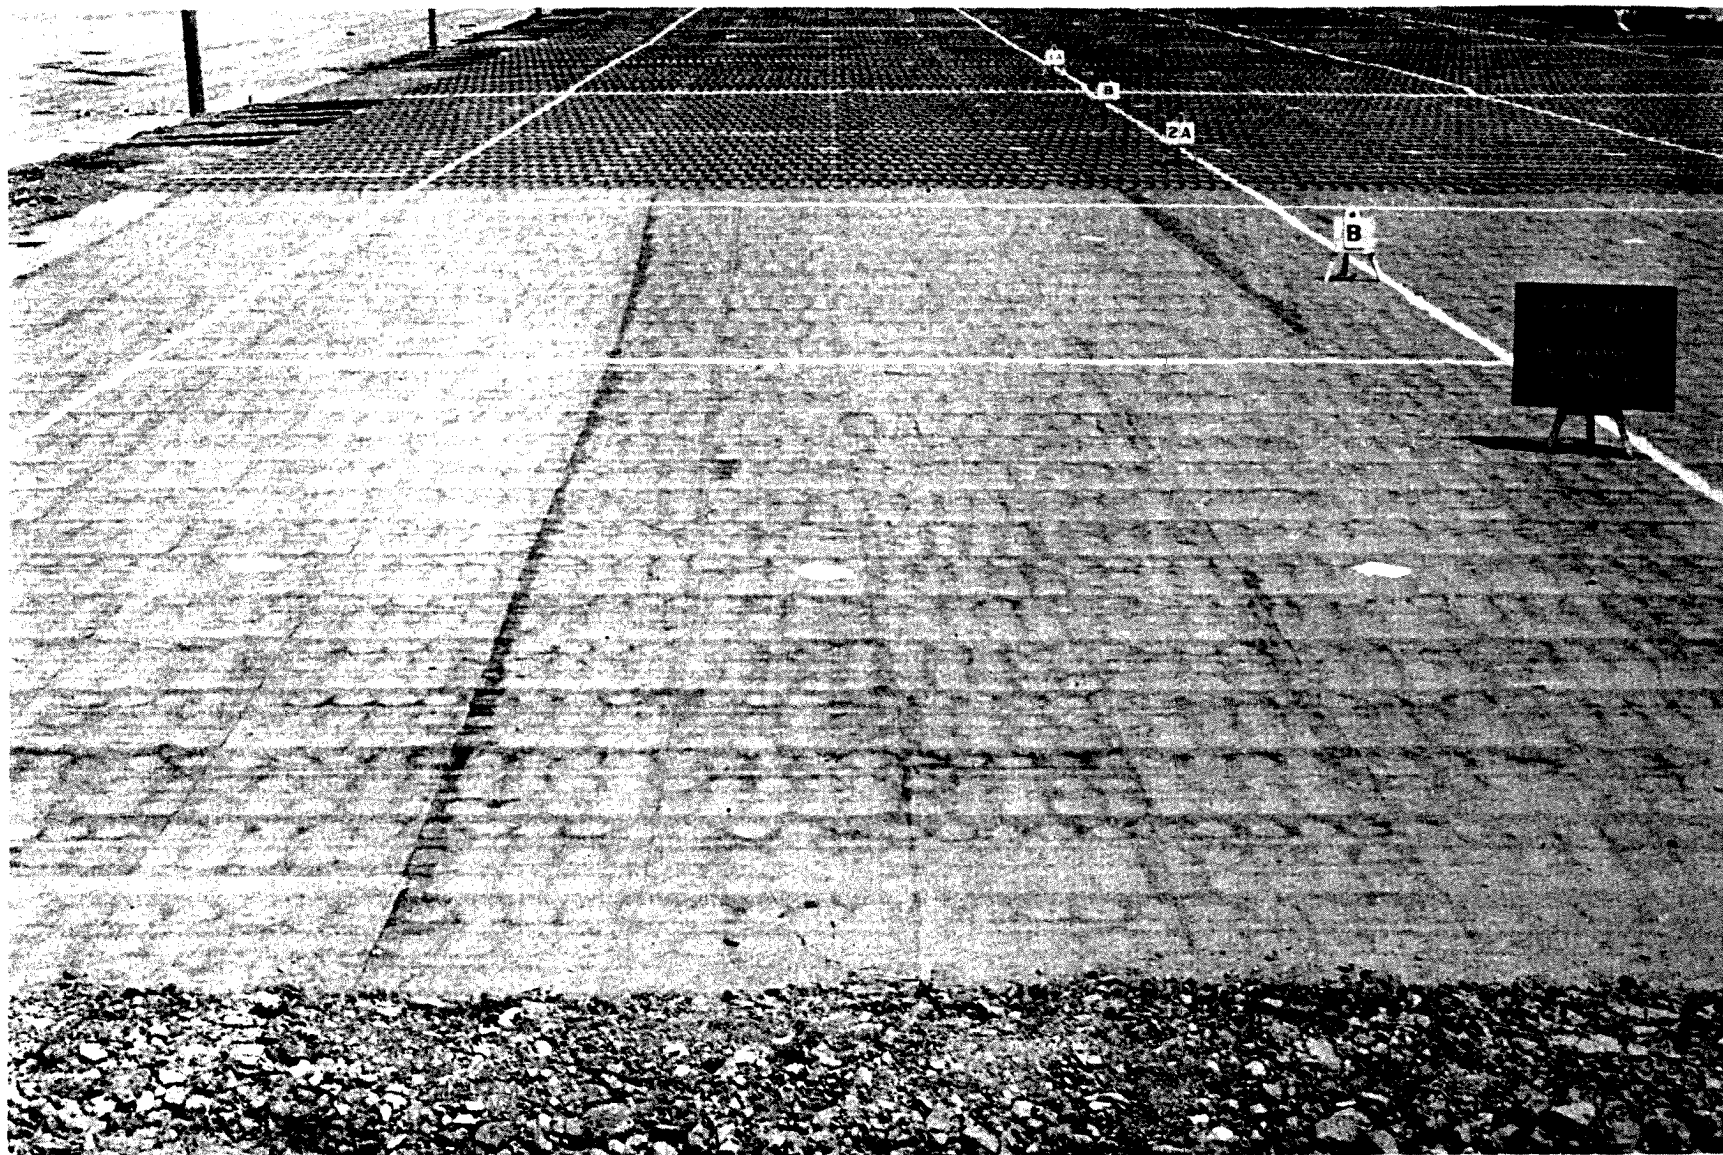
SECTION I, WITH 37,000-LB TRAFFIC LANE IN BACKGROUND, PRIOR TO TESTING

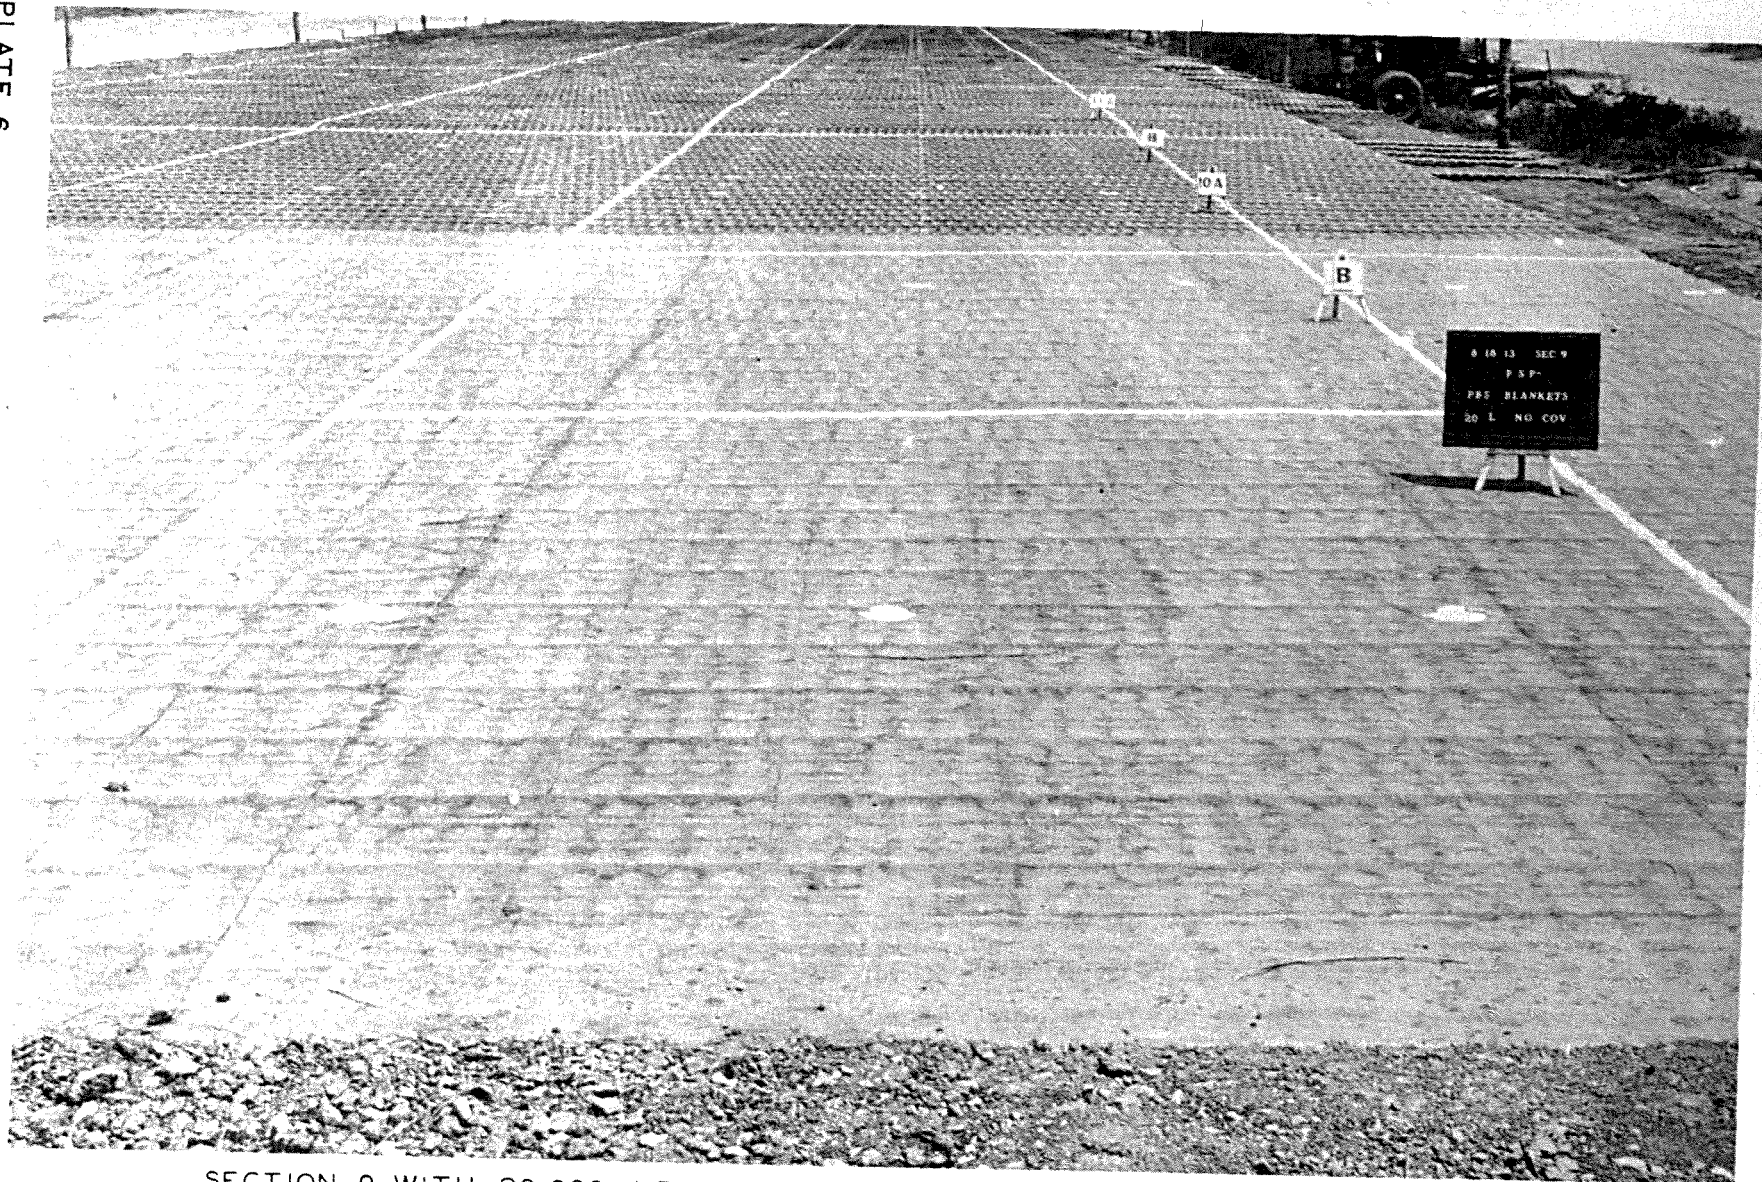
SECTION 9, WITH 20,000-LB TRAFFIC LANE IN BACKGROUND, PRIOR TO TESTING

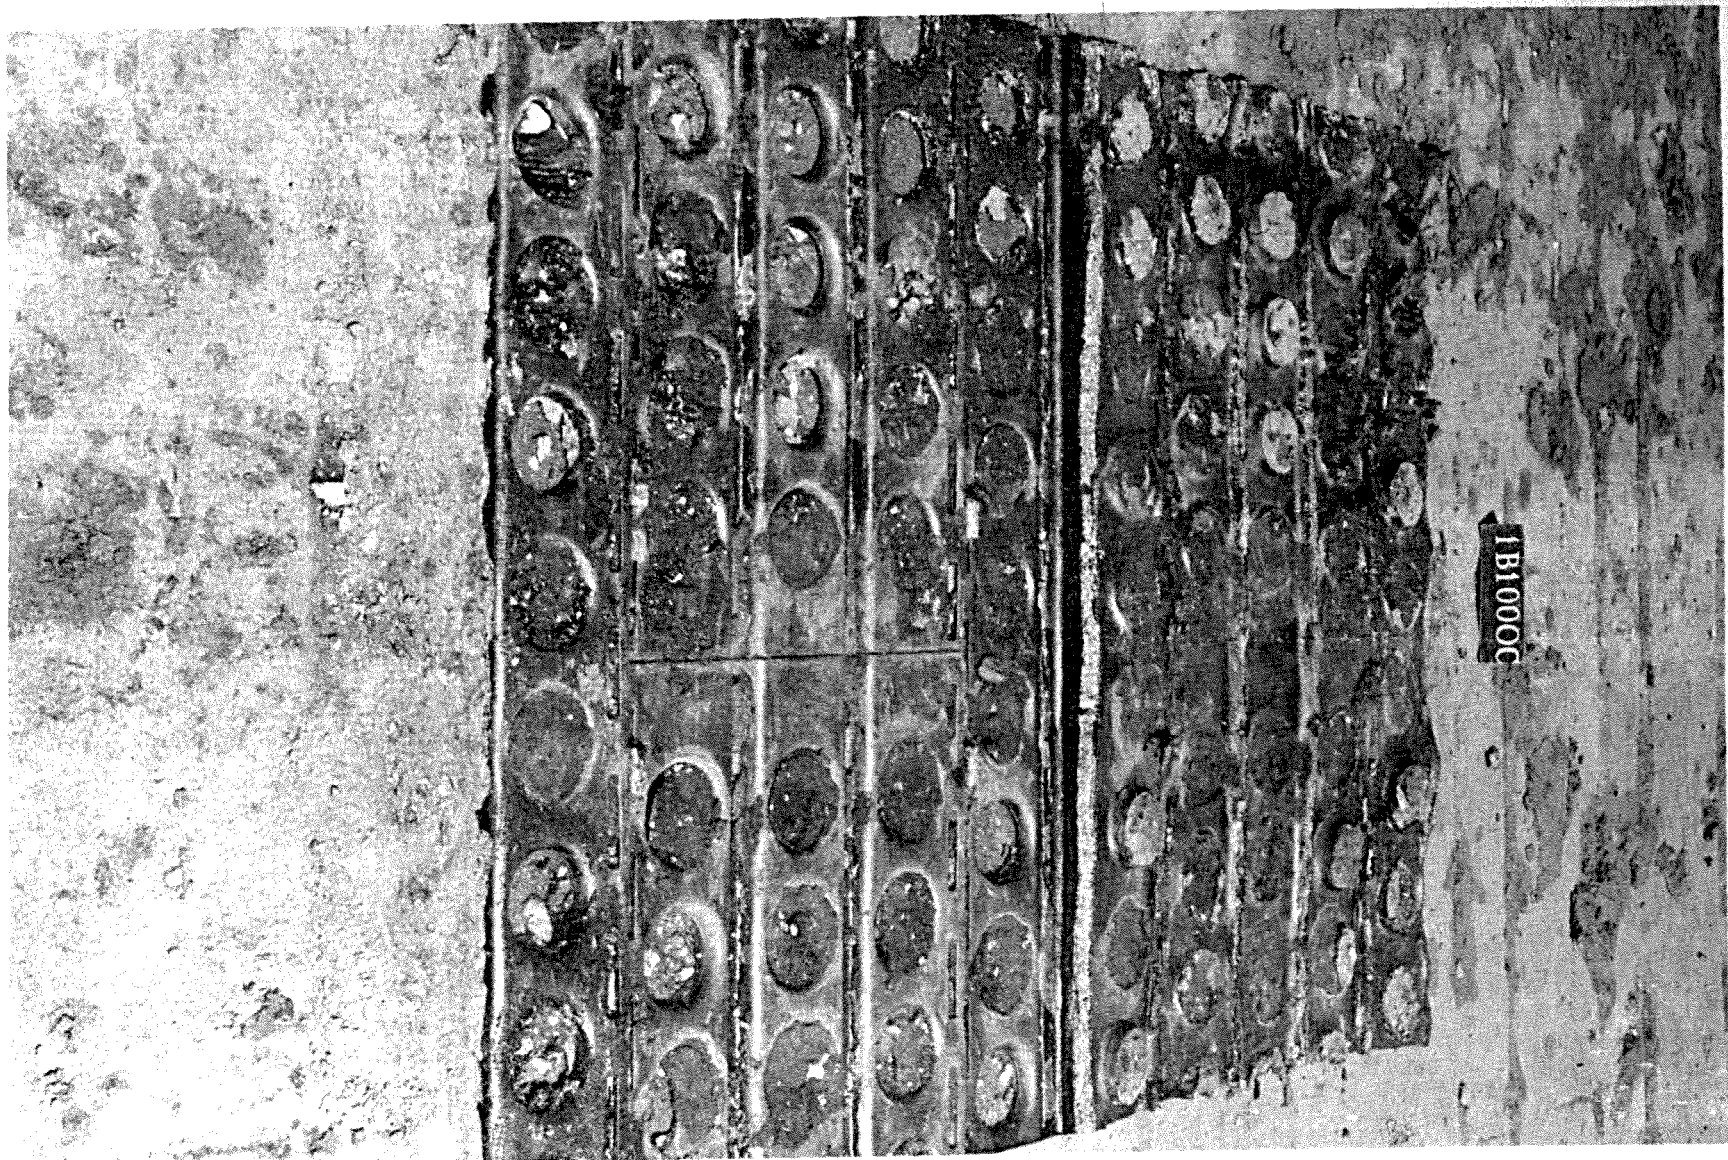
SECTION I, 37,000-LB LANE. BLANKET PUNCTURED BY SPRING CLIPS (48 COVERAGES)

SECTION I, 37,000-LB LANE, SHOWING EFFECTIVENESS OF BOND FORMED BY HOT ASPHALT CEMENT (1000 COVERAGES)

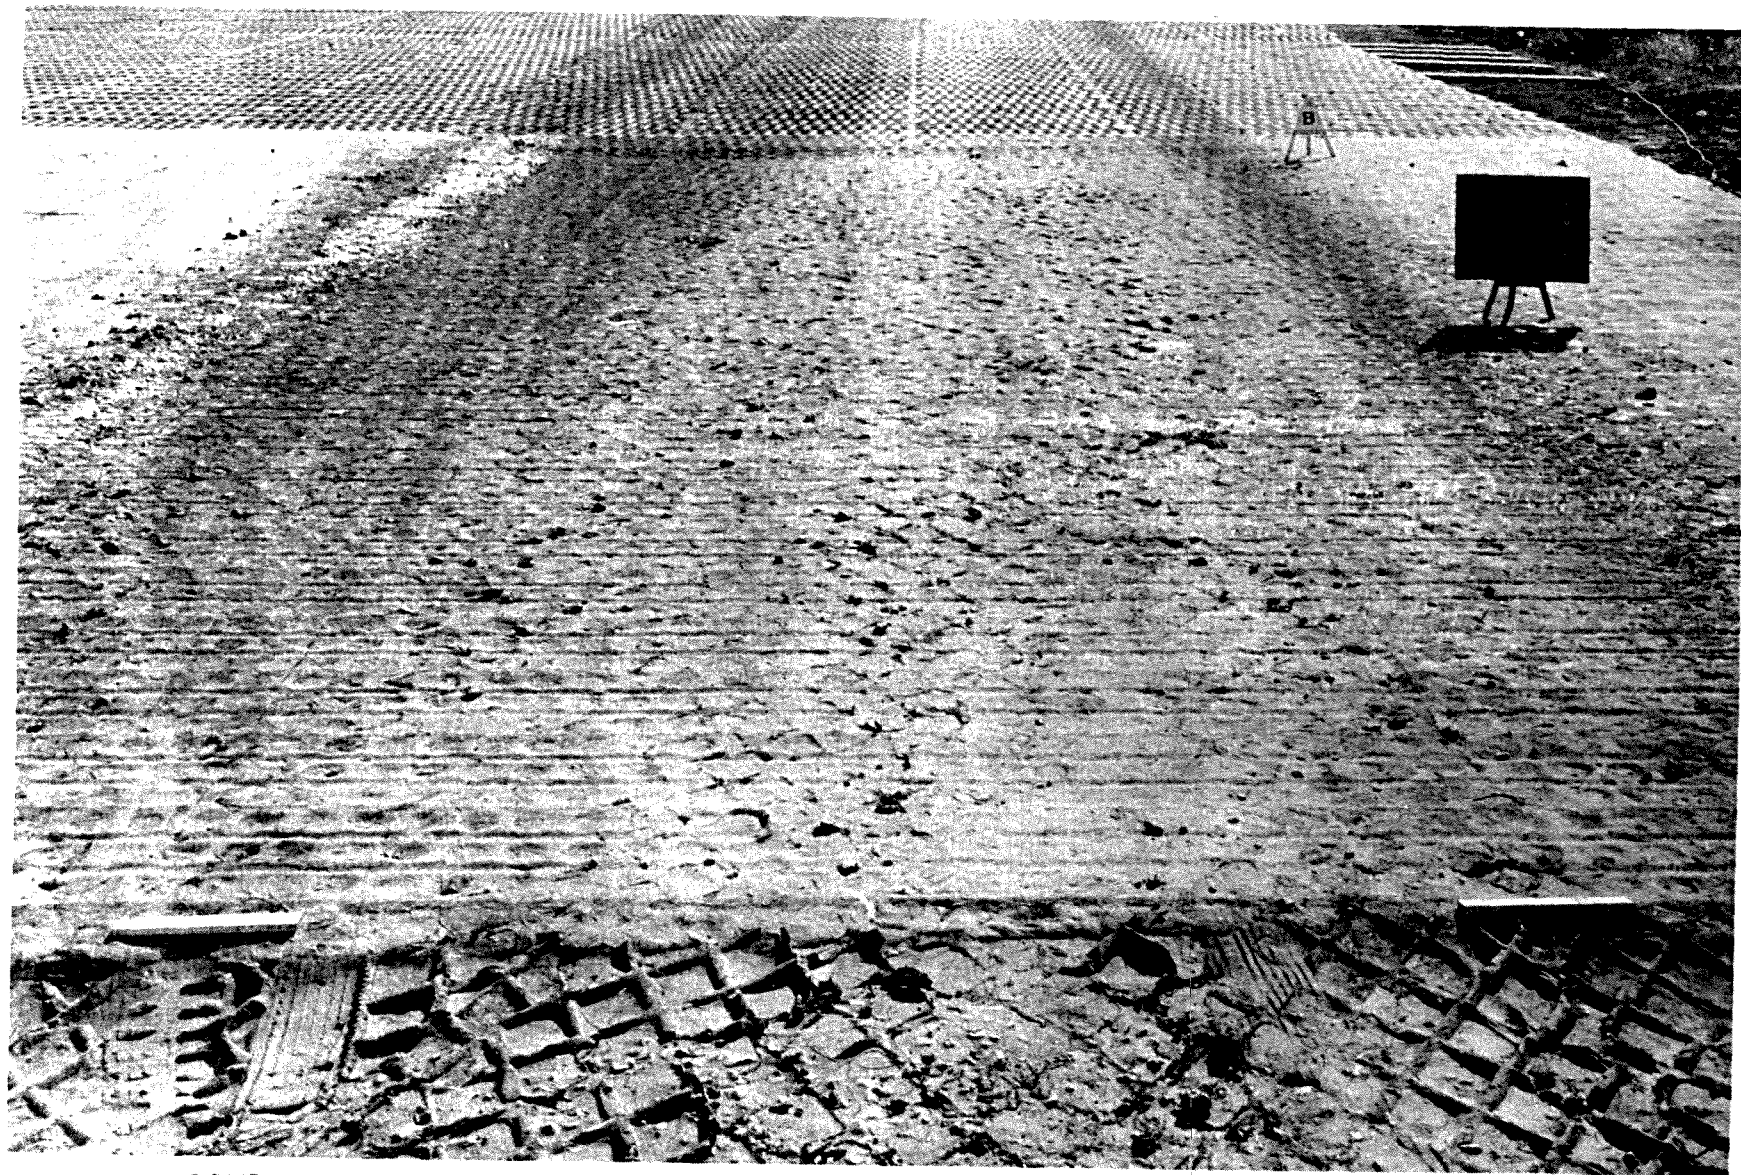
14. Sections with PBS blankets. Section 1 in the 37,000-lb traffic lane and section 9 in the 20,000-lb traffic lane contained a double thickness of PBS mat cemented to the top of a PSP mat with asphalt. Methods of placing the PBS on the steel mat are described in the last half of paragraph 6. In the 37,000-lb lane the scrubbing action of the large tires (30.00-40), as they deflected under the test load, abraded the PBS so rapidly that holes started appearing at the spring clips at 32 coverages. At 76 coverages the fabric started tearing along the seams where there was only a single thickness to resist lateral tension, and along the edges of the pierced planks where abrasion was accentuated. This abrasion increased so that at 100 coverages the PBS had failed completely as a waterproofing agent, although it continued to serve as a dust preventive throughout the test. No bond failures occurred, either between strips of PBS or between PBS and steel mat. Plate 7 shows how the spring clips punctured the blankets. In plate 8 the blanket has been cut and opened up to show the bond formed by the asphalt cement. Note how thoroughly the pierced plank mat was embedded in the base course material. In the 20,000-lb traffic lane (section 9) the blankets gave much better performance. The tires on the 20,000-lb testing machine were much smaller than those on the 37,000-lb machine (see paragraph 12) and while they had about the same contact pressure the abrasive action was much less. The spring clips did not start coming through the blankets until 300 coverages had been applied. At 700 coverages only 21 clips had come through and a light rain at this stage did little or no damage to the base course. At 1000 coverages (the end of the test) about 60% of the clips had cut through the PBS. No other holes or damage had occurred except a few punctures caused by pieces of gravel that had been picked up by the tires and brought onto the test section from the turnaround. This of course would not occur on a landing field and these punctures were not considered important. Plate 9 shows the condition of section 9 at 1000 coverages.

CONDITION OF PBS BLANKETS IN 20,000-LB TRAFFIC LANE AT 1000 COVERAGES

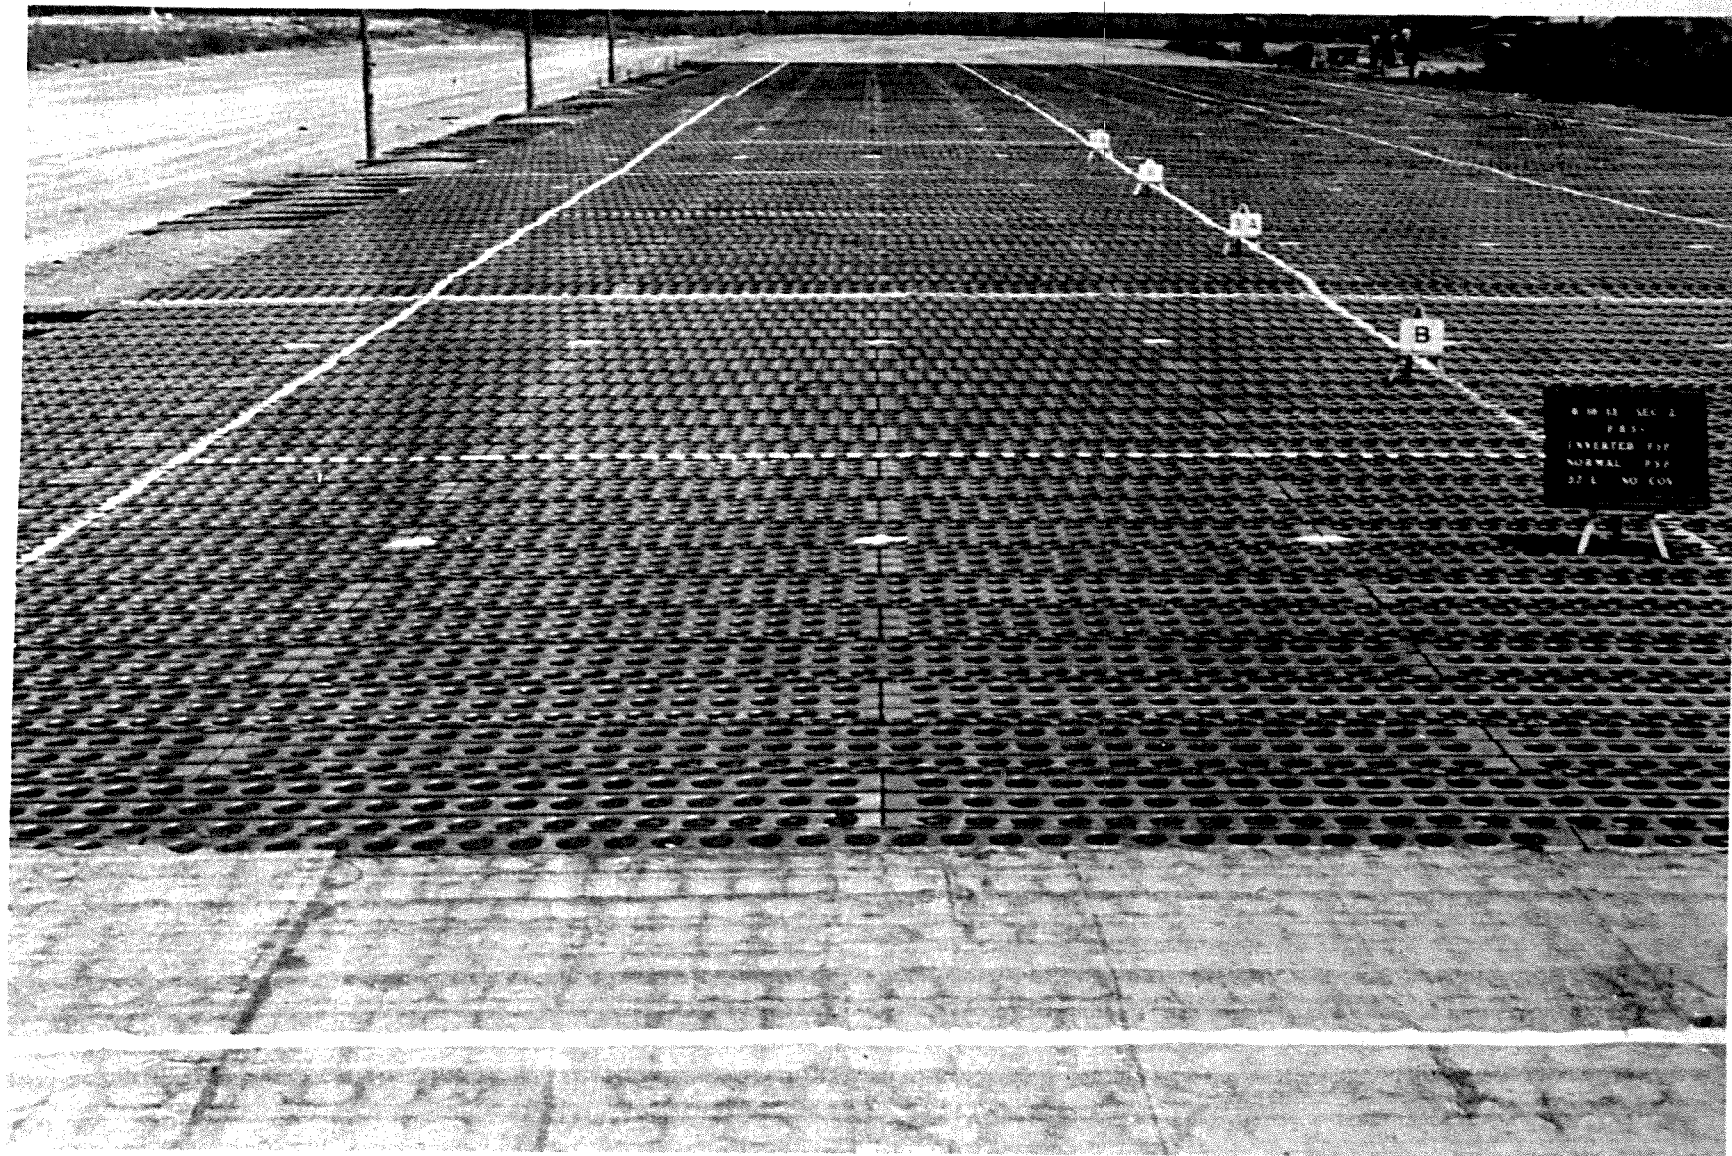
SECTION 2, WITH INVERTED PSP CUSHION, BEFORE TESTING

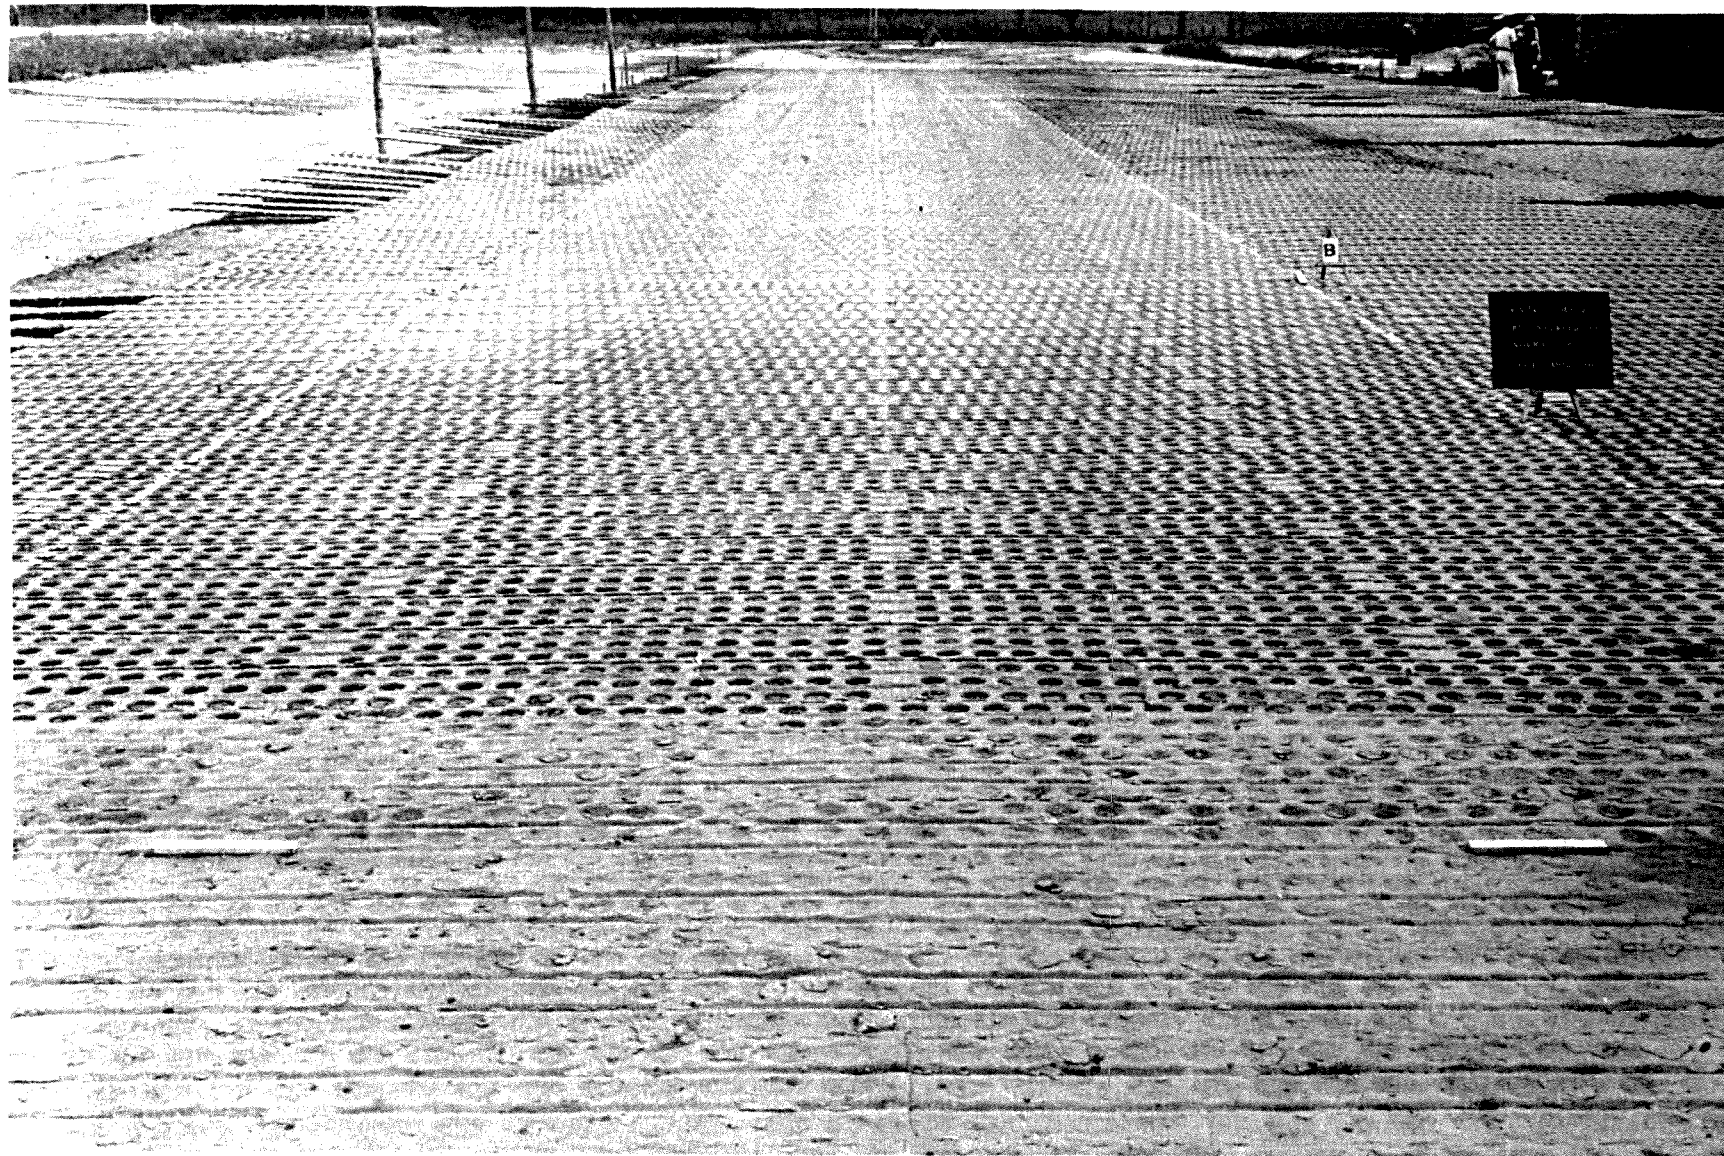
15. Sections with inverted pierced steel plank. The most noticeable feature of this combination of PSP laid normally over PSP inverted was the noise it produced under traffic. There was no damage to the PBS in either lane visible from the surface at the end of the test (1000 coverages). This is shown by comparison of plate 10 with plate 11 and plate 12 with plate 13. However, removal of the two layers of pierced plank mat after testing the 20,000-lb lane revealed that the base course material had been forced up into the ribs of the inverted layer and had torn the fabric in many places. It is believed that the operation of the 20,000-lb load at somewhat greater speed produced a tamping action which was greater than that produced by the slower 37,000-lb load and hence resulted in loosening the surface of the base course material, and forced it upward into the openings or convex surfaces of the mat. The rounded tops of the spring clips had also cut through the PBS. Careful estimates indicated that this tearing had started just prior to 700 coverages. It was also revealed that even though the base course material had been thoroughly rolled with a smooth-drum roller just before placing the PBS,

SECTION 2, WITH INVERTED PSP CUSHION, AFTER TESTING

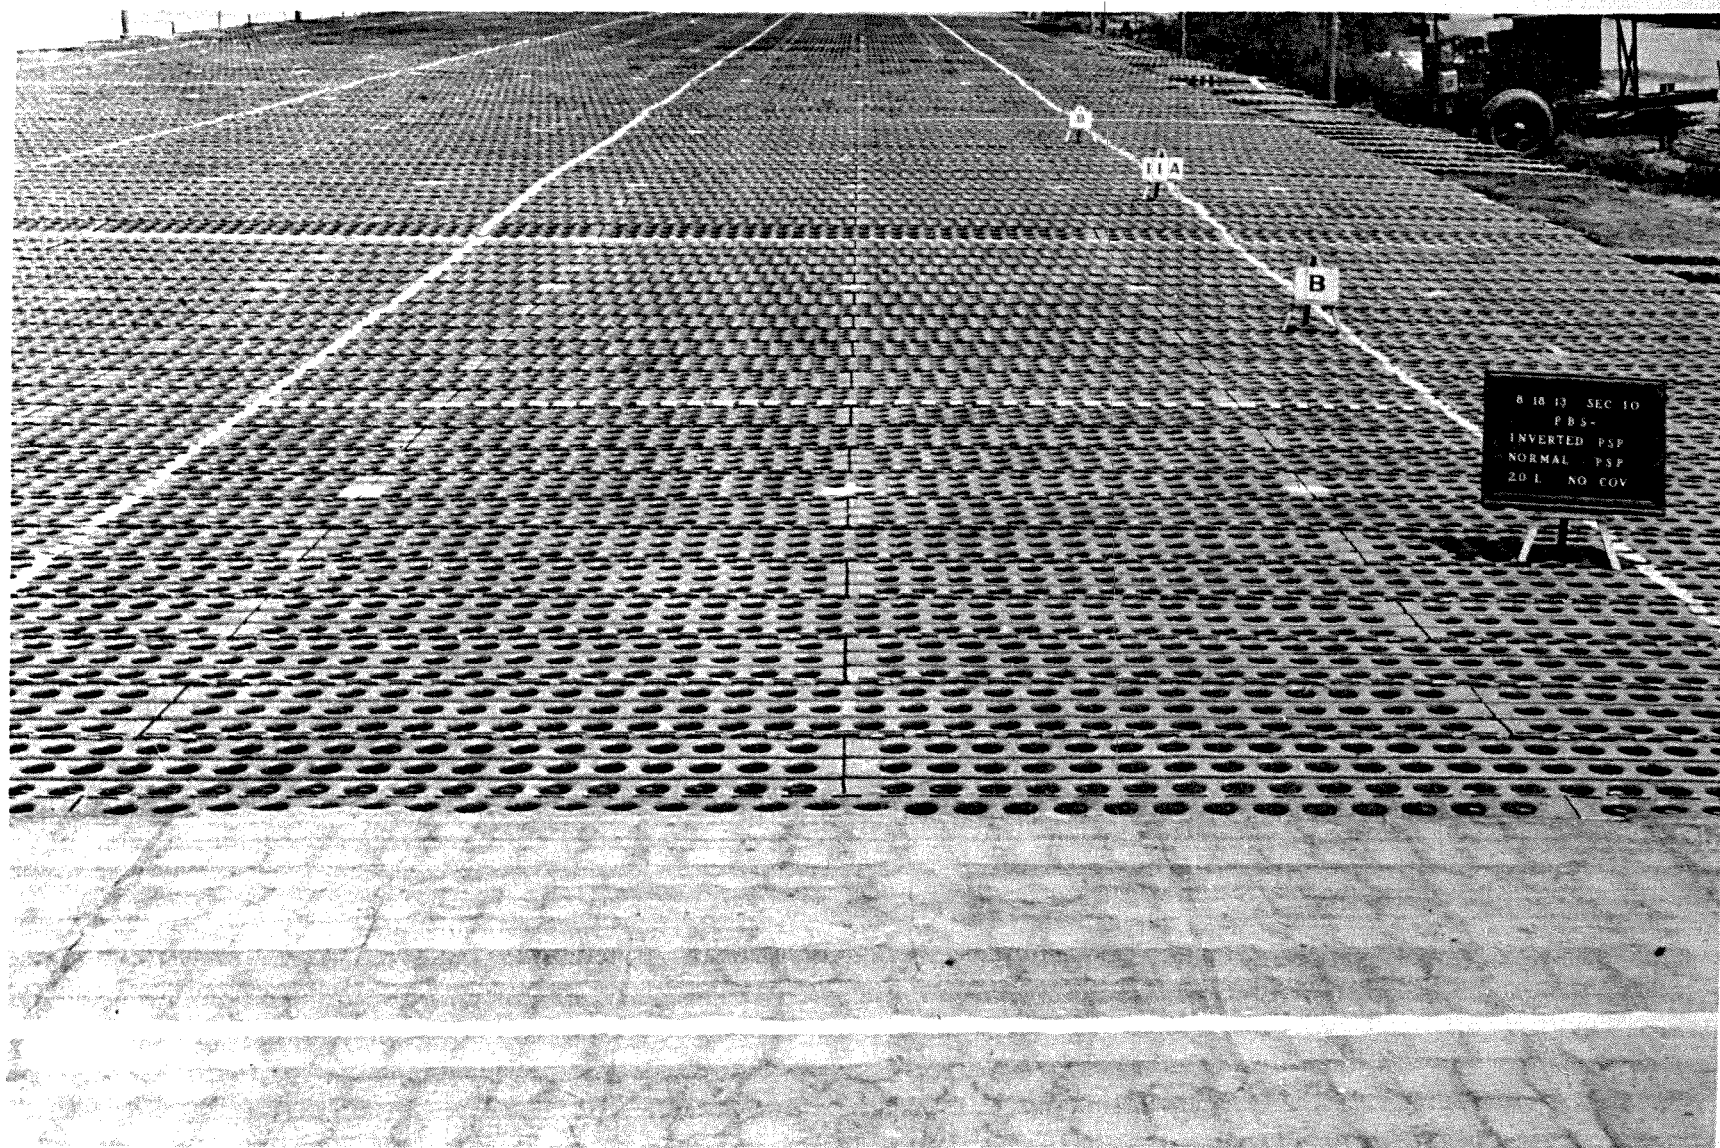
SECTION 10, WITH INVERTED PSP CUSHION, BEFORE TESTING

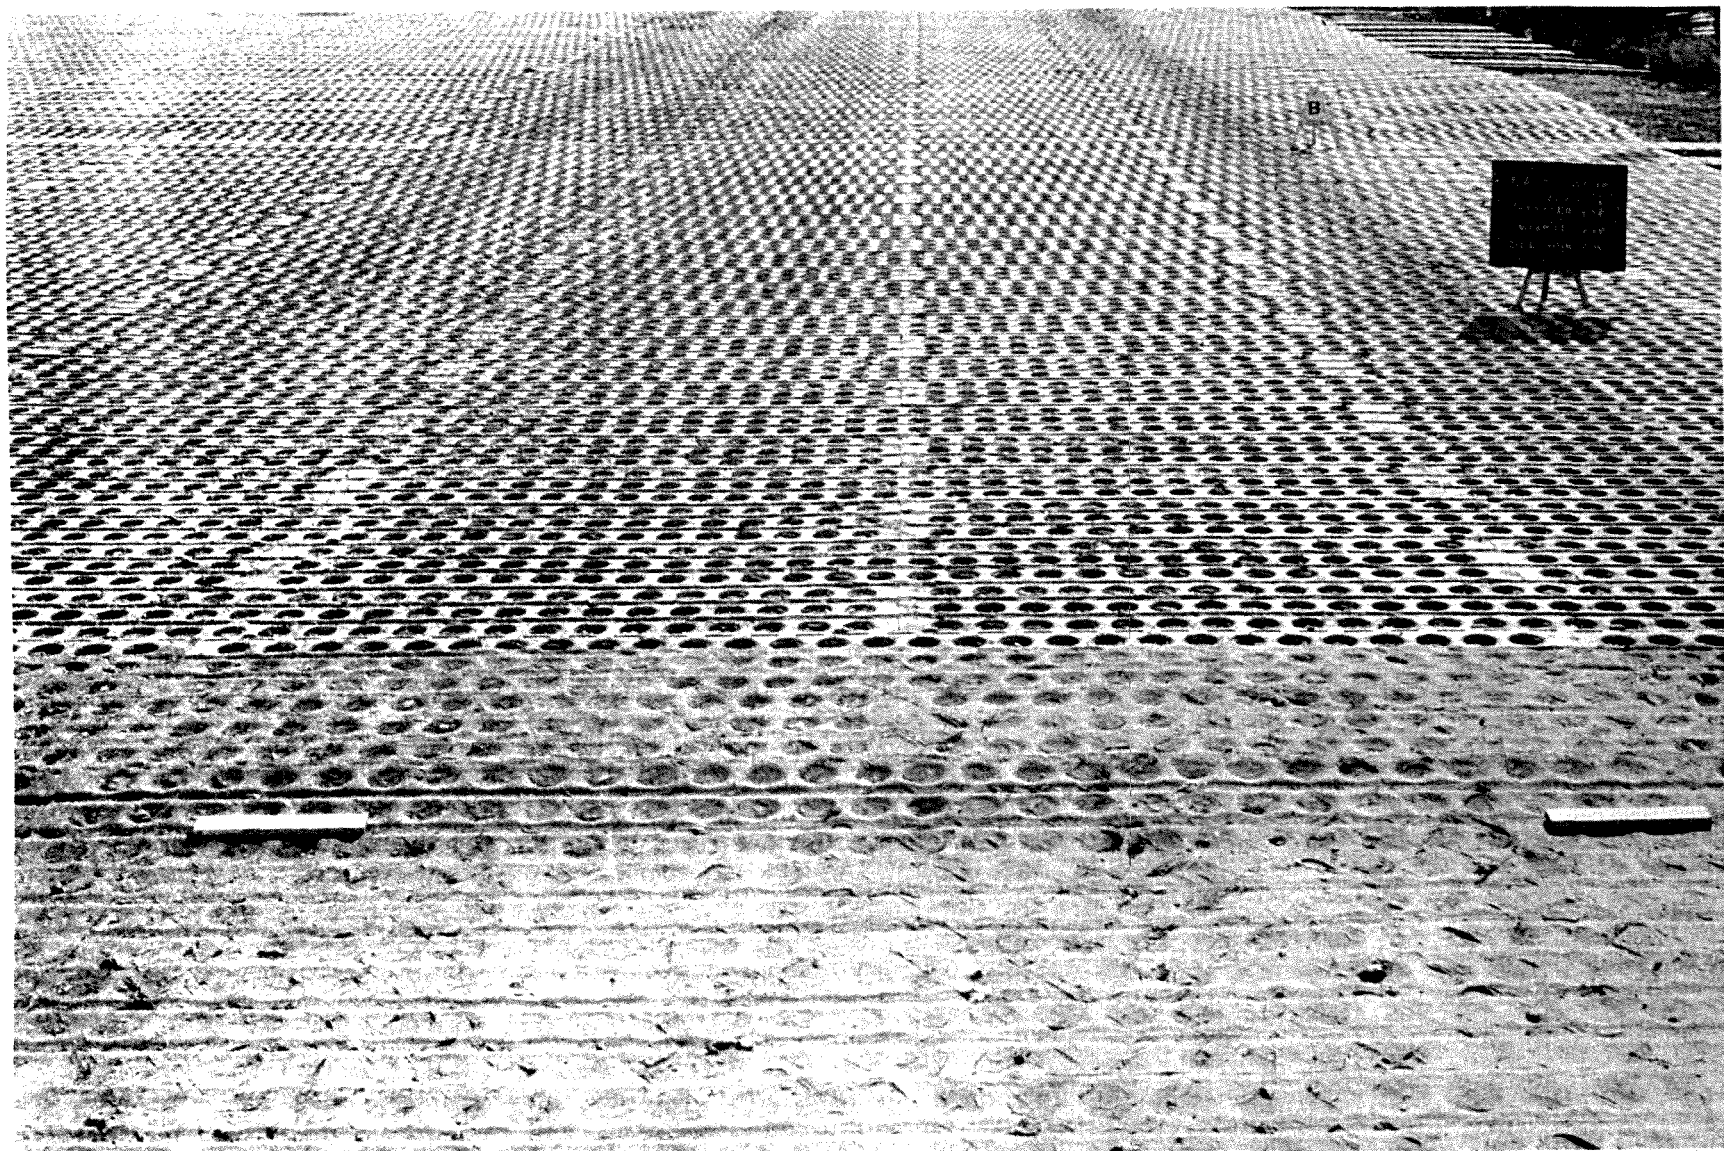
SECTION 10, WITH INVERTED PSP CUSHION, AFTER TESTING
