TESTS ON METHODS OF EMPLOYING  
PIERCED PLANK LANDING MAT WITH  
PREFABRICATED BITUMINOUS SURFACING

TECHNICAL MEMORANDUM NO. 211-4

U. S. WATERWAYS EXPERIMENT STATION  
VICKSBURG, MISSISSIPPI

5 OCTOBER 1945

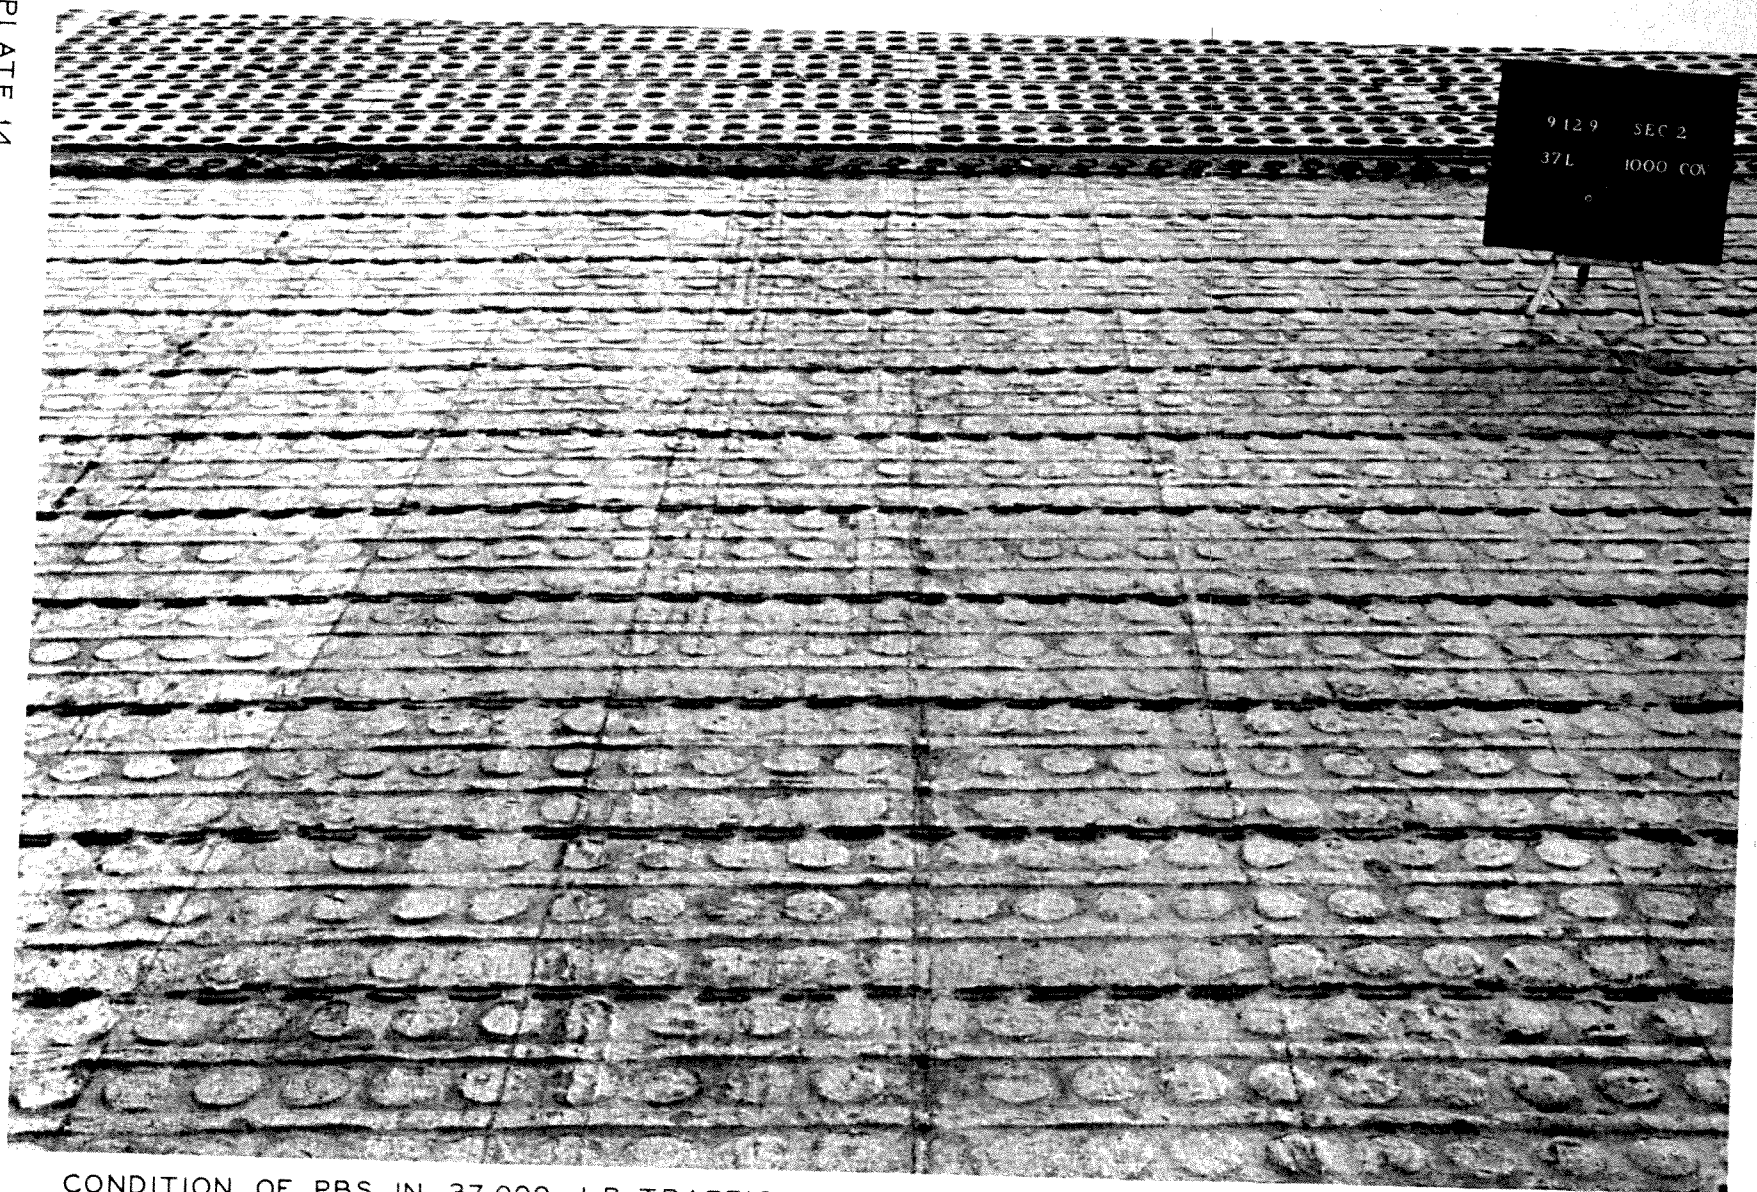
practically every piece of heavy gravel left at the surface had cut through the fabric under the tamping action referred to above. After this experience the planks were removed and periodic inspections were made of the PBS in the 37,000-lb traffic lane as the test progressed. The same conditions described for the 20,000-lb lane occurred in this lane, but to a lesser degree. The fabric started tearing between 800 and 900 coverages. Plates 14 and 15 show the condition of the PBS in these sections at the end of traffic testing and plates 16 and 17 are corresponding views of the base courses with the PBS removed.

CONDITION OF PBS IN 37,000-LB TRAFFIC LANE, INVERTED PSP MAT REMOVED AT END OF TEST

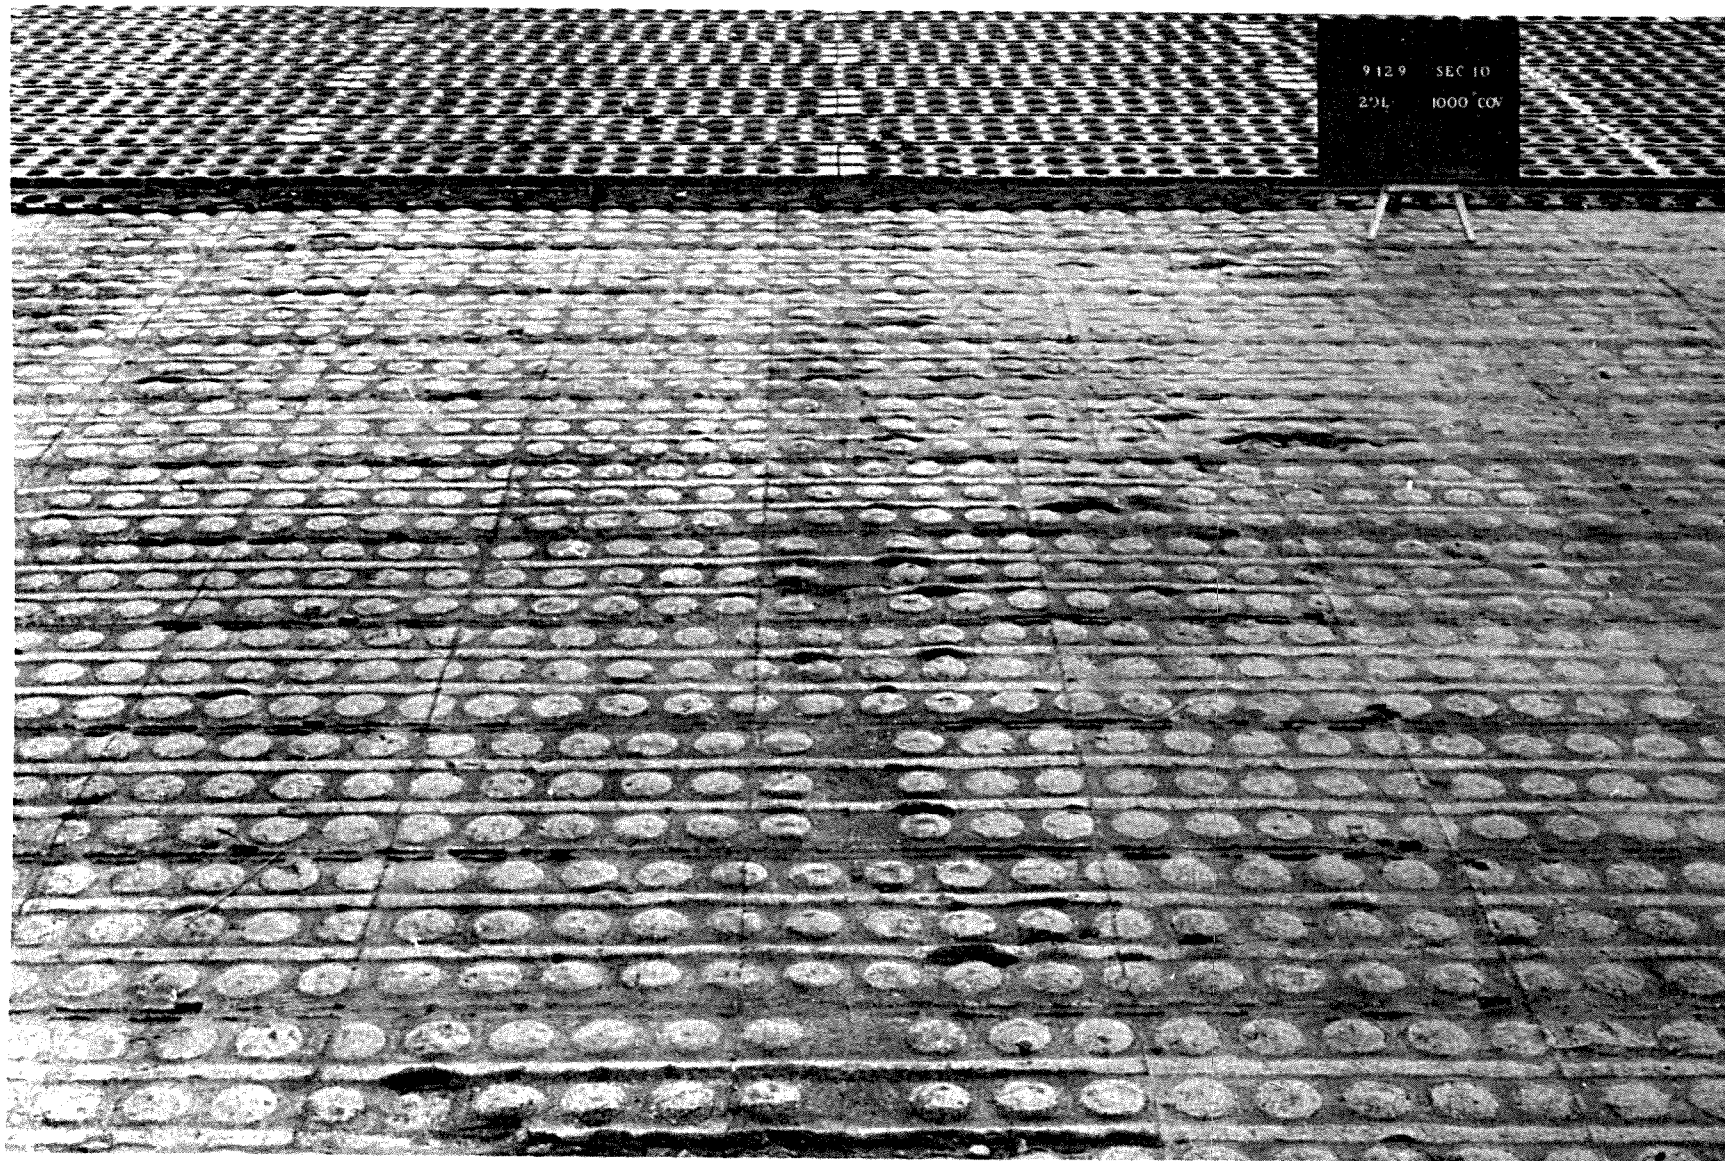
CONDITION OF PBS IN 20,000-LB TRAFFIC LANE, INVERTED PSP MAT REMOVED AT END OF TEST

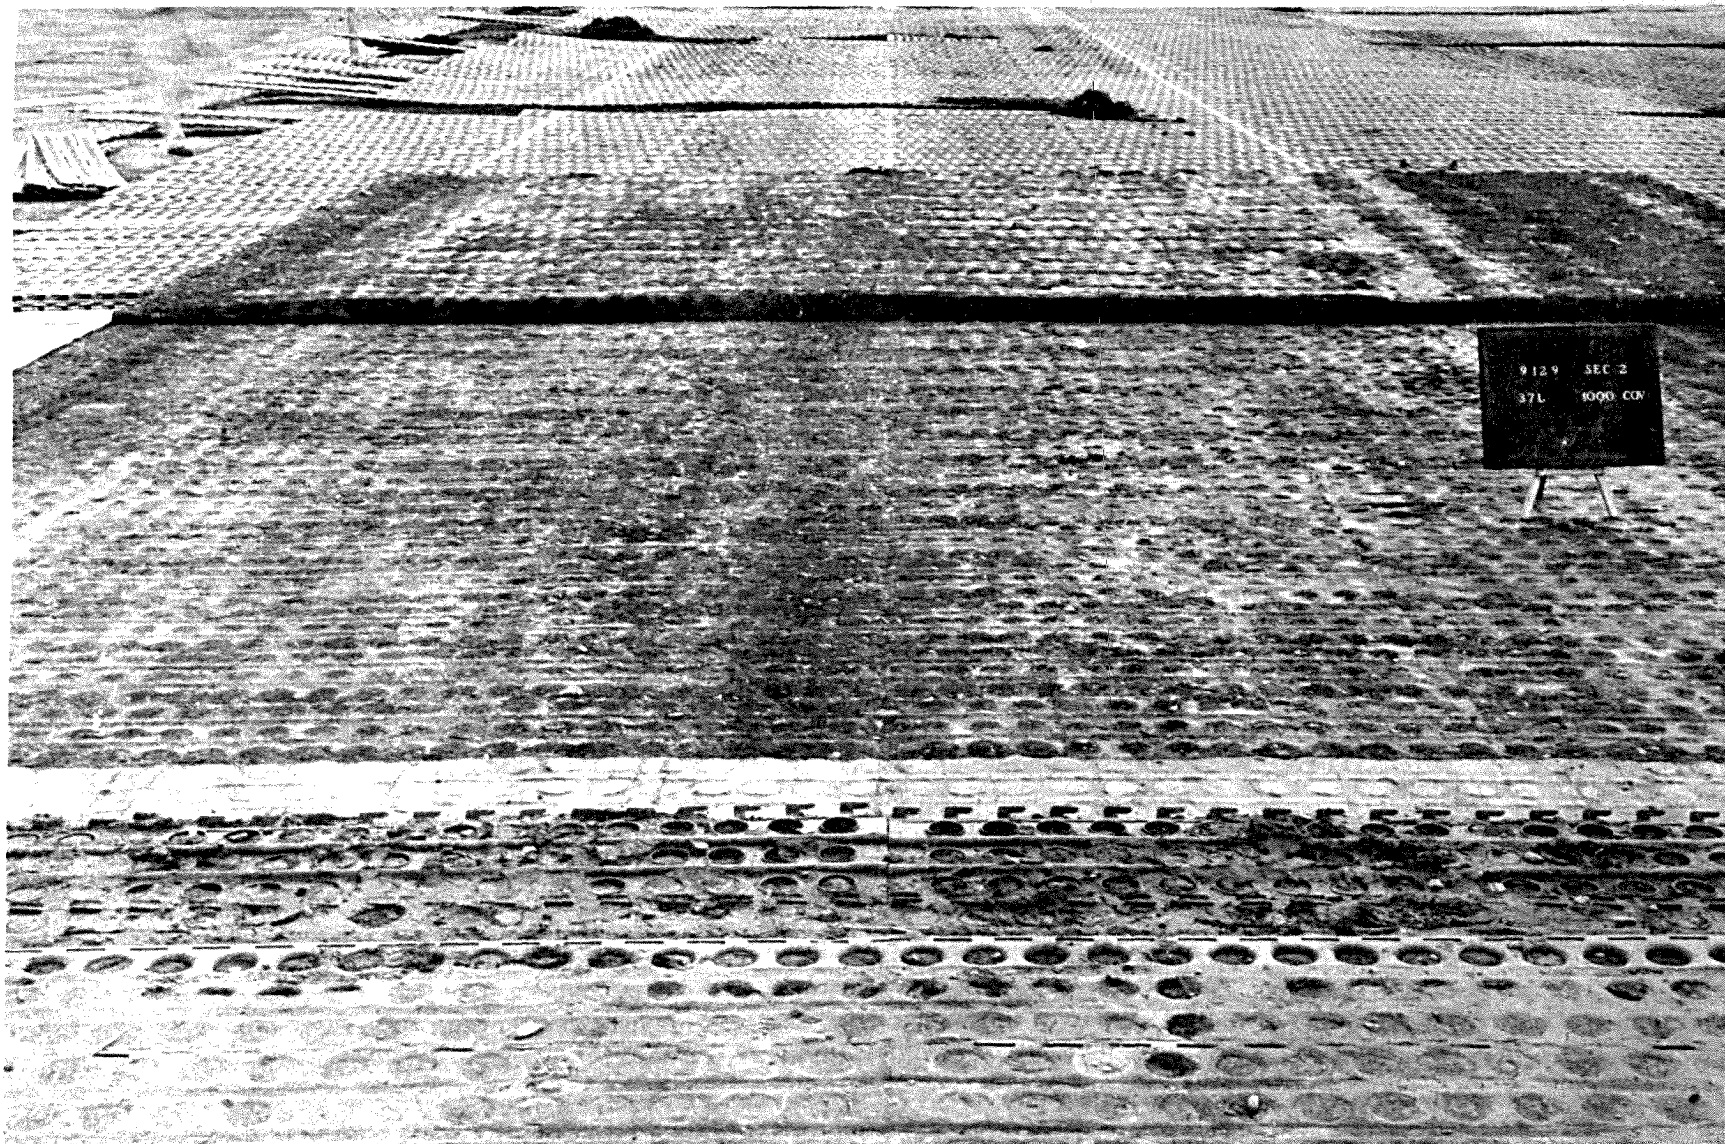
BASE COURSE UNDER INVERTED PSP IN 37,000-LB LANE, AT END OF TEST

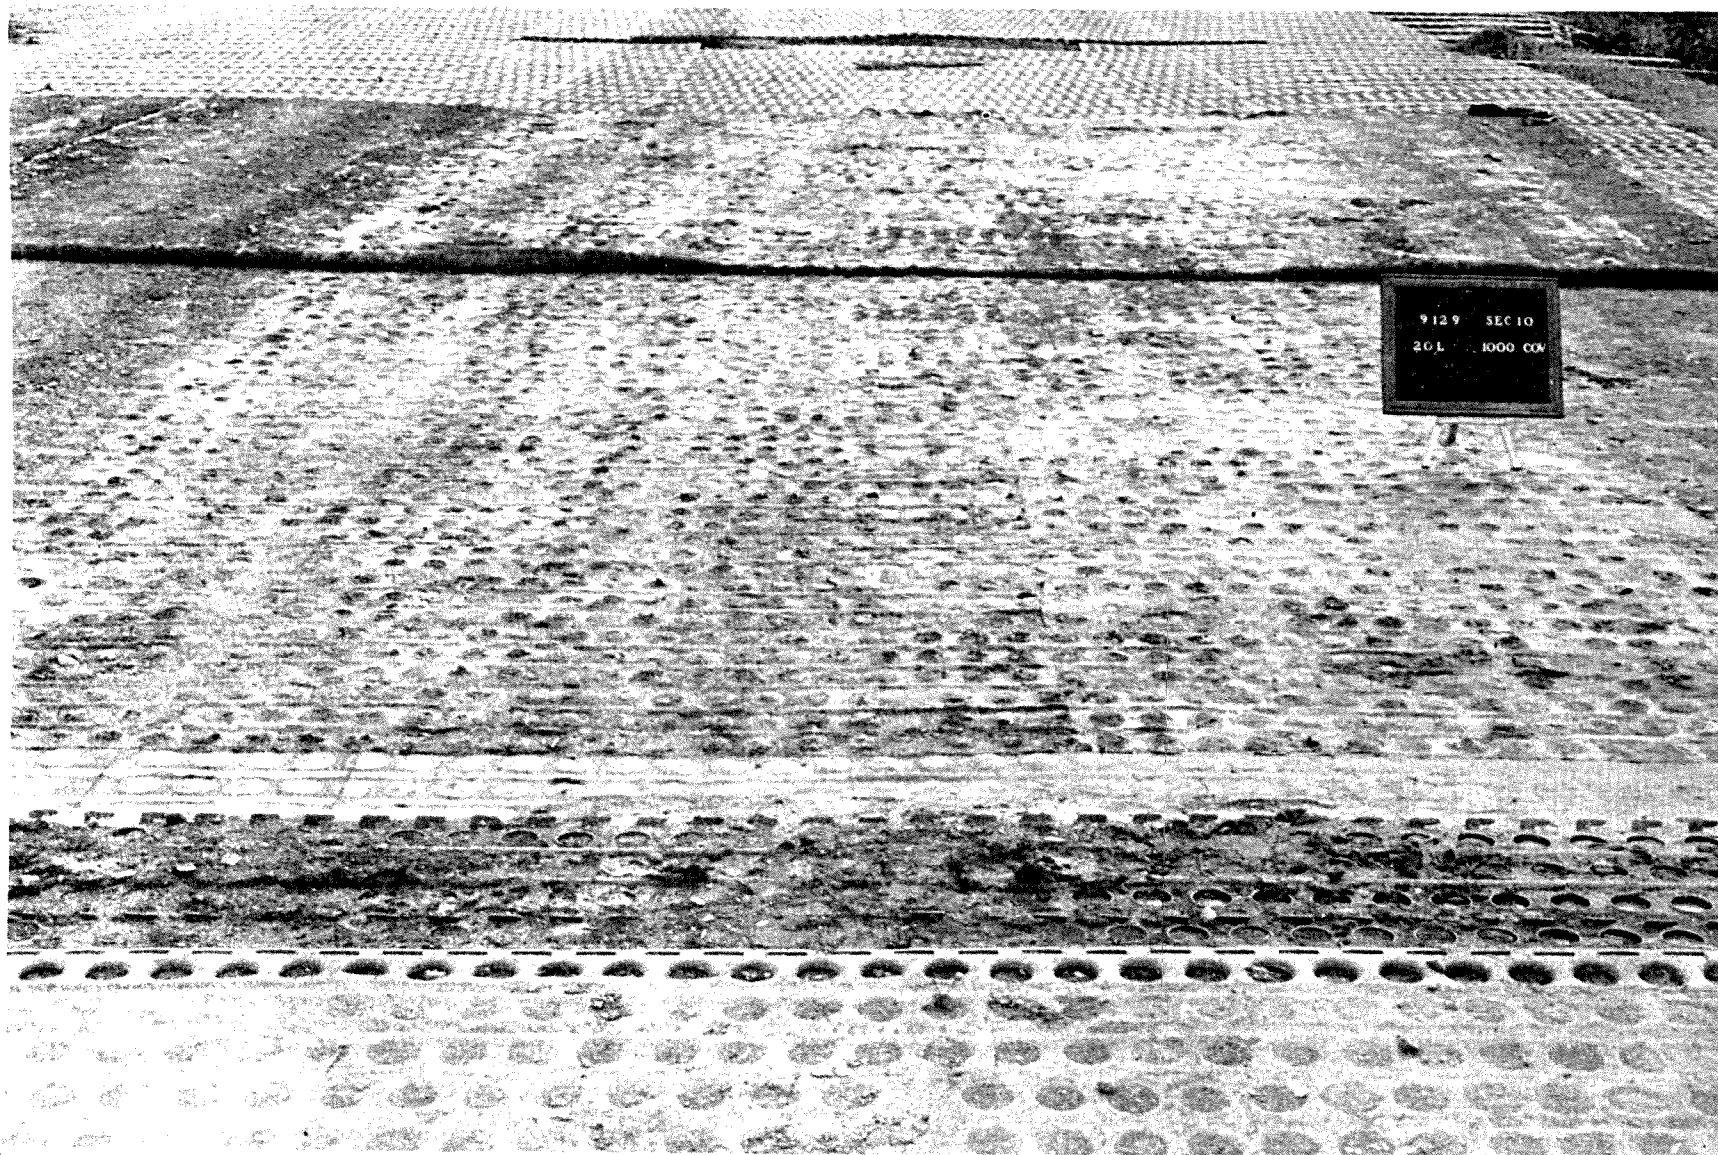
BASE COURSE UNDER INVERTED PSP IN 20,000-LB LANE, AT END OF TEST

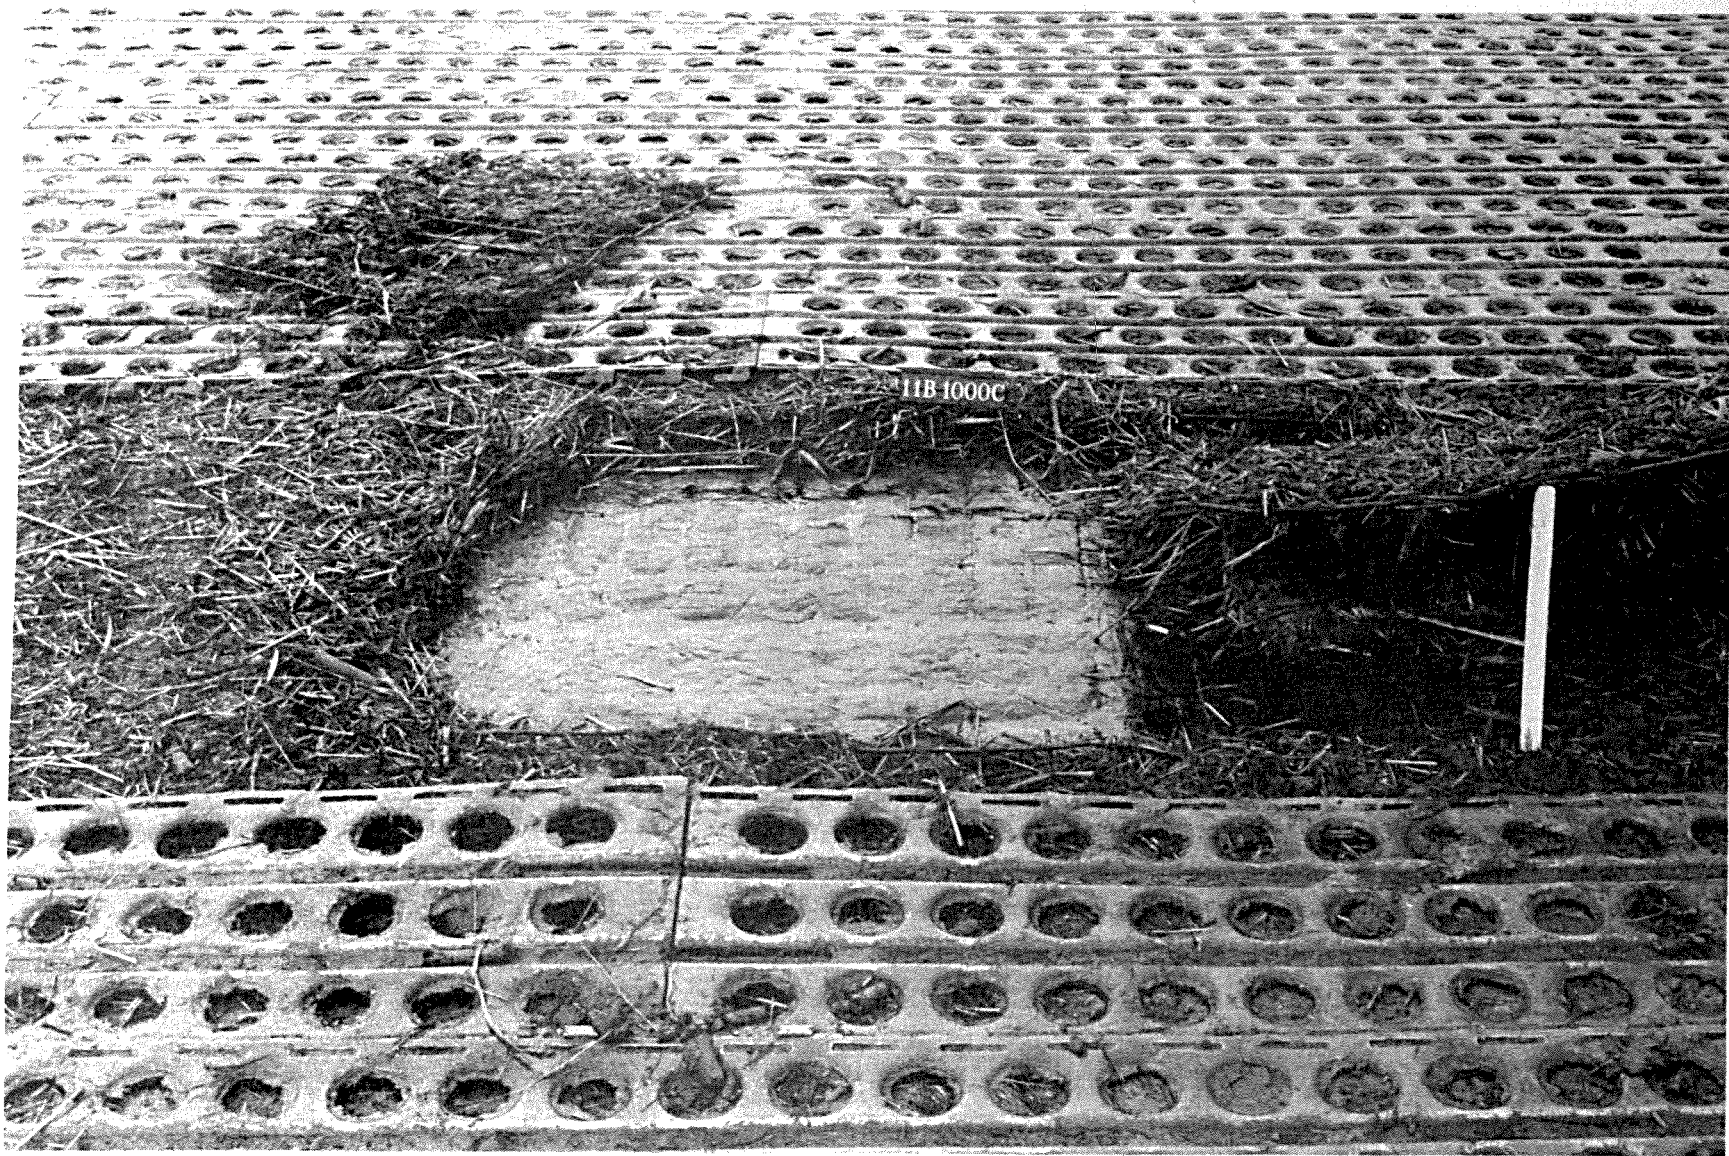
SECTION II, WIRE MESH EMBEDDED IN STRAW AT 1000 COVERAGES

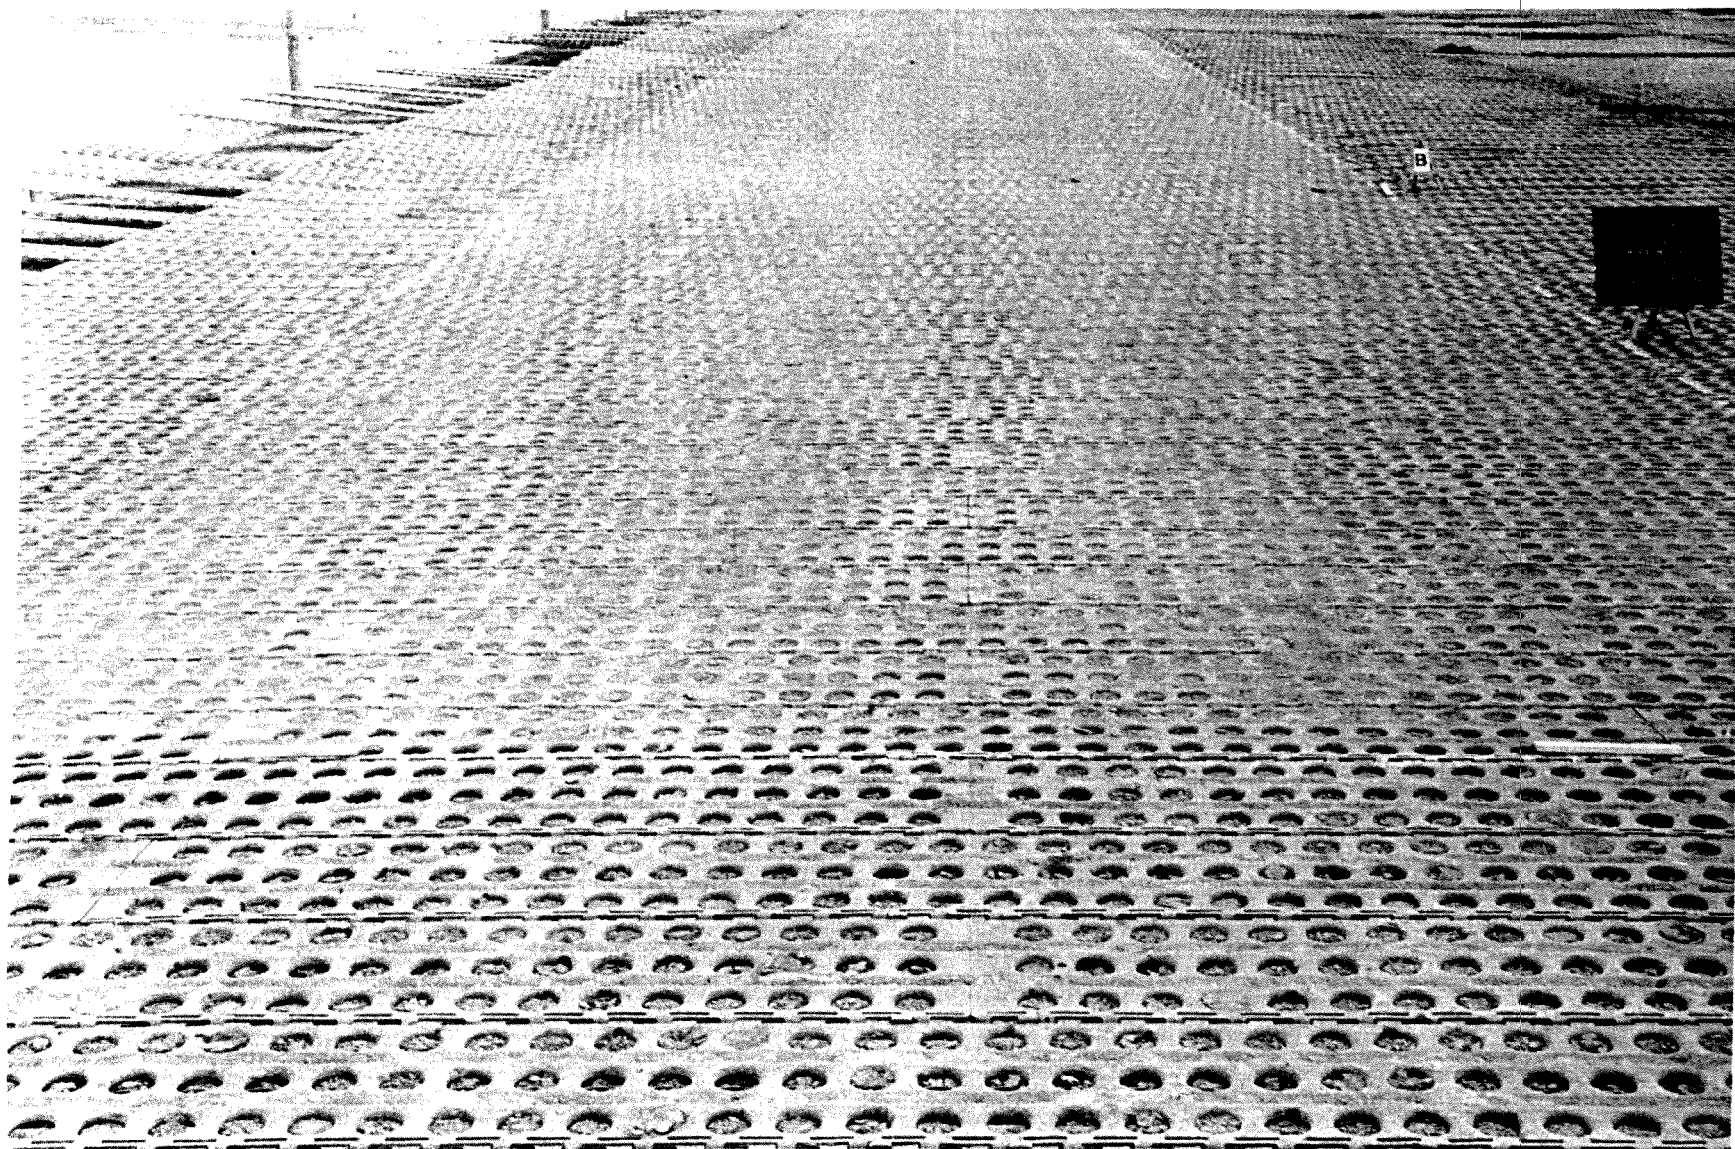
SECTION 3, AT END OF TEST

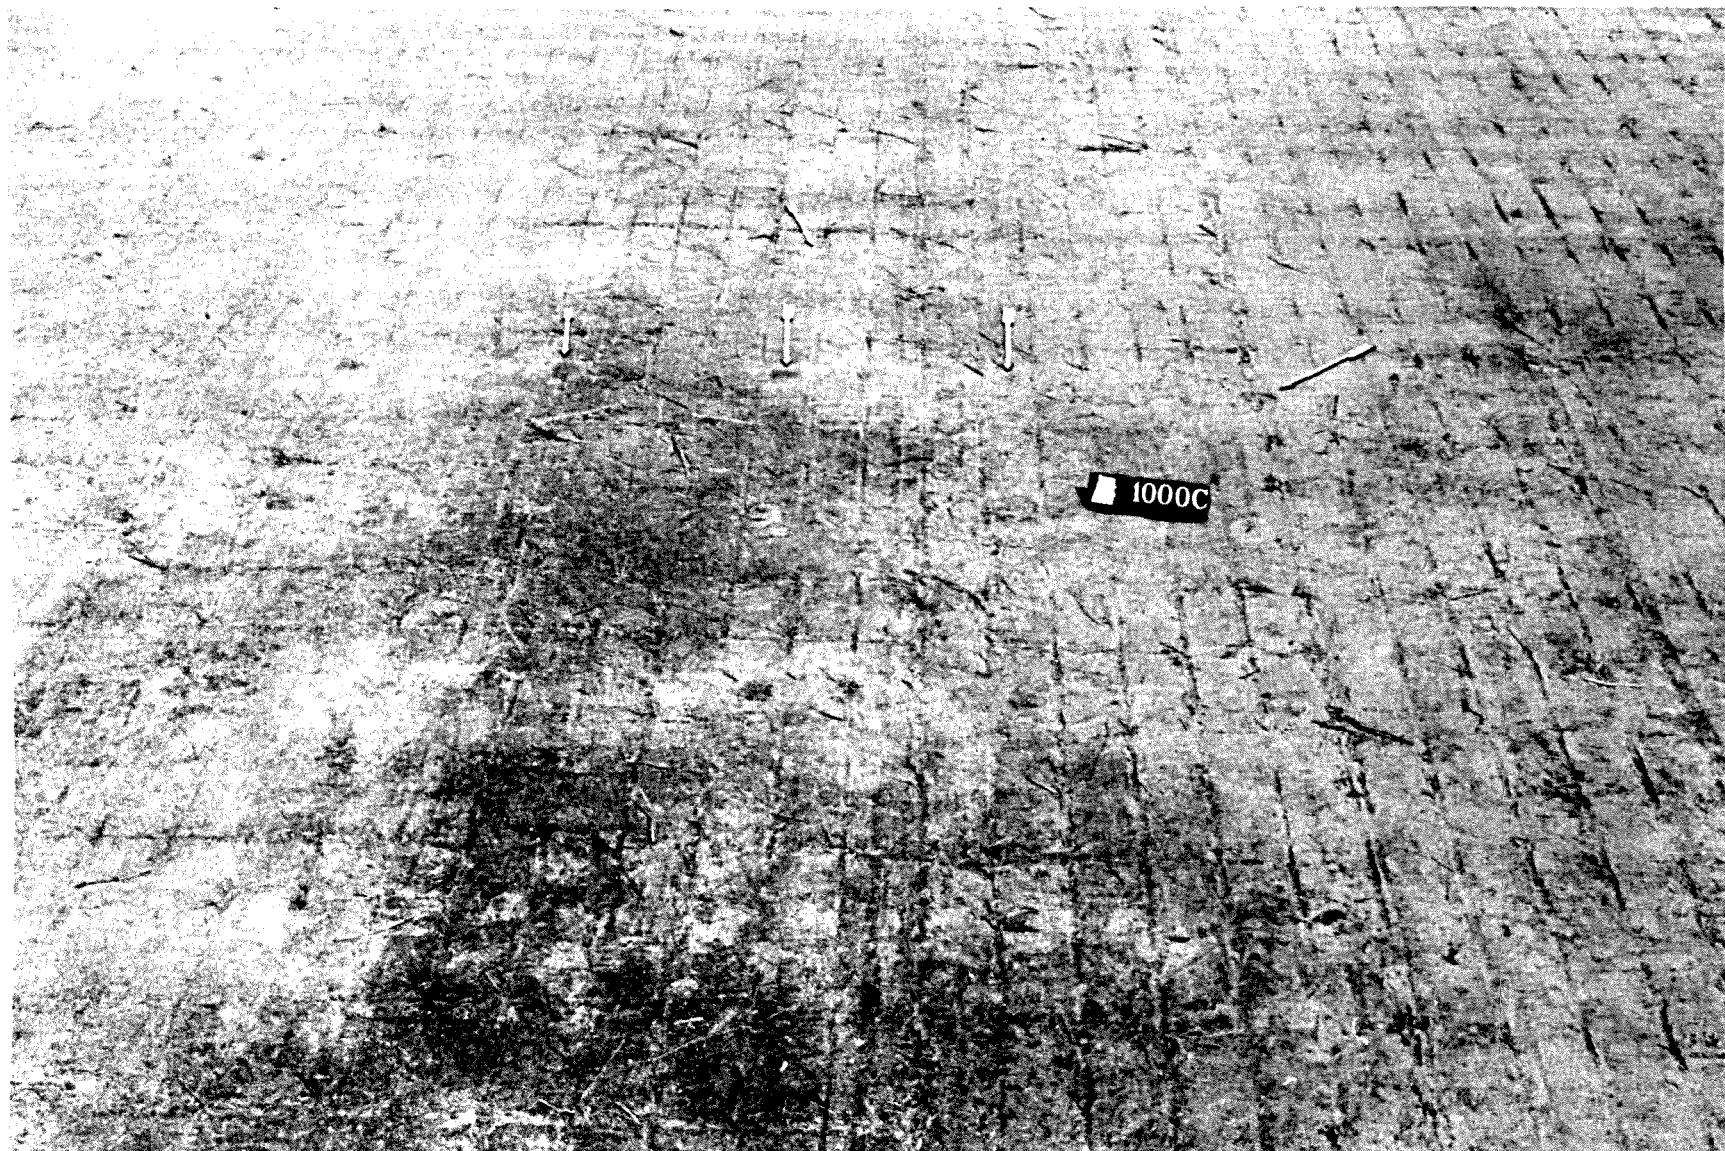
16. Sections with hay mulch cushions and wire mesh. Hay mulch held in place by wire mesh was tested as a cushion to protect the PBS in both traffic lanes (see paragraph 8 for method of placement). Test results under both wheel loads were practically the same, except that possibly a few more punctures occurred in the 37,000-lb lane. During the early part of the test there was considerable springing of the pierced plank mat as the test load passed. This decreased and finally disappeared at about 200 coverages. The hay compacted so rapidly under traffic that at 300 coverages it was only about one inch thick. At around 800 coverages in each lane it was noted that the wire mesh had been forced down into the hay mulch, forming a mat of hay and wire that actually had more hay above than below the wire mesh. This condition is shown on plate 18. Punctures started to appear in the PBS in both lanes at about 900 coverages. These holes were made by the wire mesh being forced through the fabric by the pierced plank. Plates 19 and 20 show the appearance of section 3 in the 37,000-lb lane before and after testing, respectively. Section 11 in the 20,000-lb lane is similar to section 3. Plates 21 and 22 show the condition of the PBS under the hay and wire mesh after 1000 coverages in the 37,000- and 20,000-lb lanes, respectively.

SECTION 3, APPEARANCE OF PBS UNDER STRAW AND WIRE MESH AFTER  
1000 COVERAGES (ARROWS INDICATE HOLES)

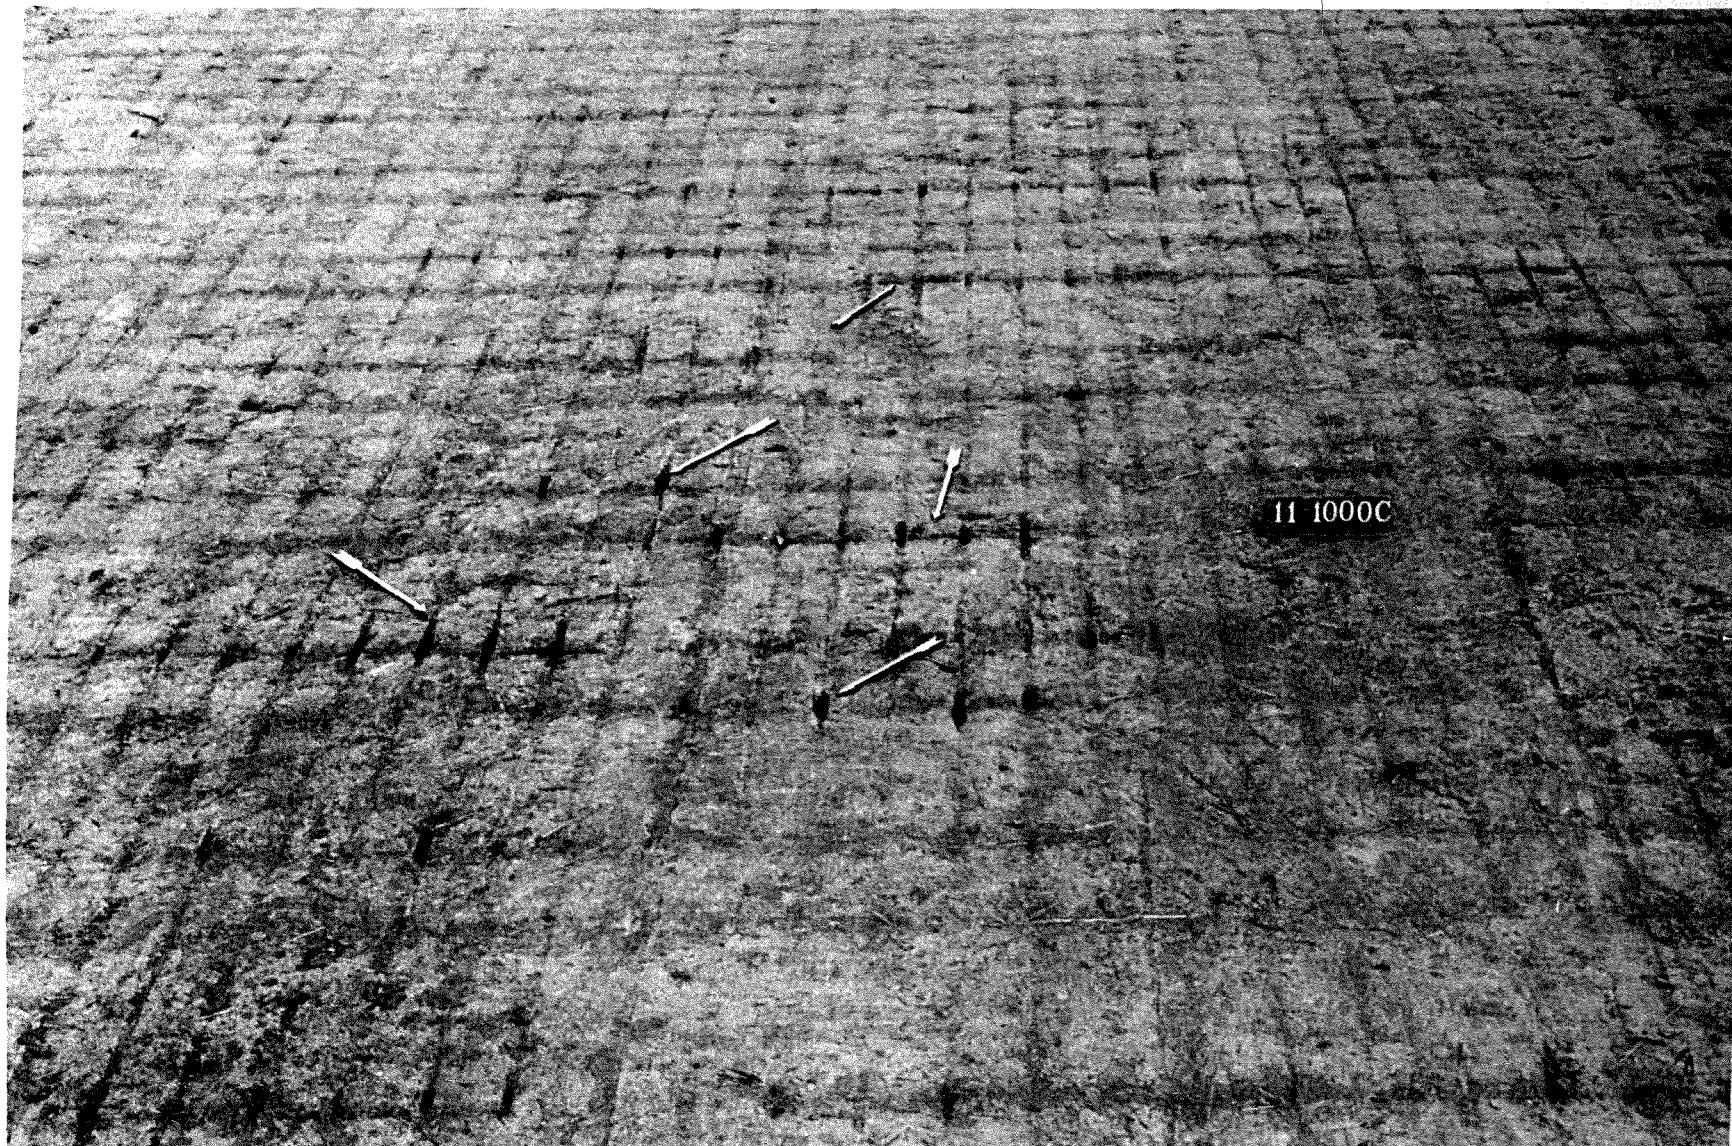
SECTION II, APPEARANCE OF PBS UNDER STRAW AND WIRE MESH AFTER  
1000 COVERAGES (ARROWS INDICATE HOLES)

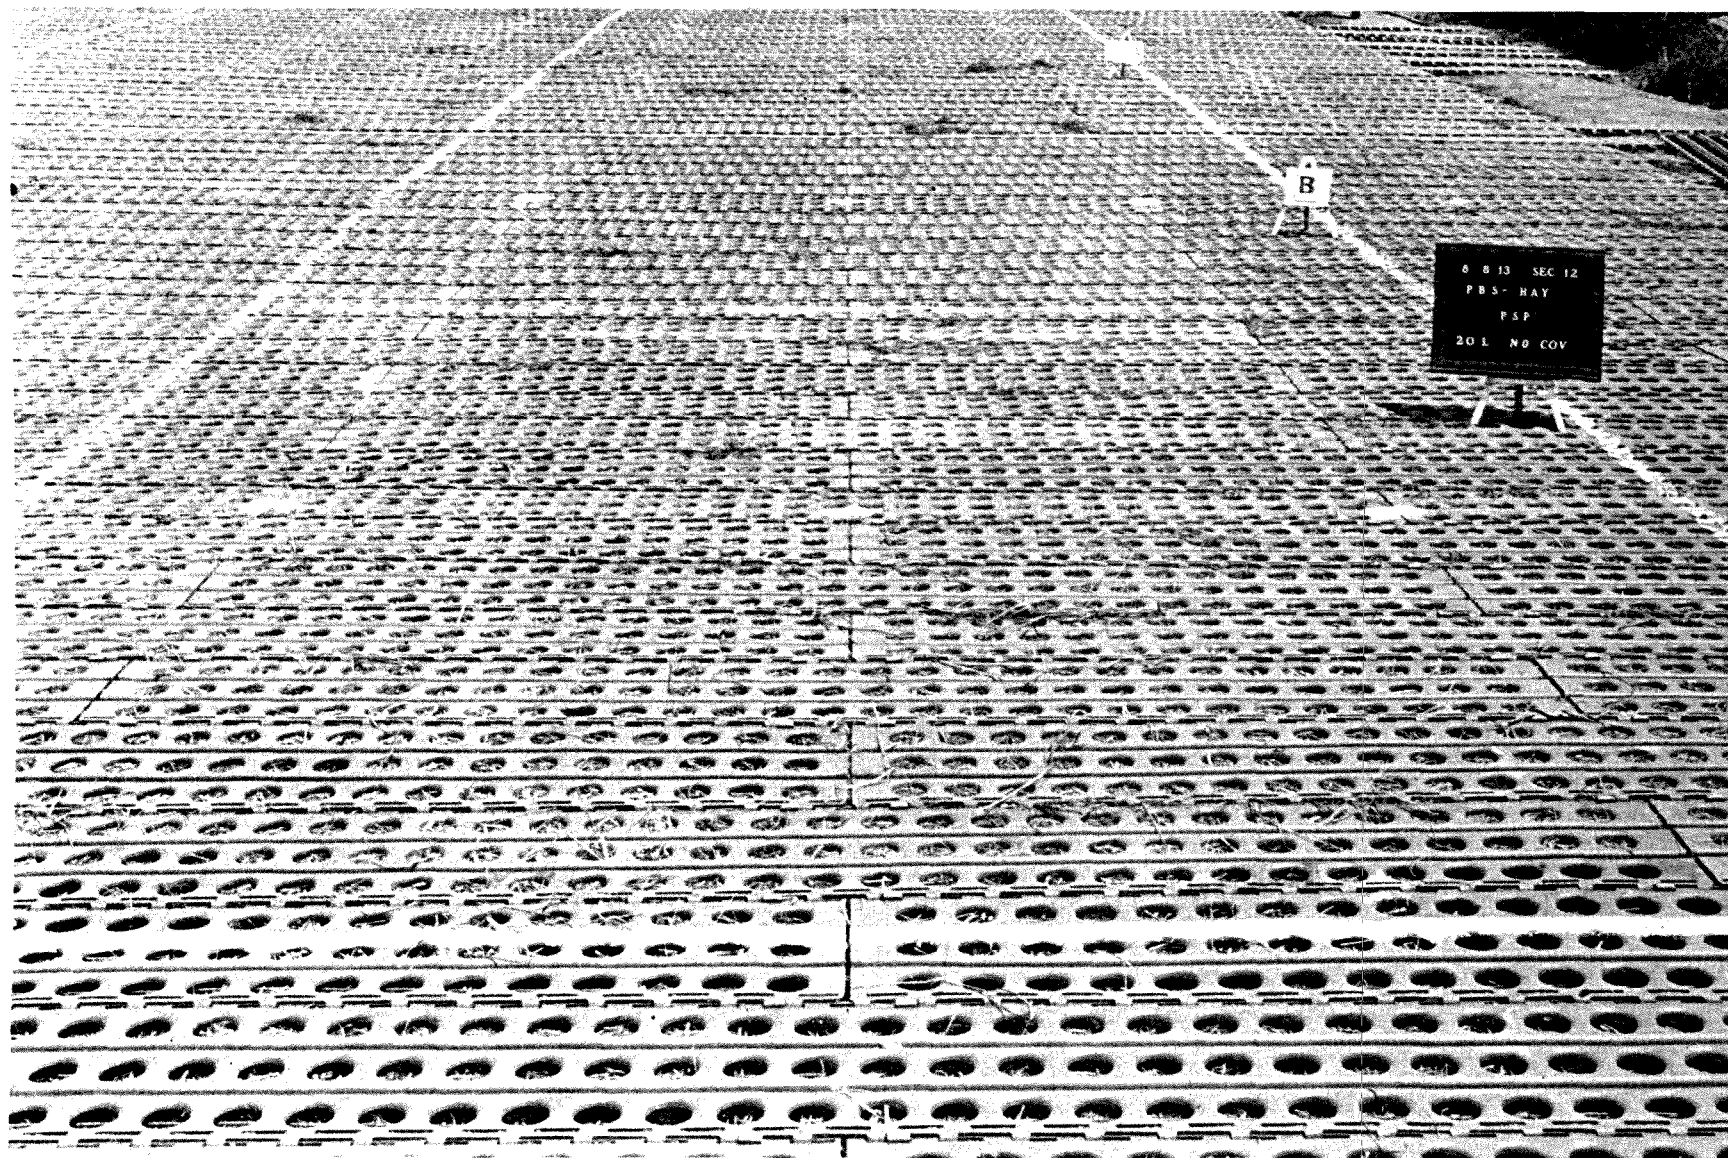
SECTION 12 (SECTION 13 IN BACKGROUND) AT BEGINNING OF TEST

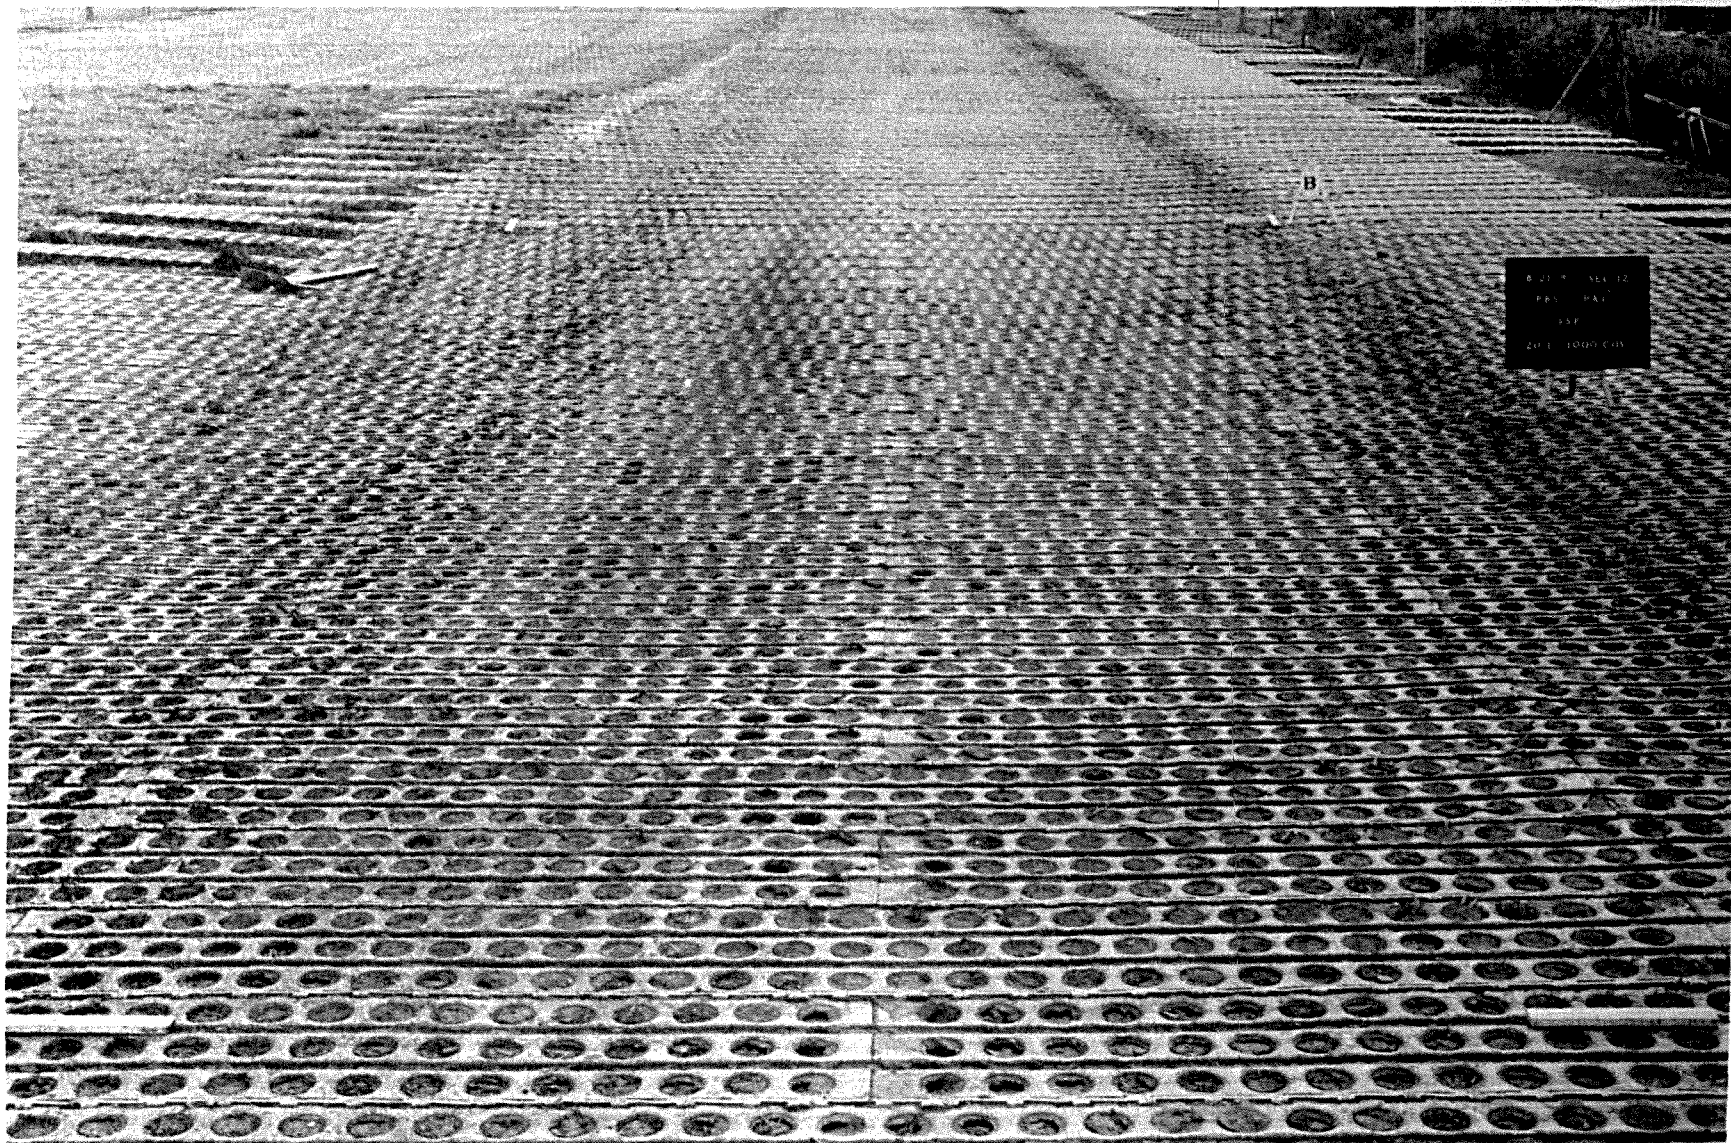
SECTION 12 (SECTION 13 IN BACKGROUND) AT END OF TEST (1000 COVERAGES)

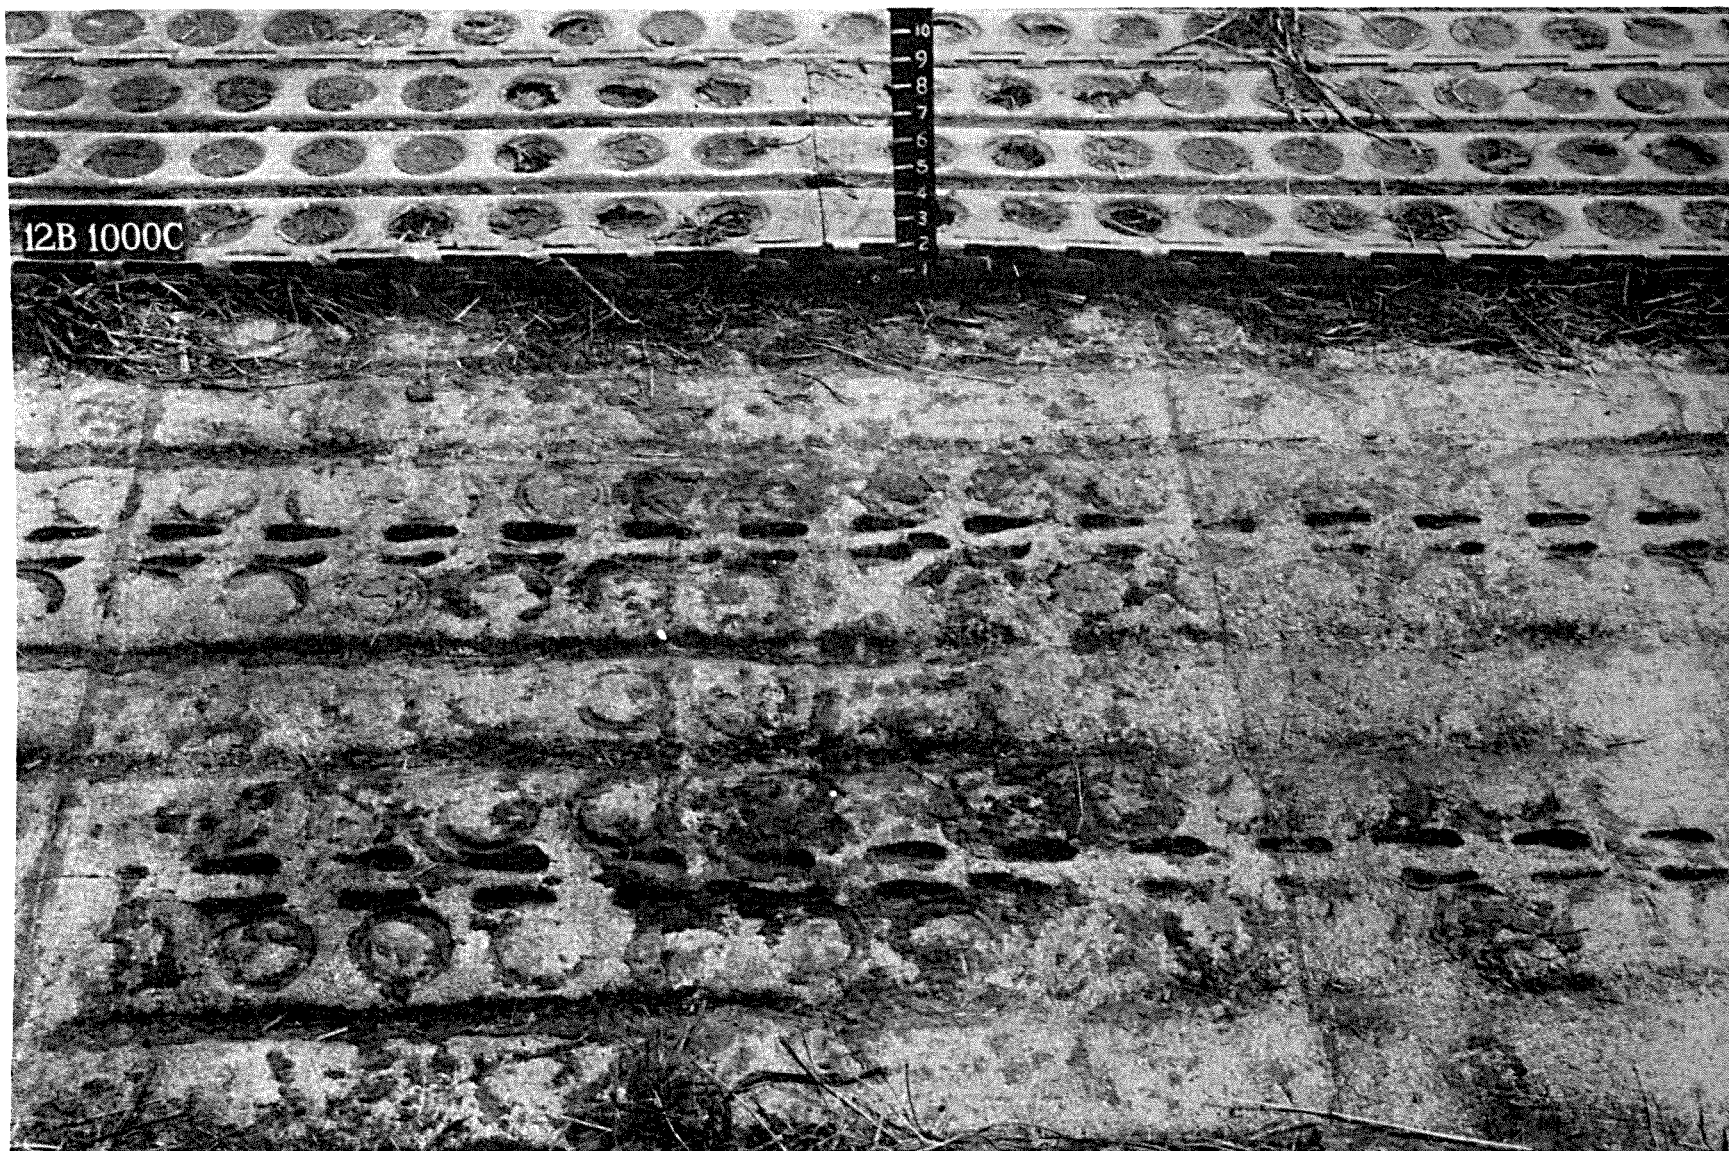
Plates 25 and 26 show the punctured PBS in section 12 at 1000 coverages and that in section 13 at 700 coverages, respectively. The increased thickness of hay mulch in sections 4 and 5 (see paragraph 9), afforded ample protection for the PBS in this portion of the 37,000-lb traffic lane throughout the test. However, the hay was beginning to decay and give off a foul odor at the end of the test. Plate 27 shows the appearance of sections 4 and 5 at 1000 coverages. Plates 28 and 29 show the sound condition of the PBS at the end of the test in these two sections.

SECTION 12, PUNCTURED PBS UNDER PSP IN 20,000-LB LANE AT 1000 COVERAGES
