TESTS ON METHODS OF EMPLOYING  
PIERCED PLANK LANDING MAT WITH  
PREFABRICATED BITUMINOUS SURFACING

TECHNICAL MEMORANDUM NO. 211-4

U. S. WATERWAYS EXPERIMENT STATION  
VICKSBURG, MISSISSIPPI

5 OCTOBER 1945

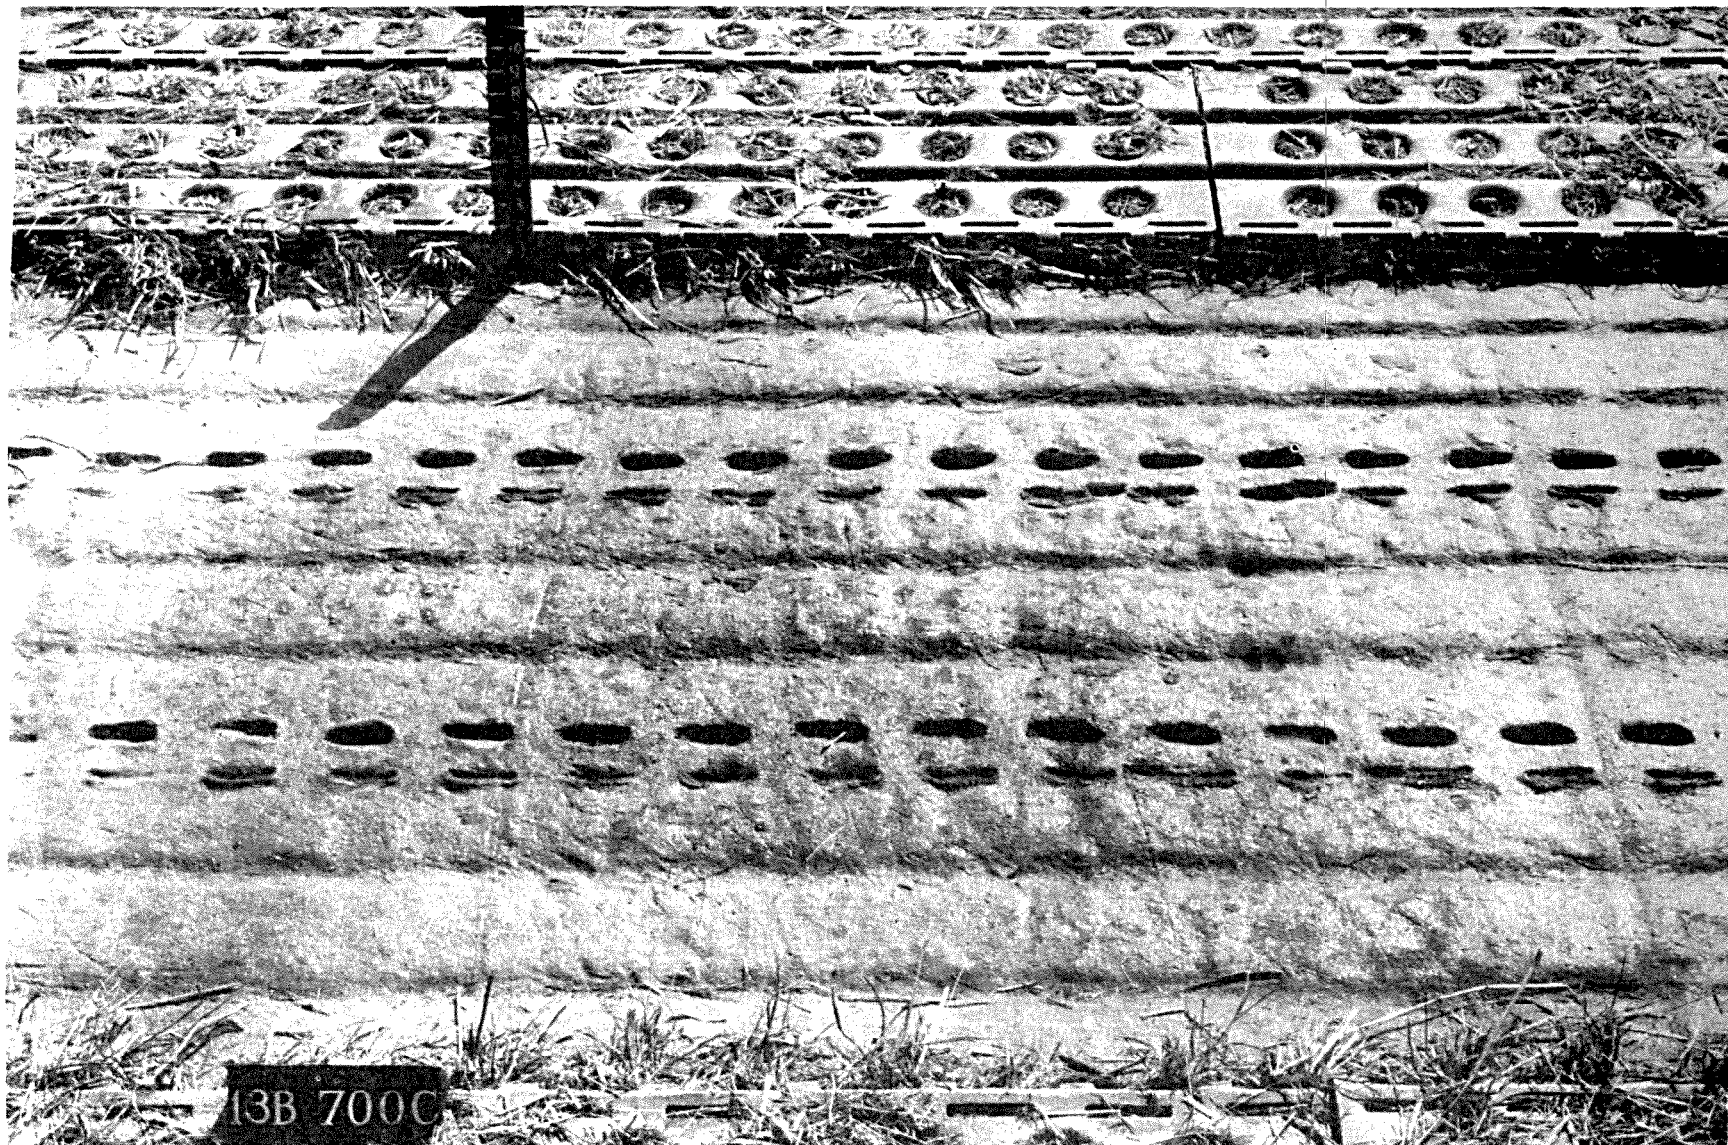
Plates 25 and 26 show the punctured PBS in section 12 at 1000 coverages and that in section 13 at 700 coverages, respectively. The increased thickness of hay mulch in sections 4 and 5 (see paragraph 9), afforded ample protection for the PBS in this portion of the 37,000-lb traffic lane throughout the test. However, the hay was beginning to decay and give off a foul odor at the end of the test. Plate 27 shows the appearance of sections 4 and 5 at 1000 coverages. Plates 28 and 29 show the sound condition of the PBS at the end of the test in these two sections.

SECTION 13, PUNCTURED PBS UNDER PAP AT 700 COVERAGES

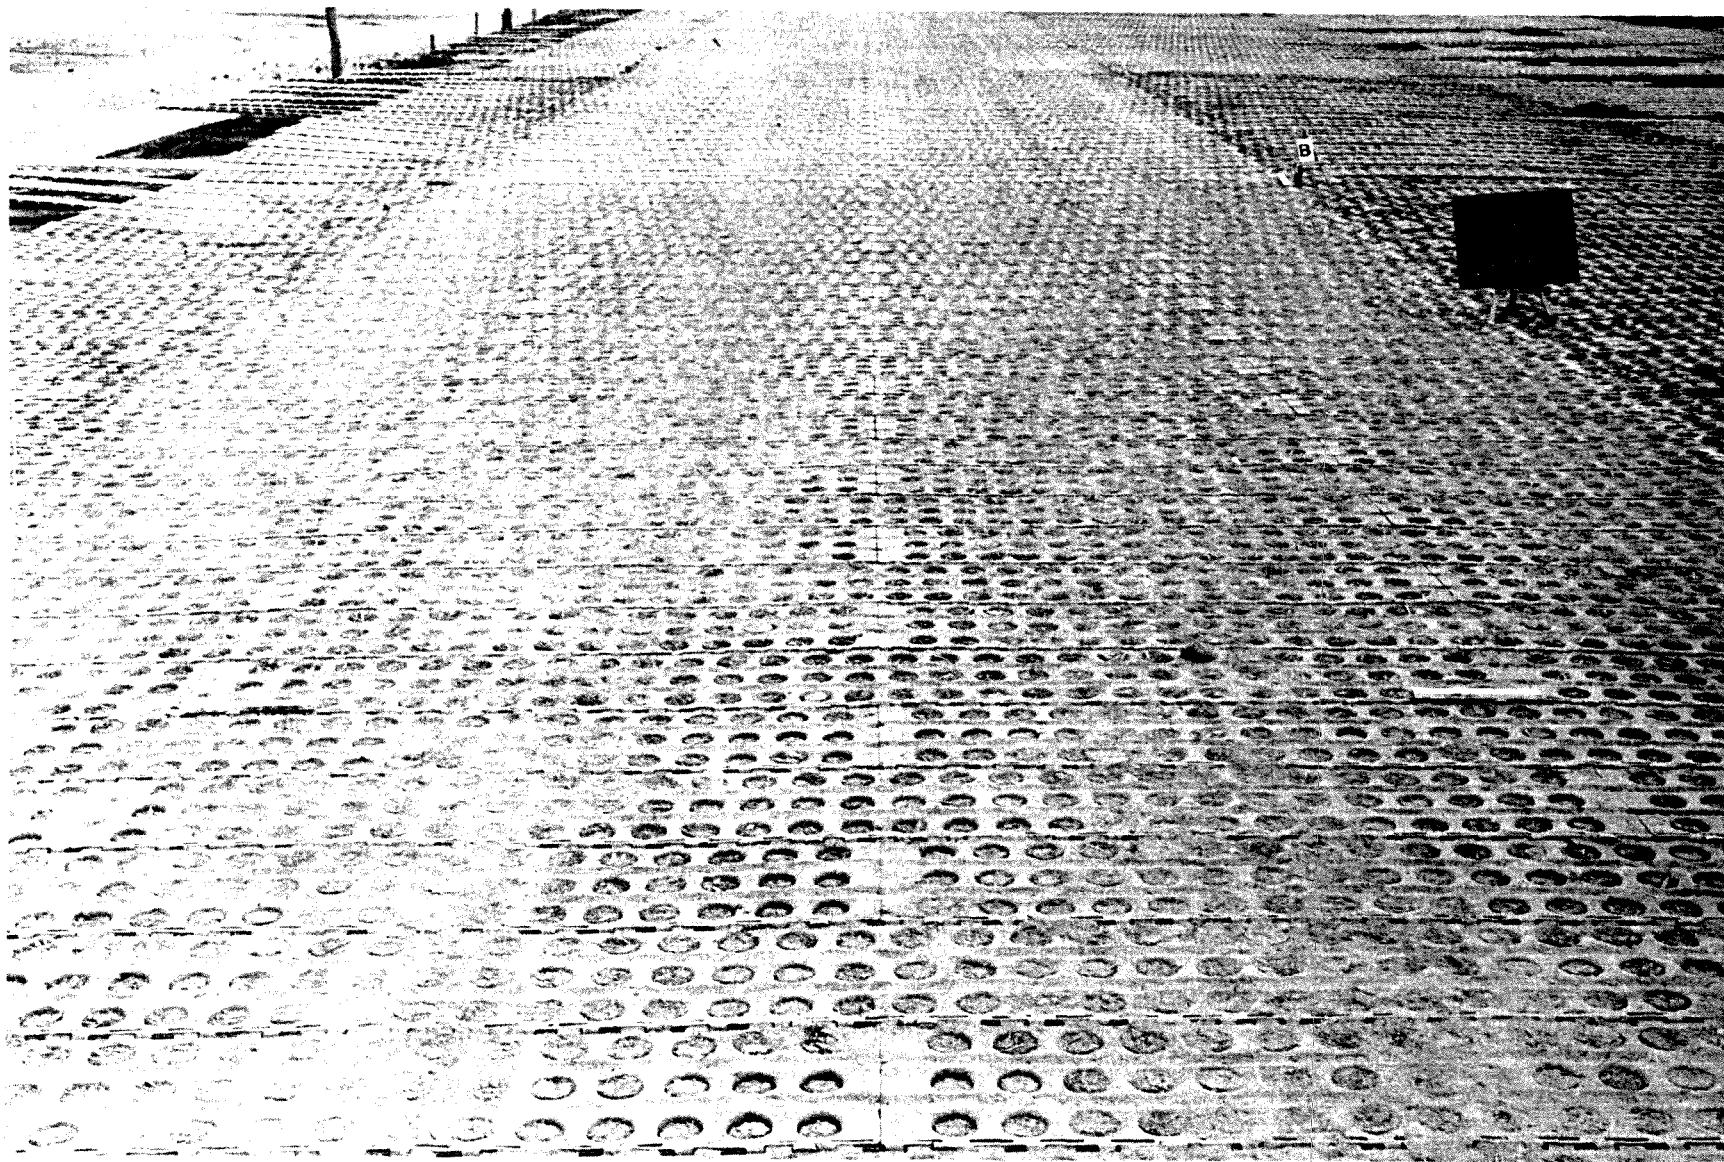
SECTION 4 (SECTION 5 IN BACKGROUND) AT END OF TRAFFIC TEST

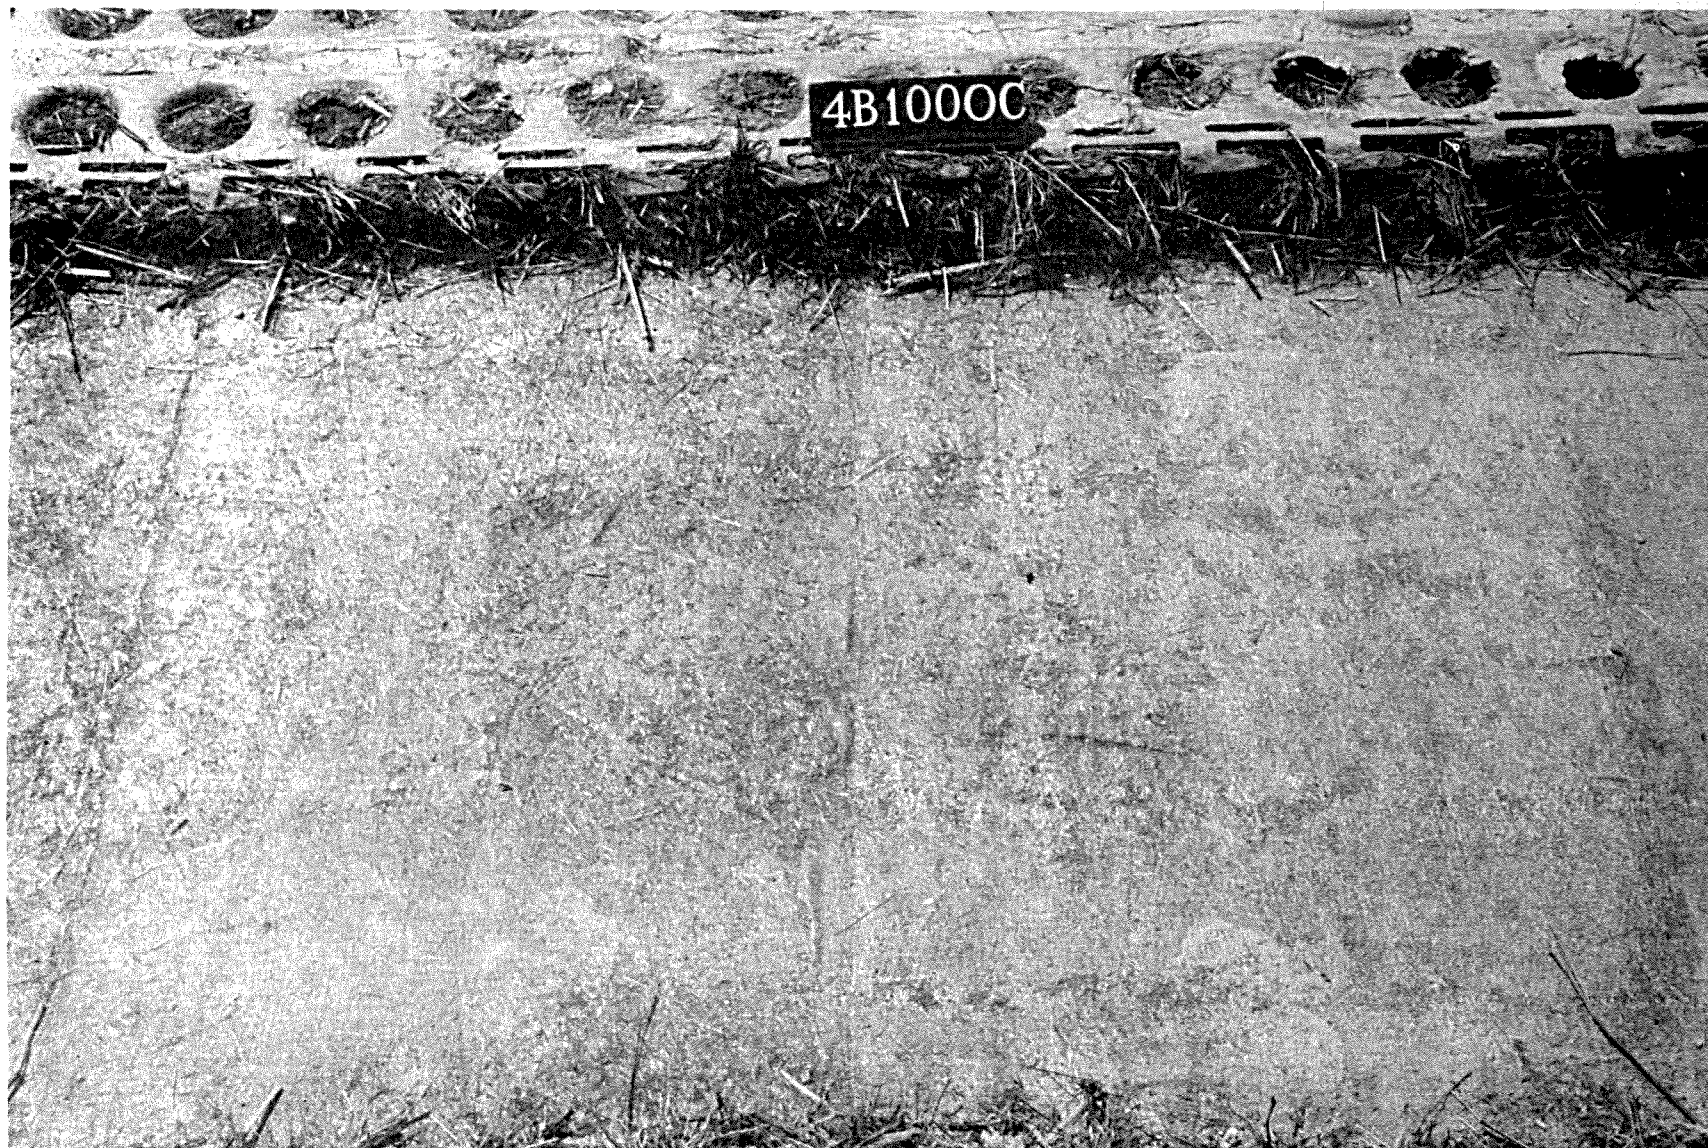
CONDITION OF PBS UNDER STEEL MAT IN SECTION 4 AT 1000 COVERAGES

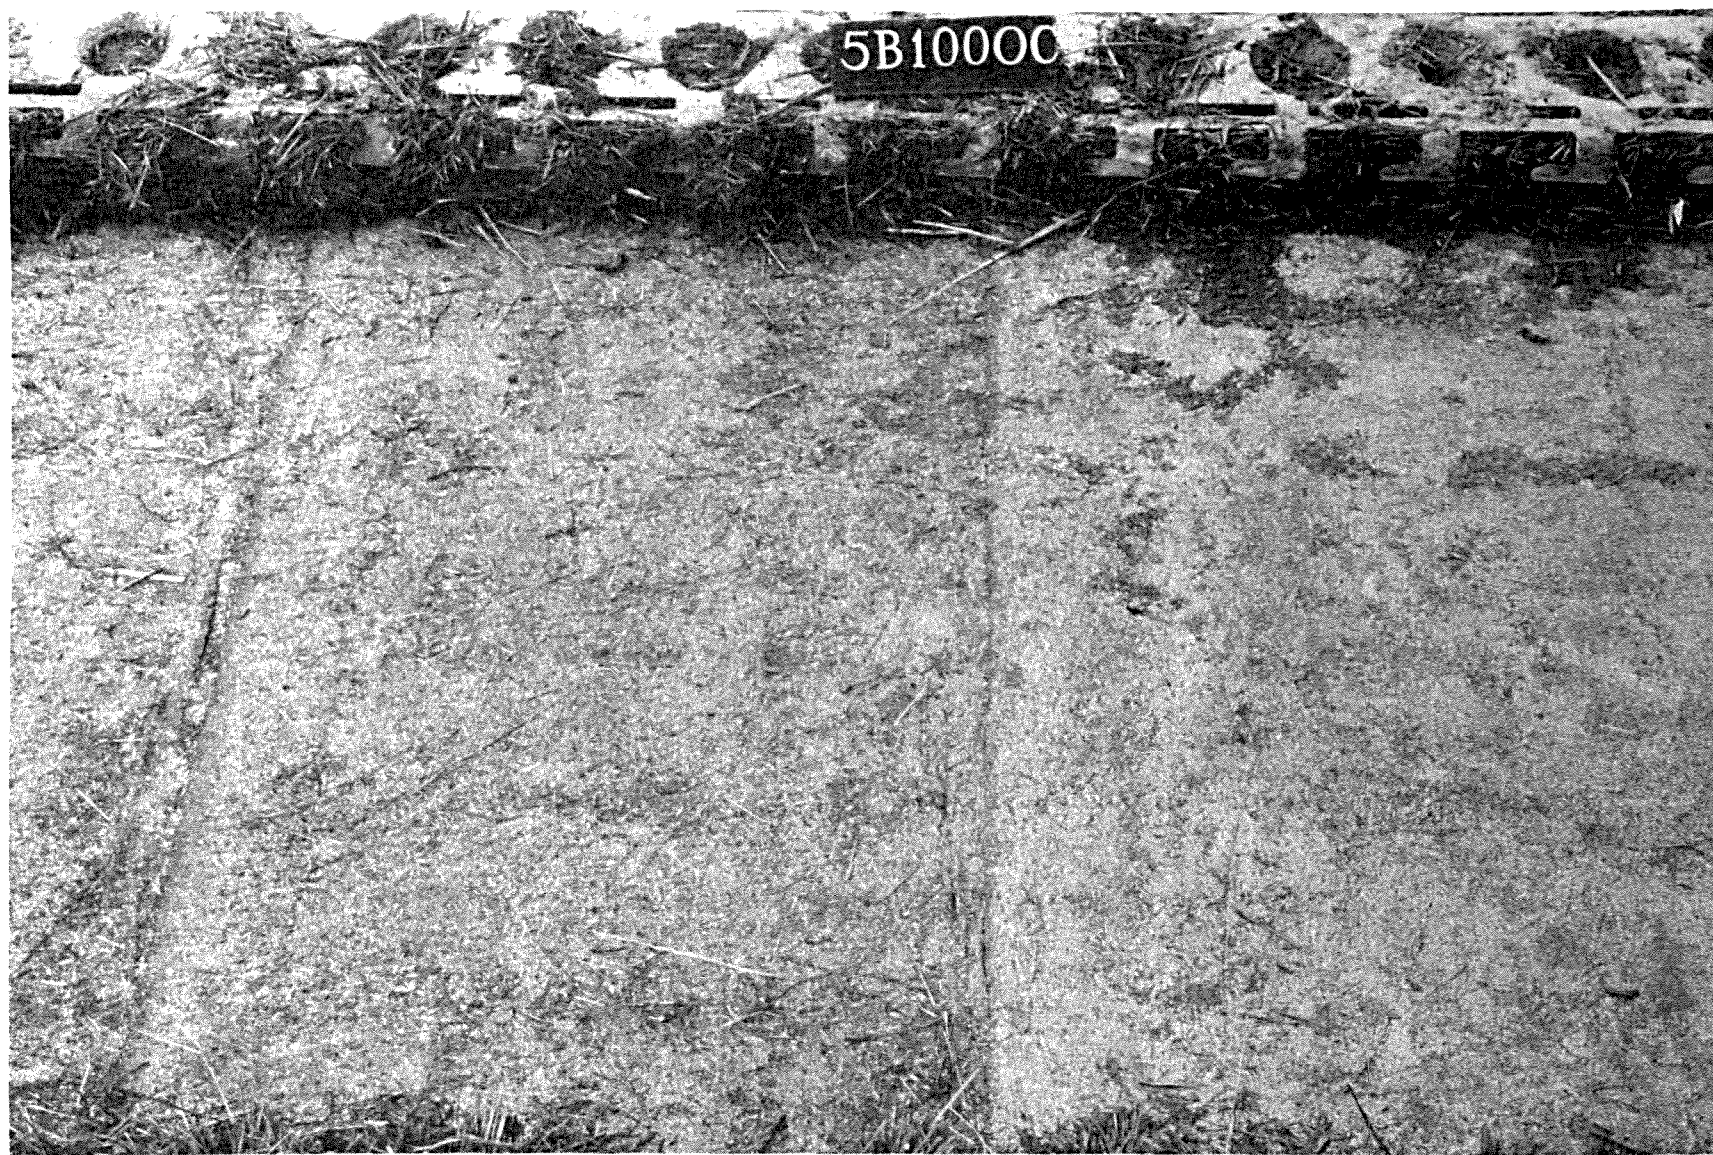
CONDITION OF PBS UNDER ALUMINUM MAT IN SECTION 5 AT 1000 COVERAGES

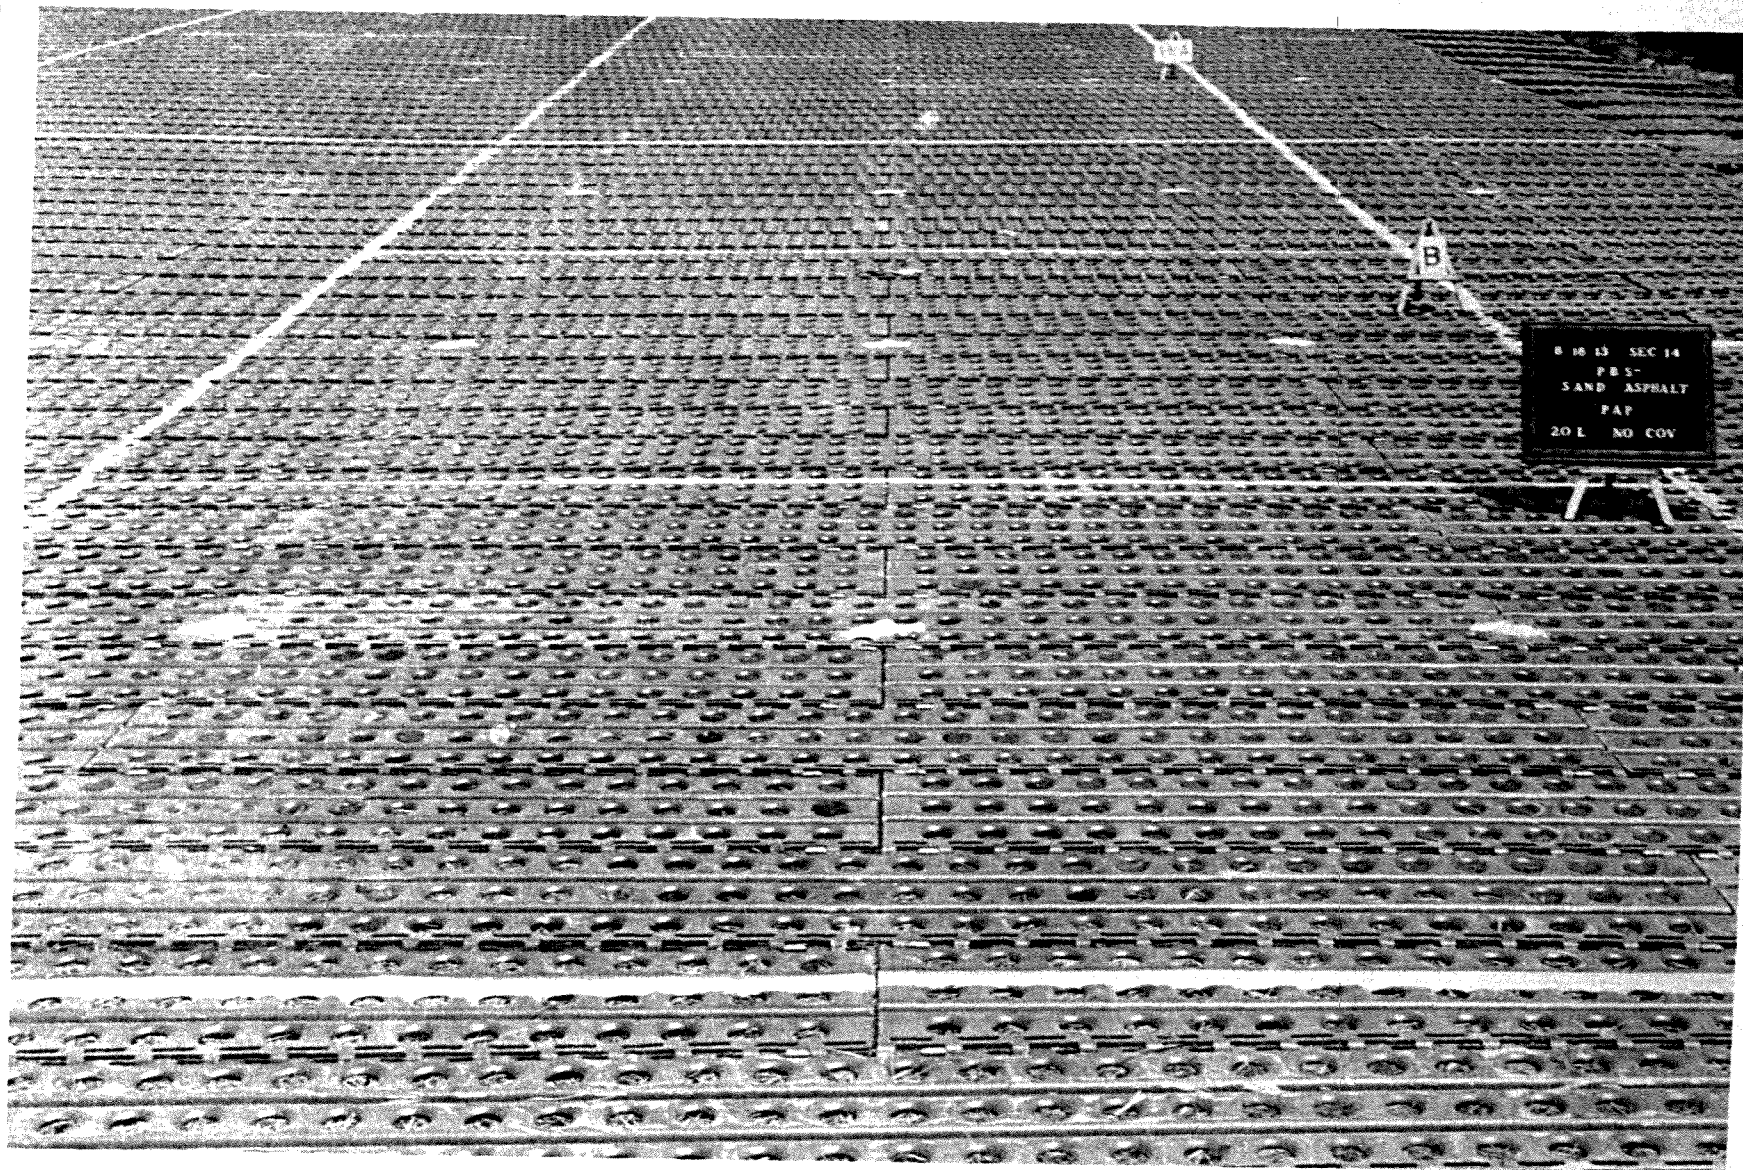
SECTION 14, BEFORE TESTING

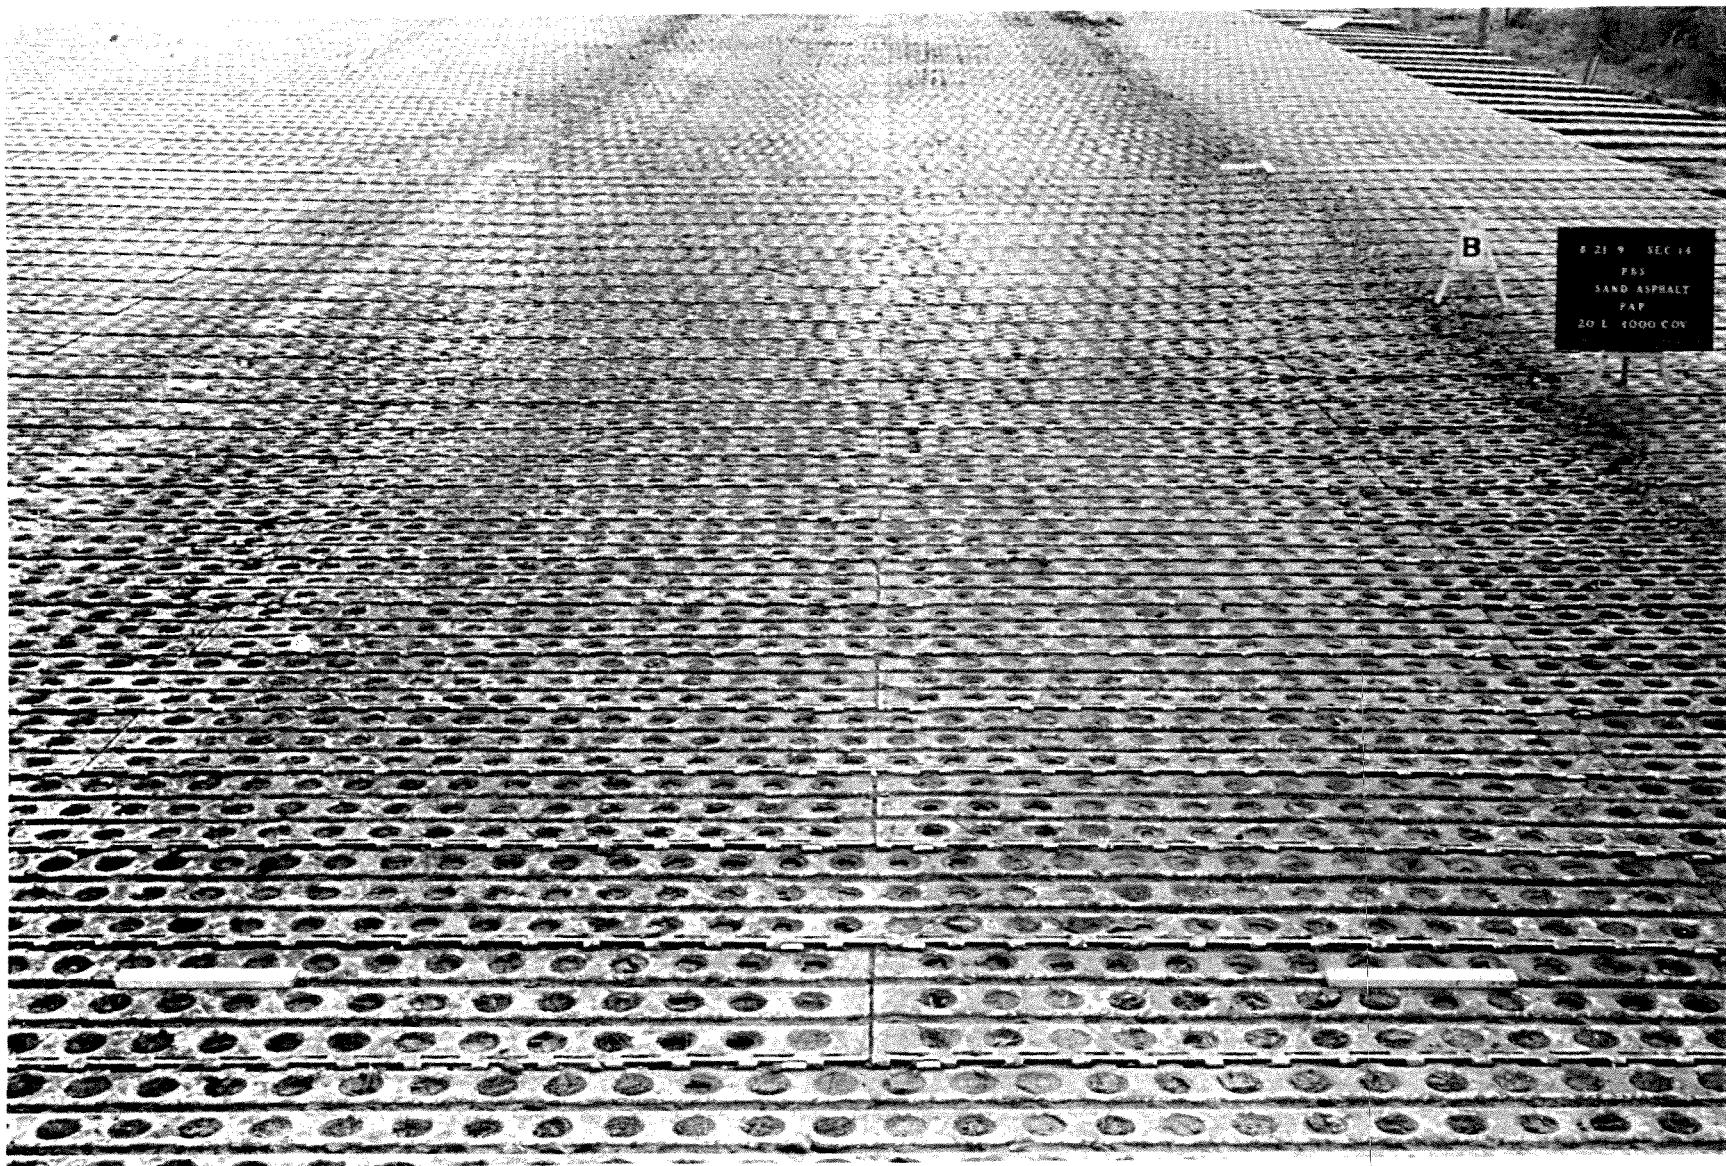
SECTION 14, AFTER TESTING

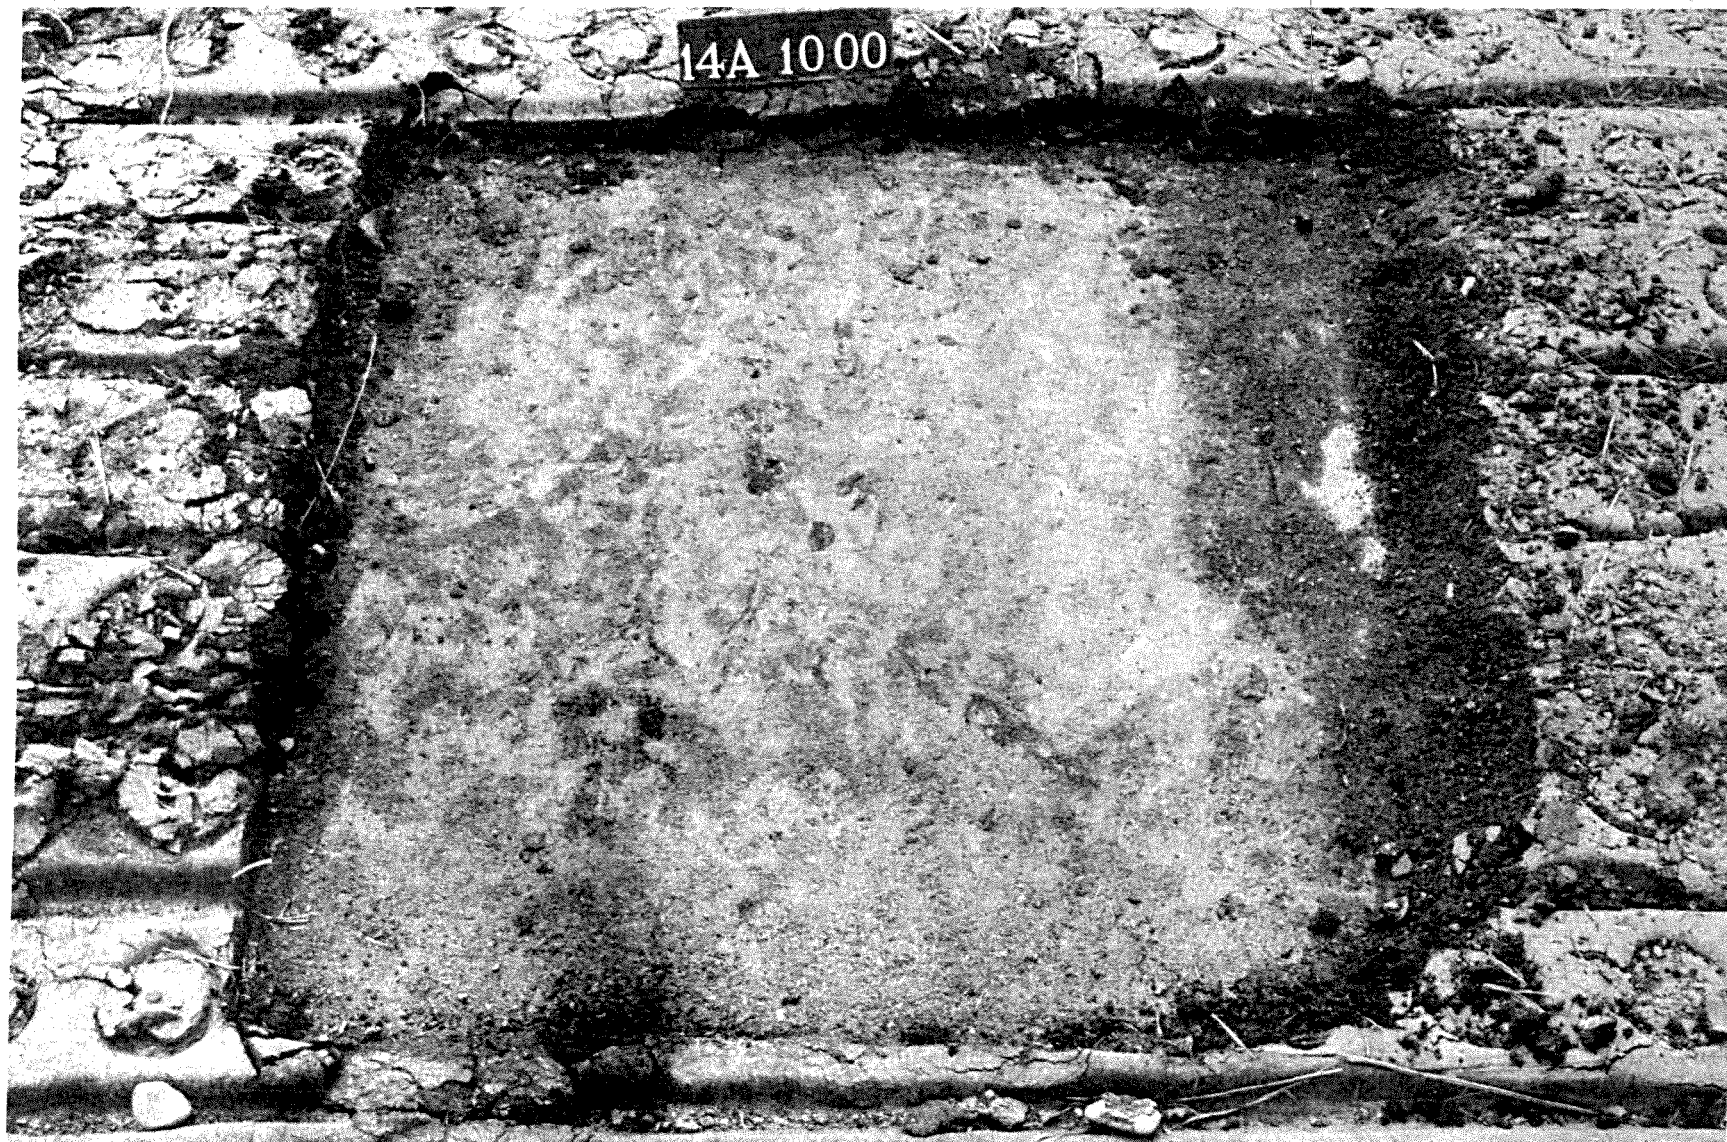
CONDITION OF PBS UNDER SAND-ASPHALT CUSHION IN SECTION 14-A AFTER TEST

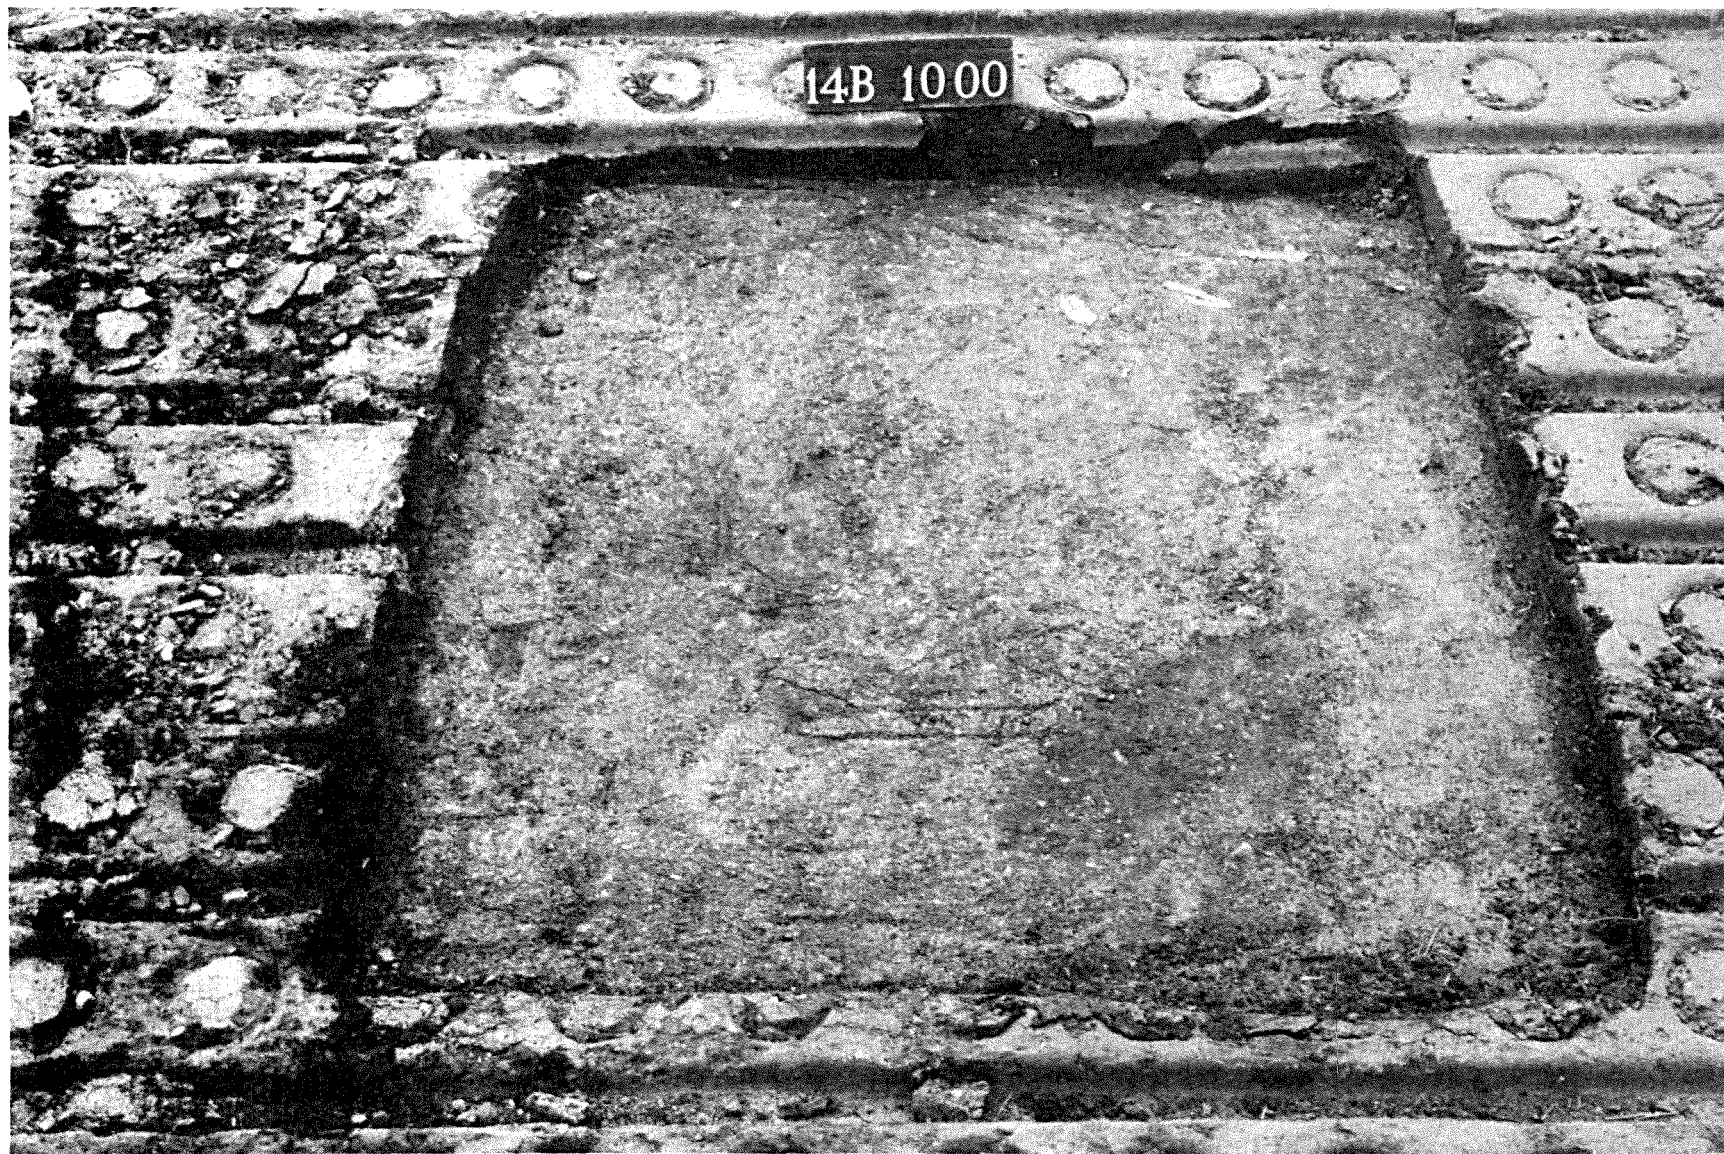
CONDITION OF PBS UNDER SAND-ASPHALT CUSHION IN SECTION 14-B AFTER TEST

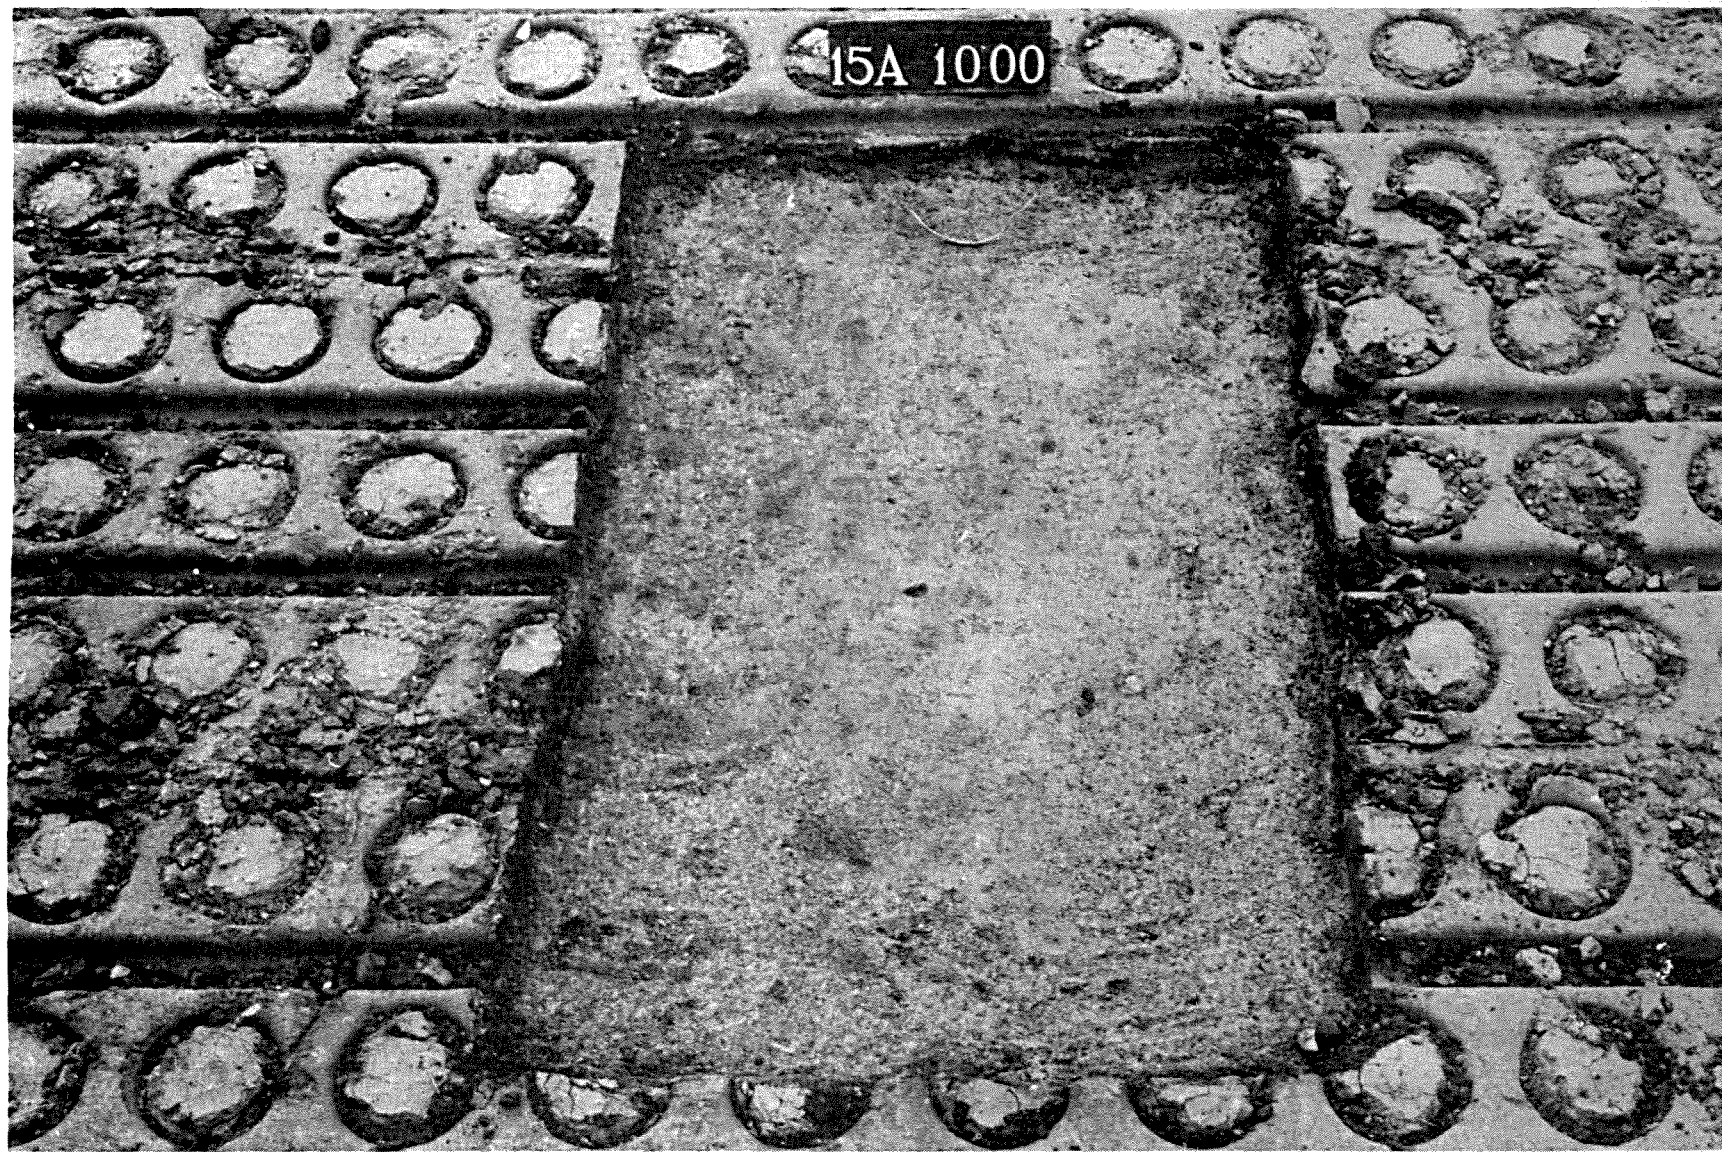
CONDITION OF PBS UNDER SAND-ASPHALT CUSHION IN SECTION 15-A AFTER TEST

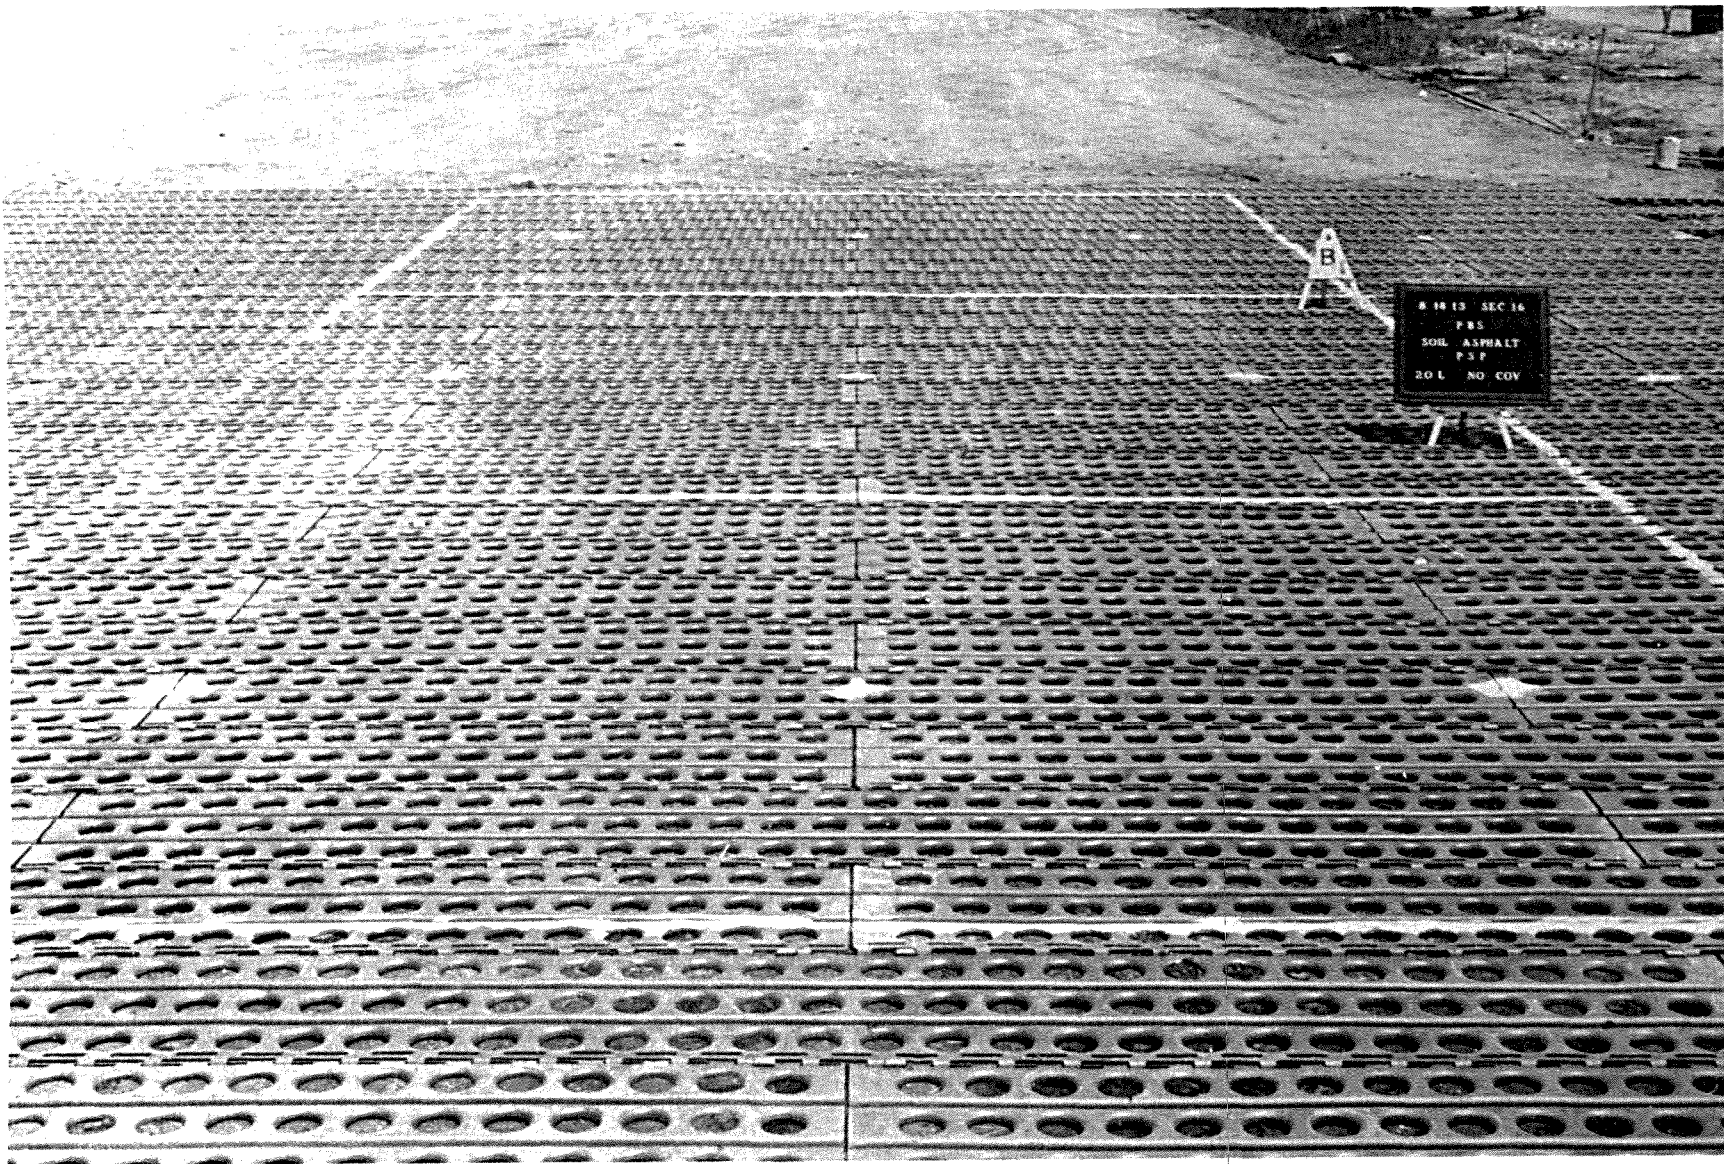
SECTION 16, BEFORE TESTING

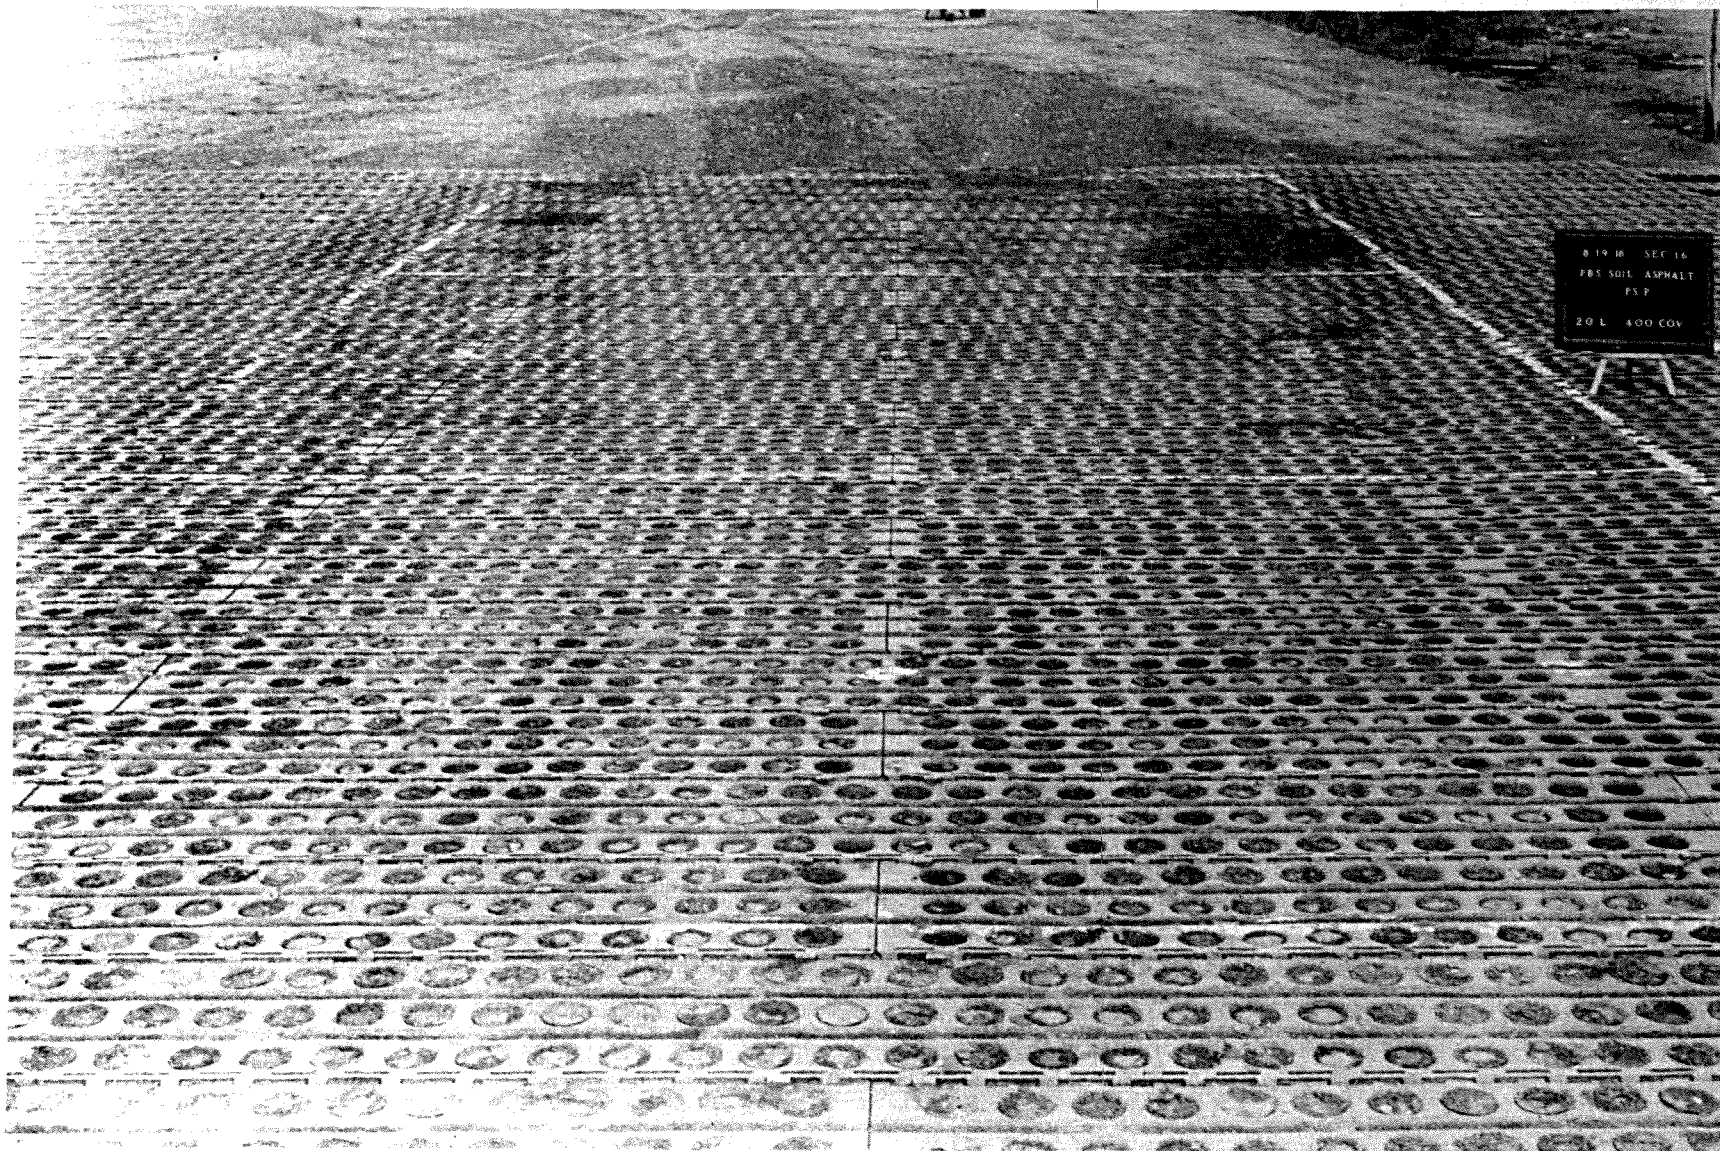
01910 SEC 16  
FBS SOIL ASPHALT  
FSP  
20 L 400 COV

SECTION 16, AT 400 COVERAGES
