TESTS ON METHODS OF EMPLOYING  
PIERCED PLANK LANDING MAT WITH  
PREFABRICATED BITUMINOUS SURFACING

TECHNICAL MEMORANDUM NO. 211-4

U. S. WATERWAYS EXPERIMENT STATION  
VICKSBURG, MISSISSIPPI

5 OCTOBER 1945

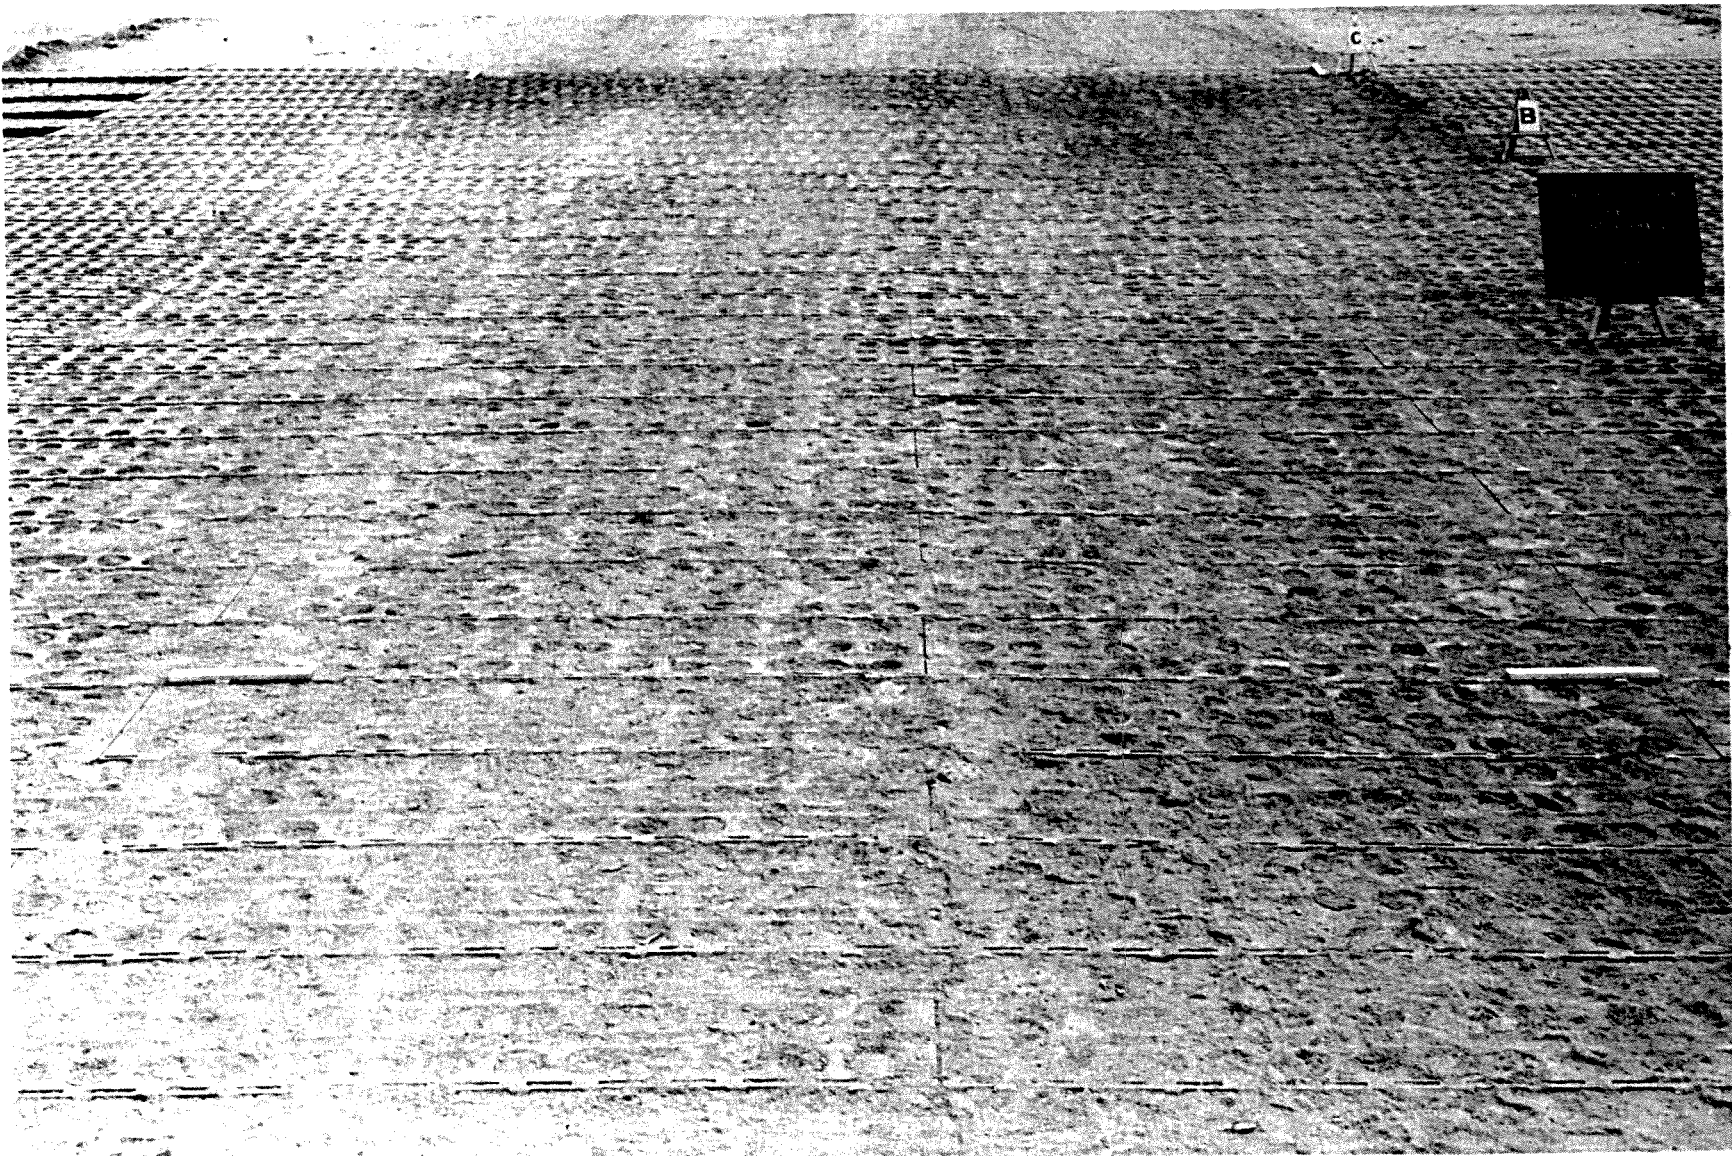
SECTION 8, AT 1000 COVERAGES

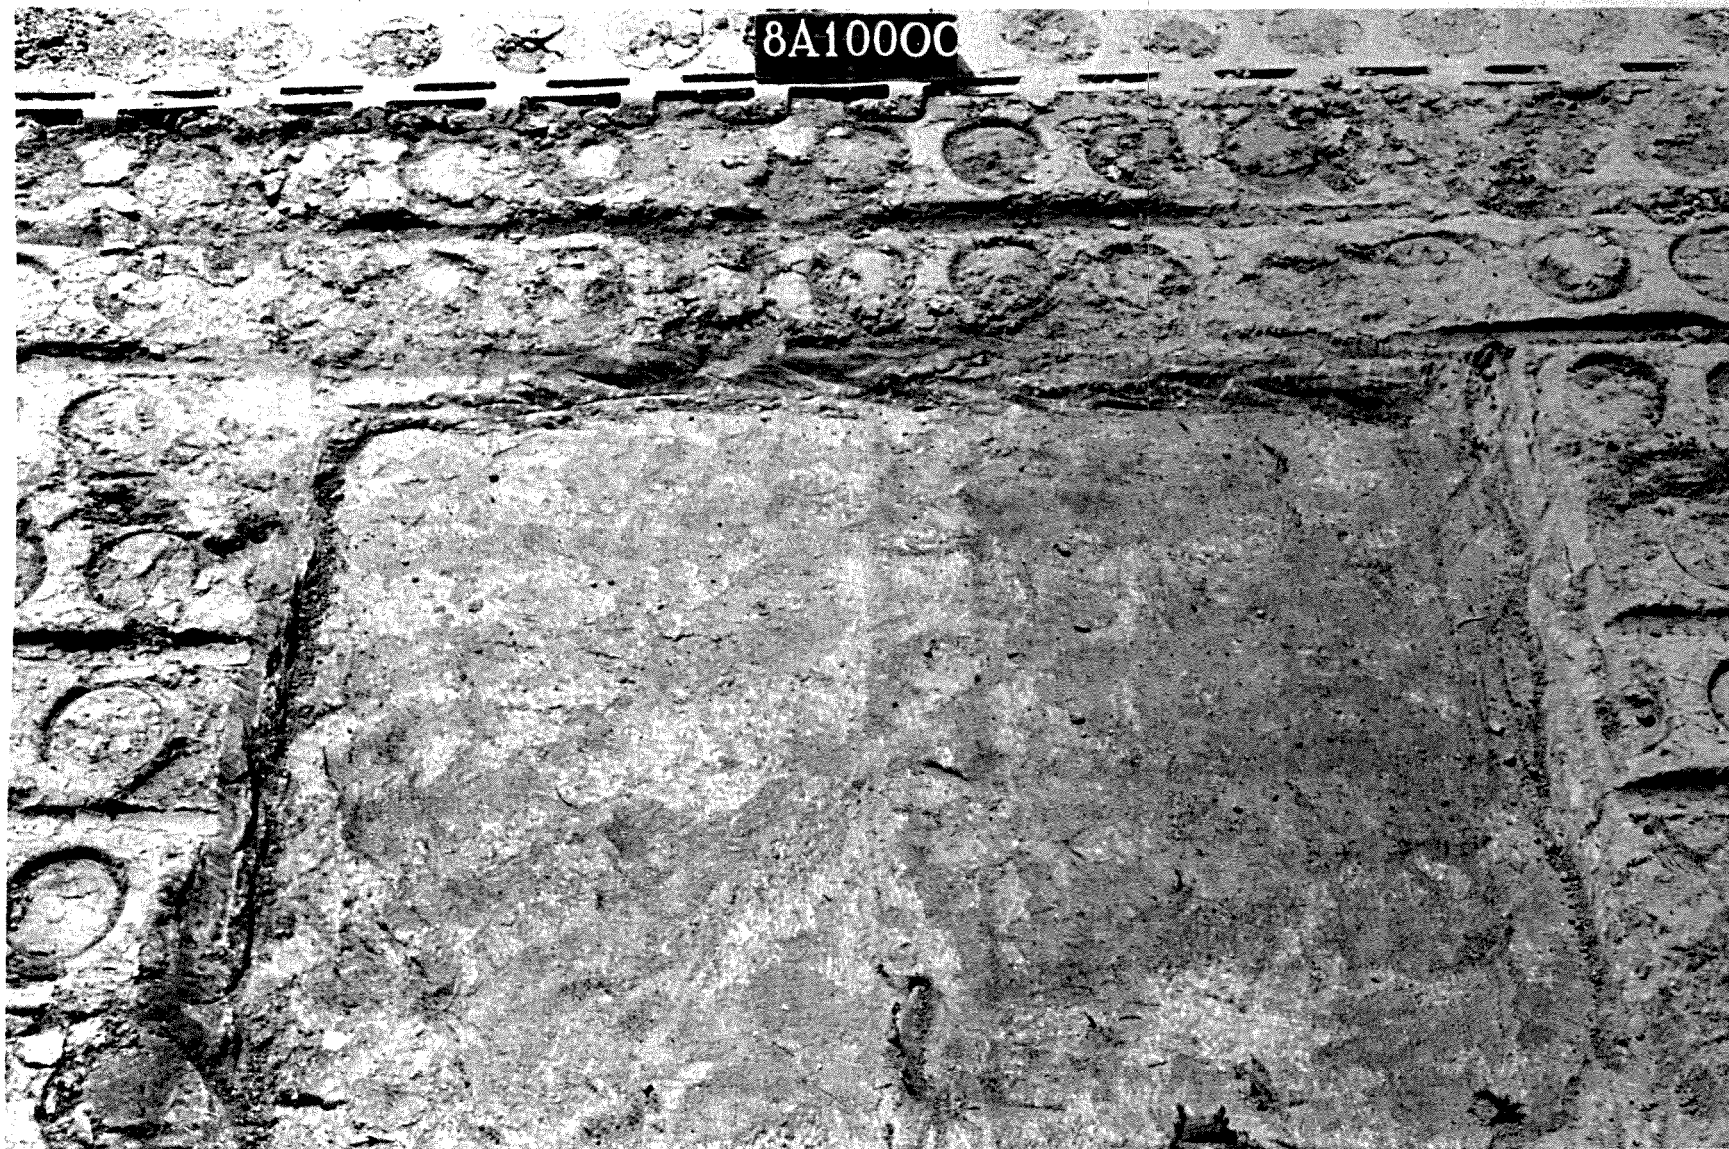
CONDITION OF PBS UNDER SOIL-ASPHALT CUSHION IN SECTION 8-A AFTER TEST

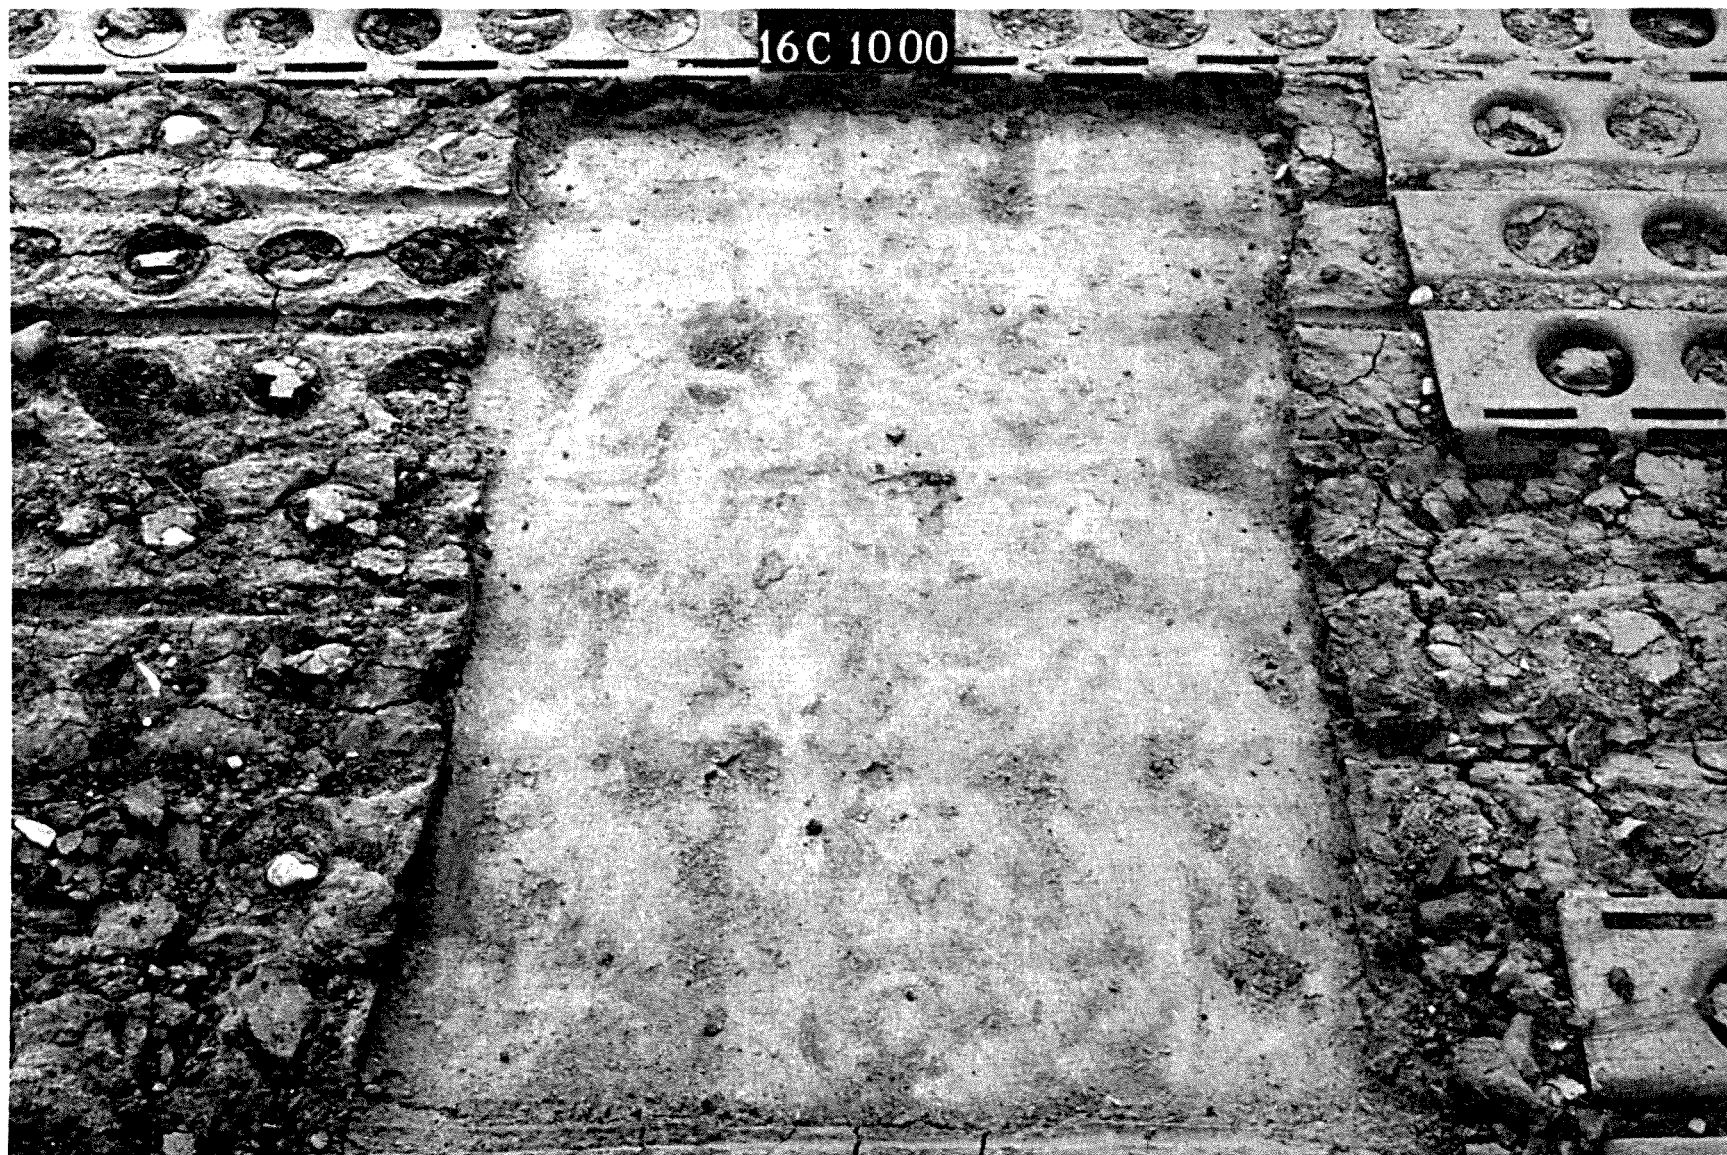
There was no noticeable difference between the behavior of the cushions under the two wheel loads. The material containing 11% of asphalt was satisfactory throughout the test. It adhered to the PBS in the same manner as the sand-asphalt. The soil with 9% of asphalt started dusting at about 300 coverages and continued to do so throughout the test. While no damage was done to the PBS in these tests, it is believed that enough material would be lost in the propeller slipstream to destroy the cushion in an airplane runway. The soil with 6% asphalt protected the PBS from damage by the pierced plank mat during these tests, but it started dusting badly at about 250 coverages and became muddy during a light rain and when sprinkled. Neither of these mixes stuck to the PBS. Plates 35 and 36 show section 16 at the beginning of the test and at 400 coverages, respectively. Note the dust on subsections 16-B and 16-C on the latter plate. Plate 37 shows the dusty appearance of section 8 at 1000 coverages. Plates 38 and 39 show the condition of the PBS under the cushions in subsection 8-A (37,000-lb lane) and 16-C (20,000-lb lane) after the test. It can be seen that while no actual damage had occurred, the PBS under the cushion material in subsection 16-C was beginning to show the results of pressure from the pierced plank mat.

CONDITION OF PBS UNDER SOIL-ASPHALT CUSHION IN SECTION 16-C AFTER TEST
