Special Report 79-20

INFRARED THERMOGRAPHY OF BUILDINGS

1977 COAST GUARD SURVEY

Stephen J. Marshall

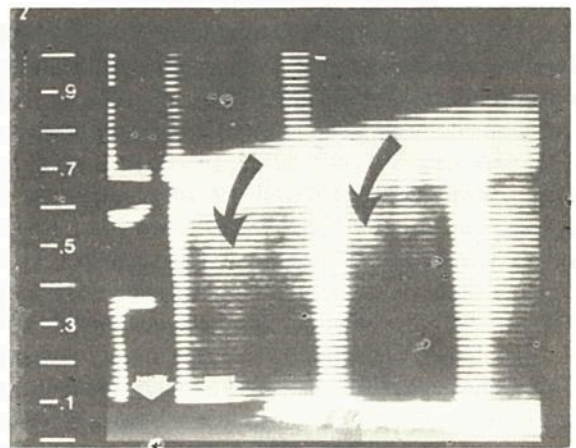
Figure 10. Nonuniform thermal patterns on south face.

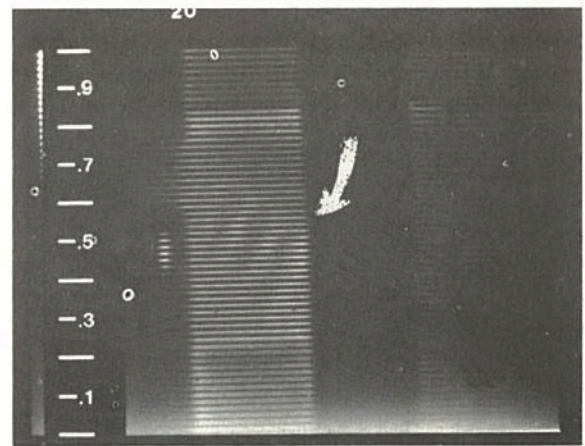
Figure 20. Glass panel under stairwell in connecting section.

Figure 20 shows a glass panel to the left of the chimney and connecting with the new section (white arrow). It was very hot (scale 20) yet serves no useful purpose because it is under the stairwell and unable to provide stairwell lighting. It should be replaced with an insulated panel.

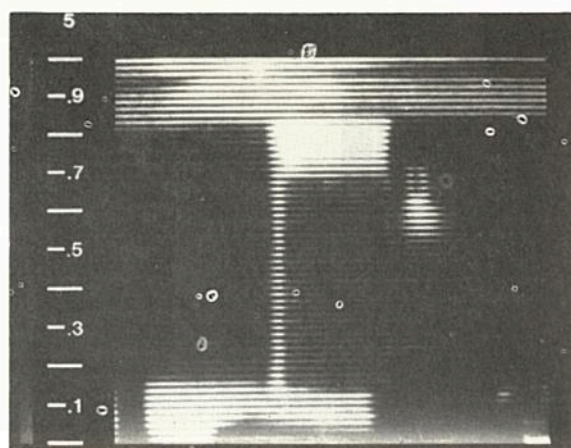
the south face, which reveals an excessive amount of heat loss through the glass transom and around the door. The door itself appears insulated. The concrete block walls appear uniformly insulated and in Figure 24 the actual outlines around each block can be recognized. The foundation is excessively warm, as are the concrete blocks immediately above the transom level and the horizontal precast beams above them.

Figure 23. Closeup of warm foundation, glass transom and door exfiltration.

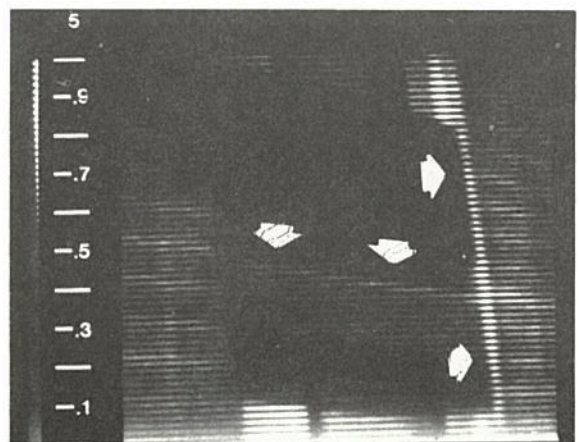
Figure 33. Exfiltration between wooden panels and at panel/wall interface.

Figure 32 shows upper and right-hand leakage between the window frame and concrete block wall interface (arrows). Figure 33 shows horizontal leakage between the upper and lower panels and between the panels and the concrete block wall (arrows). These wooden panels should be compared with the much superior insulated porcelain panels at the Portland Base (Fig. 93-97).

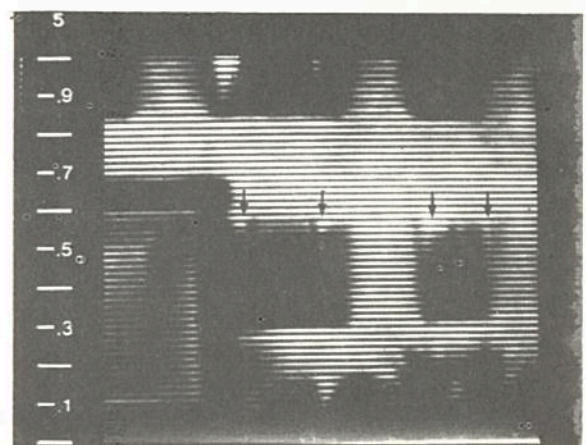
Figure 44. Main entrance with vestibule and boiler room on south face.

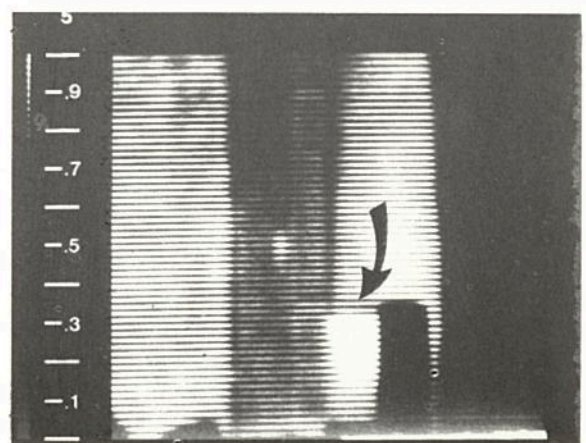
Figure 46. Hot transformer in southeast corner of station.

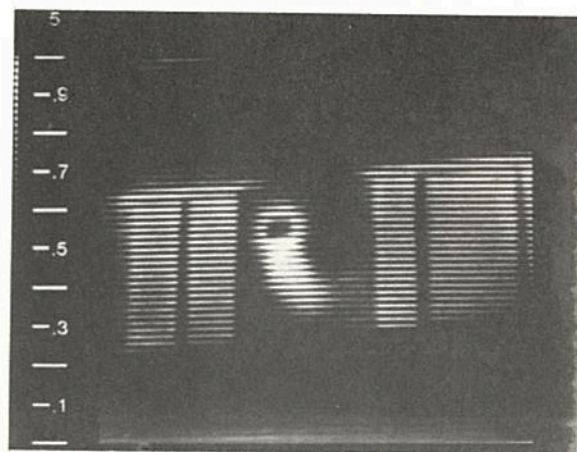
Figure 55. Plume of hot air coming from bathroom vent.

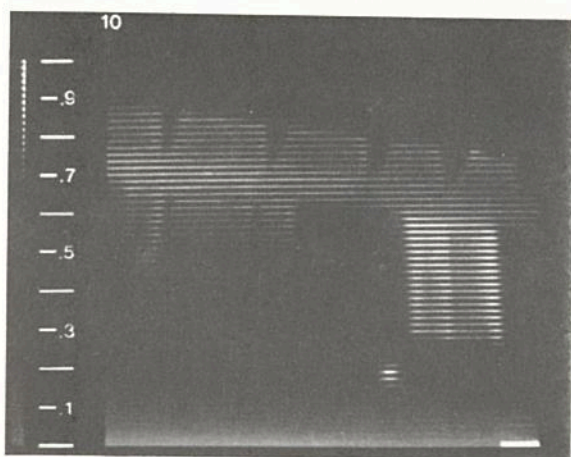
Figure 56. Excessive leakage from window in unoccupied boatswain's locker.

Figure 56 is of a window on the third-deck floor over the main entrance that exhibits excessive heat loss at scale 10. Since the room is an unoccupied boatswain's locker, the window could be replaced with an insulated porcelain panel to conserve energy.

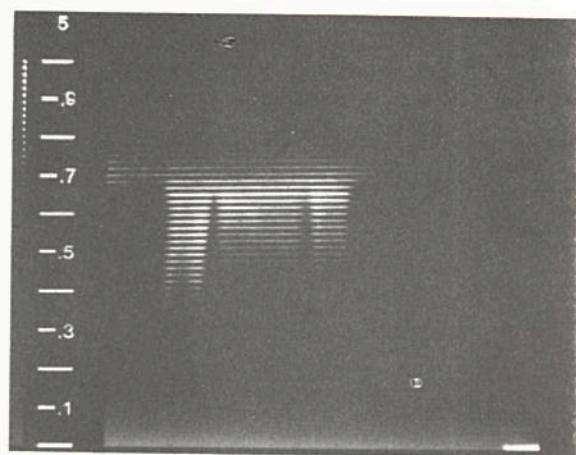
Figure 57. Excessive exfiltration from window/wall interface.

Figure 57 is of the third deck window on the upper right in Figure 54. The patterns on the glass suggest infiltration loss as well as the fact that the top horizontal interface is much warmer than most of the other windows on this face.

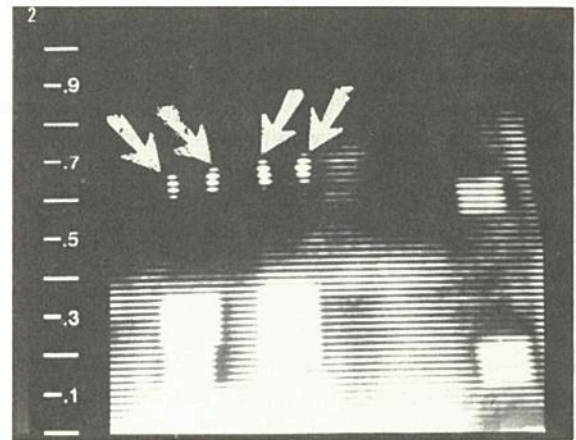
Figure 68. Leaks on both sides of the air conditioner units.

Figure 67 is a photograph of the north face of building 1 taken from the passageway between buildings 2 and 4. Note the two air conditioner units in the windows on the top deck. Figure 68 is a thermogram of these two windows. It shows how the windows themselves and the air conditioner units are dark or cool but the area to the left and right of each air conditioner leaks badly. The brick wall exhibits a cool pattern along the top deck but a warm pattern along the deck below it.

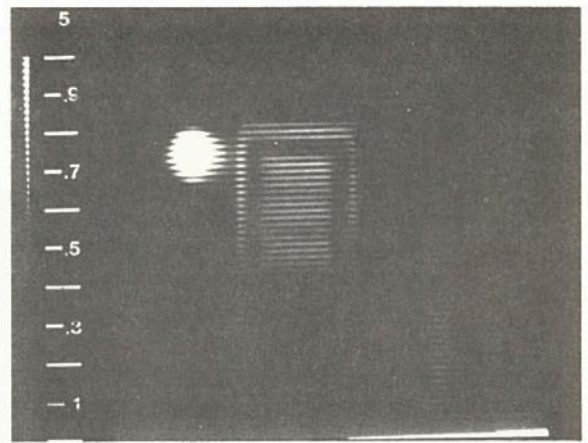
Figure 77. Badly sprung stairwell door on northeast corner of building.

Figures 77-79 are closeups of the stairwell door, garage door, and window, respectively. Figure 77 is a confirmed example of what a badly sprung metal door, i.e. a door bent by the strong winds, looks like in a thermogram. The upper horizontal and vertical interfaces show a wide thermal heat loss pattern where as there is little leakage along the bottom interface. This could result from the bottom interface experiencing infiltration of cold air while the top interface is allowing exfiltration of warm air. Other stations subjected to the same high winds (Boothbay Harbor and Jonesport) had doors with similar patterns.

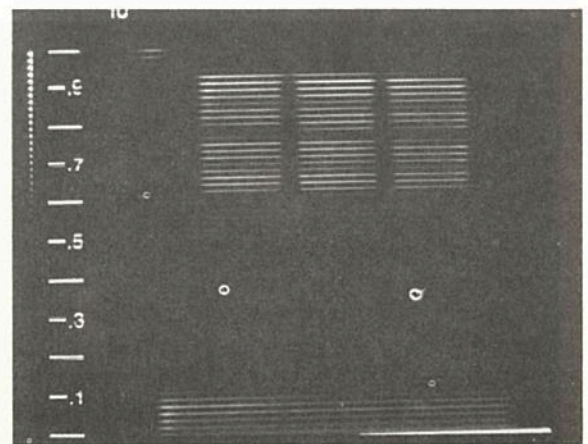
Figure 79. Windows on the north face with drawn drapes.

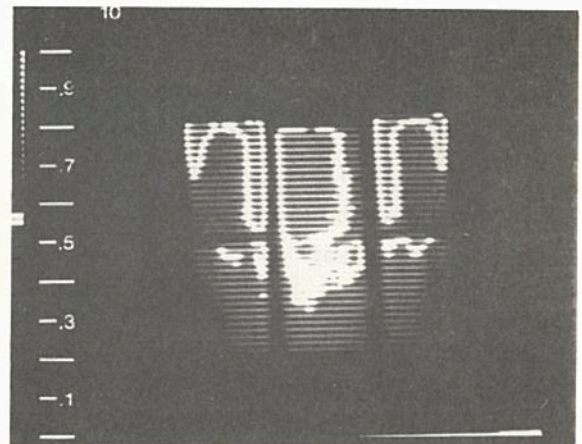
Figure 81. Isothermal infiltration patterns on glass entrance.

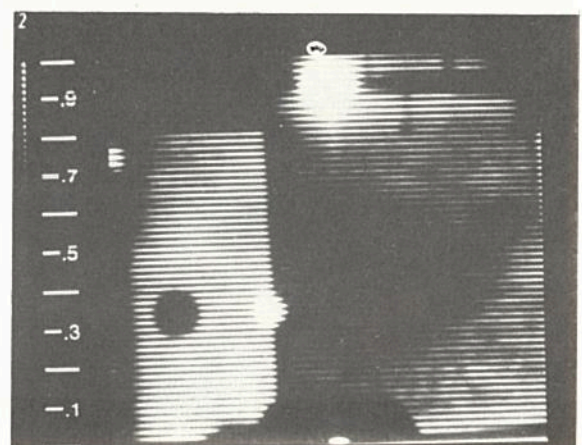
Figure 83. Mottled moisture pattern on west face of stairwell.

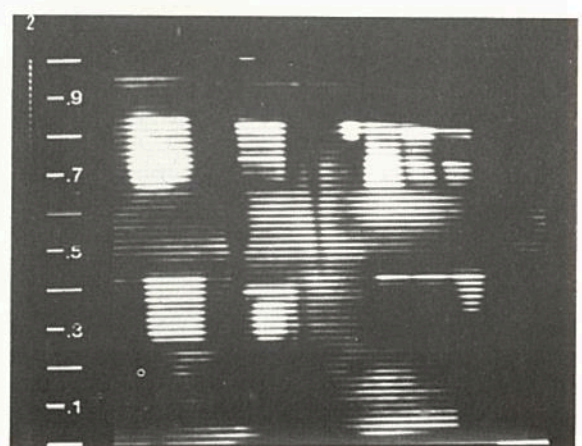
Figure 85. Radiator leakage under windows on south face.

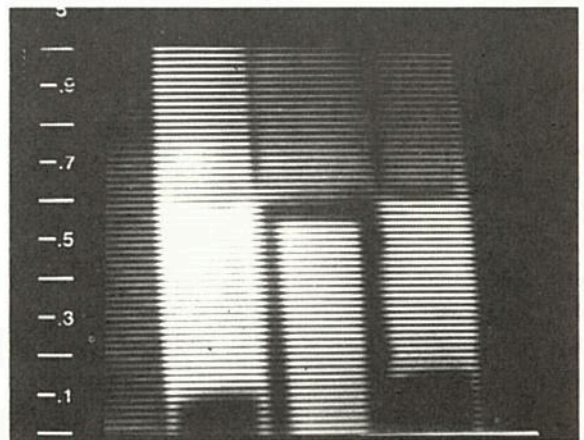
Figure 98. Door in northwest corner with leakage through the surrounding glass.

Figure 98 is a thermogram of the stairway door in the northwest corner, and except for the unnecessary loss due to the large glass area, the door is thermally tight. This is probably because this door is out of the

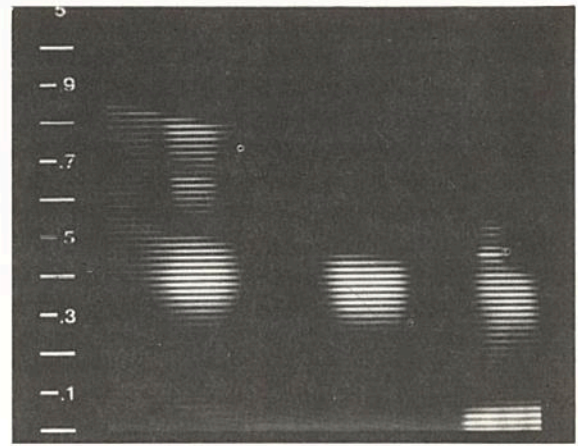
Figure 101. Radiator leakage under windows on east face.

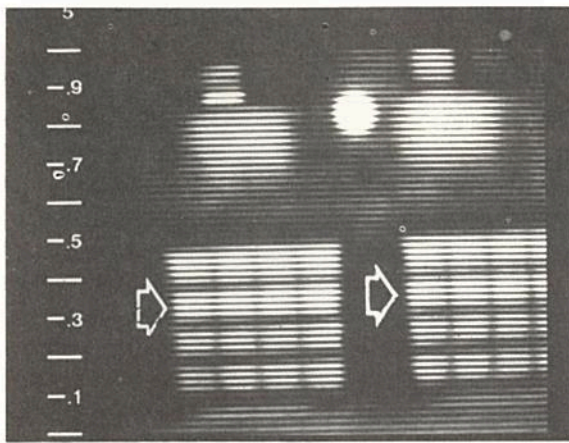
Figures 102 and 104 are thermograms of wooden garage overhead doors at Boothbay Harbor. It can be seen that the individual wooden panels lose as much heat as the glass window panes in the second row from the top of the doors. (The round object in these two thermograms is a spotlight.) Several of the other stations, such as the motor pools at New Castle, South Portland, and Southwest Harbor, exhibited the same kind of leakage through the wooden panels of the overhead garage doors. An overhead garage door found to

Figure 102. Wooden overhead garage doors with windows in them.

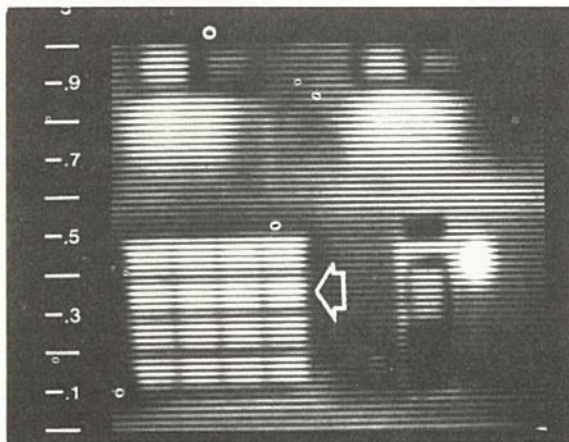
Figure 104. Leakage around door that is frequently used.

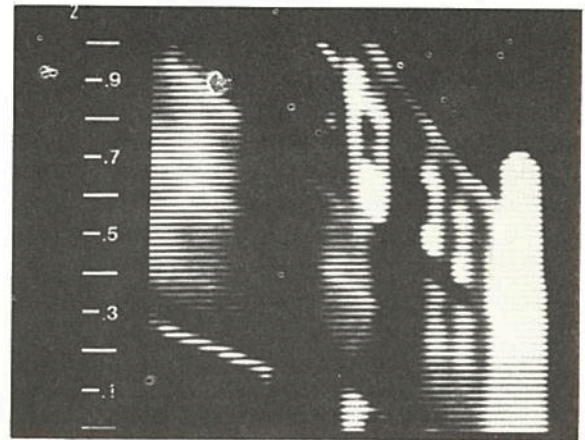
Figure 114. Radiator leakage under windows shows clearly on north face.

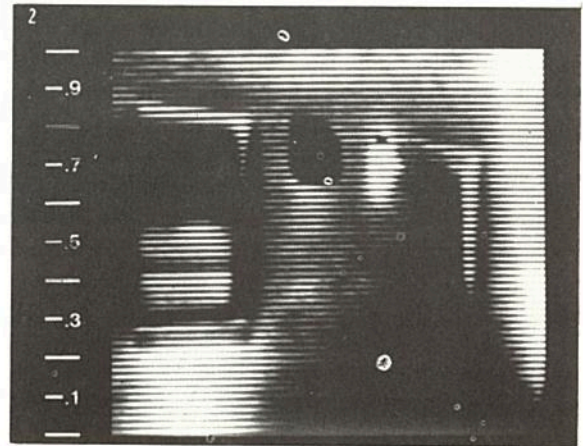
Figure 116. Window and door exfiltration leakage and solar effect.

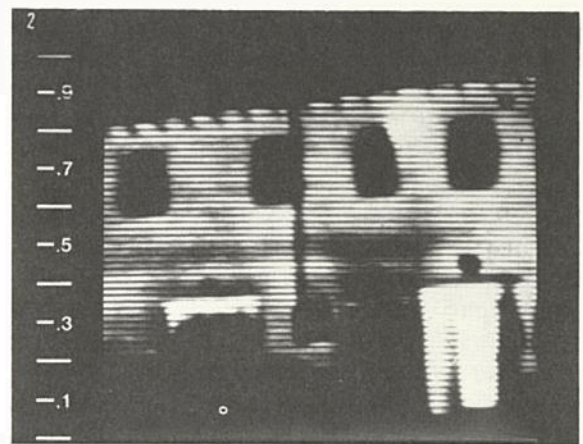
Figure 120. Excessive leakage from glass main entrance.

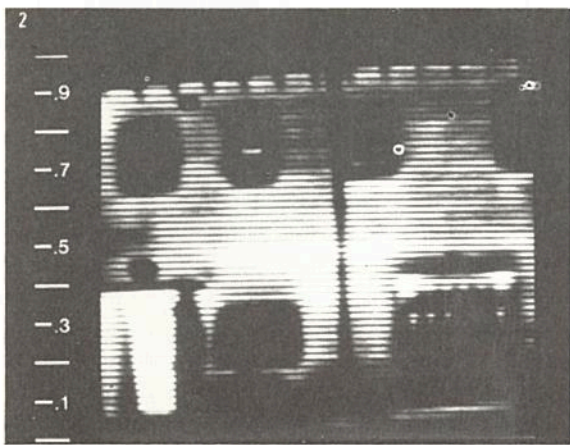
Figure 121. Leakage along top interface of garage door.

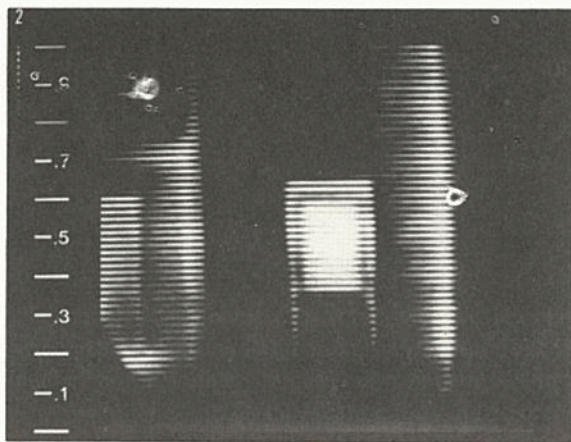
Figure 132. Leakage on north face.

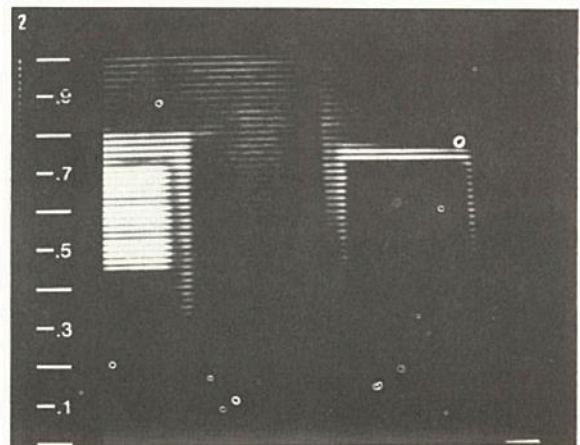
Figure 137. Paint storage locker doors losing heat.
