Miscellaneous Paper GL-94-21
June 1994

Airfield Pavement Failure Evaluation, Yap International Airport, Yap Island, Federated States of Micronesia

by Steve L. Webster, Gary L. Anderton

Final report

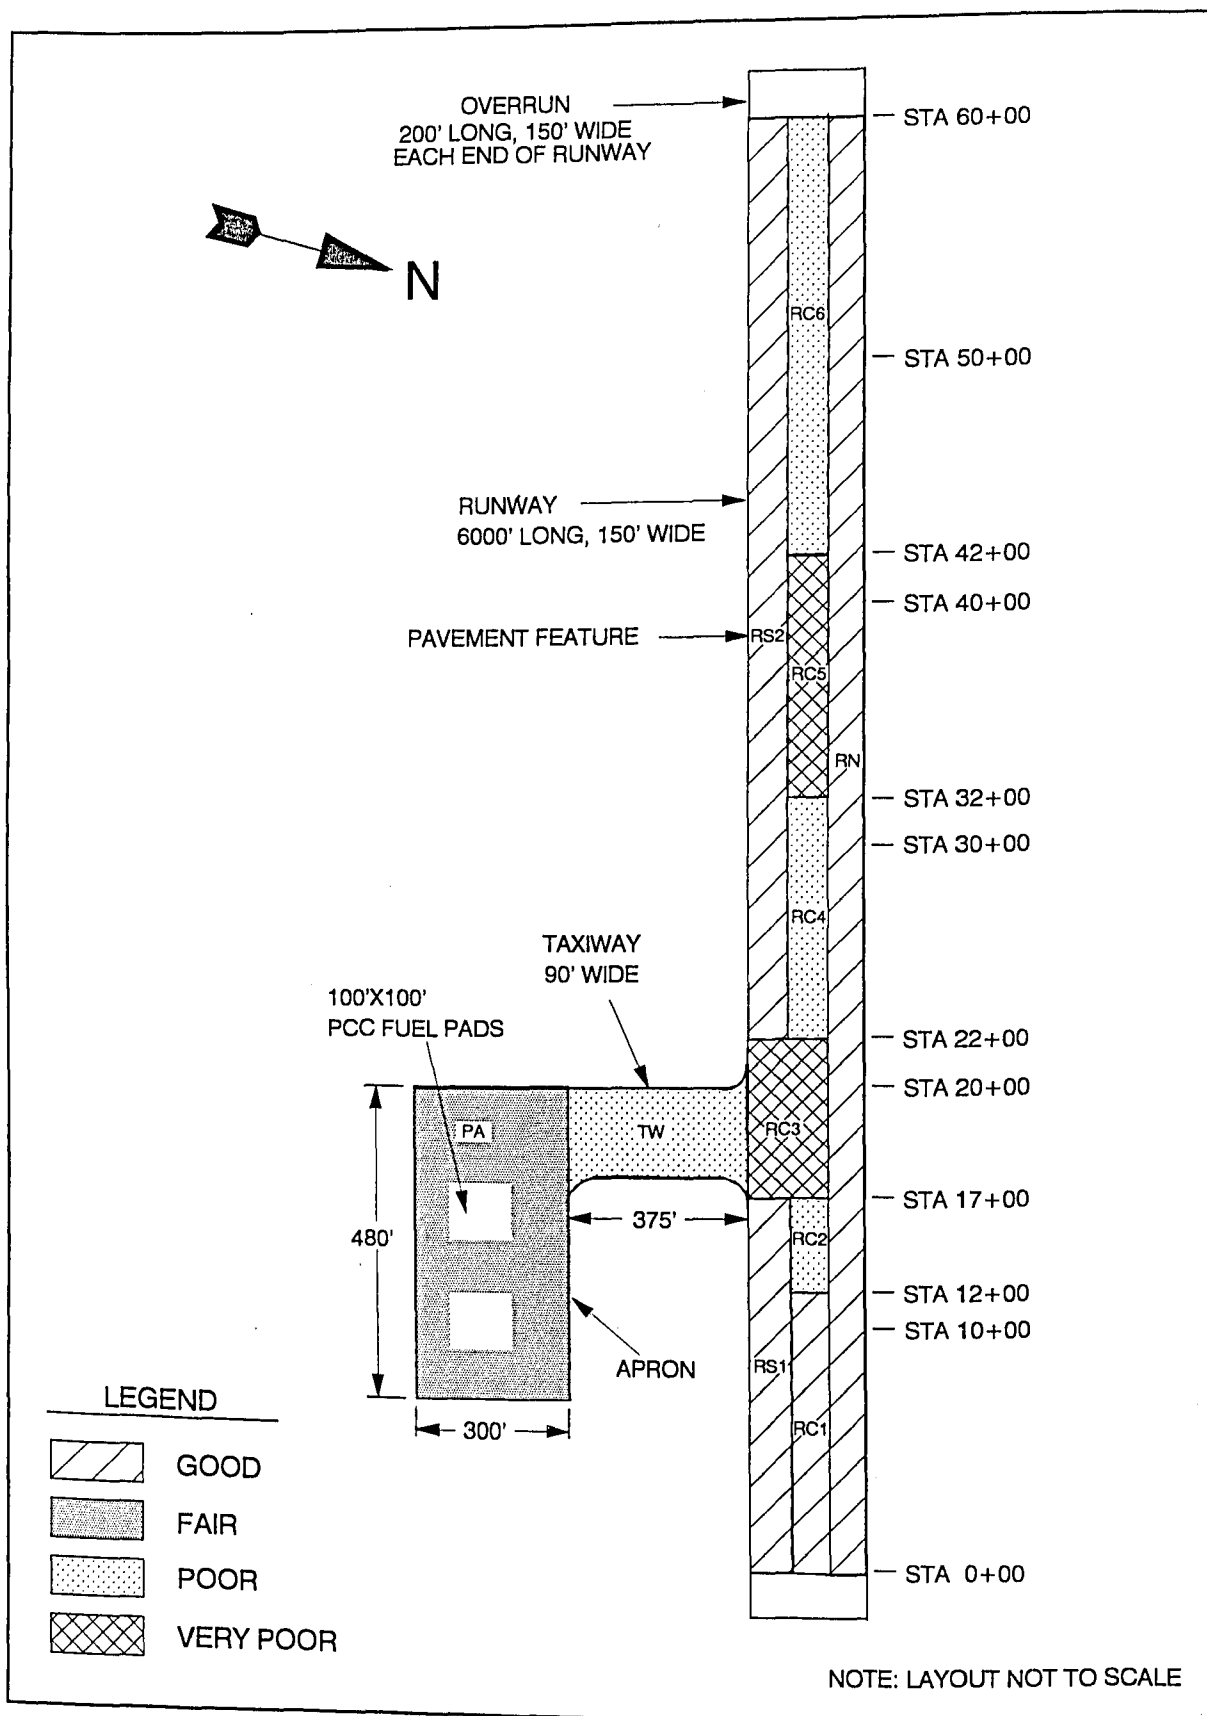
Figure 4. Pavement condition summary

The results from the Micro PAVER computer program identifying the feature, inspection date, PCI, rating, distress quantity, and distress mechanism are presented in Appendix A. The major distress types found on the AC pavements were alligator cracking, rutting, depressions, weathering, and longitudinal and transverse cracking. The patching consisted of 10-in.-thick PCC patches (with wire fabric plus some reinforcement) in the wheel paths. The depressions usually were located in areas between the PCC patches. The PCC patches were screeded level to the original pavement surface. This patching procedure left the patch at a higher elevation than the trough in wheel paths leading to and after the patch. In areas where the rutting was 3/4 to 1 in. deep, the PCC patch resulted in a 3/4 to 1 in. bump that was strongly noticeable in the B-727-200 aircraft. The only distress type observed on the PCC fuel pads was linear cracking. Photos 1 through 10 show various types of distresses observed during the survey. The PCI of features RC2, RC3, RC4, RC5, RC6, and TW ranged between 13 and 36 indicating that the pavement in these areas had deteriorated to a level where normal maintenance, or rehabilitation with an overlay, could not be expected to ensure reliable long-term performance under the current aircraft loadings.

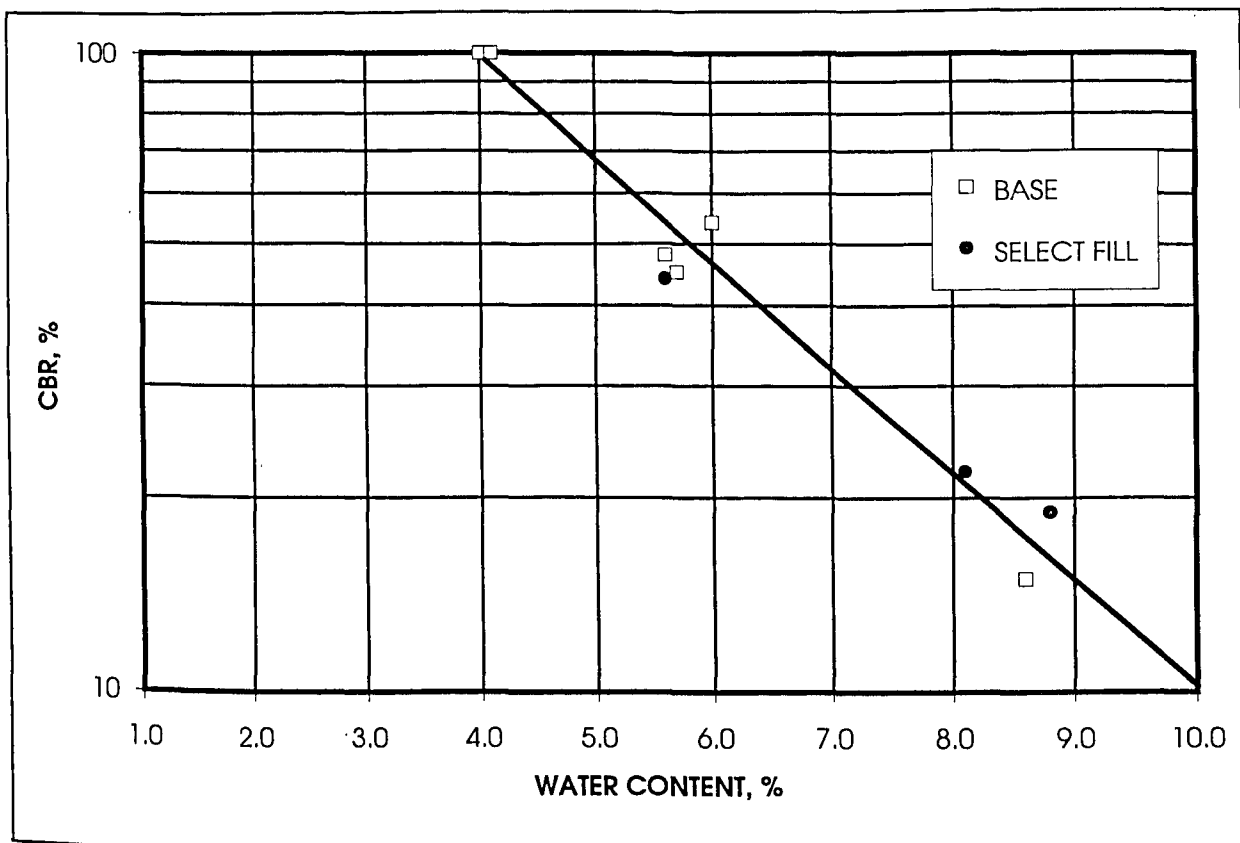
Figure 8. CBR versus water content, from test pit data

measurements. For a water content of 4 percent, CBR values were 100. As the water content increased to 8-9 percent, the CBR dropped to approximately 12-20 percent. These test results indicated that the cause of the pavement failures was due to loss of strength in the base course due to an increase in water content.

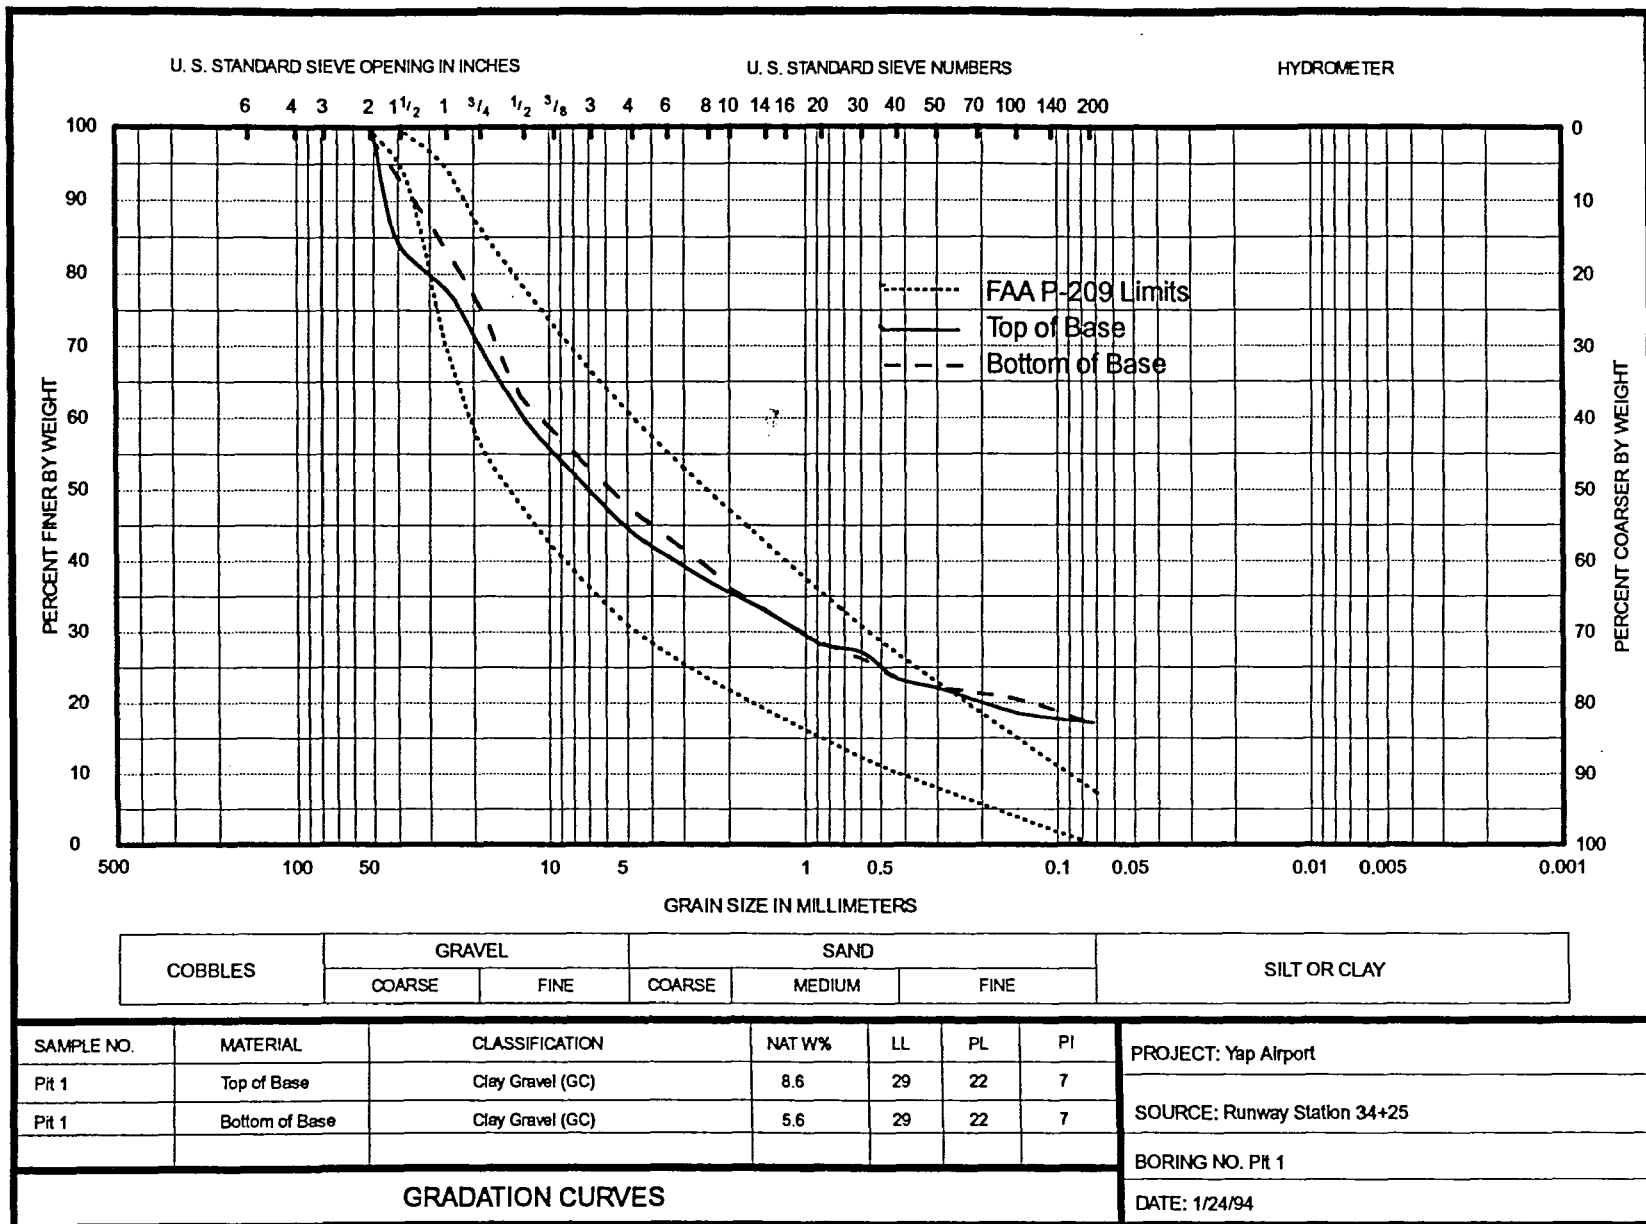
Figure 10. Gradation curves for base course from Pit 1

Sieve Analyses. The results of the sieve analyses are given in Tables 3-4 and in Figures 10-13. The results of the base course sieve analyses indicate that there is a lack of top-sized material and too many fine aggregates throughout the base course layers when compared to the specified FAA gradation requirements. The existing grading undoubtedly has a reduced permeability and holds subsurface water longer than the designed gradation. This difference is critical in the presence of plastic fines and high moisture contents, such as the case at Yap Airport.

Another item of interest in the base course sieve analyses is the notable differences between the top and bottom layers for the Pit 1 and 2 samples, while there is no significant differences between the top and bottom samples in Pit 3. Since the Pit 3 area was structurally sound when sampled and Pits 1 and 2 had significant structural failures, the reduced amount of larger aggregates in the bottom of the base may have either caused or become the result of the structural failure. Degradation of the larger aggregates under routine wheel loads and in the presence of high moisture contents is a likely scenario in these areas.

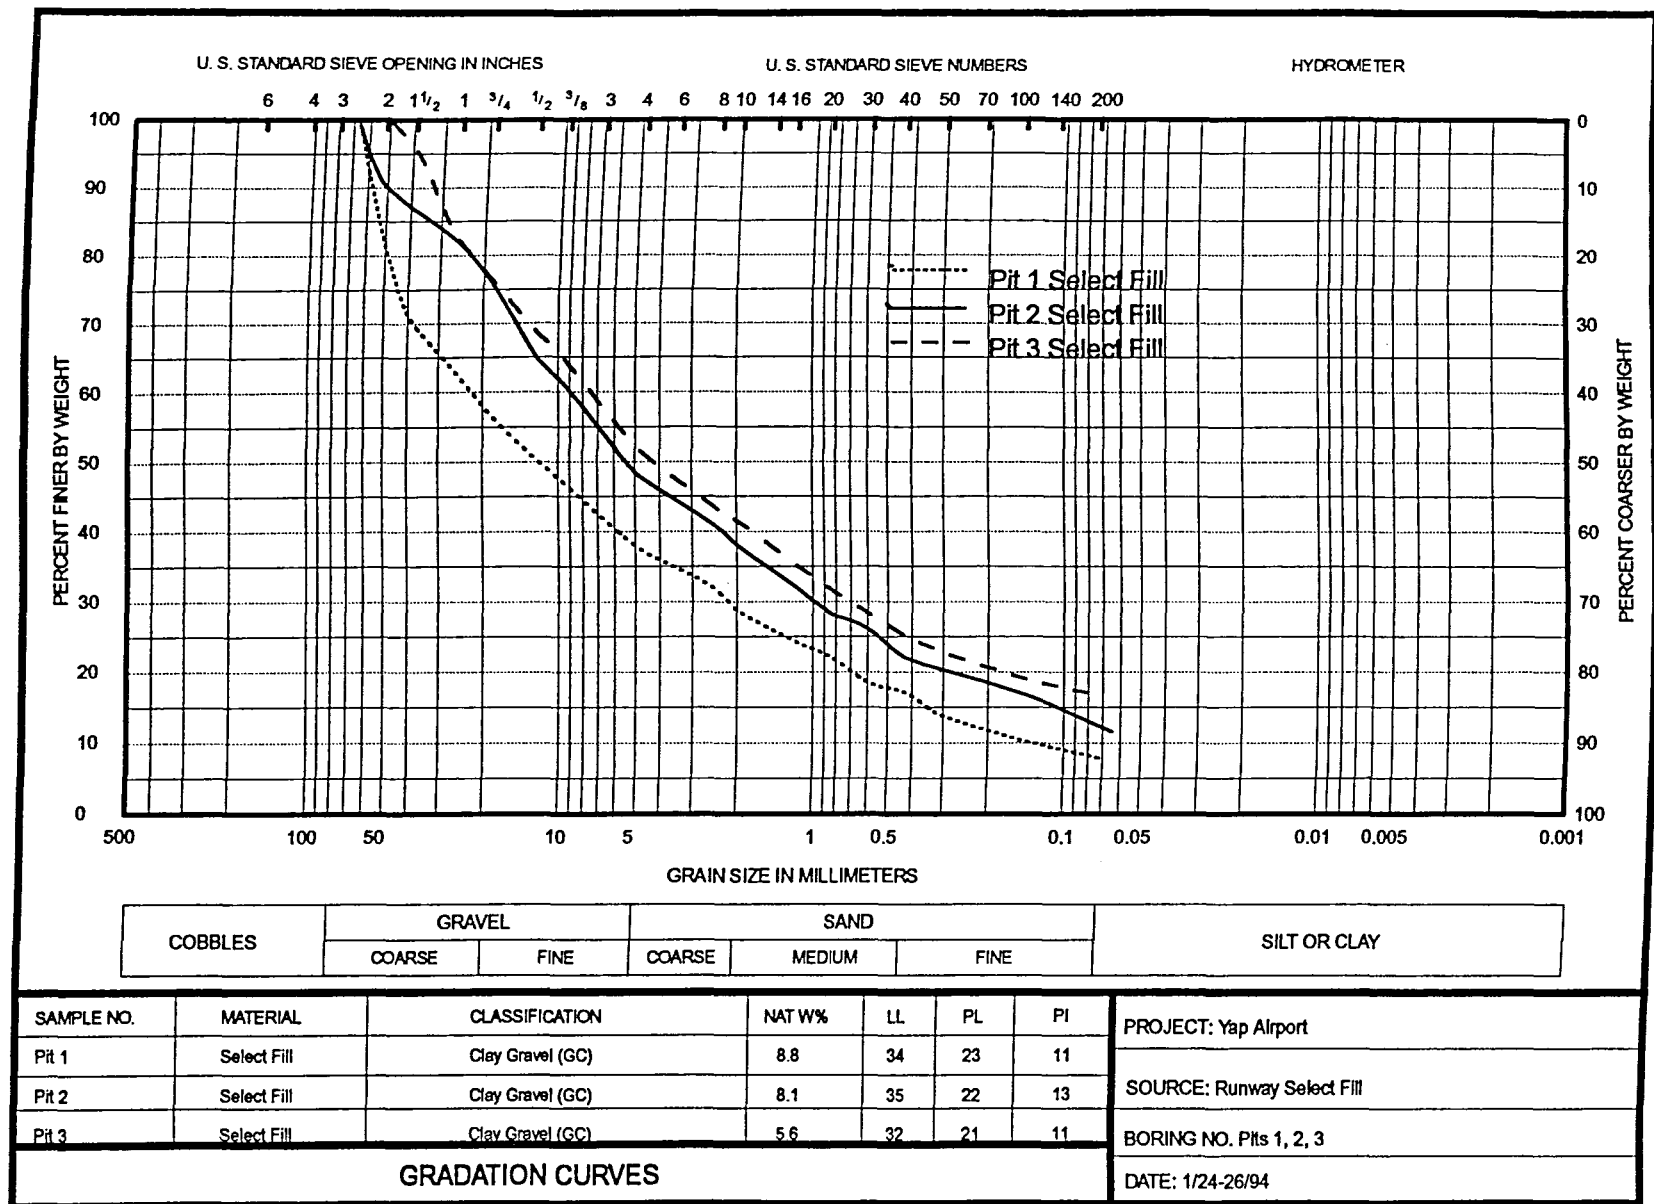
Figure 13. Gradation curves for select fill material from Pits 1-3

The results of the select fill sieve analyses are given in Table 4 and are graphically represented in Figure 13. The gradation of the Pit 1 sample differs from those of Pits 2 and 3, as the Pit 1 material is substantially coarser than the other two samples. The significance and possible reason for this difference is unknown. This variance is not suspected as a significant contributor to the current runway pavement failures at Yap Airport.

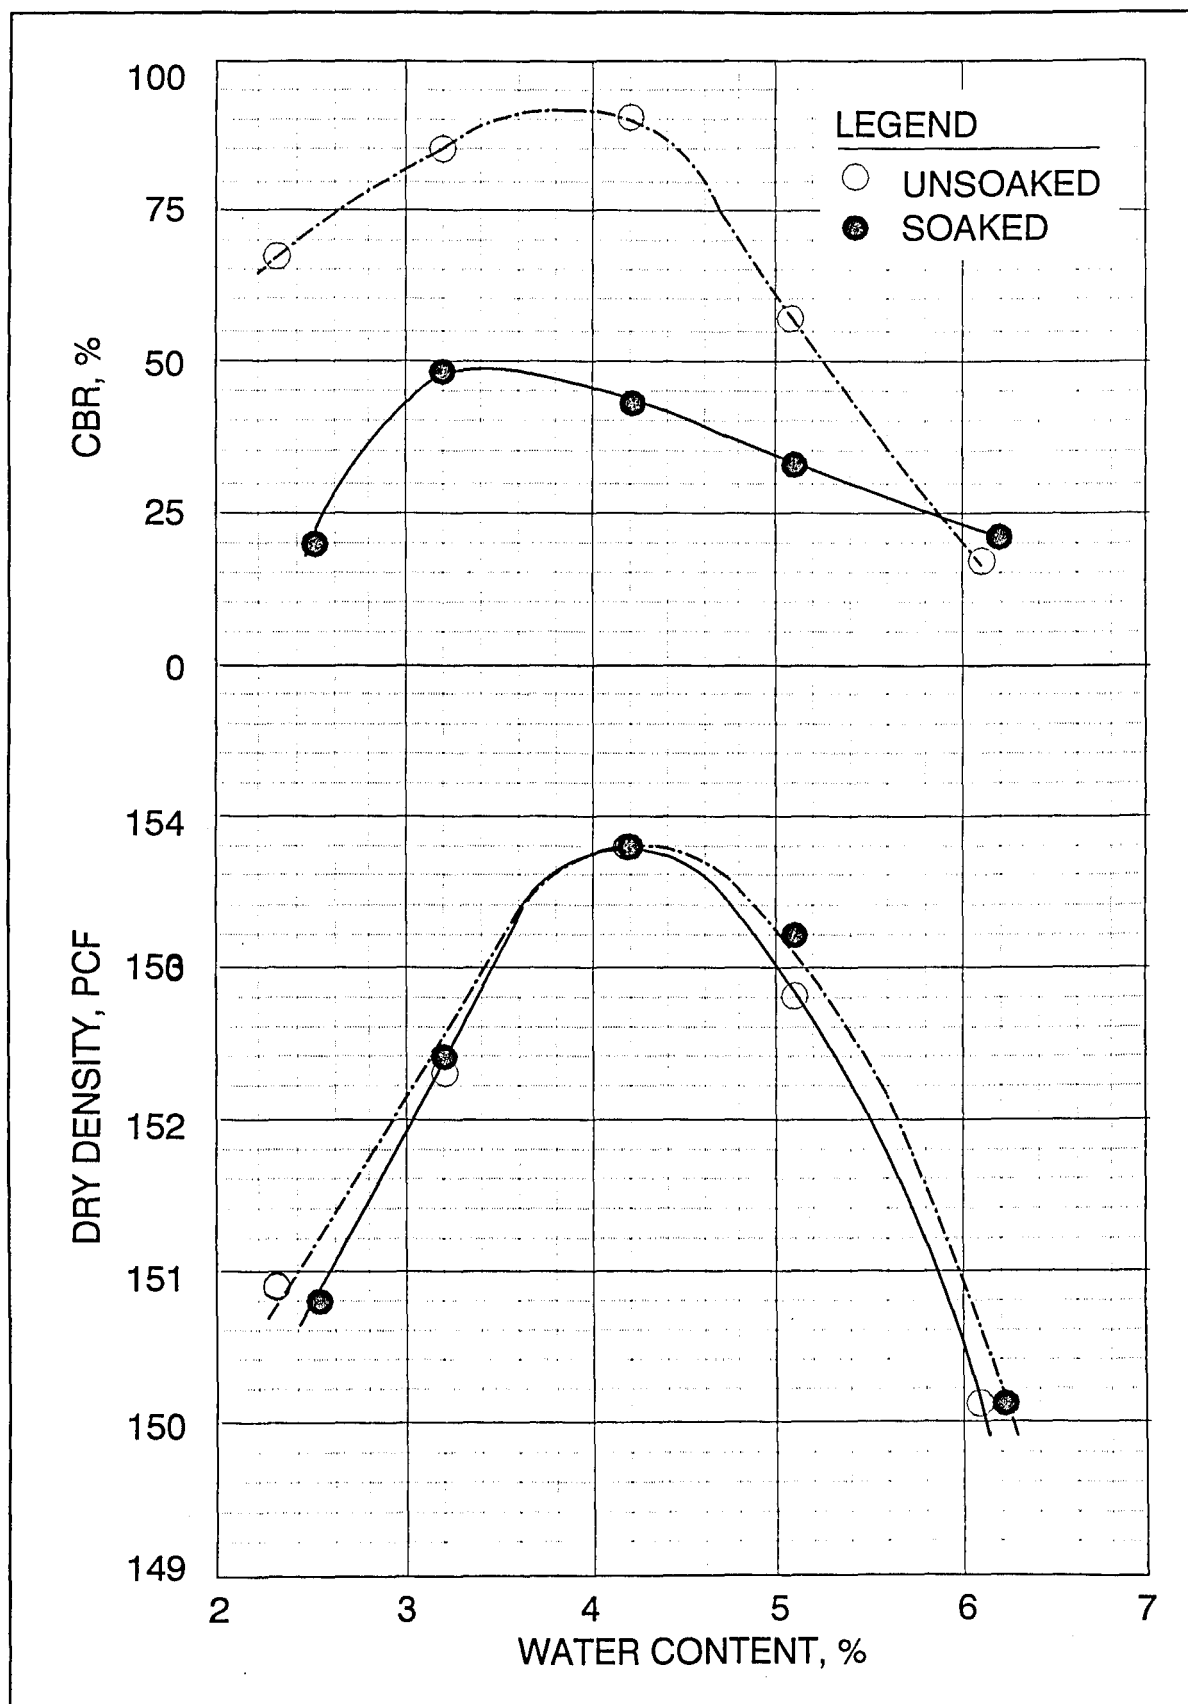
Figure 14. CBR, density, and water content data for base material from Pits 1-3

Laboratory Compaction and CBR Data. Laboratory compaction and CBR data, determined for the combined base material taken from Pits 1-3 for a CE 55-blow compactive effort (MIL-STD-621A, Method 101), are shown in Figure 14. Both the unsoaked and soaked conditions are shown in Figure 14. Optimum water content was 4.2 percent and maximum dry density was 153.8 lb/cu ft. The water contents after soaking ranged from 7.4 - 8.4 percent. Based on the laboratory compaction tests the soaked design CBR was 15 for the base material. This design CBR agrees with the field DCP data (Table 1) which measured a 15 CBR for the top of the base in Pit 1 which had a water content of 8.6 percent.

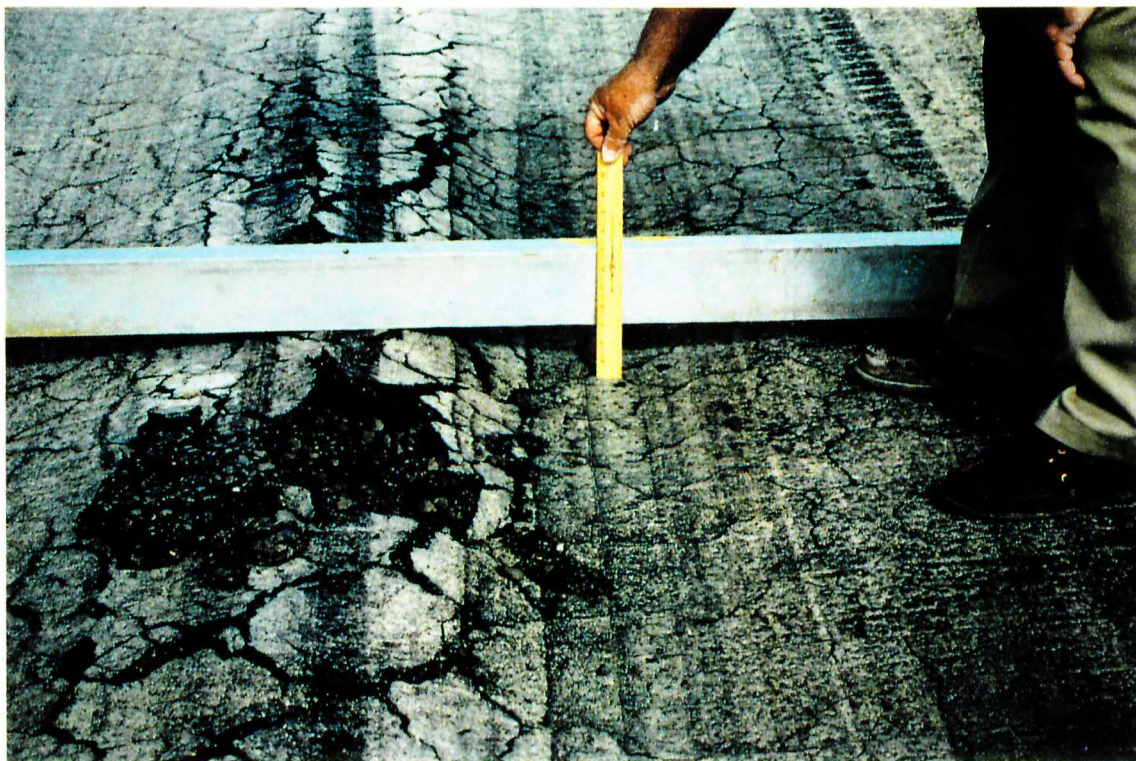
When sampling the Pit 1 Area, the AC was noted to be deteriorated to the point where some small AC chunks could be removed by hand. Other AC samples were easily removed with hand tools. The AC surfacing in the severely deteriorated Pit 1 Area consisted of approximately 2-in.-thick intact AC material with numerous fatigue cracks over a 2-in. thickness of loose asphalt coated aggregates with much of the asphalt cement stripped away. The deteriorated condition of the AC surfacing in this area was likely caused by the progression of a weakening base course, repeated wheel loads, increasing fatigue cracking, and rain water infiltration. At this location, as the condition of the AC worsened, the rate of deterioration increased as the increased cracking allowed more water to infiltrate and the base to weaken even more. The repeated shearing action in these areas from routine wheel loads in wet conditions is the cause of the stripping action on the bottom of the AC layer. The slurry seal coat had infiltrated the AC material through the numerous cracks and this contamination combined with the deteriorated condition of the AC samples prevented any testing of physical properties in the laboratory.

Photo 1. High severity alligator cracking and rutting at Pit 1 location

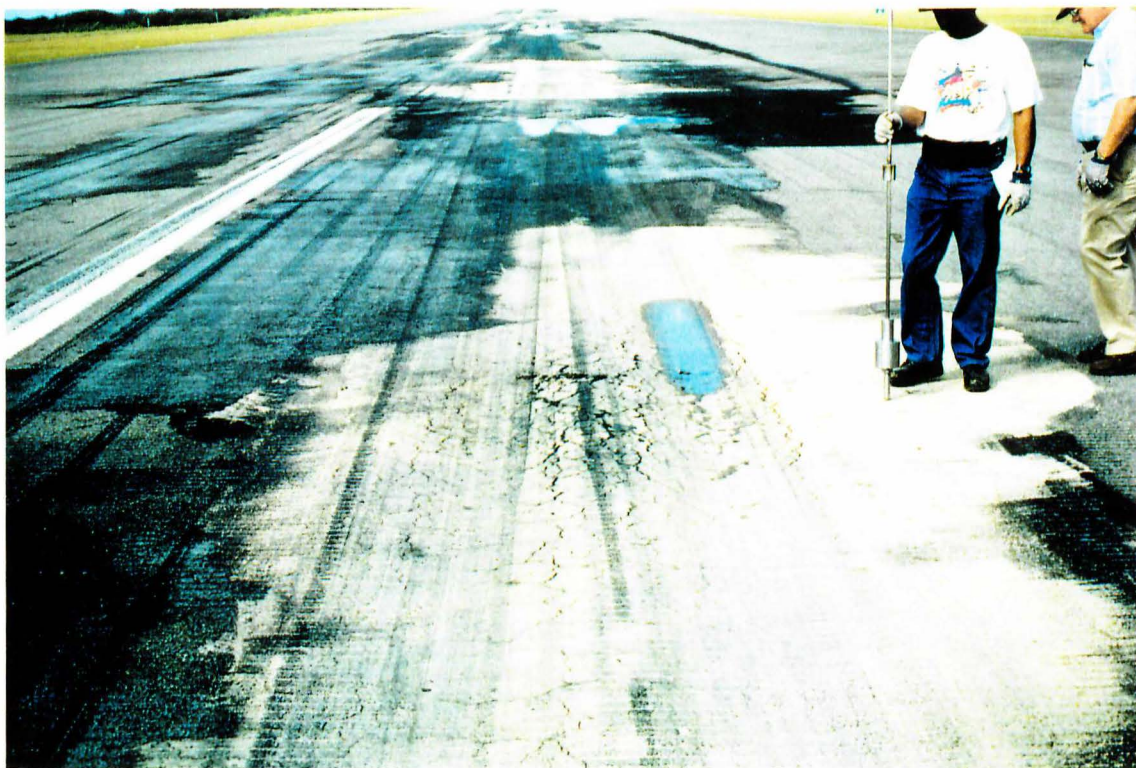
Photo 2. High severity alligator cracking and rutting at Pit 2 location

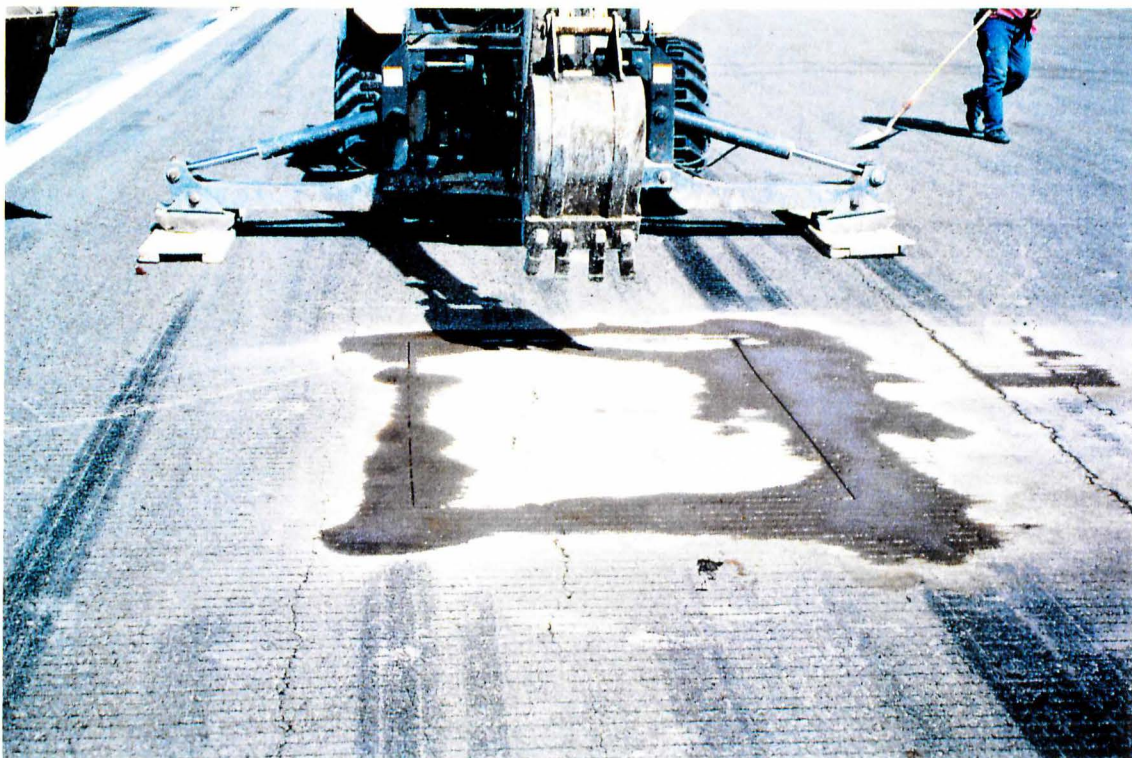
The AC samples from the Pit 3 Area were intact and the AC appeared to be in good condition. Laboratory tests conducted on the Pit 3 AC samples included a measure of in-place density and voids, recompact density, gyratory testing machine analysis, asphalt extraction to determine asphalt content, and a sieve analysis on the mineral aggregates in the AC mixture. A summary of these test results are presented in Table 2.

Photo 3. Pavement condition at Pit 3 location

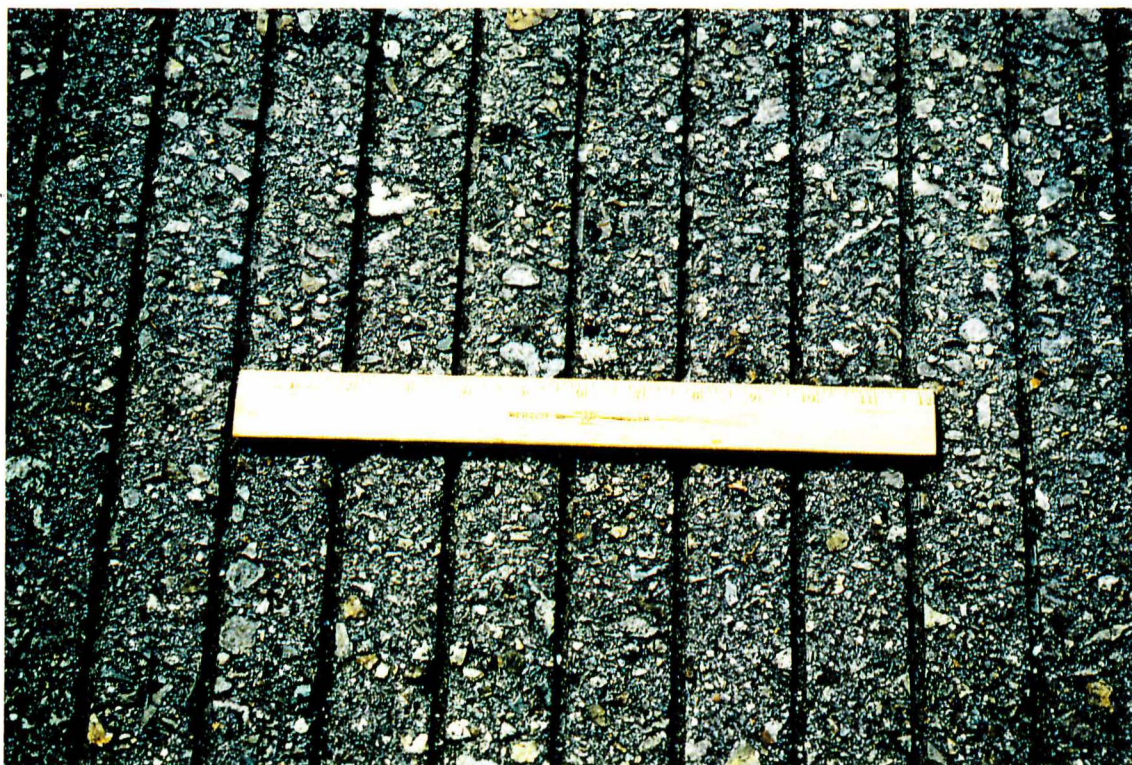
Photo 4. Low severity raveling/weathering typical for all Yap airfield pavements

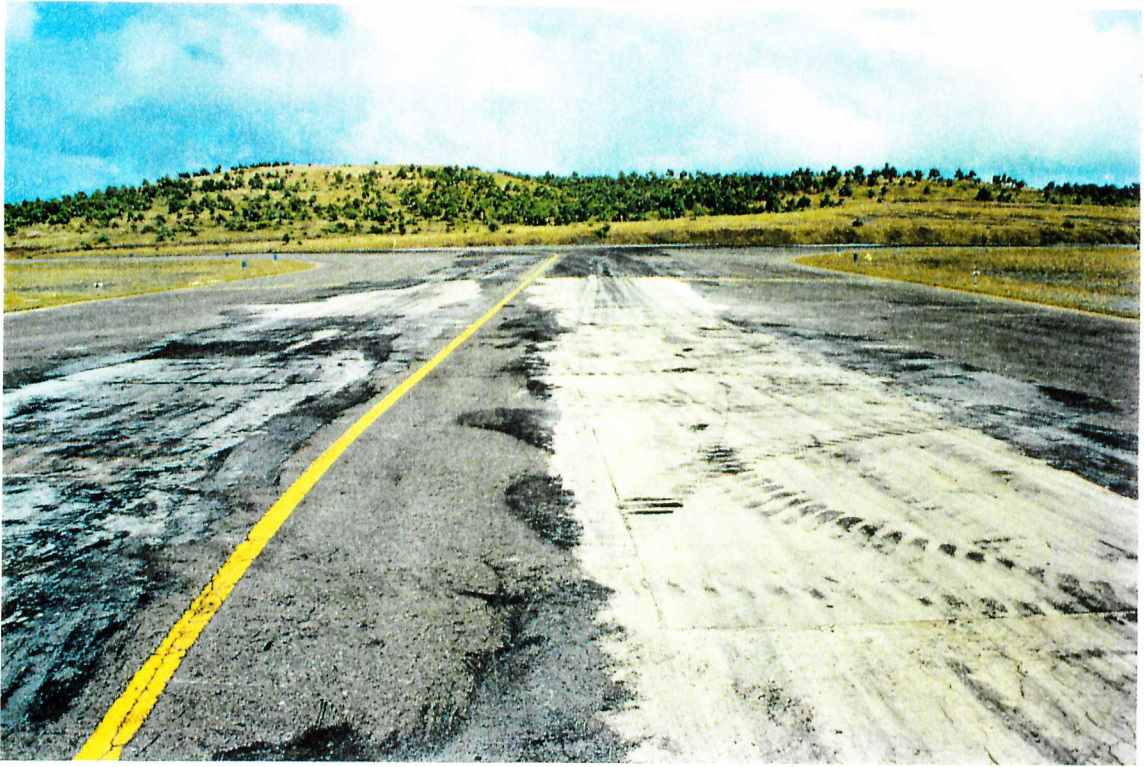
Photo 5. Concrete patches with liquid asphalt/sand seal on taxiway

- a. The drainage system be checked and maintained on a regular basis.
- b. The surface cracks be sealed and kept sealed based on a regular inspection and maintenance schedule. The current sealing procedure using emulsified asphalt and sand is an adequate maintenance procedure.
- c. The current repair procedure for failed areas using PCC patches with wire/rebar reinforcement should be modified. The current procedure of screeding the surface to match the original pavement surface creates a bump in the rutted pavement that is strongly felt in the aircraft as it travels over the patch. If possible, the final surface of the patch should match the existing ruts in the wheel paths. Under the current patching procedure, the rutted area between two patches may pond water.

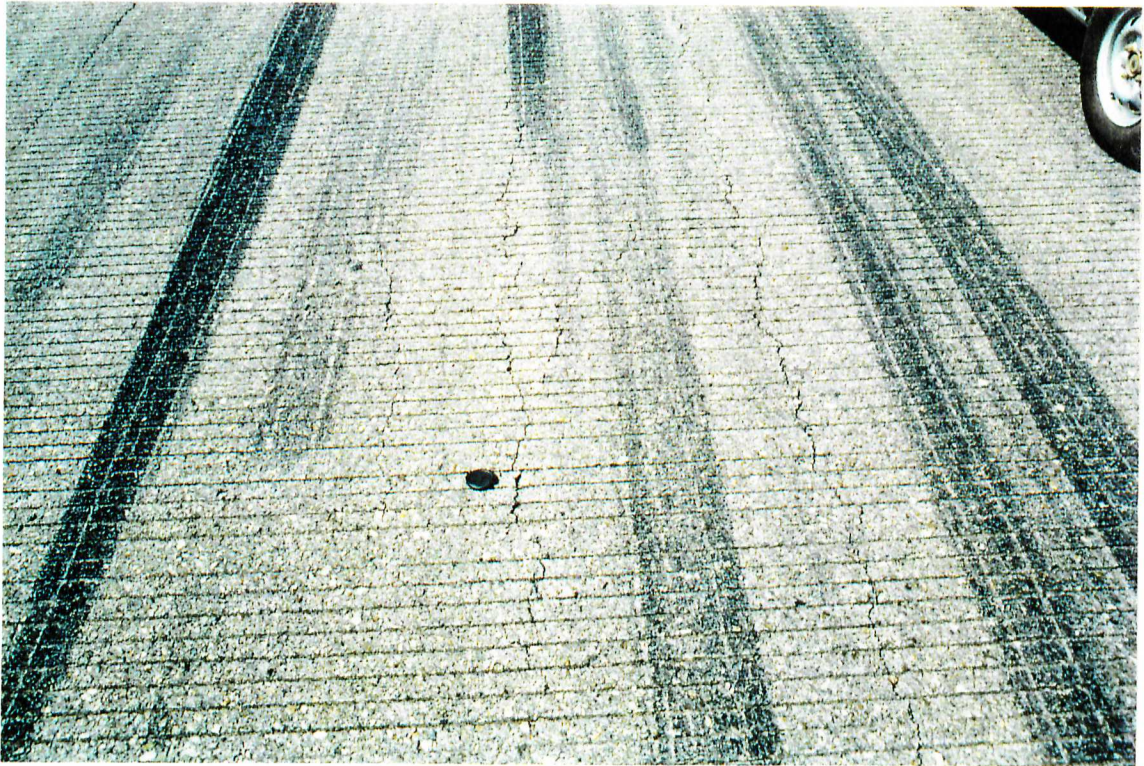
Photo 6. Low severity alligator cracking on runway

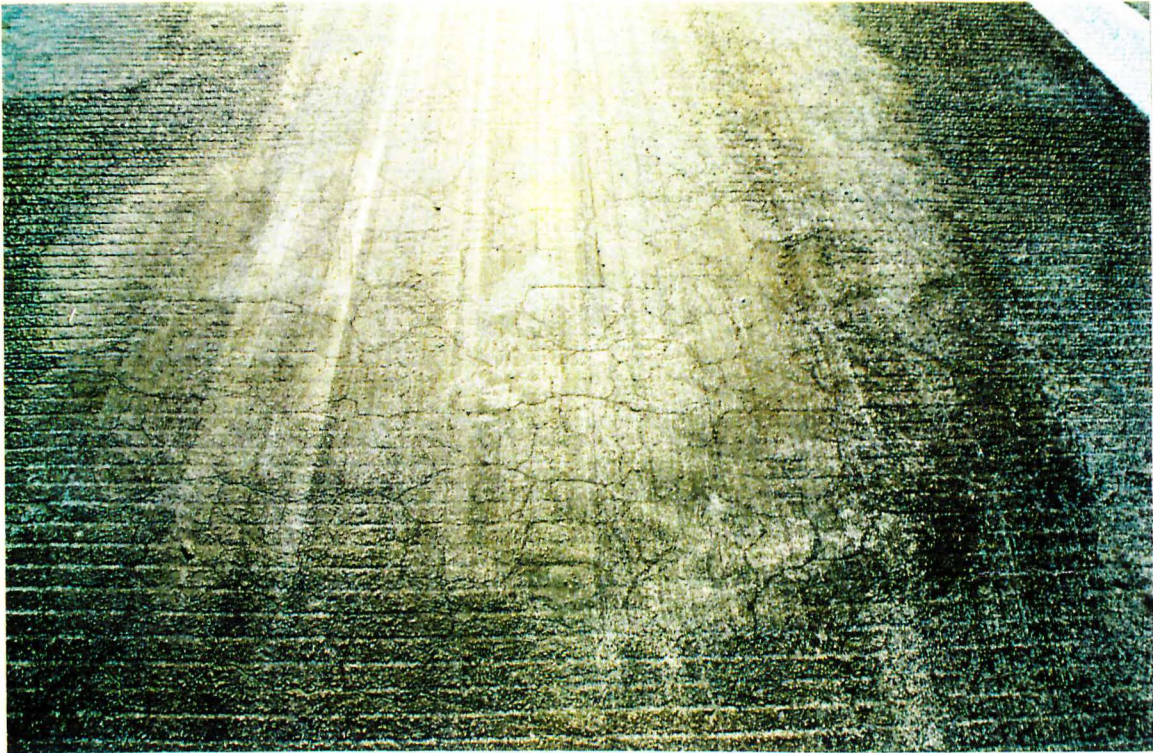
Photo 7. Medium severity alligator cracking with liquid asphalt seal on runway

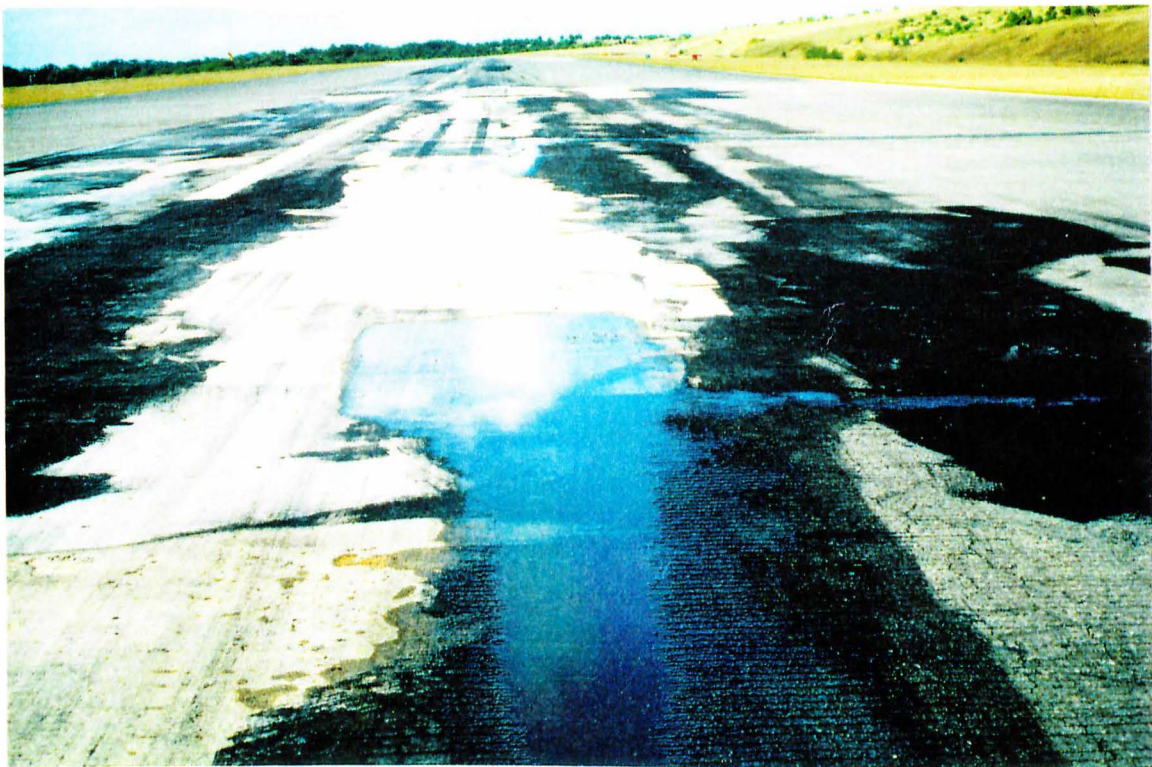
Photo 8. Medium severity depression at end of PCC patch on runway

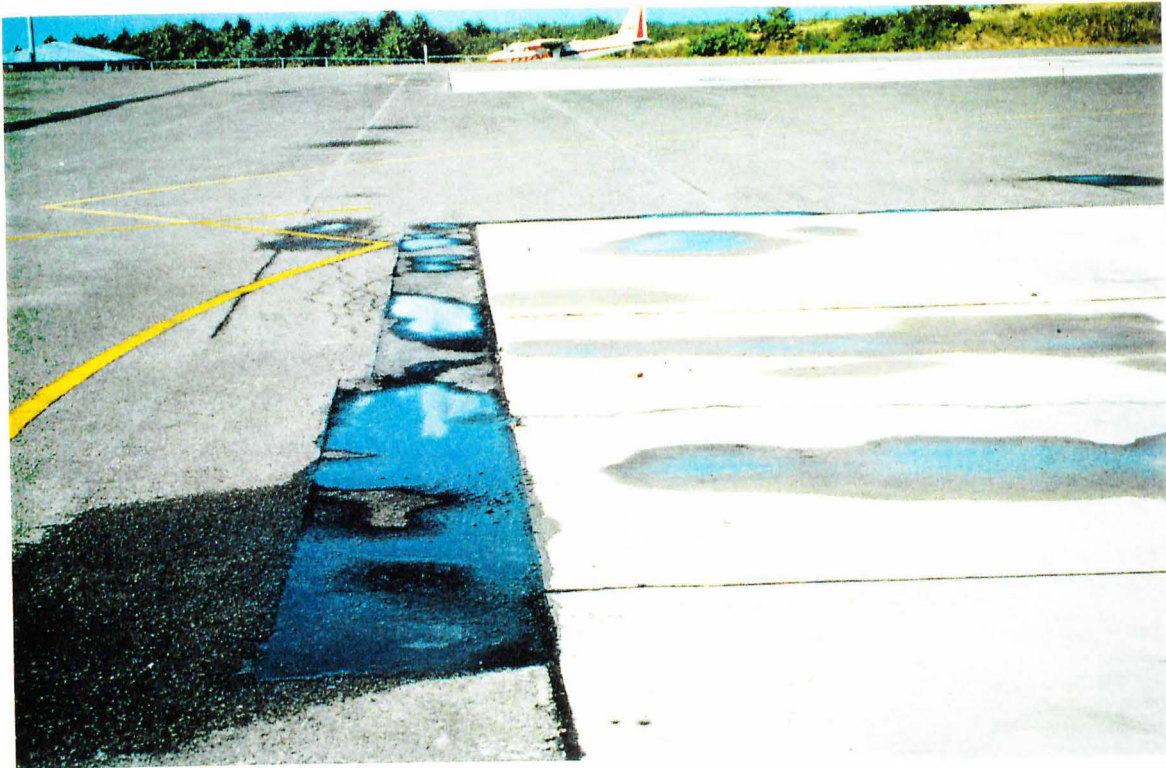
Photo 9. Medium severity patch at apron fuel pad

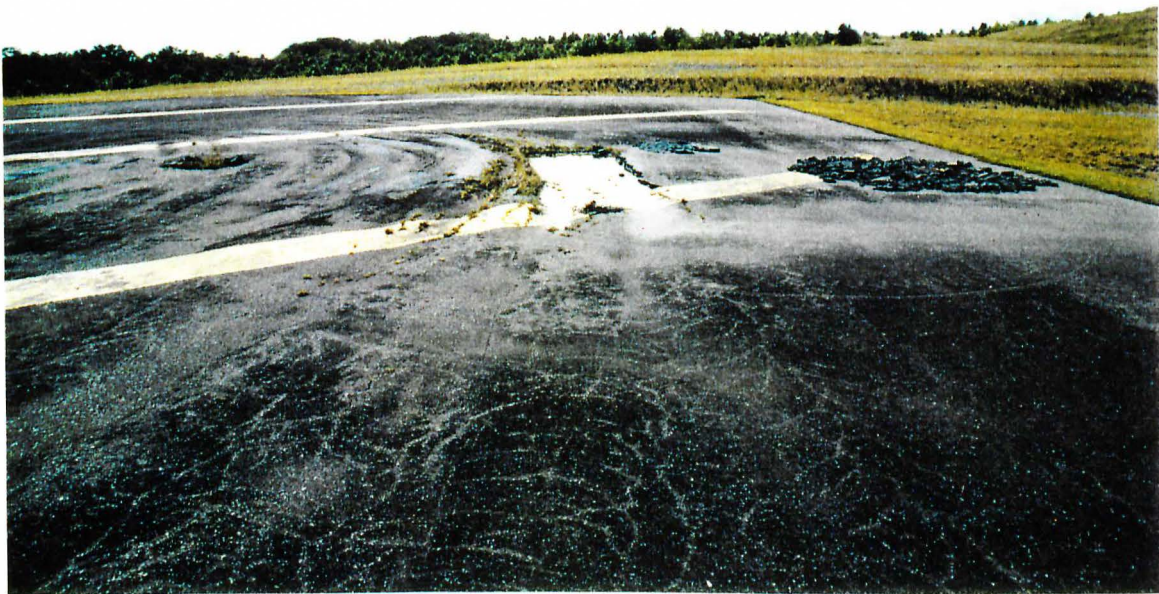
Photo 10. Failure on West overrun (airplane got stuck turning around)

- c. *Runway overruns:* Repair failed areas and overlay with 2-in. AC.
- d. *Drainage outlets:* Check all drainage outlets and add a concrete drop basin around those that can potentially clog with grass and roots. The drainage system should be checked and maintained on a regular basis.

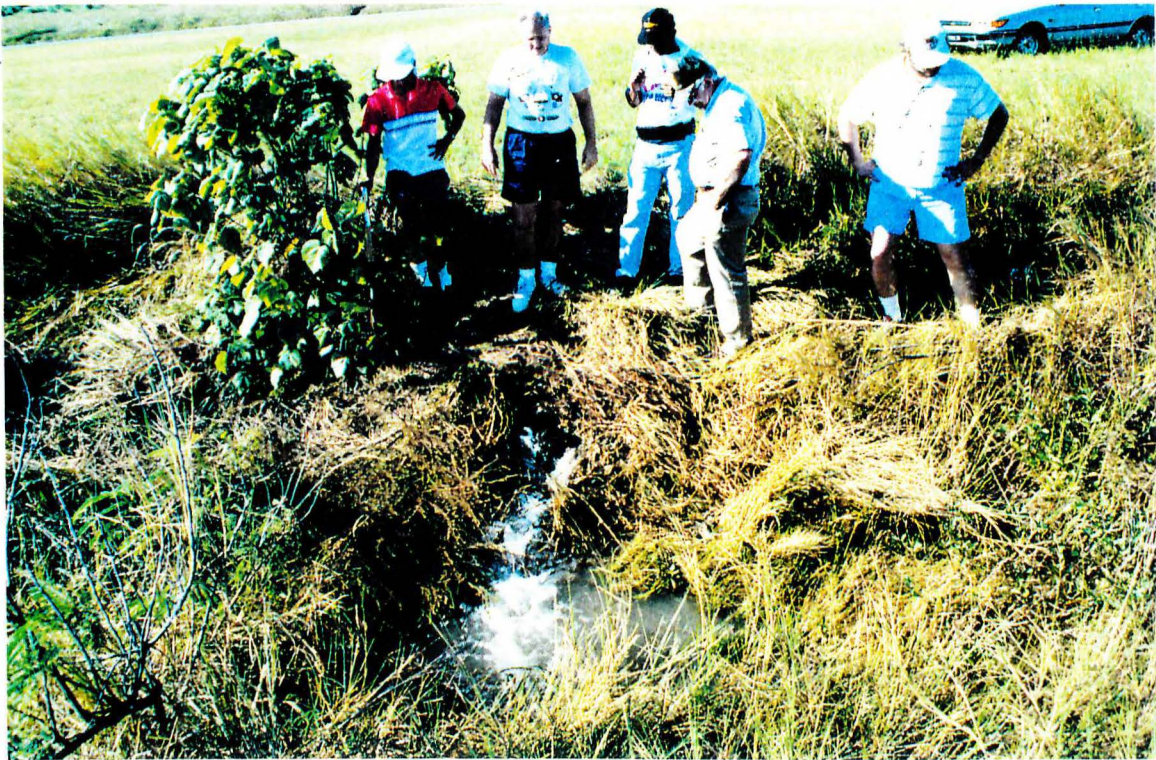
- c.* The clogged edge drain at Sta 37+00 probably accelerated the pavement failures by offering a ready supply of water to the base and select fill material.

Photo 11. Water flowing from unplugged drain at runway Sta 37+00

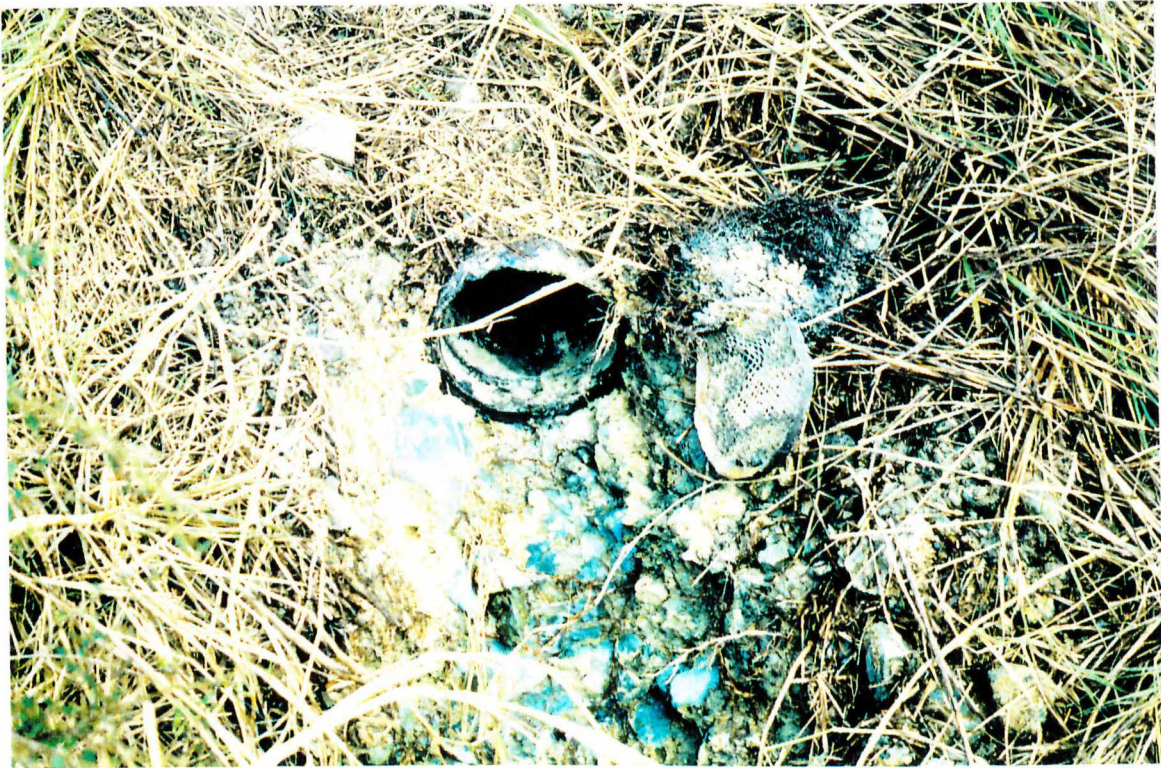
Photo 12. Closeup of unplugged drain at Sta 37+00
