Demonstration of Antimicrobial Corrosion-Resisting Interior Coating Systems for Military Facilities in Warm, Humid Locations

Final Report on Project F10-AR04

June 2017

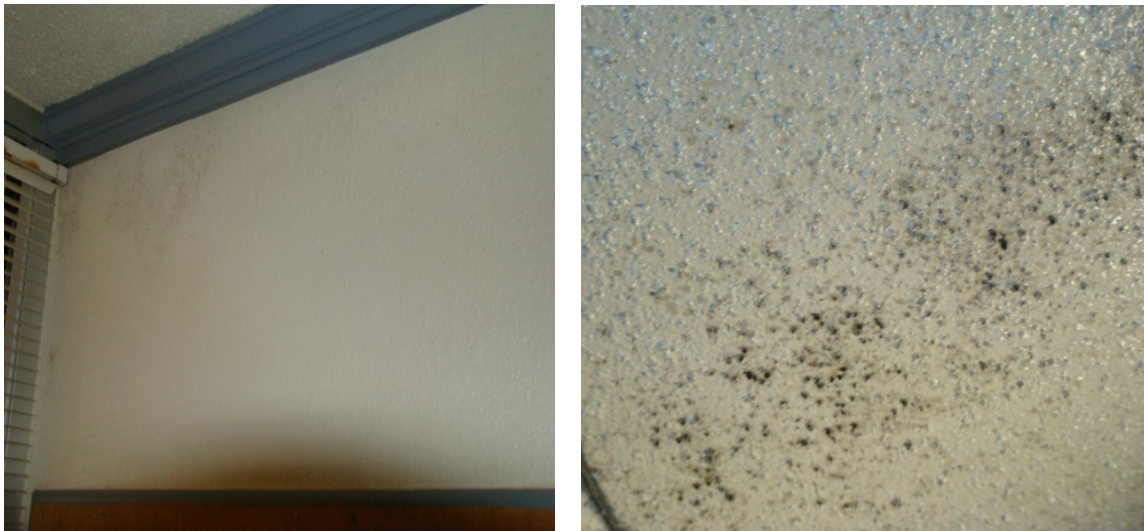
Figure 1. Mold in Fort Polk barracks on concrete block walls and concrete ceiling.

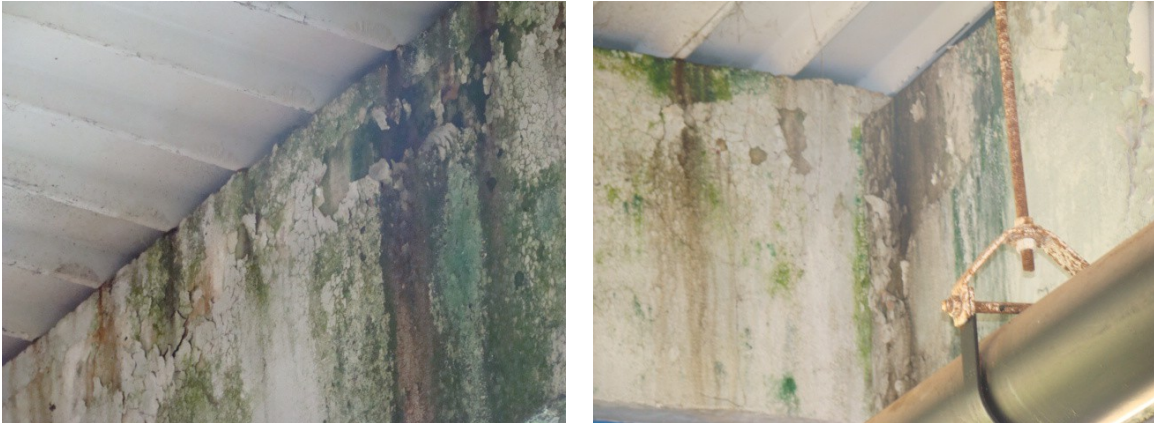
Figure 2. Mold in Fort Polk pumphouse with concrete block walls.

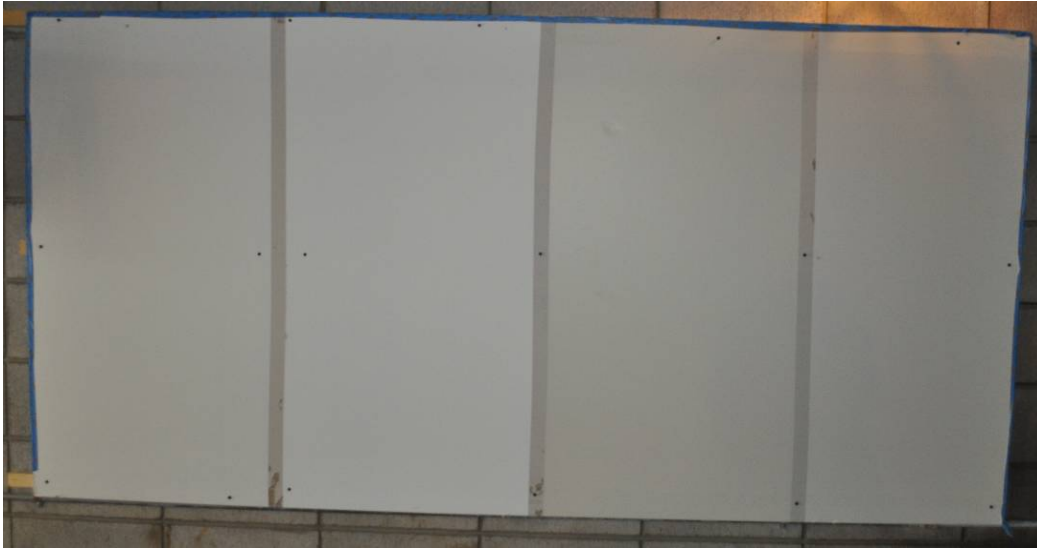
Mechanical room test panels. None of the test panels in the mechanical room showed any signs of mold or mildew in this inspection (Figure 9).

Figure 9. Test panels in the mechanical room after 4 months.

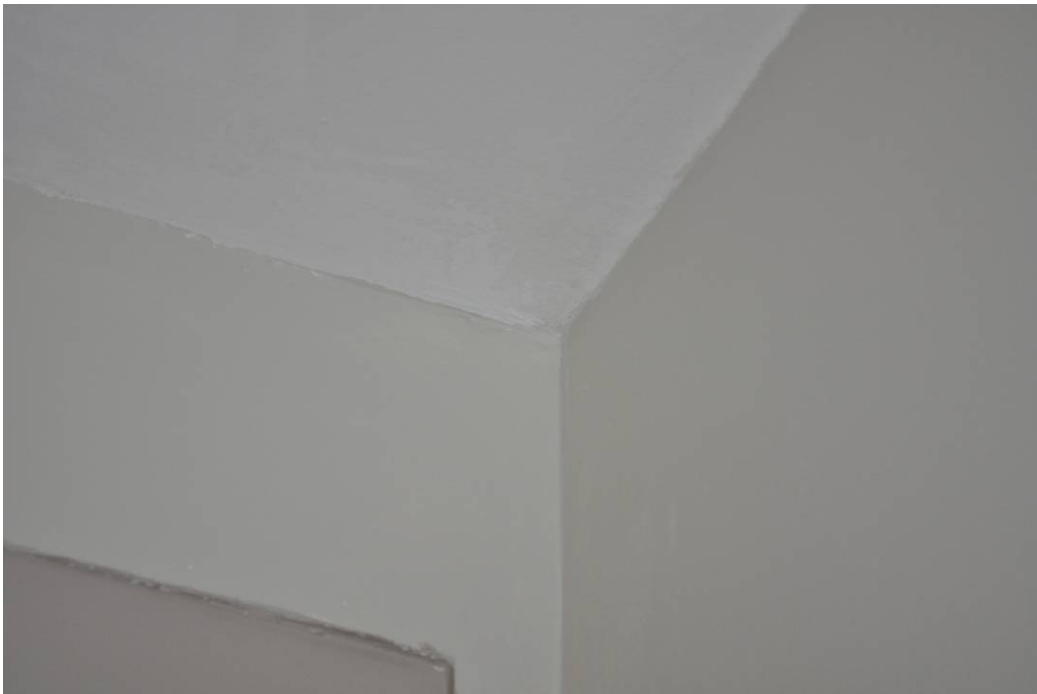
Room 4 – Foster 40-20. Noting the addition of a new HVAC system and repainting of most test surfaces, the inspection found no signs of mold or mildew on the ceiling. The repainted walls also showed no signs of mold or mildew (Figure 10 and Figure 11).

Figure 10. Walls in Room 4 coated with an unknown coating, and ceiling coated with Foster 40-20 after 4 months.

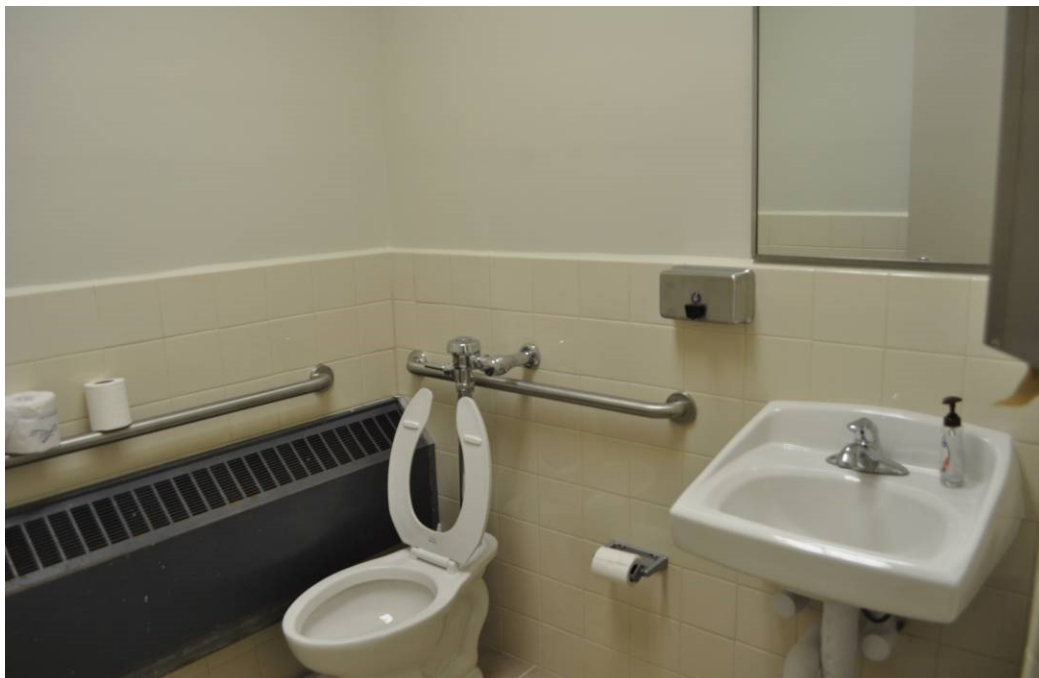
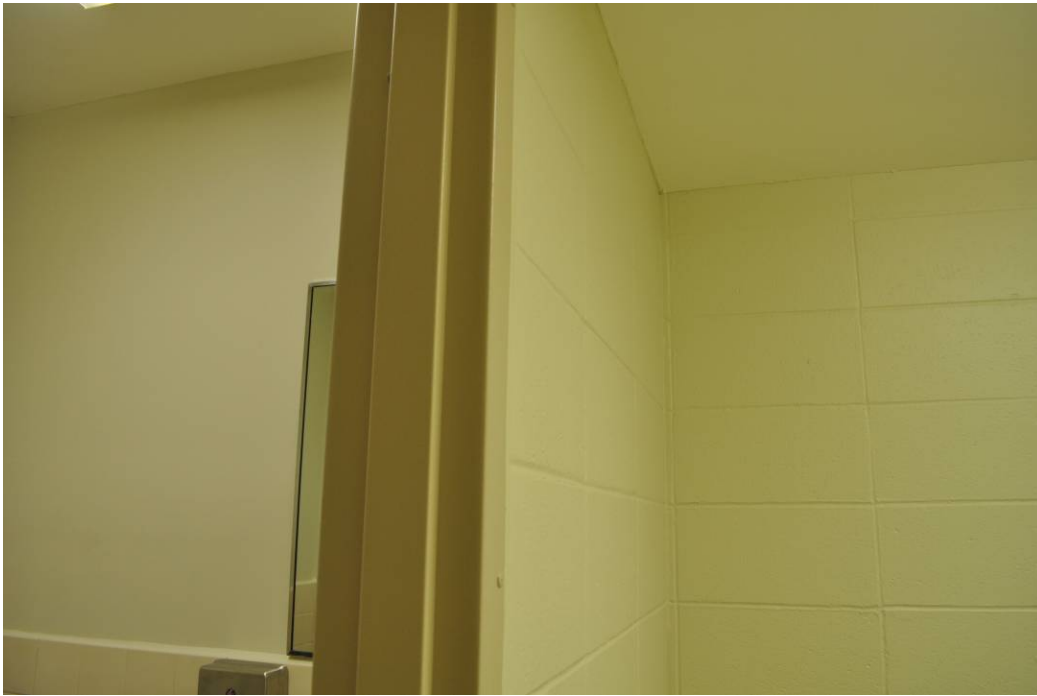
Room 9 – Caliwel with BNA. Under the conditions noted above, the washroom by Room 9 appeared to be unaffected by any mold or mildew growth (Figure 12 and Figure 13).

Figure 12. Washroom of Room 9 recoated with an unknown coating after 4 months.

Figure 13. Division of Room 9 with unknown coating in the washroom walls and Caliwel on the ceiling.

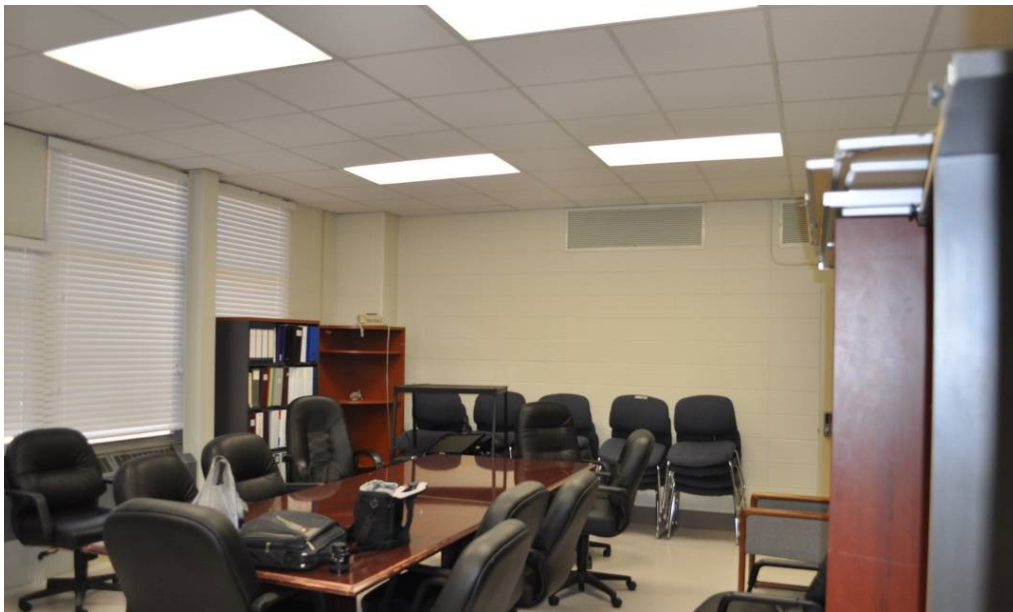
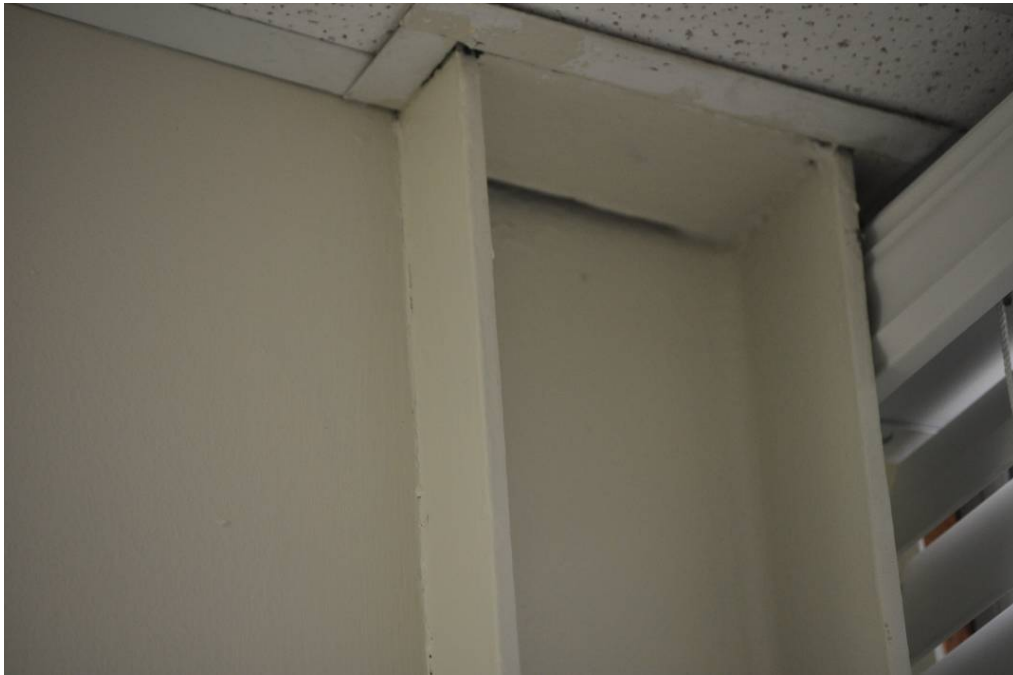
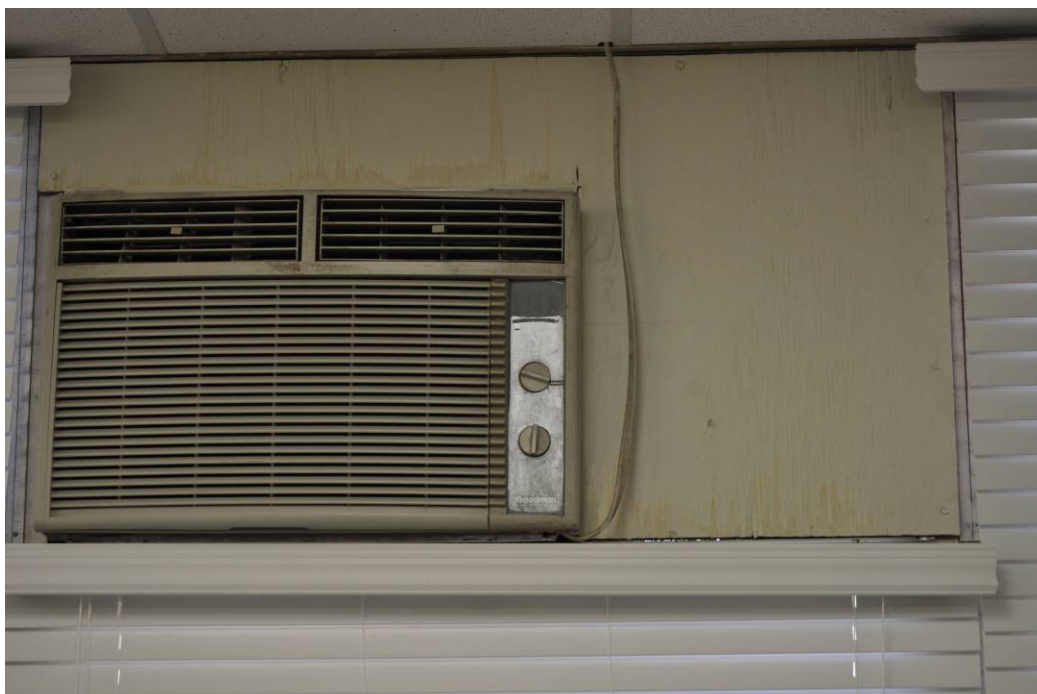
Room 11 – Hirshfield’s Platinum Ceramic. Room 11 showed no signs of mold or mildew other than stains found on the piece of plywood that frames a window air-conditioning unit. The stains appeared to be from exterior water intrusion. This area was specified for close monitoring during the follow-on inspections (Figure 14, Figure 15, and Figure 16).

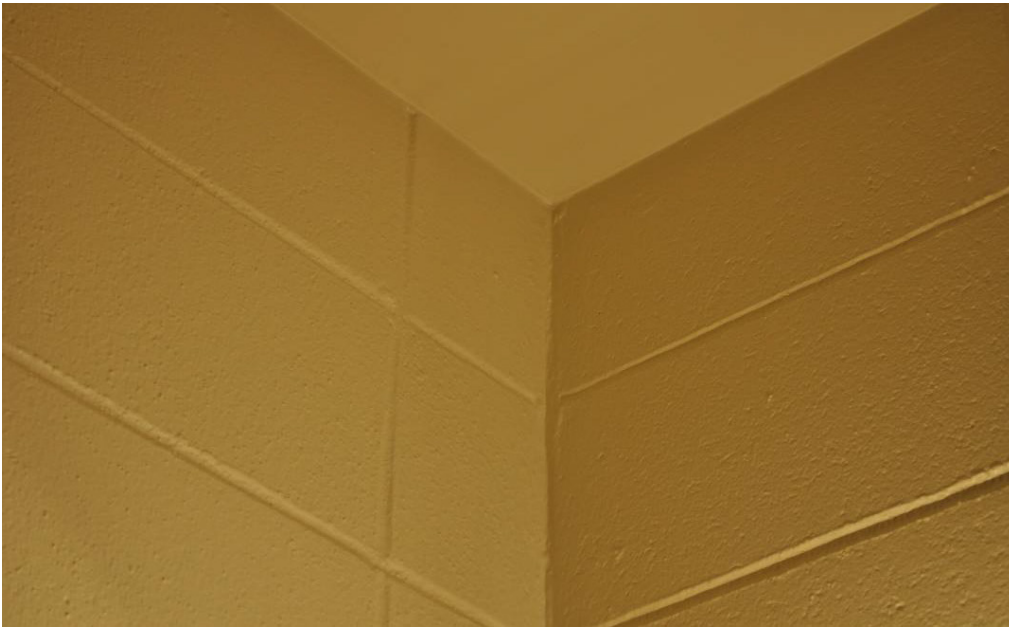
Room 14, adjacent washroom – Sherwin William ProMar 200 (control).
The washroom next to Room 14 showed no signs of mold or mildew. The room was originally coated from floor to ceiling, but tile had been installed

halfway up the side walls, including around the sink and toilet areas, after coating application (Figure 17, Figure 18, and Figure 19).

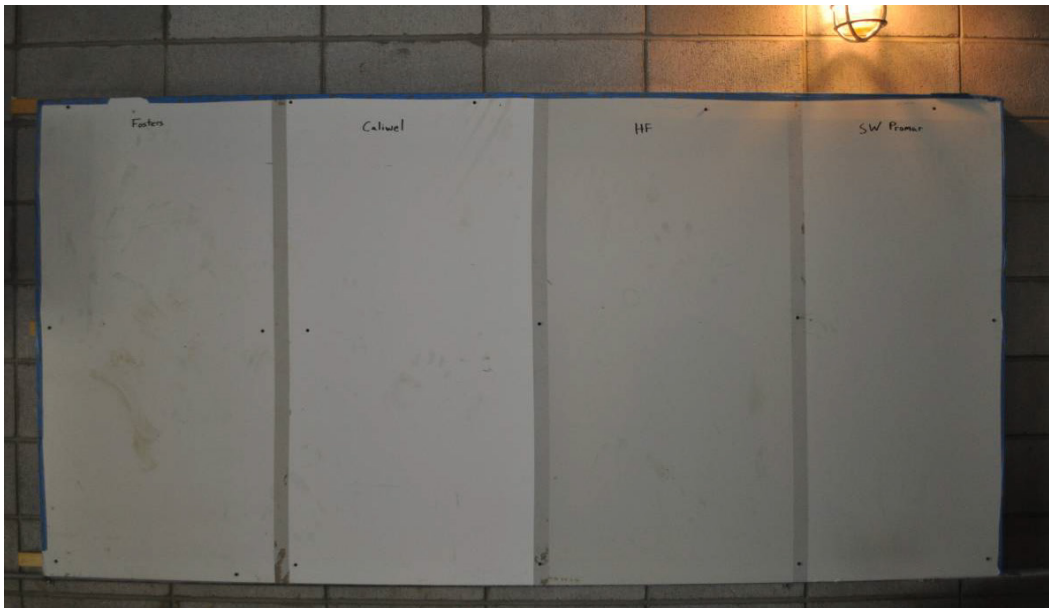
Mechanical room test panels. None of the test panels in the mechanical room showed any signs of mold or mildew (Figure 20). Handprints and residue had been left on the gypsum test panel. The condition inside the room continued to be less humid than previously due to refurbishment of the building.

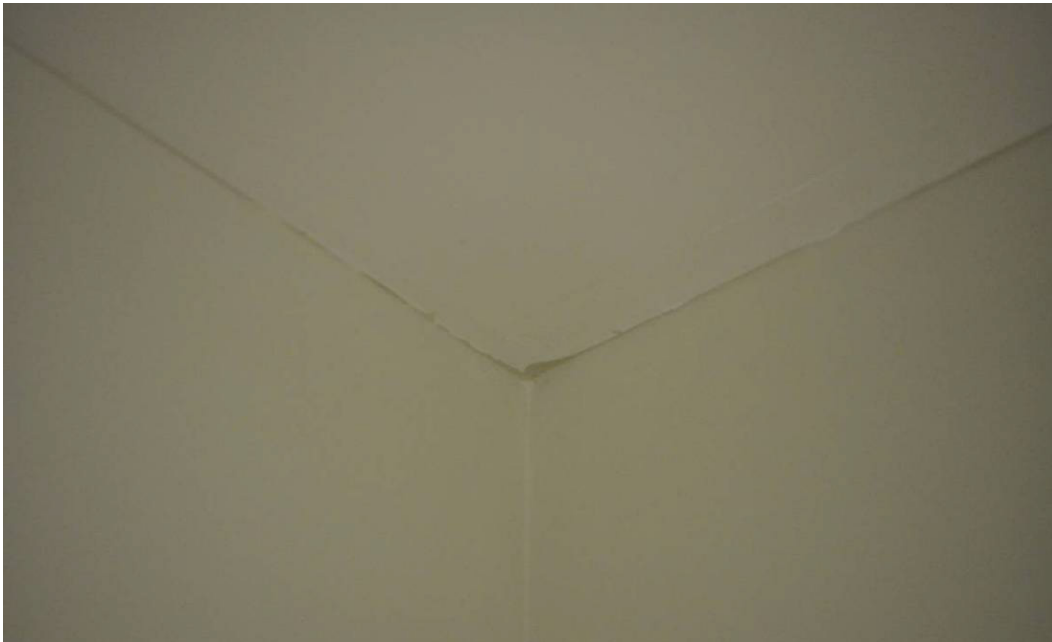
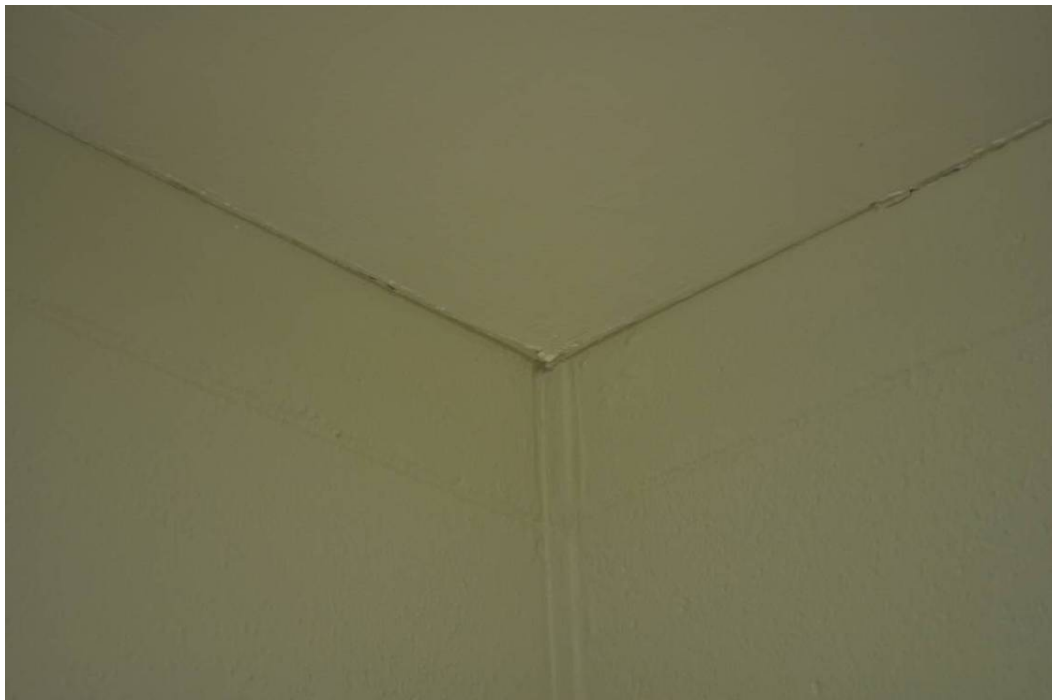
Room 9 – Caliwel with BNA. The demonstration coating on the ceiling showed no signs of mold or mildew (Figure 23). The repainted walls, using an unknown coating, also showed no signs of mold or mildew (Figure 24).

Figure 23. Washroom of Room 9, after 8 months, with an unknown coating on the block walls. Caliwel is still present on the ceiling.

Figure 24. Washroom of Room 9, after 8 months, with unknown coating on the block walls. Caliwel is still present on the ceiling.

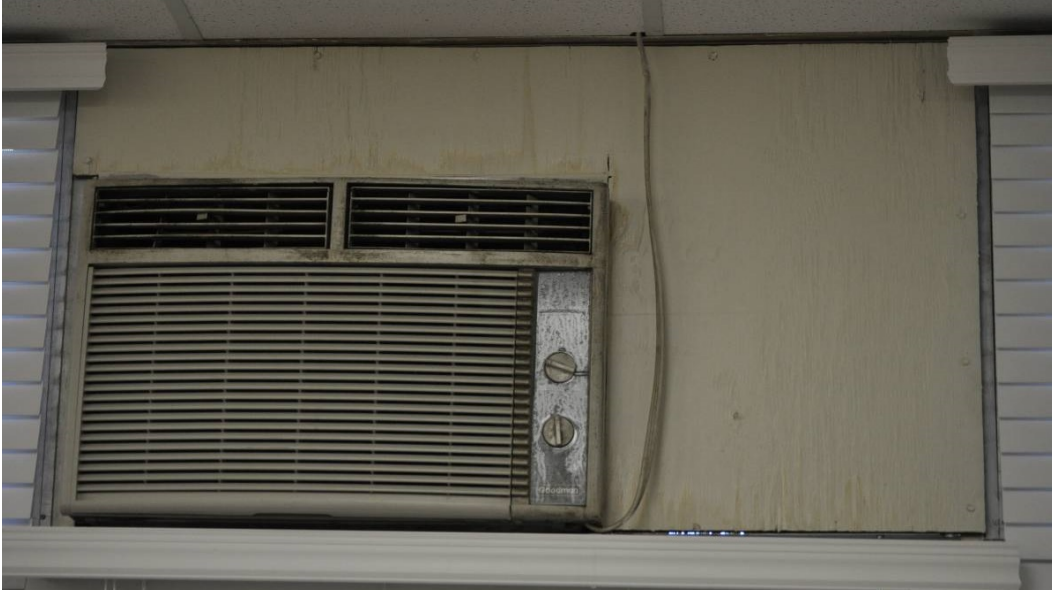
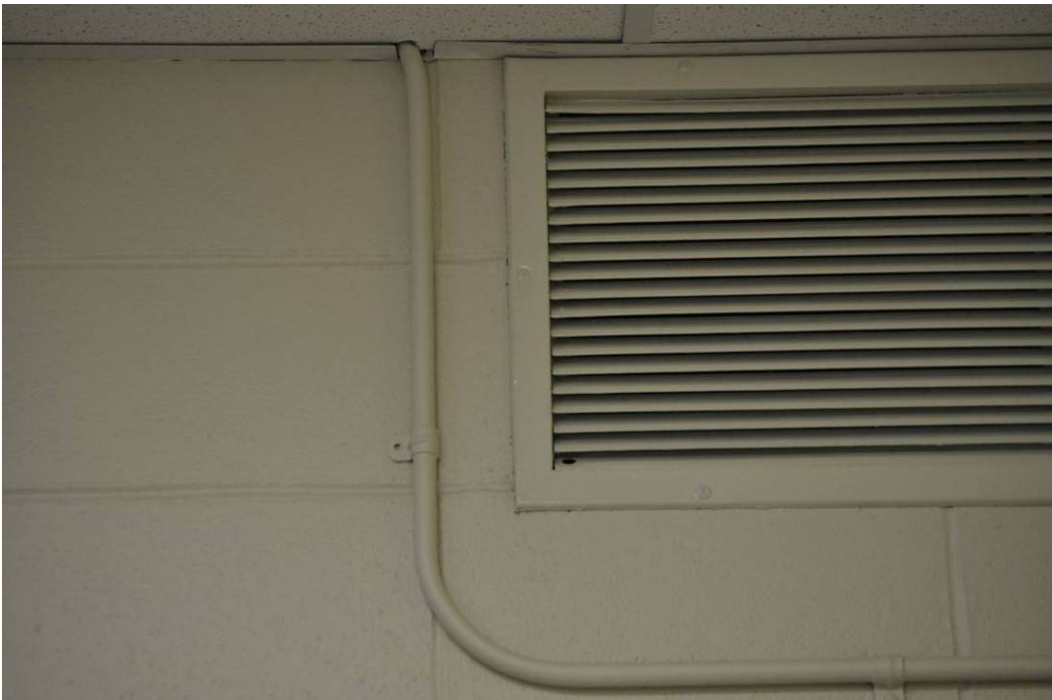
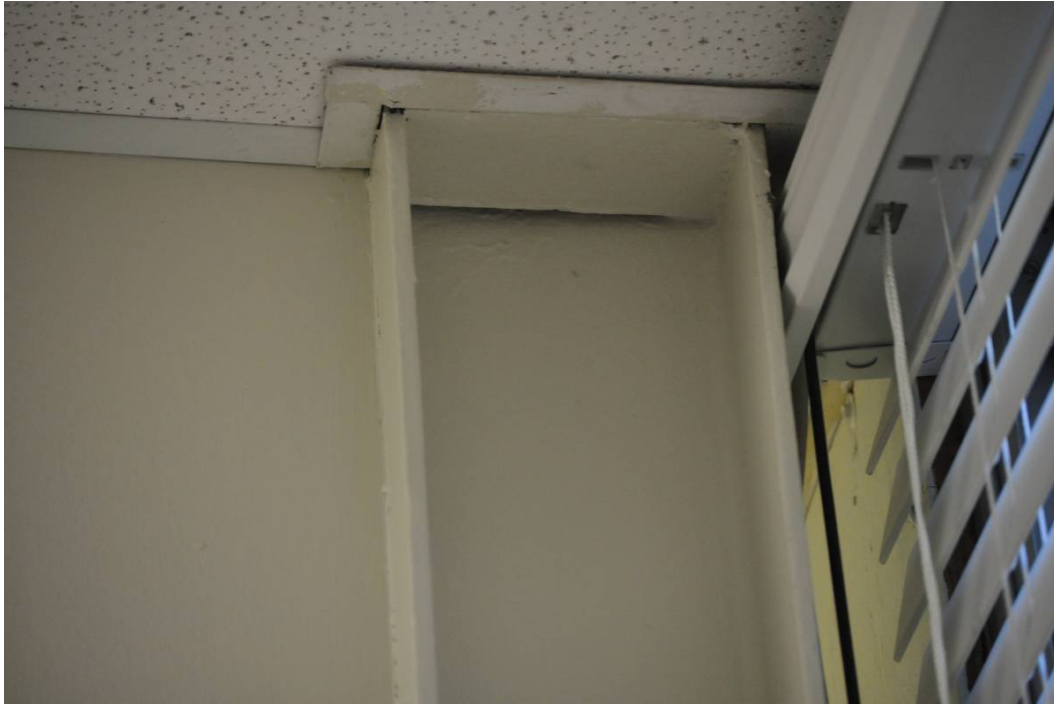
Room 11 – Hirshfield’s Platinum Ceramic. Room 11 showed no signs of mold or mildew other than the stains found on the piece of plywood that surrounds a window air-conditioning unit (Figure 25). The stains appeared to be from exterior water intrusion. There were no additional signs of mold or mildew since the previous inspection (Figure 26 and Figure 27).

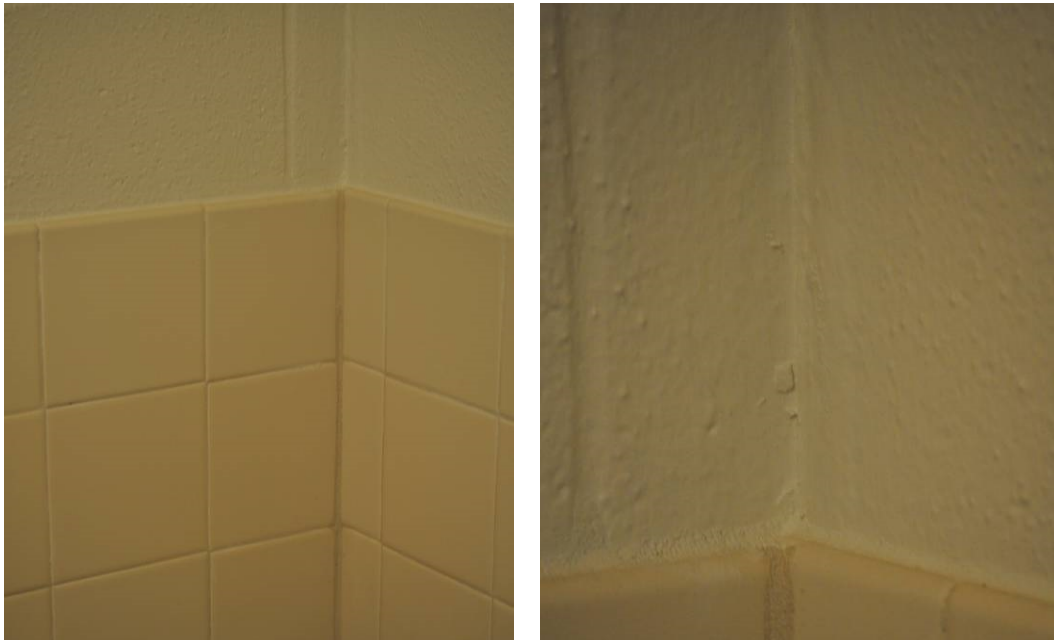
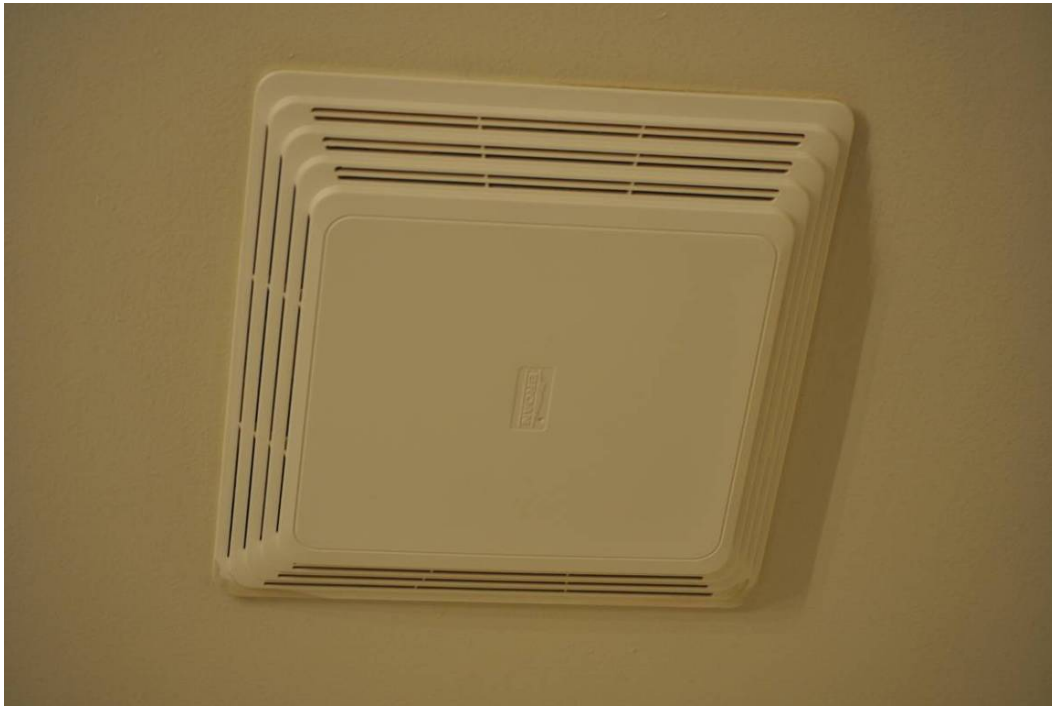
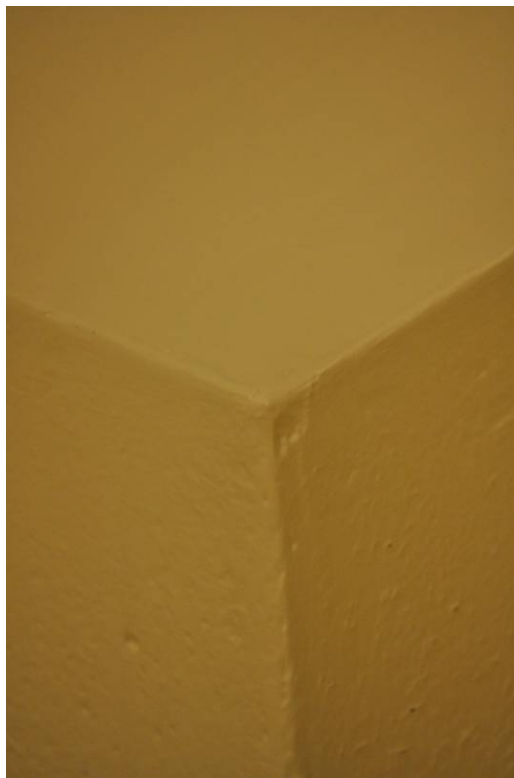
Room 14, adjacent washroom – Sherwin William ProMar 200 (control).
The washroom next to Room 14 showed no signs of mold or mildew (Figure 28, Figure 29, and Figure 30).

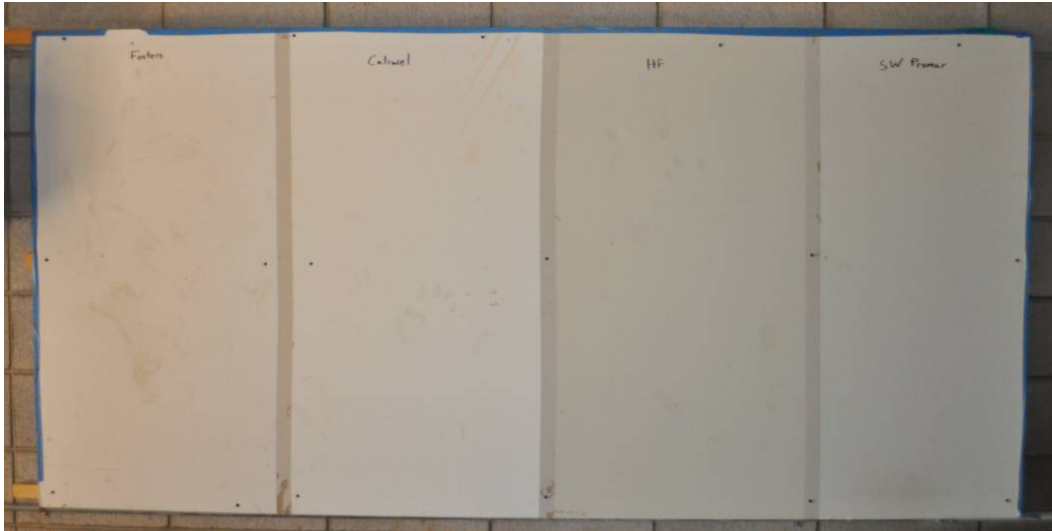
Mechanical room test panels. None of the test panels in the mechanical room showed any signs of mold or mildew (Figure 31). All standing water that was present in the beginning of the test period dried up and did not reoccur. Humidity remained significantly lower than before renovations.

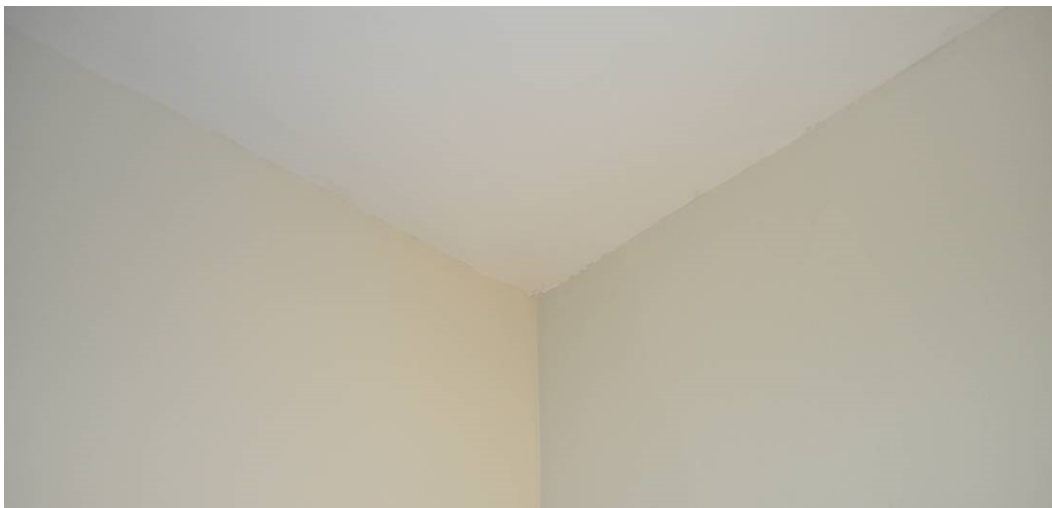
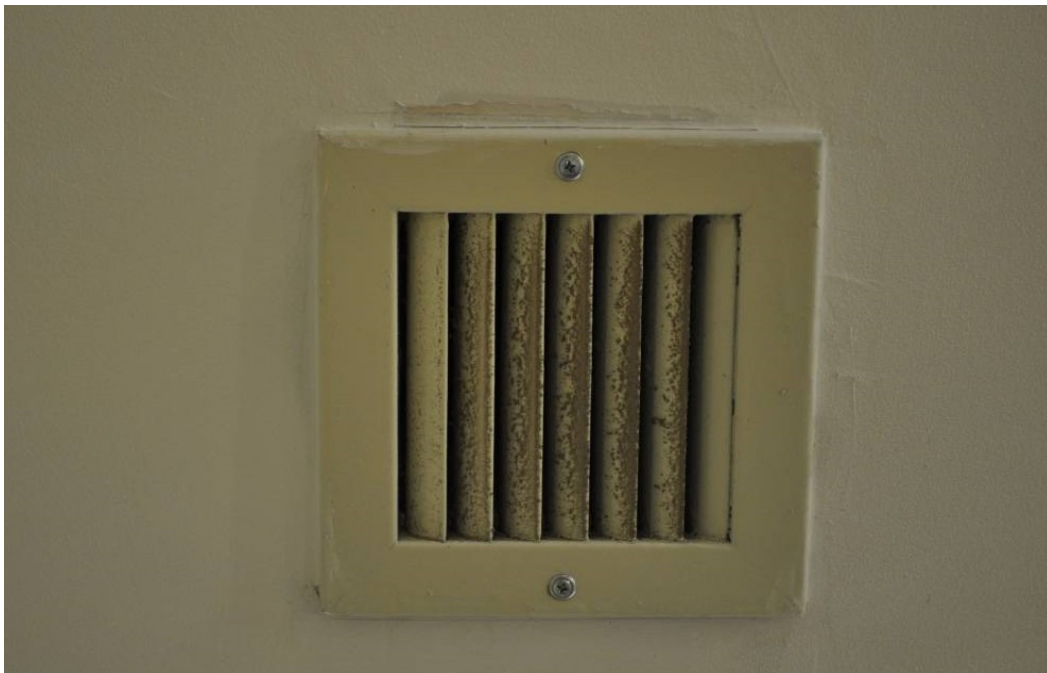
Room 4 – Foster 40-20. There were no signs of mold or mildew on the ceiling (Figure 32 and Figure 33). The repainted walls (coating unknown) also showed no signs of mold or mildew.

Figure 33. Vent in Room 4 after 12 months; inspector noted that no mold was present.

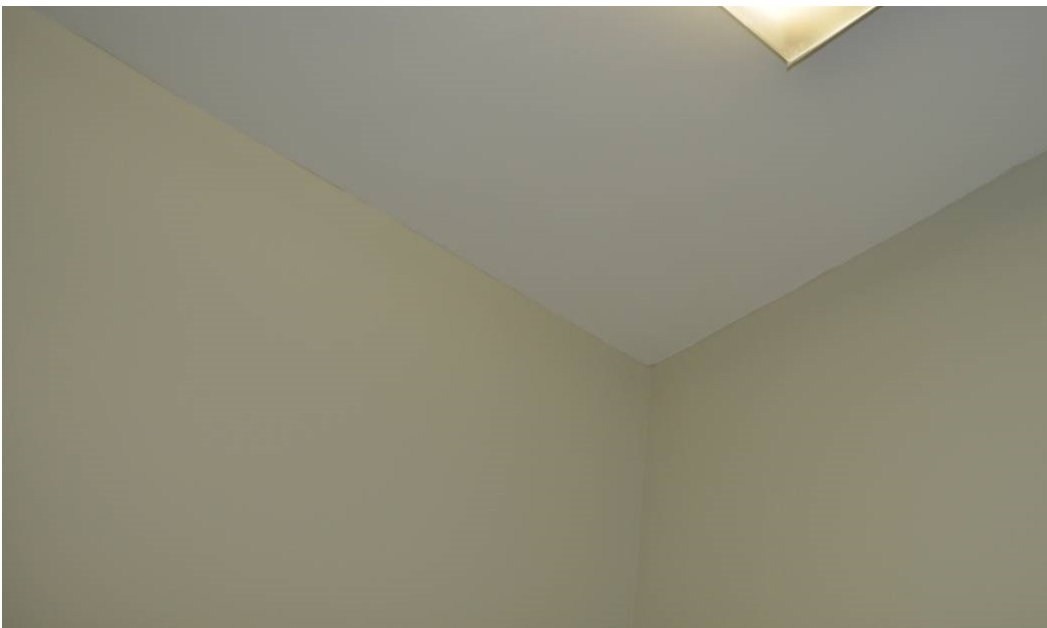
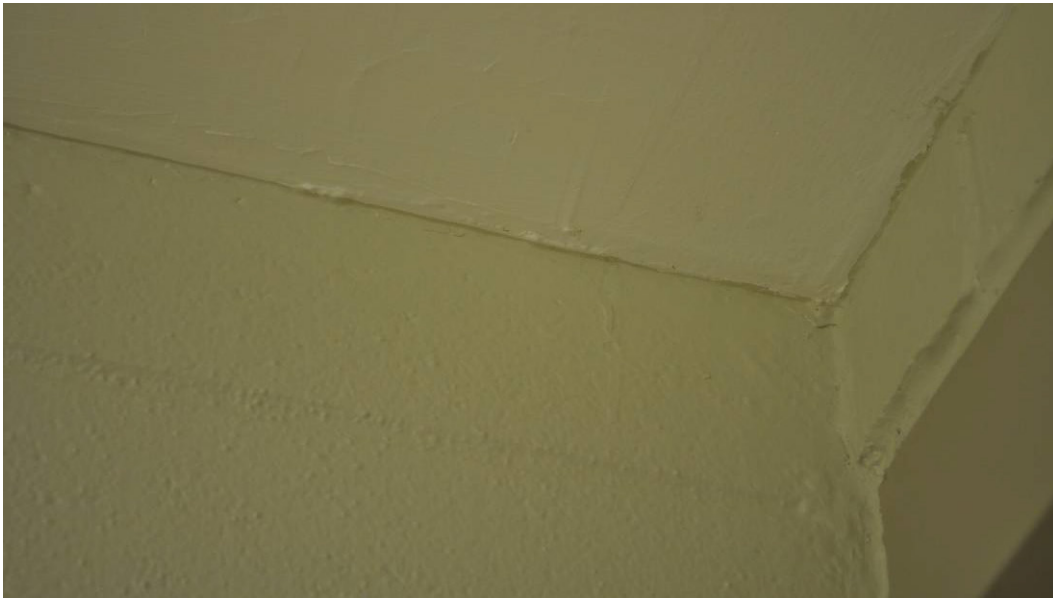
Room 9 – Caliwel with BNA. The ceilings continued to show no signs of mold or mildew. The repainted walls (coating unknown) also showed no signs of mold or mildew (Figure 34 and Figure 35).

Figure 34. Washroom of Room 9, recoated with an unknown coating, after 12 months.

Figure 35. Room 9 with unknown coating in the washroom and on the block walls, after 12 months.

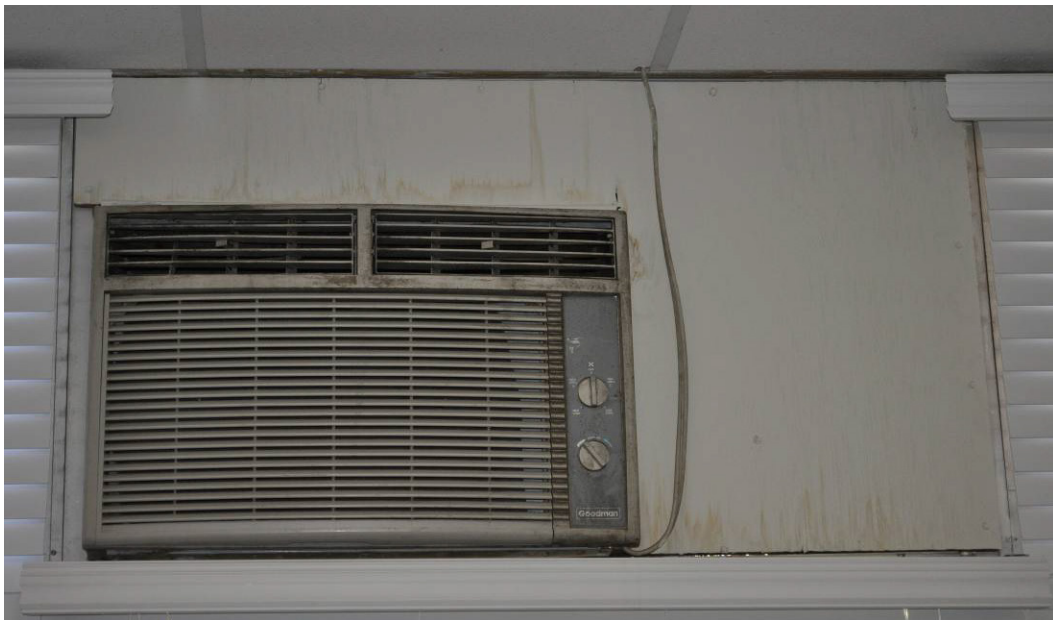
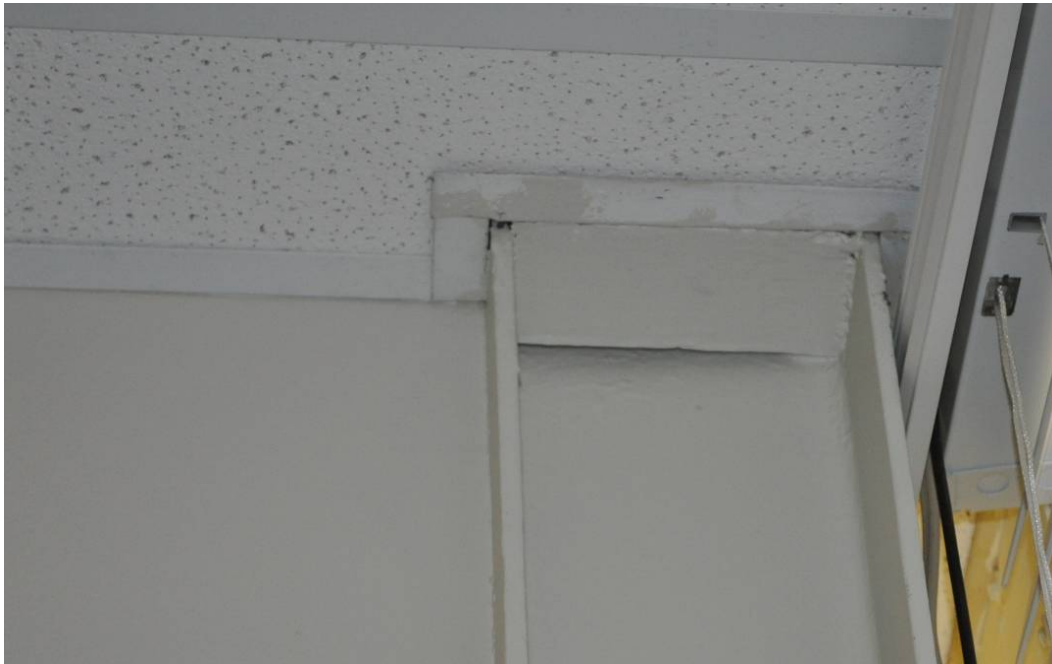
Room 11 – Hirshfield’s Platinum Ceramic. Room 11 showed no signs of mold or mildew other than the stains found on the piece of plywood that surrounds a window air-conditioning unit. The stains appeared to be from exterior water intrusion (Figure 36). Mostly, there appeared to be no additional signs of mold, mildew, or water intrusion from the last inspection (Figure 37). However, an HVAC vent on the interior of the room had begun to show signs of mildew, as shown in Figure 38.

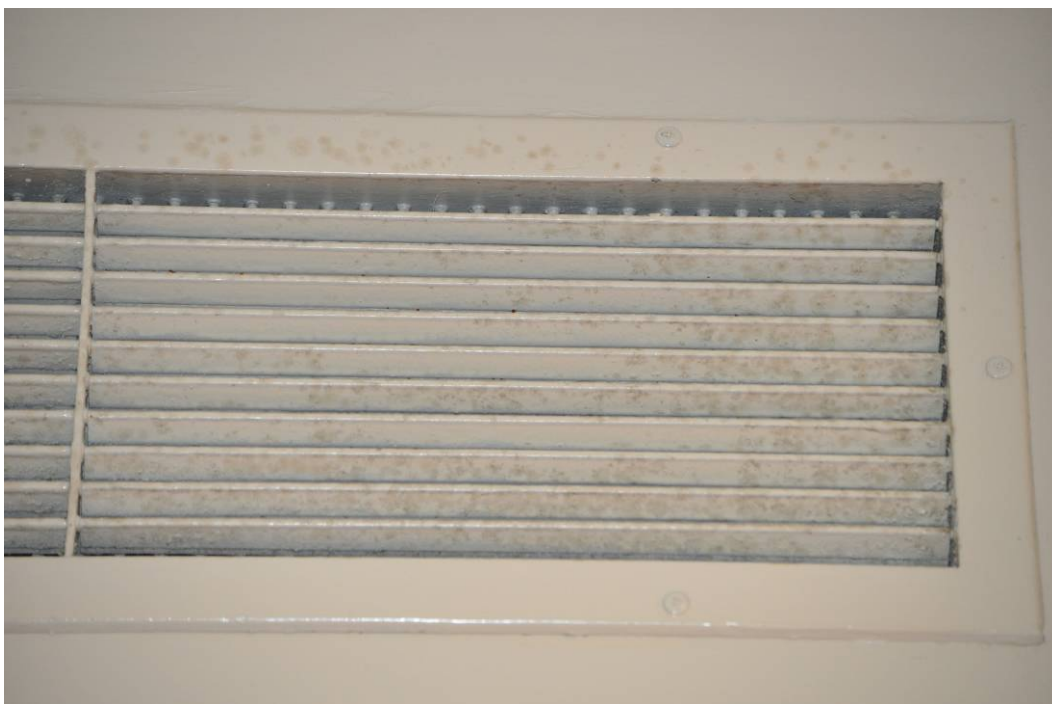
Figure 38. Air vent in Room 11, after 12 months.

Alternative 3. The Hirshfield's coating failed to prevent mildew growth on a metallic ceiling duct after 12 months of testing and therefore, it is not part of this analysis. This observation does not indicate a definite failure to perform, but rather, it is inconclusive because of the loss of experimental control.

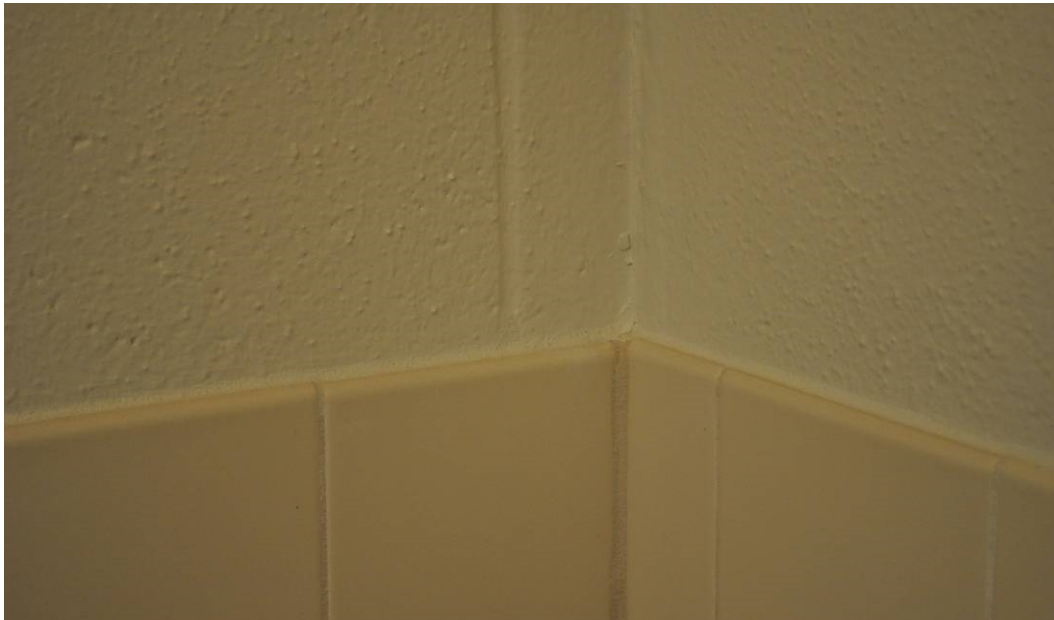
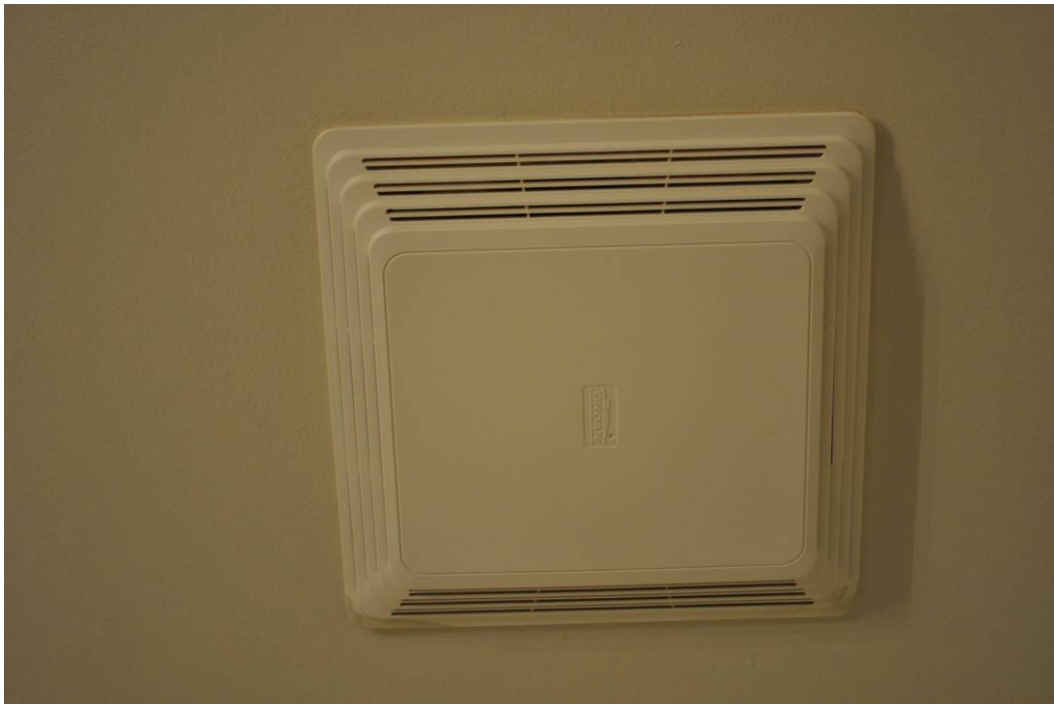
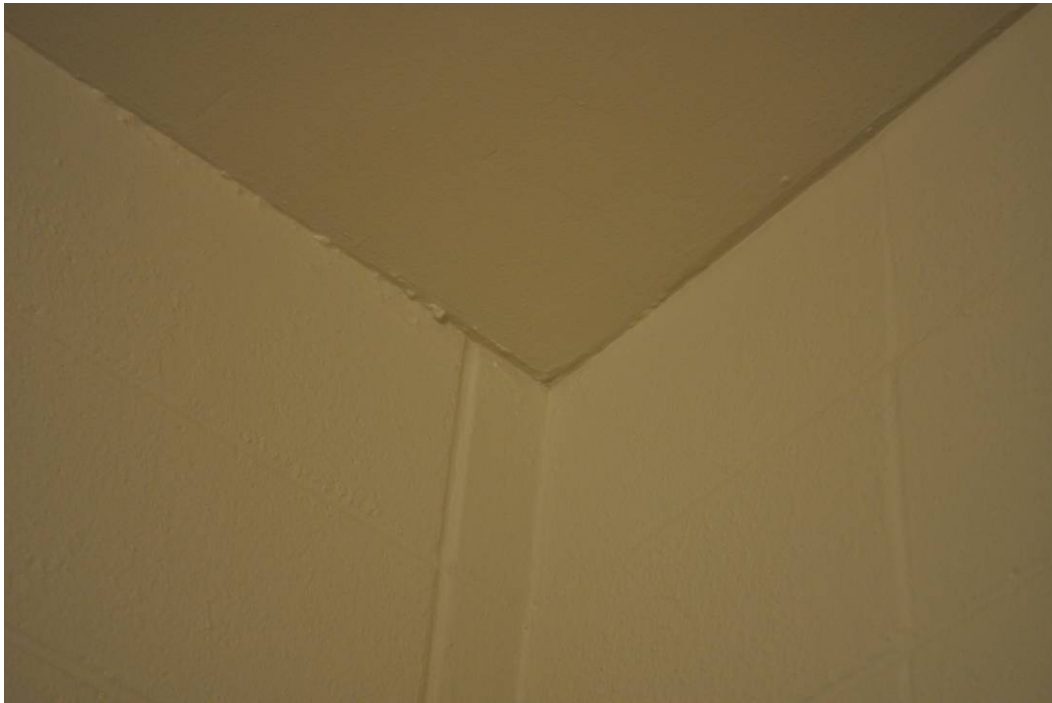
Room 14, adjacent washroom – Sherwin William ProMar 200 (control).
The washroom next to Room 14 shows no signs of mold or mildew (Figure 39, Figure 40, and Figure 41).
