**CAMP CENTURY REVISITED  
A PICTORIAL VIEW-JUNE 1969**

**Austin Kovacs**

**July 1970**

**CORPS OF ENGINEERS, U.S. ARMY  
COLD REGIONS RESEARCH AND ENGINEERING LABORATORY  
HANOVER, NEW HAMPSHIRE**

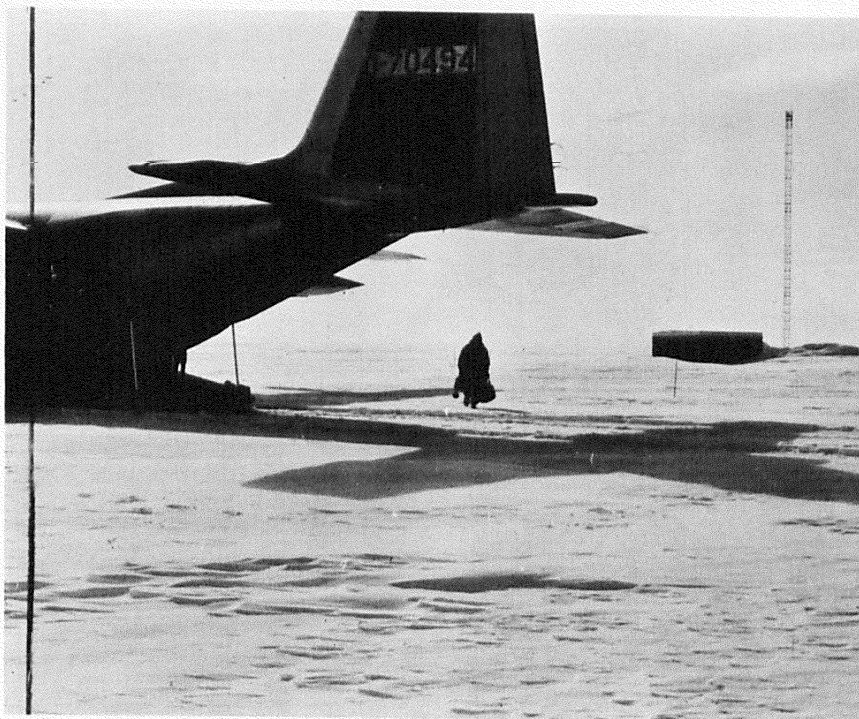
*Figure 3. Arrival day. The structure protruding above the snow surface was built in 1964 on piles and was at that time 12 ft above the surrounding snow surface (see Fig. 4). This facility was occupied by the 1967 and 1969 field parties. In the background is the Sig. Met Tower.*

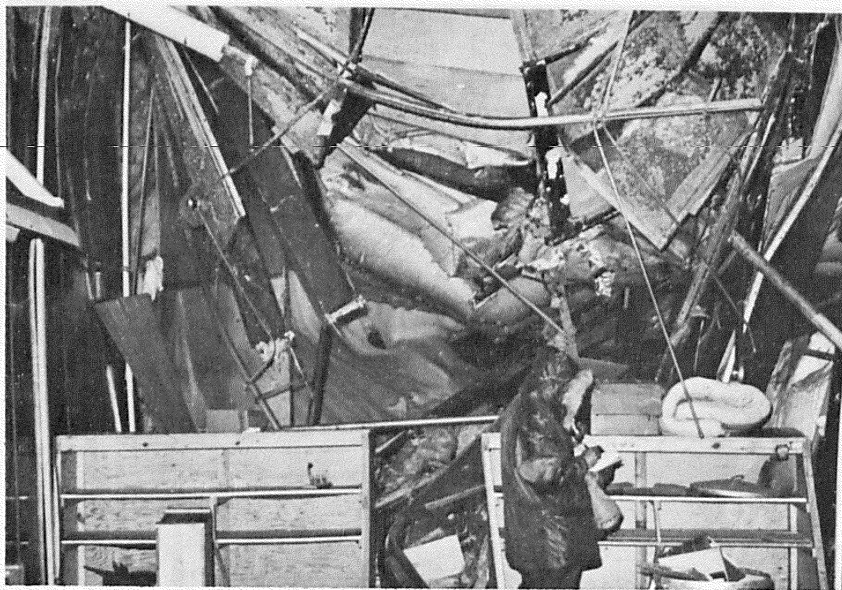
*Figure 17. Metal arch pushing through roof at west end of reactor building (Trench 5).*

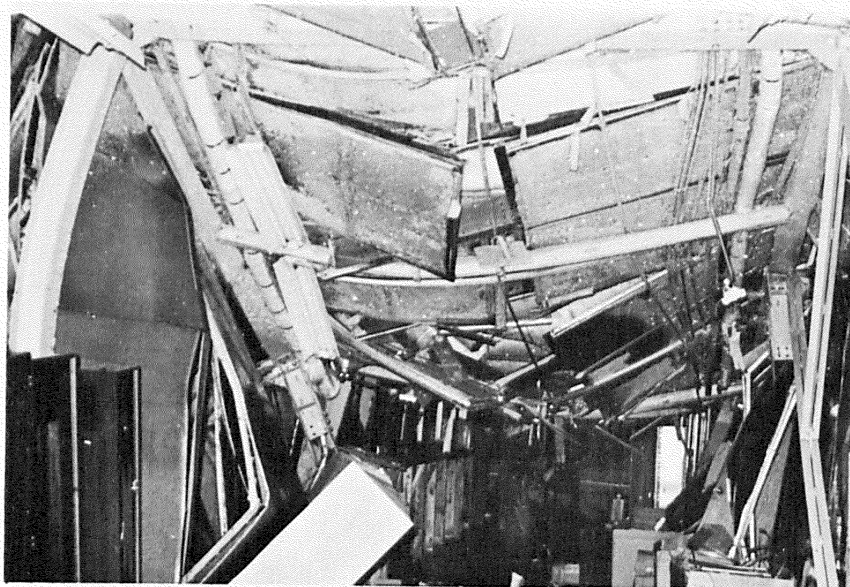
*Figure 18. Deterioration of reactor building (Trench 5).*

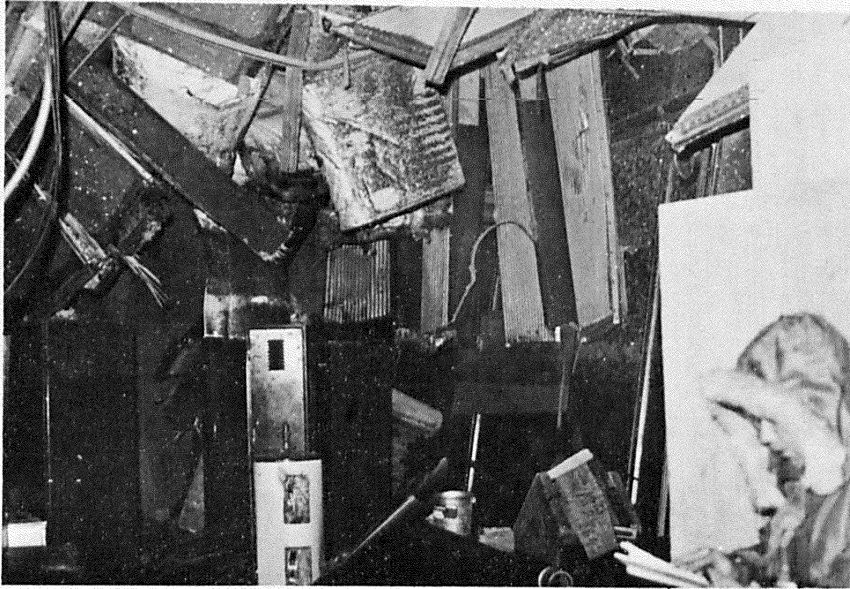
*Figure 19. Deterioration of reactor building (Trench 5).*

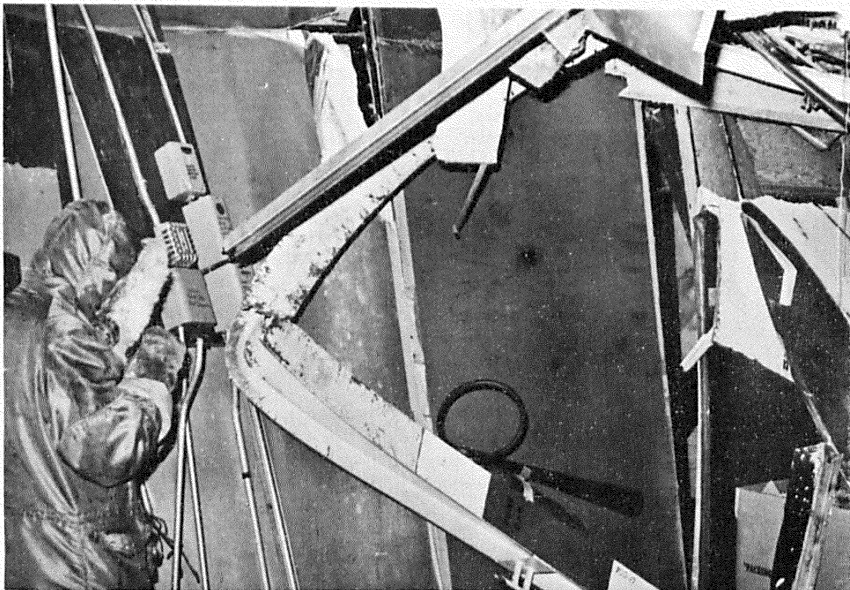
*Figure 20. Torn and twisted steel (Trench 5).*

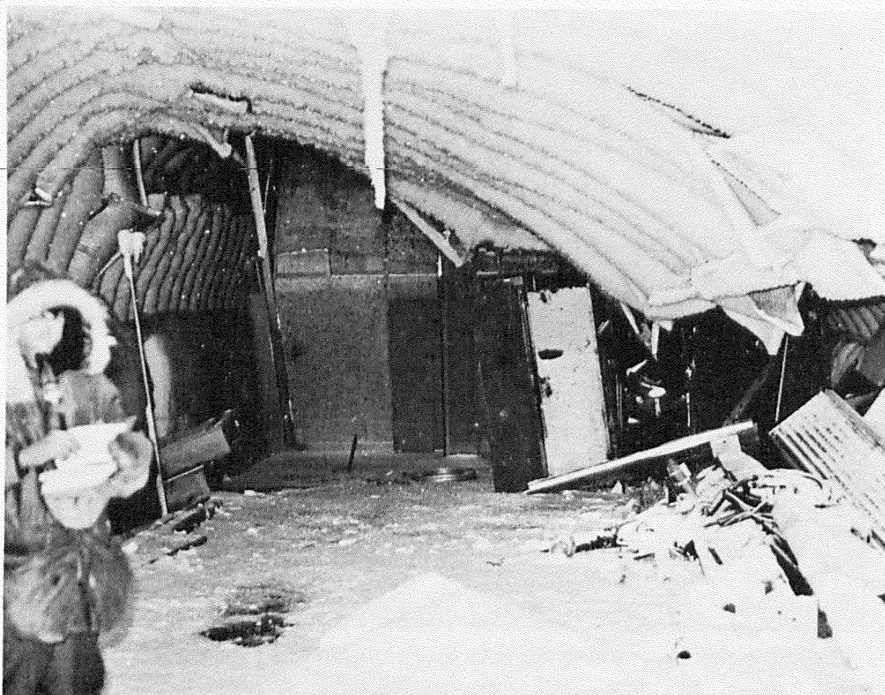
Figure 21. Metal arch buckling (Trench 5).

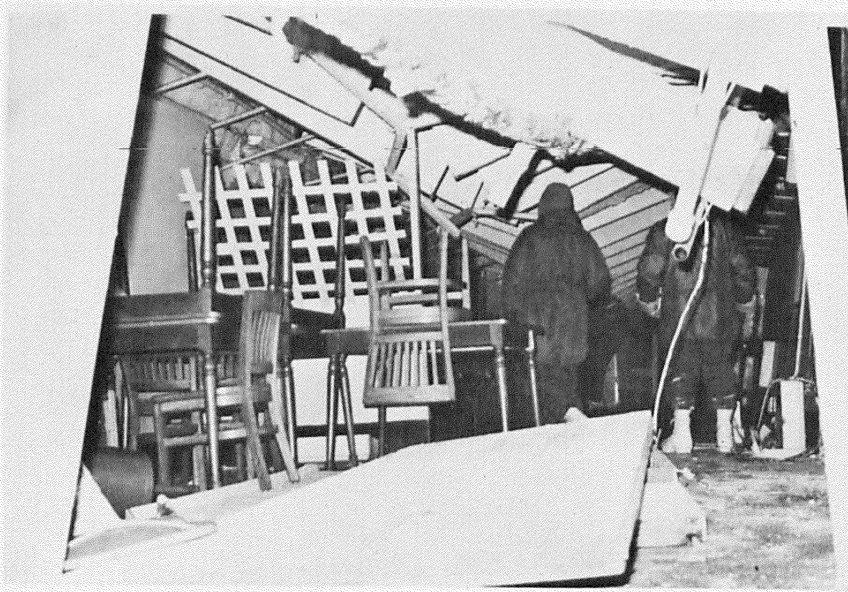
*Figure 24. Ceiling joists pushed downward by snow encroachment upon mess hall roof.*

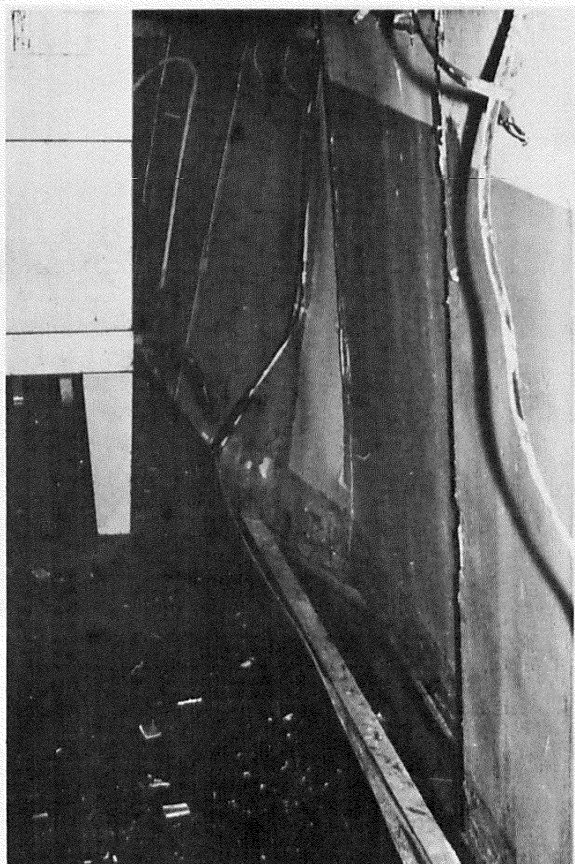
*Figure 26. Displacement of wall panels in mess hall.*

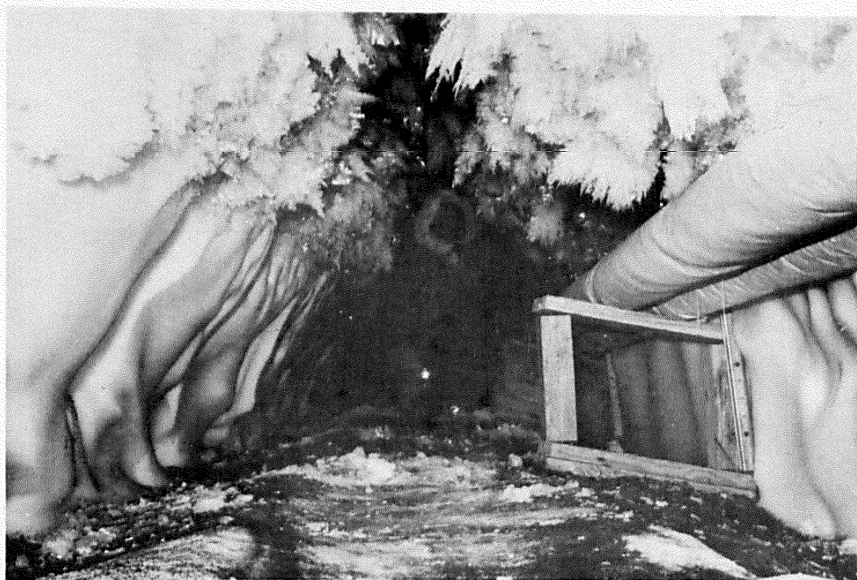
*Figure 29. Where a man could once walk upright, only a crawl space exists in the passageway to water well 2.*

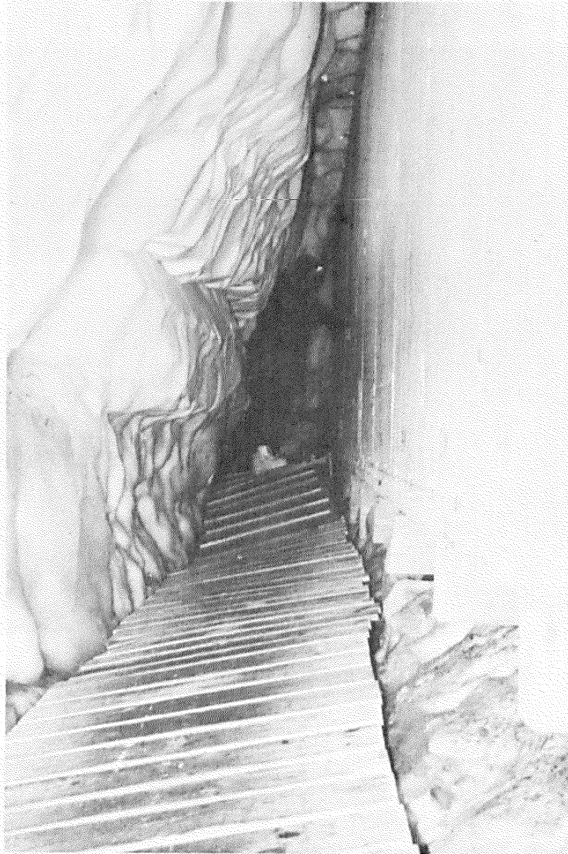
*Figure 35. Trench floor arching causes board walkway to tilt (Trench 7).*

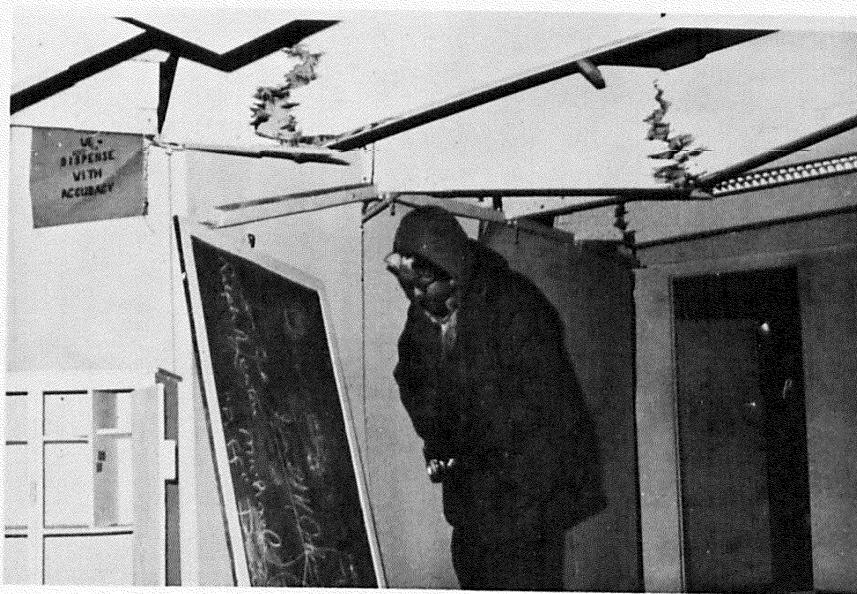
*Figure 37. Overloaded ceiling joists in dispensary.*

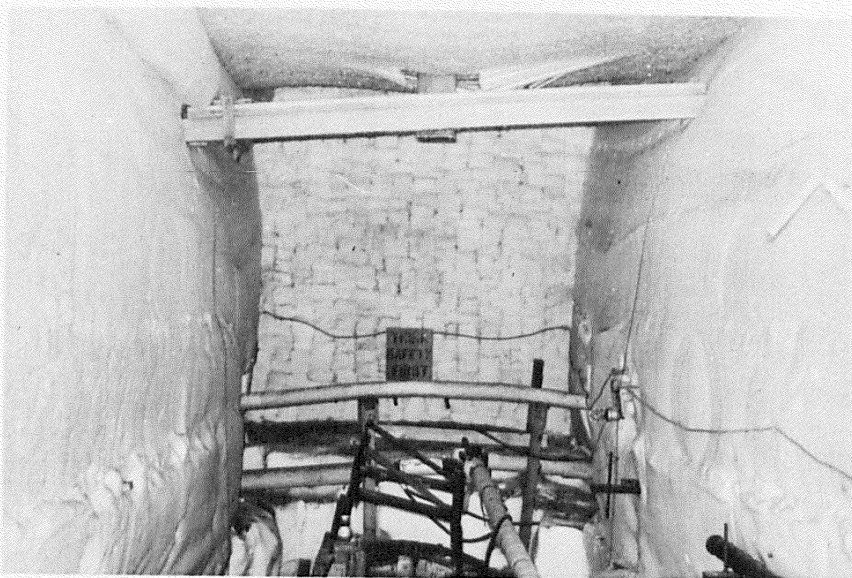
*Figure 39. Snow deformation in Trench 8 causes pipeline to buckle.*

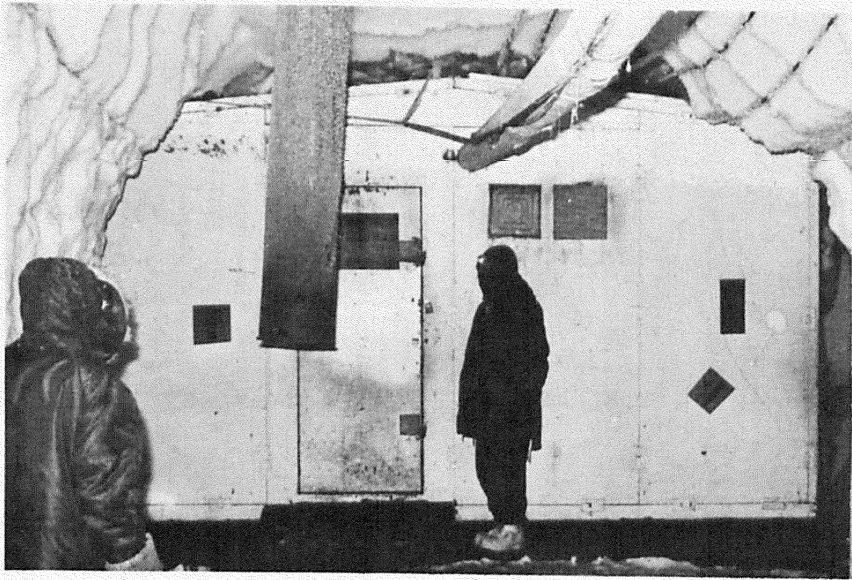
*Figure 41. Entrance to EM latrine (Trench 9). Note snow encroaching upon building.*

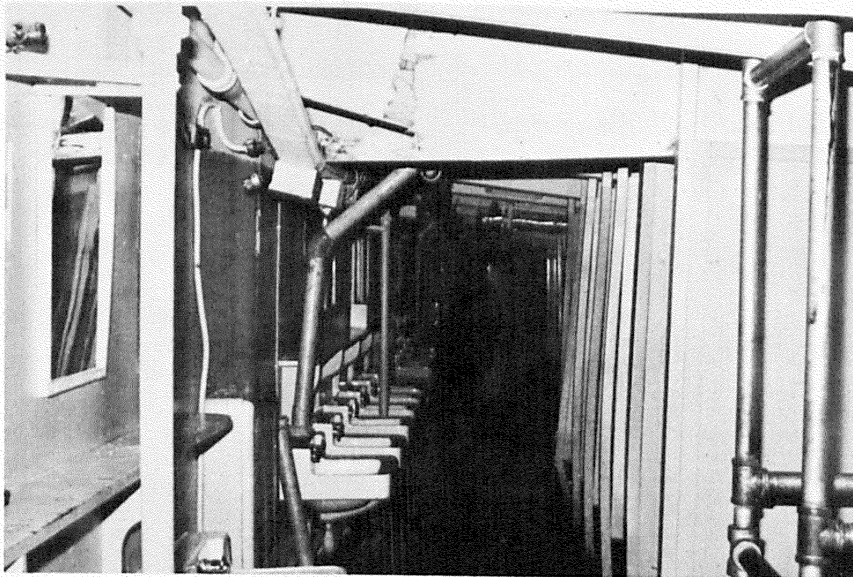
*Figure 42. Broken pipes and cracked ceiling joists (EM latrine).*

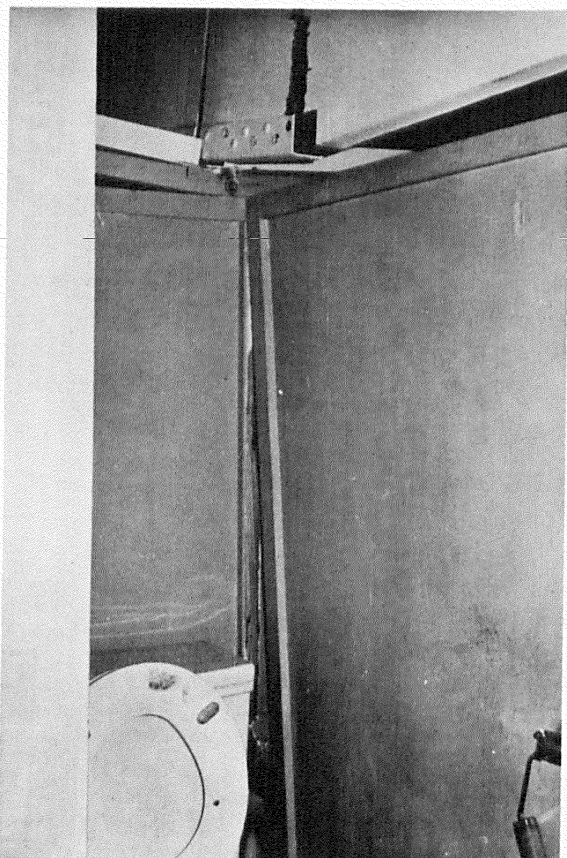
Figure 43. Ceiling and wall deterioration.

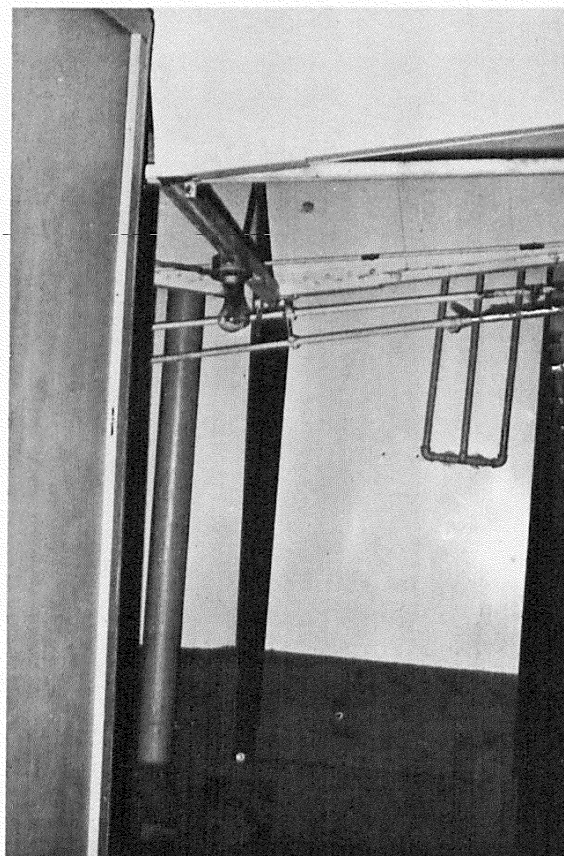
Figure 44. Roof deformation pushes shower stalls apart.

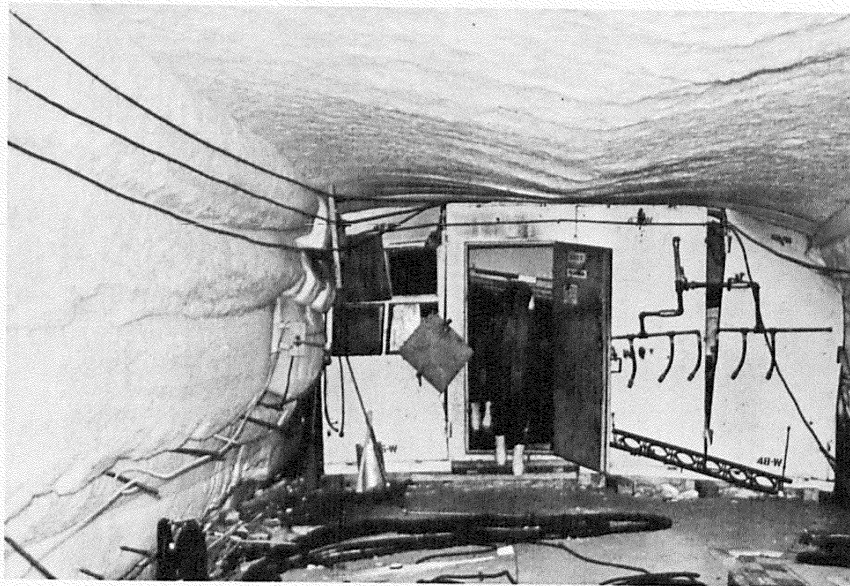
*Figure 52. Back entrance to R & U shop. Note displaced wall panels.*

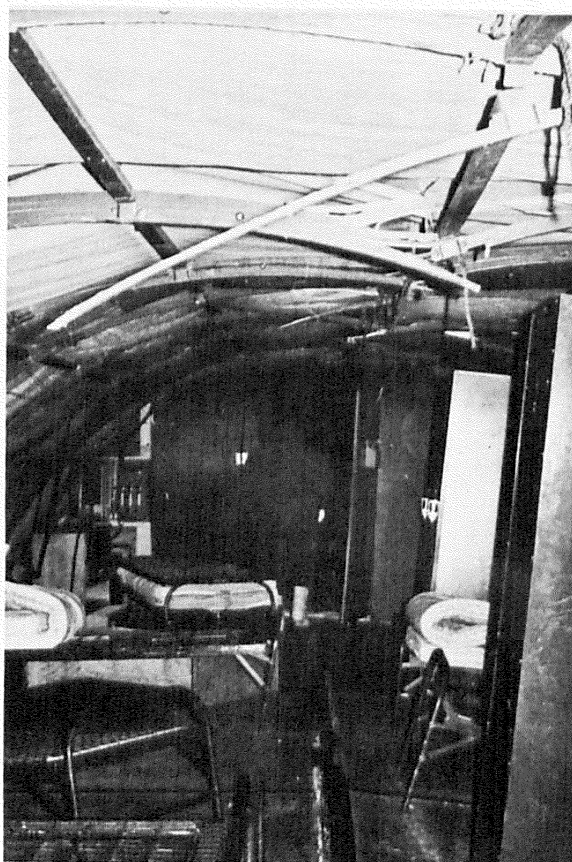
*Figure 53. Interior view of Jamesway, Trench 10.  
Note floor panel being displaced by effect of trench  
floor arching.*

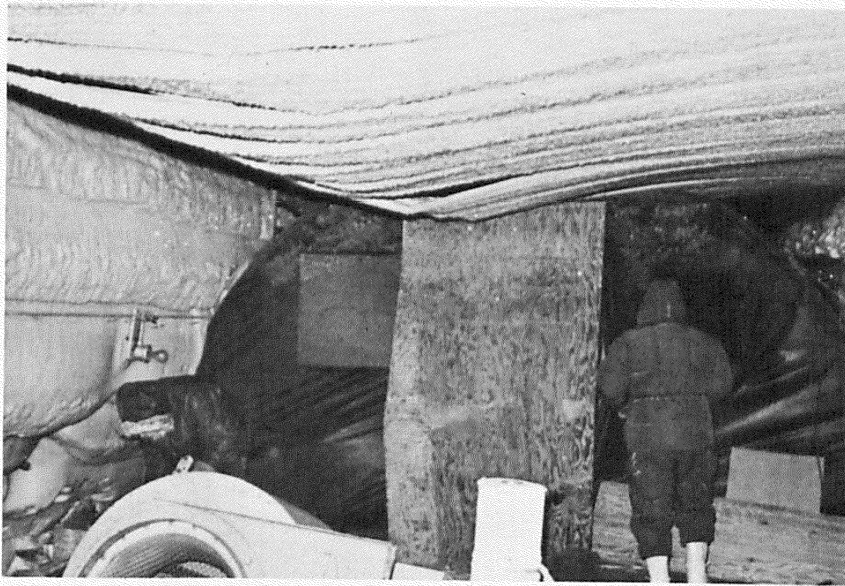
*Figure 54. Metal roof arch deformation and snow encroachment upon Jamesway (Trench 10).*

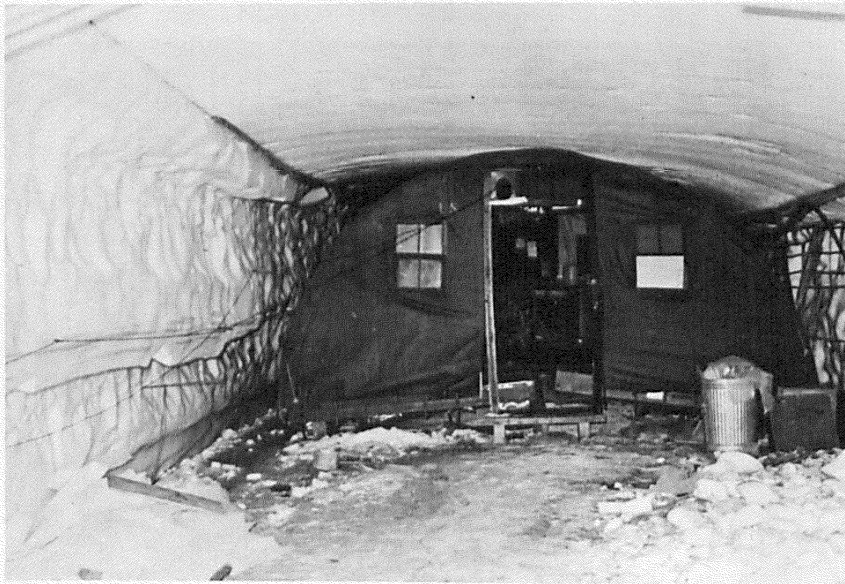
*Figure 58. Jamesway Lab. Note effect of trench floor arching on Jamesway floor panels.*

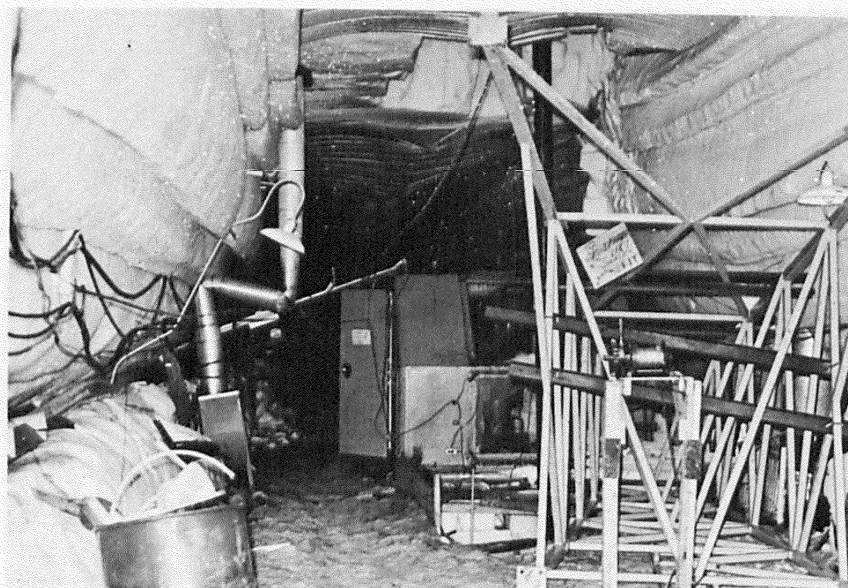
*Figure 64. Drill rig and tower. Note kink in stack as a result of ceiling and snow subsidence.*

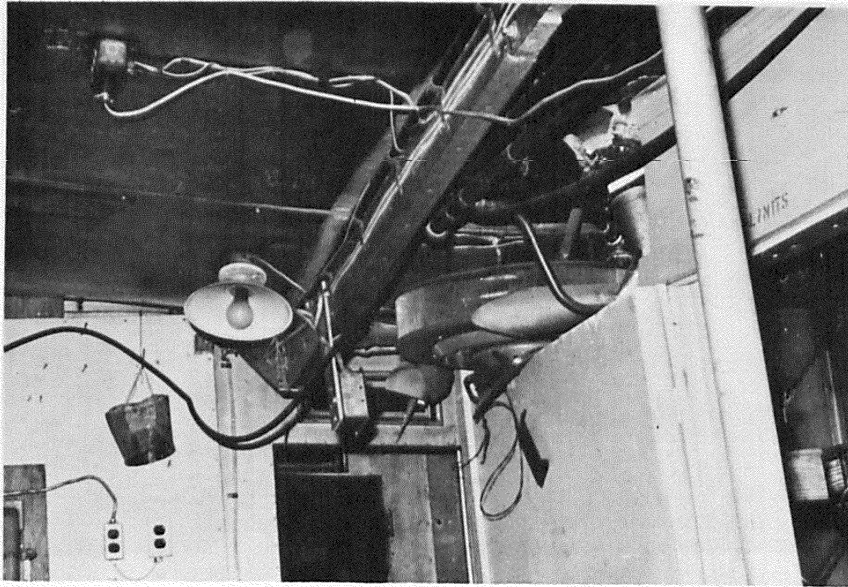
*Figure 66. Snow loading of workshop ceiling has caused carrying beam to fracture and heating fan housing to be pushed into partition.*

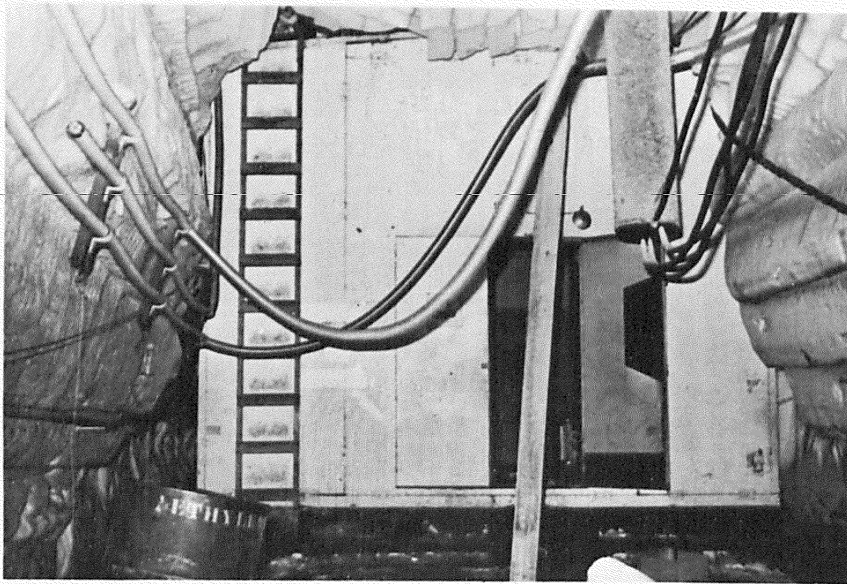
*Figure 68. Snow encroaching on standby generator building.*

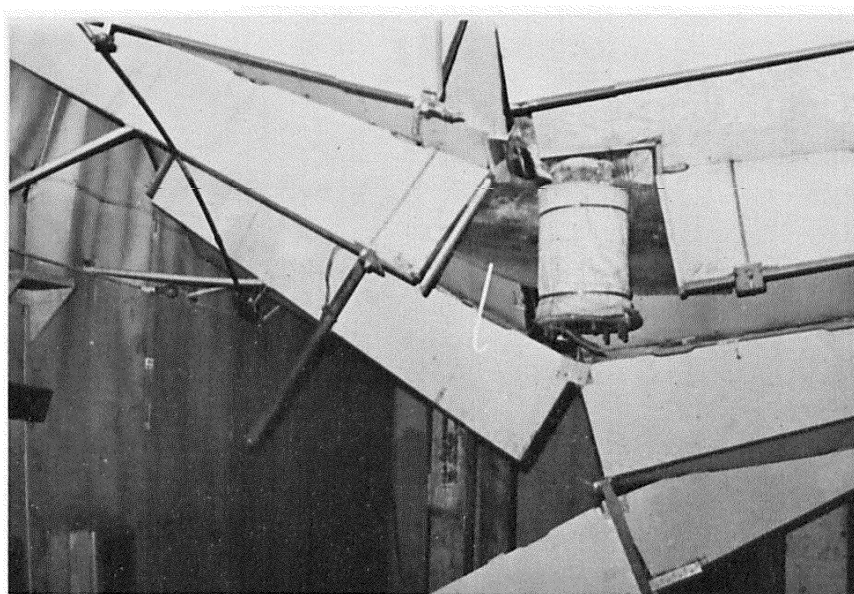
Figure 69. Effect of snow on truss ceiling Trench 15.

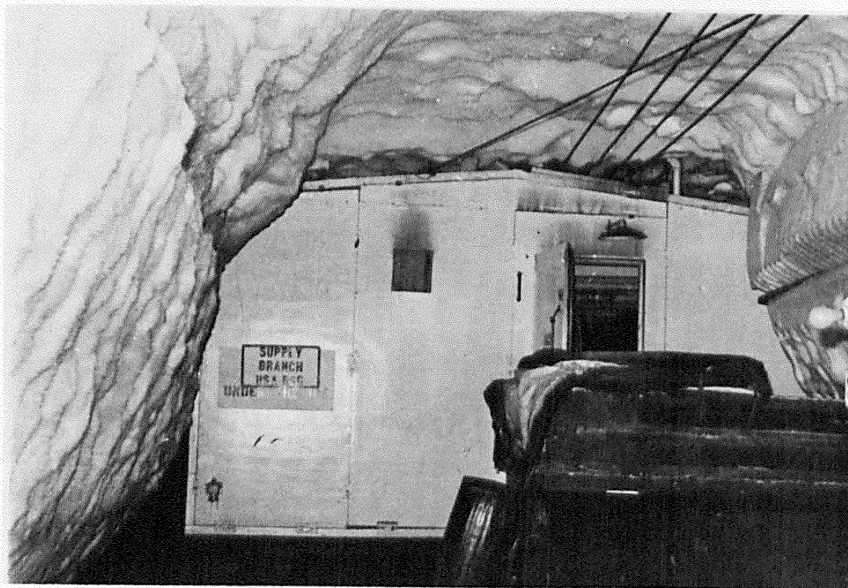
Figure 72. Snow load on roof and walls causes T-5 end wall panels to pull apart.

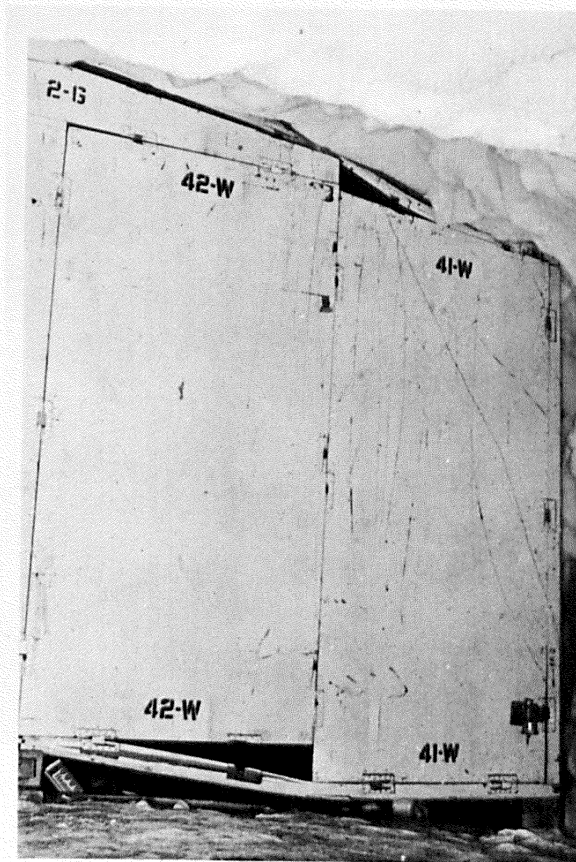
Figure 74. End wall deterioration of T-5 quarters (Trench 16).

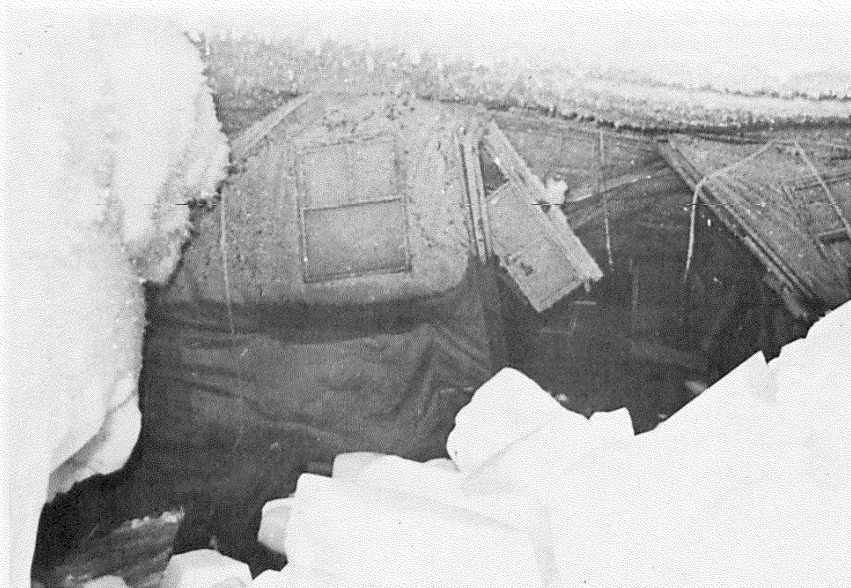
*Figure 75. Effect of snow load on Jamesway (Trench 16).*

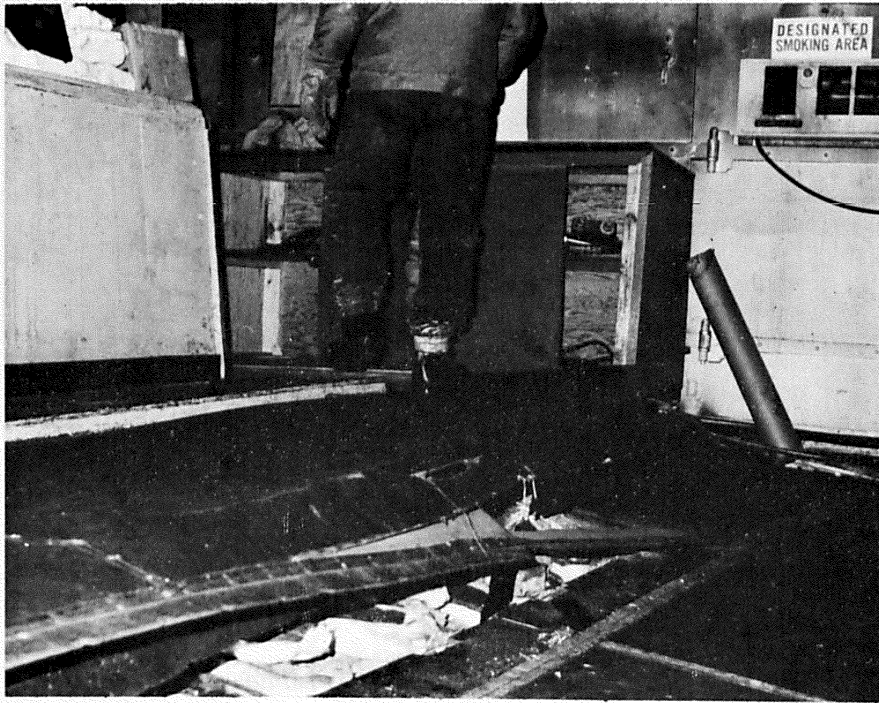
*Figure 83. Tearing of maintenance shop floor as a result of trench floor arching.*

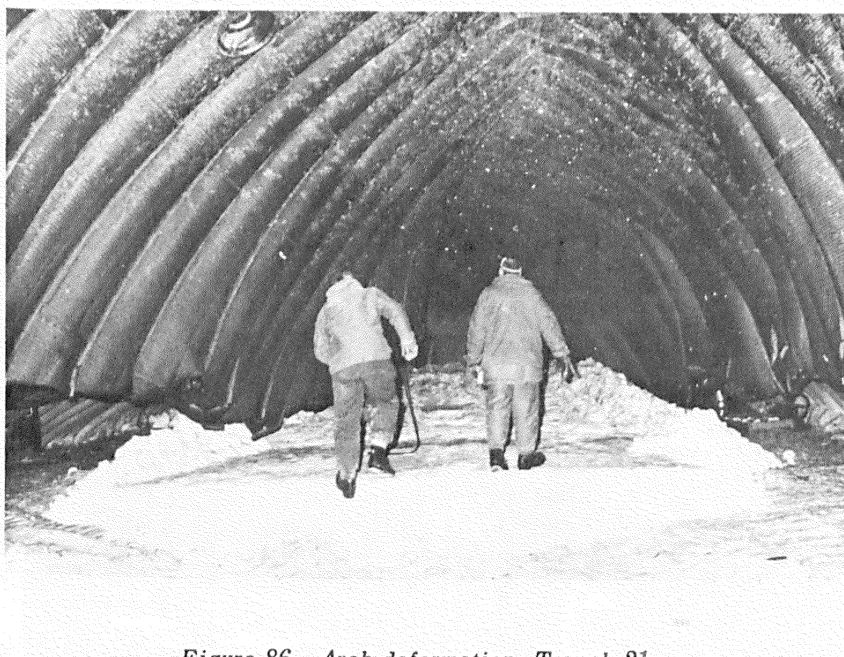
*Figure 86. Arch deformation, Trench 21.*

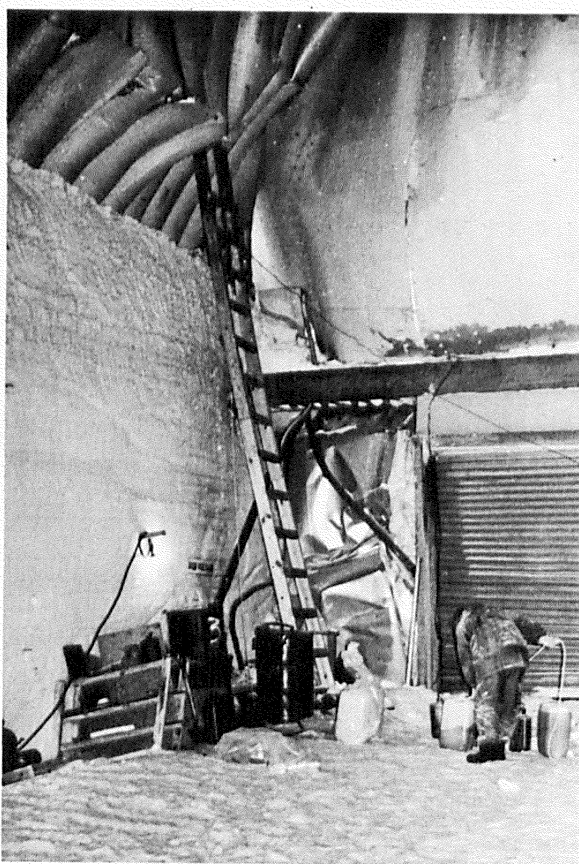
*Figure 94. Effects of snow load are visible on Trench 33's deformed arch, end wall and access ladder.*

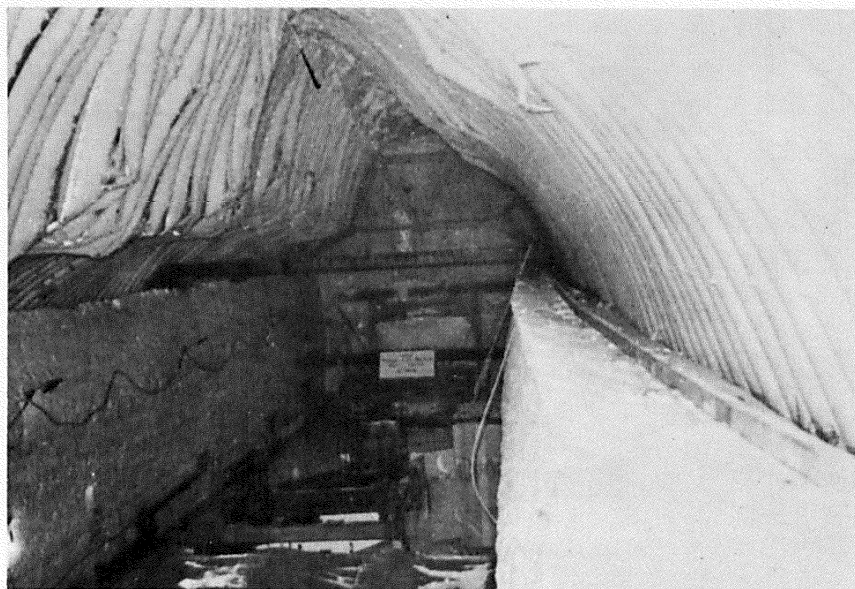
*Figure 95. Looking toward north end wall of Trench 33. Note bowing and bulging of side walls.*
