**EIS
SUB-APPENDIX J
PHASE I ASSESSMENT**

**FINAL
FEASIBILITY REPORT
AND ENVIRONMENTAL IMPACT STATEMENT
PORT EVERGLADES HARBOR NAVIGATION STUDY
BROWARD COUNTY, FLORIDA**

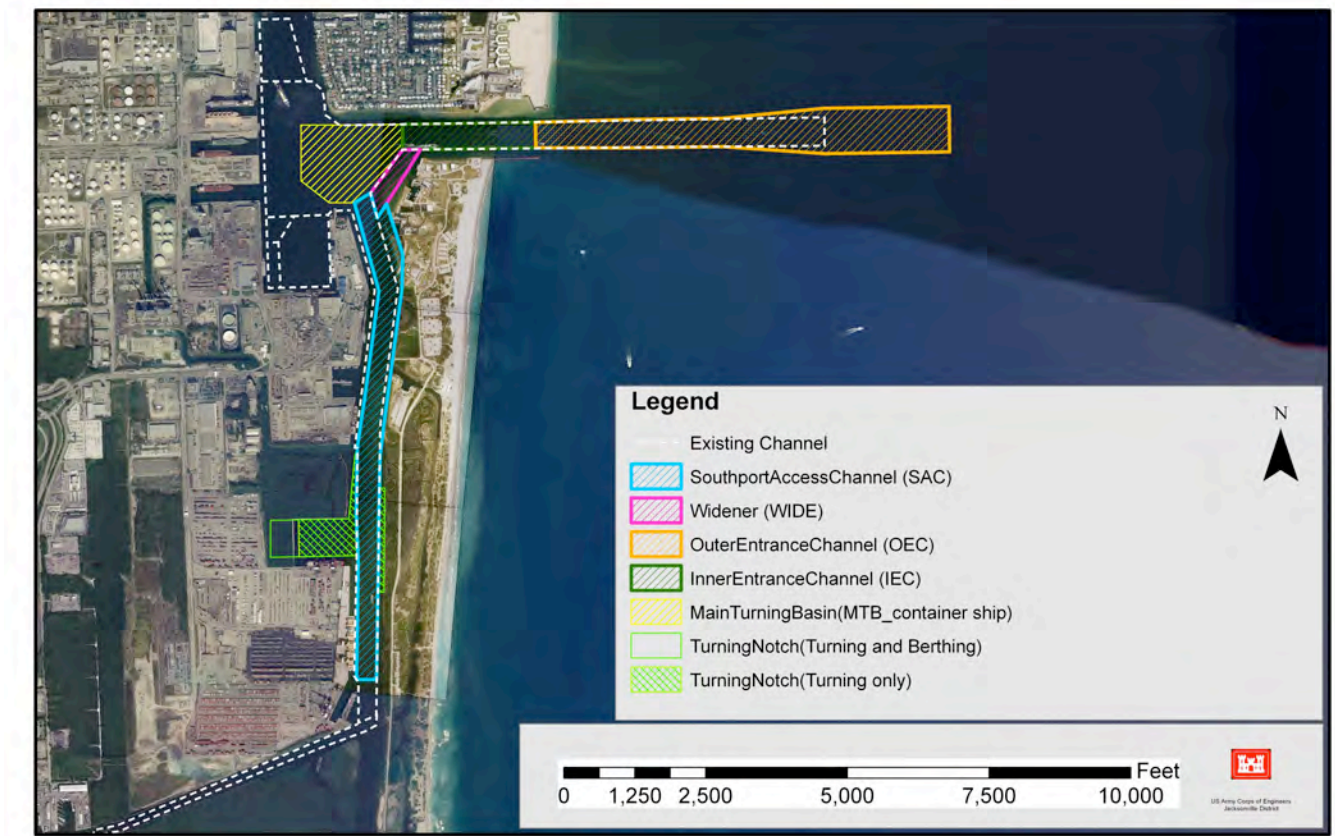
Project details and Location Map..... Figure

1.4.2 Physical Setting Source(s) The Project details and Location Map figure A1 indicates that the dredging sites are located within the developed seaport operation area.

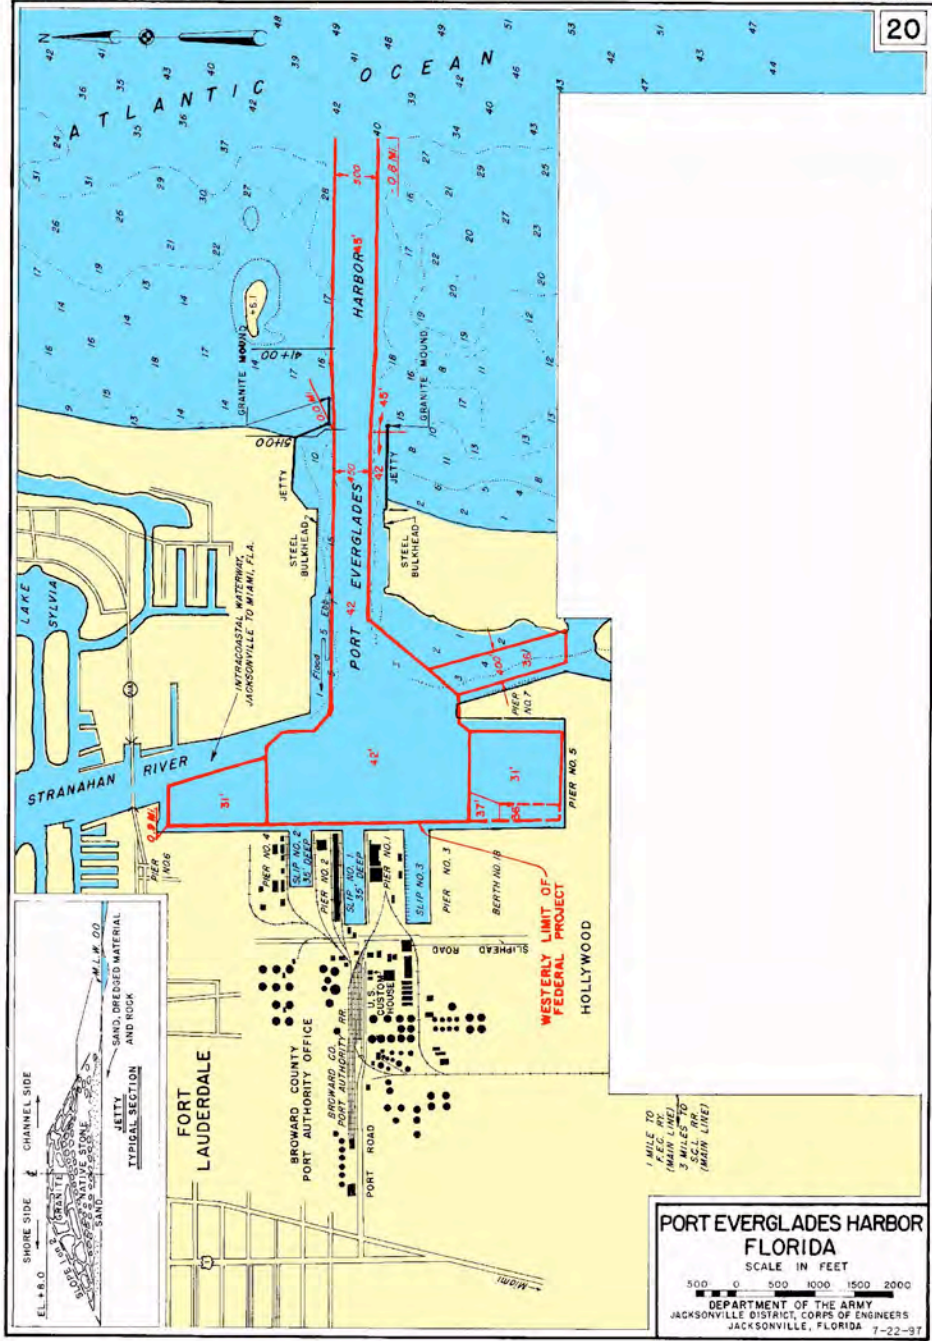
Historical uses Location Map.....Figure A2

1.3.7 Past Uses of the Property (to the extent identified). The past uses of the port are the same as the current use. Since this is not an upland site this is N/A. See Historical uses Location Map Figure A2

1.3.8 Current and Past Uses of Adjoining Properties (to the extent identified) By all indications observed throughout the site investigation, the adjoining properties relate to port operations. The dredging sites are surrounded by parking lots, roads, a metal recycler, etc. Historical uses Location Map Figure A2

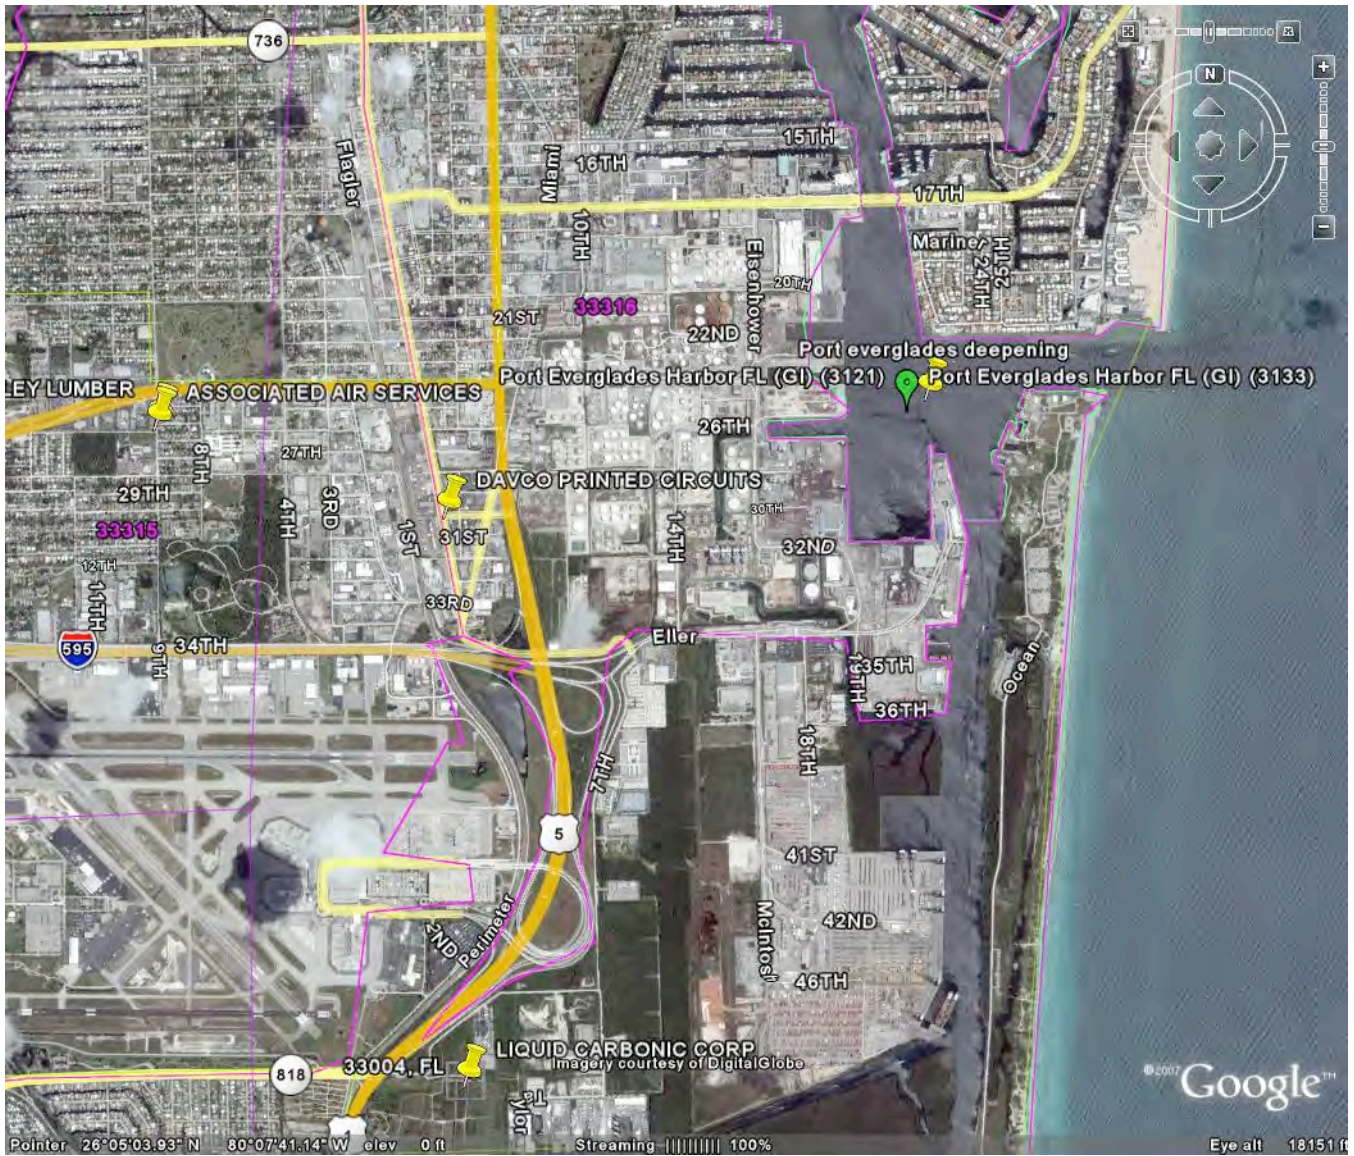
Non NPL CERCLIS. Site Location Map.....Figure A4

1.5.6 Physical Setting Analysis, if migrating Hazardous Substances are an issue. Migration of hazardous substances from pollution sources off-site was considered. Four "non NPL CERCLIS sites were found in the vicinity none of which appear to be close enough to have ever impacted the basin
