PERFORMANCE OF RUBBERIZED-TAR CONCRETE PAVEMENTS ON AIRFIELD FACILITIES

MISCELLANEOUS PAPER NO. 4-304

February 1959

U. S. Army Engineer Waterways Experiment Station
CORPS OF ENGINEERS

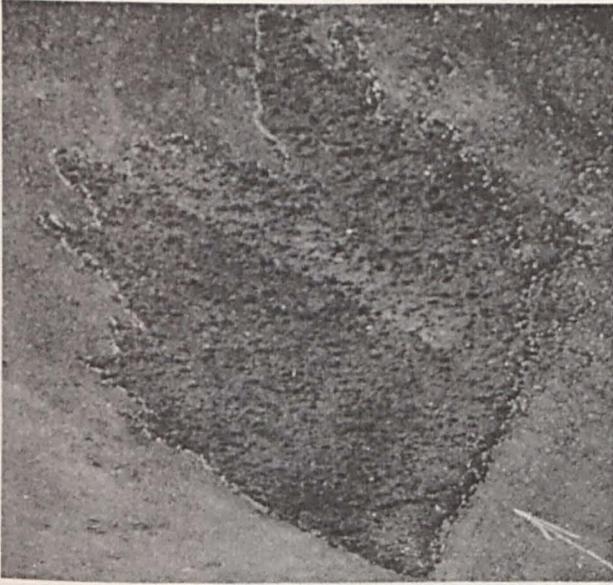
12. Although considerable fuel spillage has occurred on most of the rubberized-tar pavements, the pavements do not appear to have been weakened. Damage has been noted only where fuel ponds in depressed areas or penetrates through a surface crack to the underlying asphalt binder. In areas subjected to jet heat and blast, no definite pattern of erosion was visible; however, the surface of the aggregate appeared to be stripped of tar, and erosion to about 1/4-in. depth was measured at some locations. Photograph 1 shows typical results of jet blast on rubberized-tar and asphaltic concrete. In general, jet blast caused only minor pavement surface flaking, and damage is considered to have been insignificant.

Photograph 1. Effect of jet blast on rubberized-tar surface

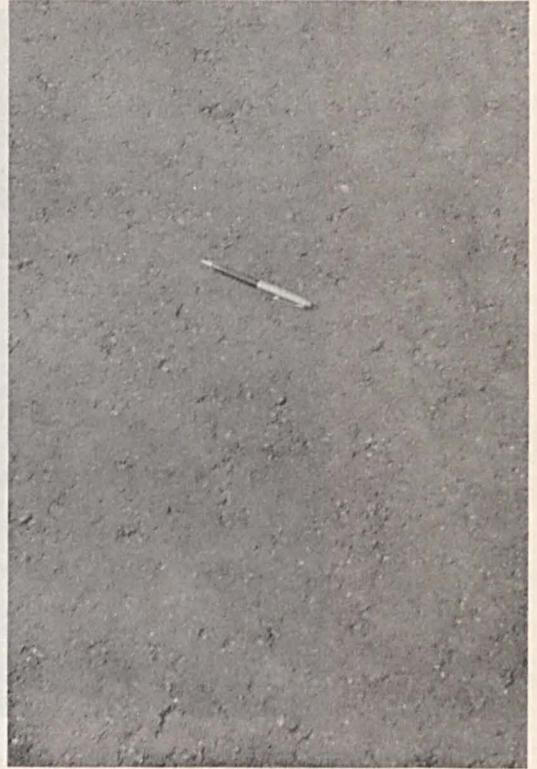
14. Texture of the pavements was generally fair at all of the fields; however, at many fields the construction joints between paving lanes showed more segregation and open texture than the other portion of the pavement. Photograph 2 shows the typical surface texture of rubberized-tar pavement.

Photograph 2. Typical surface texture of rubberized-tar concrete

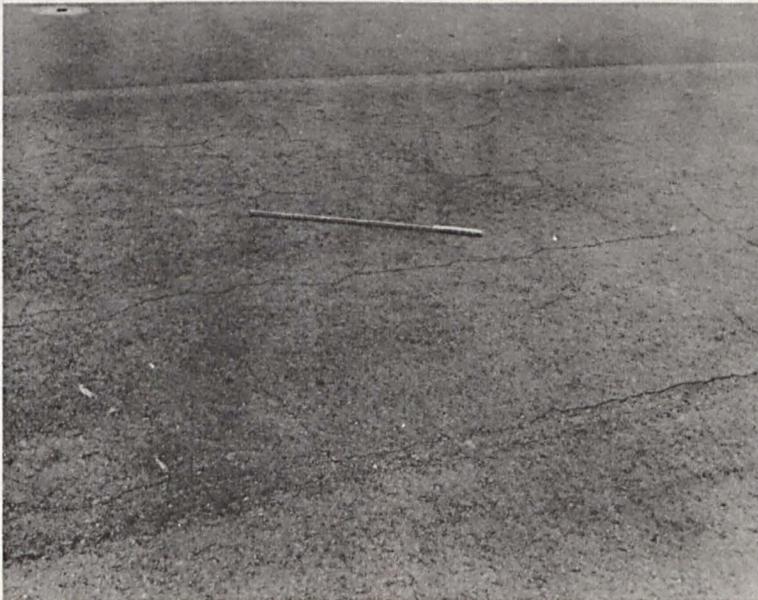
Photograph 3. Rectangular block pattern formed in advanced cracking stage

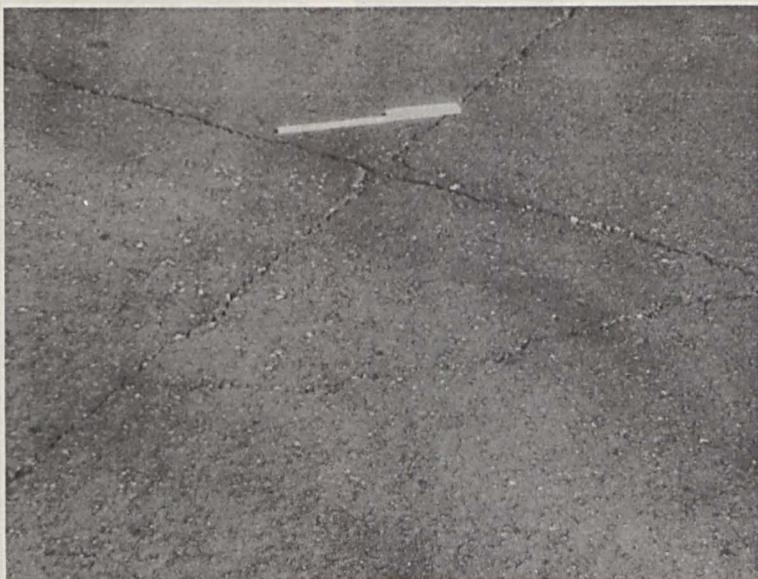
Photograph 4. Reflection cracks

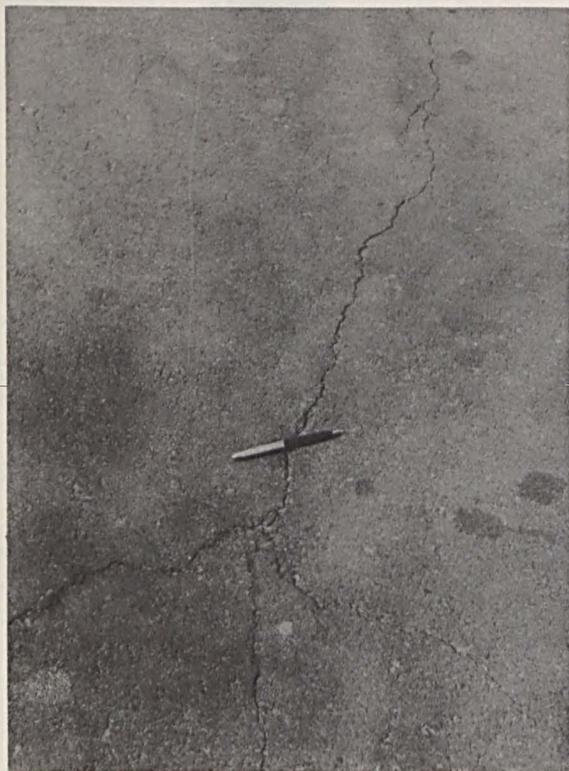
Photograph 5. Shrinkage cracks

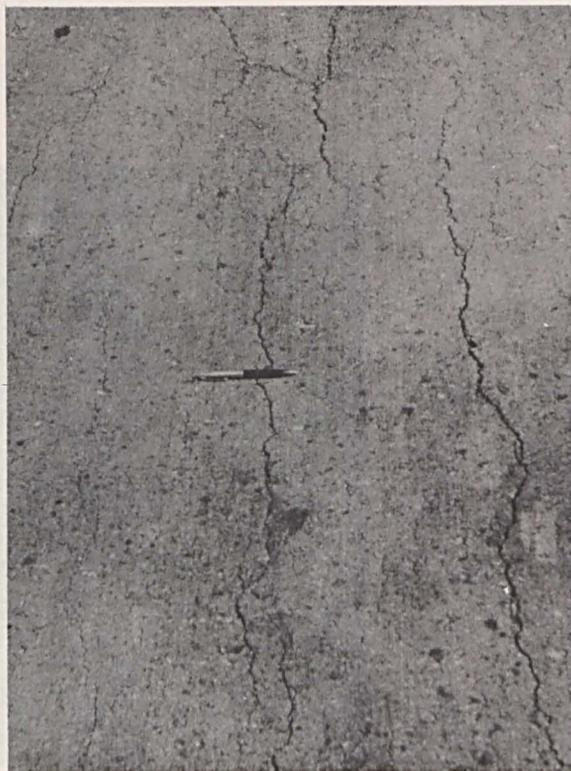
Photograph 6. Cracks from excessive loads

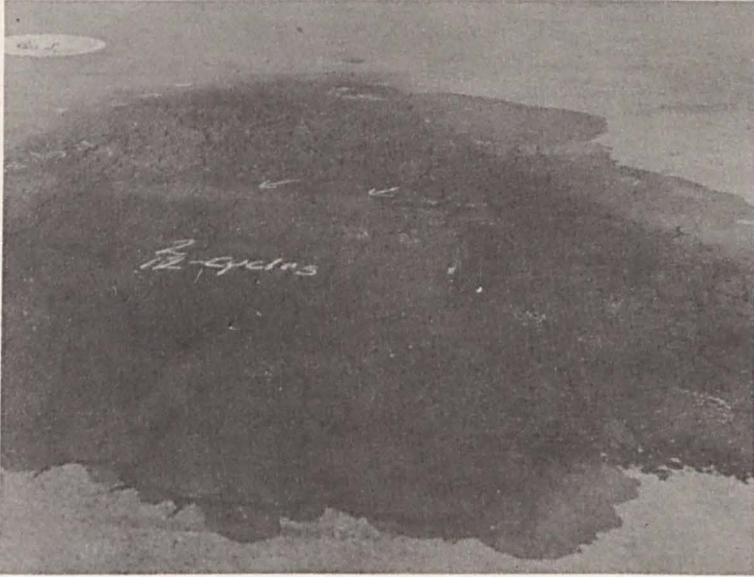
Photograph 7. Cracks in area of jet-fuel spillage

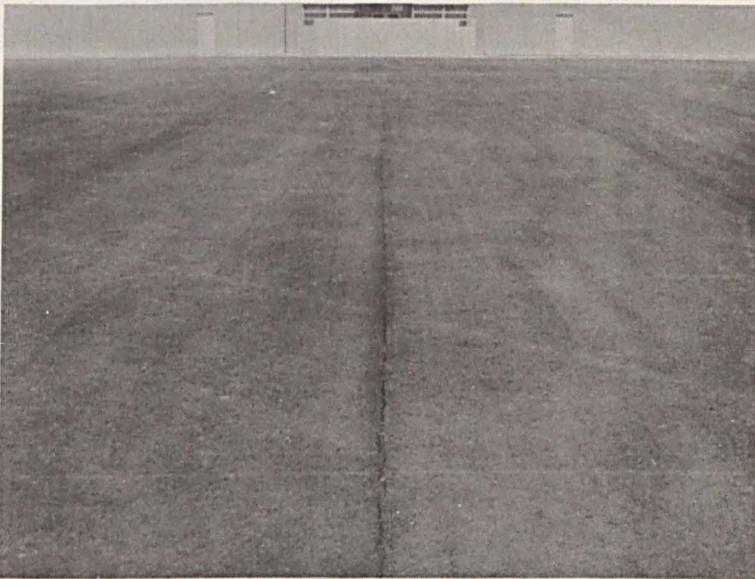
Photograph 8. Open construction joints

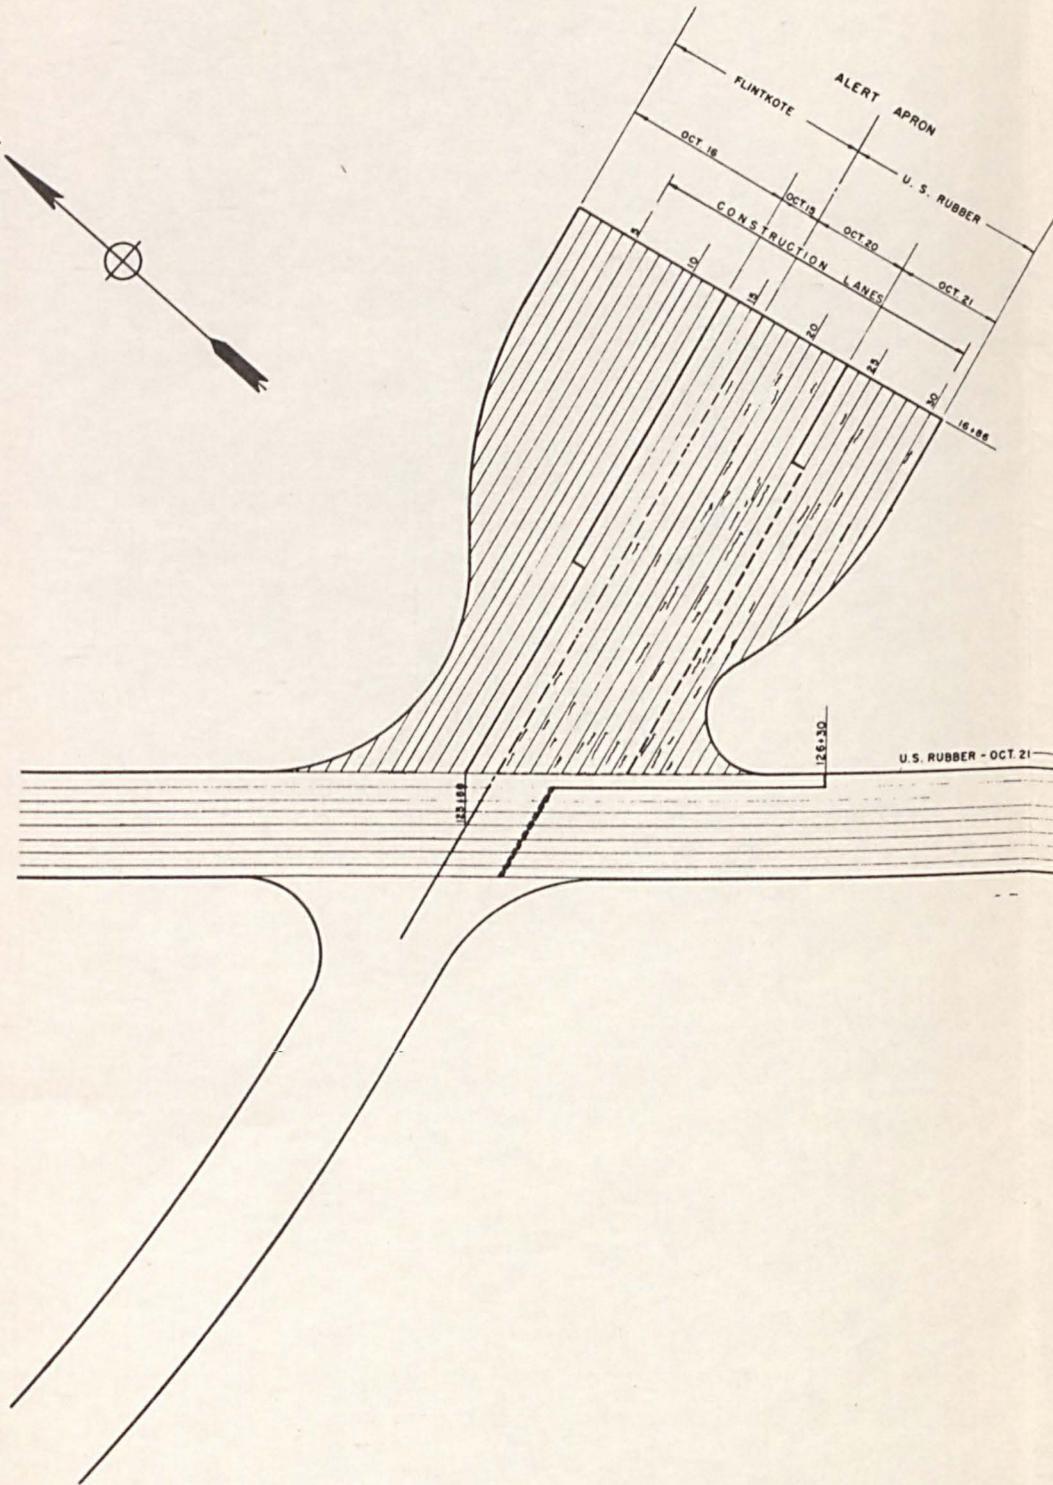
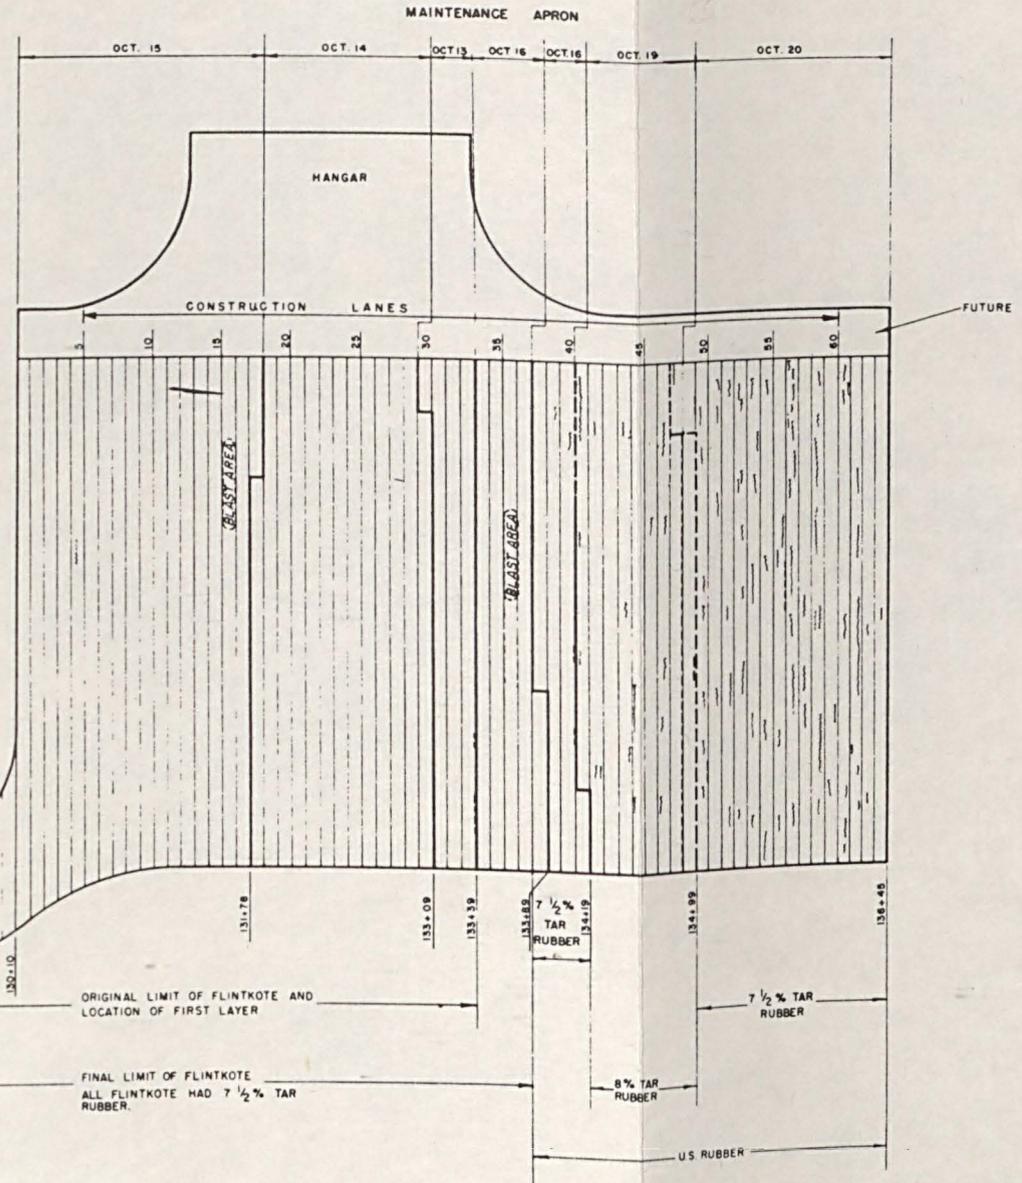
PLATE 1
29683

15. The pavements generally began to crack in the first or second winter after construction, and usually had received little or no aircraft traffic. The usual trend was for either longitudinal construction joints to open or cracks to appear within the paving lanes parallel to the direction of laying (see plate 1). Transverse cracking usually accompanied or closely followed the longitudinal cracking. As cracking progressed, small cracks also appeared, forming a rectangular block pattern of varying sizes (see photograph 3). This formation and pattern did not always occur, for cracks appeared in some pavements in a random fashion, forming crowfoot-, map-, or even alligator-type patterns. The cracks ranged in width from hairline to $3/8$ in. Some construction joints were open as much as $3/8$ to $3/4$ in., and this appeared to be the most serious type of crack or opening.
