REPORT NO. 9-1

BANK CAVING INVESTIGATIONS
KEMPE BEND REVETMENT, MISSISSIPPI RIVER

SOILS INVESTIGATION

NOVEMBER 1951

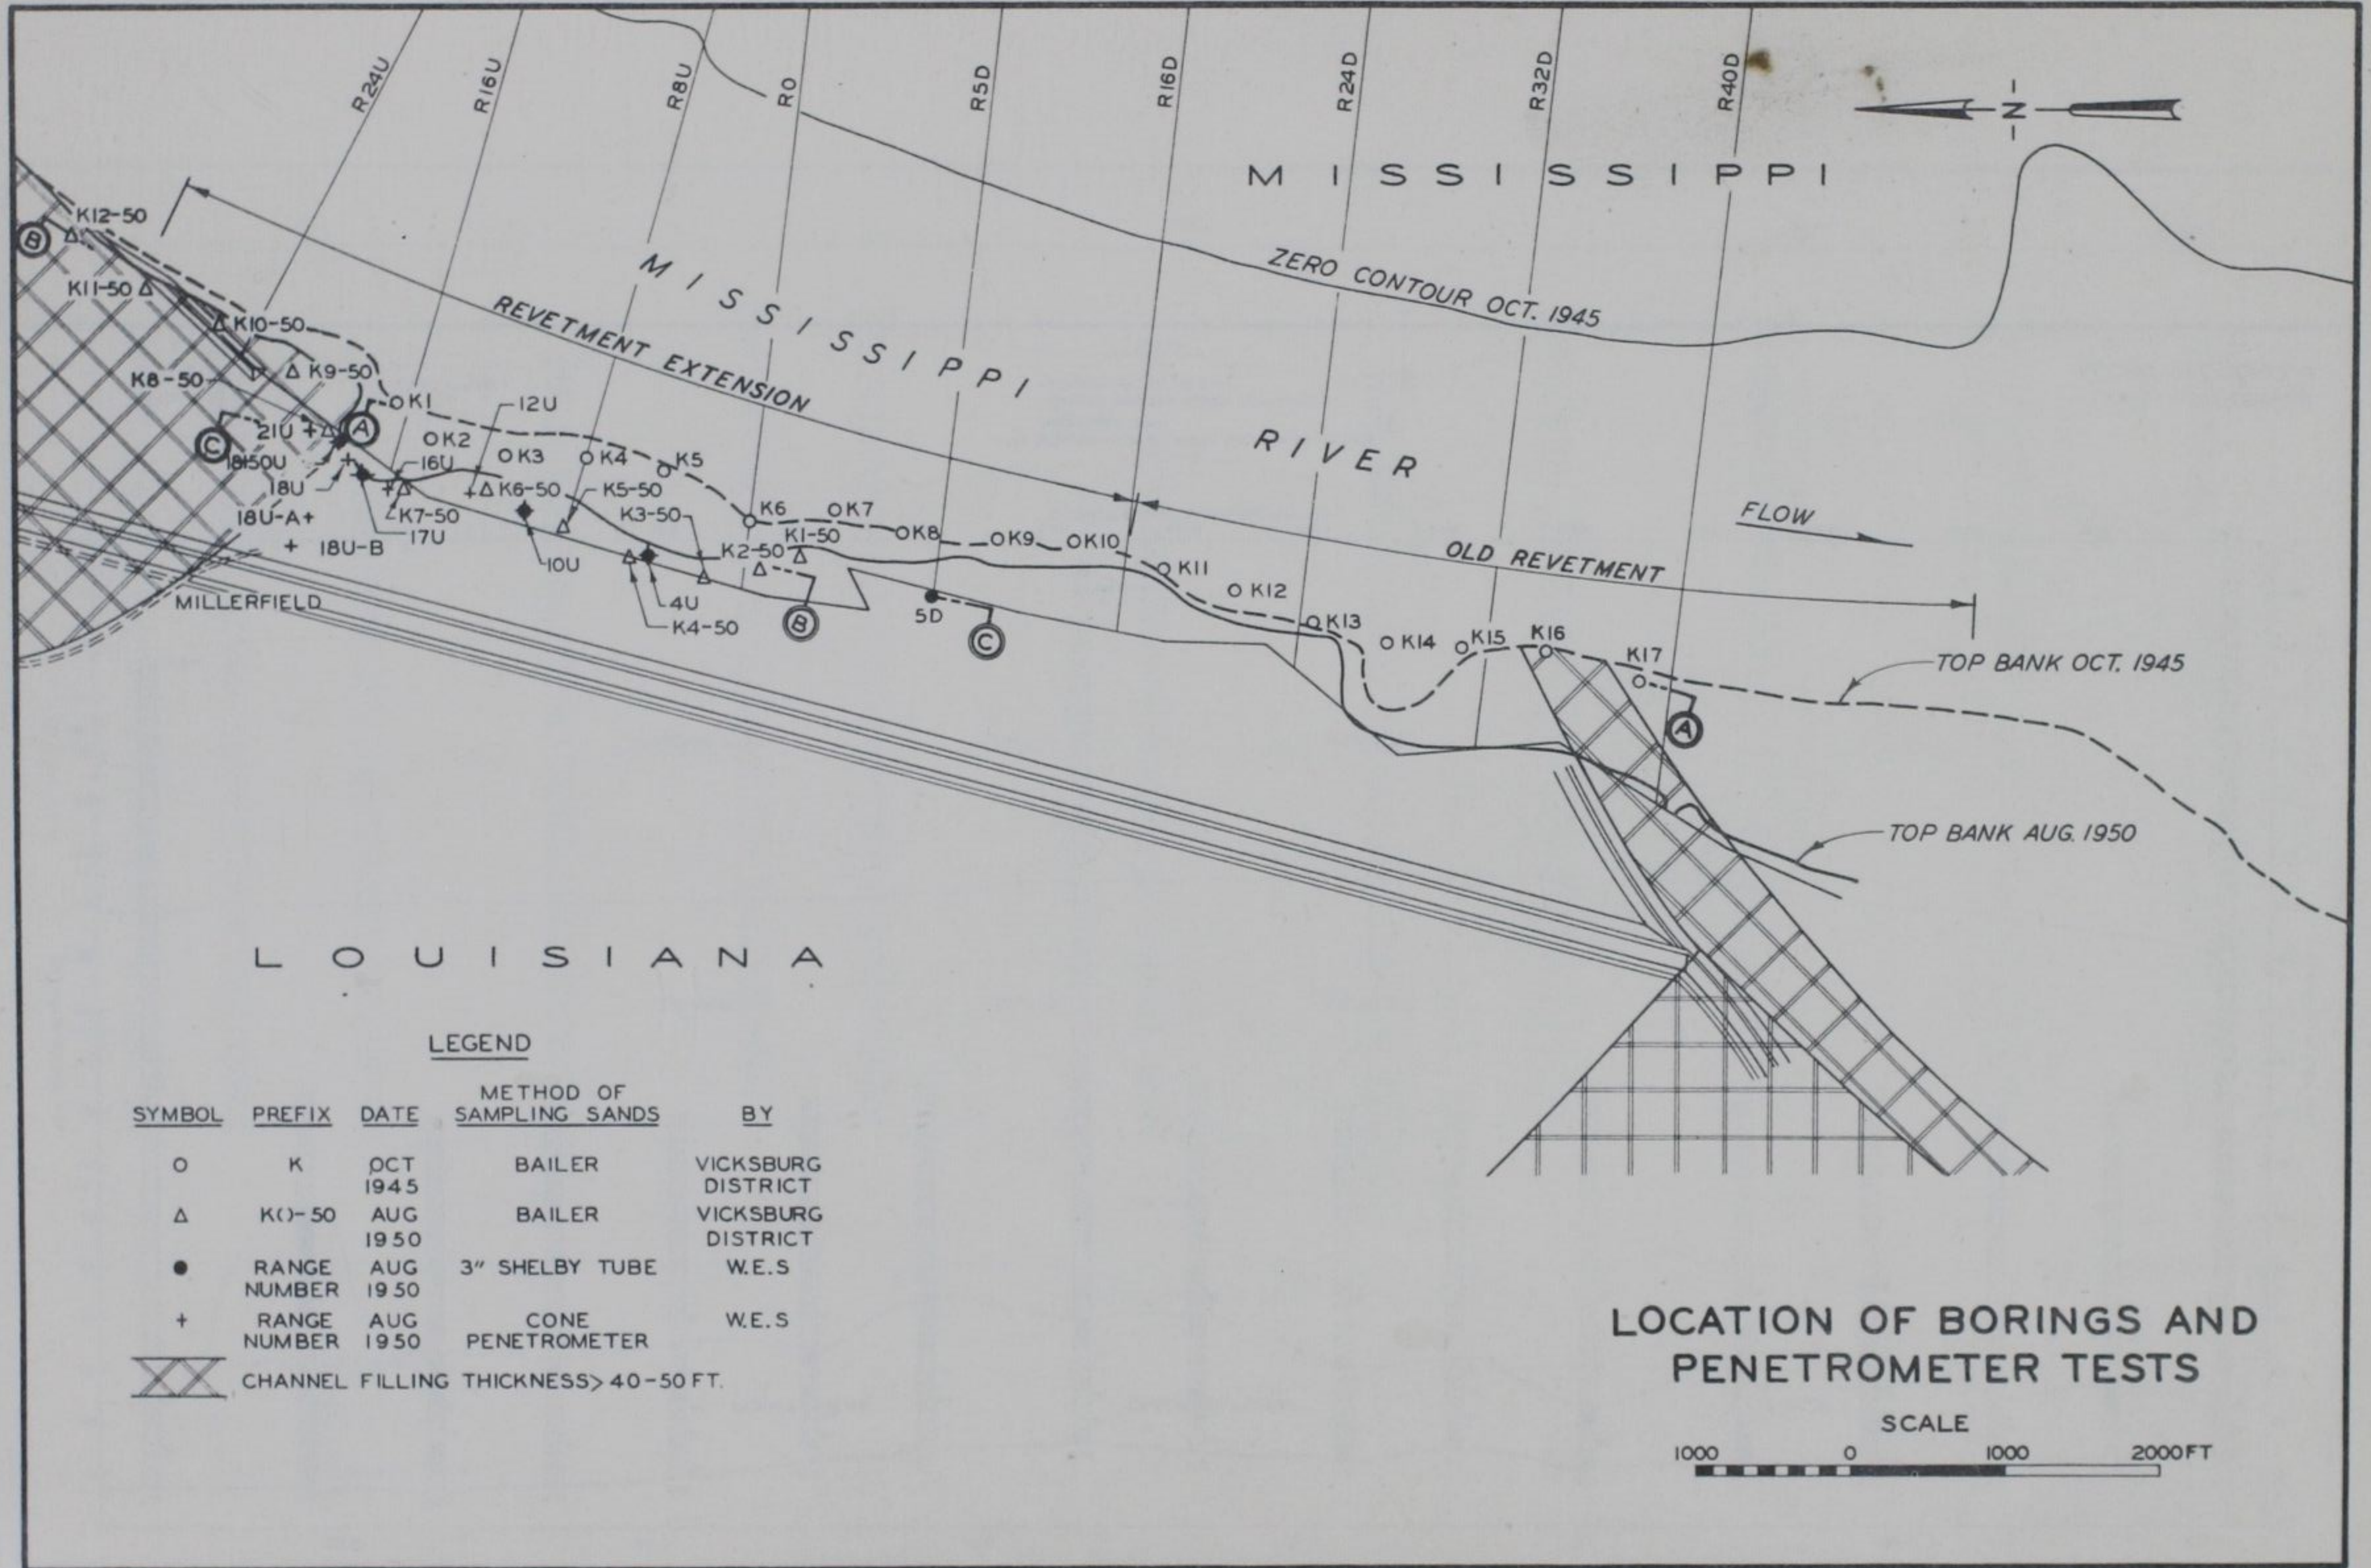
LOCATION OF BORINGS AND PENETROMETER TESTS

2. The soils composing the bank of the Kempe Bend revetment site are point-bar deposits, bounded at the upstream end of the revetment extension and at the downstream end of the old revetment by shallow channel fillings. The locations of the channel fillings are shown on plate 1. The general soil conditions are similar to those observed and studied at other sites along the Lower Mississippi River. The soils may be subdivided into three major units or groups on the basis of certain characteristics. These groups are discussed below.

13. The locations of all soil borings are shown on plate 1. They include general sample borings made by the Vicksburg District, and

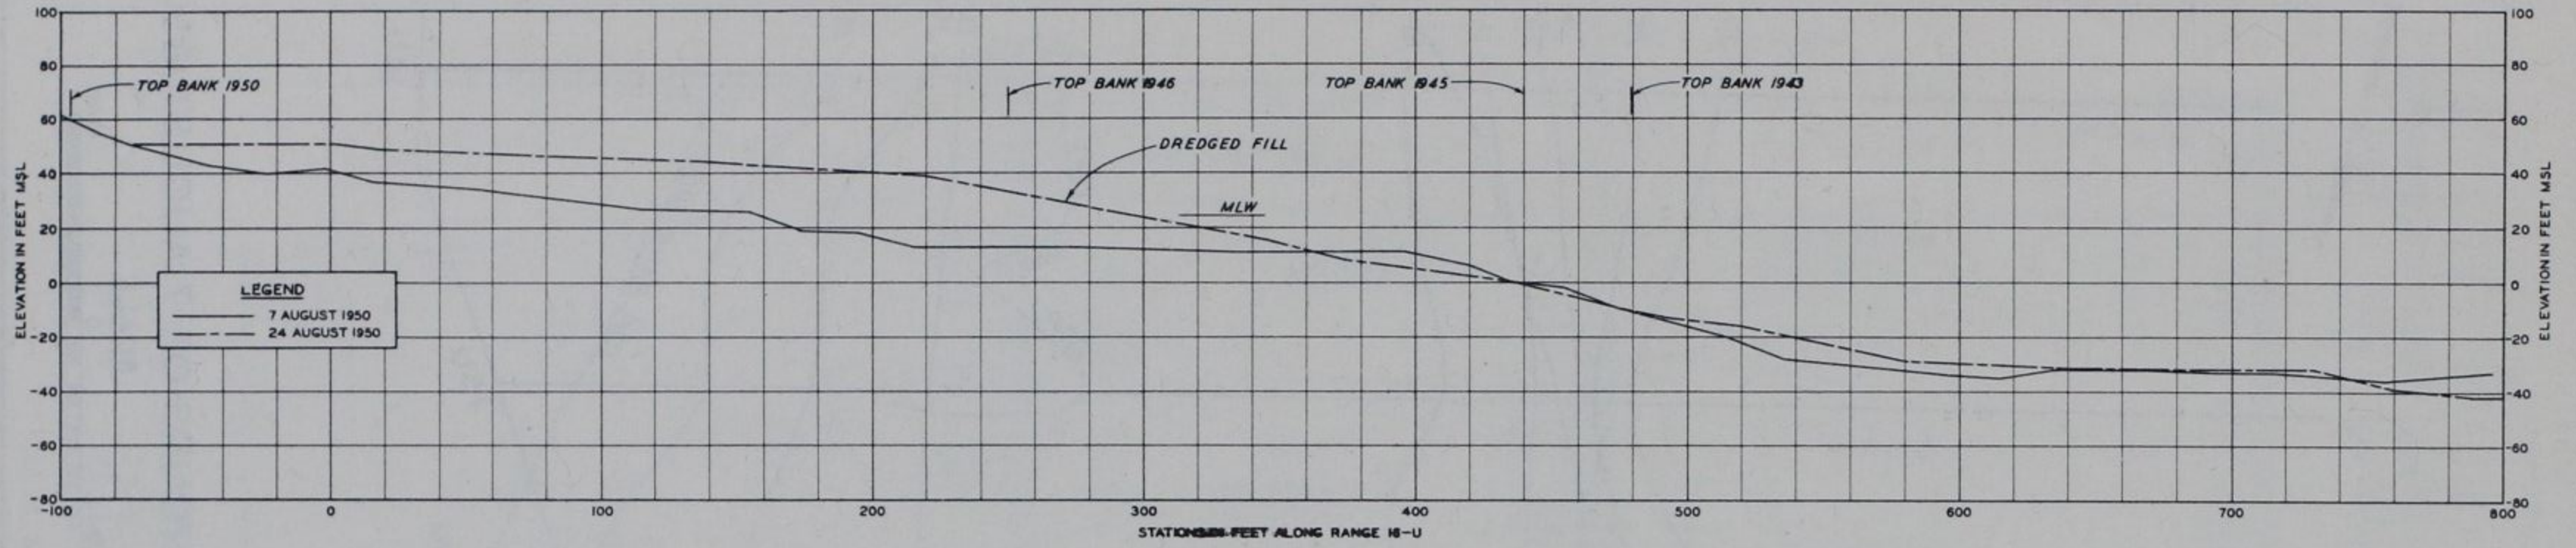
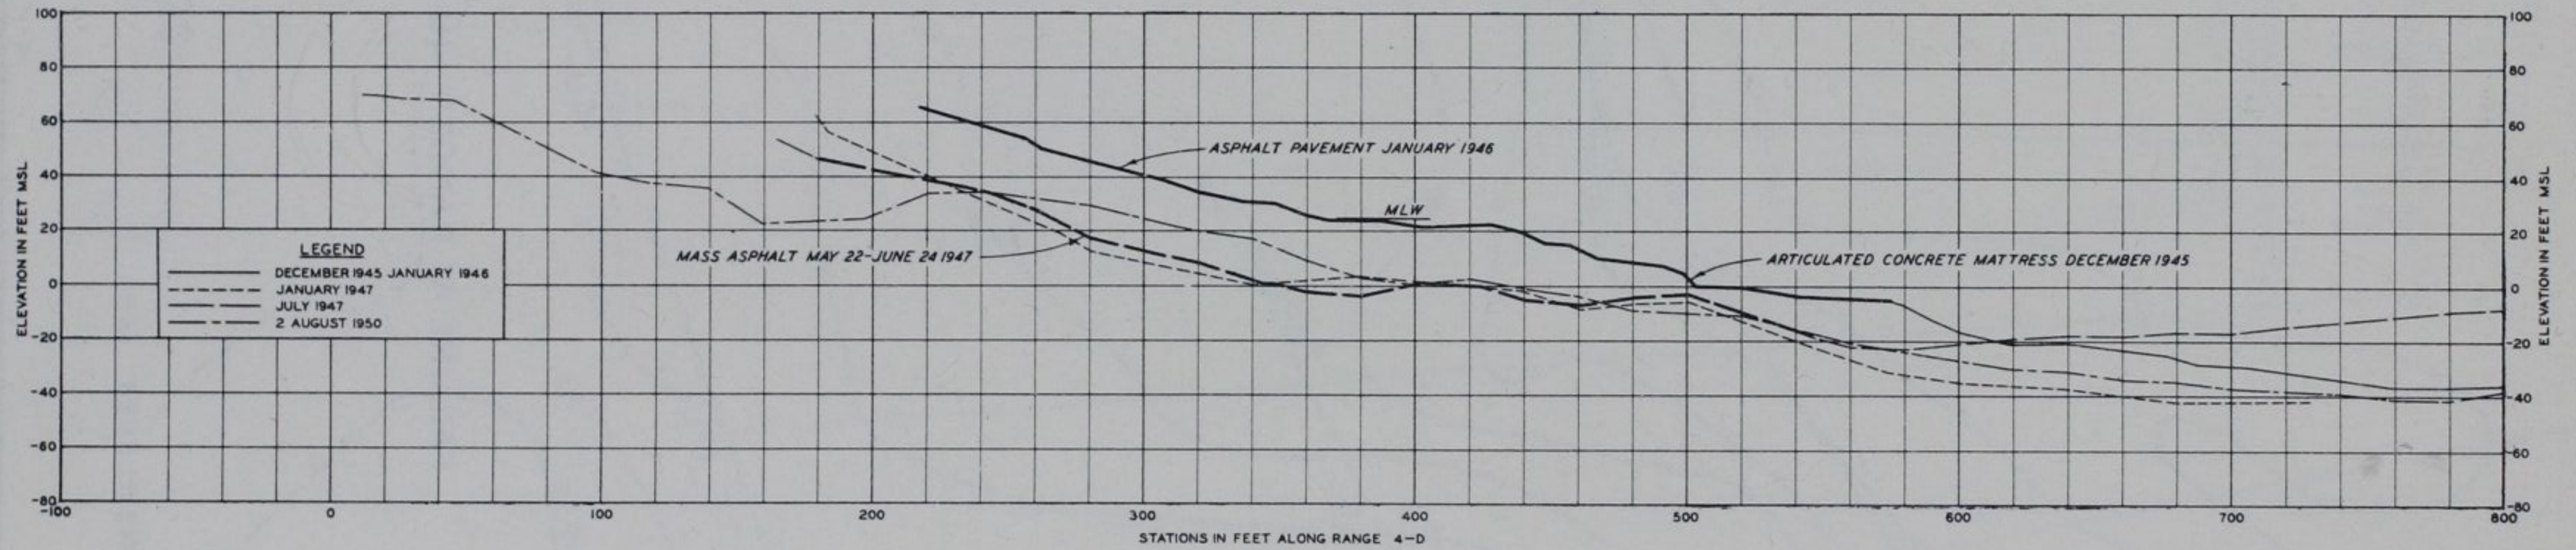
PROFILES ALONG RANGES 16-U AND 4-D

9. Conditions a and b listed above are illustrated by bank profiles at ranges 4D and 12D, plates 6 and 7. The recession at range 4D between January 1946 and January 1947 extended from the thalweg to the top of bank. Recession occurred between the top of bank and elevation +20 ft msl between January 1947 and August 1950 with some deepening at the thalweg. The recession at range 12D has occurred only between the top of the bank and elevation 0 to +20 ft msl and at the thalweg, with the bank from elevation 0 to -20 ft msl remaining fairly stable. The recessions at these ranges cannot be connected in plan (as stated in c above) to form a pattern indicative of large flow failures. The most logical explanation of the bank recession is that numerous shallow flow failures have occurred down to elevations of approximately +20 msl, accompanied by scour at the thalweg.

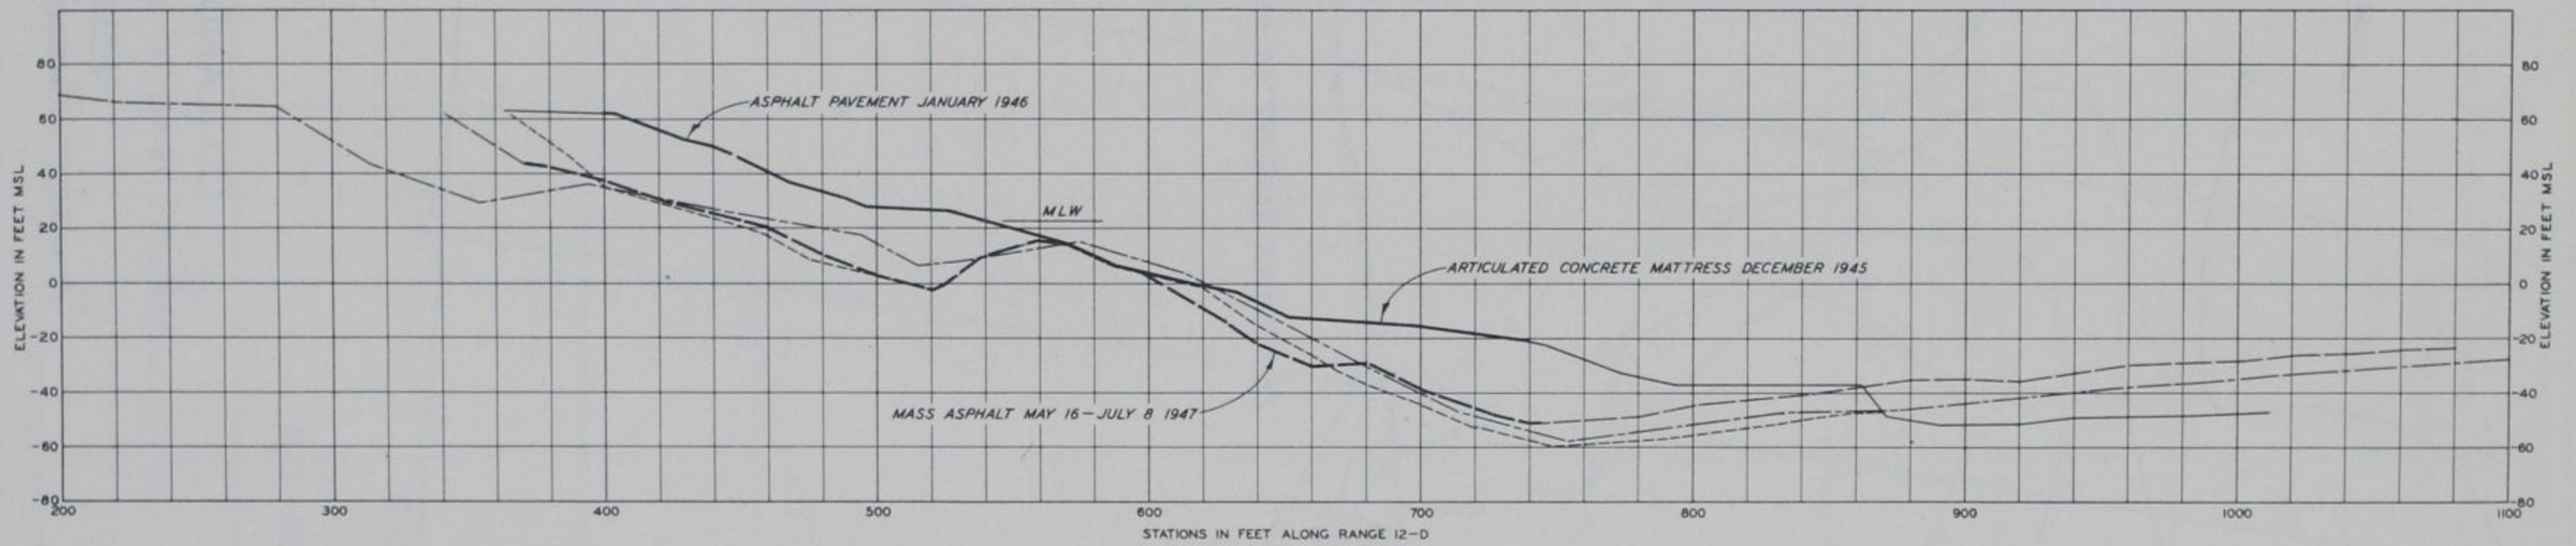
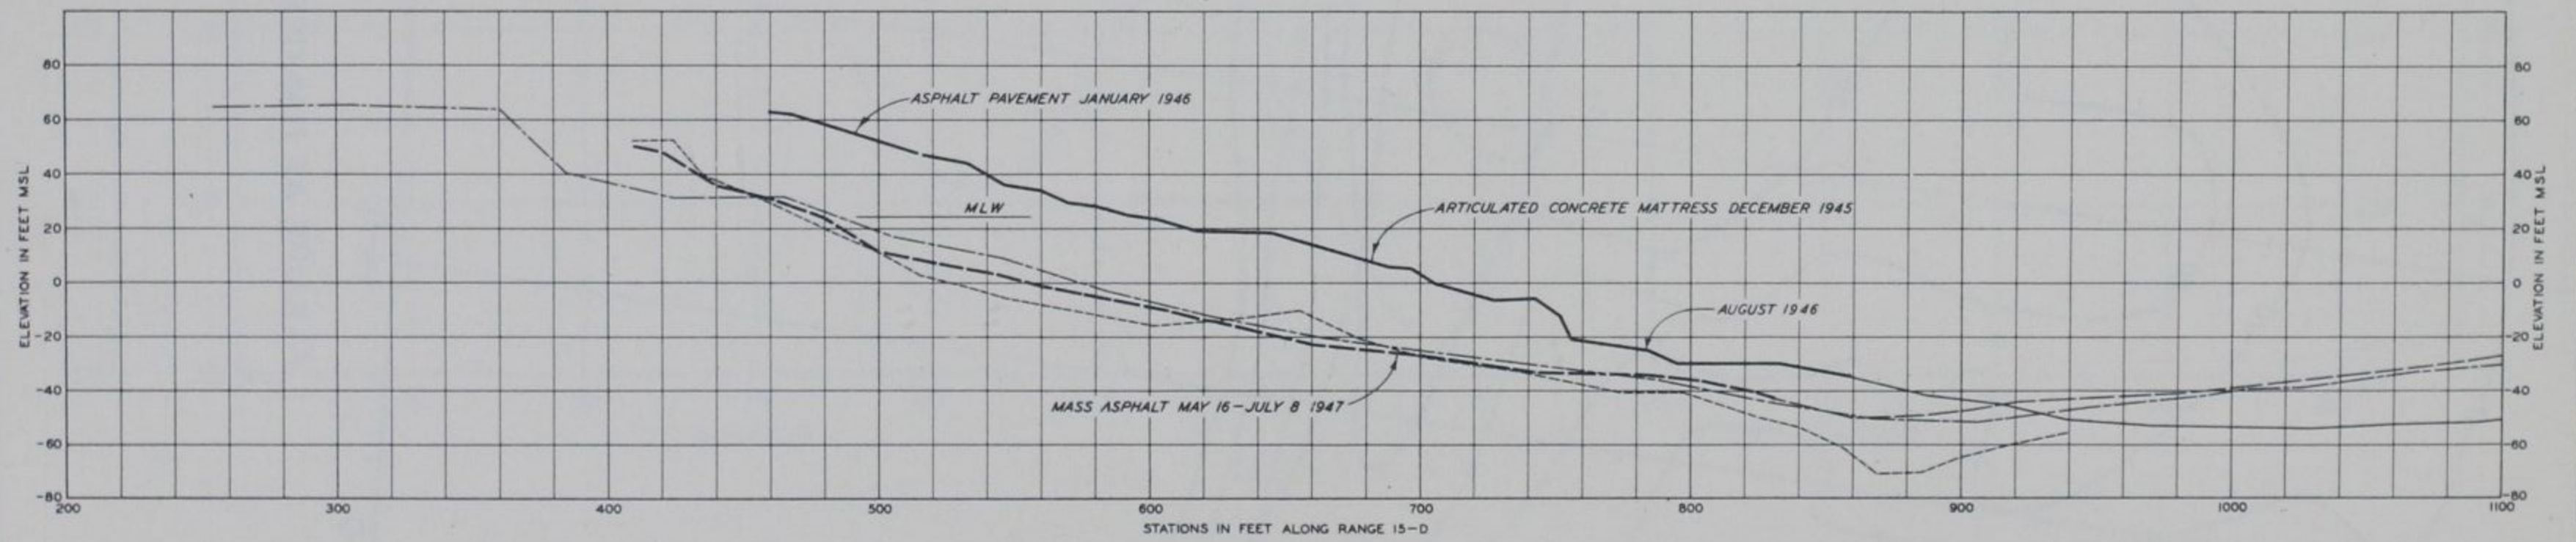
PROFILES ALONG RANGES 12-D AND 15-D

10. A possible exception to the general rule of shallow flow failures occurred between ranges 13D and 17D sometime during the period of August 1946 to January 1947. A profile along range 15D is shown on plate 7. The amount of recession is shown on plate 8 in contours of cut (measured in feet), the maximum amount being 40 ft on range 15D. No

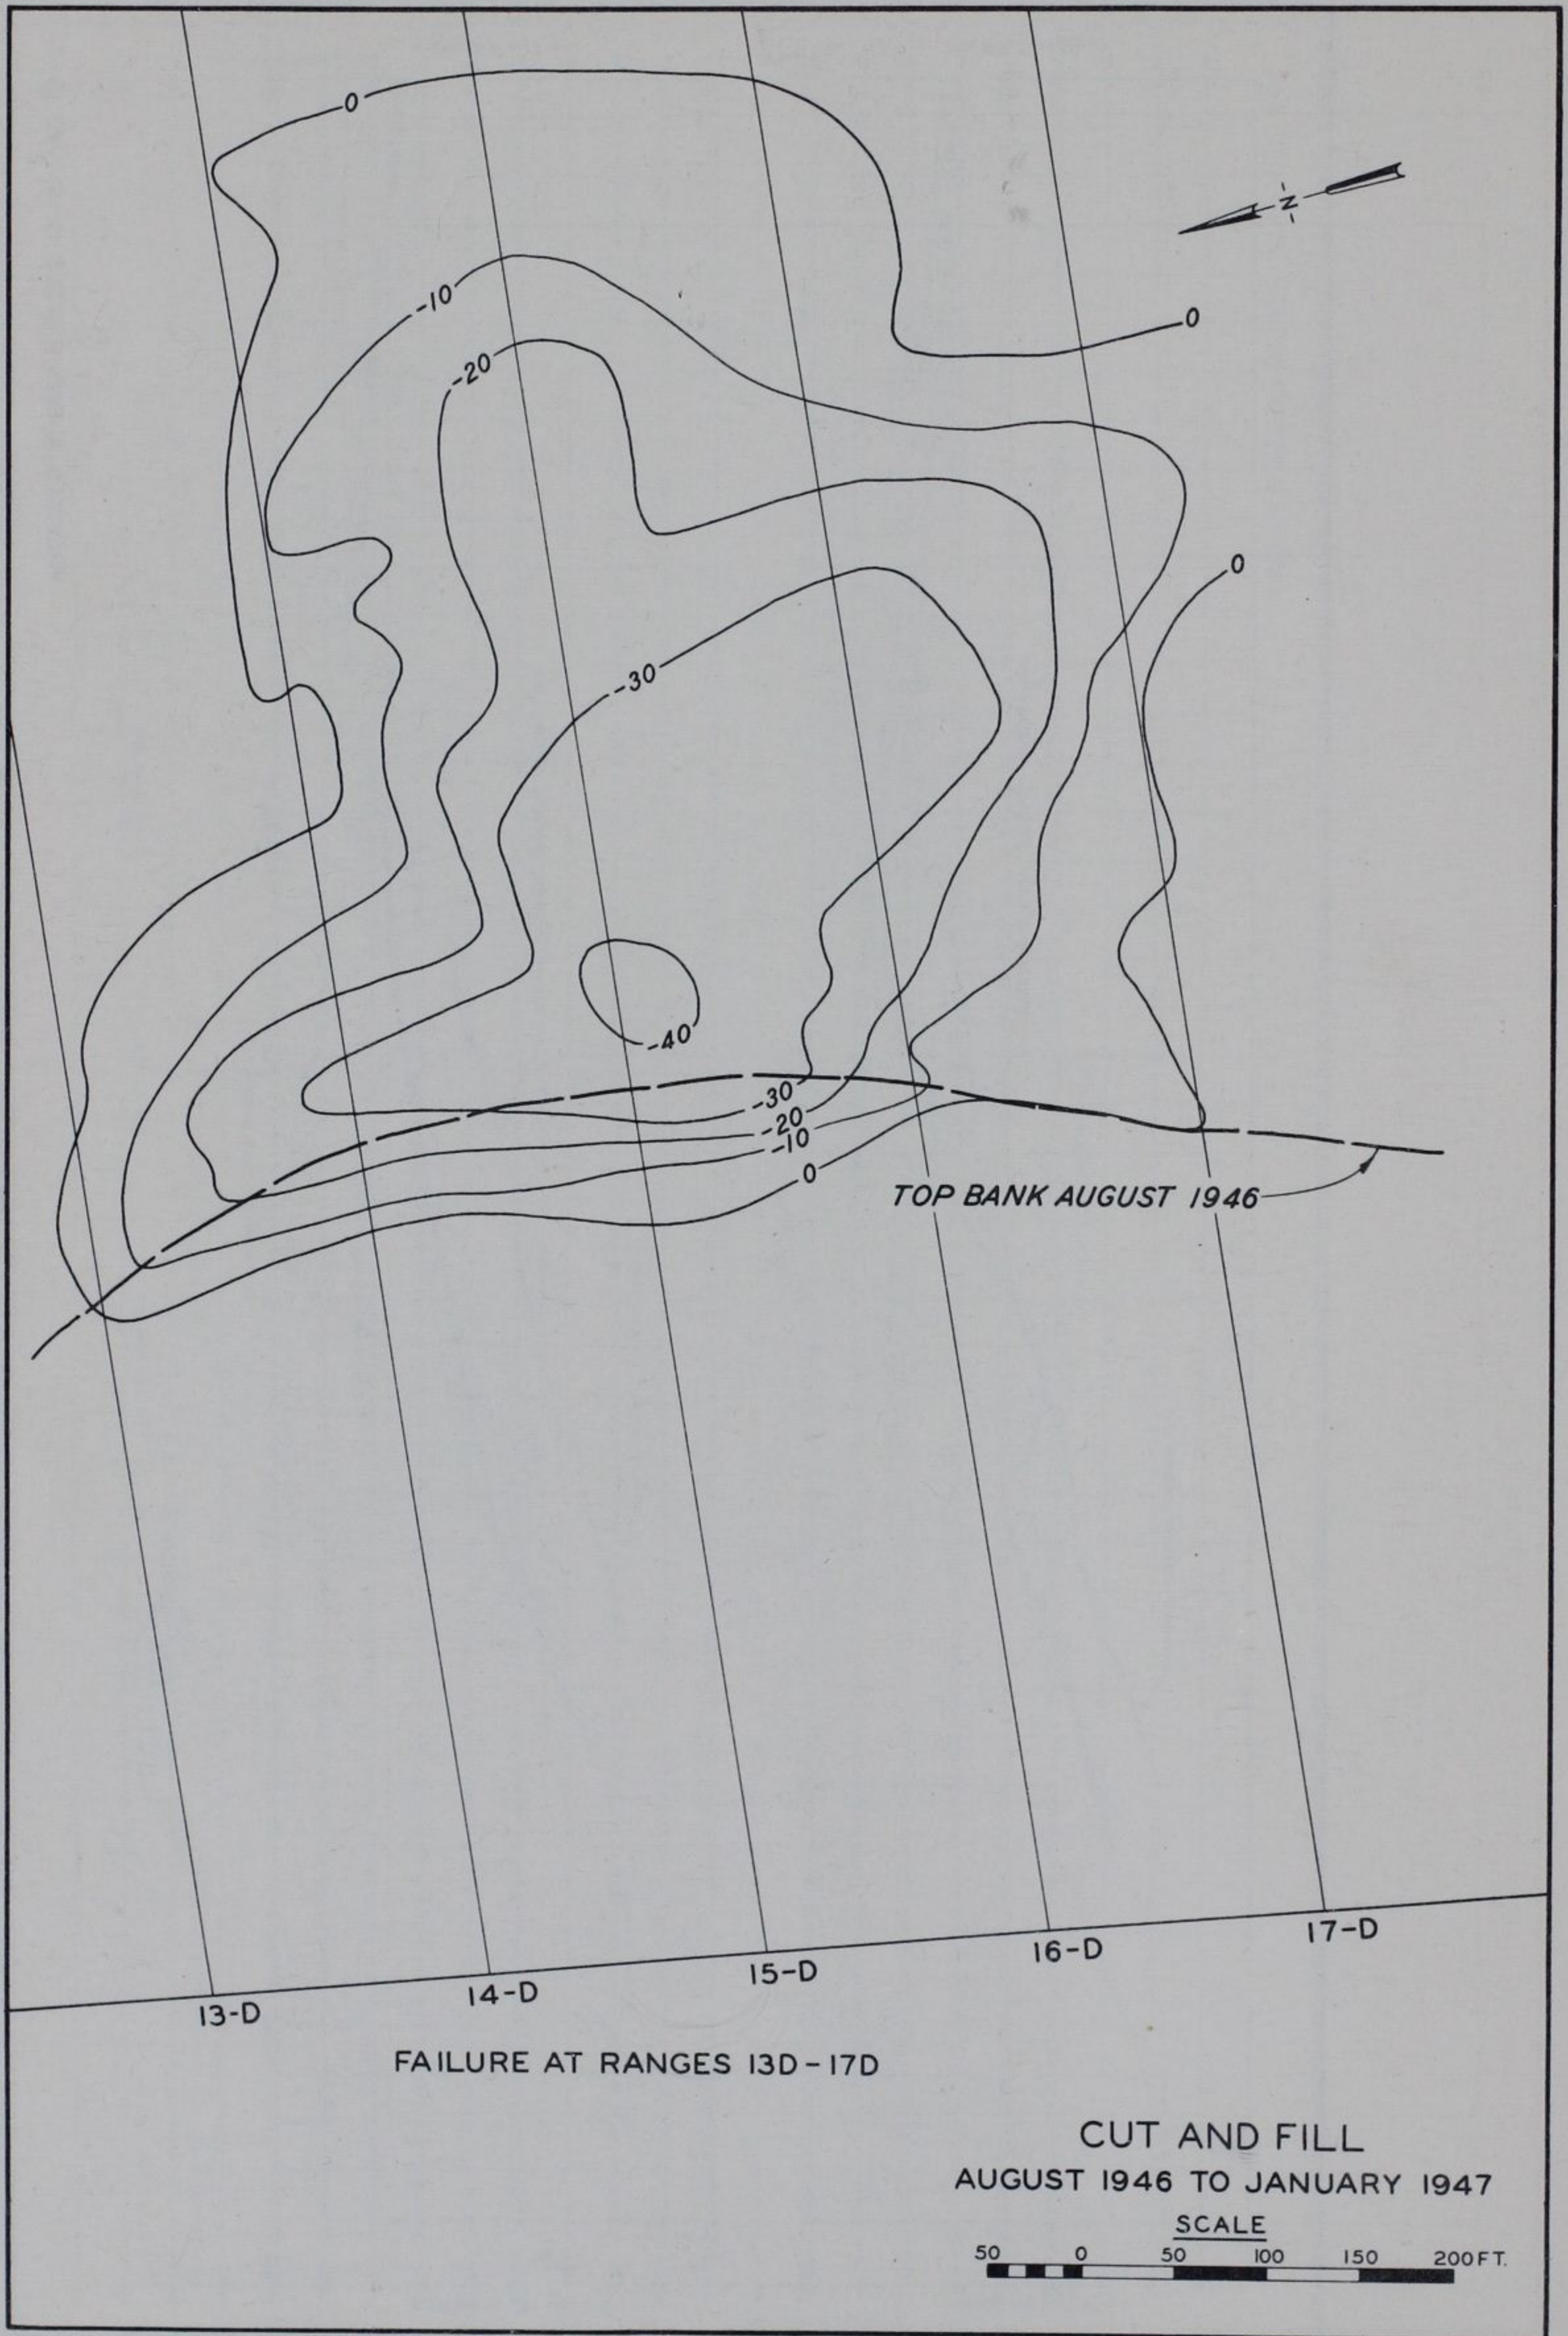
fill was found, but it probably was removed during the time between surveys. The pattern of cut shown on plate 8 is typical of scallops observed at other sites which are thought to have been flow failures. The scallop at this site is the largest observed between any two surveys, and the period between surveys was shorter (6 months compared to 1 year at most other ranges). It seems probable that this scallop actually represents a large deep failure, although the recession may have occurred as a series of small shallow failures followed by scour.

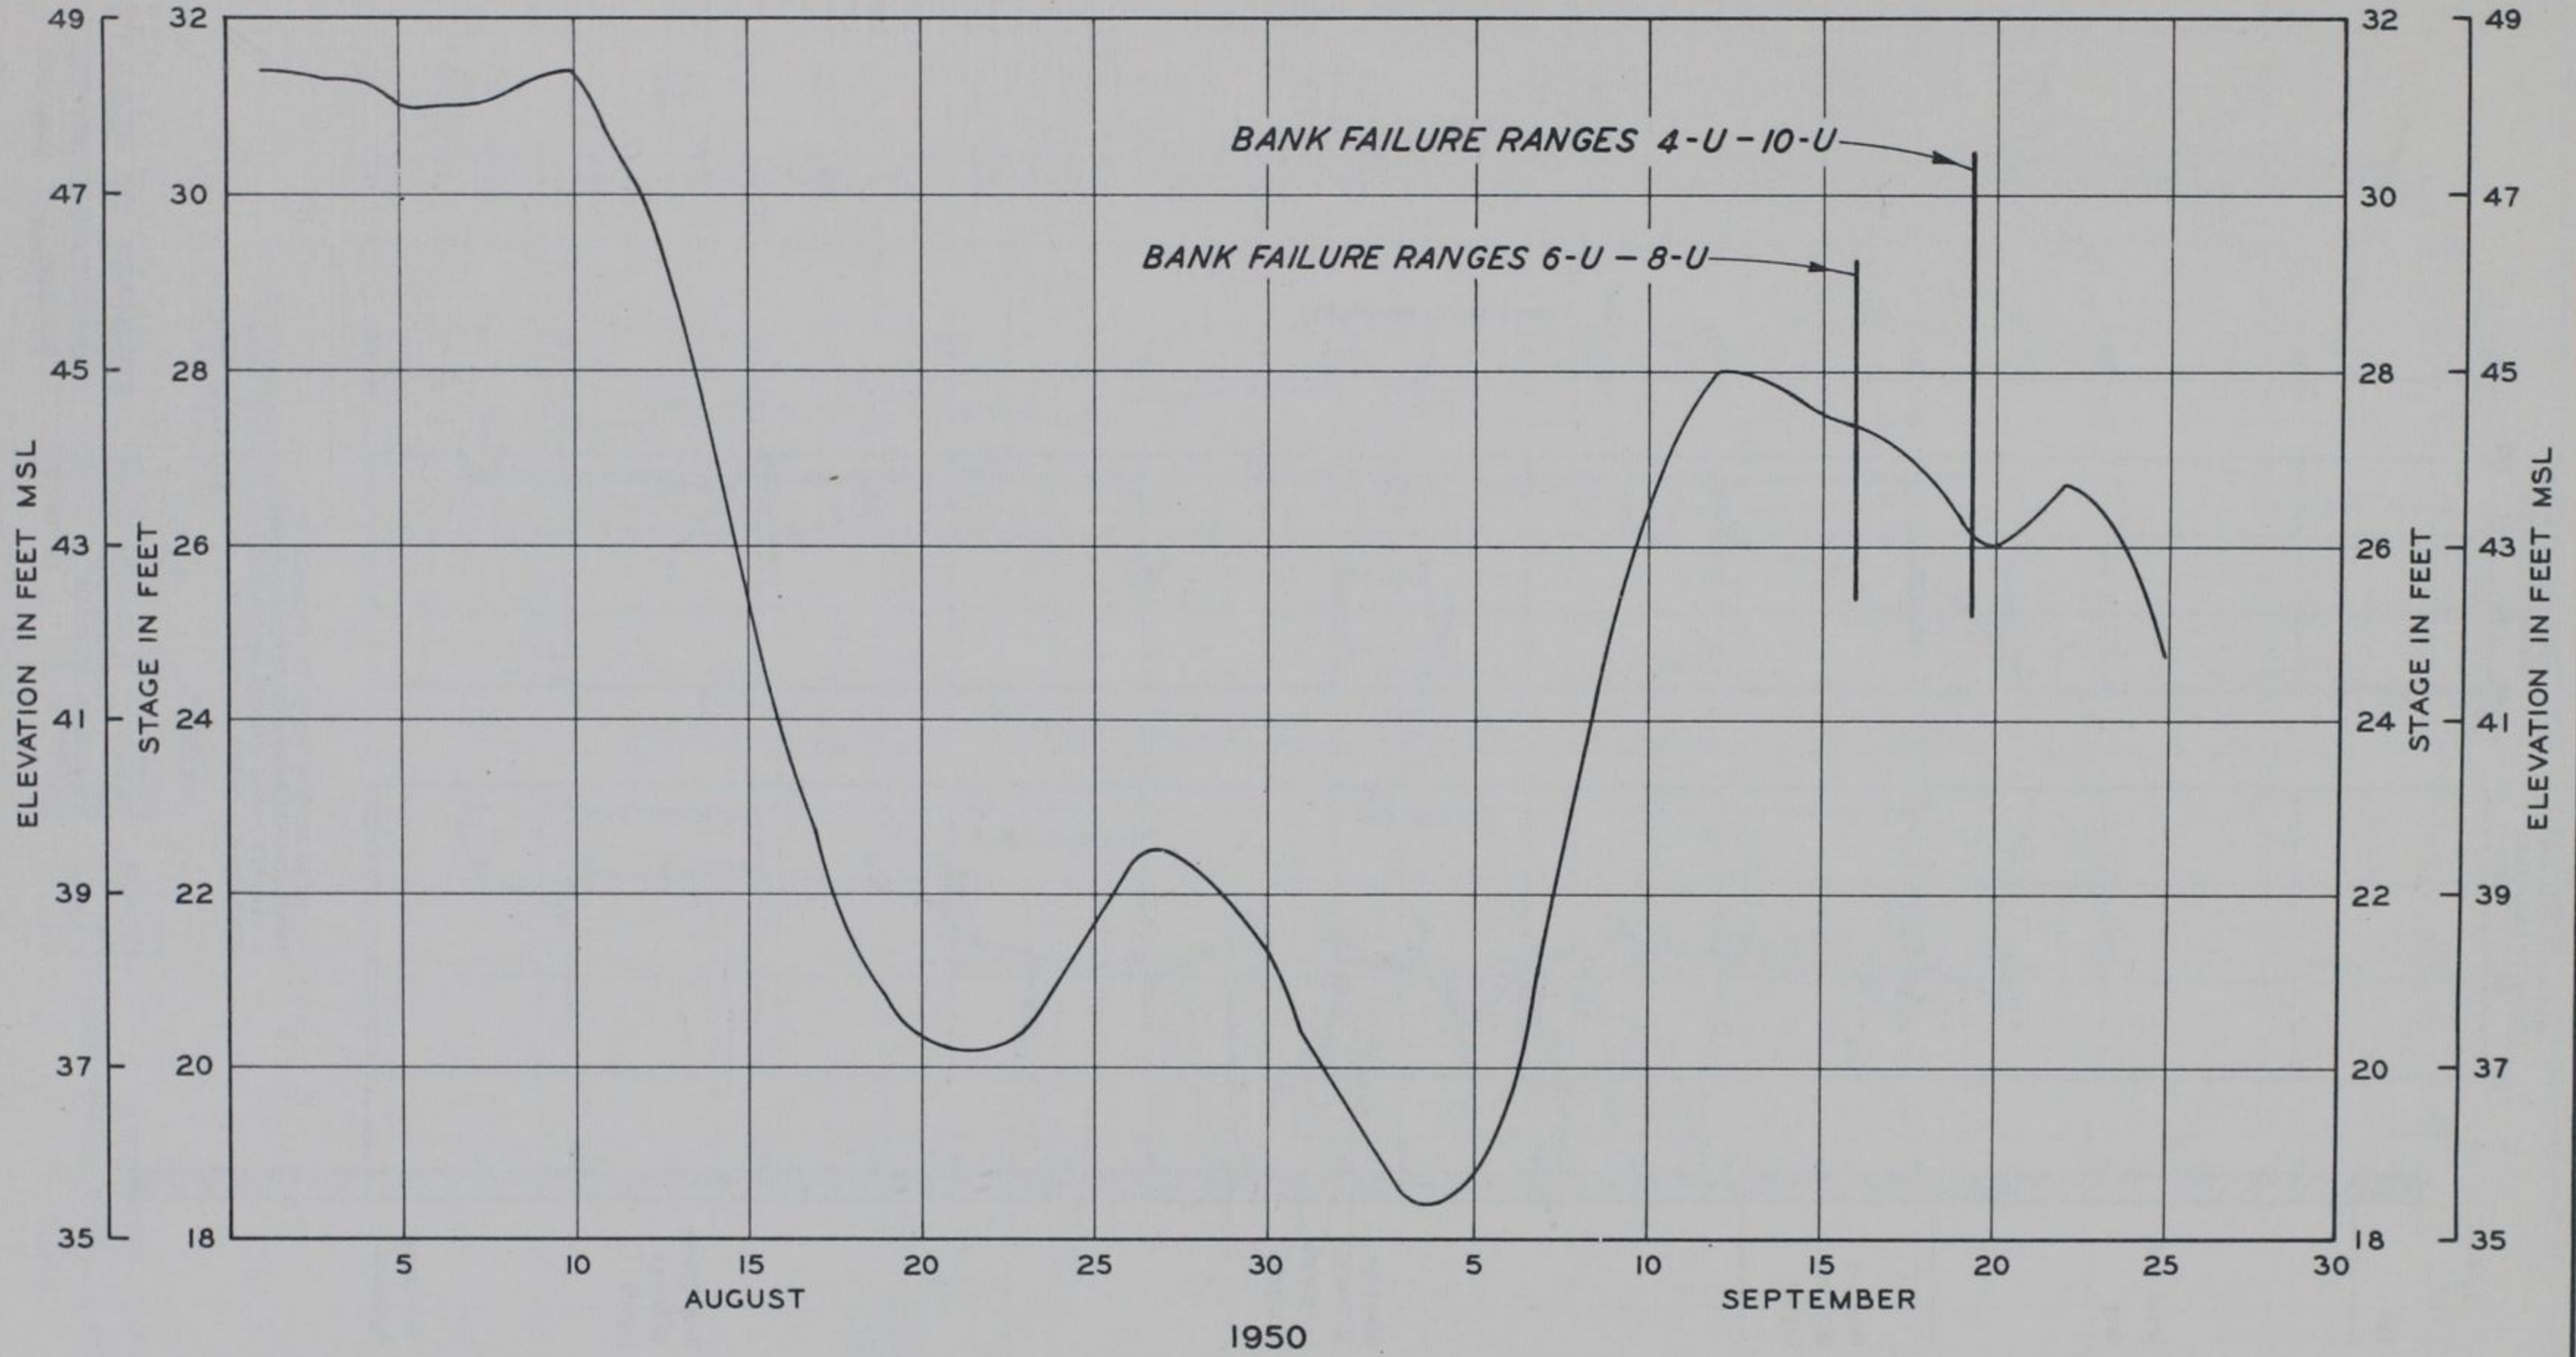
STAGE HYDROGRAPH
NATCHEZ BRIDGE GAGE

It is also important to note that these failures did not occur after a major drop in river surface elevation (see plate 9). The maximum fall of

the river prior to the last failures was in the order of 2 ft and the river had actually risen approximately 10 ft prior to the first failure. On the other hand, the failures did occur during bank-grading operations when a large amount of heavy equipment was being moved over the top bank area. It was observed that the upper bank became soft and spongy during these operations and excess water was visible on the surface. Based on the observed characteristics of the failures and the river and bank conditions, it seems reasonable to assume that these failures are typical of those previously discussed; i.e., they are relatively shallow flow failures.

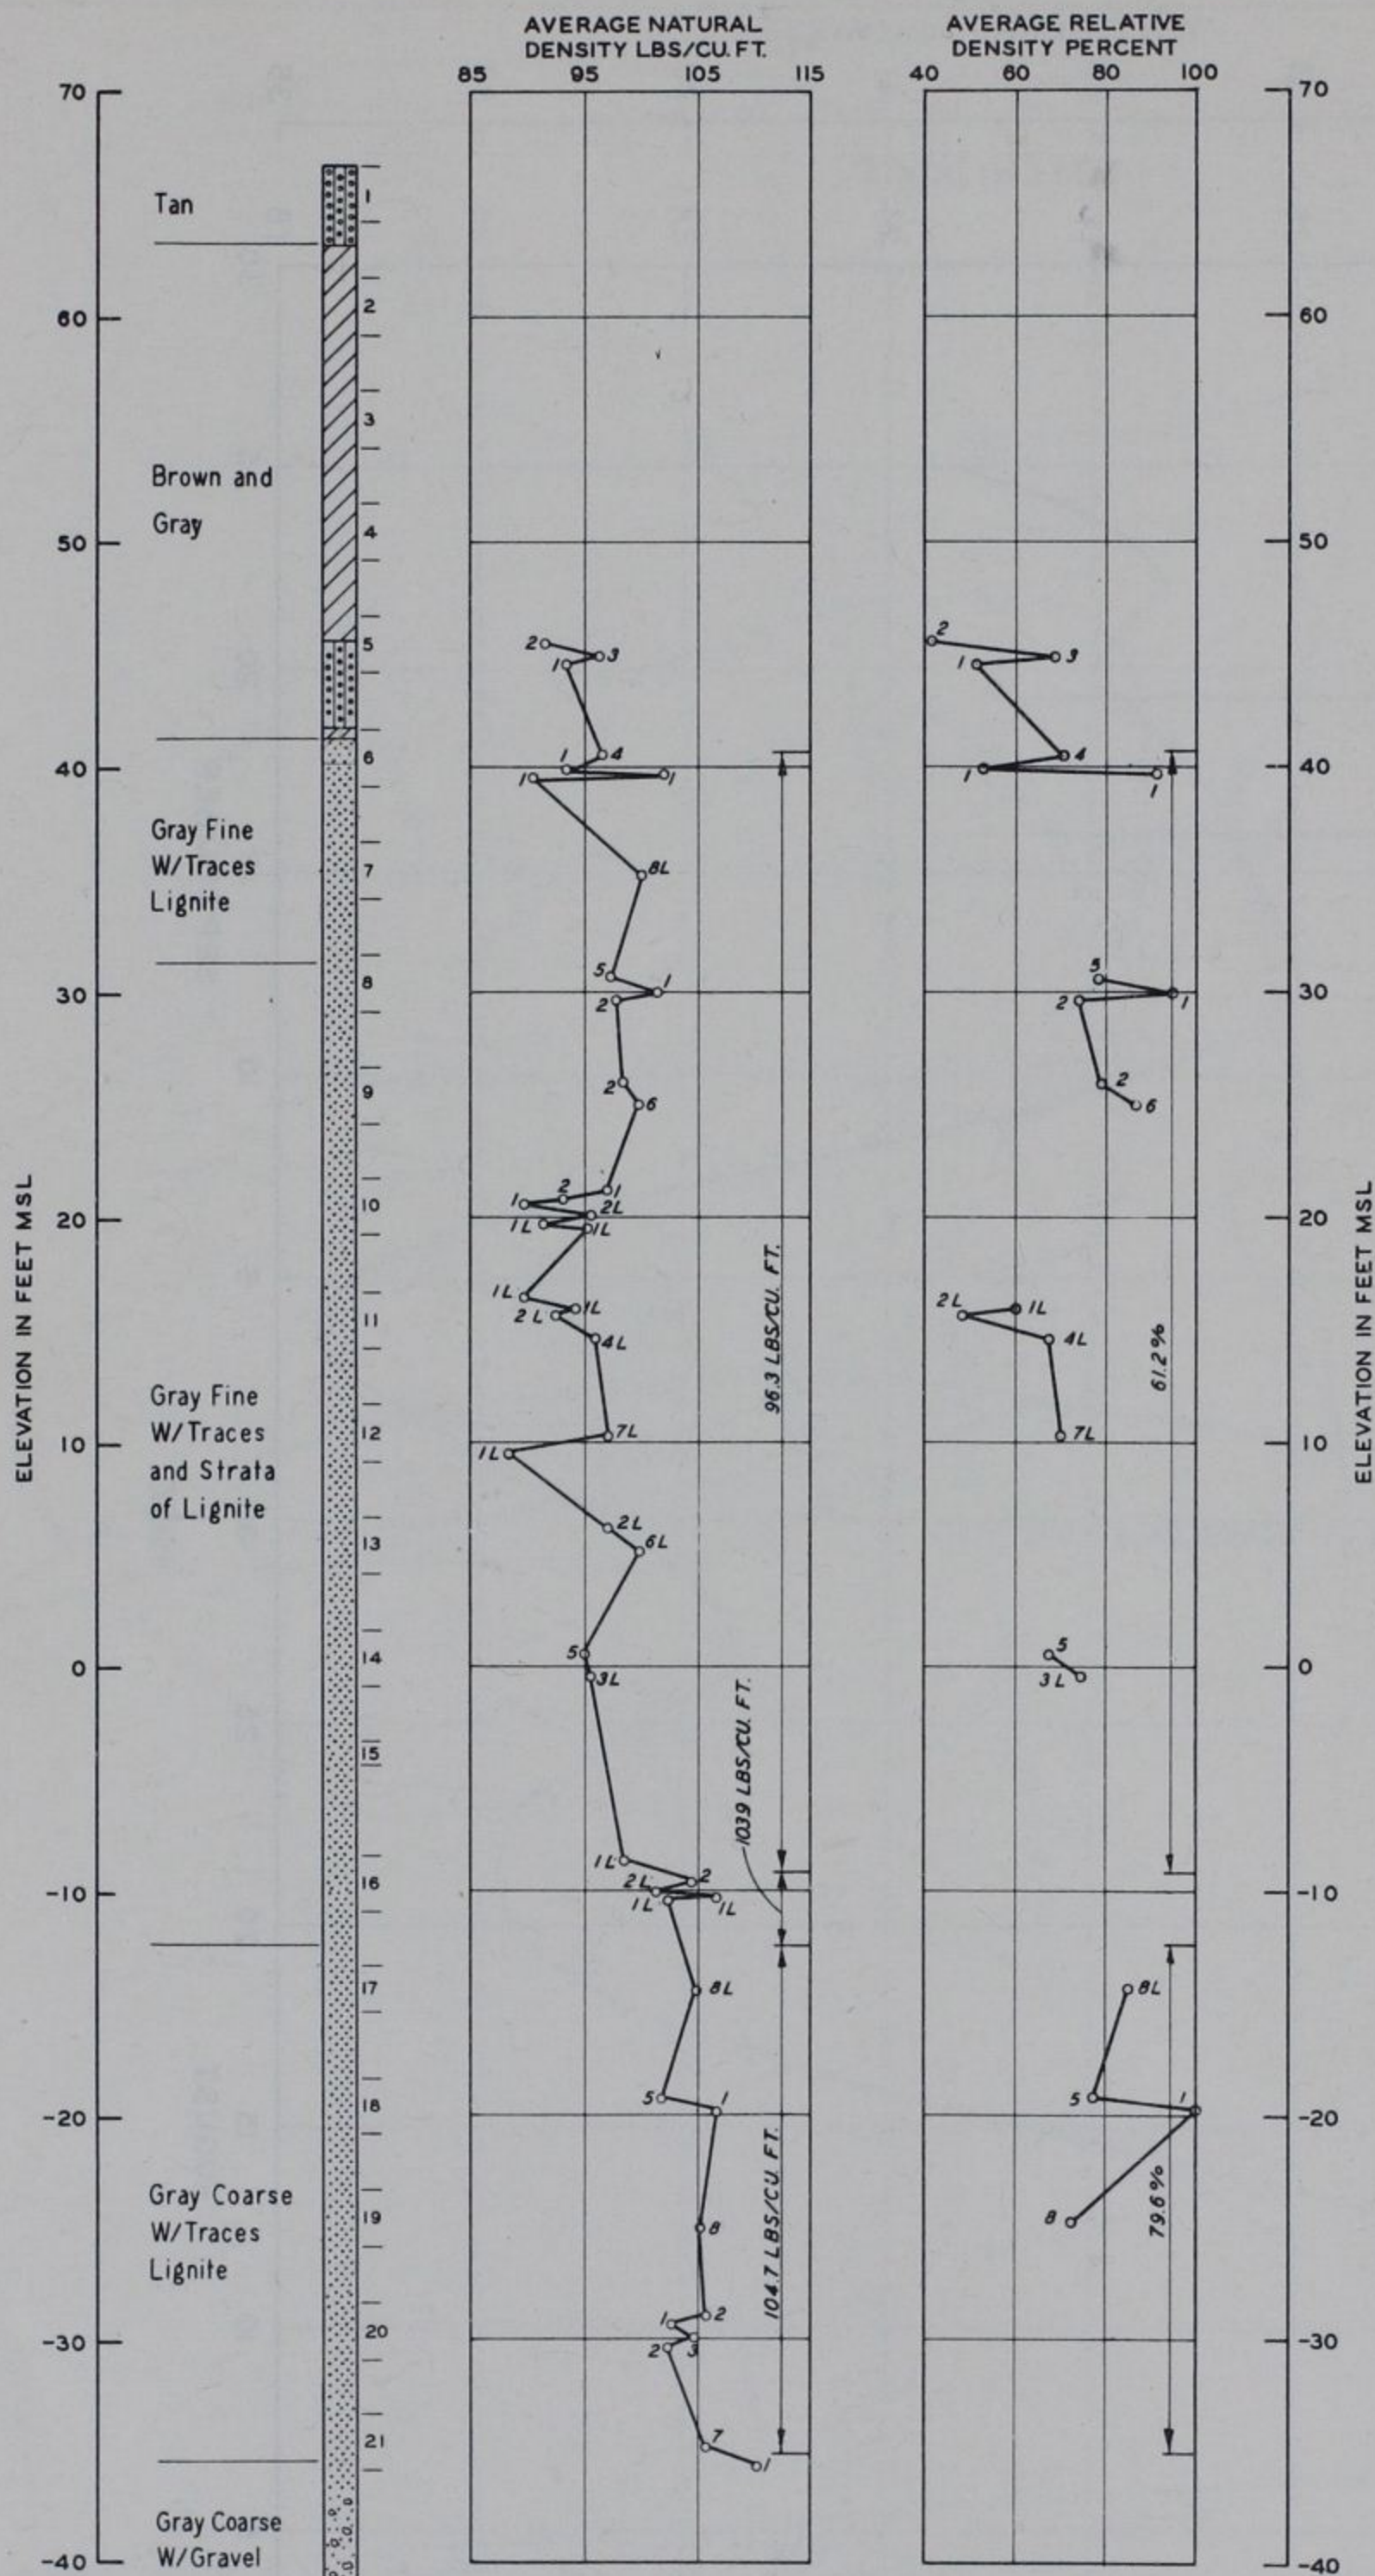
SUMMARY OF RESULTS
 UNDISTURBED BORING
 RANGE 5-D

24. Shallow failures will probably occur at the site of the revetment extension, since Zone A is apparently continuous over the entire reach. The continuity of these failures may be somewhat altered or possibly prevented by the remedial measures taken at the sites of the 1950 bank failures. A deep failure may occur at range 5D since Zone A

is very deep at this location, however, bank surveys show no past indications of large failures. The thickness of Zone A may not be as great at the face of the riverbank slope on range 5D as it is at the location of the boring. Soil conditions at other unexplored locations may be similar to those at range 5D and thus permit large failures to occur. It seems reasonable to suspect that this may be true at range 15D.
