POTAMOLOGY INVESTIGATIONS

Report 21-1

SAND - FILLED BAGS AS DIKE MATERIAL POTAMOLOGY RESEARCH PROJECT 9

U. S. Army Engineer District, Memphis CORPS OF ENGINEERS Memphis, Tennessee

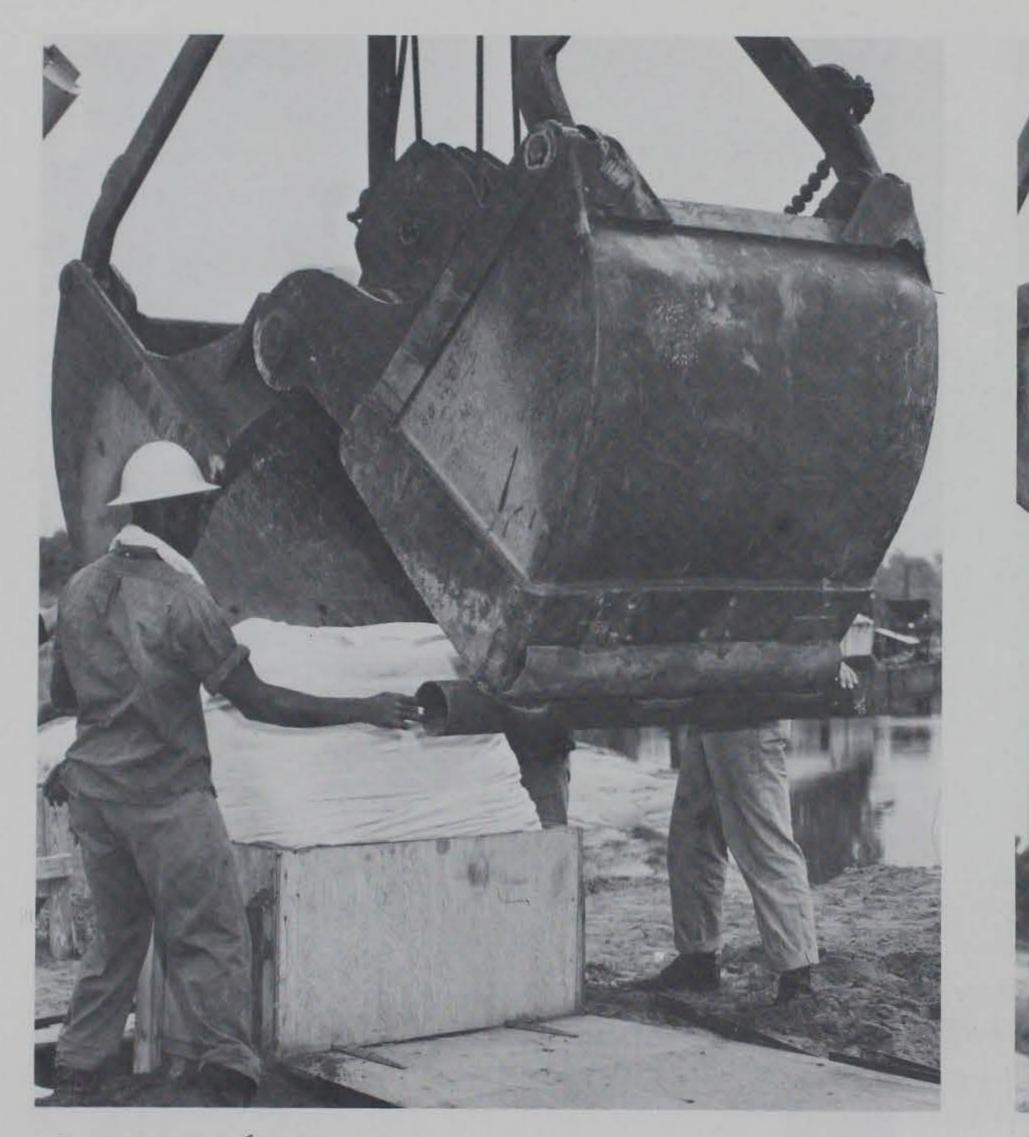
11. <u>Nylon.</u> The filled bags were removed from the bank and loaded on barges by means of a floating crane. For handling the nylon bags, a clamshell bucket was altered by welding 6-in. pipes, 6 ft in length, across the teeth on each side of the bucket to prevent direct contact between the bags and the sharp edges of the bucket (see photograph 6). Bags were first picked up near the tops as shown in photograph 7, resulting in some breakage of the fabric from pressure exerted below the point of contact. Picking up from the side of the bags was tried but with no better results. Further damage to the bags from rough edges on the sides of the jaws of the bucket and the jagged ends of the pipes was remedied to some extent by using rubber padding.

Photograph 6. Clamshell used in handling nylon bags. Note 6-in. pipe welded to jaws of bucket to protect nylon bag from damage

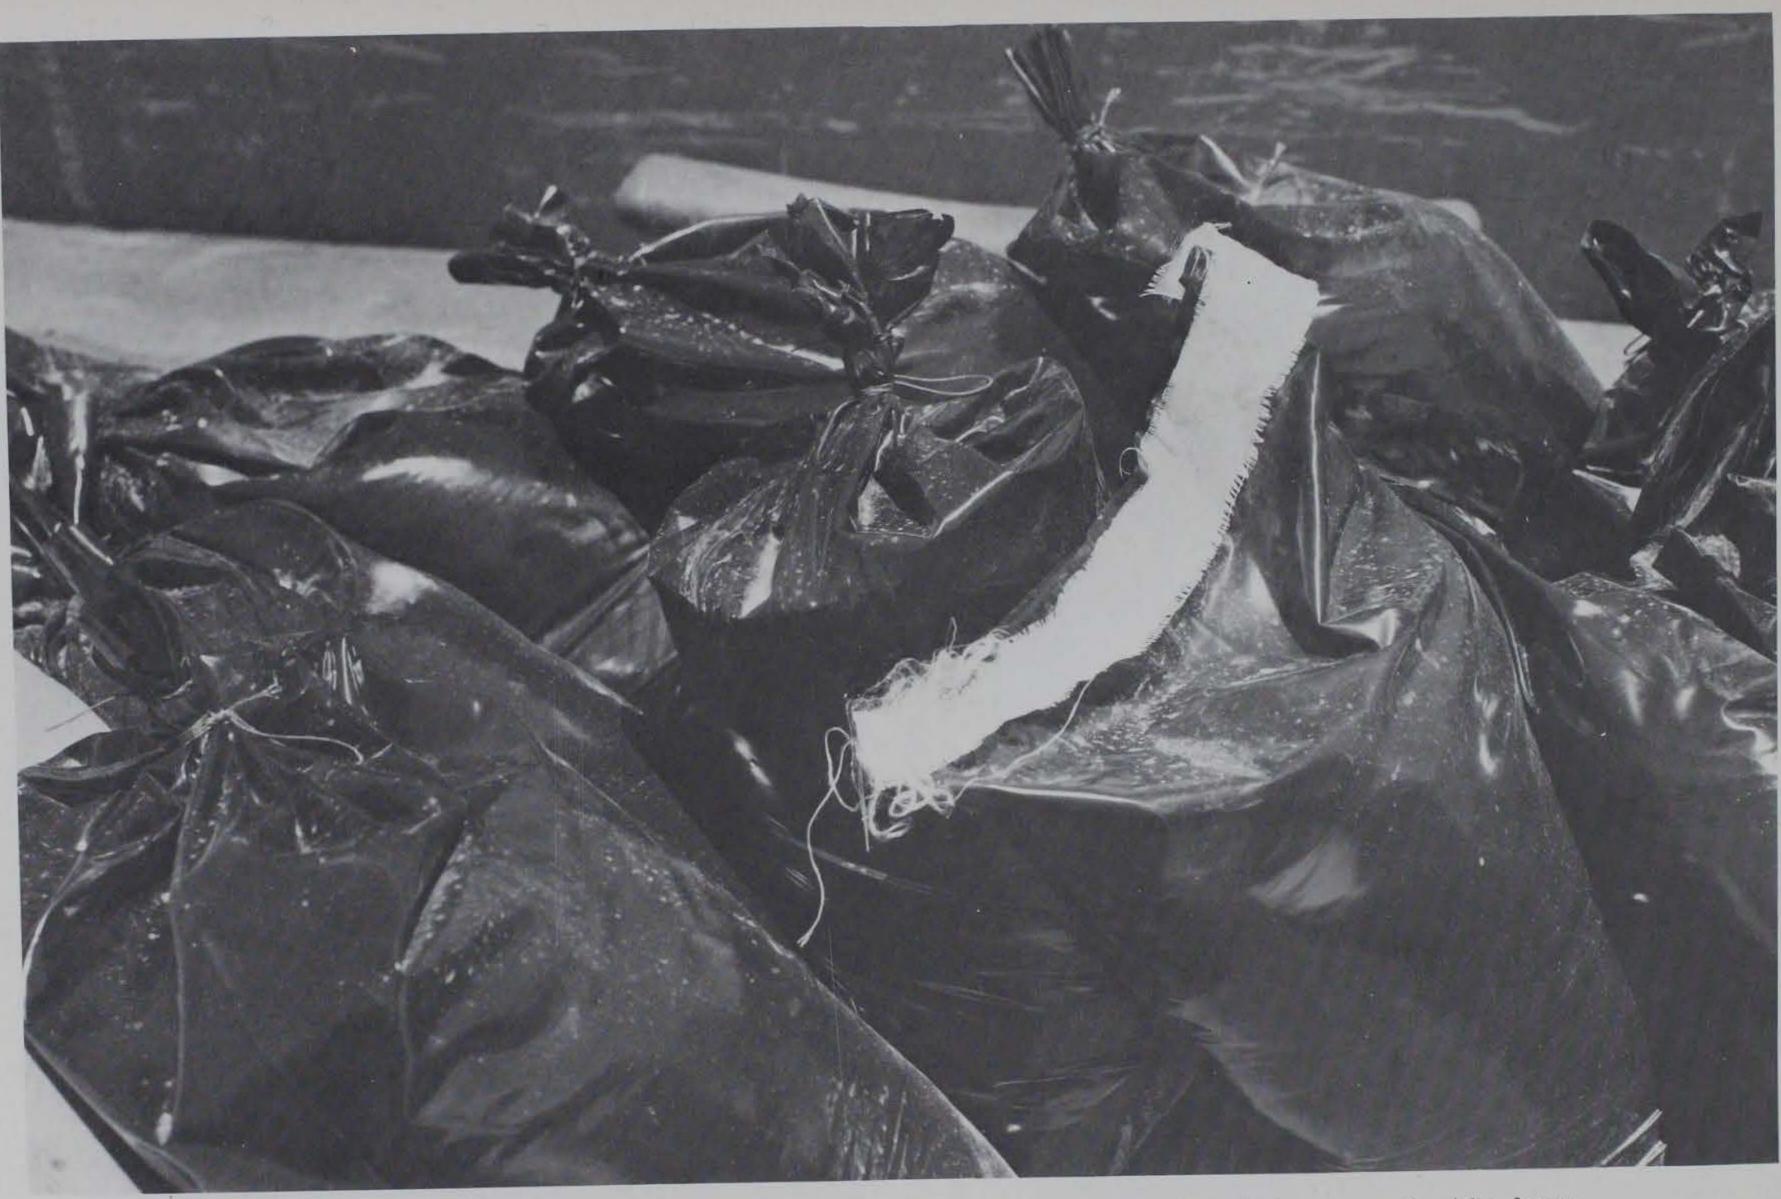
the use of this method except under laboratory conditions. Sewing was tried (see photograph 11) but this was also unsatisfactory. Consequently, a method of tying the bags by hand with treated cord was decided upon, also shown in photograph 11. This resulted in faster operations and satisfactory results. In addition to the 3,987 black plastic bags for use in the test section, 90 clear plastic bags with a capacity of approximately 0.05 cu yd were furnished by Union Carbide Corp., principally to test the self-sealing feature of the bags. This feature consisted of a spout, or flap, which closed after being filled, preventing loss of the material. Filling of these bags with the equipment on hand was difficult due to the small opening provided in the bag.

Photograph 11. View showing method used in unsuccessful attempt to sew plastic bags. Also method of tying bags

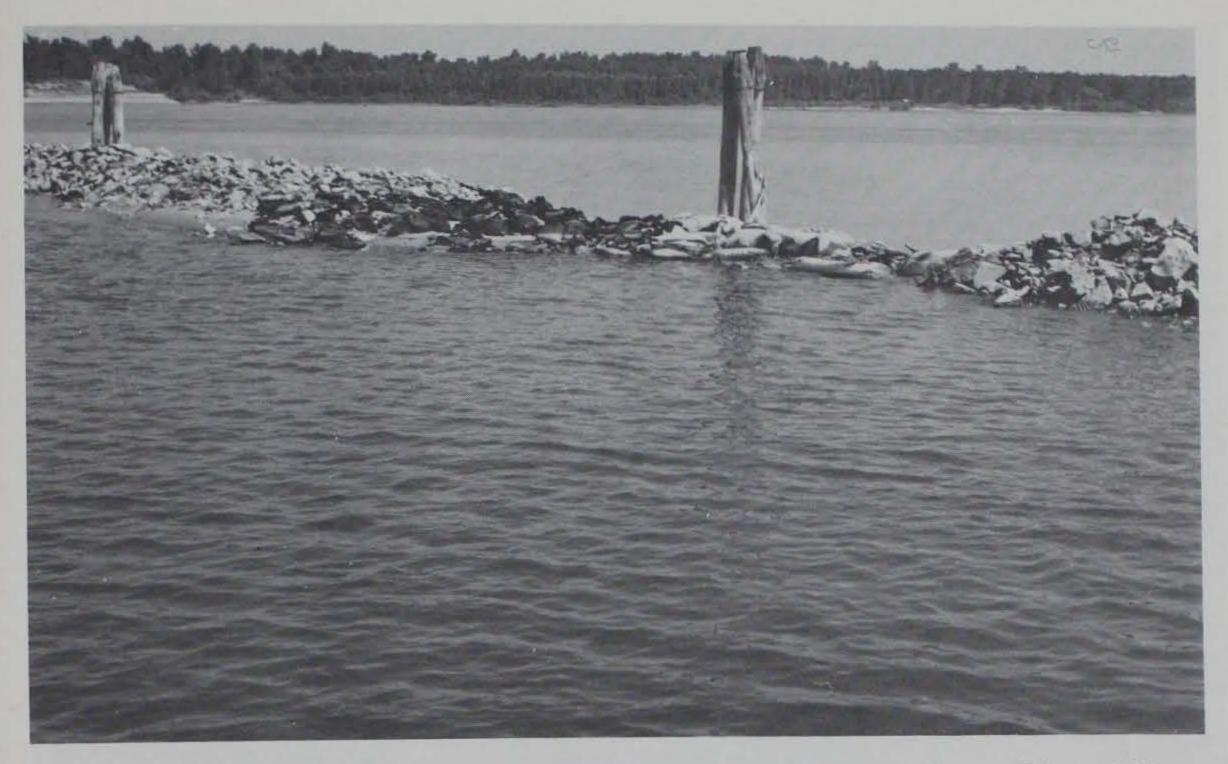
and the profile over the bag section showed an additional lowering of from 1 to 4 ft below the adjacent stone section. The survey also revealed a large failure in the stone portion of the dike 400 ft riverward of the bag section. In addition to the loss in elevation of the bag section, most of the plastic bags in the top portion of the dike, as well as about 20 ft of the adjacent stone dike, had been moved about 10 ft downstream by current action. Both plastic and nylon bags which had been exposed to the current were badly damaged, and fill material had been washed out. However, there had been little apparent movement of any of the undamaged nylon bags. Photographs 26-31 show the general condition of the test section after one high-water period.

Photograph 26. Looking upstream, showing profile of damaged bag dike

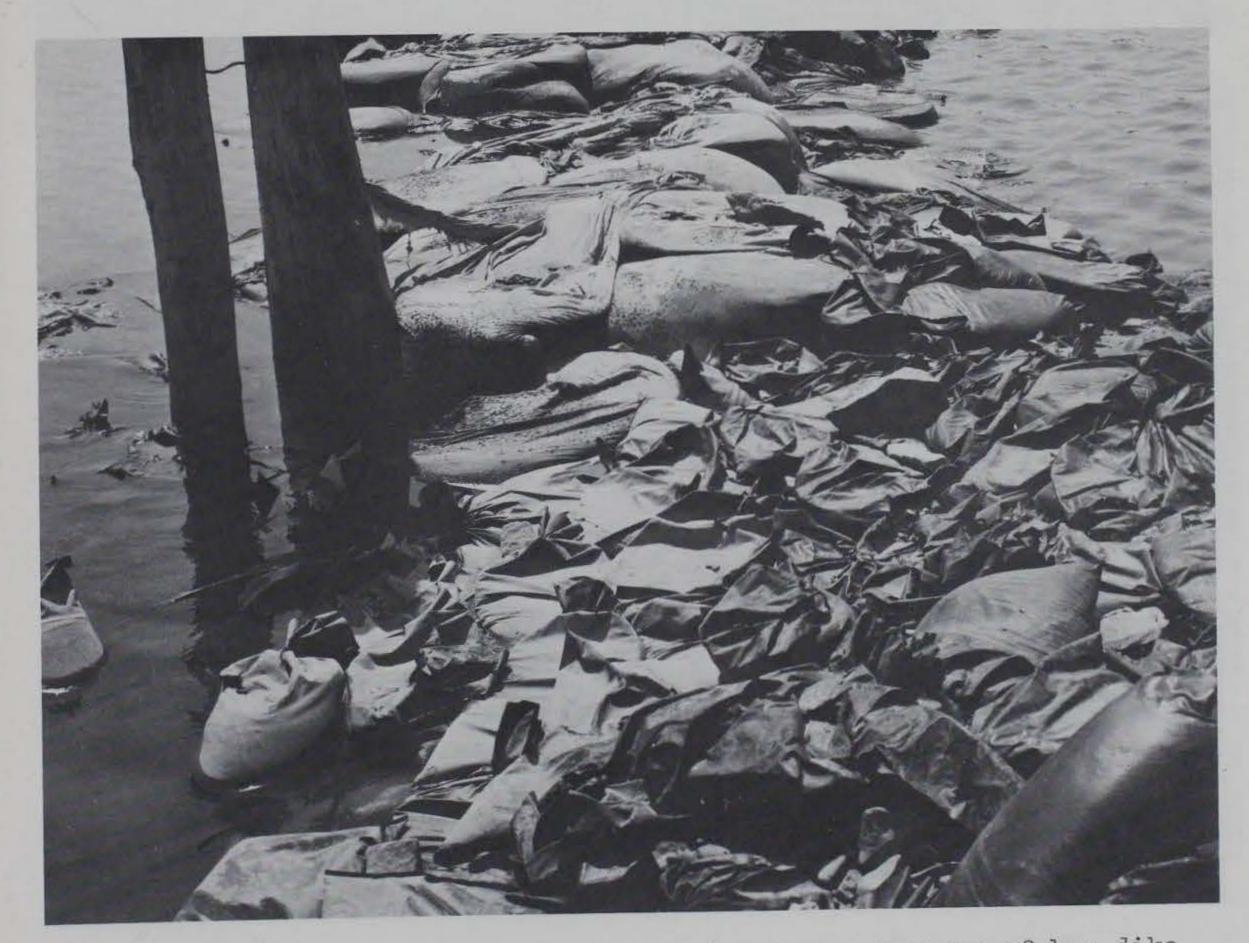
Photograph 27. Looking landward, showing damaged crown of bag dike

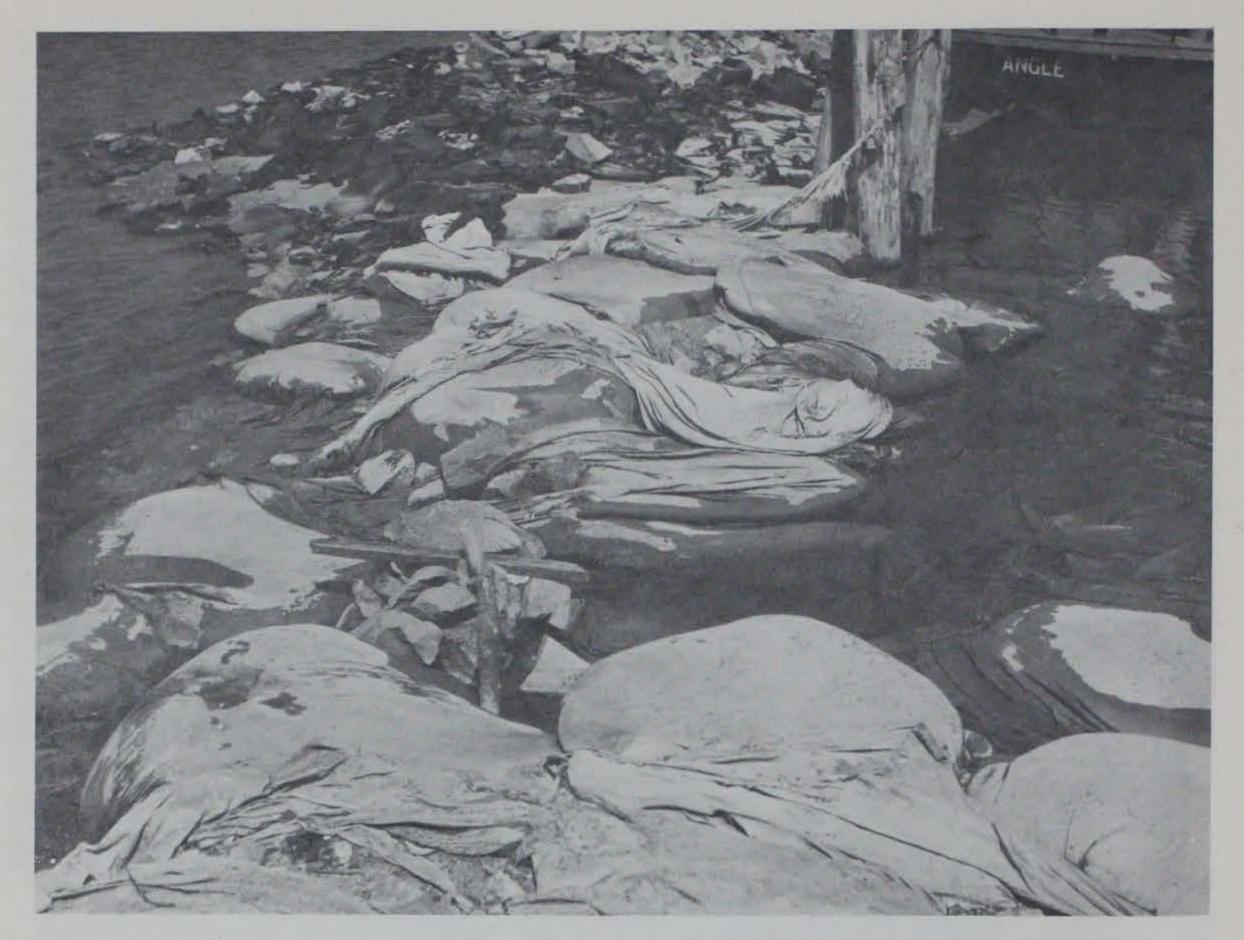
23. <u>Durability of bags.</u> Although some of the smaller and lighter plastic bags were moved by the current, the principal cause of failure of both types of bags was the loss of fill material due to rupture of the bags. This was evidently caused by drift or other floating objects during stages at or near the dike elevation. During the period of stage fluctuations, as indicated on the hydrograph (plate 7), the bag section was alternately submerged and exposed a total of six times, during which extensive damage could have occurred from drift or even boats.

Photograph 28. Looking riverward, showing damage to both nylon and plastic bags. Note how plastic bags have shifted downstream

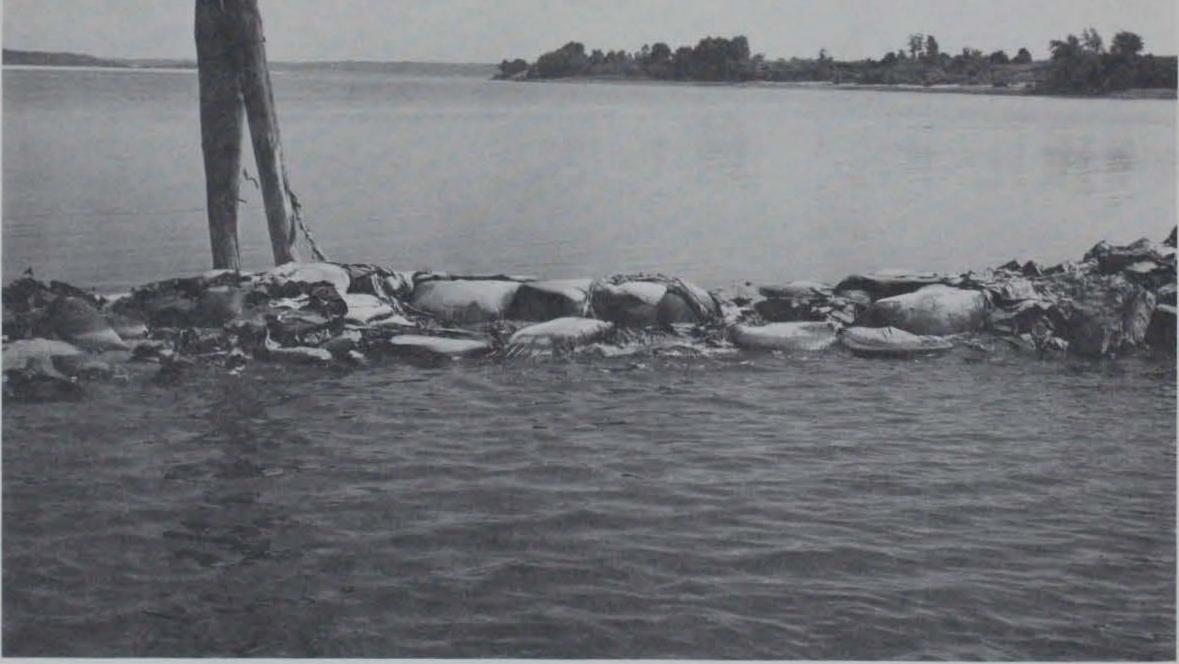
Photograph 29. Upstream profile of damaged nylon bags

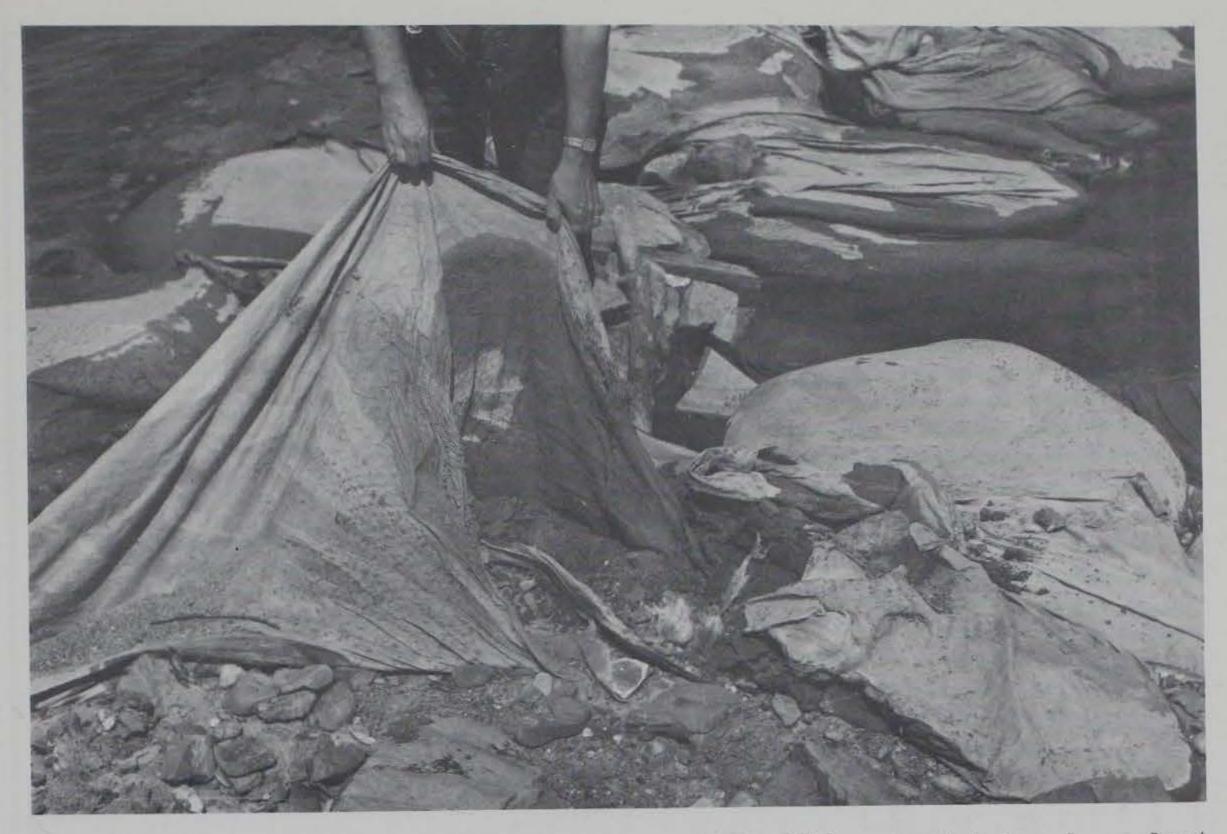
Photograph 30. Damaged nylon bags from which fill material has been lost

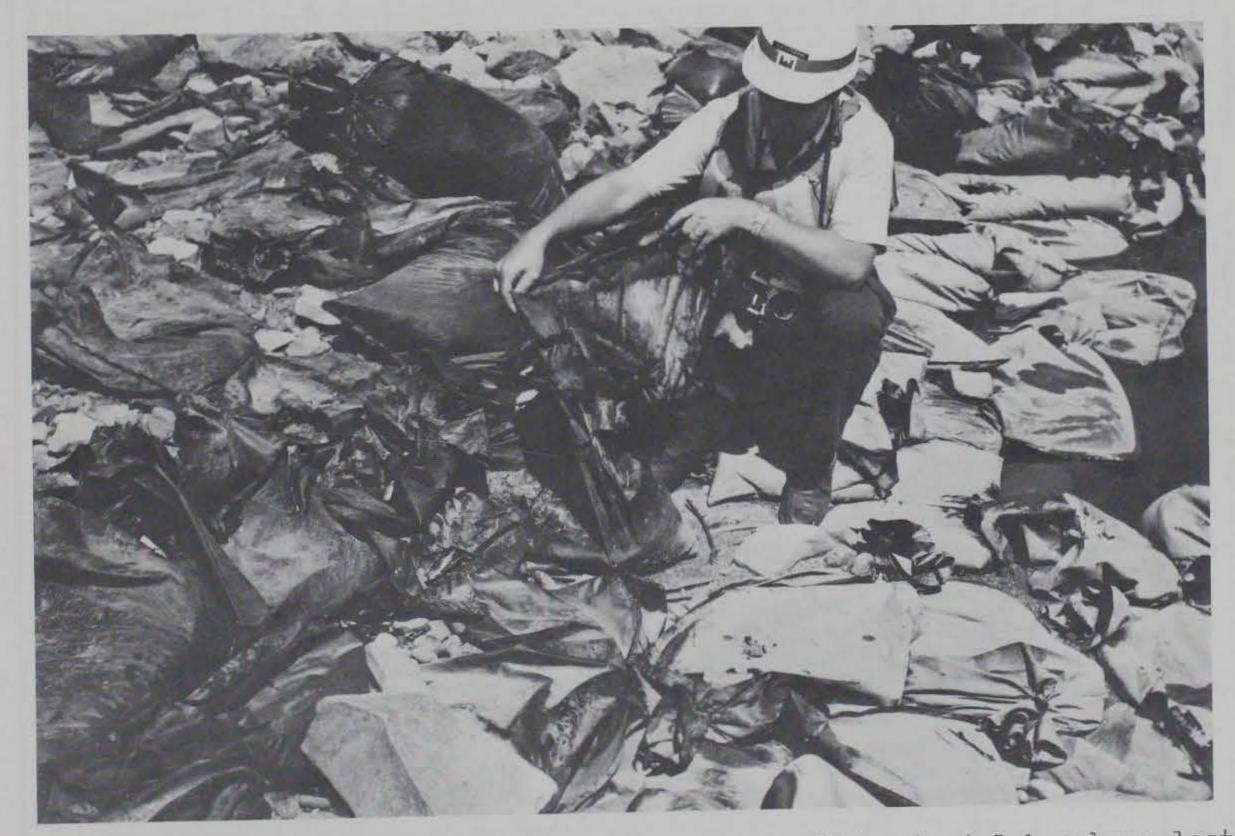
Photograph 31. Damaged plastic bags from which fill material has been lost
