# **Guided-Wave Inspection of California Department of Water Resources Tainter Gate Trunnion Rods**

Inspection of Oroville Dam, Thermalito Bypass, and Pyramid Dam

Jason D. Ray, Richard D. Brown, and James A. Evans

September 2019

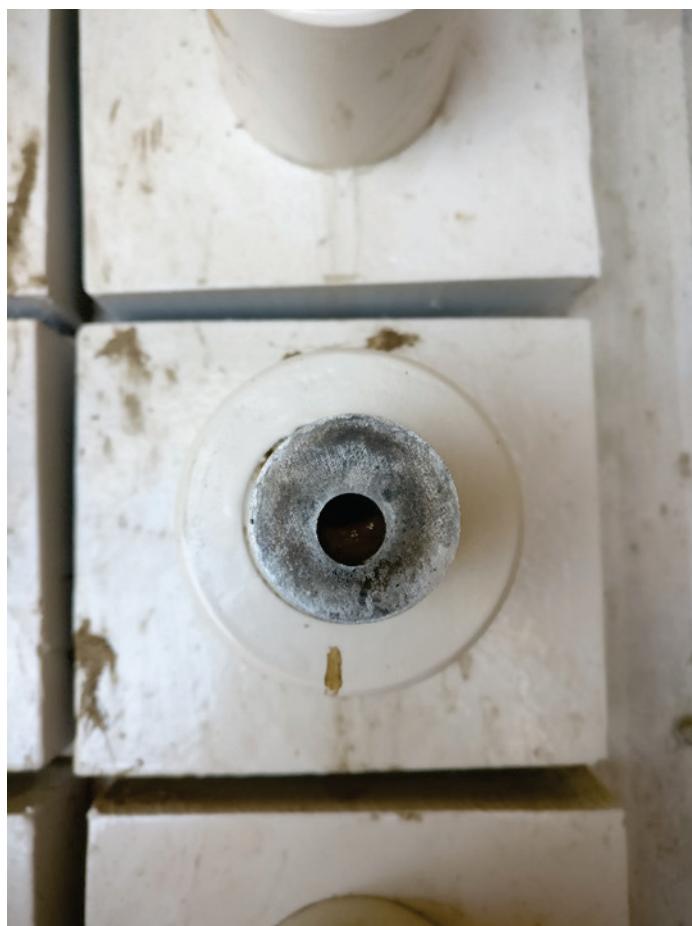
Figure 2. Drilled tendon at Oroville Dam.

Initial photos of the tendon ends showed the first possible issue (Figure 2). Each rod contains a drilled out end of varying depth and location on the rod face. The guided wave technology relies on a flat surface for the ultrasonic transducer to couple with. Any anomalies in the rod surface directly affects the resulting signal response.

Even though it was proven possible to still work within the confines of the Oroville Dam rod condition, several methods were tested to amplify the response. The first was the use of a plug to insert into the hole. The plug was made to fit using the same material as the rod. Coupling grease was applied inside the drilled hole in order to fill any imperfections from the drilling. This method provided a marginally better response, however, due to variability in the drilled tendons at Oroville Dam, this would not work, as inserts for every tendon could not be made. The second method was to attach a matching coupling rod end to extend the length of the rod slightly, thus, providing enough length for the guided wave modes to set up. This required tapping the drilled tendon end so that the coupling piece could be screwed on. The response with this method also did not provide enough of an increase in signal response to warrant trying to design for all possible cases at the dam. For these reasons it was decided to rely on injecting enough acoustical energy to simply overcome the loss in surface area.

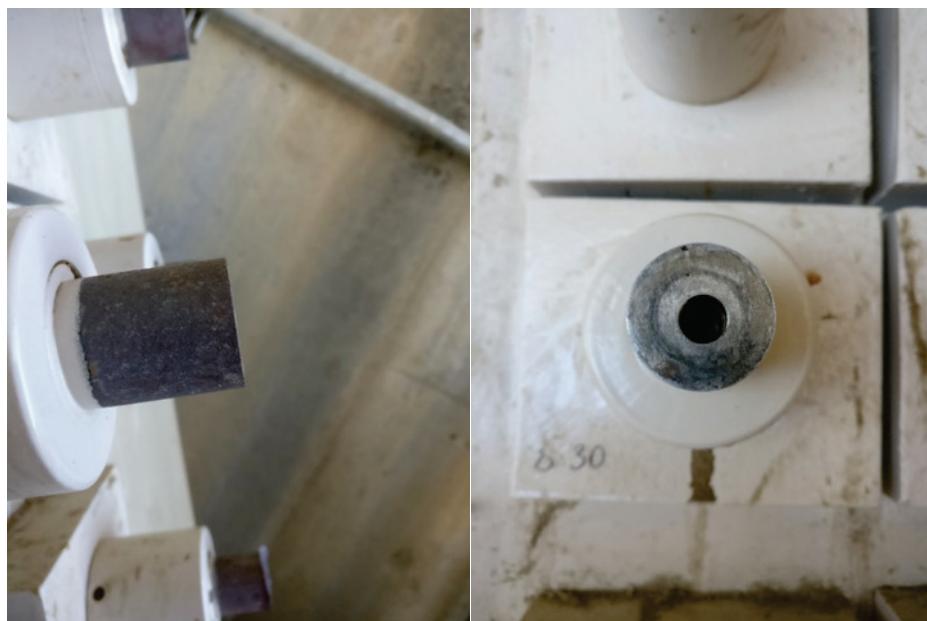
Figure 7. Oroville Dam rod condition.

In addition to the drilled tendons as previously discussed, the smoothness of the rod end and how perpendicular the surface is with the length of the rod are major factors in how much energy is able to cross the air gap between the transducer and rod surface. Upon arrival, the rod ends were found to be in overall good shape. The ends were smooth and mostly perpendicular. Examples are shown in Figure 7.

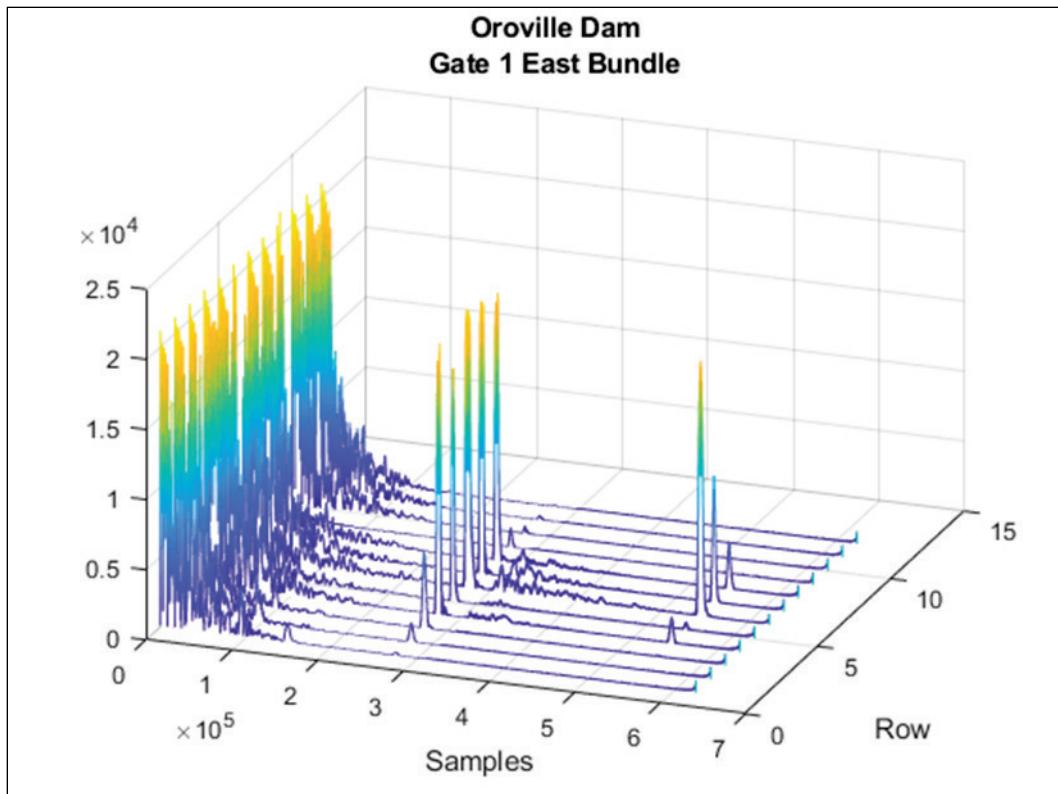
Figure 9. Oroville Dam rod curvature effects.

The rod curvature resulted in more issues than originally expected. As the bend of the rod increased (the upper and lower rows of rods), the signal attenuated at a faster rate. For example, the results of each row from a single column at Oroville Dam is show in Figure 9.

The right axis of Figure 9 represents the row number within the bundle. The middle most rods often result in a response that clipped the input of the oscilloscope requiring the overall gain to be reduced. The larger responses allow for multiple end of rod rebounds to occur, often resulting in three total. In every sample, at least one end of rod rebound was obtained, however, for the upper and lower limit rods, the response was very small.

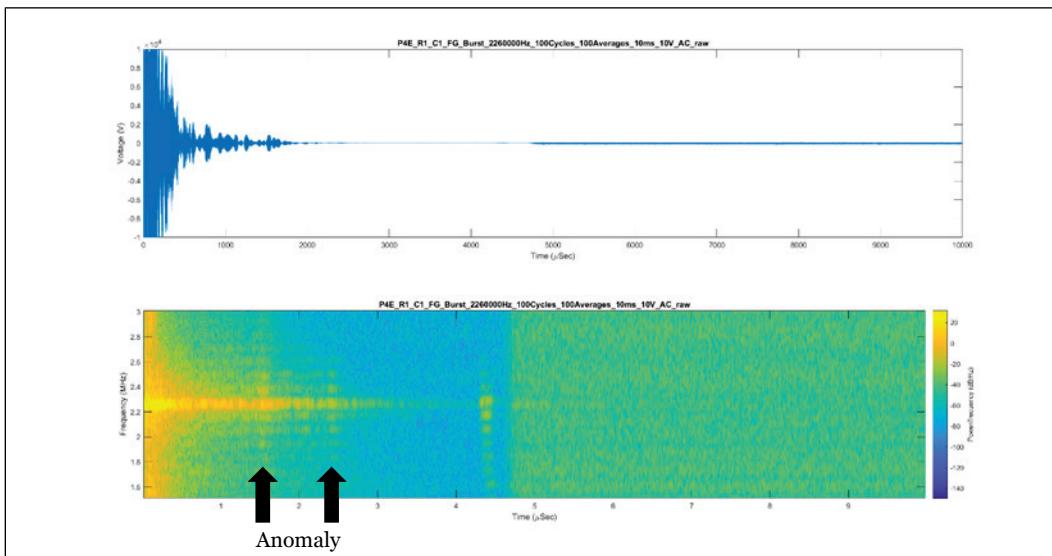
Figure 12. Oroville Dam: Gate 4, west; Row 1, Column 1; anomaly.

The Anomaly category is mostly limited to the upper and lower most rods. In addition to the attenuated signal response, the reflectors were noticed before the end of rod response. These reflectors appear at roughly the same point in time for the rods labeled as anomaly. As detailed in 2.1.2, these rods were curved during installation. Due to the frequency of occurrence within the curved rods, it appears that the curvature is the cause for these anomalies. One possibility for this occurrence would be sleeve contact where the rod sleeve rests on internal guides as seen in Figure 11. According to the original drawings, the first of these guides appear at a rod length of 18'6" plus the exposed length of rod. The first anomaly reflector appears around 15' in the rod according to the received data.

These two rods are a part of Gate 4 different bundles. Figure 12 is on the west bundle; Row 1, Column 1. Figure 13 is on the east bundle; Row 12, Column 2. The location of these anomalies is roughly the same for each case shown in the results section. Due to how frequent the anomaly appears, these rods are not labeled as damage.

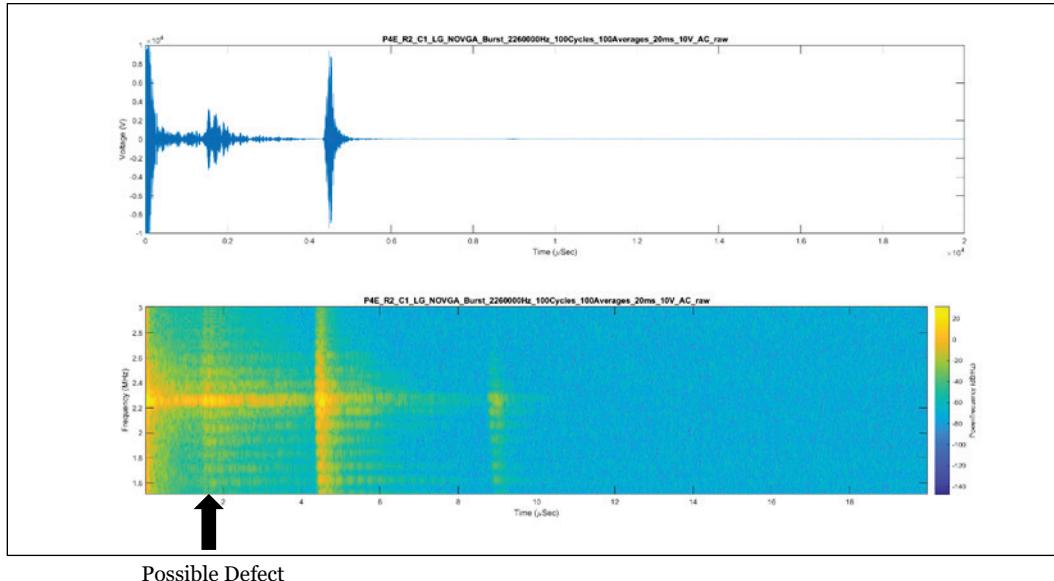
**Figure 14.** Oroville Dam: Gate 4, west; Row 2, Column 1; possible defect.

Of the 384 rods tested, two rods are labeled as possible defects — Gate 4, west bundle; Row 2, Column 1, and Gate 7, west bundle; Row 2, Column 2. The responses of these two rods are shown in Figure 14 and Figure 15.

Of these two, Figure 14 shows the greatest possibility of being an actual defect. Both the time-voltage and time-frequency plots show a strong signature similar to that of the end of rod response. In Figure 15, the time-frequency signature looks similar to the anomalous rods though the time-voltage plot has a stronger response than other anomalous rods. For this reason it is being classified as a possible defect.

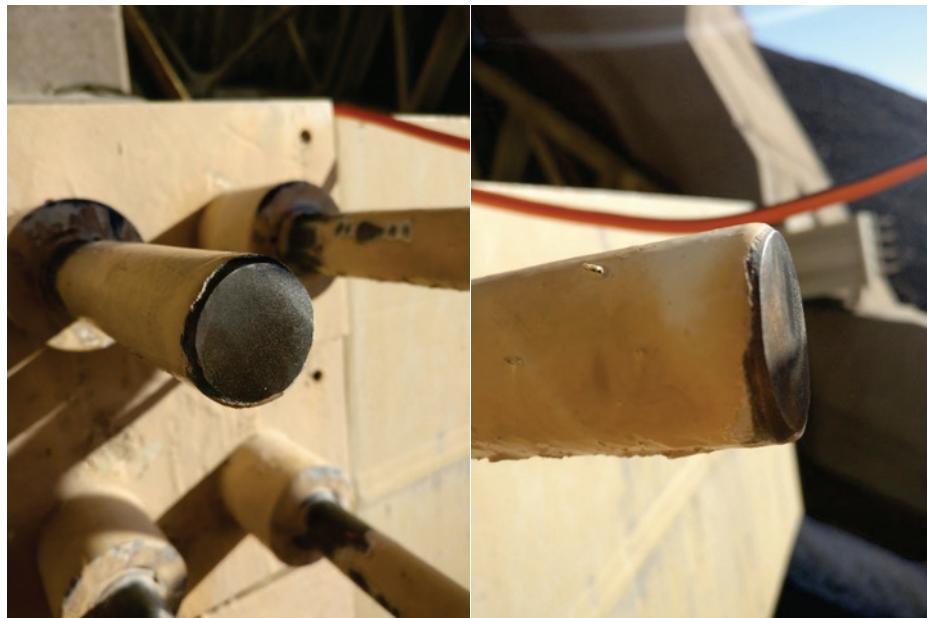
Figure 25. Thermalito bypass rod condition.

Figure 25 shows the condition of the rods at the time of testing. Although the rod ends look smooth, there are irregularities in the surface which could lead to poor transducer contact. However the irregularities here are minor and the coupling grease fills in the imperfections to provide good surface contact with the transducer.

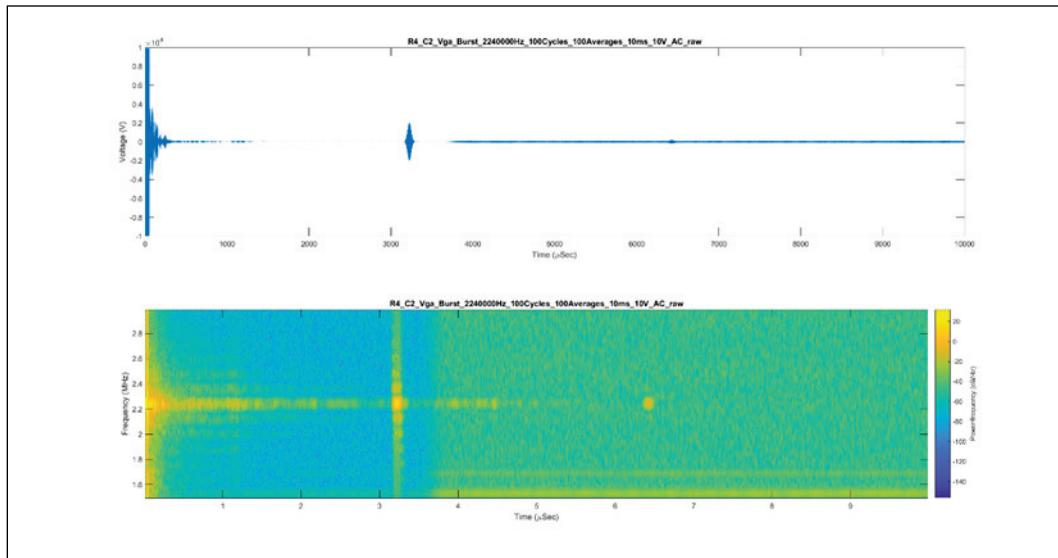
Figure 27. Thermalito Bypass: east; Row 4, Column 2; anomaly.

As with Oroville Dam, the more curved rods showed evidence of reflectors while the straighter rods came back with no evidence of issues. 16 rods were tested, Figure 26 shows the results of one of the rods showing No Issue. Figure 27 shows the results of one of the rods being labeled as an anomaly.

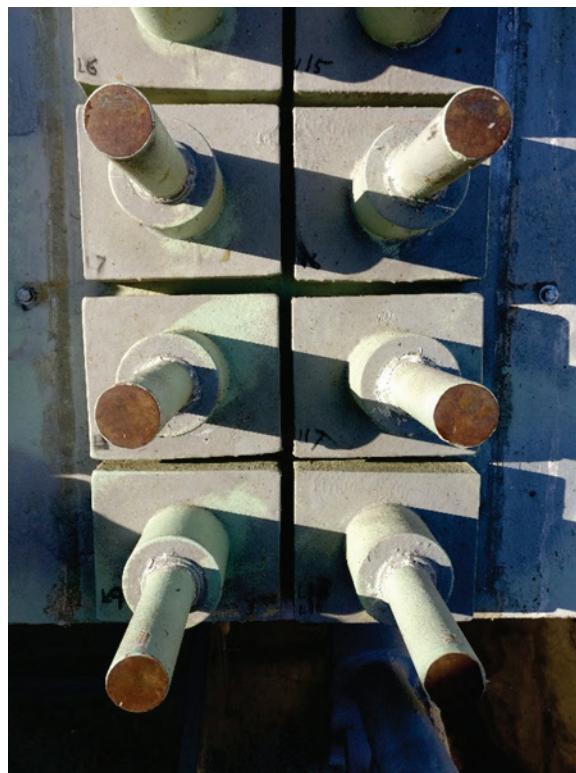
Figure 29. Pyramid Dam rod condition.

The rods at Pyramid Dam were both smooth and perpendicular to the length of the rod. No issues were seen with coupling. Figure 29 shows the condition.

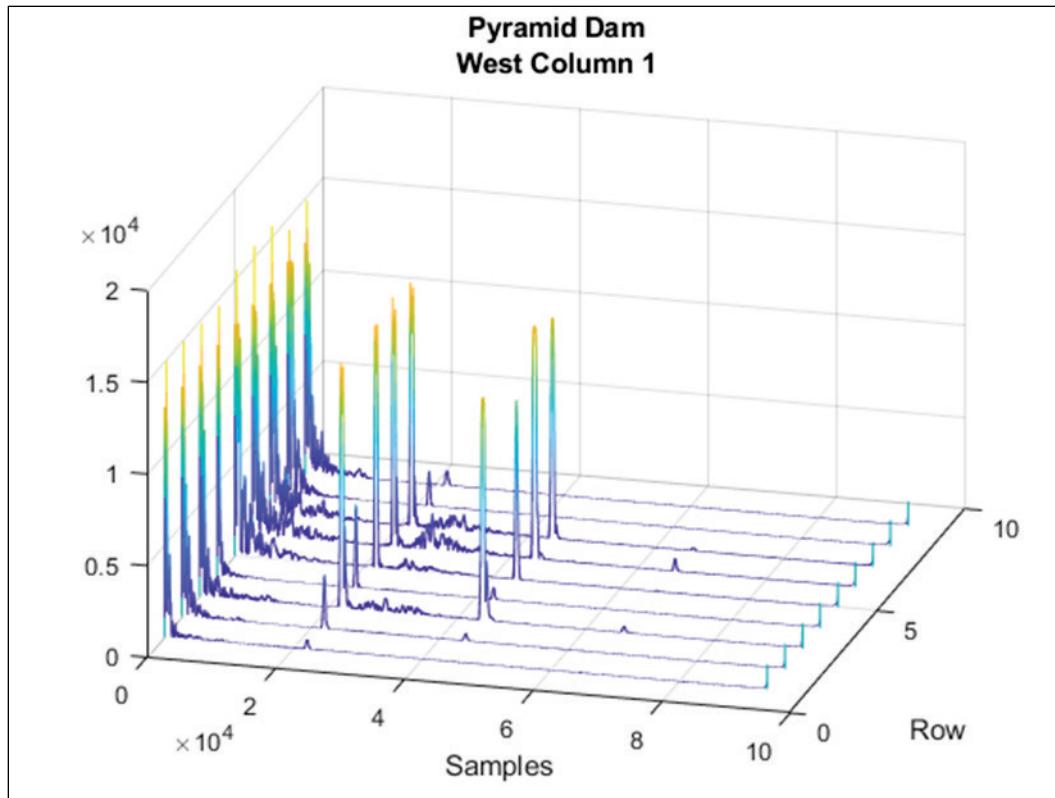
Figure 30. Pyramid Dam rod curvature effects.

Like Oroville Dam and Thermalito Bypass, Pyramid Dam contains rods that are curved. The rods of a single column in a bundle were plotted together to show the effects the curvature has on the signal. The results are shown in Figure 30.

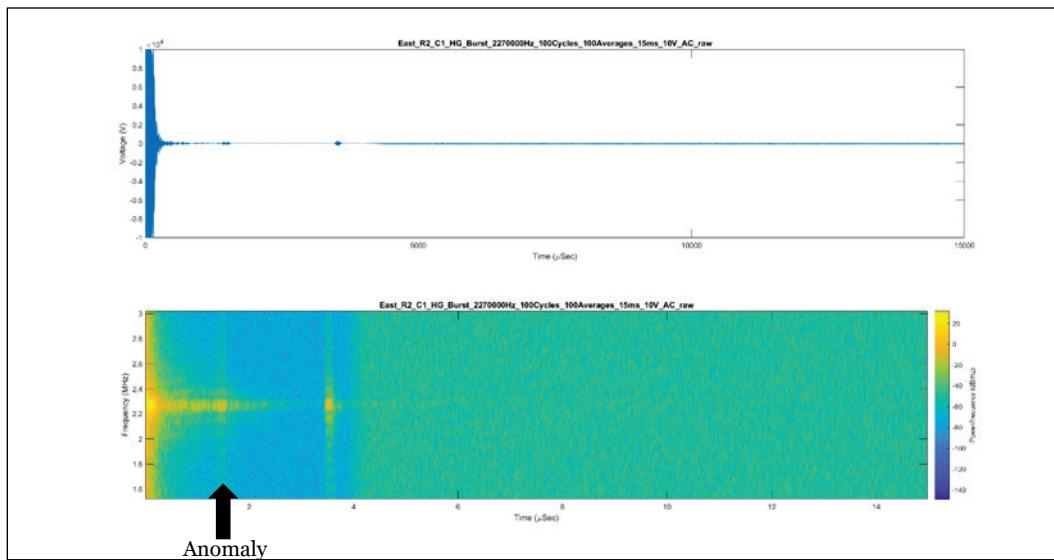
Figure 32. Pyramid Dam: east; Row 2, Column 1; anomaly.

Figure 31 is an example of a rod showing No Issues. Further evidence supporting the theory that rod curvature causes anomalies in the data; the rods at Pyramid Dam exhibited reflectors on the rods that bend upward and downward within the dam. This effect is seen in Figure 32.

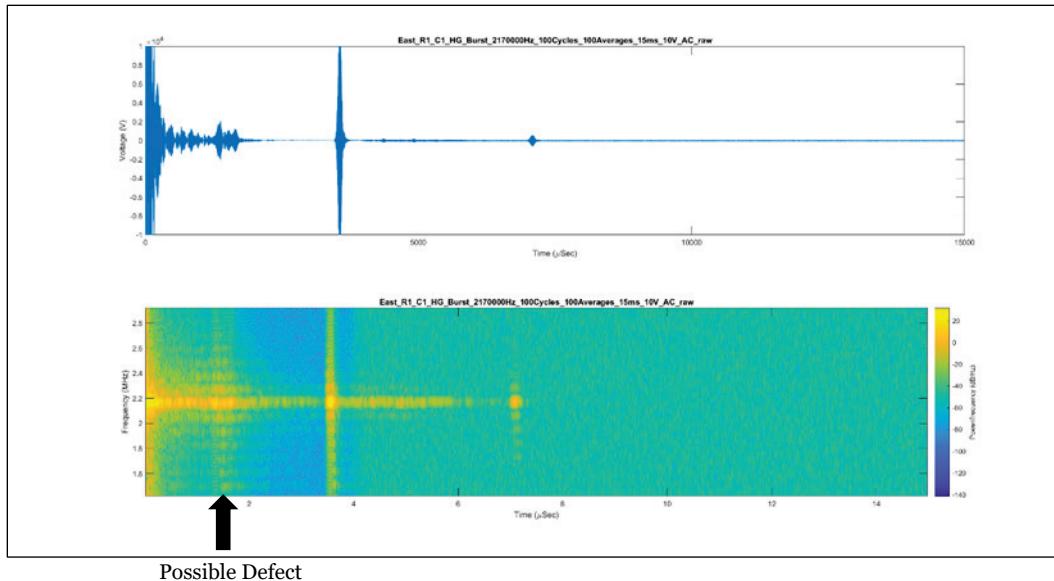
Figure 33. Pyramid Dam: east; Row 1, Column 1; possible defect.

Very similar to the Oroville rod response of Figure 14, Figure 33 shows a possible defect on rod east bundle; Row 1, Column 1. Even though the response time of this anomaly is similar to the other curved rods, the amplitude is much greater than the others.
