Review of Long-Term Maintenance Plans for the South Jetty, Grays Harbor, Washington

*by Special Subcommittee of the Committee on Tidal Hydraulics and
Coastal Engineering Research Board*

June 1995

Final report

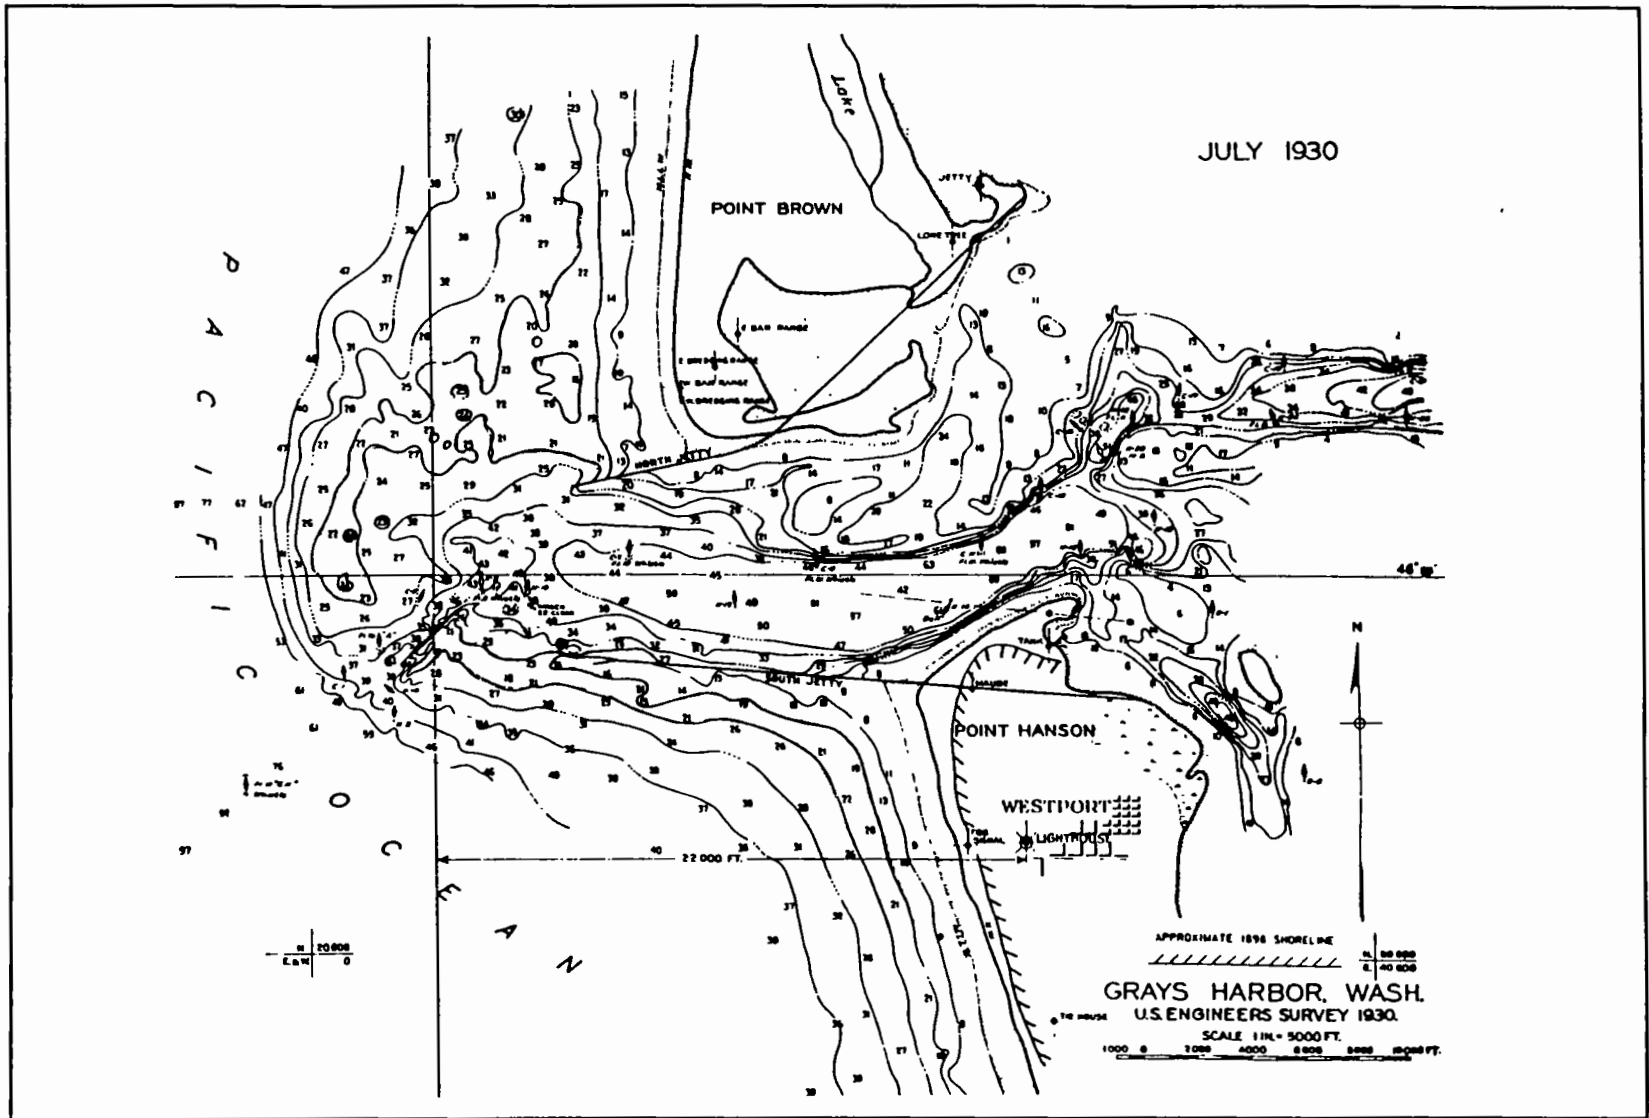
16. Figure 4 shows the configuration of the entrance in 1930. Comparison with Figure 3 shows that the entrance channel is deeper but narrower, and the north side of the entrance channel has moved south. Depths of water over the outer bar were greater, and Point Brown extended further south and west. The west shore of Point Hanson (South Beach) was eroded.

Figure 4. Entrance configuration in 1930

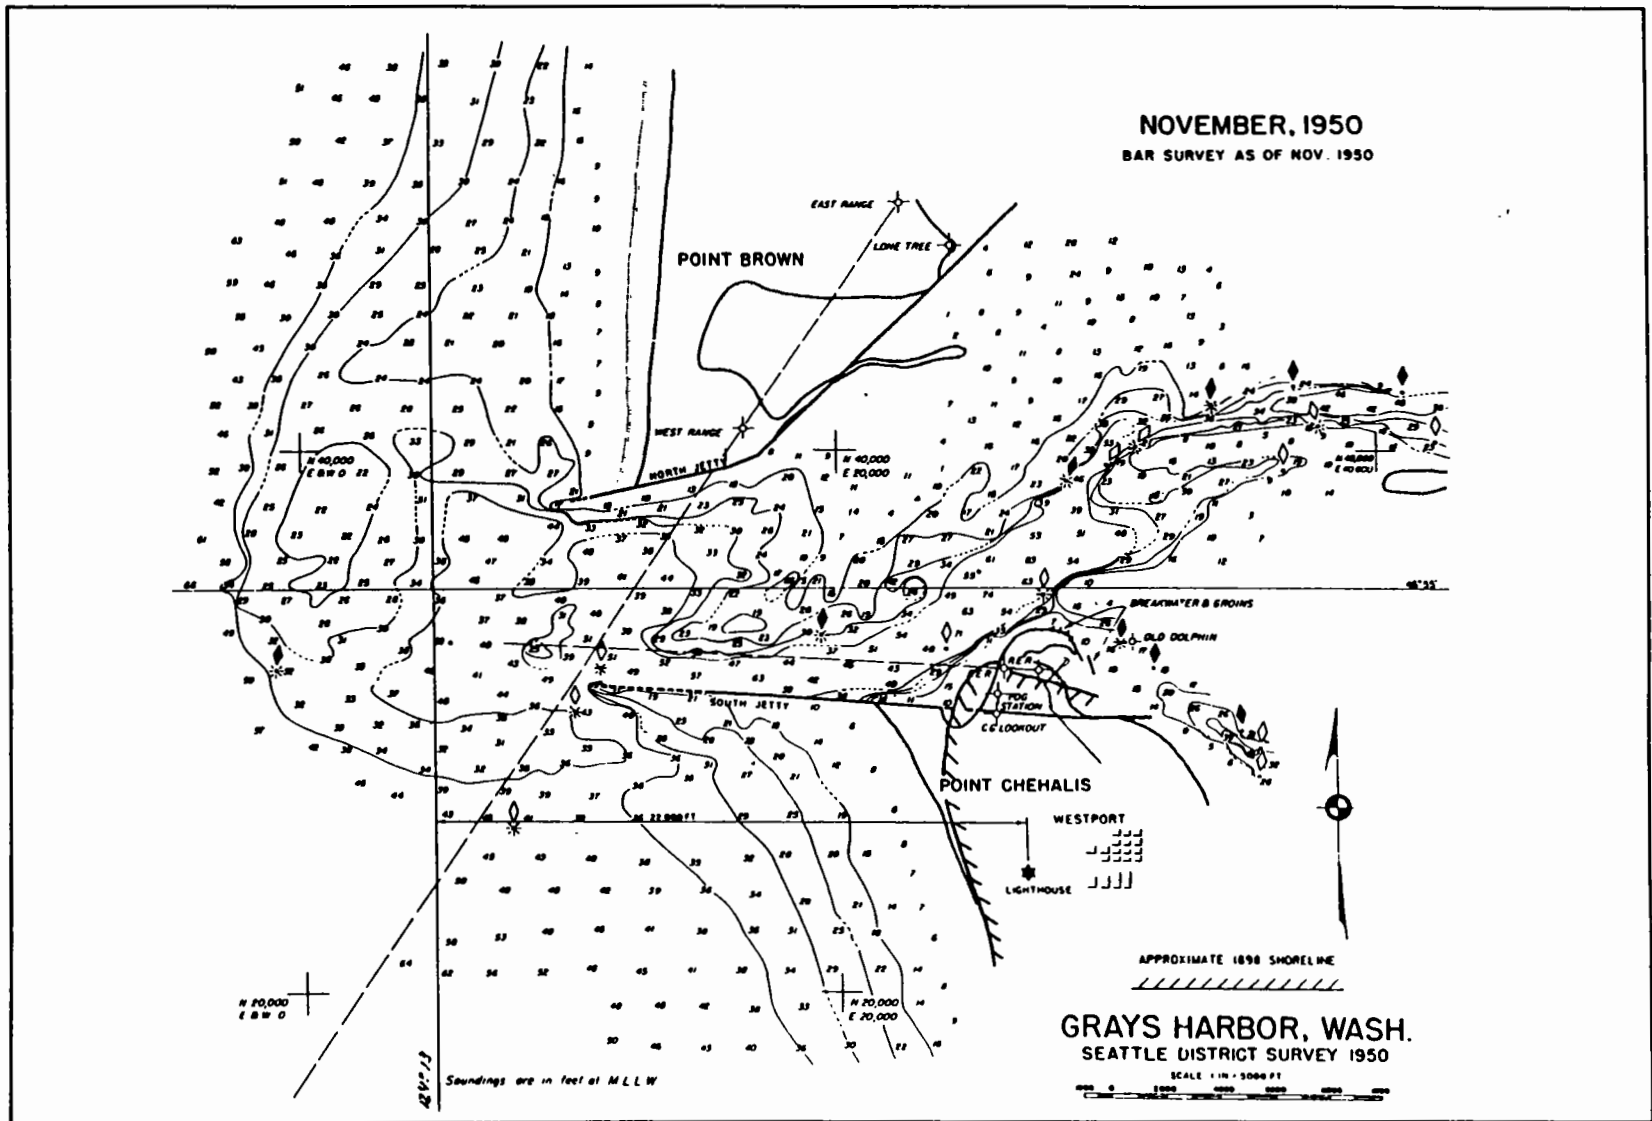
18. Figure 6, dated 1950, shows continuing evolution as described above. The entrance channel was still narrower and deeper, the inner bar deposit north of the channel had accumulated more sediment, and North Beach on Point Brown had advanced toward the outer end of the north jetty. It appears that there was some deposition at the north end of South Beach. This plot shows the first indication of erosion at the east end of the south jetty and of the Point Chehalis shoreline.

Figure 6. Entrance configuration in 1950

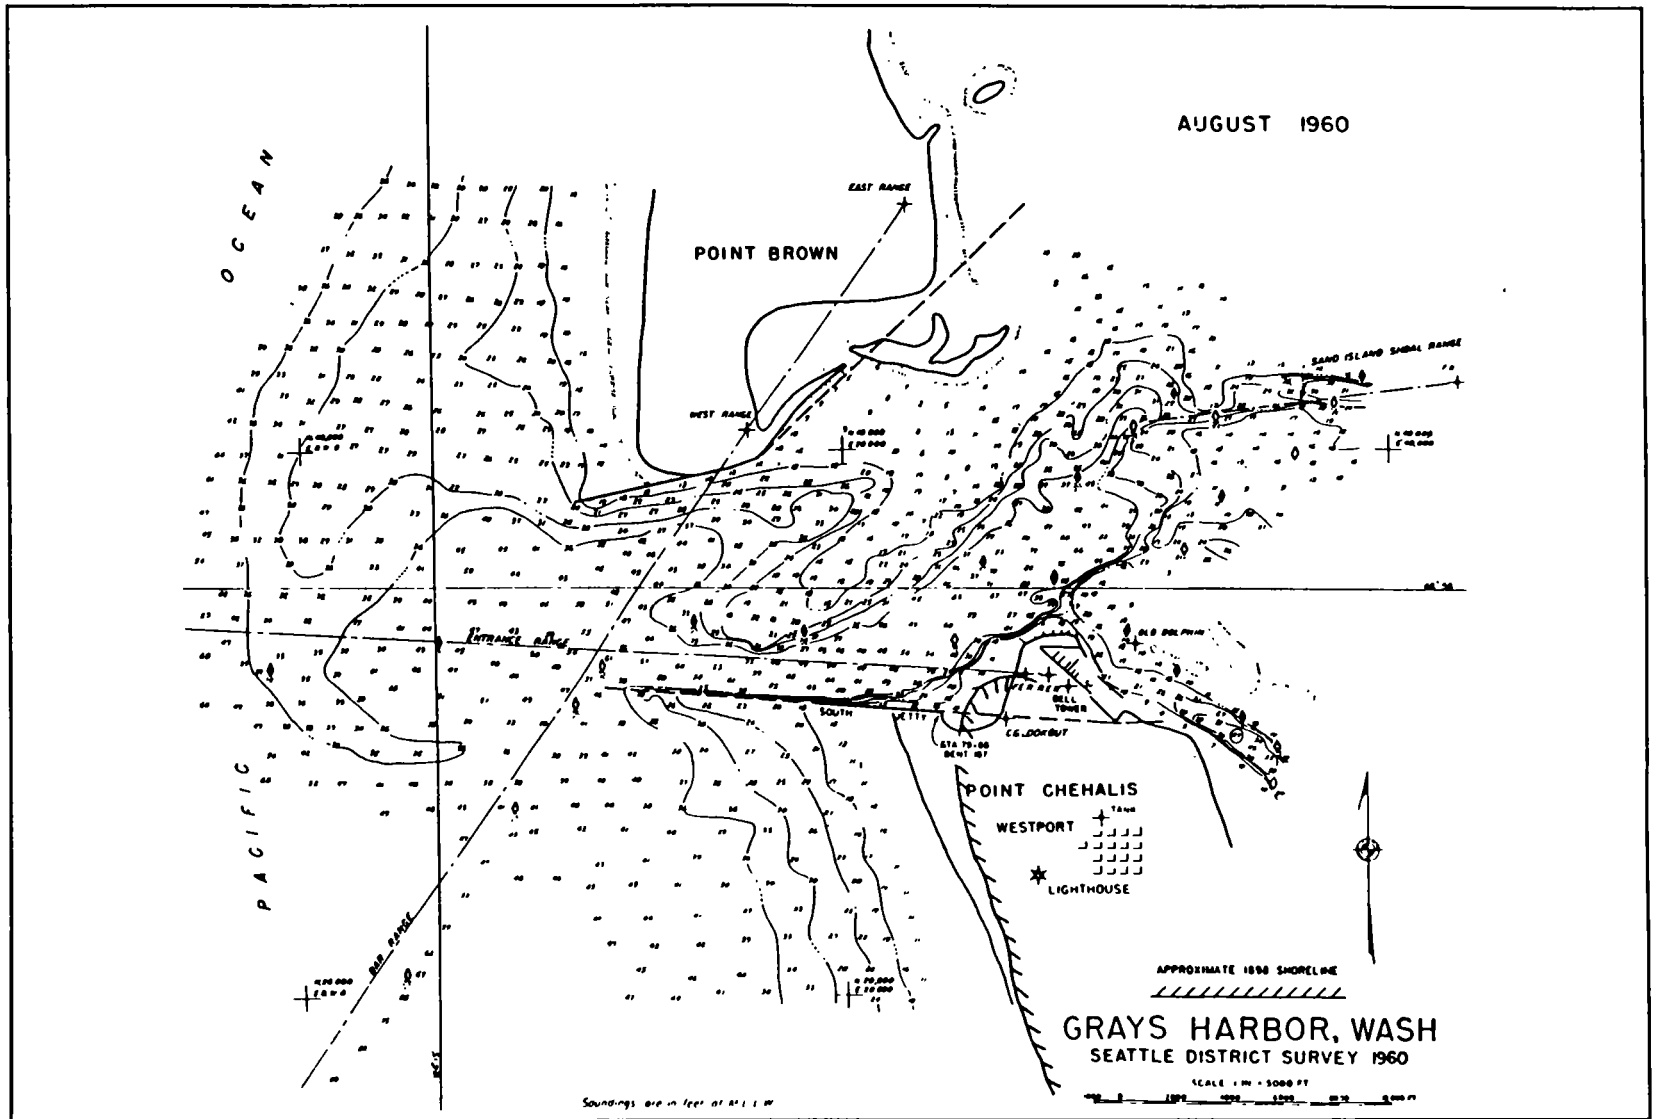
19. Figure 7, dated 1960, when compared with Figure 6, shows erosion of the outer bar and widening of the entrance channel. There was slight erosion of North Beach and some deposition on South Beach. Erosion at the east end of the south jetty had progressed, forming Half Moon Bay. Further erosion of the Point Chehalis shoreline had occurred.

Figure 7. Entrance configuration in 1960

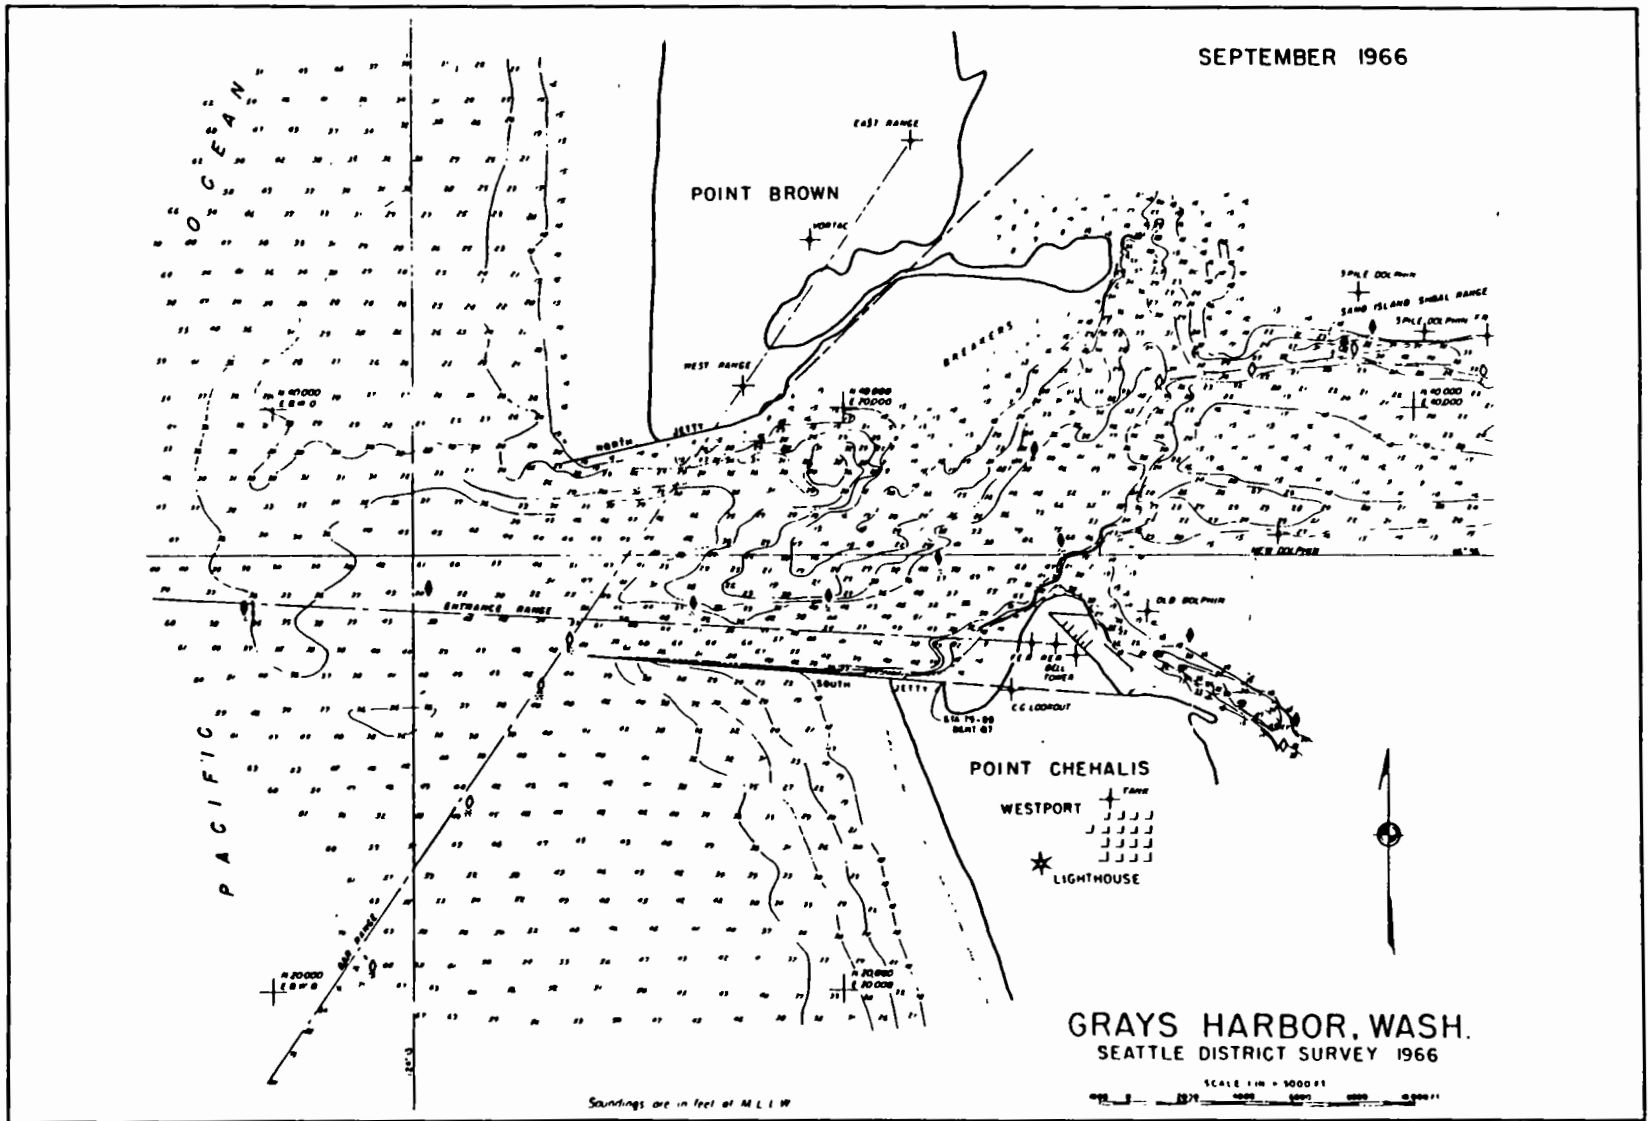
20. Figure 8, dated 1966, when compared with Figure 7, shows additional deposition on the inner bar deposit south of the north jetty and some erosion of the east shore of Half Moon Bay. There was further erosion of the outer bar.

Figure 8. Entrance configuration in 1966

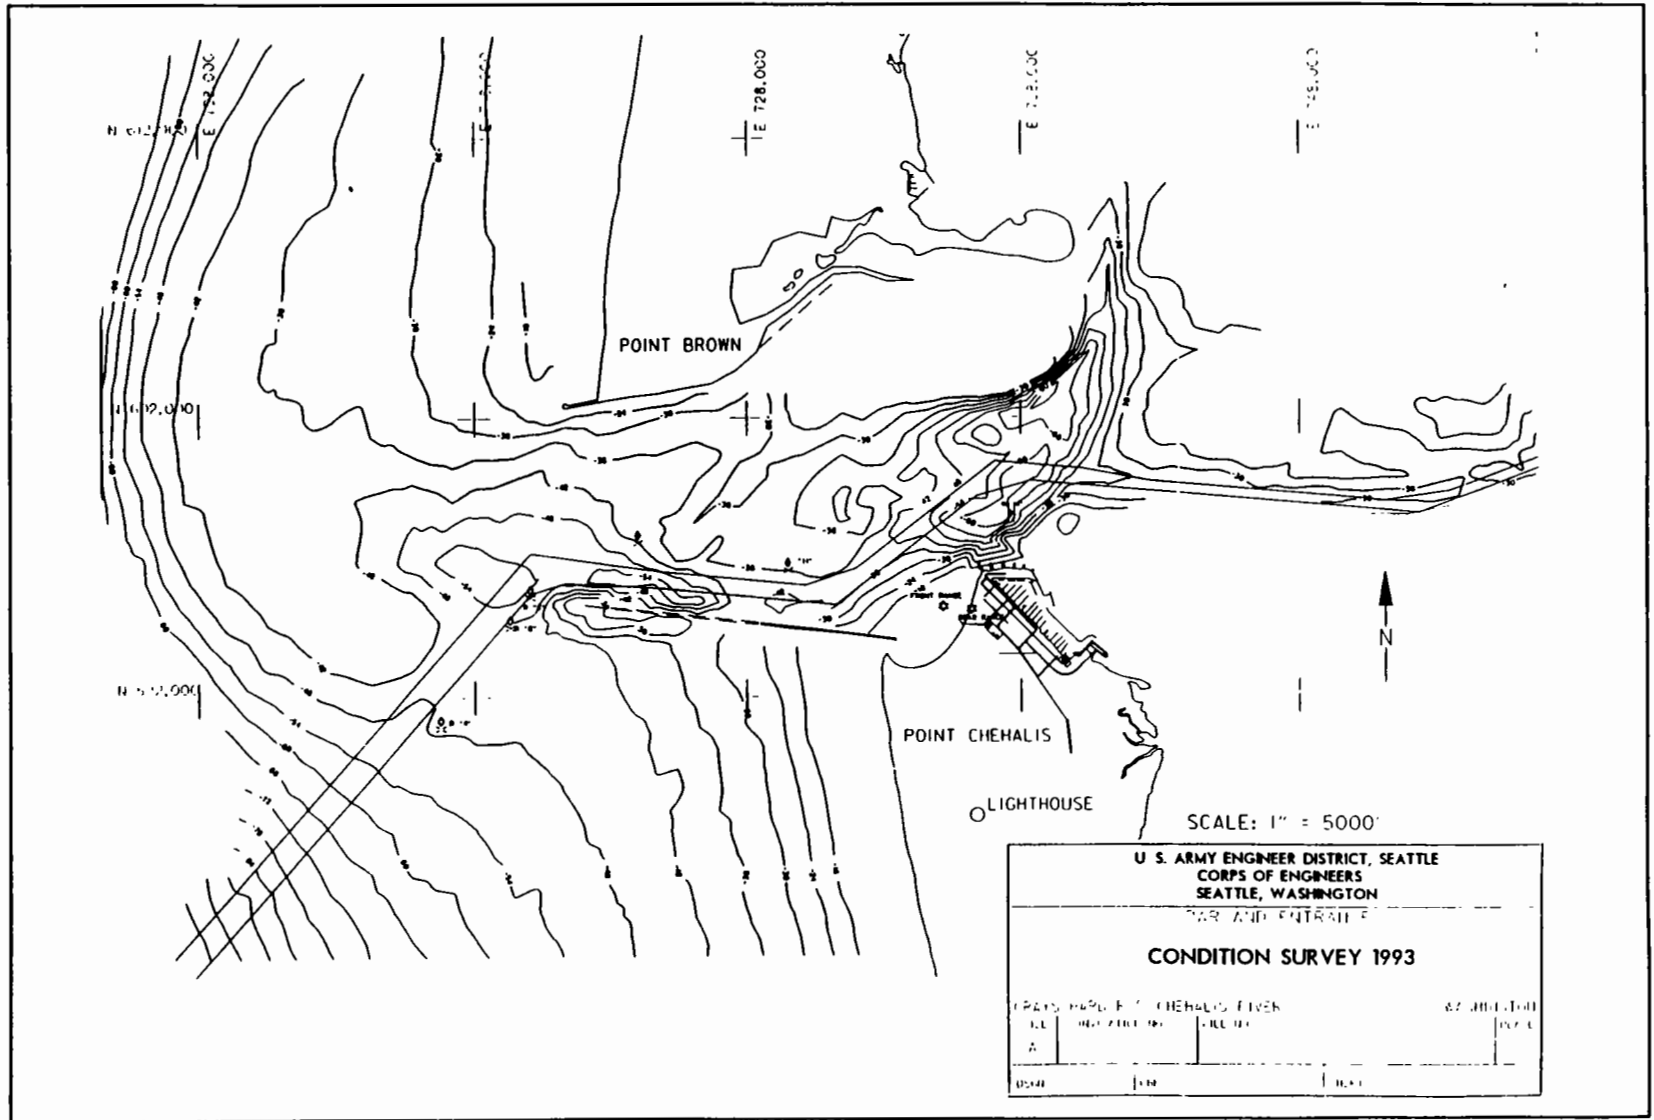
21. Figure 9 shows the December, 1993 configuration of the entrance including the recent breach at the east end of the south jetty. The trends

shown in the previous figures continued. South Beach was eroded, Half Moon Bay was enlarged, and North Beach was filled westward nearly to the outer end of the north jetty. The shallowest contour on the outer bar is -42 ft (the contour interval is 6 ft).

Figure 9. Entrance configuration in 1993

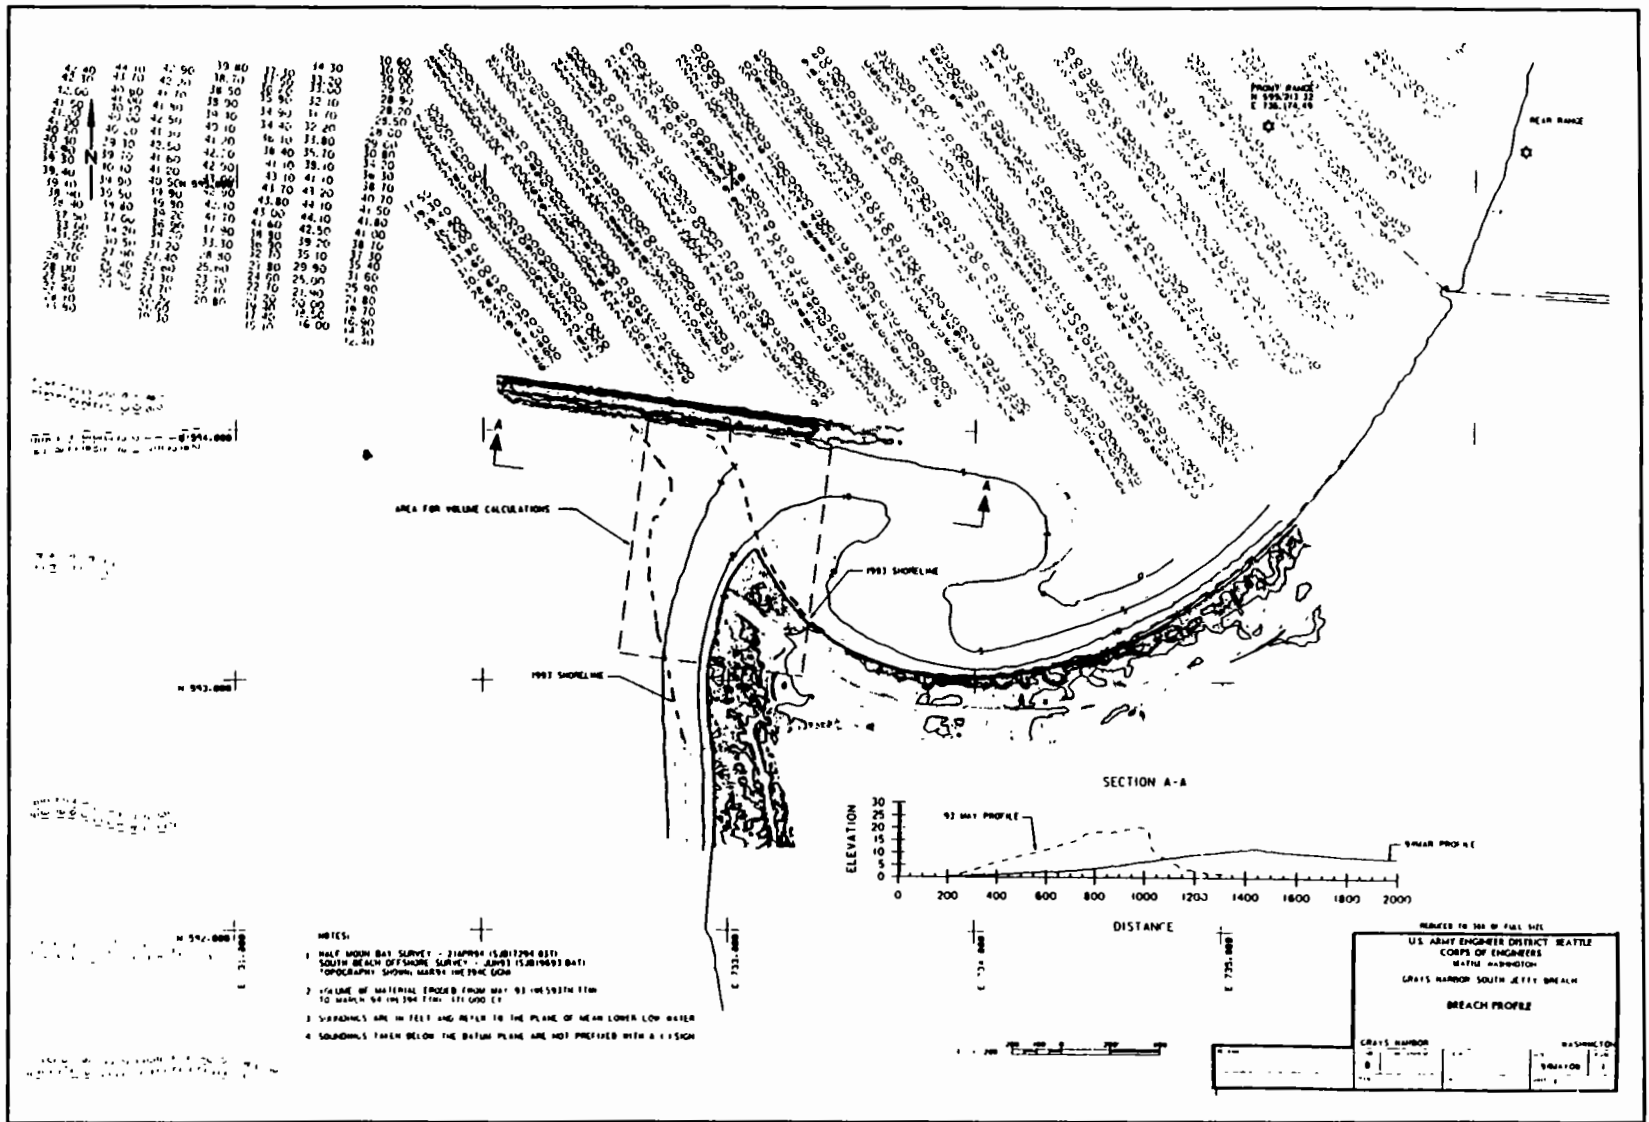
22. The breach occurred during a storm on December 10, 1993. The storm started on the evening of December 8 and lasted until December 15 (Hartman Associates 1994, p 7). The maximum significant offshore wave height was recorded by the Grays Harbor buoy at 0230 December 10. The wave height was 25 ft and the period was 13 seconds. The direction of offshore waves varied from 33 to 91 degrees relative to the shore. Hartman & Associates calculated the largest wave height at the 33-ft depth to be 16.7 ft with a length of 450 ft. They calculated a wave recurrence interval of two years. Evidently, setup from south winds combined with high waves caused overtopping of the narrow portion of the spit between South Beach and Half Moon Bay. Much of the material that was washed out of the breach has deposited in Half Moon Bay. Figure 10 shows details of the breach in May, 1994.

Figure 10. Breach and deposit in Half Moon Bay

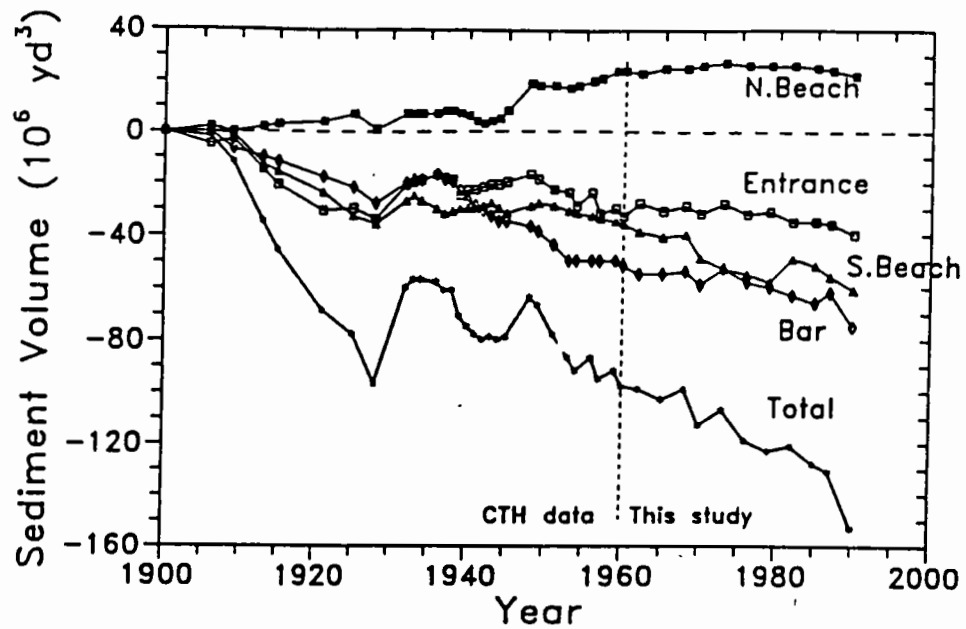
38. The plot of total volumes in Figure 13 shows continuing loss of sand from the region over a period of ninety years. This period is too long to attribute the loss to cyclic causes, such as variability of winter weather. It is most likely a result of the impacts of the jetties on the areas included in the computation. The jetties first caused erosion of sand from the entrance and its deposition on the bar, where it was subsequently eroded by waves and coastal currents. Sand that entered the entrance from North Beach crowded the entrance channel until velocities were sufficient to carry additional sand seaward or landward beyond the areas included in the calculation. Waves in the entrance must also have contributed to movement of sand. And finally, South Beach was deprived of a sand supply and subjected to erosion as described in paragraph 31.

Figure 13. Historic volume changes for selected areas (from Battelle/Marine Sciences Laboratory 1992)

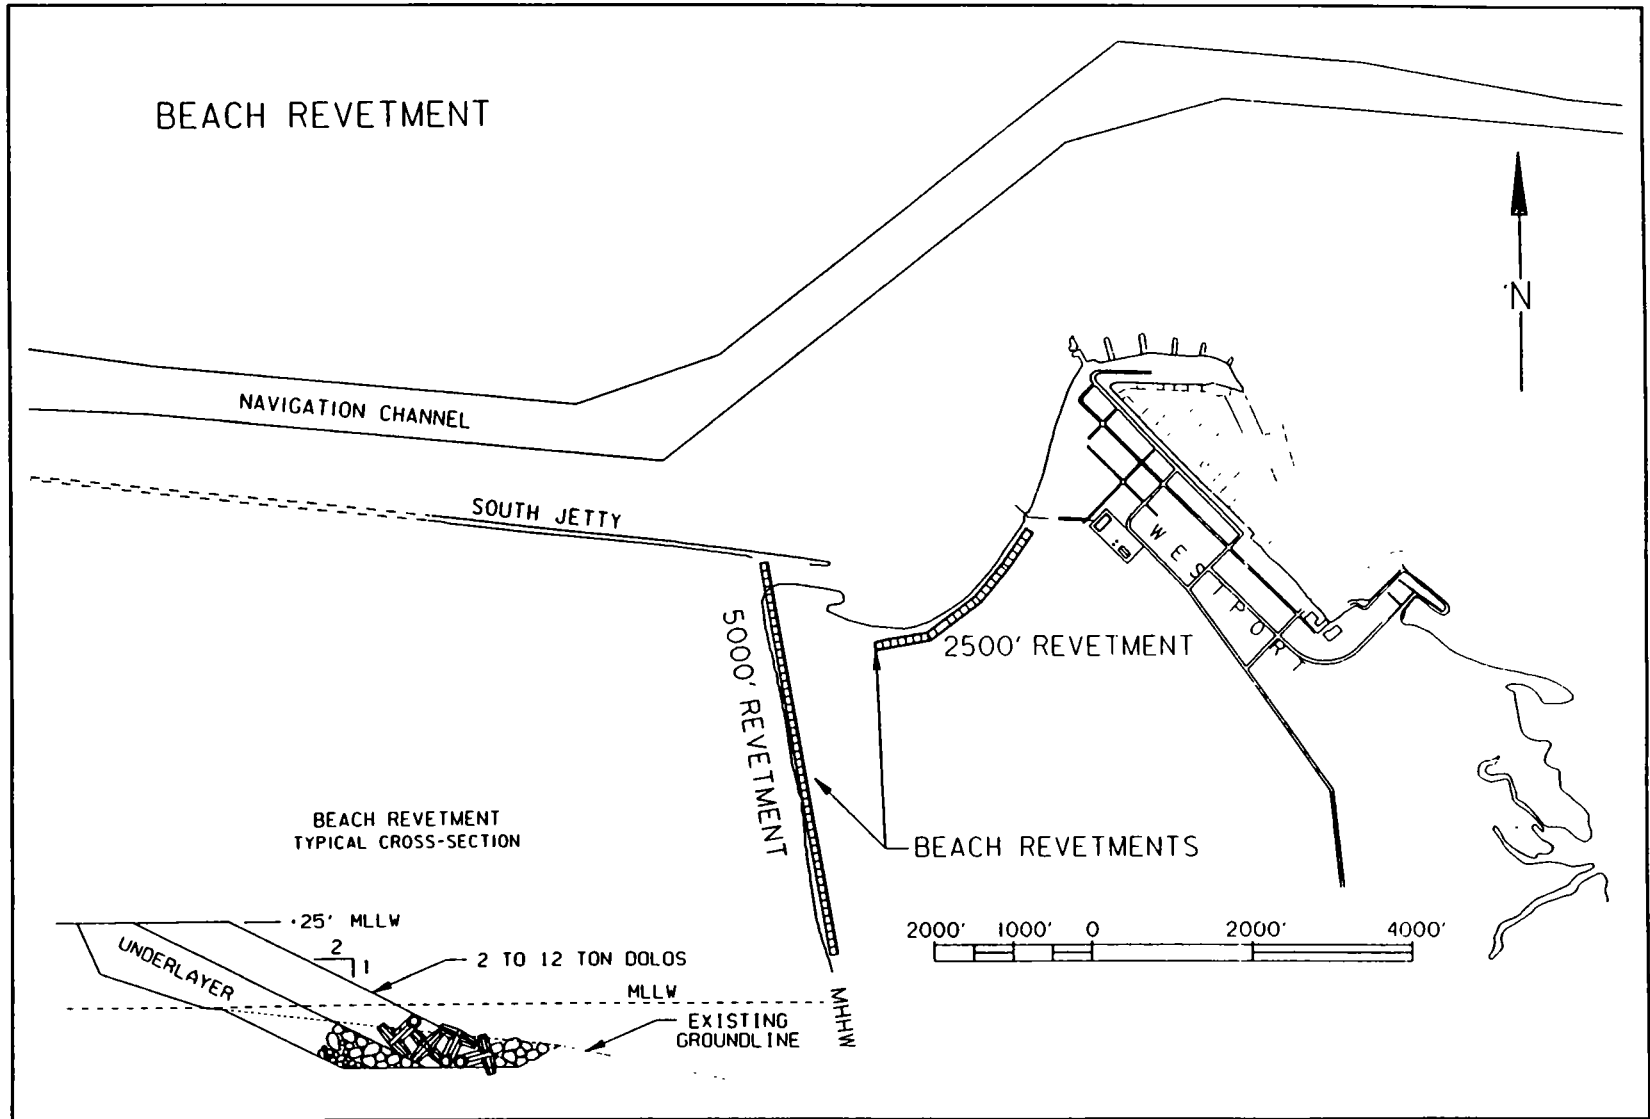
Figure 15. Beach revetment alternative

46. This alternative is shown in Figure 15. It includes revetment along South Beach and extension of the revetment in Half Moon Bay. In addition to a very high initial cost, erosion of sand at the base of the revetment down South Beach would cause continuing requirements for expensive maintenance.

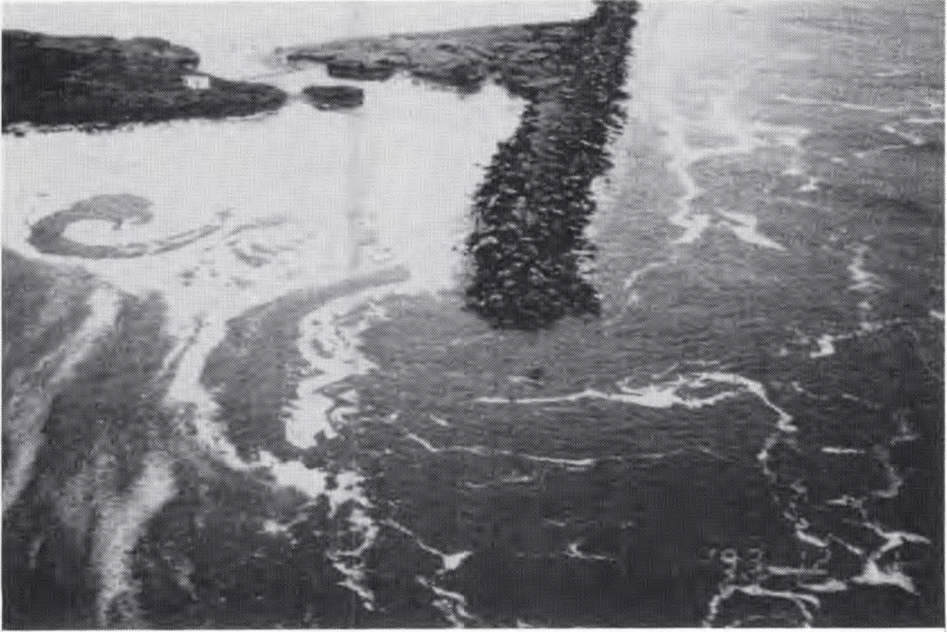
Photo 1. Initial breach formation, looking seaward, 10 December 1993

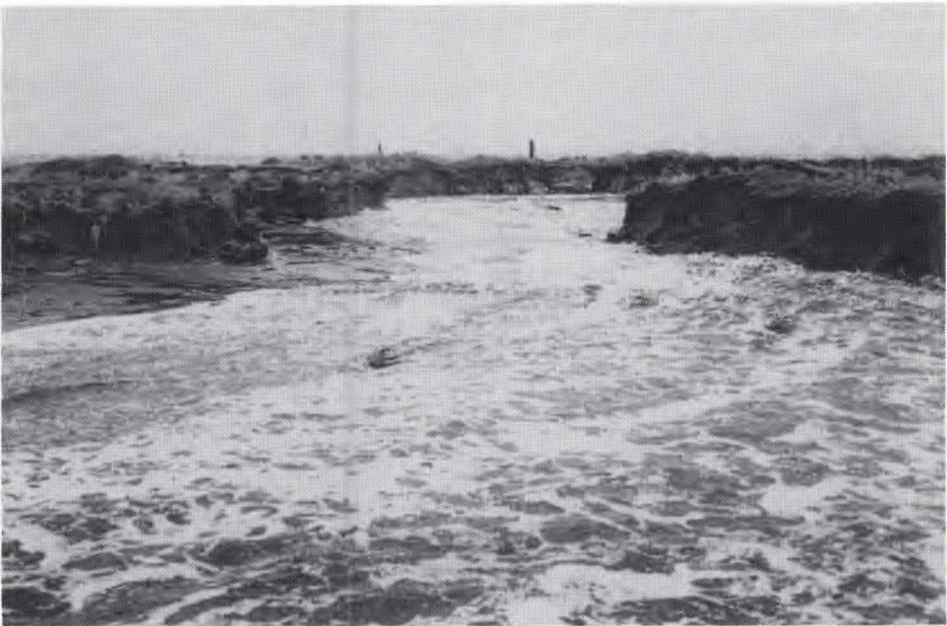
Photo 2. Initial breach formation, looking landward, 10 December 1993
