Alternatives for Large Crater Repairs using Rapid Set Concrete Mix®

Lulu Edwards, Haley P. Bell, and Marcus L. Opperman

June 2021

Final report

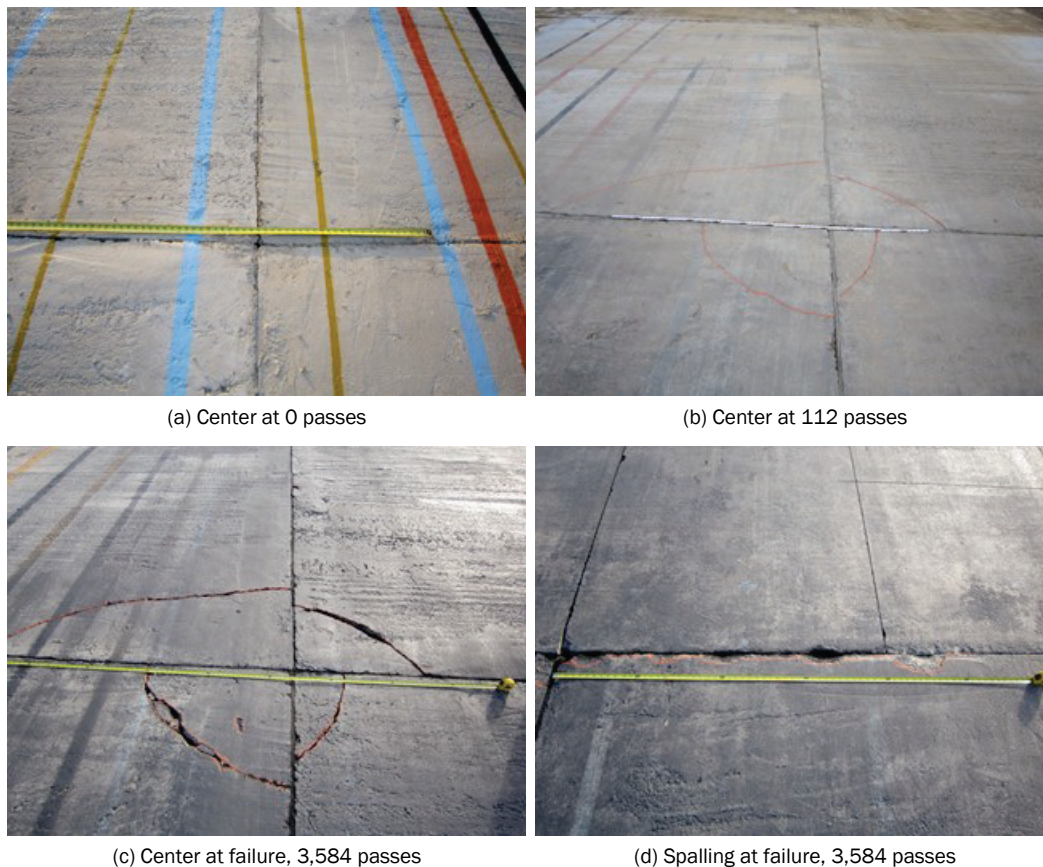
Figure 35. Repair 1 progression of distresses.

Repair 1 was trafficked with the C-17 load cart 2 hr after the fourth quadrant was placed to demonstrate the rapid return to service for a RADR scenario. Figure 35 shows that there were no cracks prior to trafficking. Cracking began around 56 passes (48 coverages). After 112 passes (96 coverages), low-severity corner breaks were observed at the center of the repair in each quadrant, which formed somewhat of a circle, as shown in Figure 35. This is indicative of inadequate foundation support and is consistent with prior testing of large craters (Barna et al. 2010).

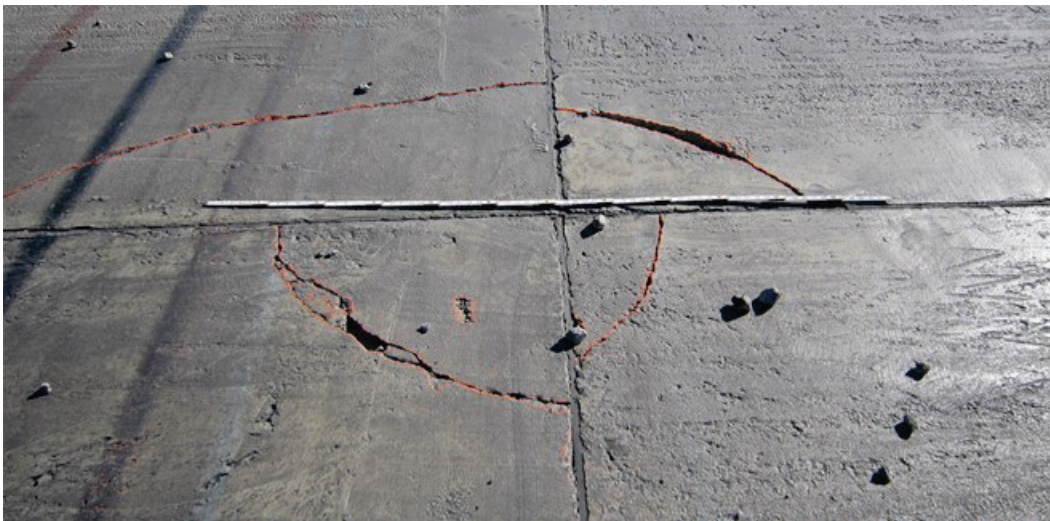
Figure 36. Large 2-in. FOD after 1,680 passes, in the center of Repair 1.

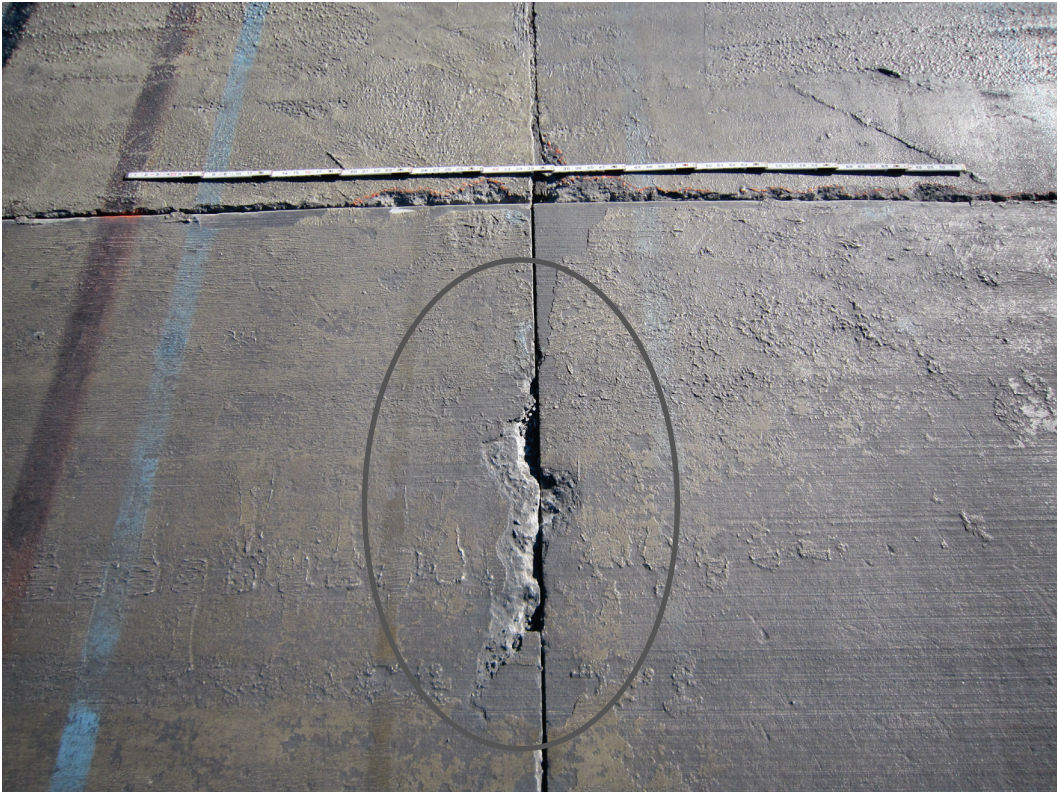
Figure 38. Parent slabs adjacent to the repair started to spall after 1,680 passes.

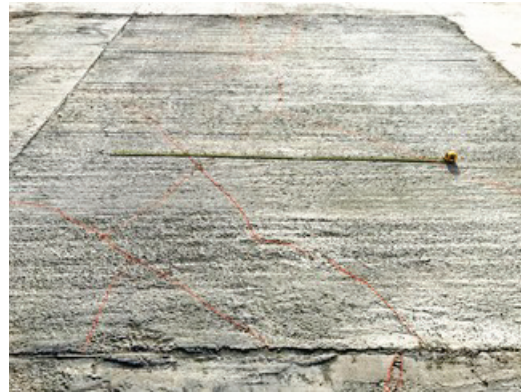
(b) Low severity shattered slab at 112 passes

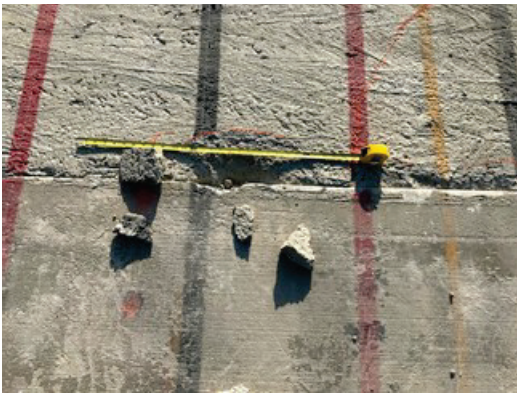
(c) FOD and spall on the western edge at 112 passes

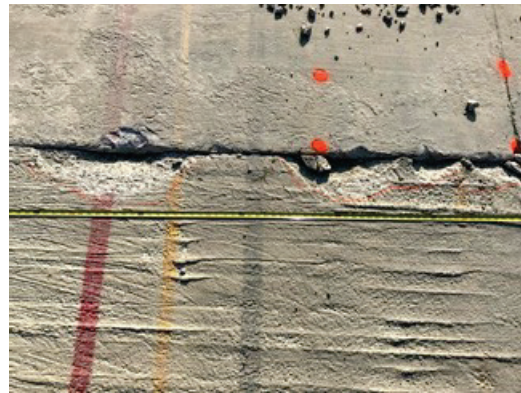
(d) FOD on the eastern edge at 112 passes

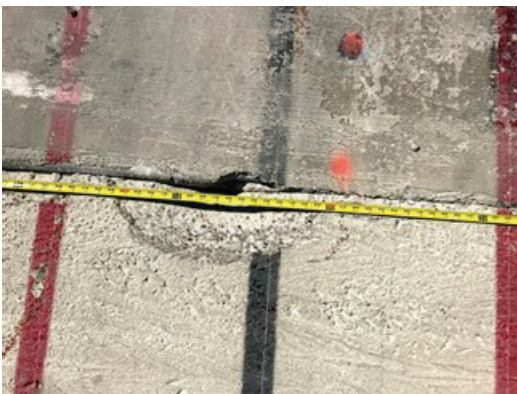
(e) Spall on the western edge at 224 passes

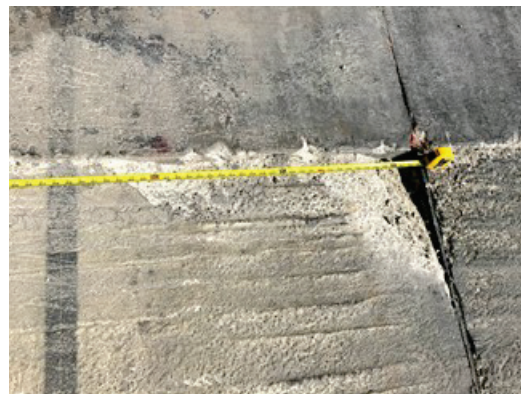
(f) Spall on the eastern edge causing failure at 224 passes.

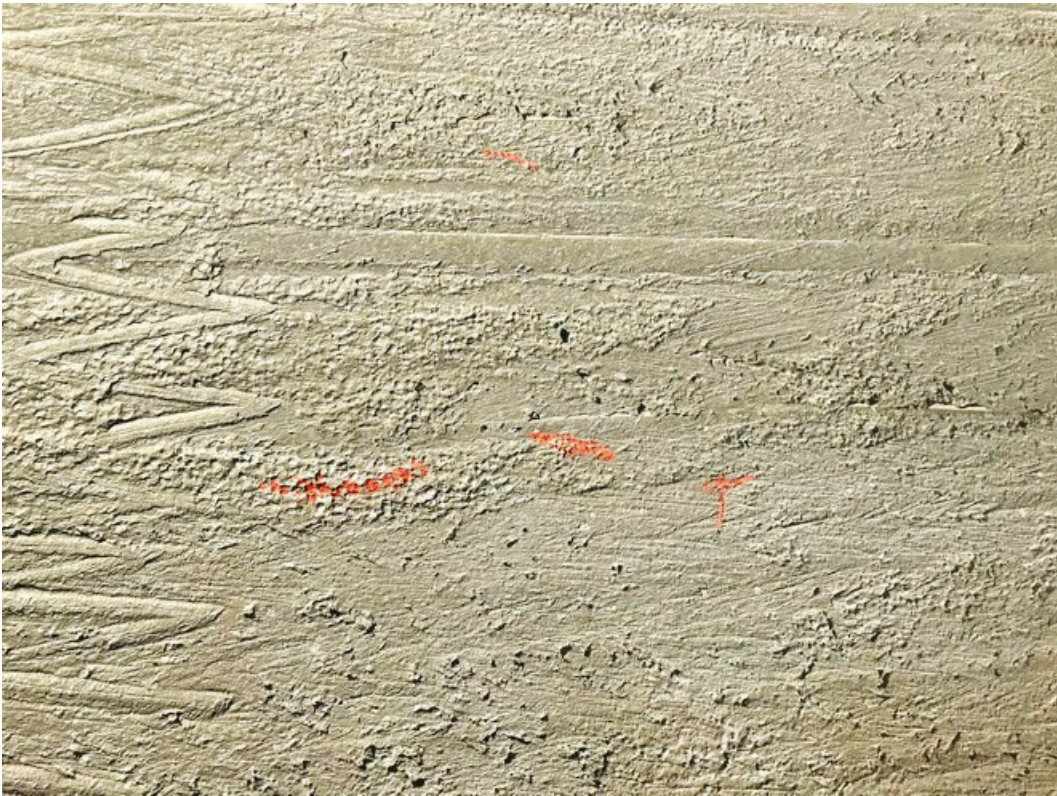
Figure 40. Minor shrinkage cracking at 0 passes.

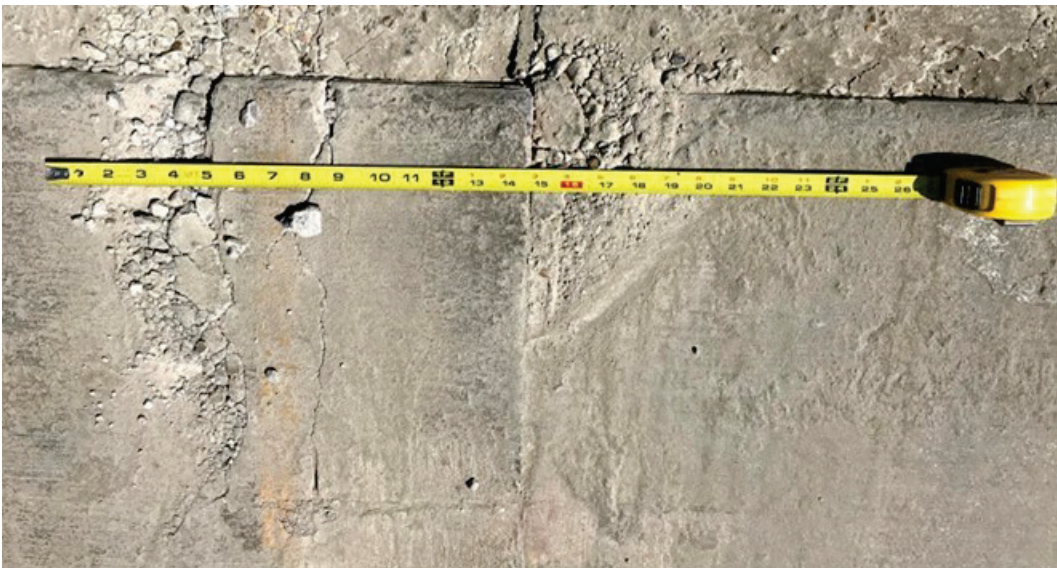
Figure 41. Spalling on parent slab in the trafficking area at 224 passes.

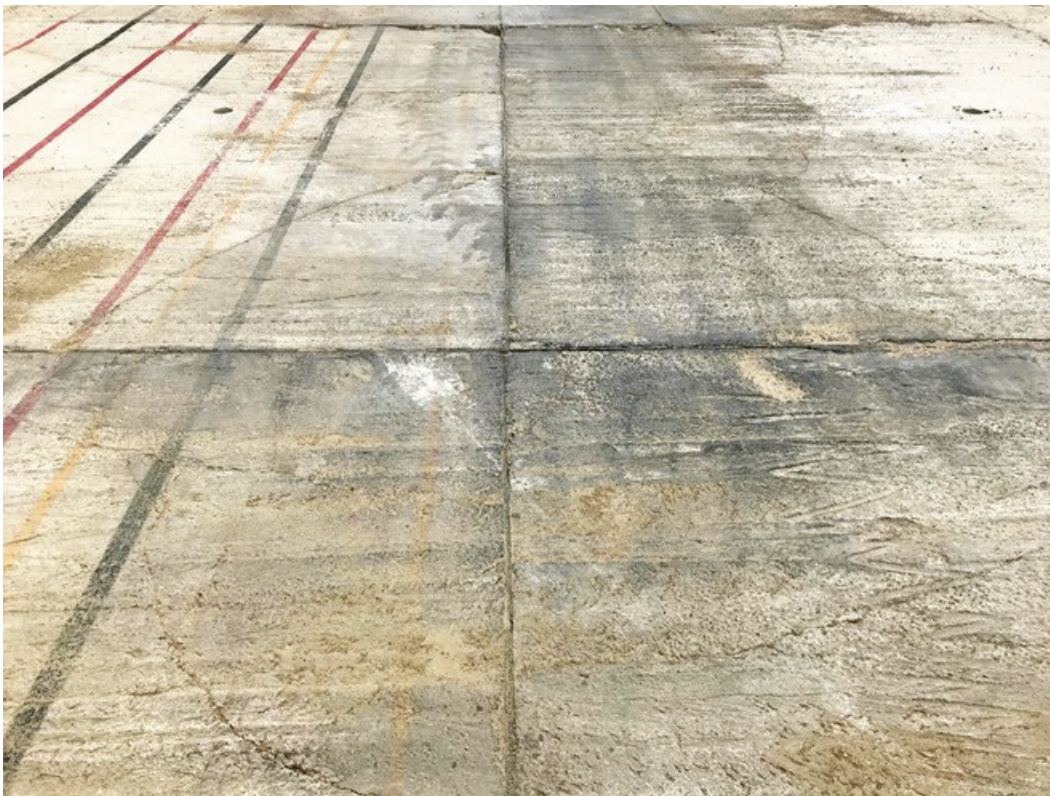
Figure 42. Cracking in the center of Repair 2 at 224 passes.

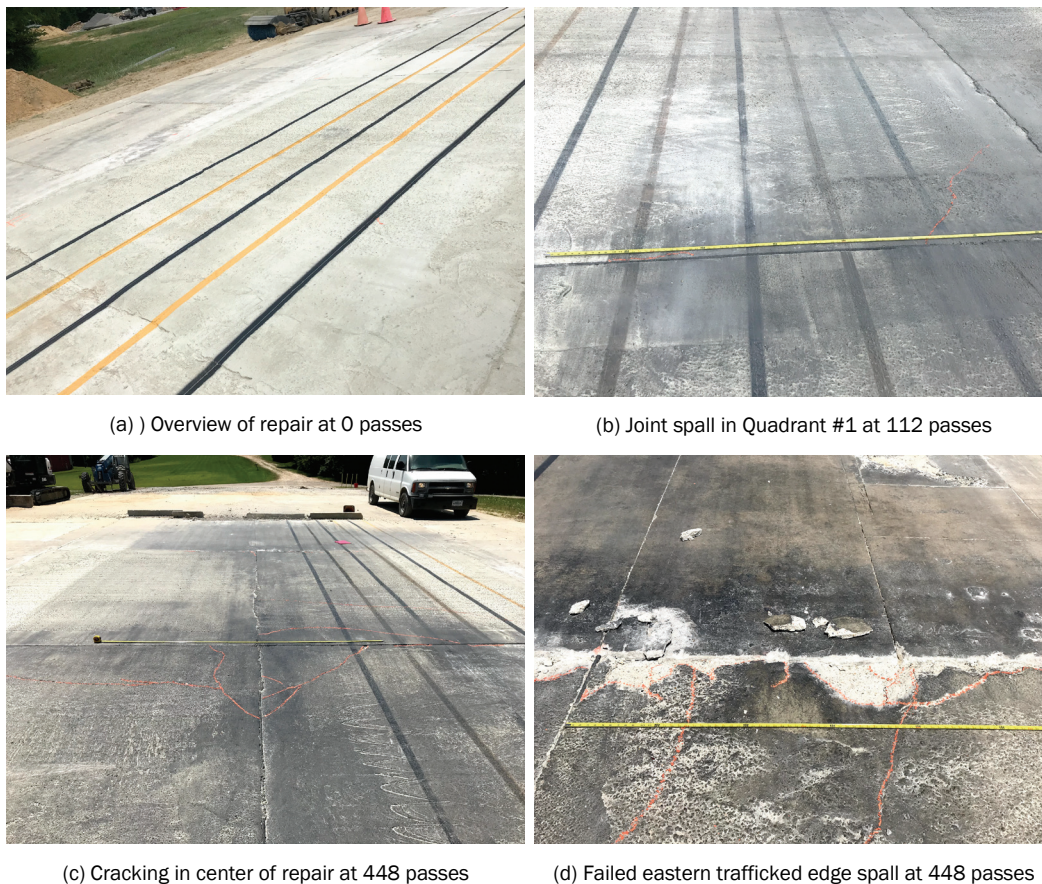
Figure 43. Repair 3 progression of distresses.

After 112 passes (96 coverages), a 12-in.-long joint spall was noted at the interior northwest joint. Several more joint spalls, interior corner breaks, and linear cracks were created on three of the four quadrants by the time the repair received 336 passes (287 coverages) with the C-17 load cart. After 392 passes (335 coverages), all quadrants had joint spalling along the trafficked edges; however, corner breaks and linear cracks were still noted on only three of the four quadrants. The joint spalls progressed when failure was noted at 448 passes (383 coverages). Trafficking continued after failure to observe the joint spalling progression. One joint spall created a minimal amount of FOD at 504 passes (431 coverages); however, all existing spalls were not any deeper, wider, or longer than they were at 448 passes (383 coverages).

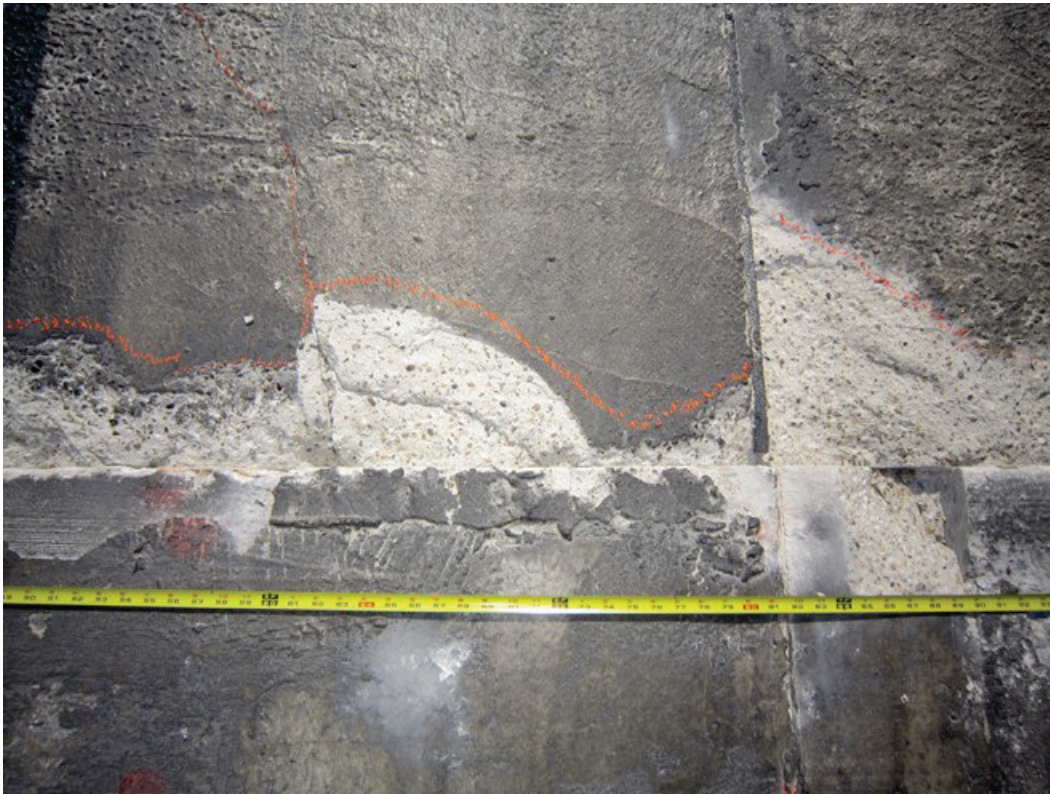
Another 112 passes (96 coverages) were applied to the repair after failure. No new cracks developed; however, the pre-existing cracks became more severe (Figure 47). Additional high-severity joint spalling developed along both the eastern and western trafficked edges. After 500 passes (427 coverages), the linear cracks had not progressed in severity; however, the joint spalls did continue to deteriorate.

Figure 47. Western edge of Repair 4 after 336 passes.

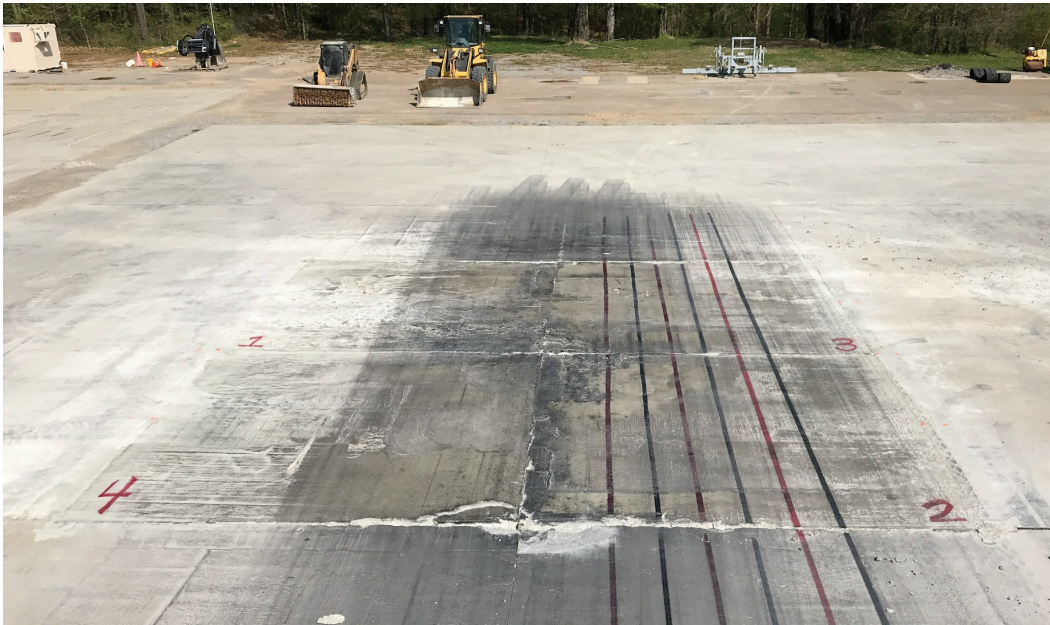
Trafficking continued after failure. After 274 passes (234 coverages), no new cracks developed (Figure 49). The joint spalls were slightly more severe. The west side of the repair was more deteriorated than the east side. After 336 passes (287 coverages), the joint spalls and cracking had not progressed significantly, but the parent slabs on the west edge were heavily spalled. The spalling on the western edge can be seen in Figure 49. The parent slab joint spalls did not seem to affect the condition of the repair during trafficking.

Figure 49. Overview of Repair 5 at 274 passes.

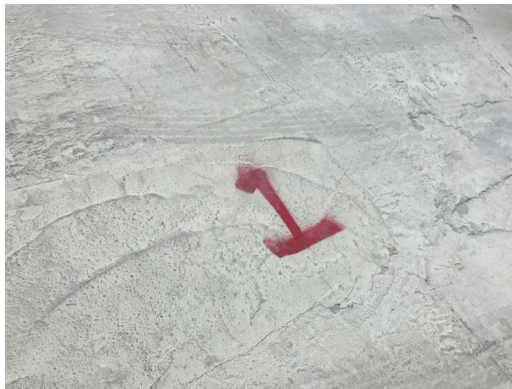
(a) Shrinkage cracks at 0 passes

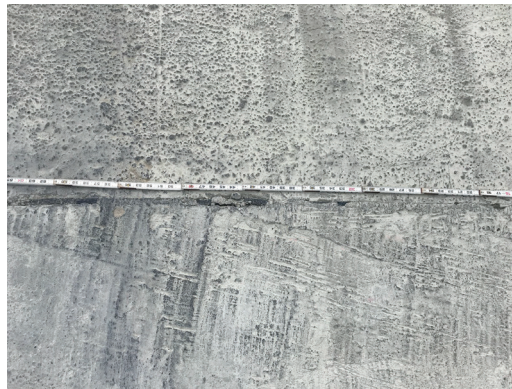
(b) Paste at joint starting to break up at 112 passes

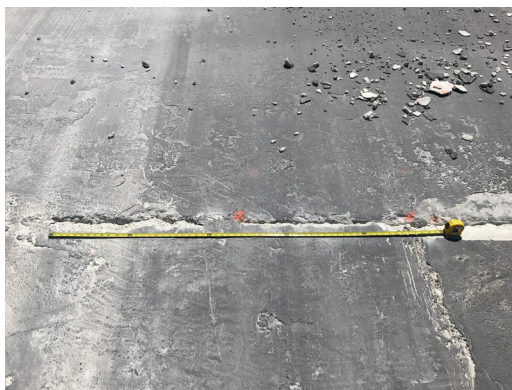
(c) Spalling at joint on Quadrant #1 at 224 passes

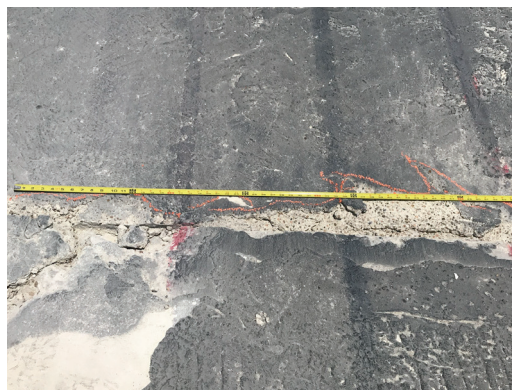
(d) Spalling on Quadrant #2 at 768 passes

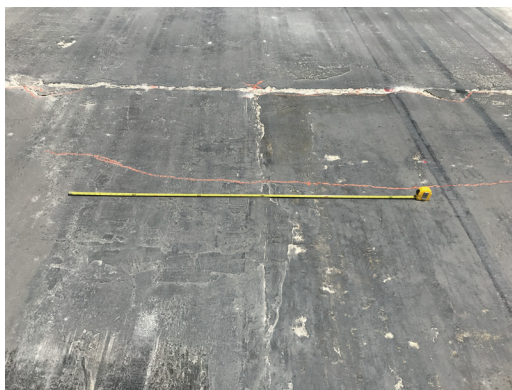
(e) Crack from Quadrant #1 to #3 at 768 passes

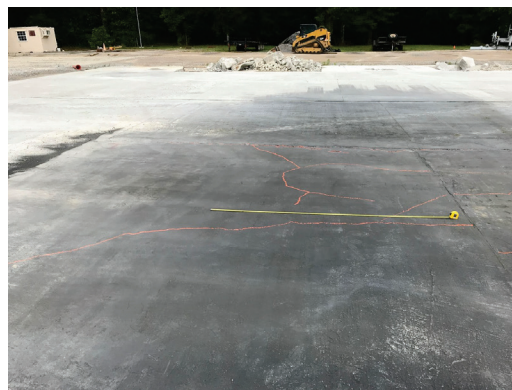
(f) Low-severity shattered slab in Quadrant #1 at 1,664 passes

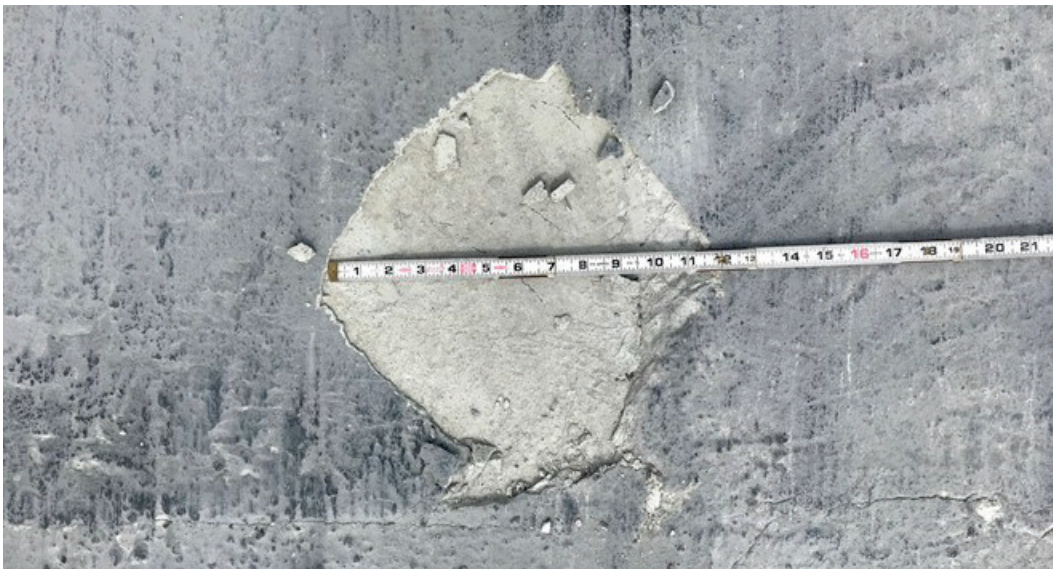
Figure 51. Surface paste observed up to 112 passes.

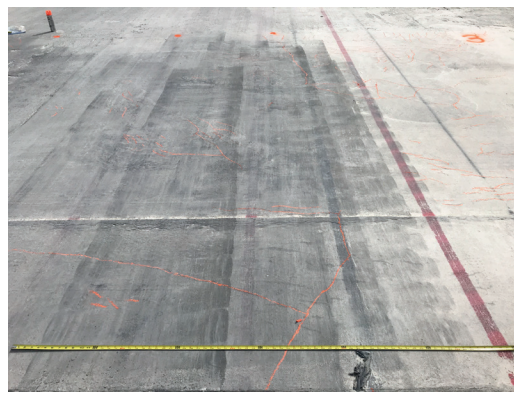
(b) Cracking in the paste at 112 passes

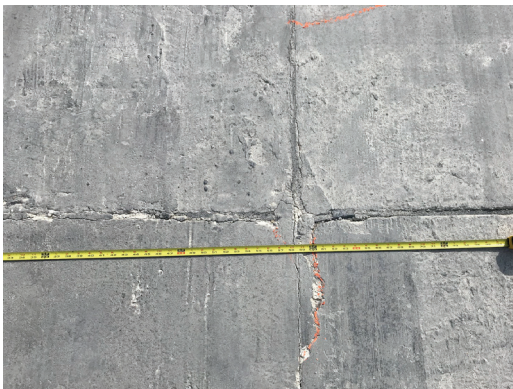
(c) Small corner break in center of repair at 112 passes

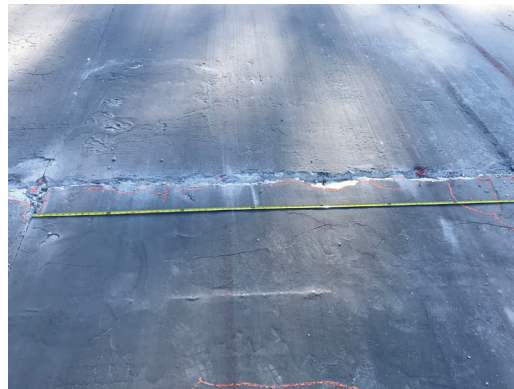
(d) Spalling in Quadrant #3 at 448 passes

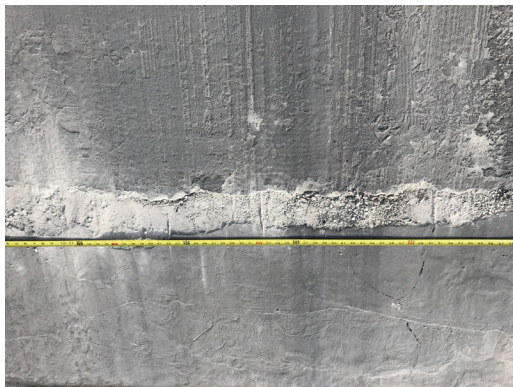
(e) Spalling in Quadrant #3 at 784 passes

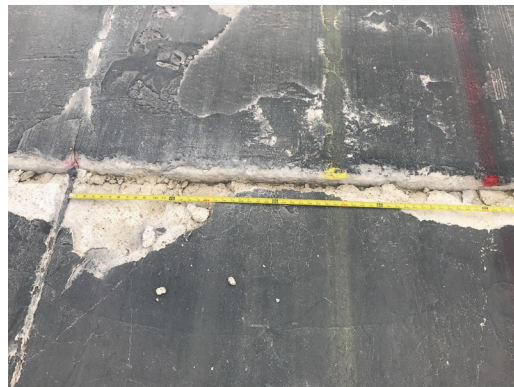
(f) Spalling in Quadrant #3 at 896 passes

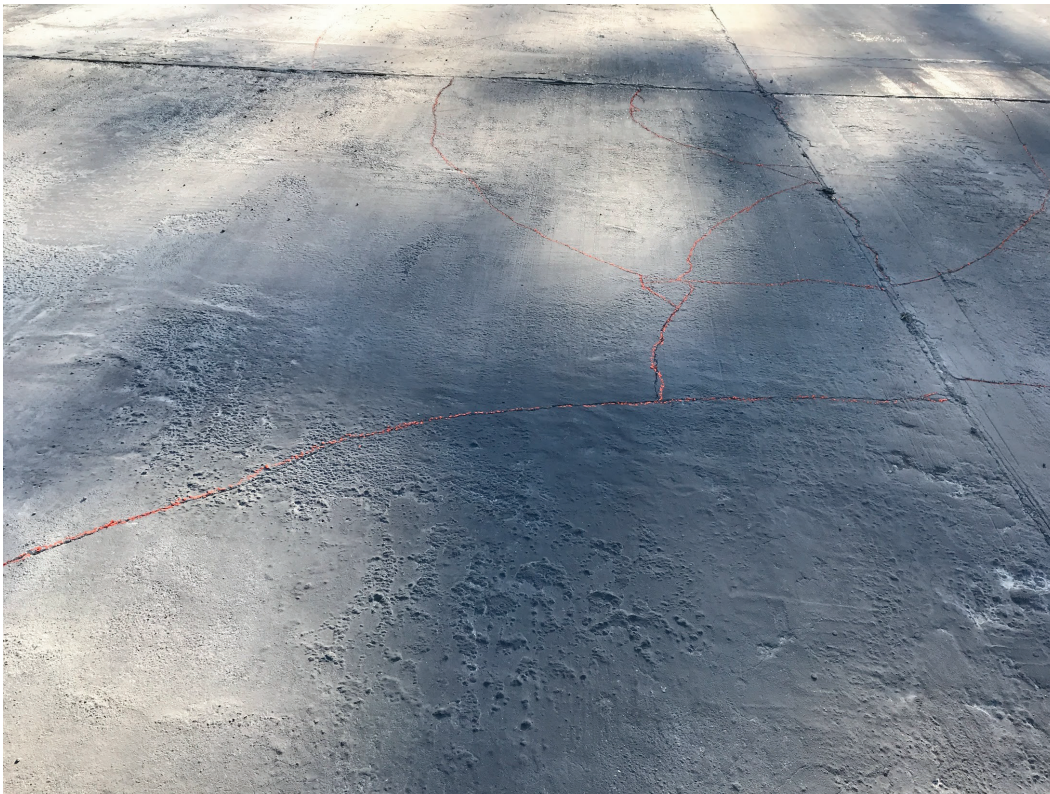
Figure 54. Low-severity shattered slab at 448 passes.
