Deconstruction Feasibility Assessment of Warehouse District Facilities at Fort Leonard Wood, Missouri

January 2022

Final Report

Prepared for Fort Leonard Wood
597 Mascen Loop
Fort Leonard Wood, MO 65473

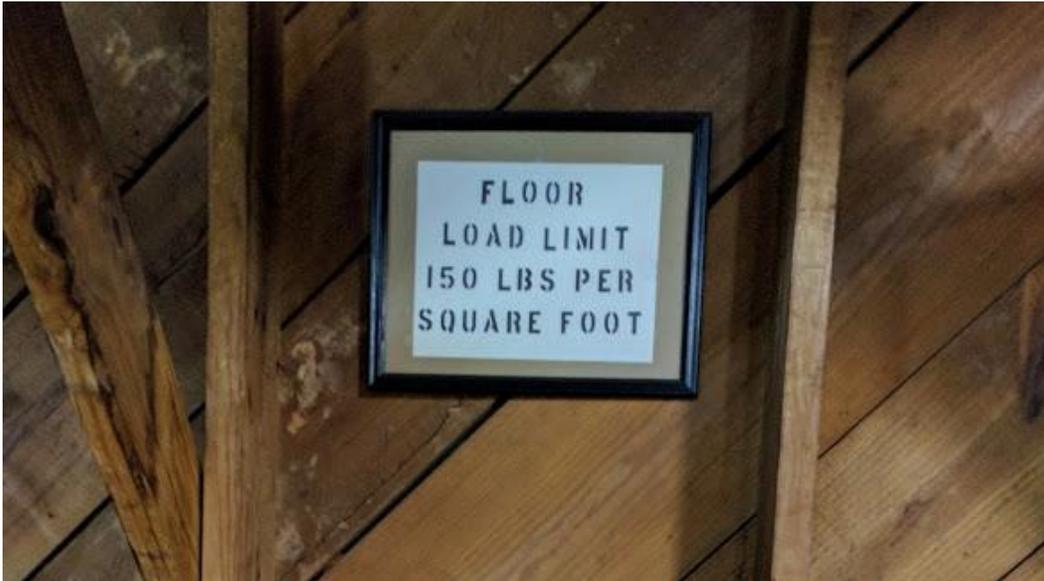
The floor systems of Bldgs. 2338 and 2339 consist of 2 ft × 12 ft joists spaced 12 in. on center spanning the foundation walls (Figure 6). The joists bear on 2 in. × 6 in. sill plates, and 2 in. × 12 in. band joists run the length of the building at the exterior walls. The floor deck was observable from the crawlspace. The construction of the floor system is conducive to equipment operation during deconstruction; construction details reported on a placard in an identical building indicate that the floor is designed to support 150 lb/ft² (Figure 7).

Figure 7. Sign indicating warehouse floor load limit.

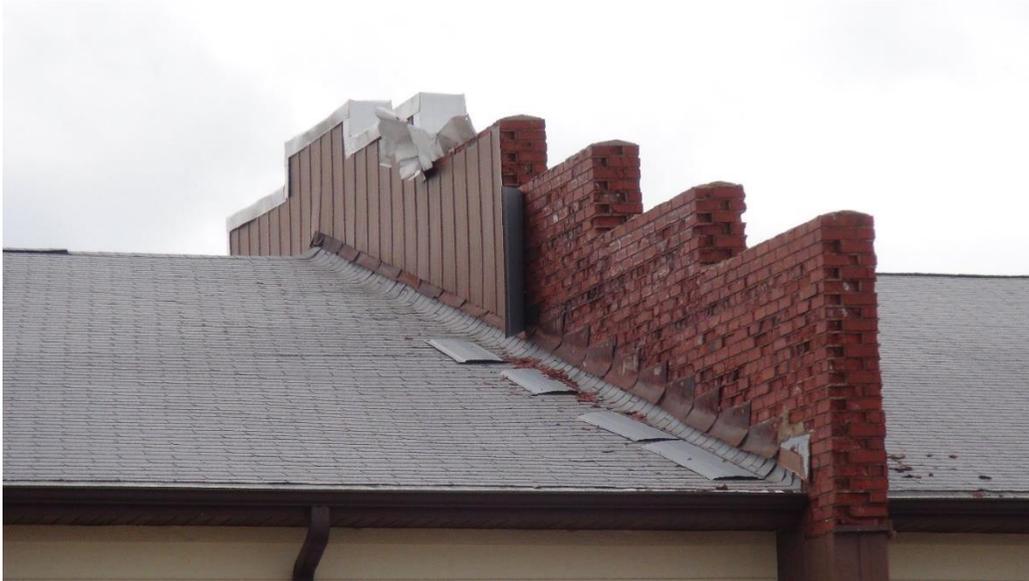
Figure 11. Brick firewall above the roof was covered with siding until damaged from weather.

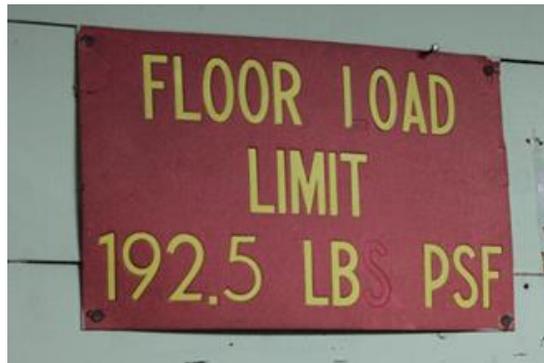
The floor system is supported by 2 in. × 12 in. joists spaced at 12 in. on center, spanning the foundation walls. The joists bear on 2 in. × 6 in. sill plates and 2 in. × 12 in. band joists that run the length of the building along the exterior walls. It is assumed that the condition of this subflooring is similar to that of Bldgs. 2338 and 2339. Signage posted in the building (Figure A-4) indicates that the floor can support 192.5 lb/ft².

Figure A-4. Labeled load limit of Bldgs. 2310 and 2311 floor.

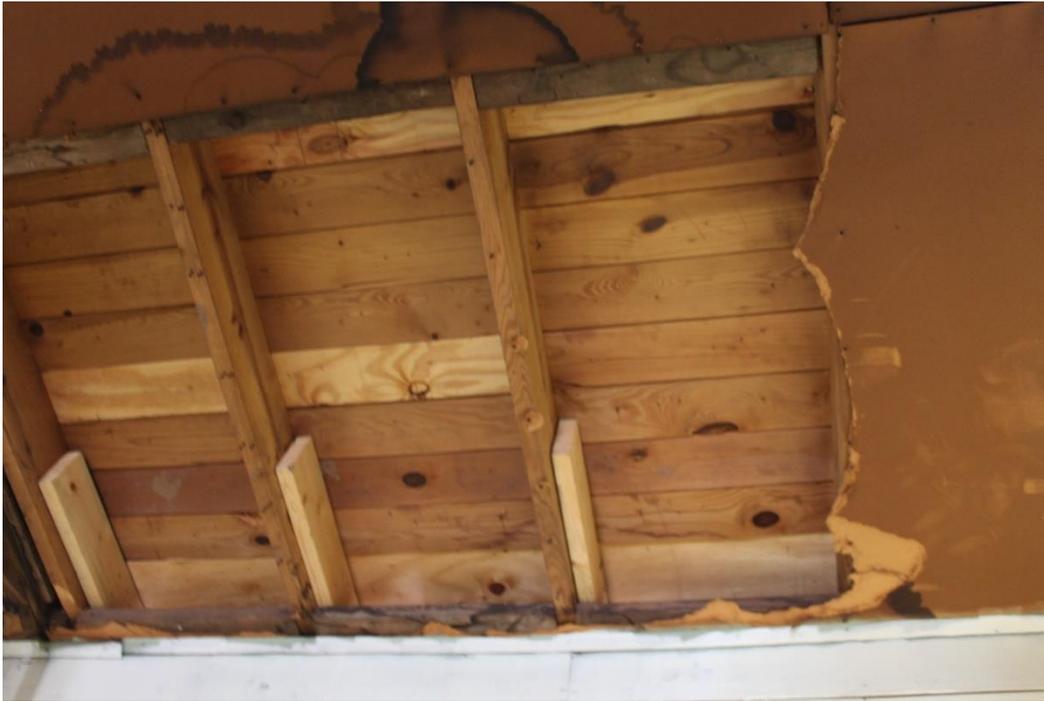
The roof shows signs of water leaks, and many sections have been patched or replaced (Figure A-6). Based on this observation, it is assumed that some of the roof decking may not be in reusable condition.

Figure A-6. Roof section showing patches and repairs.

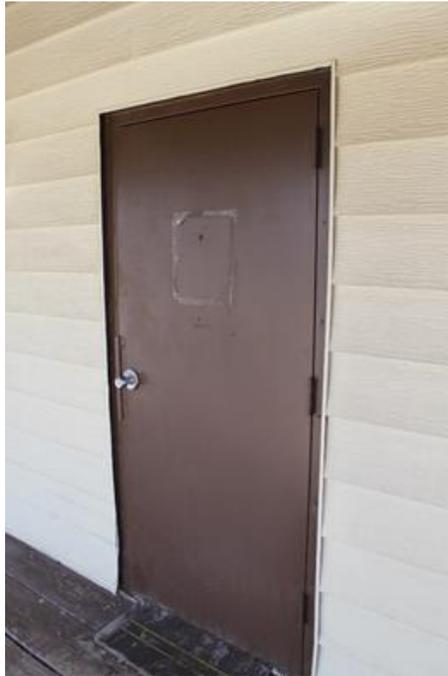
Bldg. 2310 has two 8 ft × 8 ft overhead metal doors, both in serviceable, reusable condition, and four 30 in. × 80 in. single exterior doors, also in good condition. Bldg. 2311 has three overhead doors and two single exterior doors in the same condition (Figure A-7).

Figure A-7. Single exterior door, in good condition.

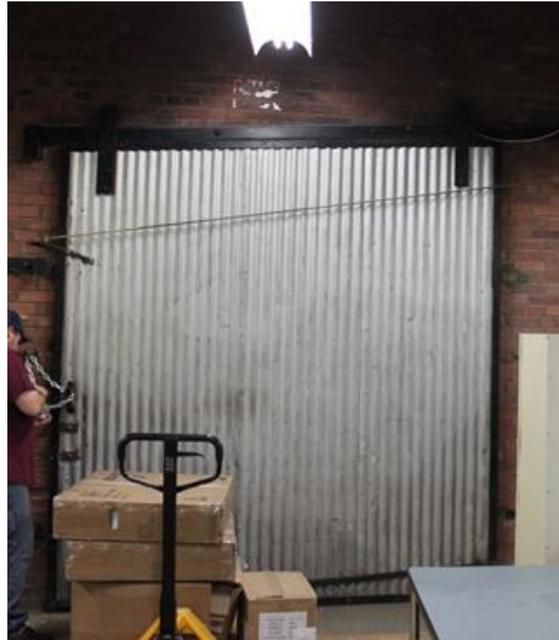
The two halves of the warehouse are separated by a brick firewall; two large corrugated metal doors on either side of the firewall (Figure A-8) allow passage through the center of the building. The doors are in good condition and have potential for reuse.

Figure A-8. Corrugated metal doors on either side of the fire wall.

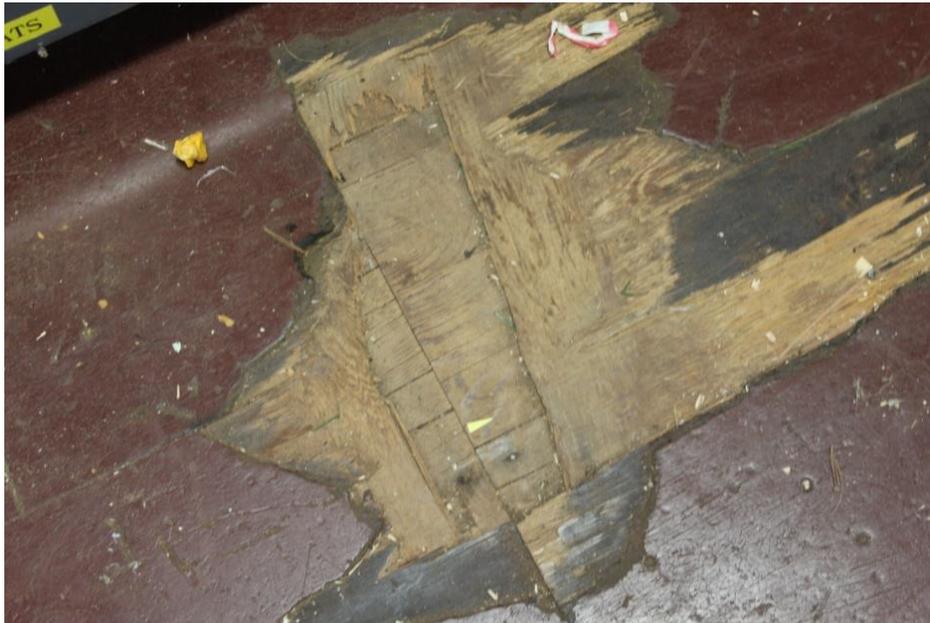
The flooring in Bldg. 2310 is covered with plywood and linoleum. The plywood is in poor condition and the top layer of linoleum is suspected to contain asbestos. In Bldg. 2311, the flooring consists of diagonal maple boards in moderate condition with sporadic gouges in high traffic areas (Figure A-9). Nevertheless, much of the floor remains serviceable and can be reclaimed (Figure A-10).

Figure A-9. Flooring with sporadic gouges in high traffic areas.

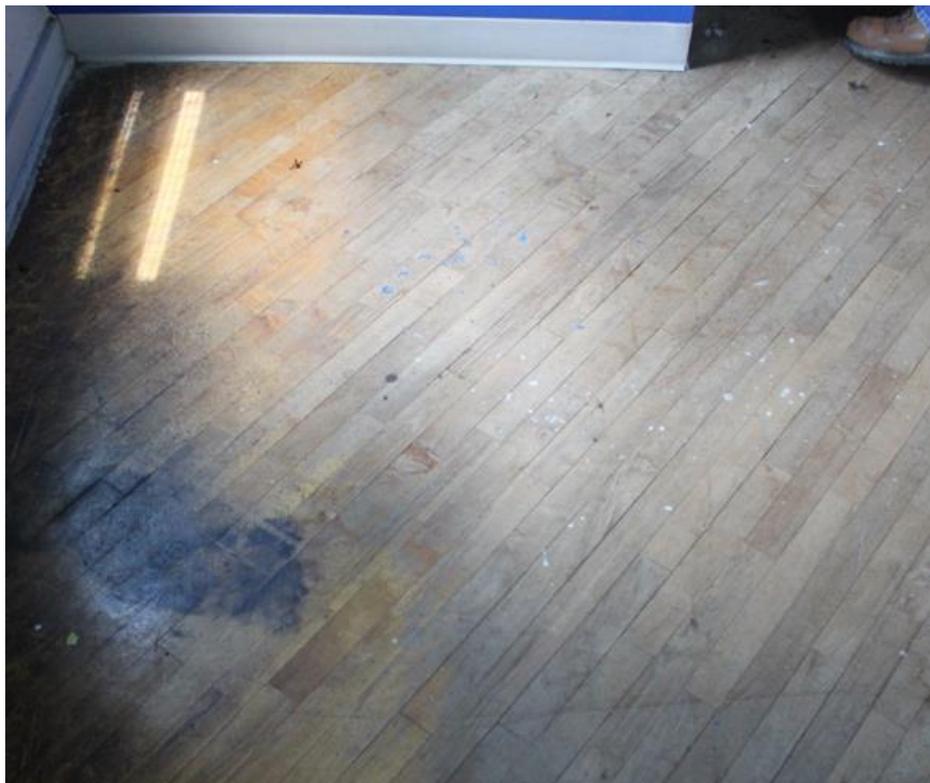
Figure A-10. Flooring in serviceable condition that can be reclaimed.

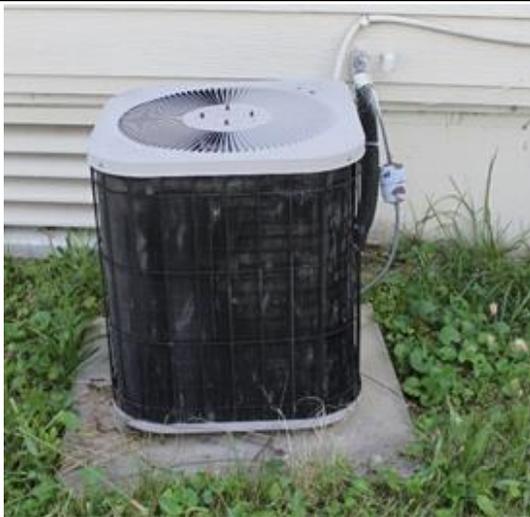
Only the Bldg. 2310 side of the building has mechanical equipment: two furnaces and one air-conditioner (Figure A-14). All are in fair condition and could be reused in similar environments. The larger furnace, a GMH8 Goodman product (Figure A-15) located in the mechanical room, services the storage section of the warehouse via an estimated 120 ft of ductwork ranging from 2 ft² down to 18 in². There is also a brick chimney about 20 ft tall and 3 ft². A smaller furnace (a Ck24-18 Goodman product) and an A/C unit service the office area (Figure A-16).

Figure A-14. Air-conditioner.

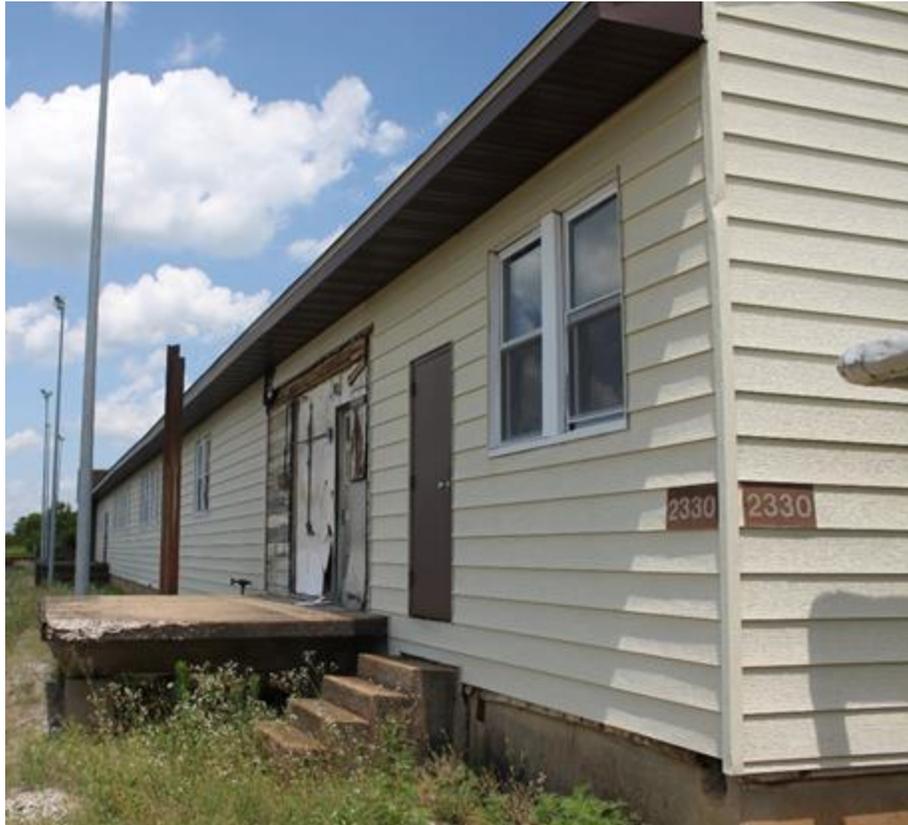
Figure B-2. Loading docks on the back side of the warehouse that are no longer in service.

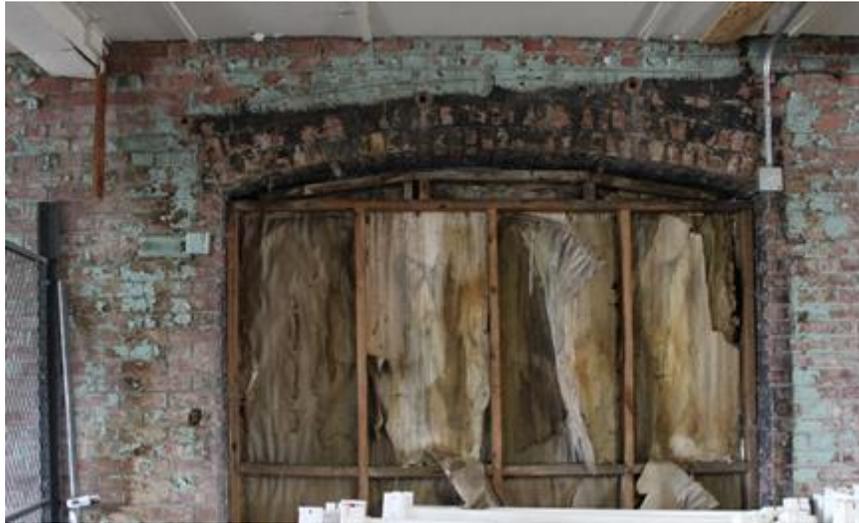
Figure B-6. Loading doors capped with plywood panels.

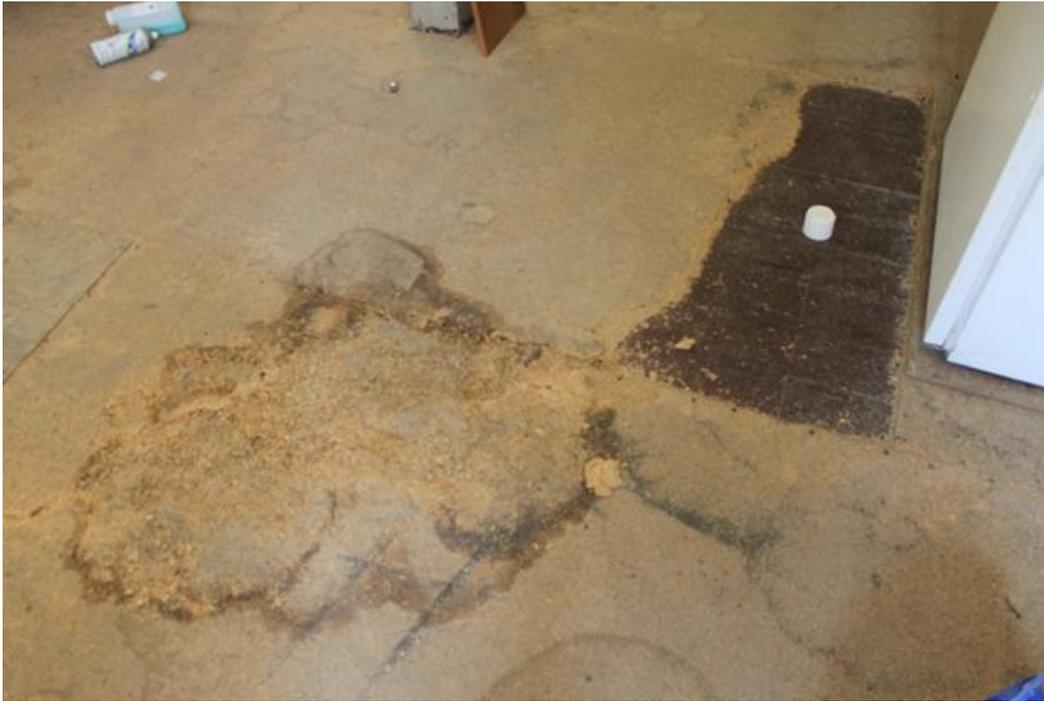
Figure B-7. Heavily worn flooring in Bldg. 2330.

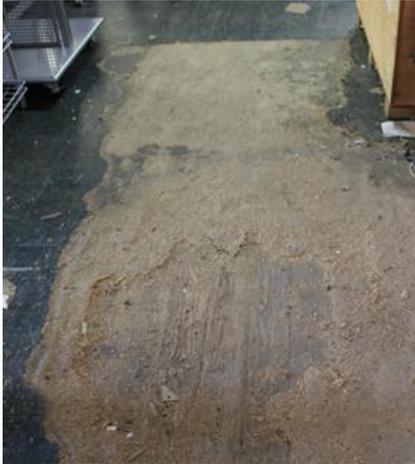
Figure C-4. Worn flooring in Bldg. 2332.

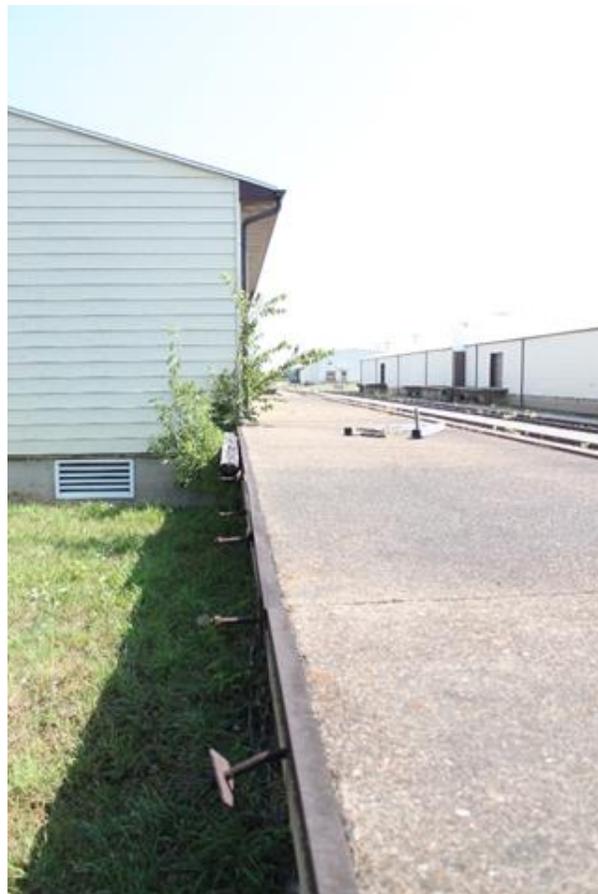
Figure D-3. Disused loading docks on the back side of the Bldgs. 2344 and 2345 (warehouse).

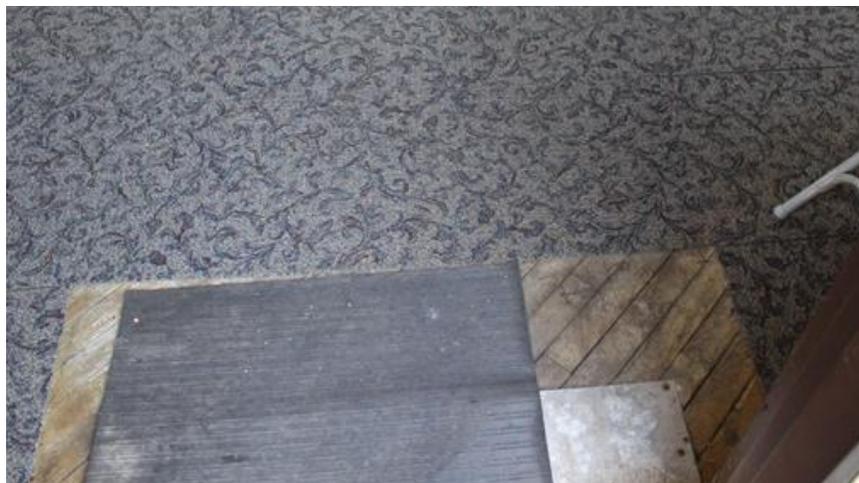
The flooring in the main storage area of Bldg. 2345 is covered with plywood; under the plywood there is evidence of the same diagonal maple floorboards found in other warehouses (Figure D-8). The condition of the plywood is moderate, but the maple boards should be well protected and in good shape. The floors in Bldg. 2344 are of the same materials, although the maple floorboard shows heavier wear patterns. That being said, much of the floor remains serviceable and can be reclaimed.

Figure D-8. Flooring in Bldg. 2345 showing diagonal maple boards.
