TECHNICAL REPORT REMR-CS-13

**REHABILITATION OF NAVIGATION  
LOCK WALLS: CASE HISTORIES**

James E. McDonald

December 1987

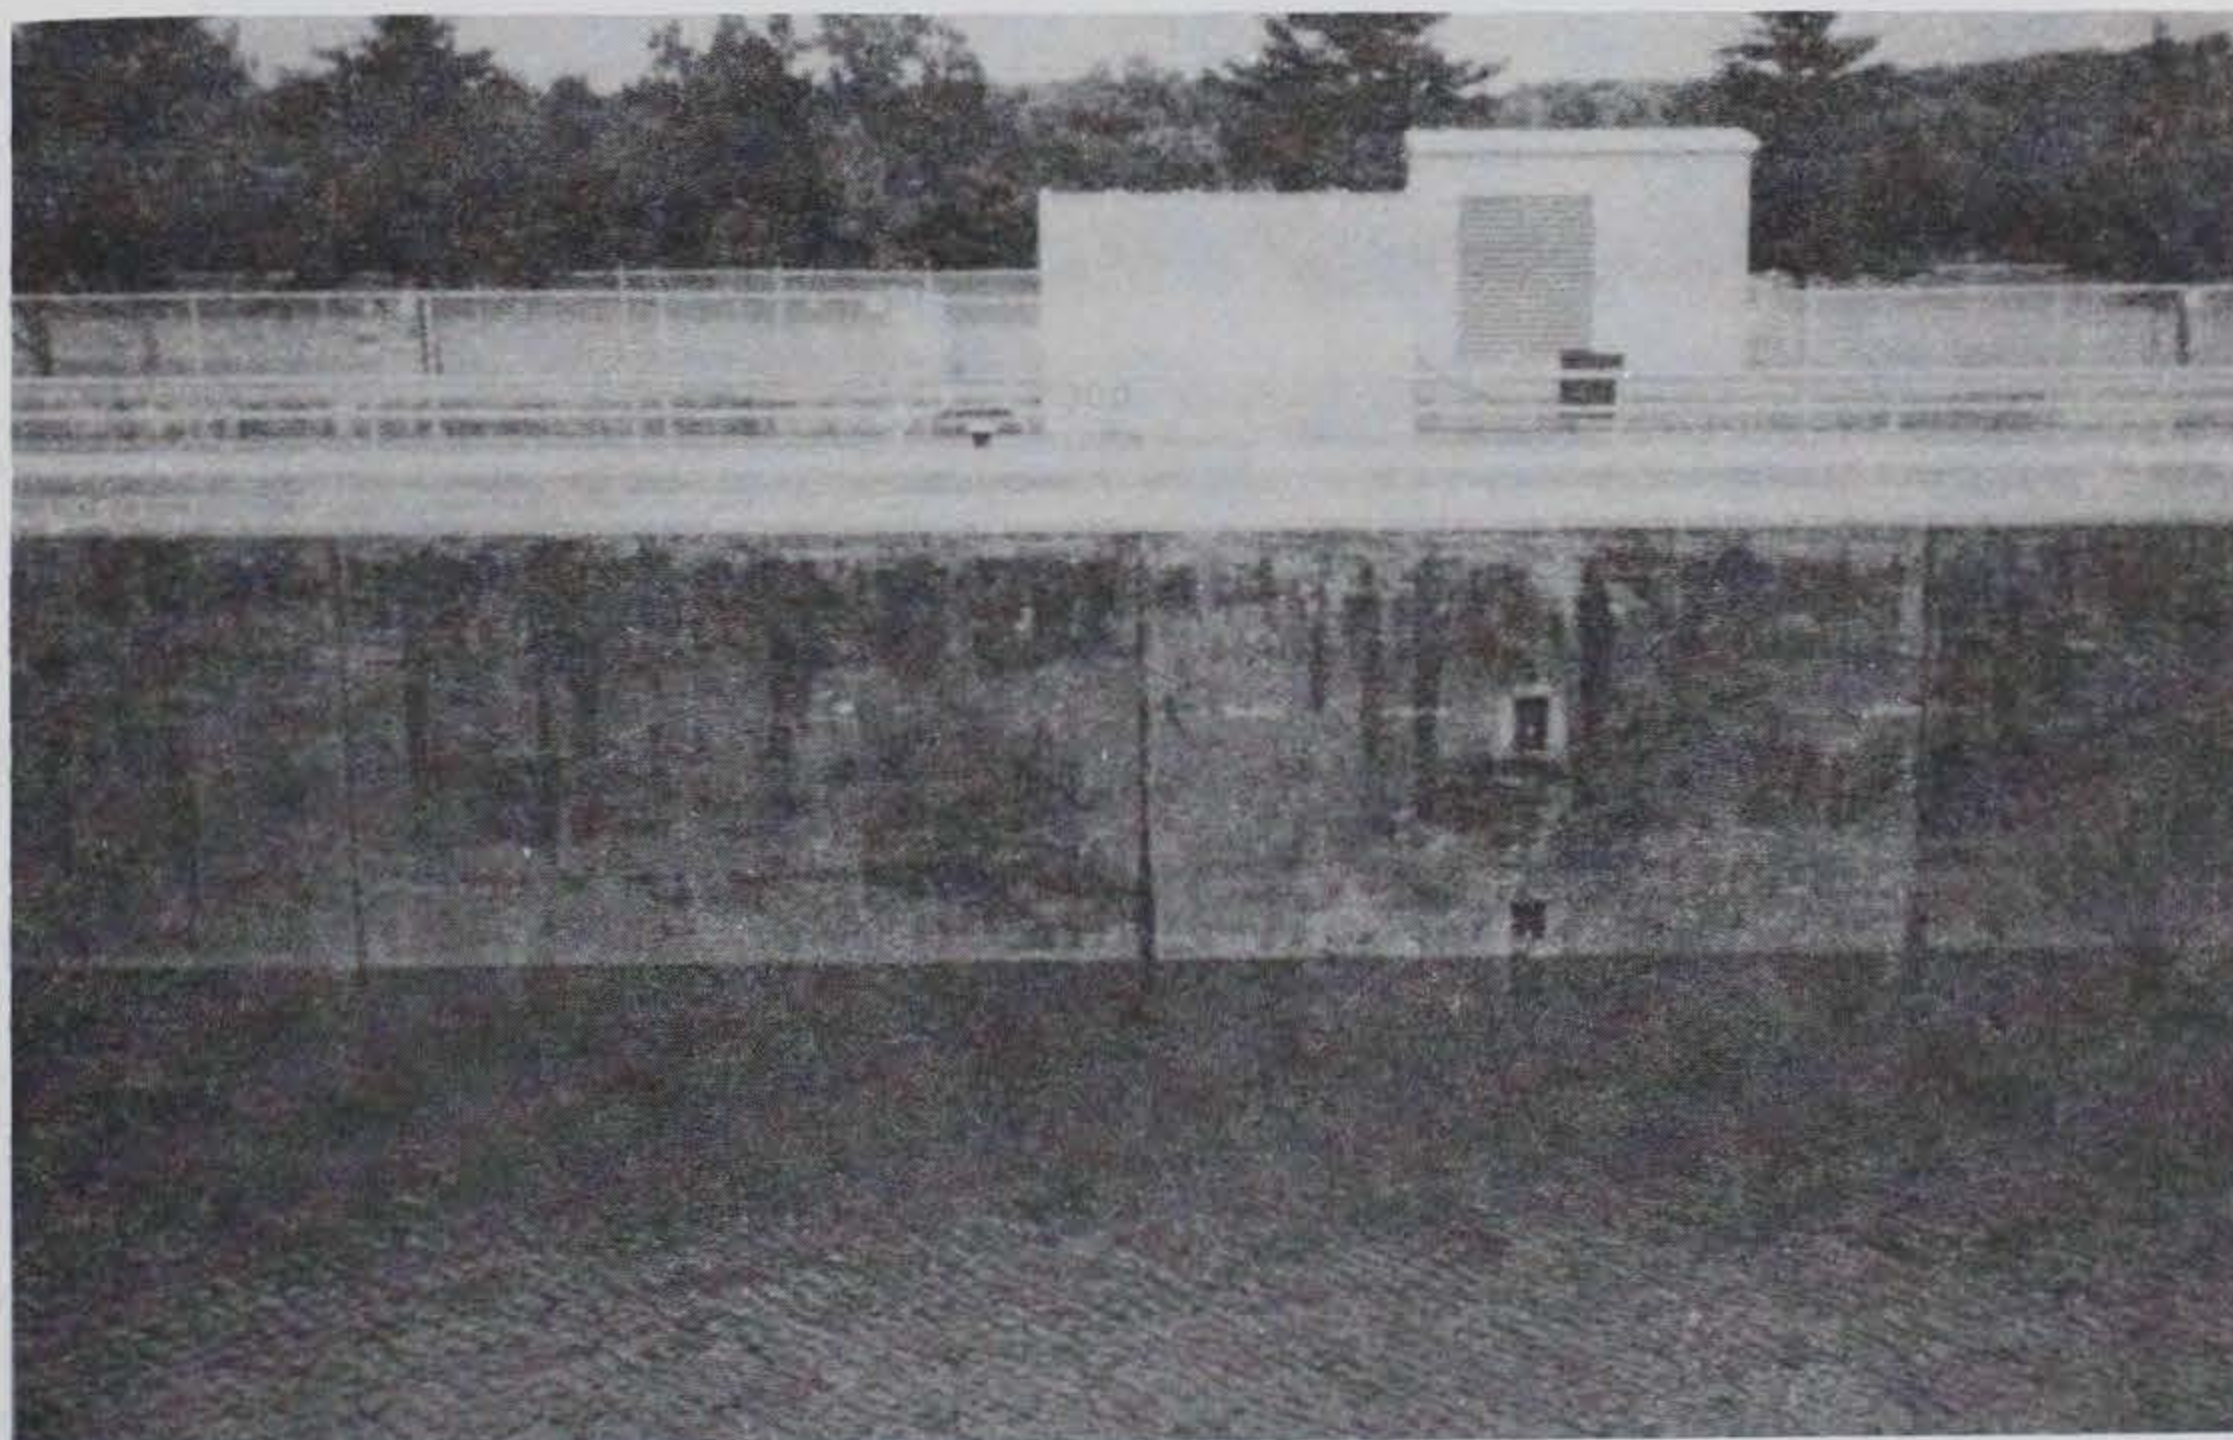
42. The epoxy applications were a "fiasco" (Juzenas 1979). Delamination of the epoxy layer below the top corner protection plate of the lock wall started within days after reopening of the lock to the waterway traffic. In many places the epoxy mortar was rubbery and easily bent by hand. The Waterways Experiment Station (WES) was engaged to determine the causes of the failure. Upon performance of a battery of tests on the materials and on samples taken from the wall, WES concluded that delaminations were predominantly caused by barge impacts on the epoxy mortar overlay that was poorly bonded to the underlying material. Lack of cleaning and smoothness of the underlying material were thought to be the principal contributing factors in producing a poor bond. The extraction tests indicated that insufficient curing caused the epoxy mortar to be soft. Insufficient curing was attributed to improper mixing or proportioning. As a result of the epoxy mortar failure, a horizontal steel plate was used to cover the failure area (Figure 14).

Figure 14. Steel plate below corner protection armor used to cover epoxy mortar failure, May 1985, Marseilles Lock

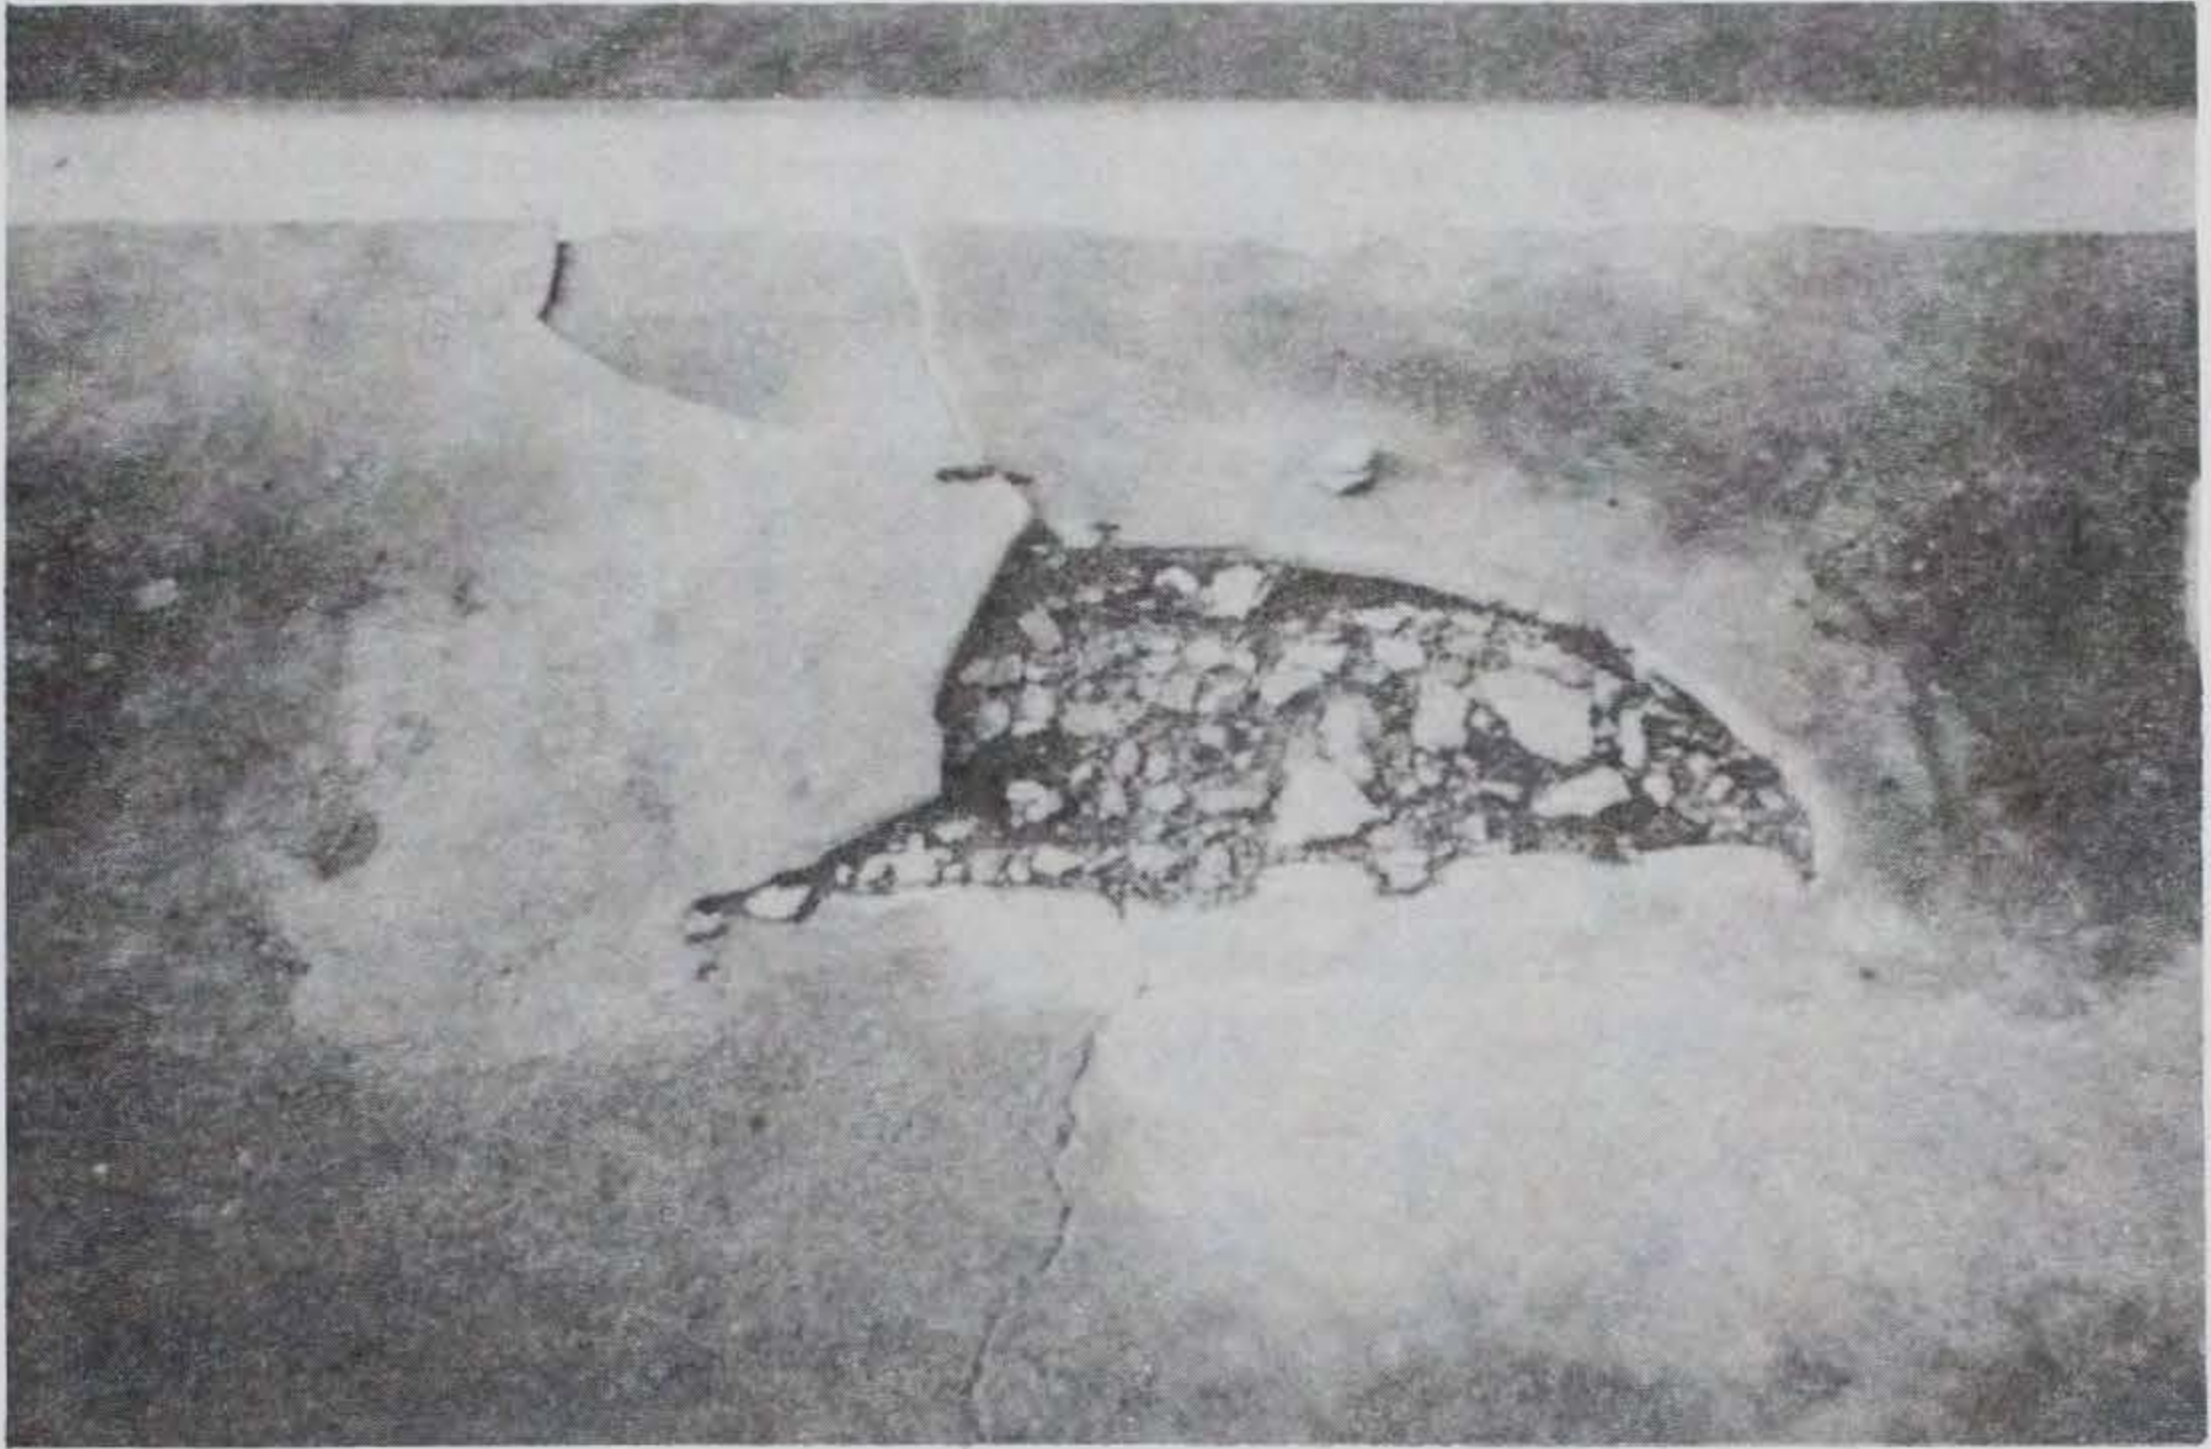
Figure 15. Typical delamination of epoxy overlay, May 1985,  
Marseilles Lock

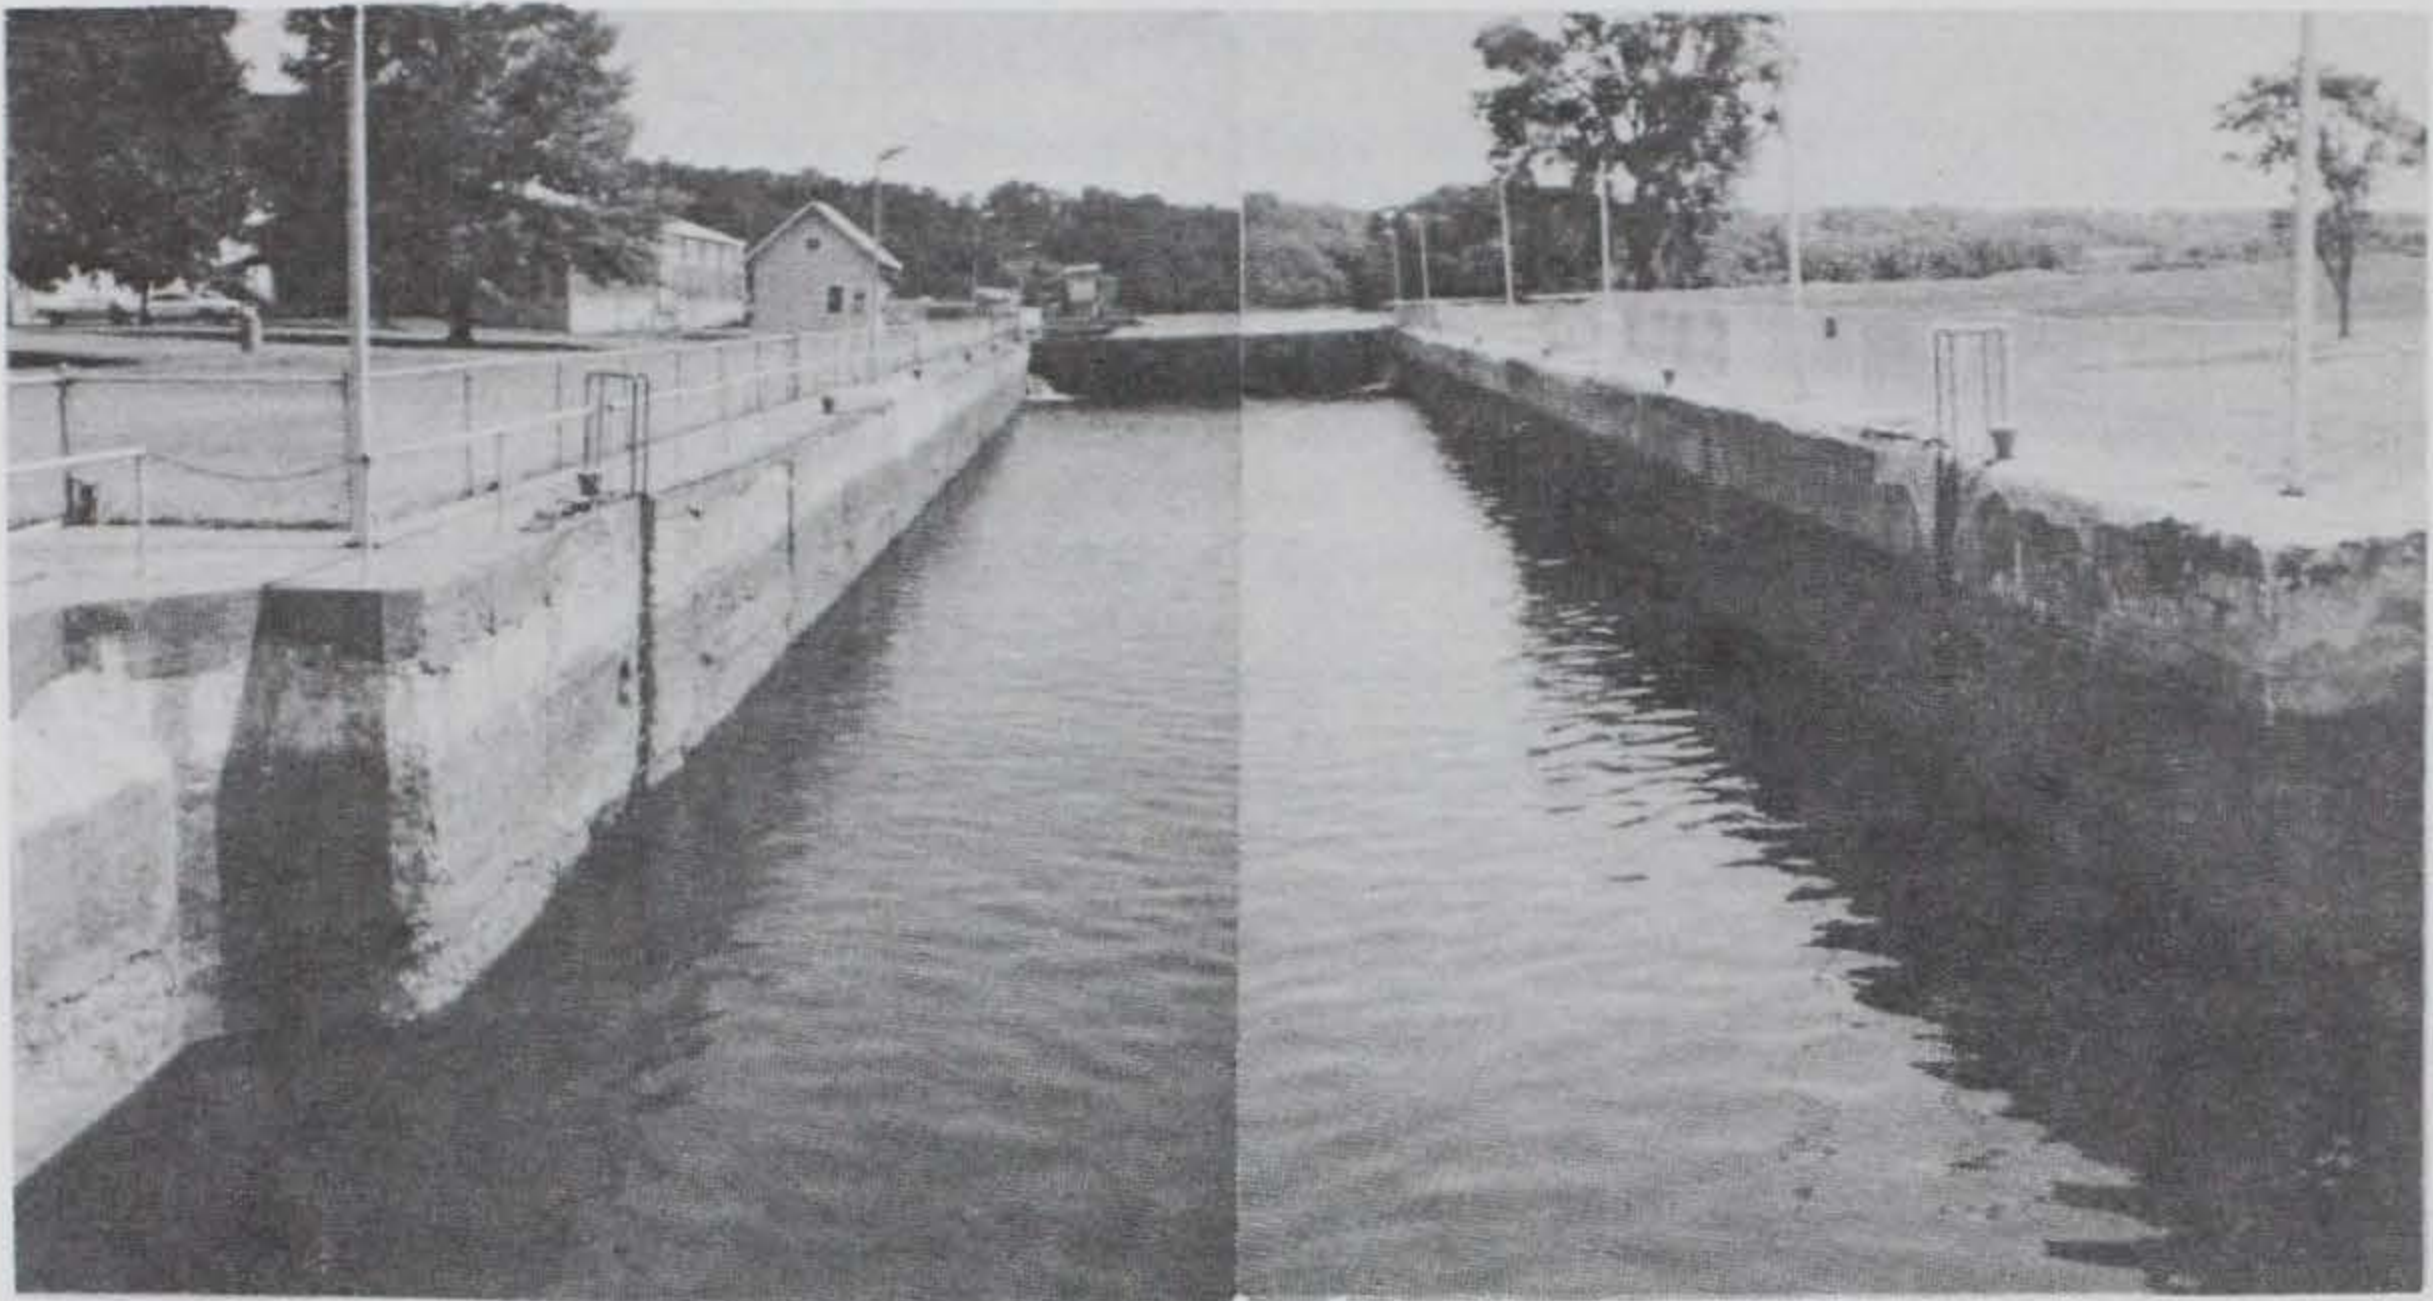
49. After 55 years exposure to the elements, lock concrete surfaces were severely scaled (Figures 17 and 18). An investigation was initiated in 1977 to determine the extent and causes of the concrete deterioration. Two 6-in.-diam holes were core drilled vertically through the landside lock wall and 5 ft into the underlying bedrock. In addition, 6-in.-diam cores were obtained from a total of 12 horizontal and vertical holes drilled to depths of

Figure 17. General view of lock looking upstream 1977,  
Old Lock No. 14, Mississippi River

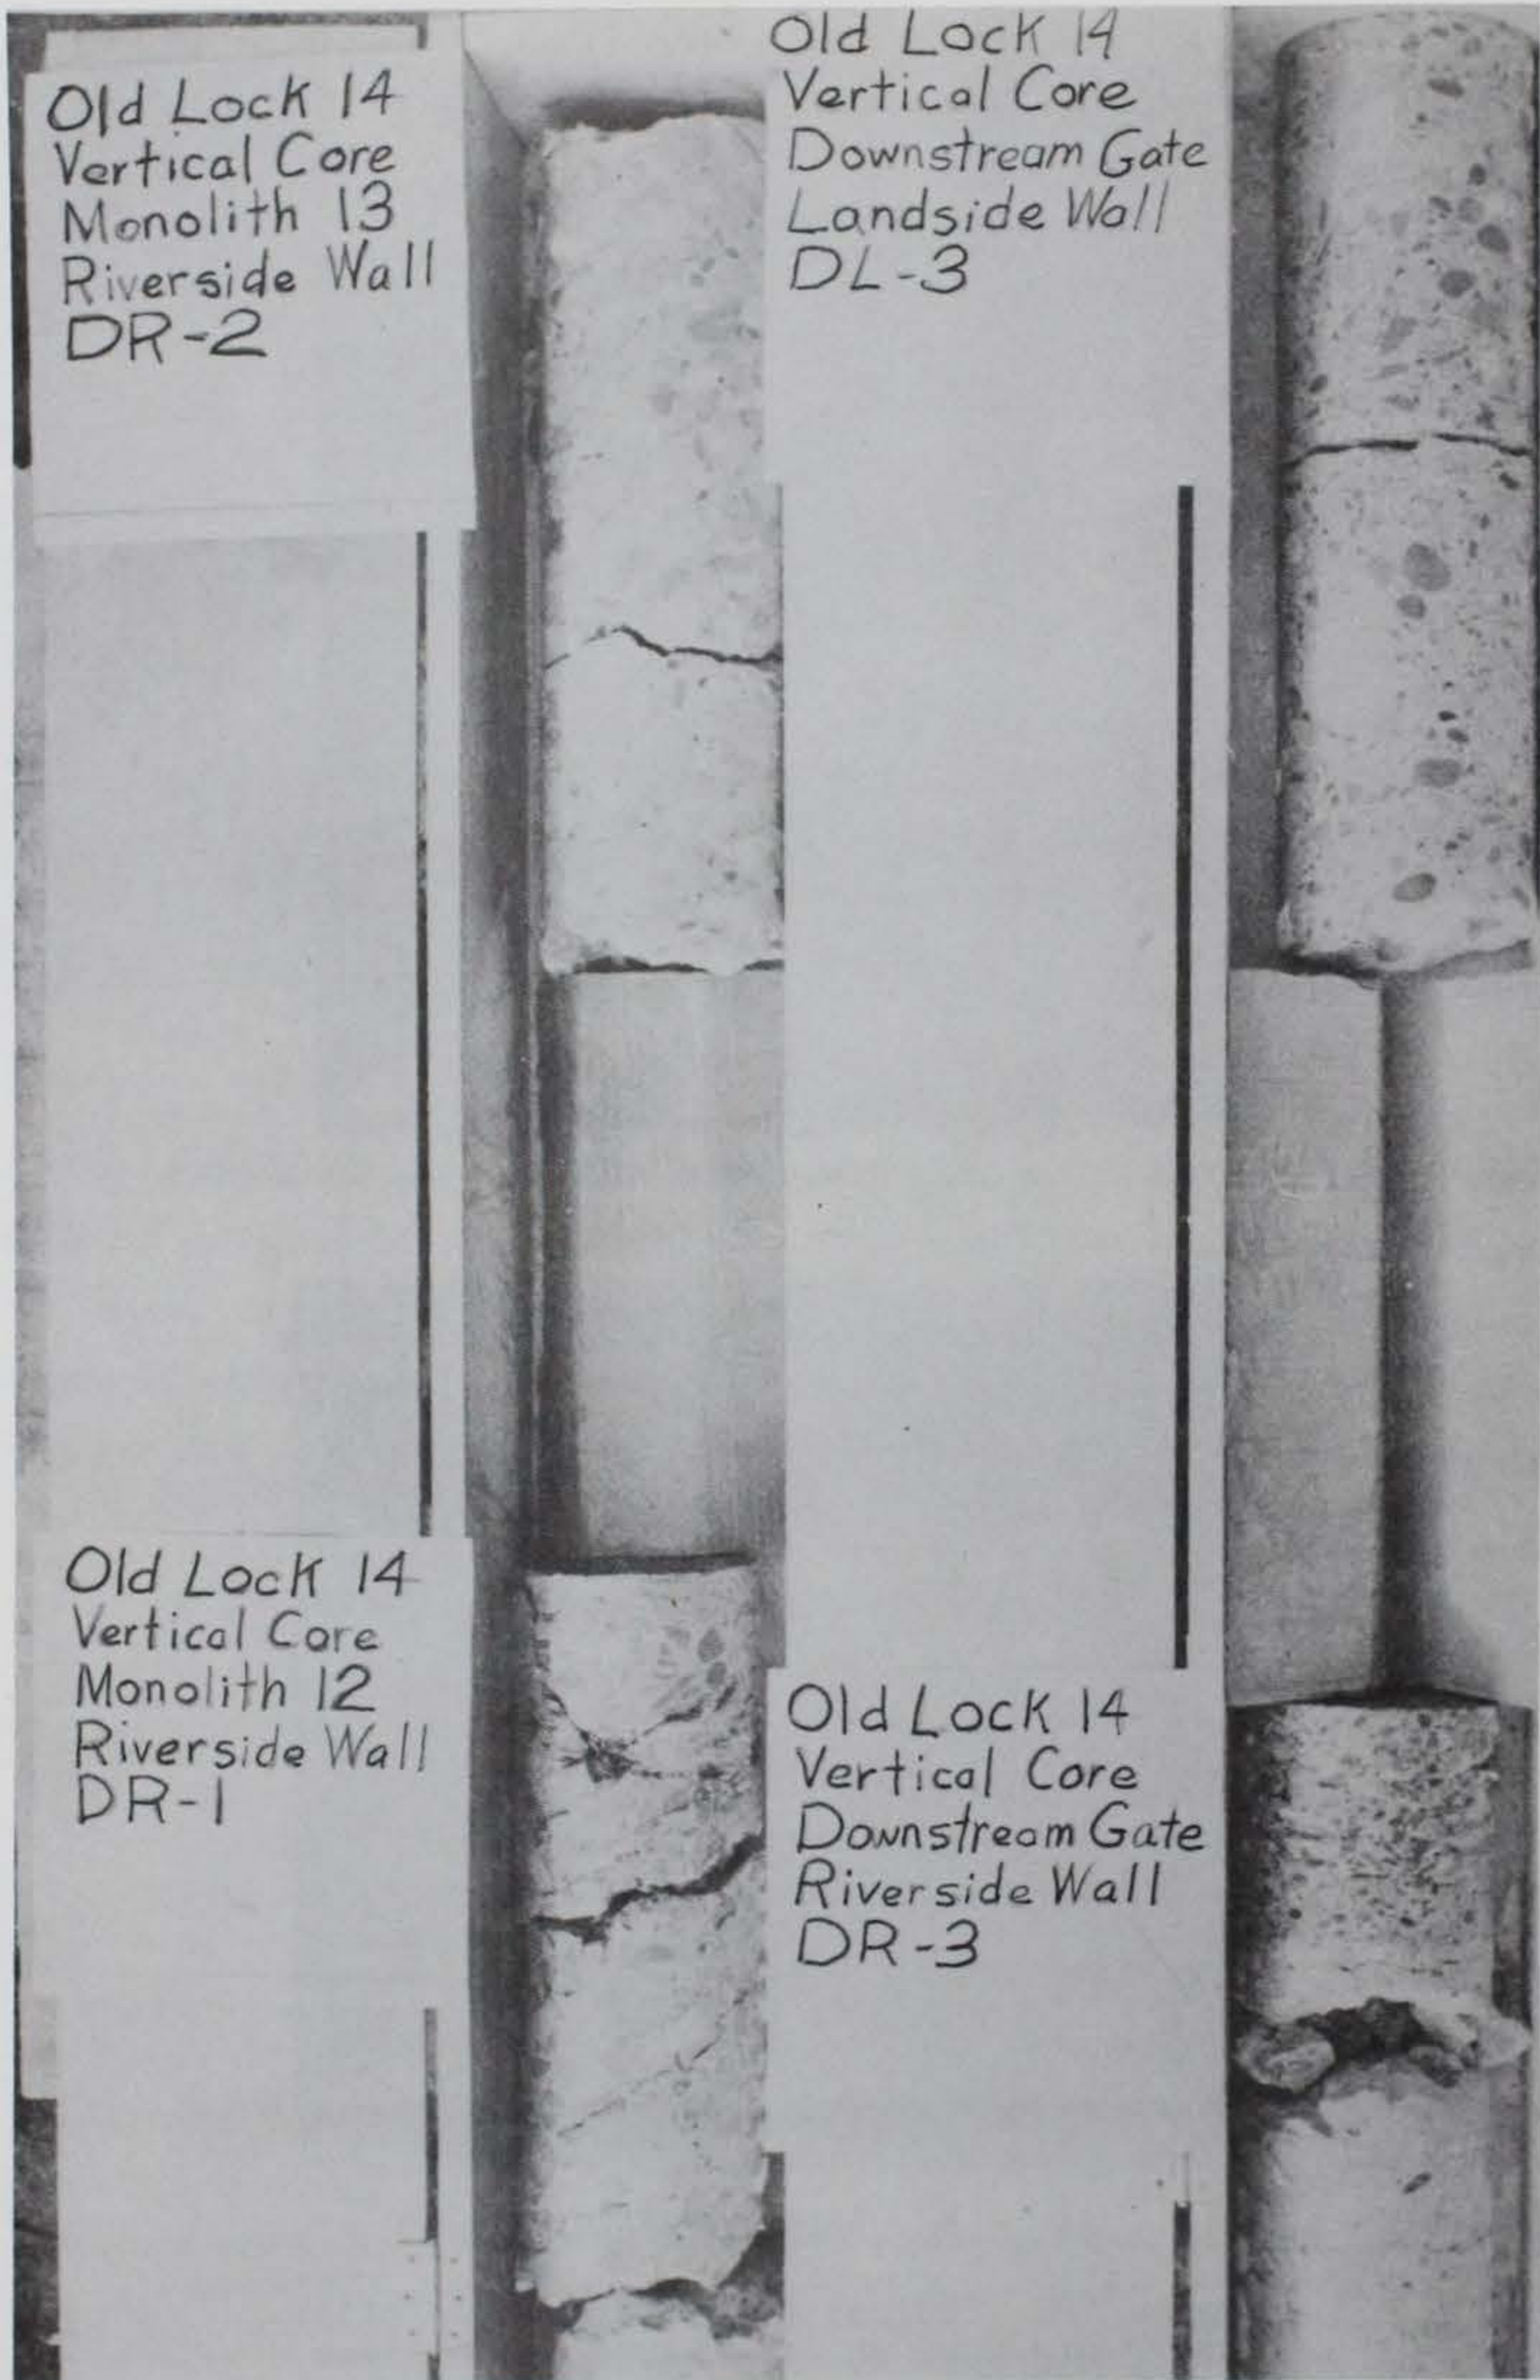
Figure 19. Photographs of selected concrete cores, 1977,  
Old Lock No. 14, Mississippi River

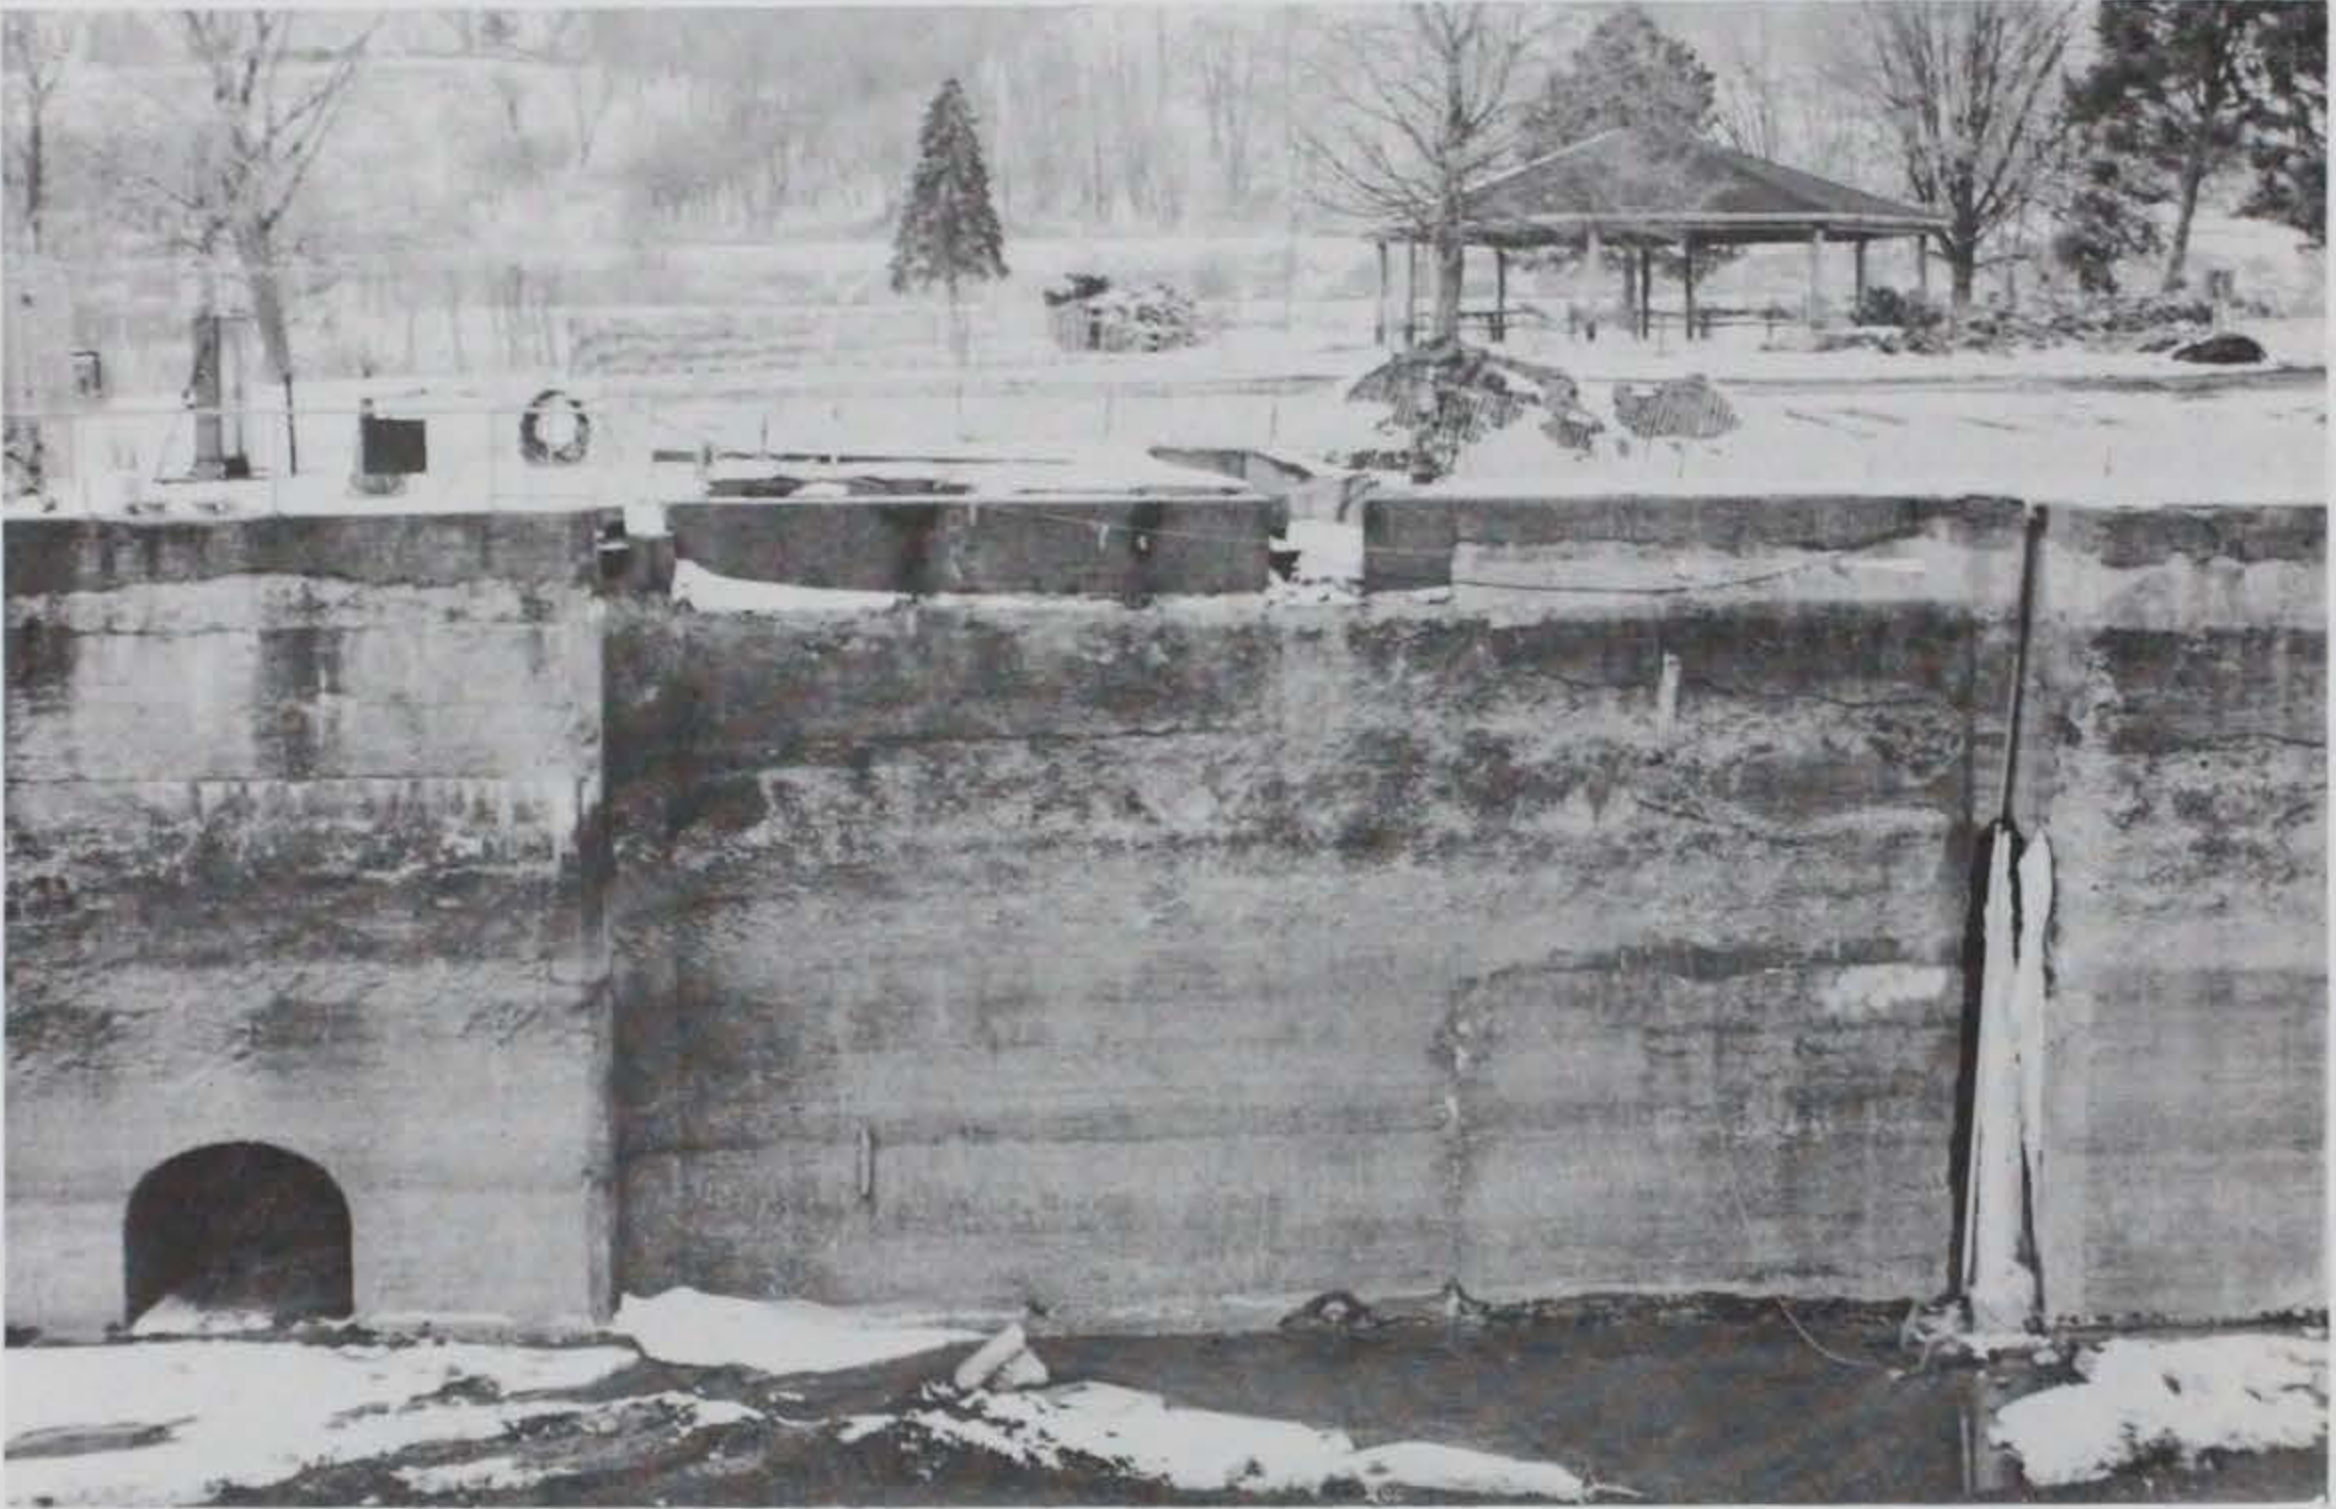
Figure 20. Typical concrete deterioration, February 1980, Old Lock No. 14, Mississippi River
