TECHNICAL REPORT REMR-CS-13

**REHABILITATION OF NAVIGATION  
LOCK WALLS: CASE HISTORIES**

James E. McDonald

December 1987

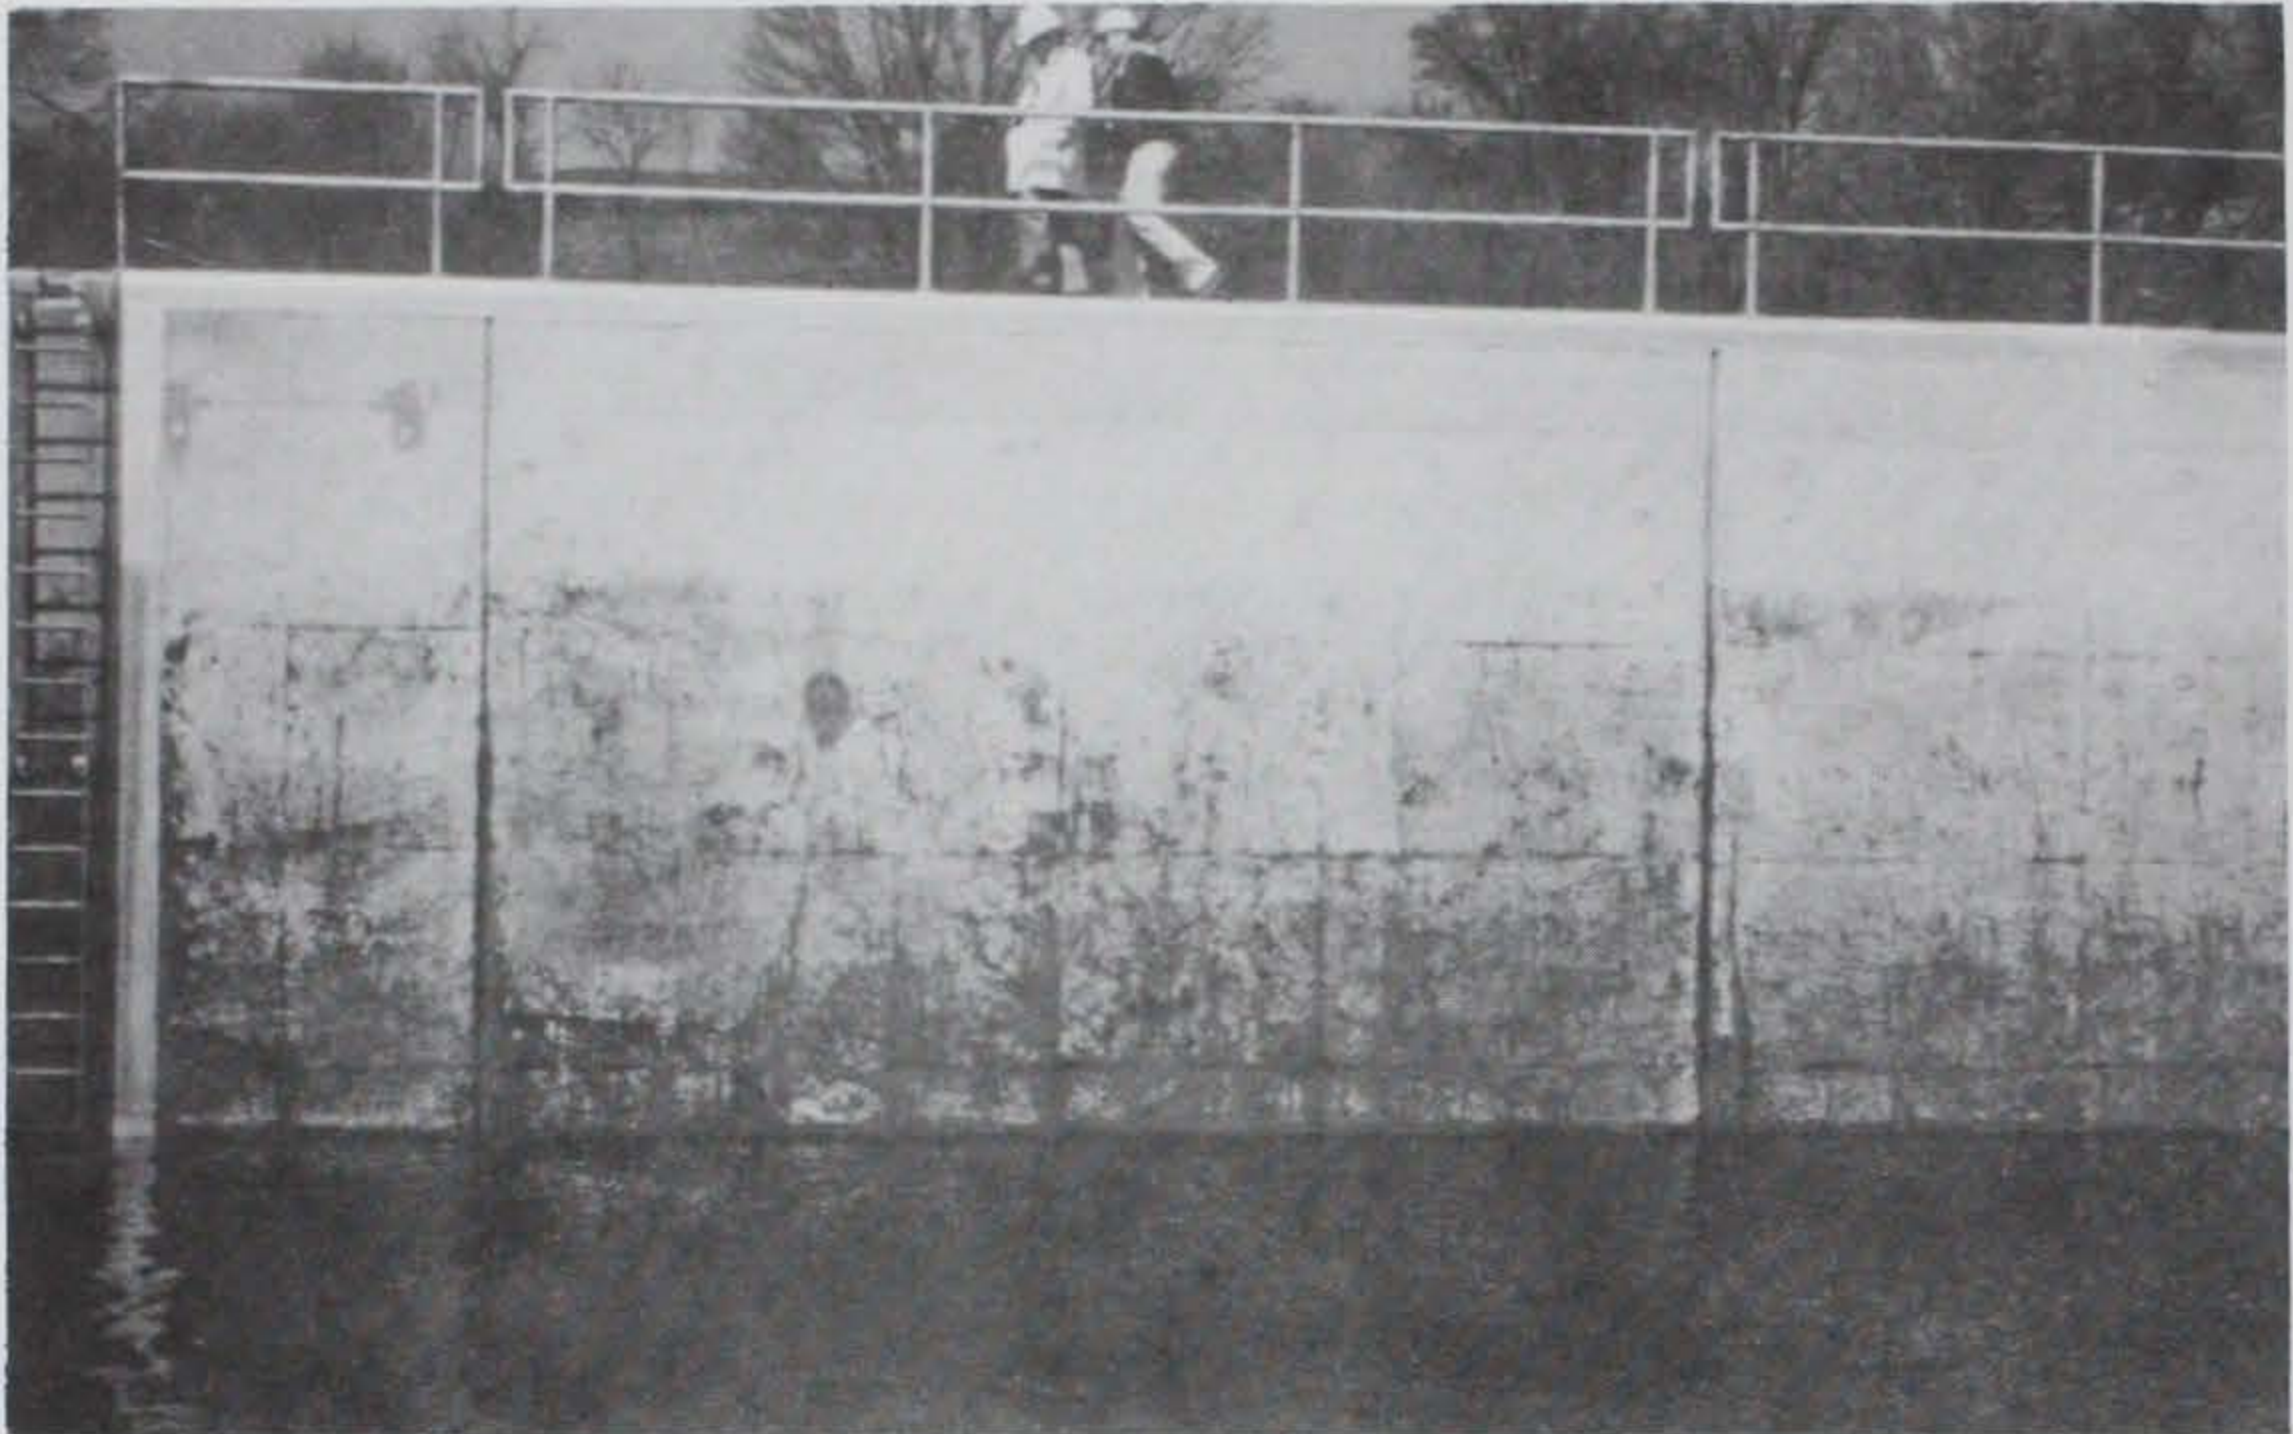
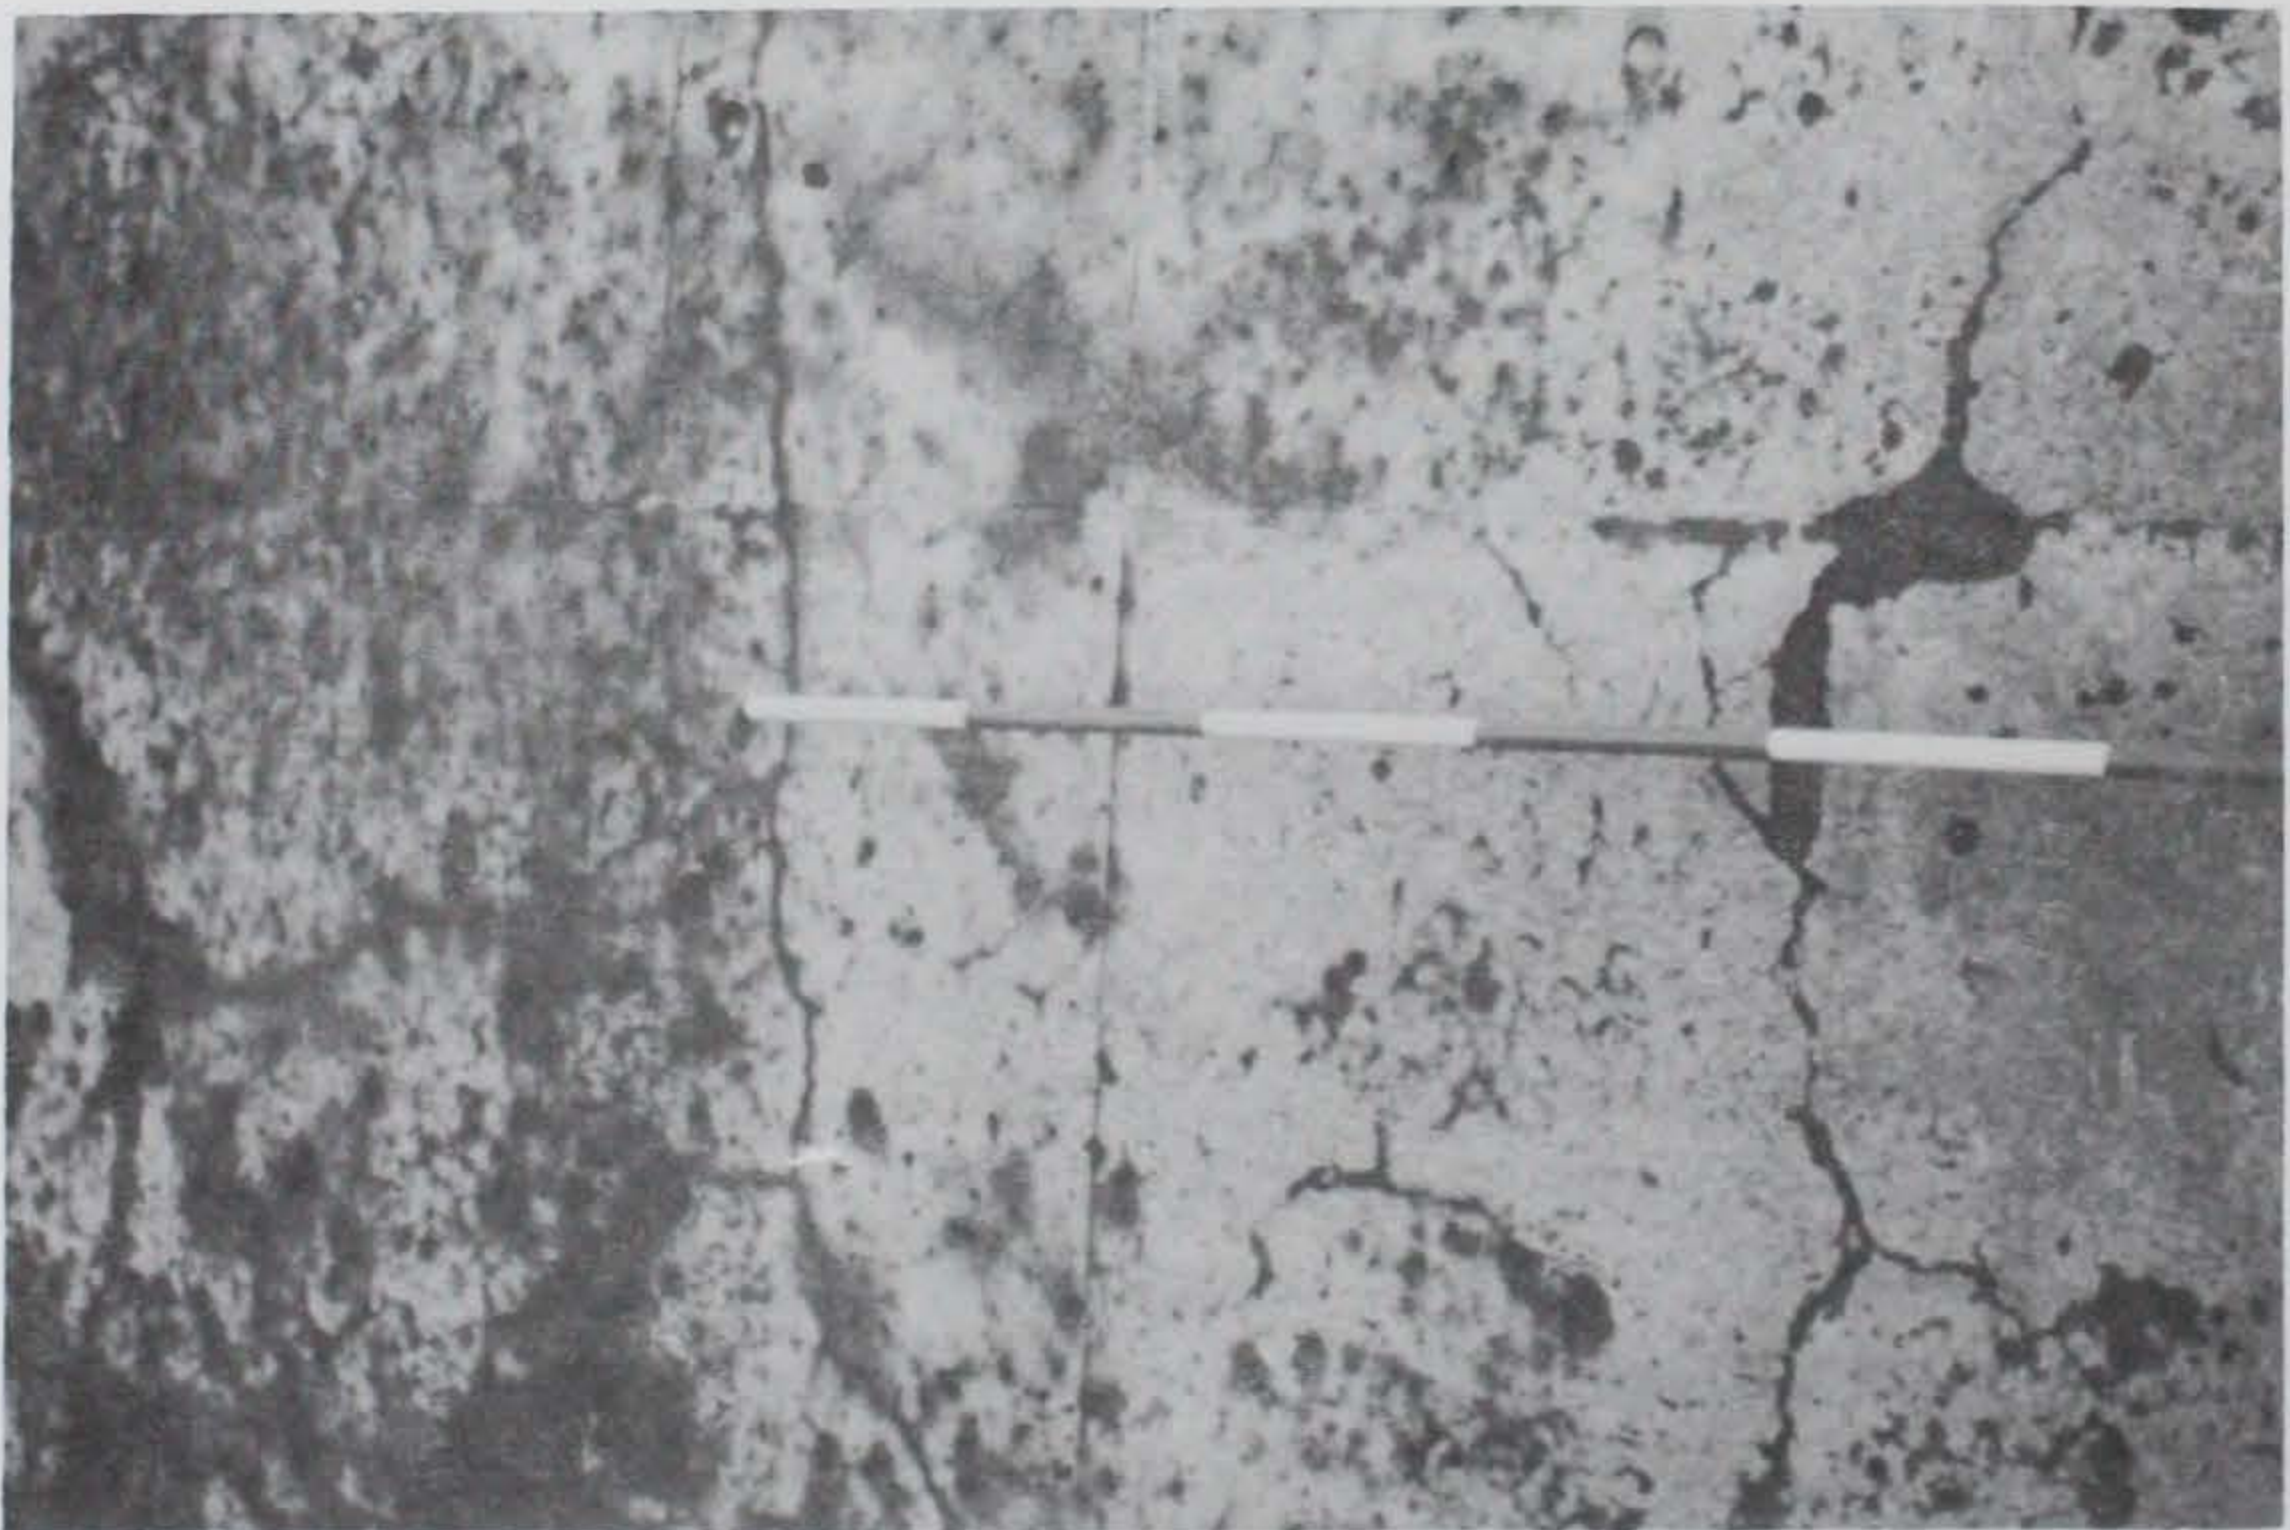
Figure 24. Typical concrete condition, August 1984,  
Old Lock No. 14, Mississippi River

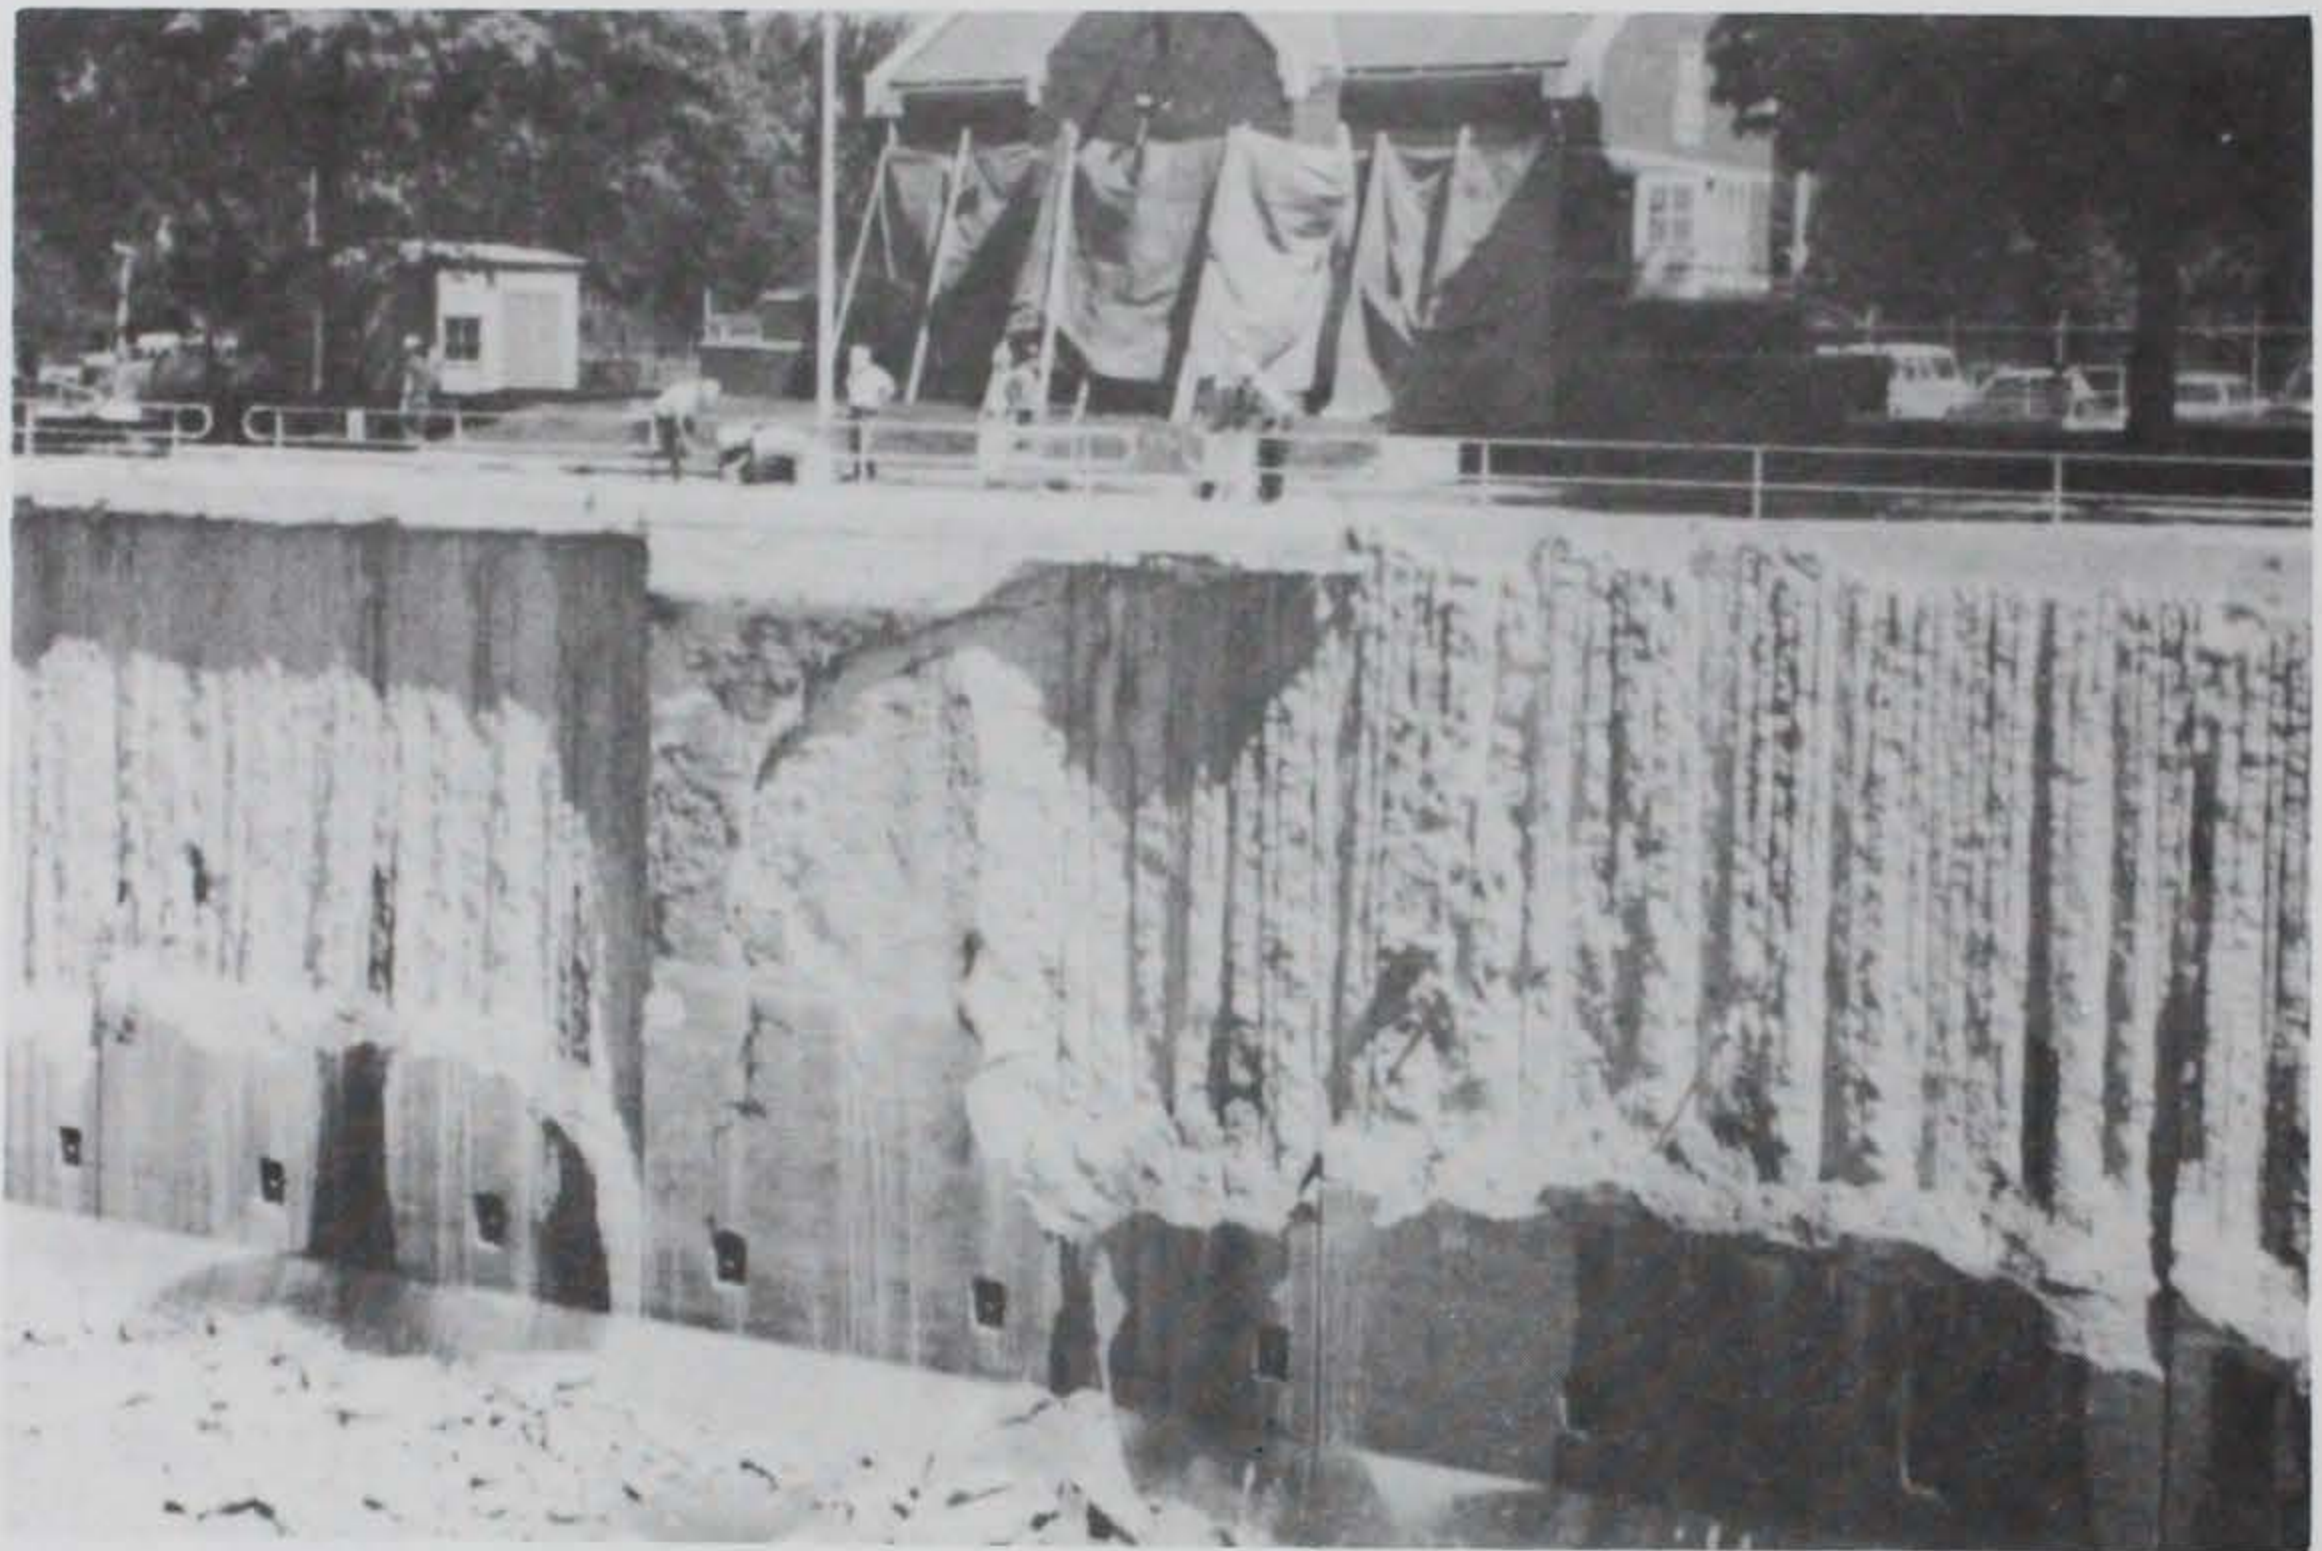
Figure 35. Typical concrete surface conditions after blasting, Dresden Island Lock

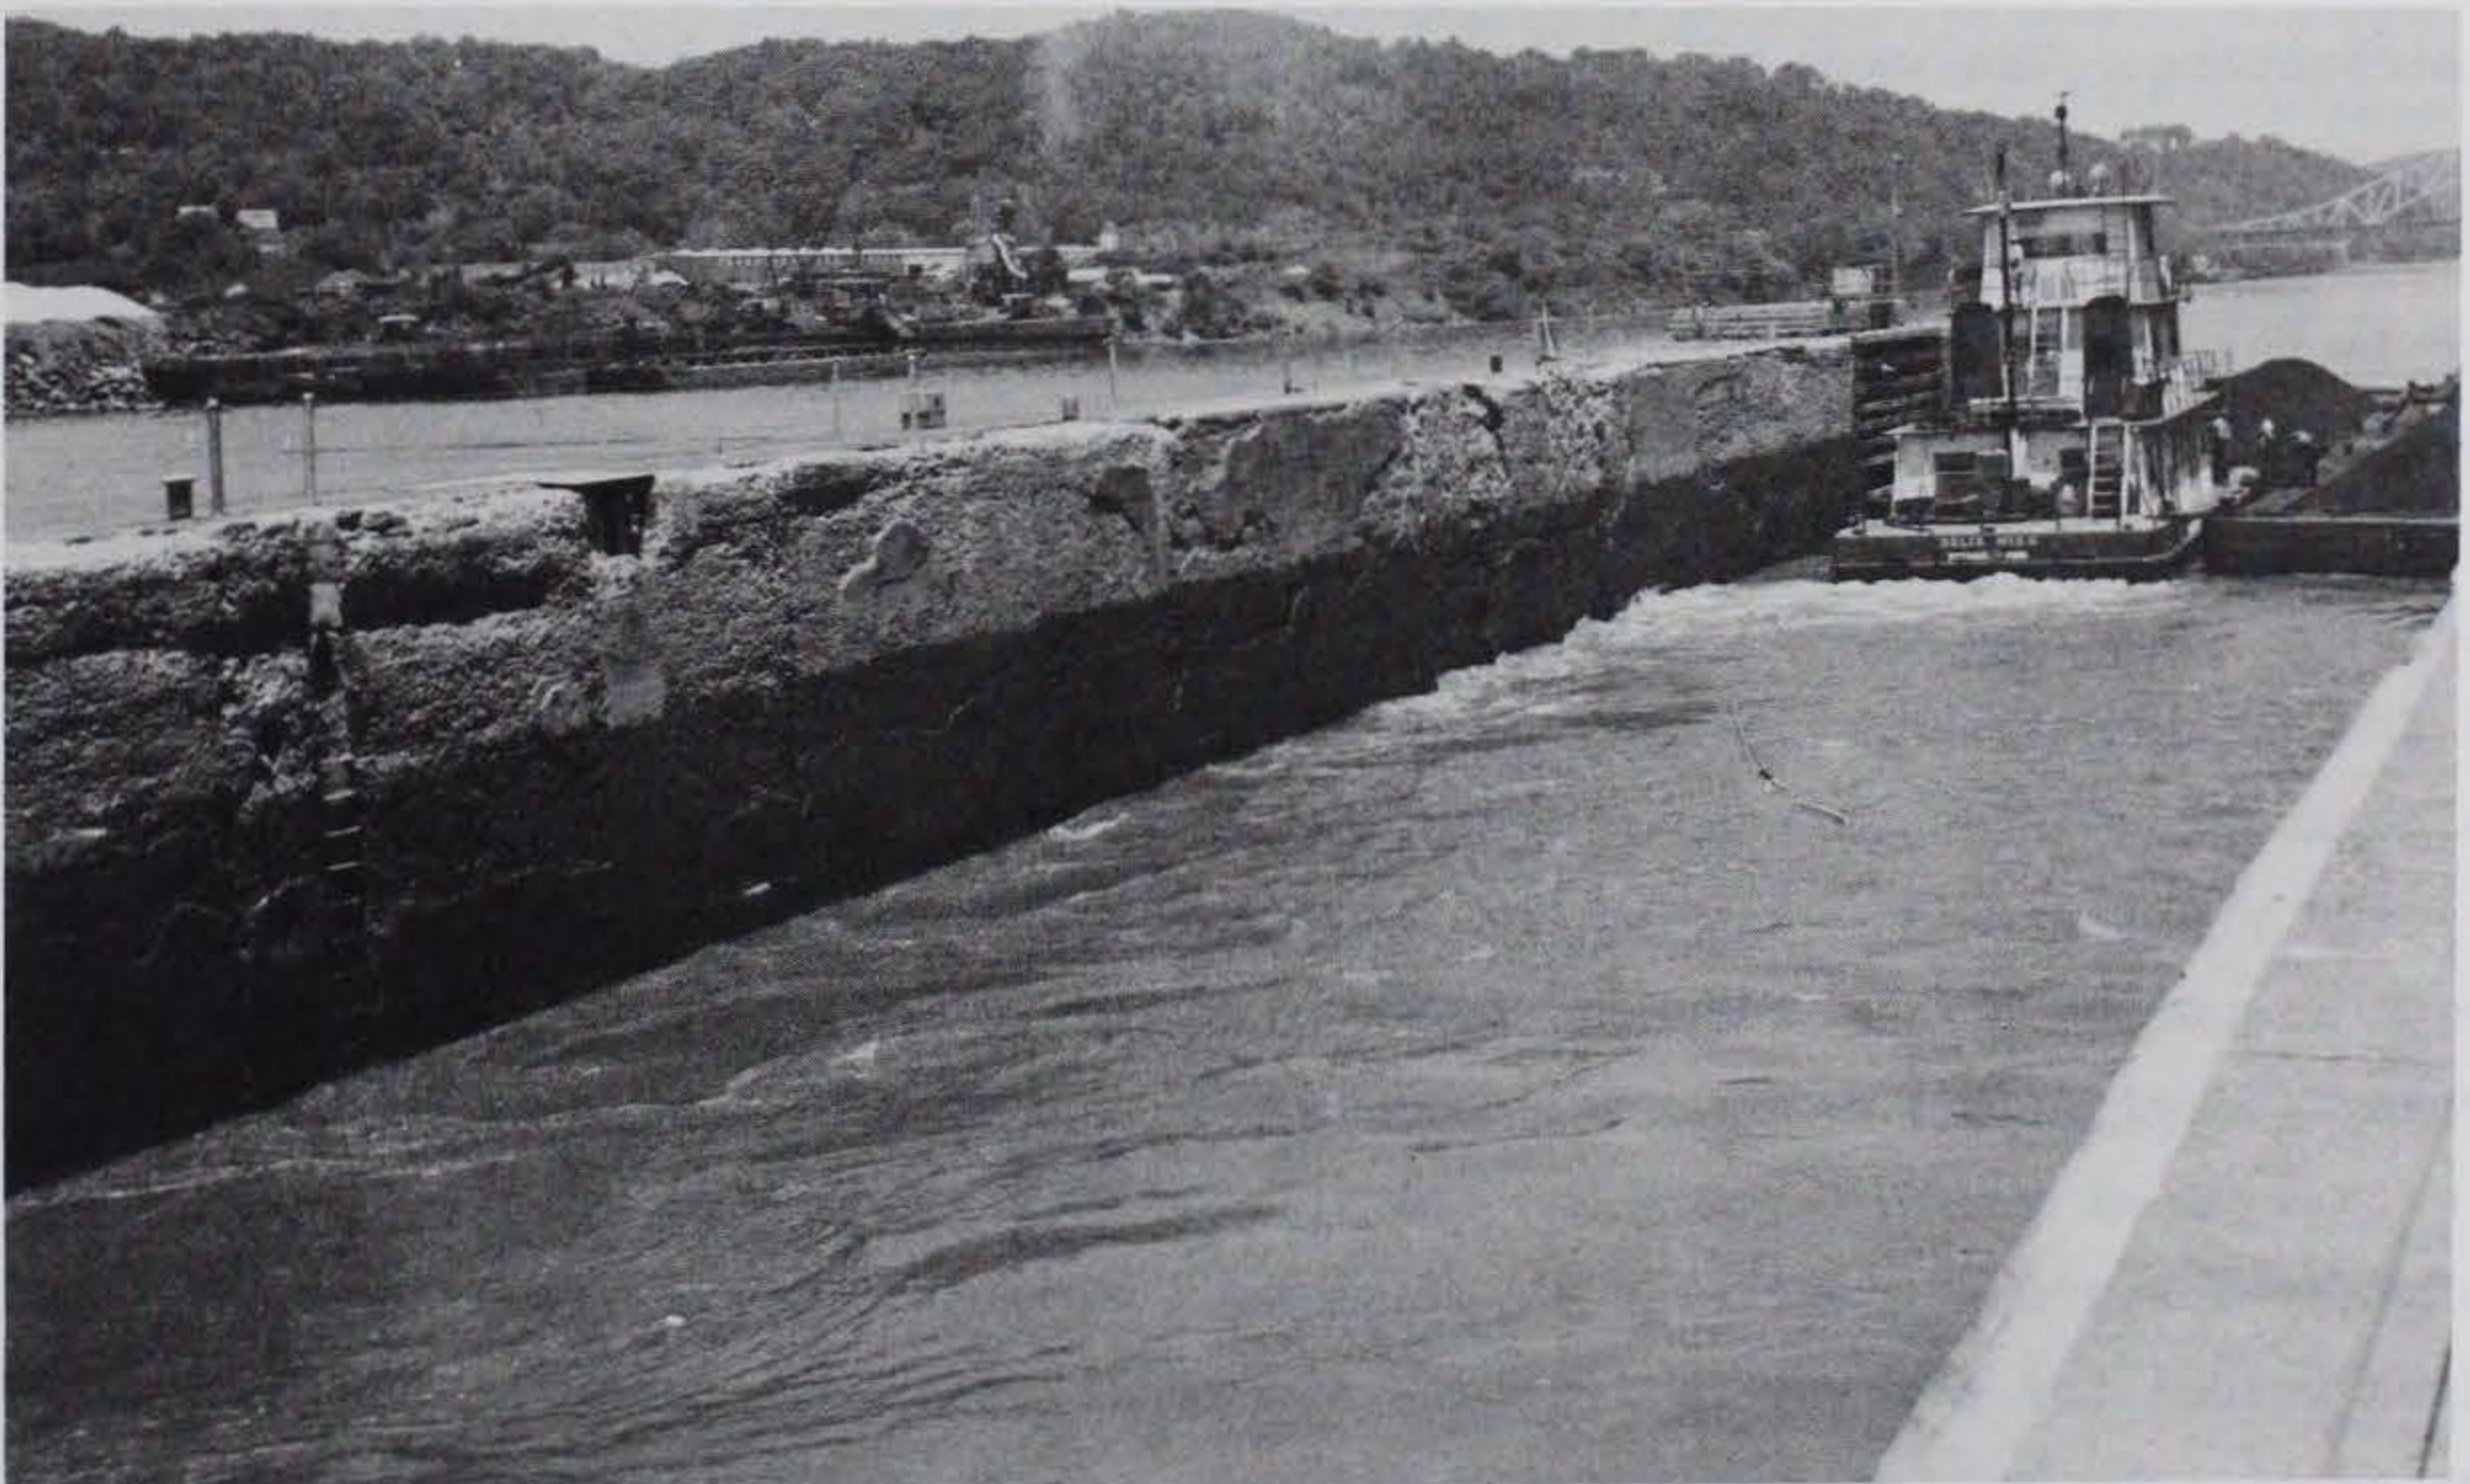
96. From general observations, it was noted that the lock walls were badly spalled and scoured. Previous shotcrete repairs of the wall faces were almost completely deteriorated (Figure 47). The structural beams supporting

Figure 47. Concrete deterioration in river chamber, June 1978, Lock No. 3, Monongahela River

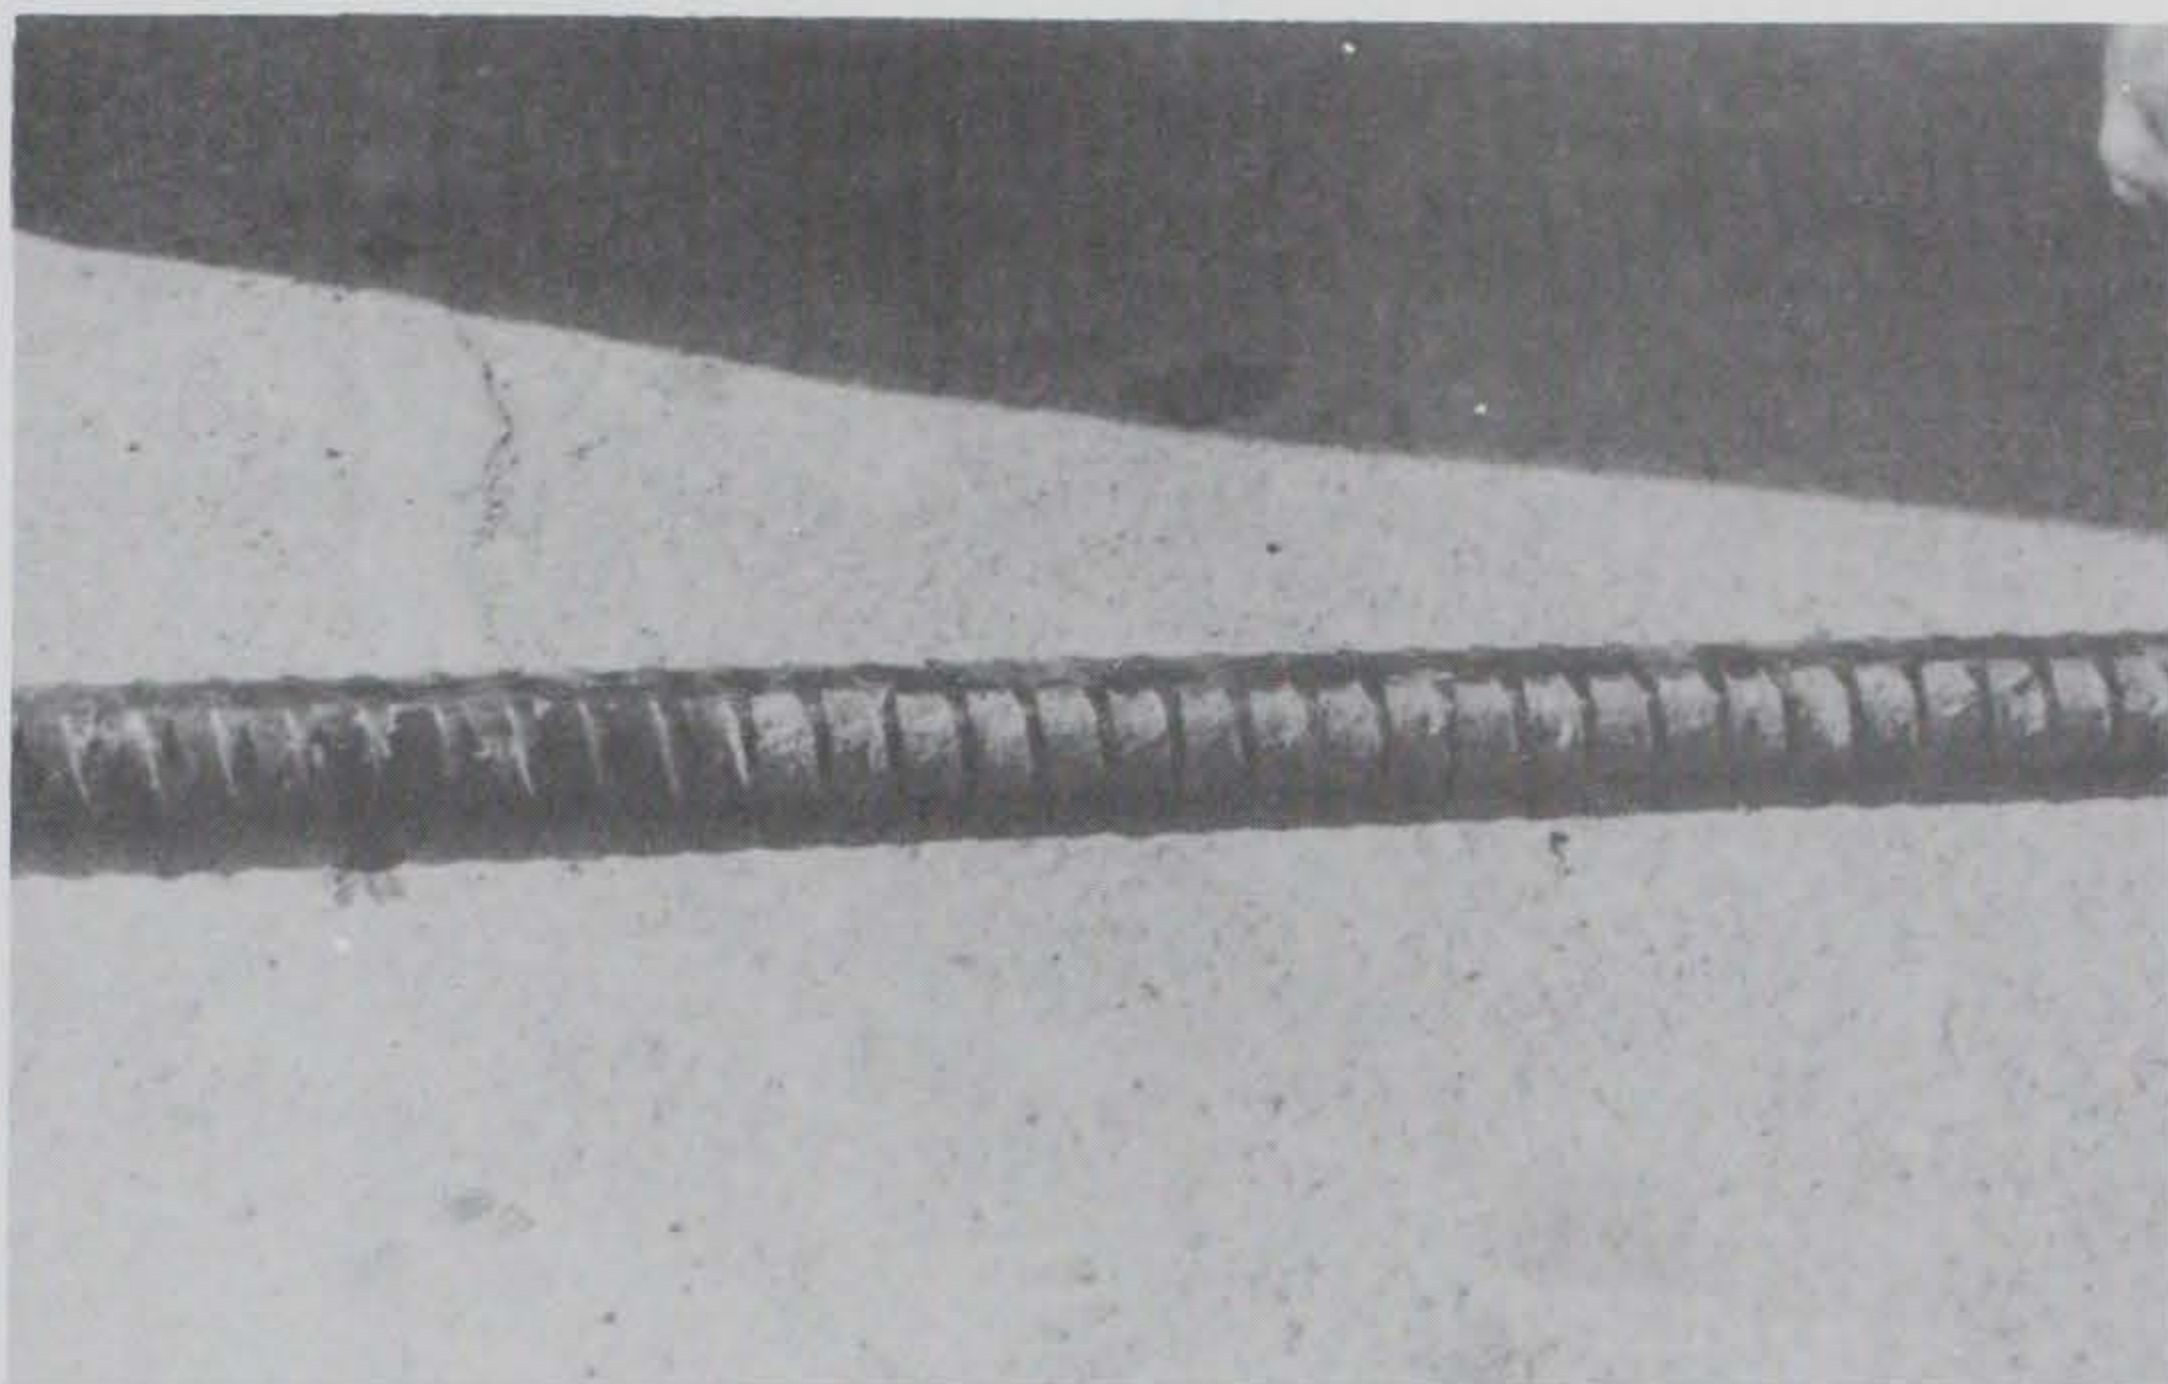
137. A failed anchor was removed from the middle wall and closely examined for any possible explanation of the failure. The general appearance of the bar in the anchorage zone indicated that the polyester resin grout had not bonded to the bar (Figure 57). The lower 5 ft had a light gray material lodged between the deformation of the bar that appeared to be resin grout (Figure 58). However, this resin was soft and pliable and could easily be removed from the bar. In other reaches of the bar, the resin was not soft,

Figure 57. Typical condition of anchorage zone of failed anchor, Lock No. 3, Monongahela River

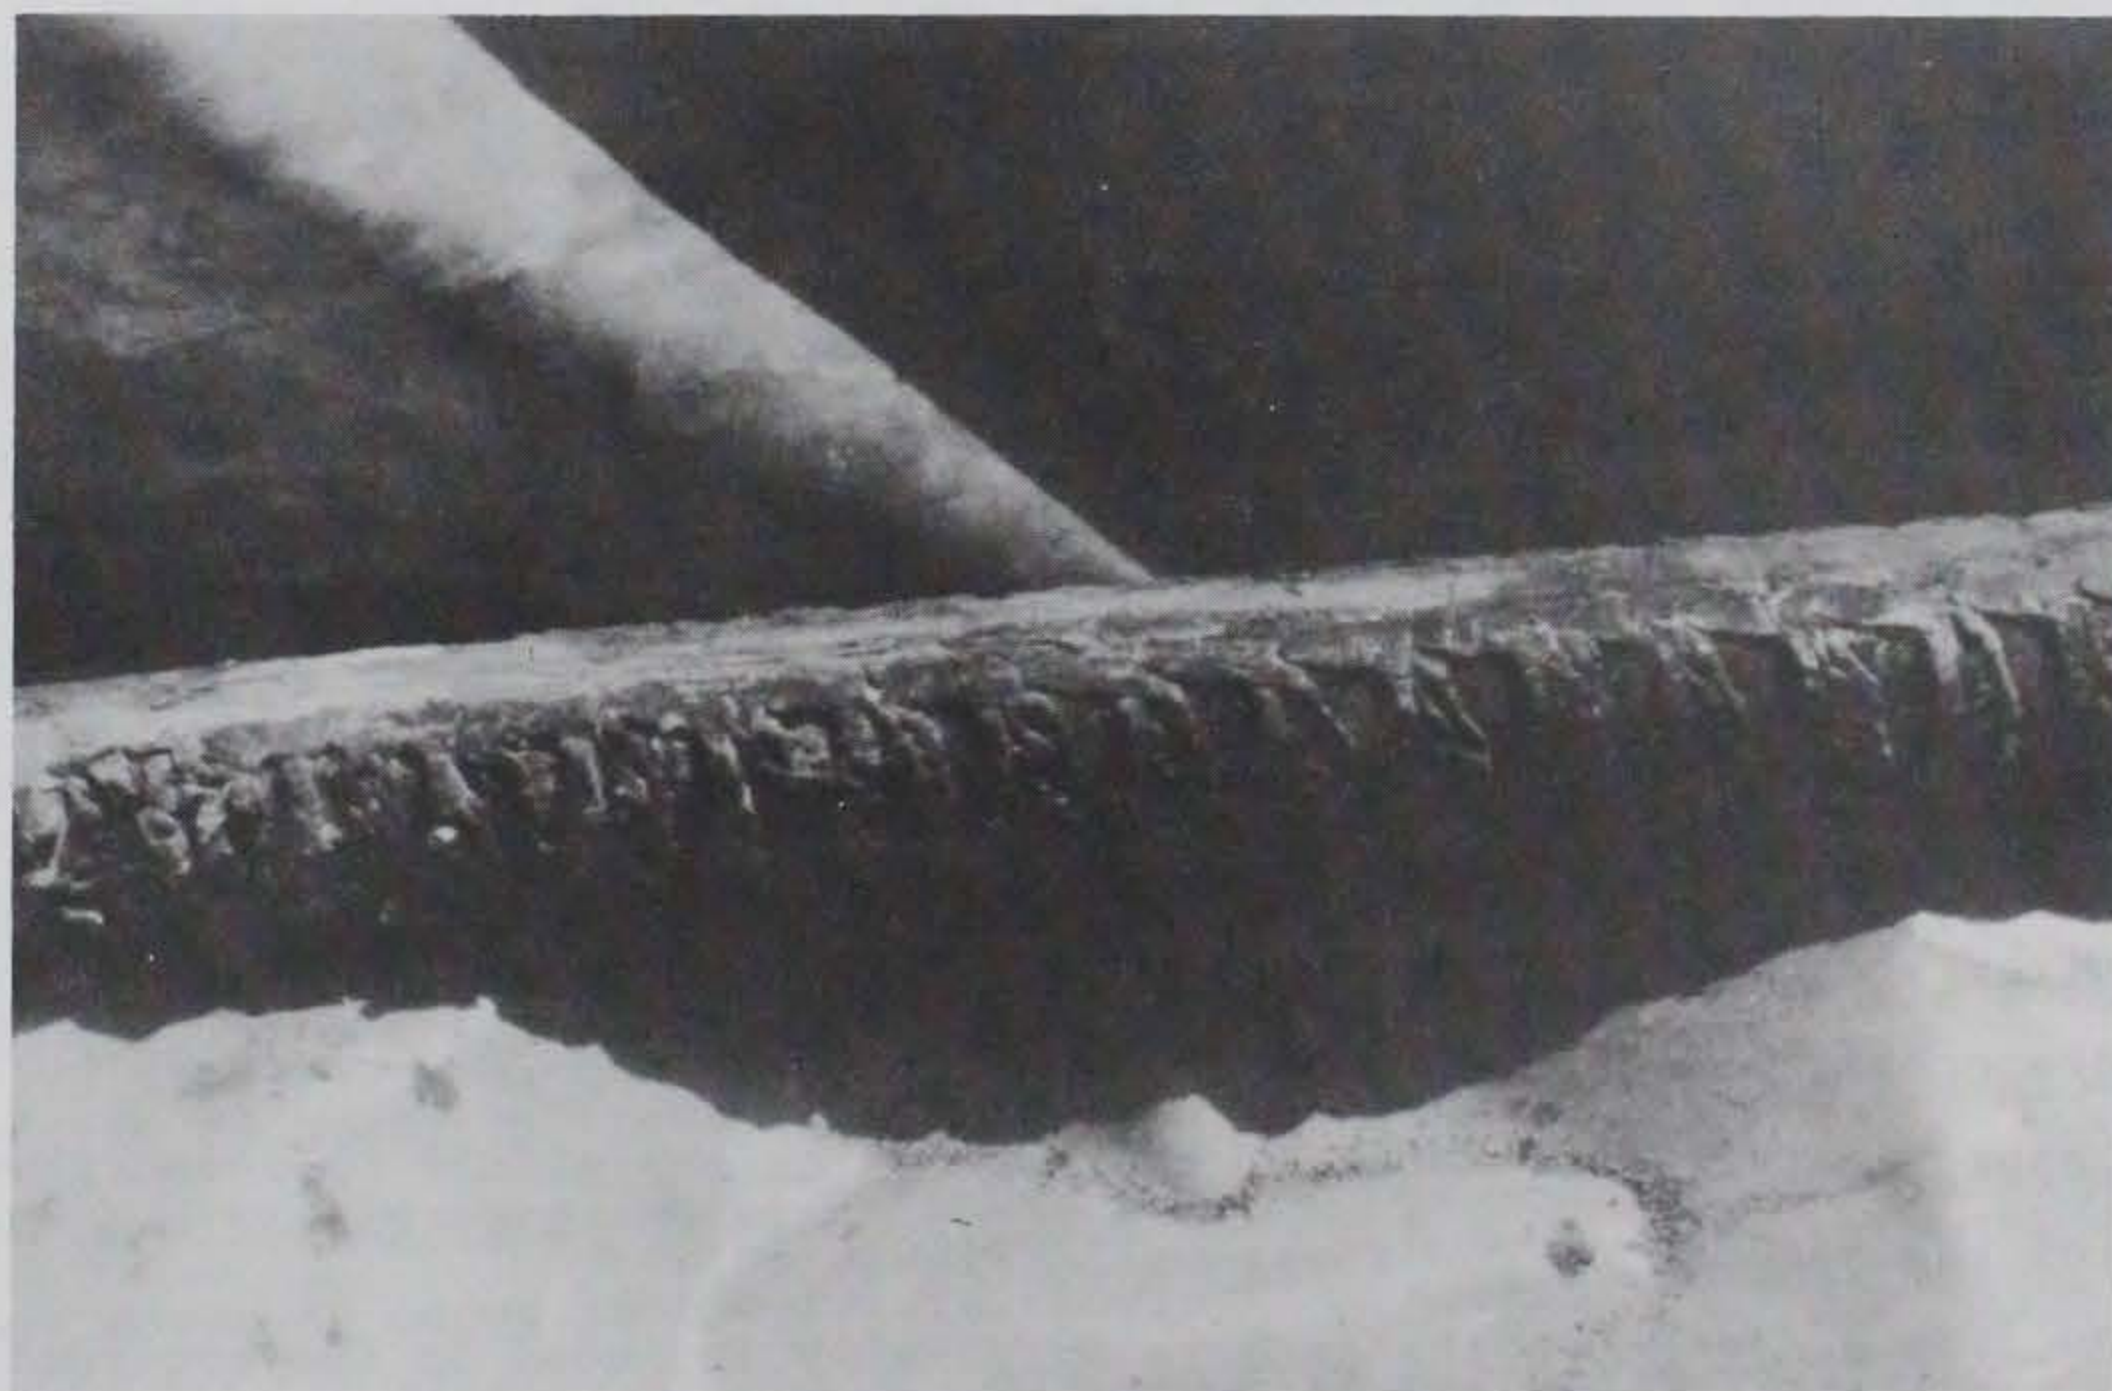
Figure 58. Soft grout lodged between bar deformations, Lock No. 3, Monongahela River

and it was harder to remove from the bar. The contractor claimed that improper mixing occurred because the hole was enlarged by the caving of the hole in the poor rock which would not have happened if he had been allowed to pre-grout each hole. To determine if the 2-1/4-in.-diam hole was possibly being enlarged during drilling, the hole from which the failed anchor was removed was grouted with a reddish grout and a core boring was taken (Figure 59). The core showed that the hole was consistently 2-1/4 in. in diameter.
