TECHNICAL REPORT REMR-CS-13

**REHABILITATION OF NAVIGATION  
LOCK WALLS: CASE HISTORIES**

James E. McDonald

December 1987

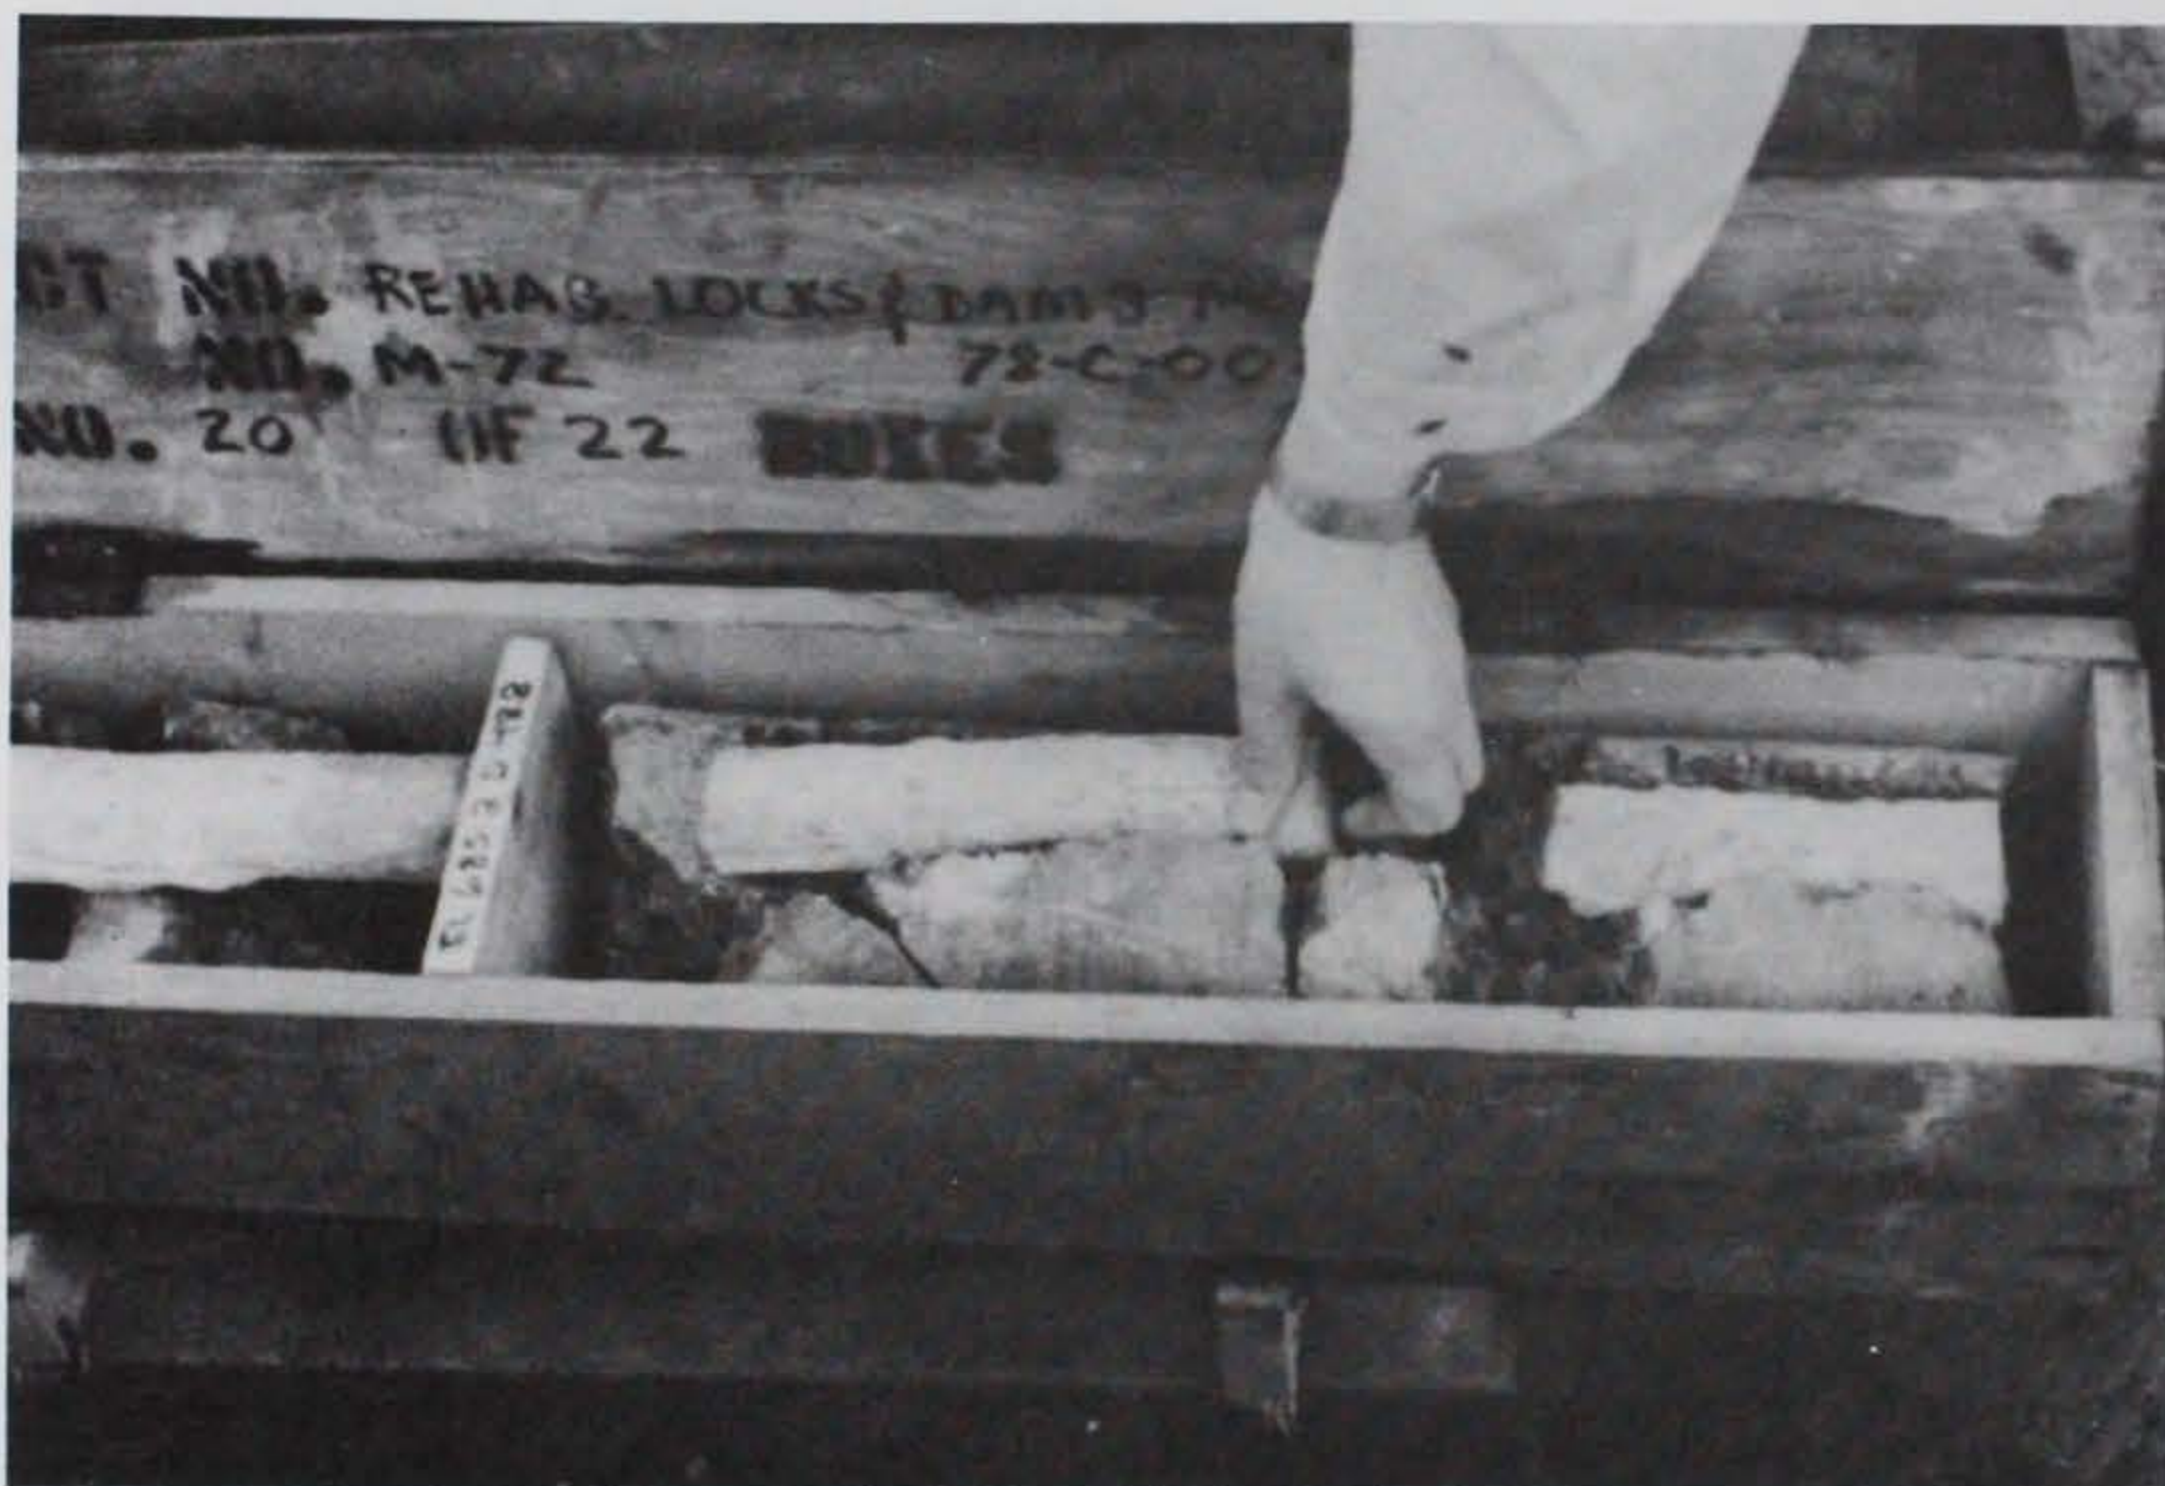
Figure 59. Core from hole where failed anchor was removed, Lock No. 3, Monongahela River

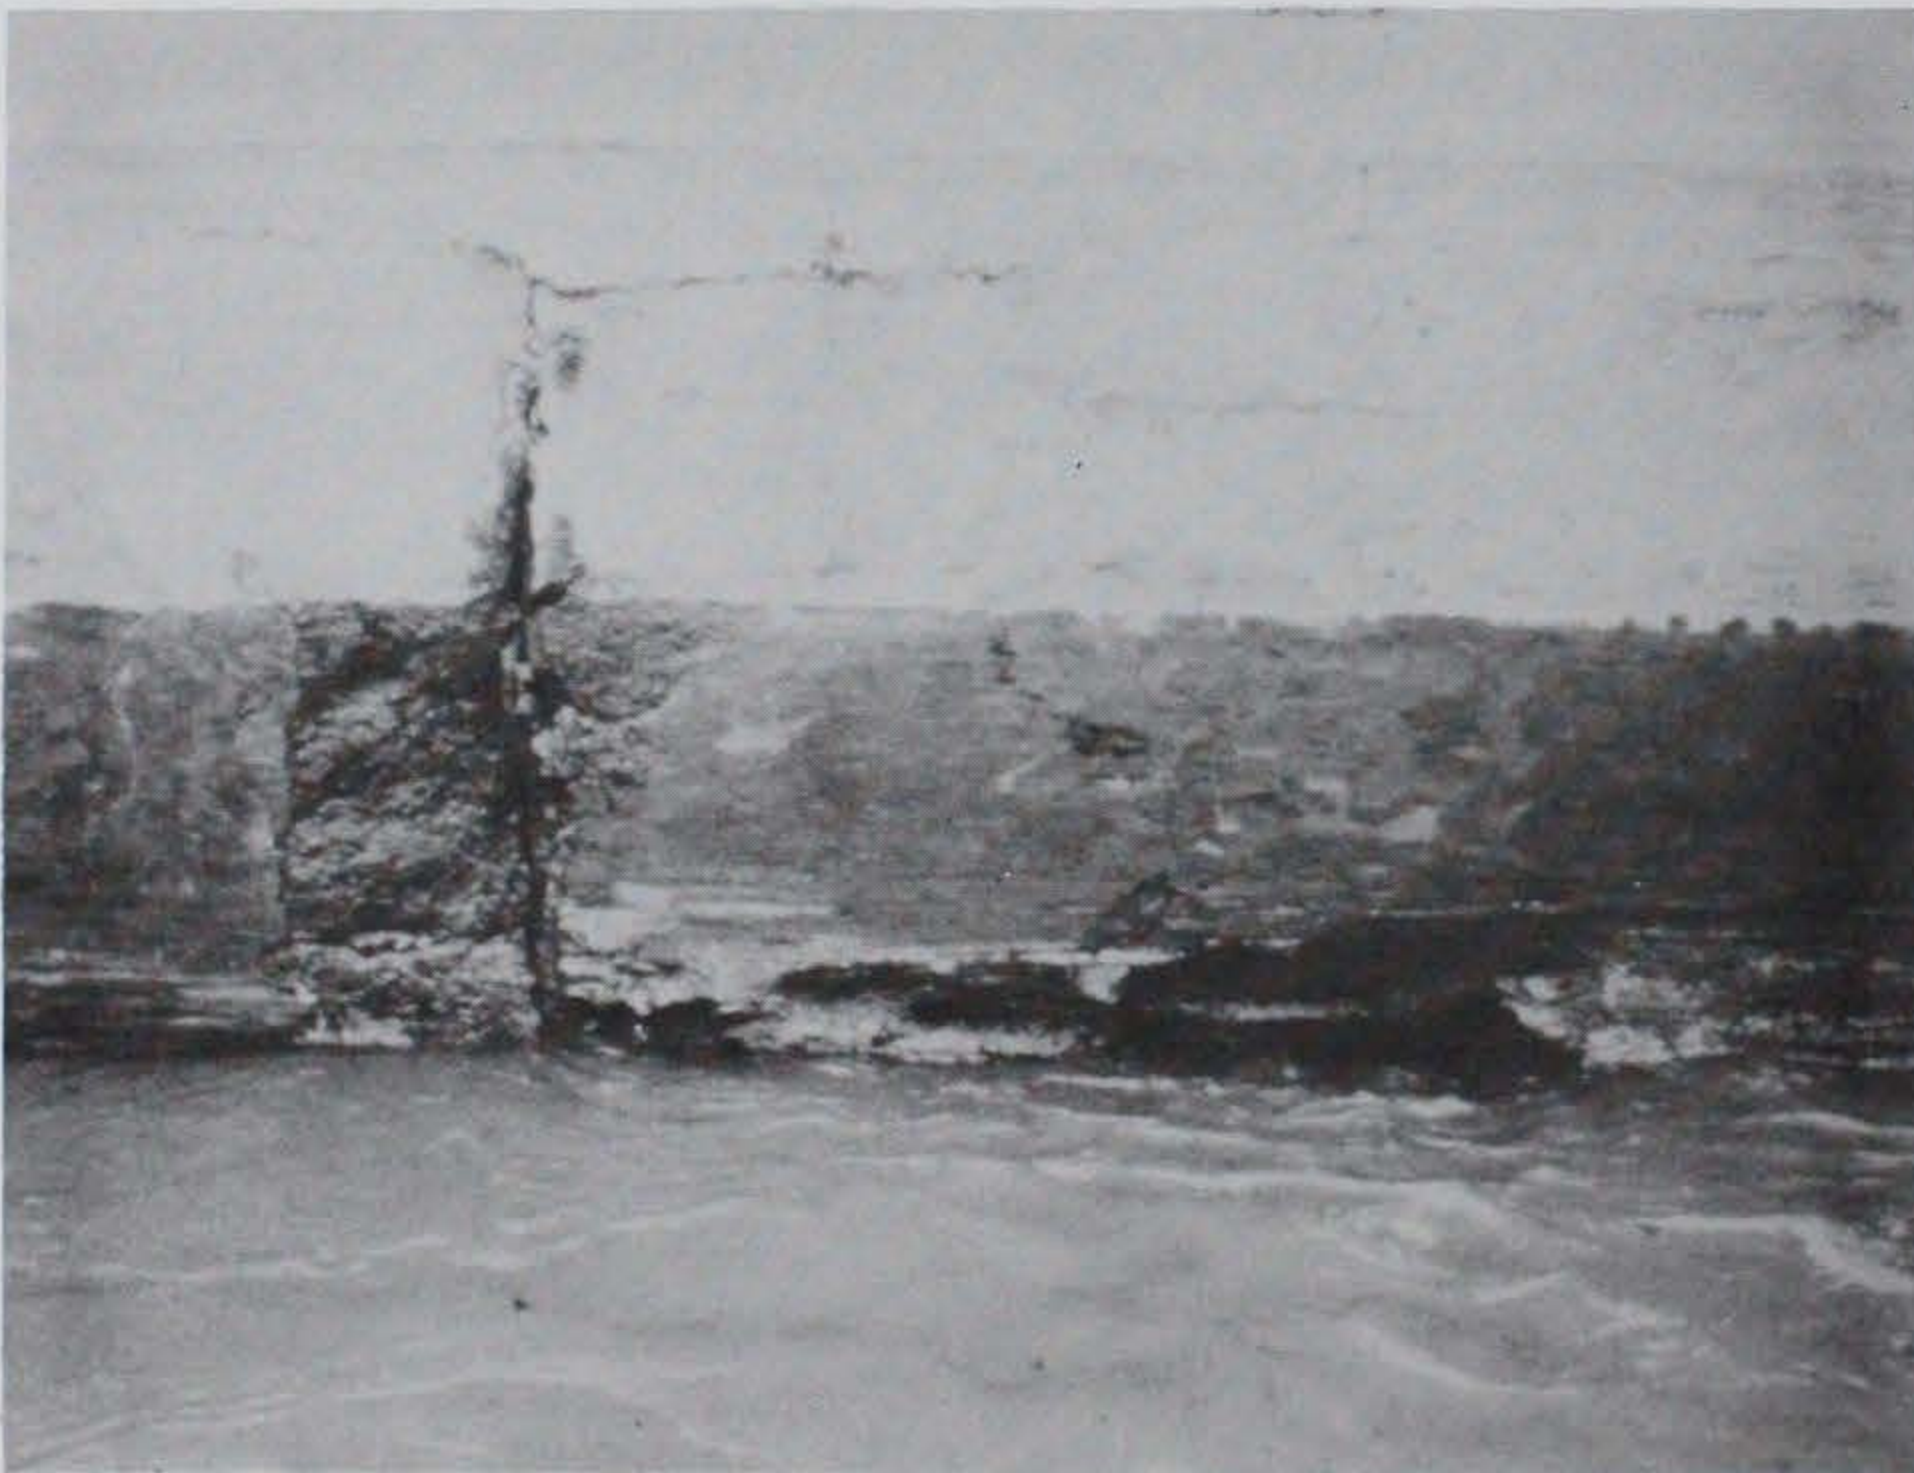
Figure 64. Lock wall concrete deterioration, 1974,  
Lock No. 3, Monongahela River

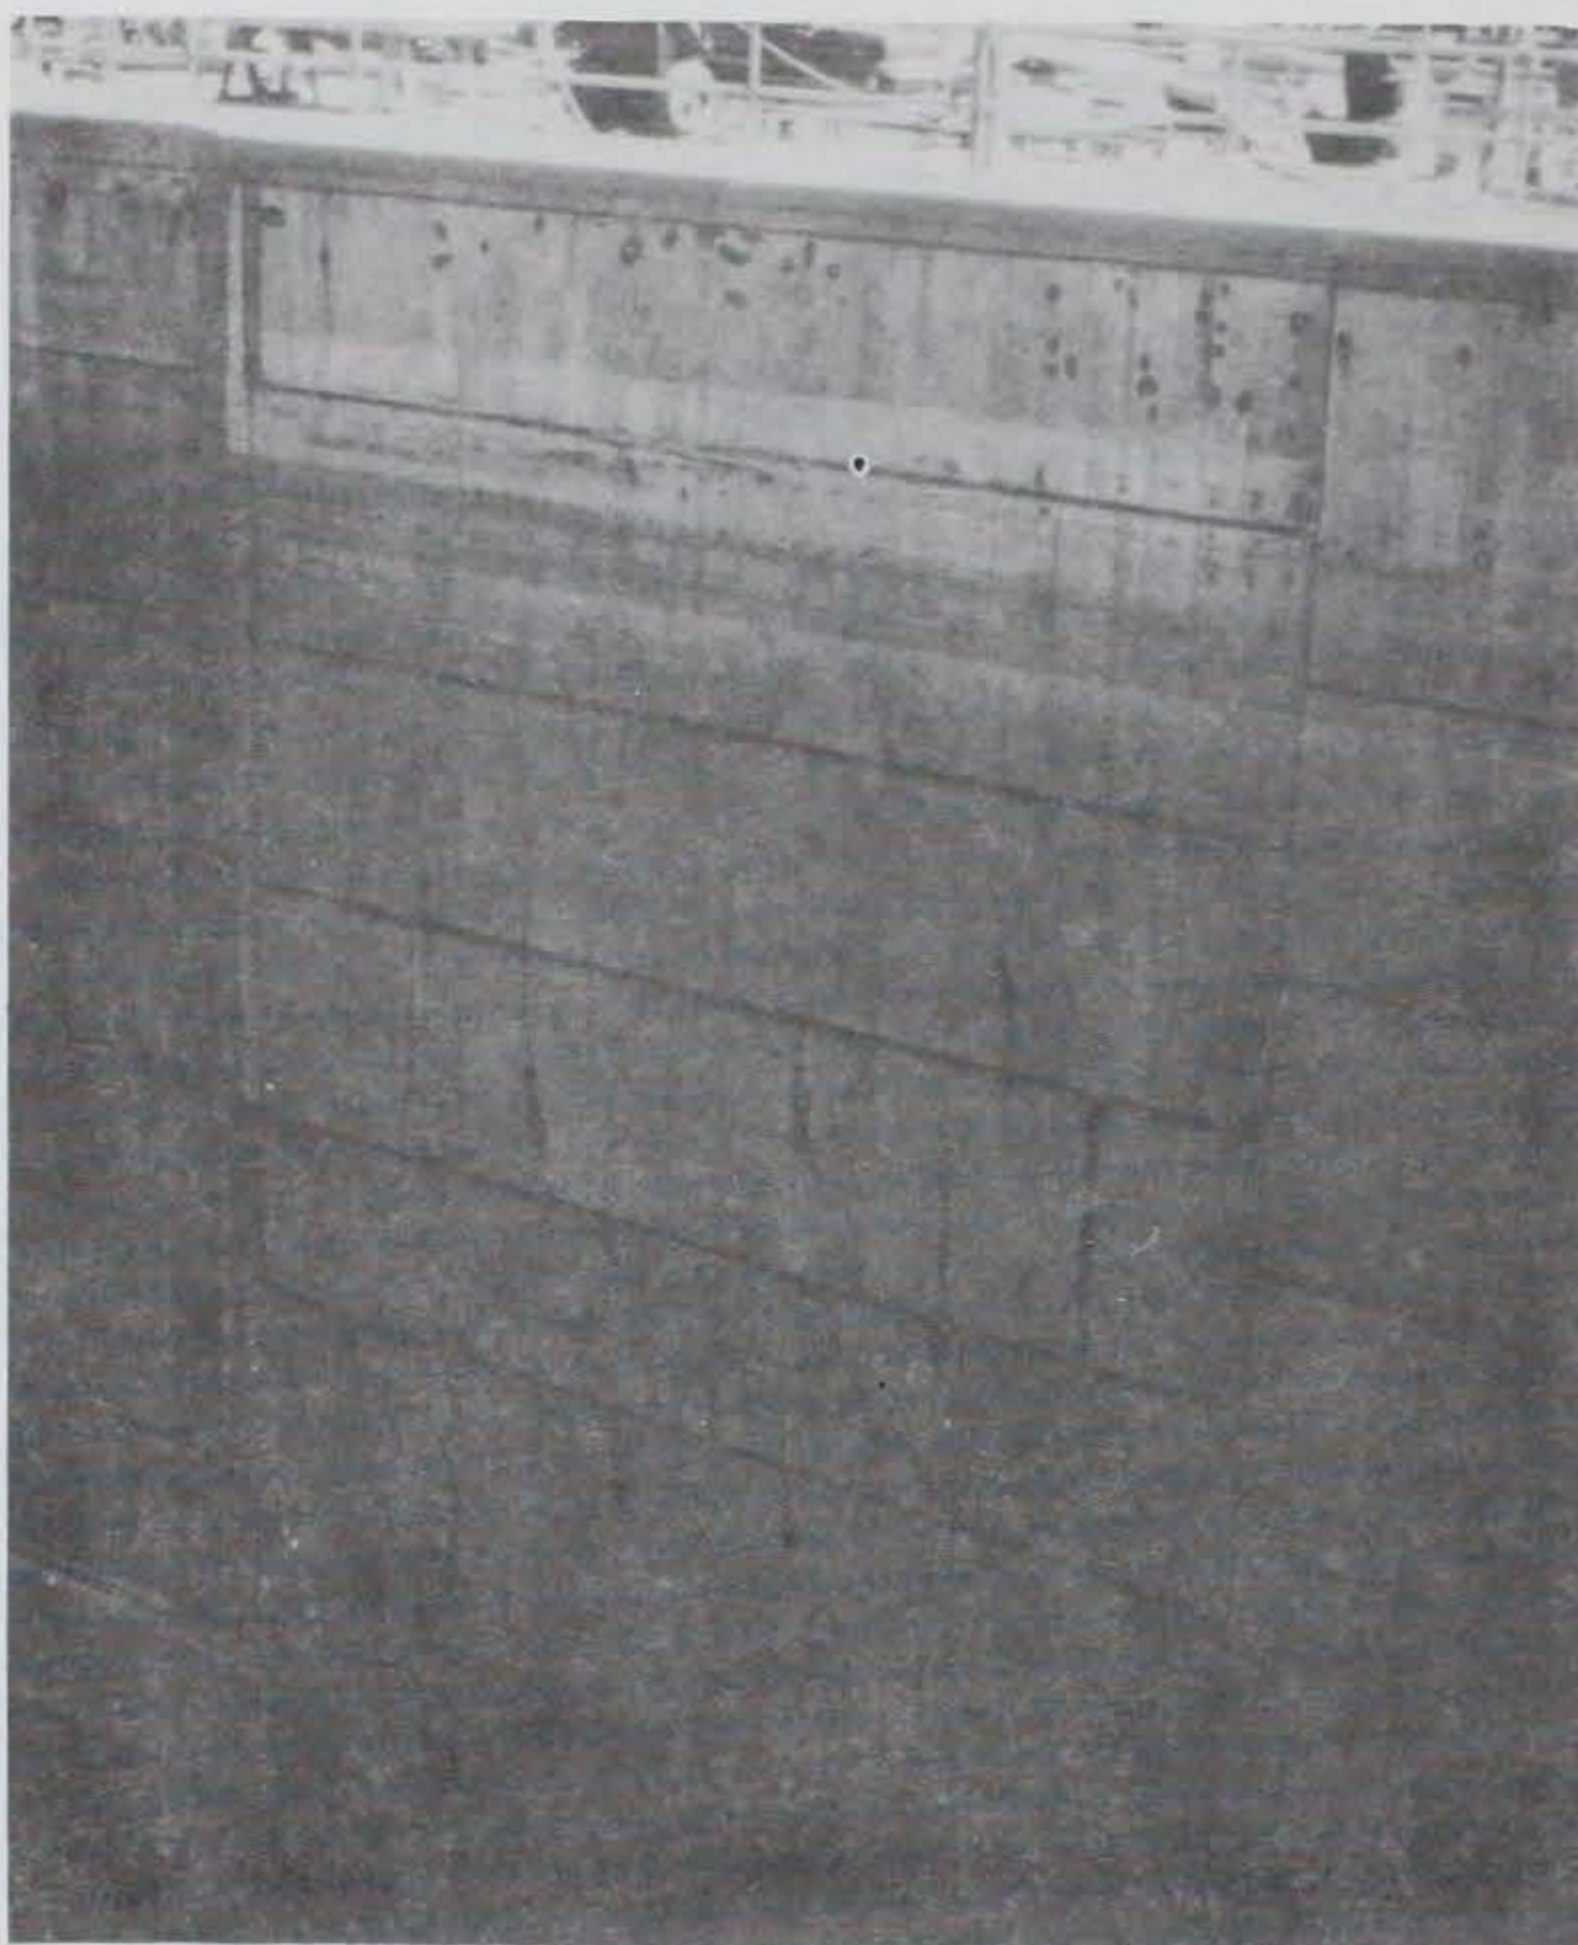
Figure 106. Vertical cracking in the concrete resurfacing, Lock No. 1, Mississippi River

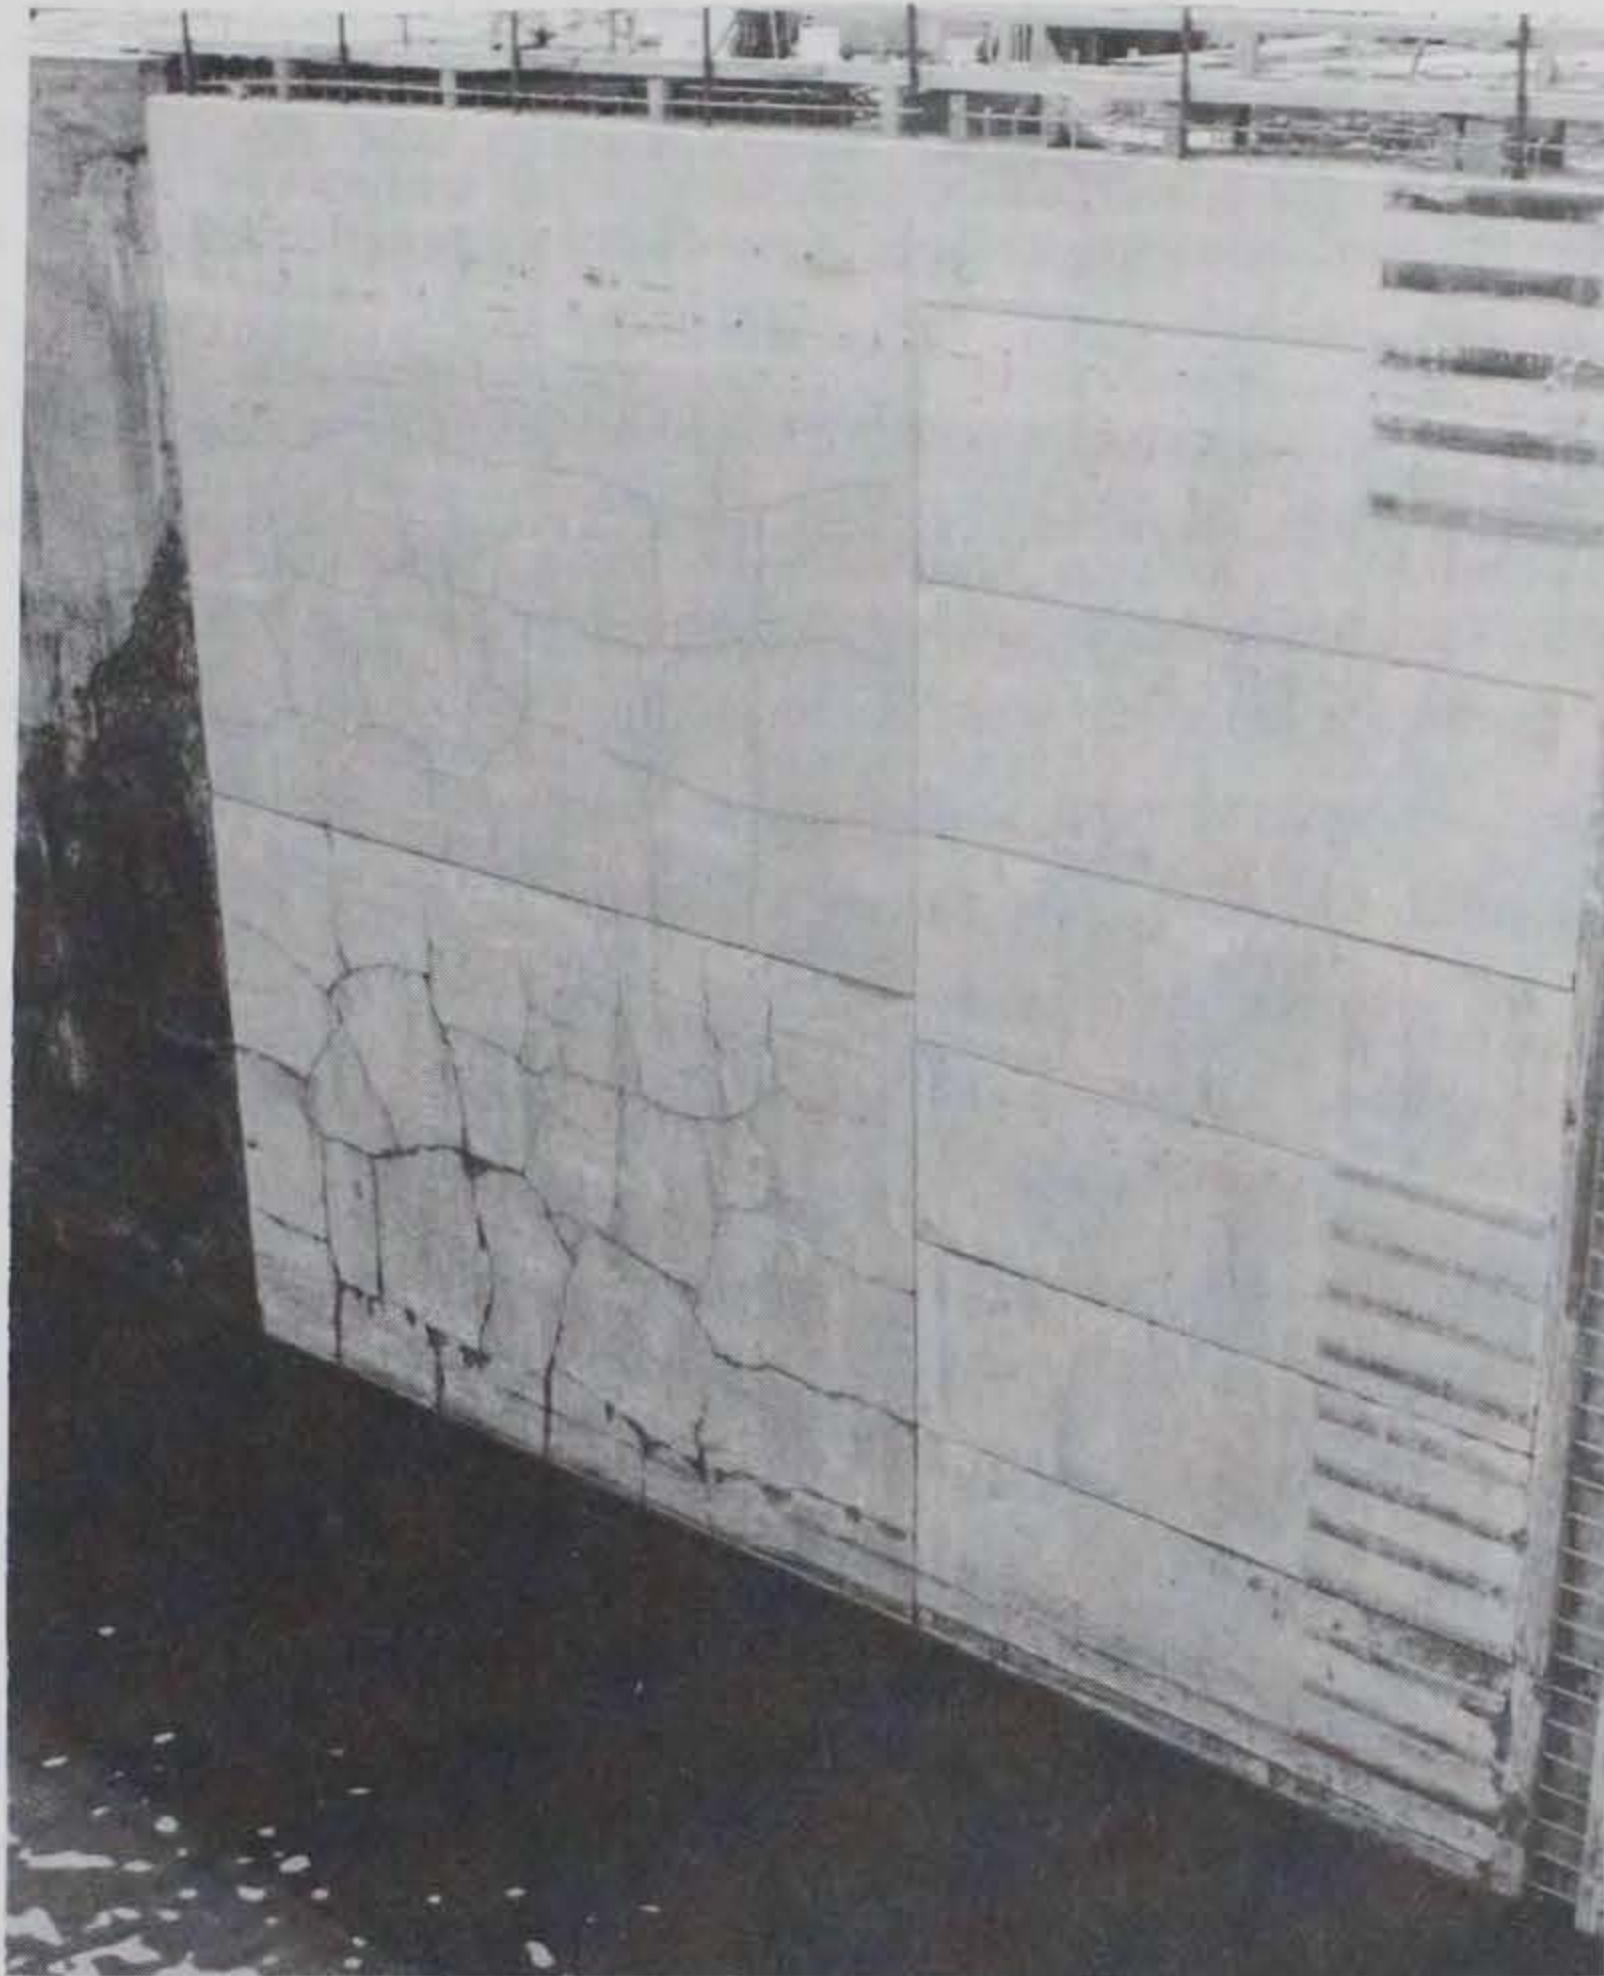
Figure 107. Concrete cracking in a resurfaced monolith (left) compared to reconstructed monolith, Lock No. 1, Mississippi River

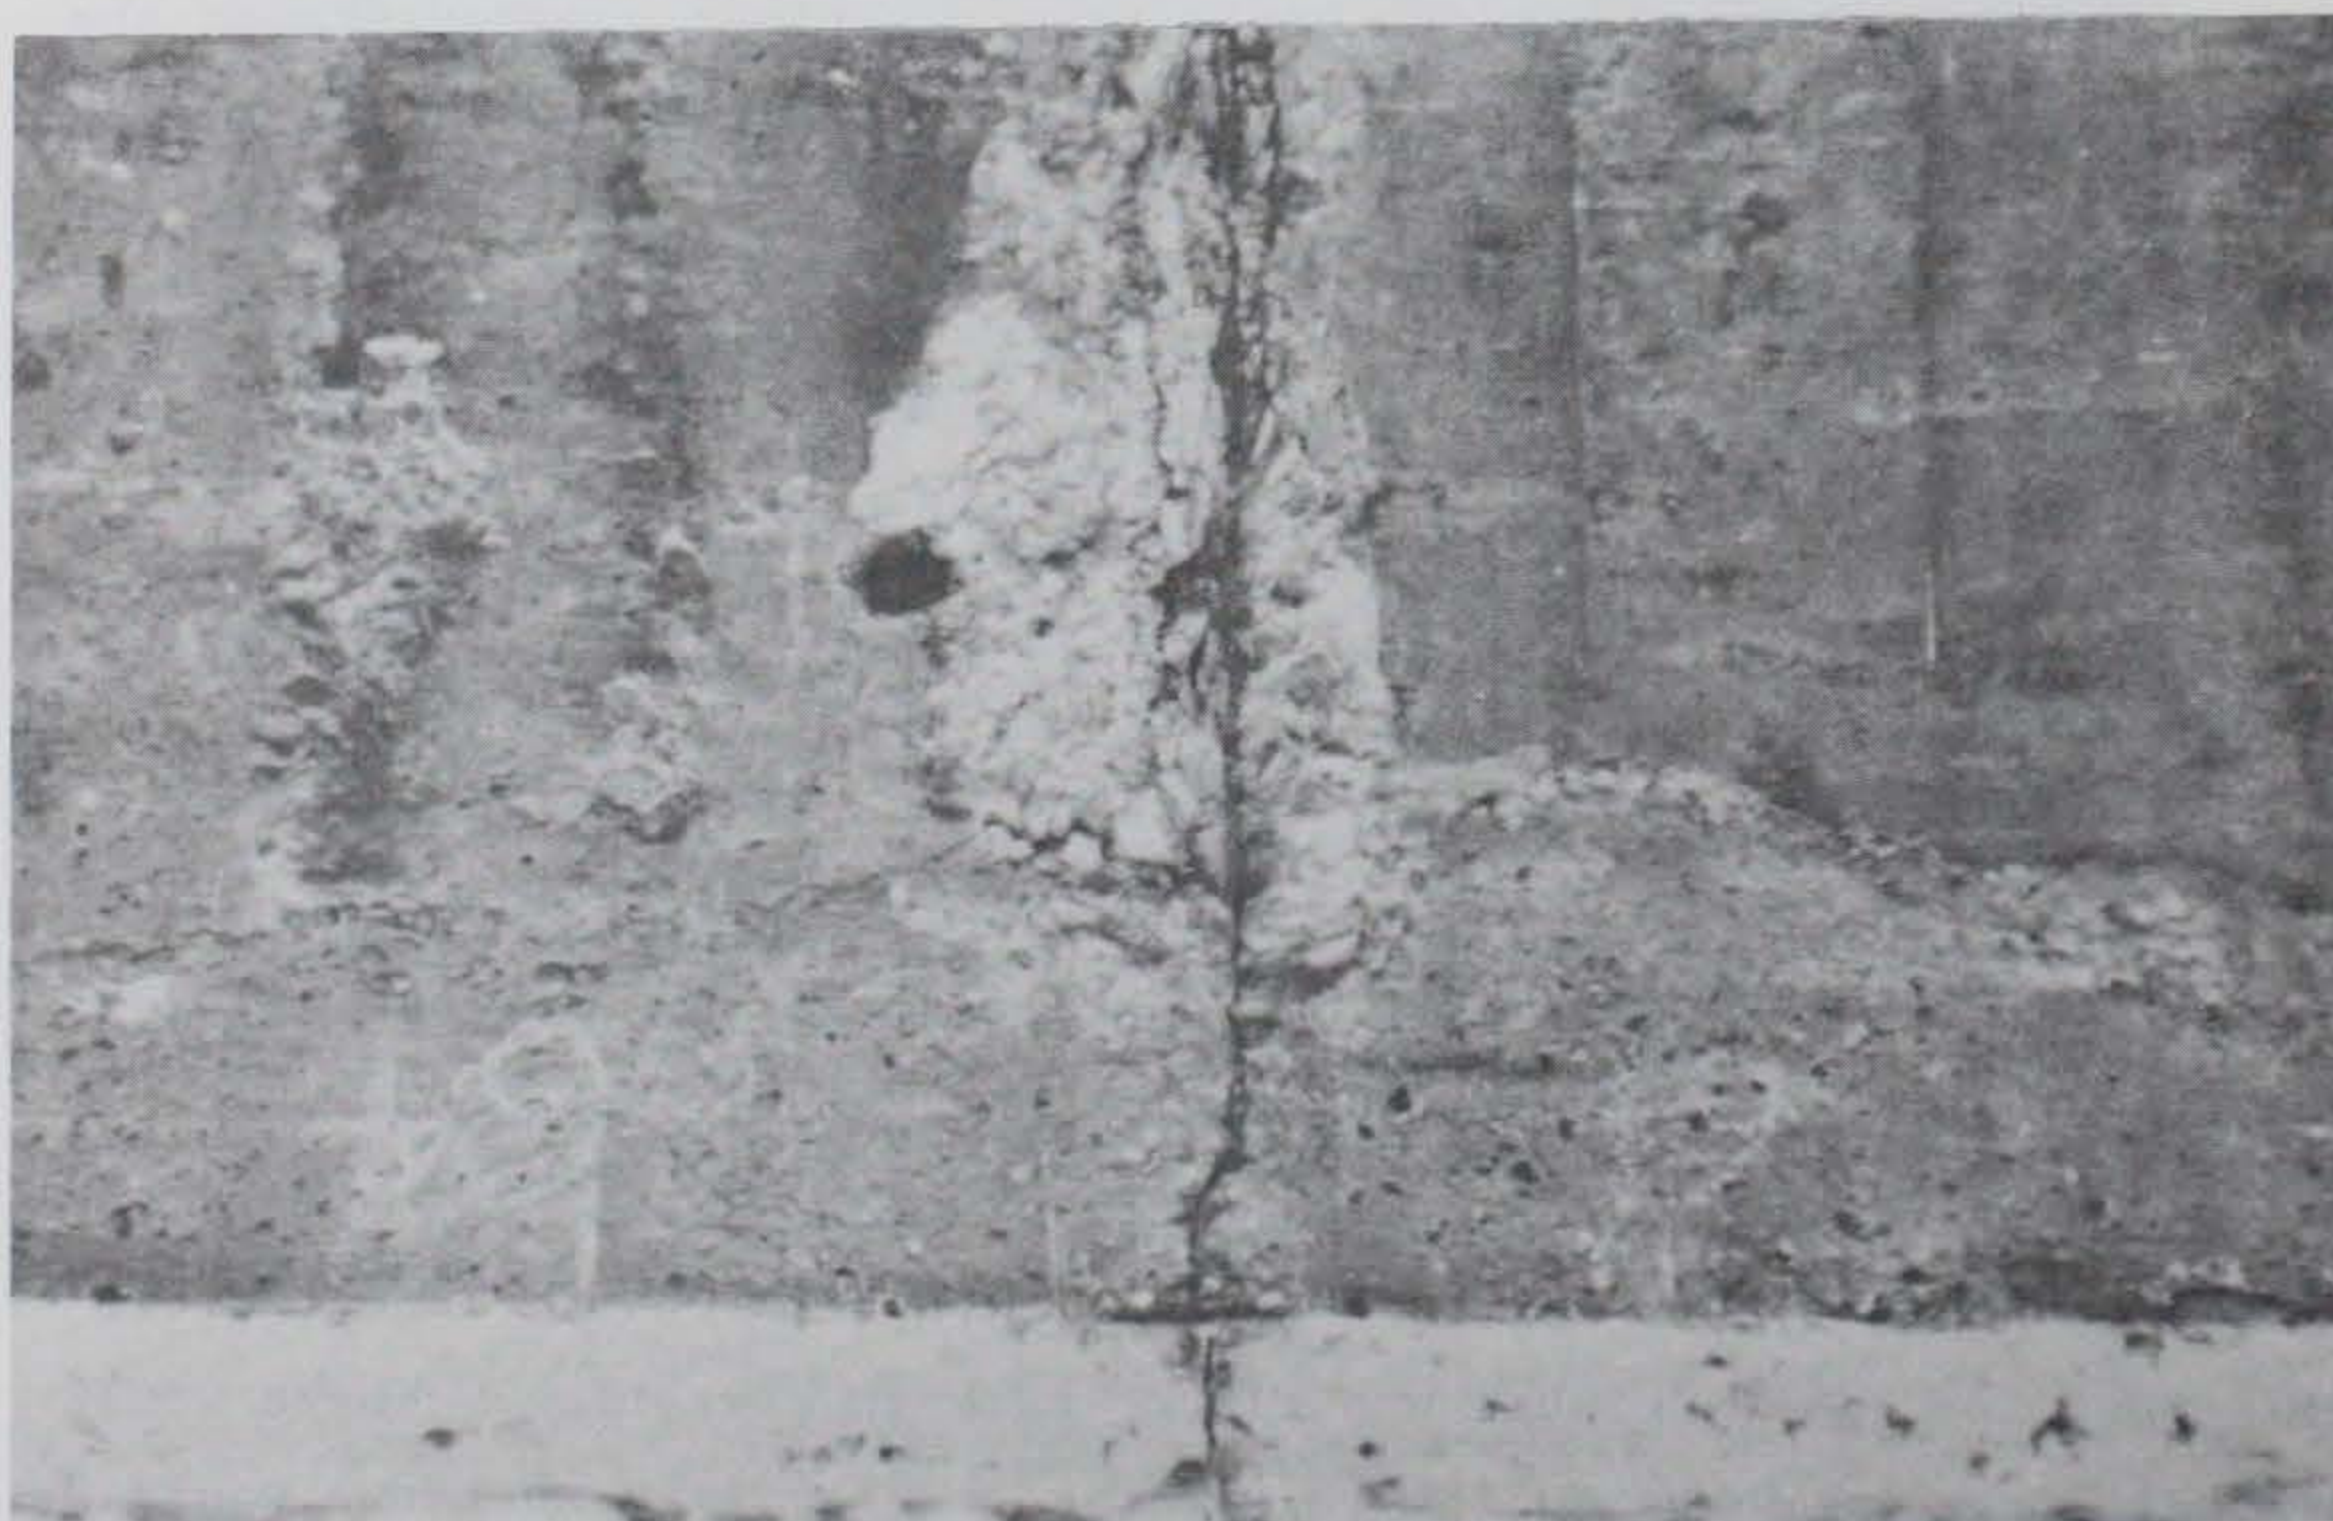
Figure 126. Examples of typical joint deterioration, land lock chamber wall, 1981, Emsworth Locks

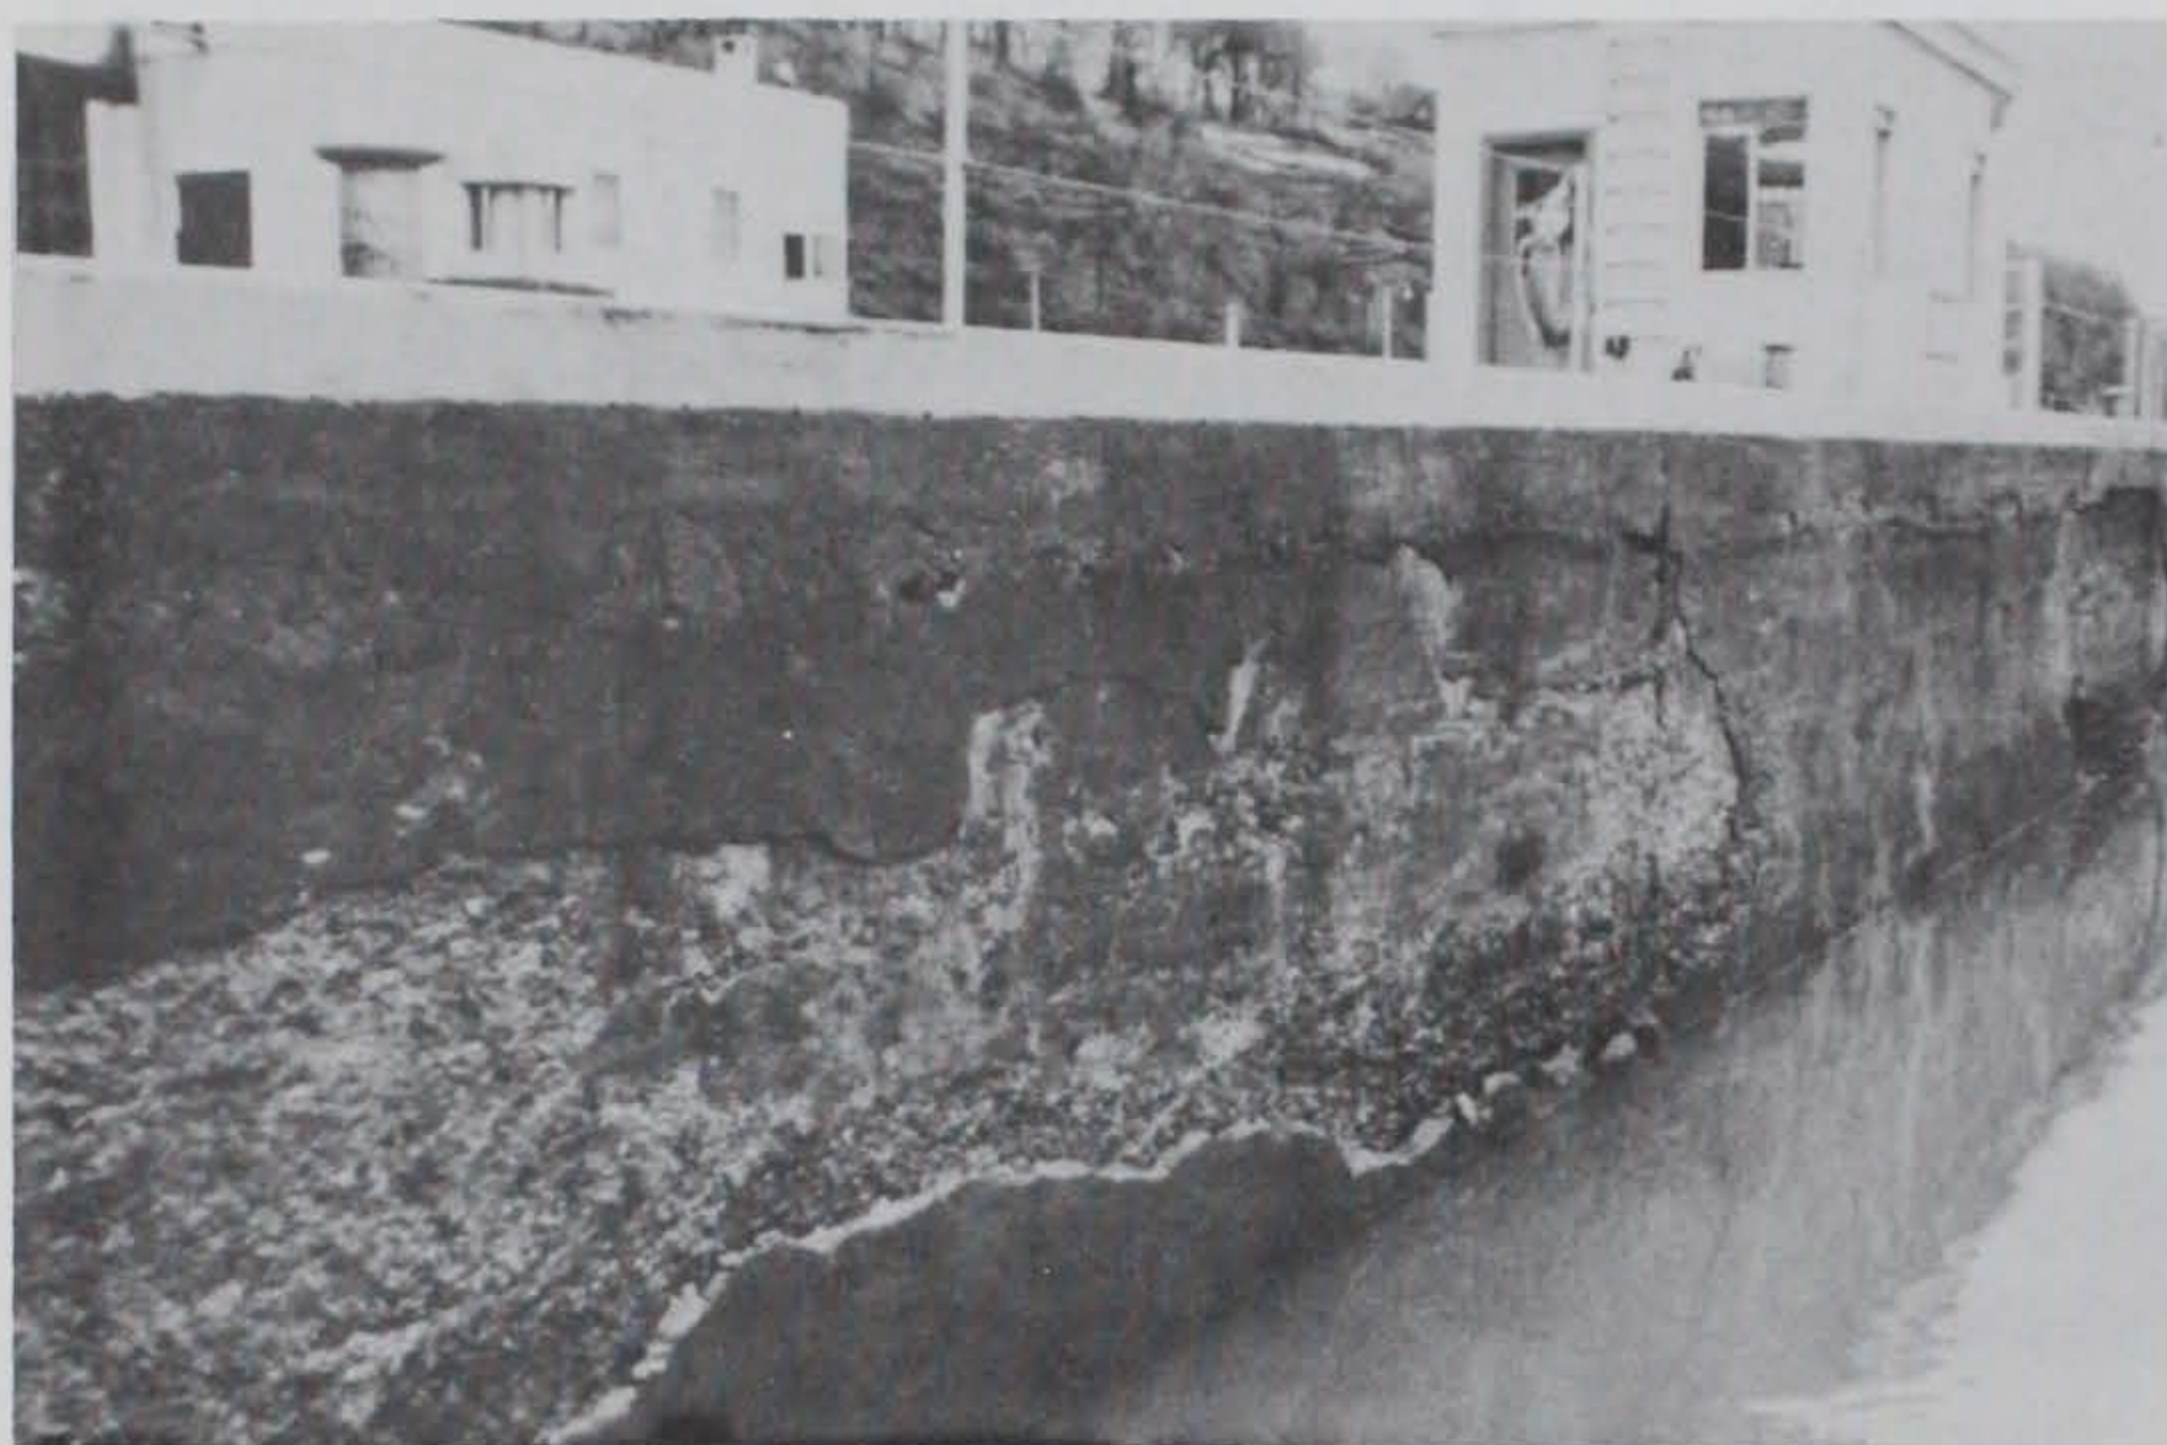
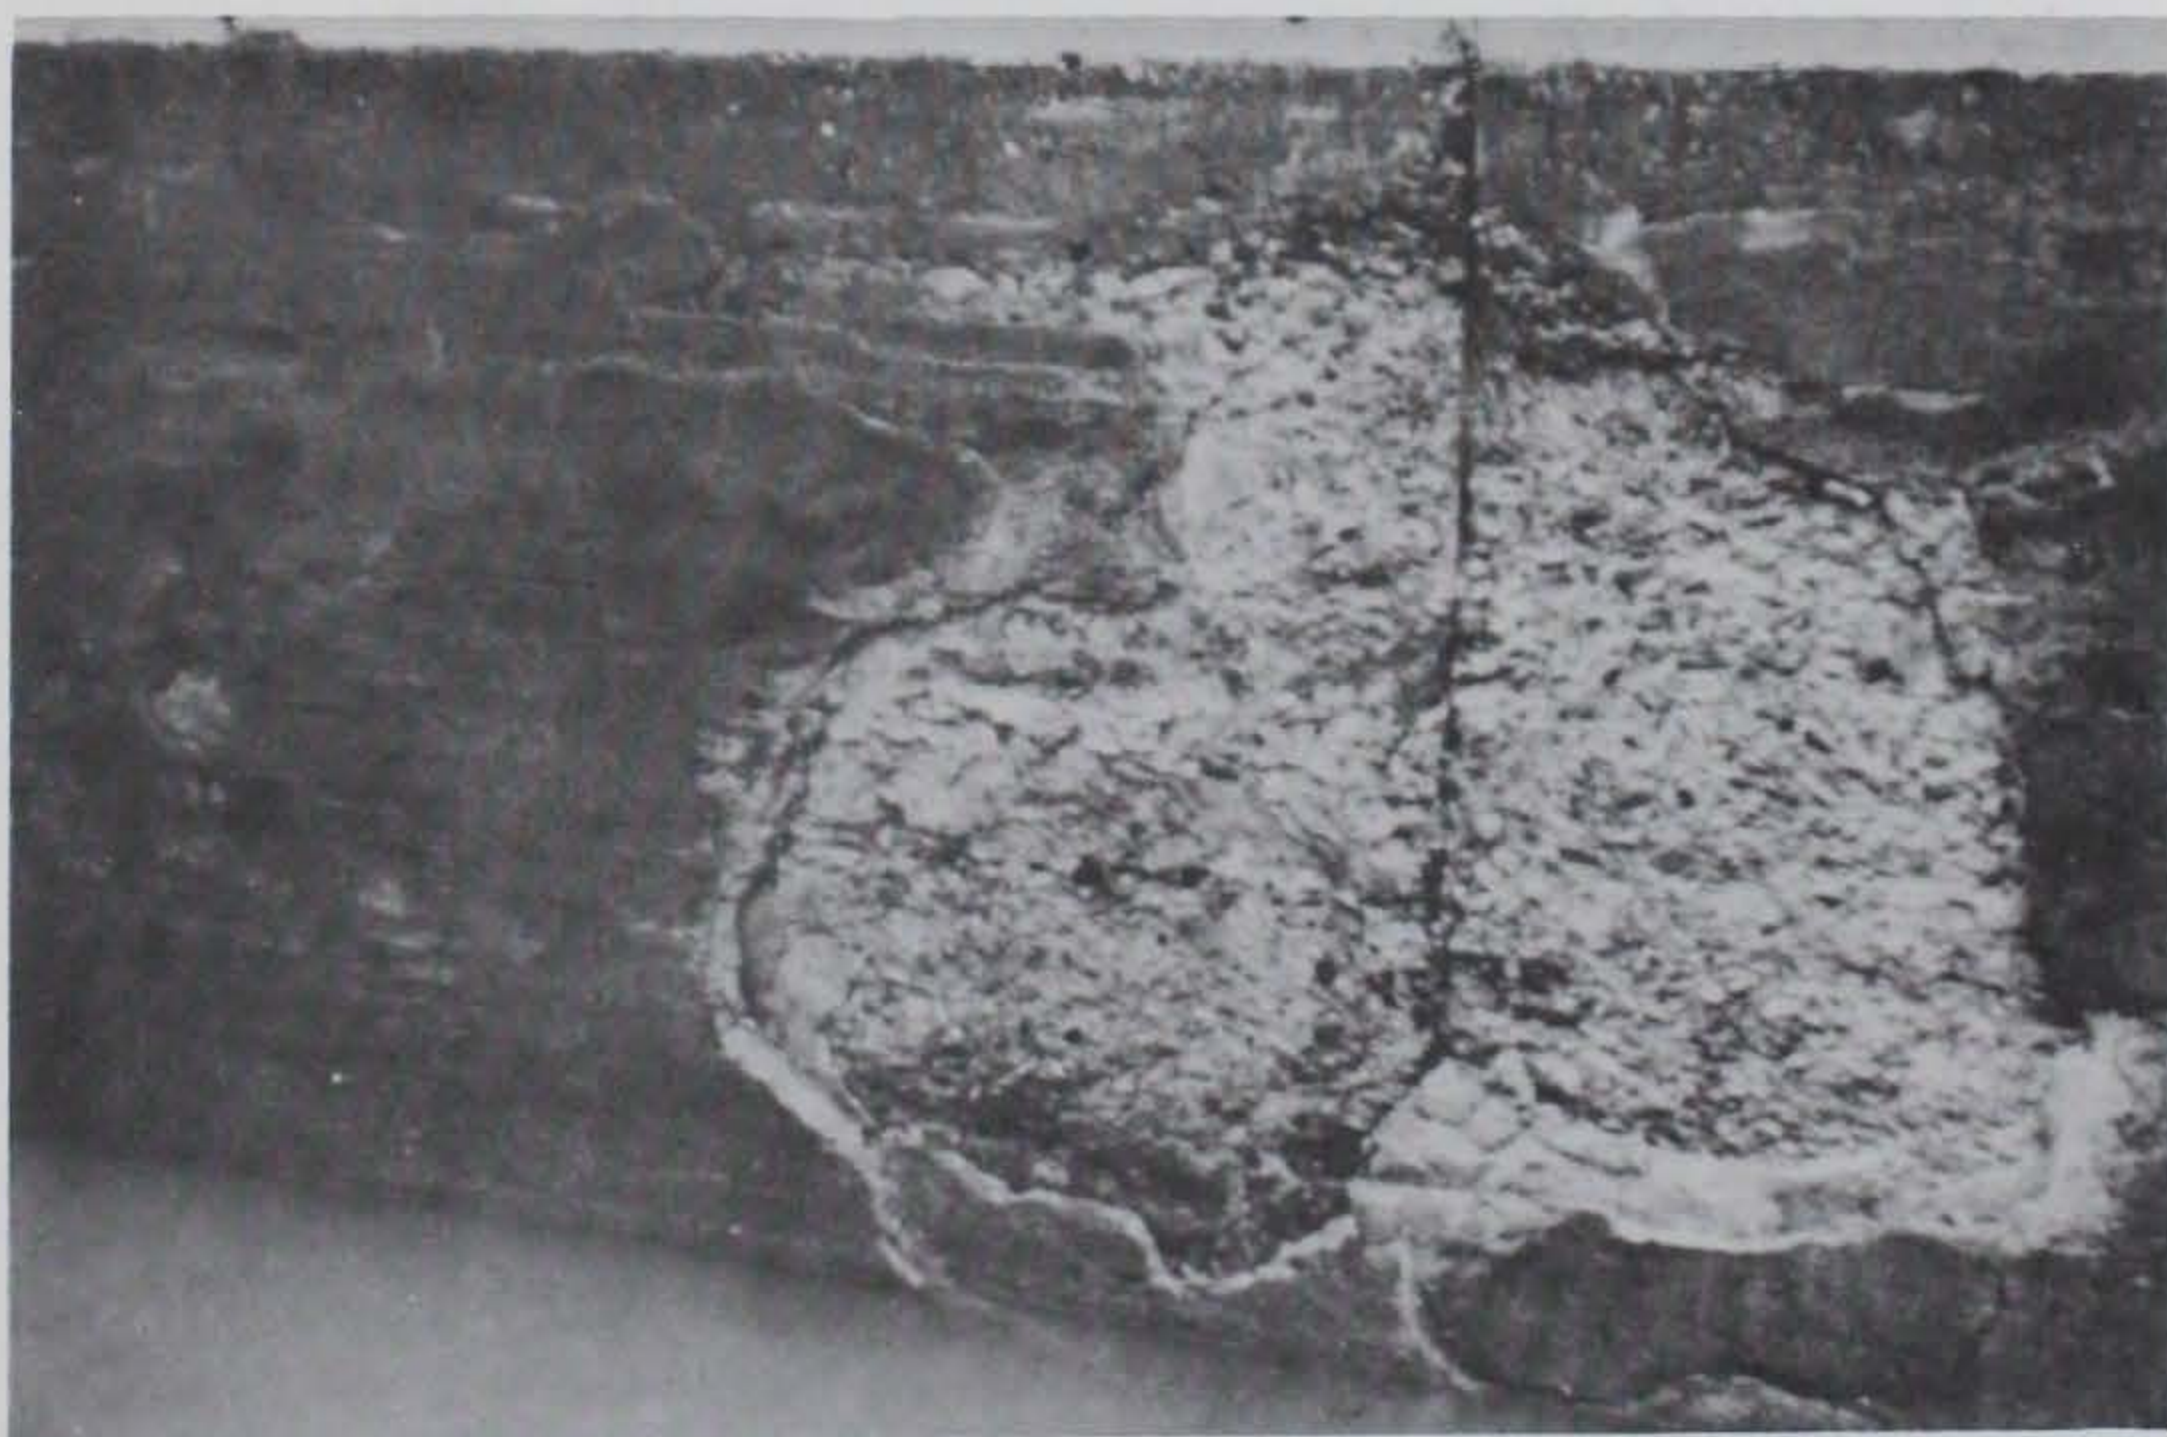
Figure 127. Typical concrete surfaces where shotcrete has spalled on the land wall of the river lock chamber, 1981, Emsworth Locks
