TECHNICAL REPORT REMR-CS-13

**REHABILITATION OF NAVIGATION  
LOCK WALLS: CASE HISTORIES**

James E. McDonald

December 1987

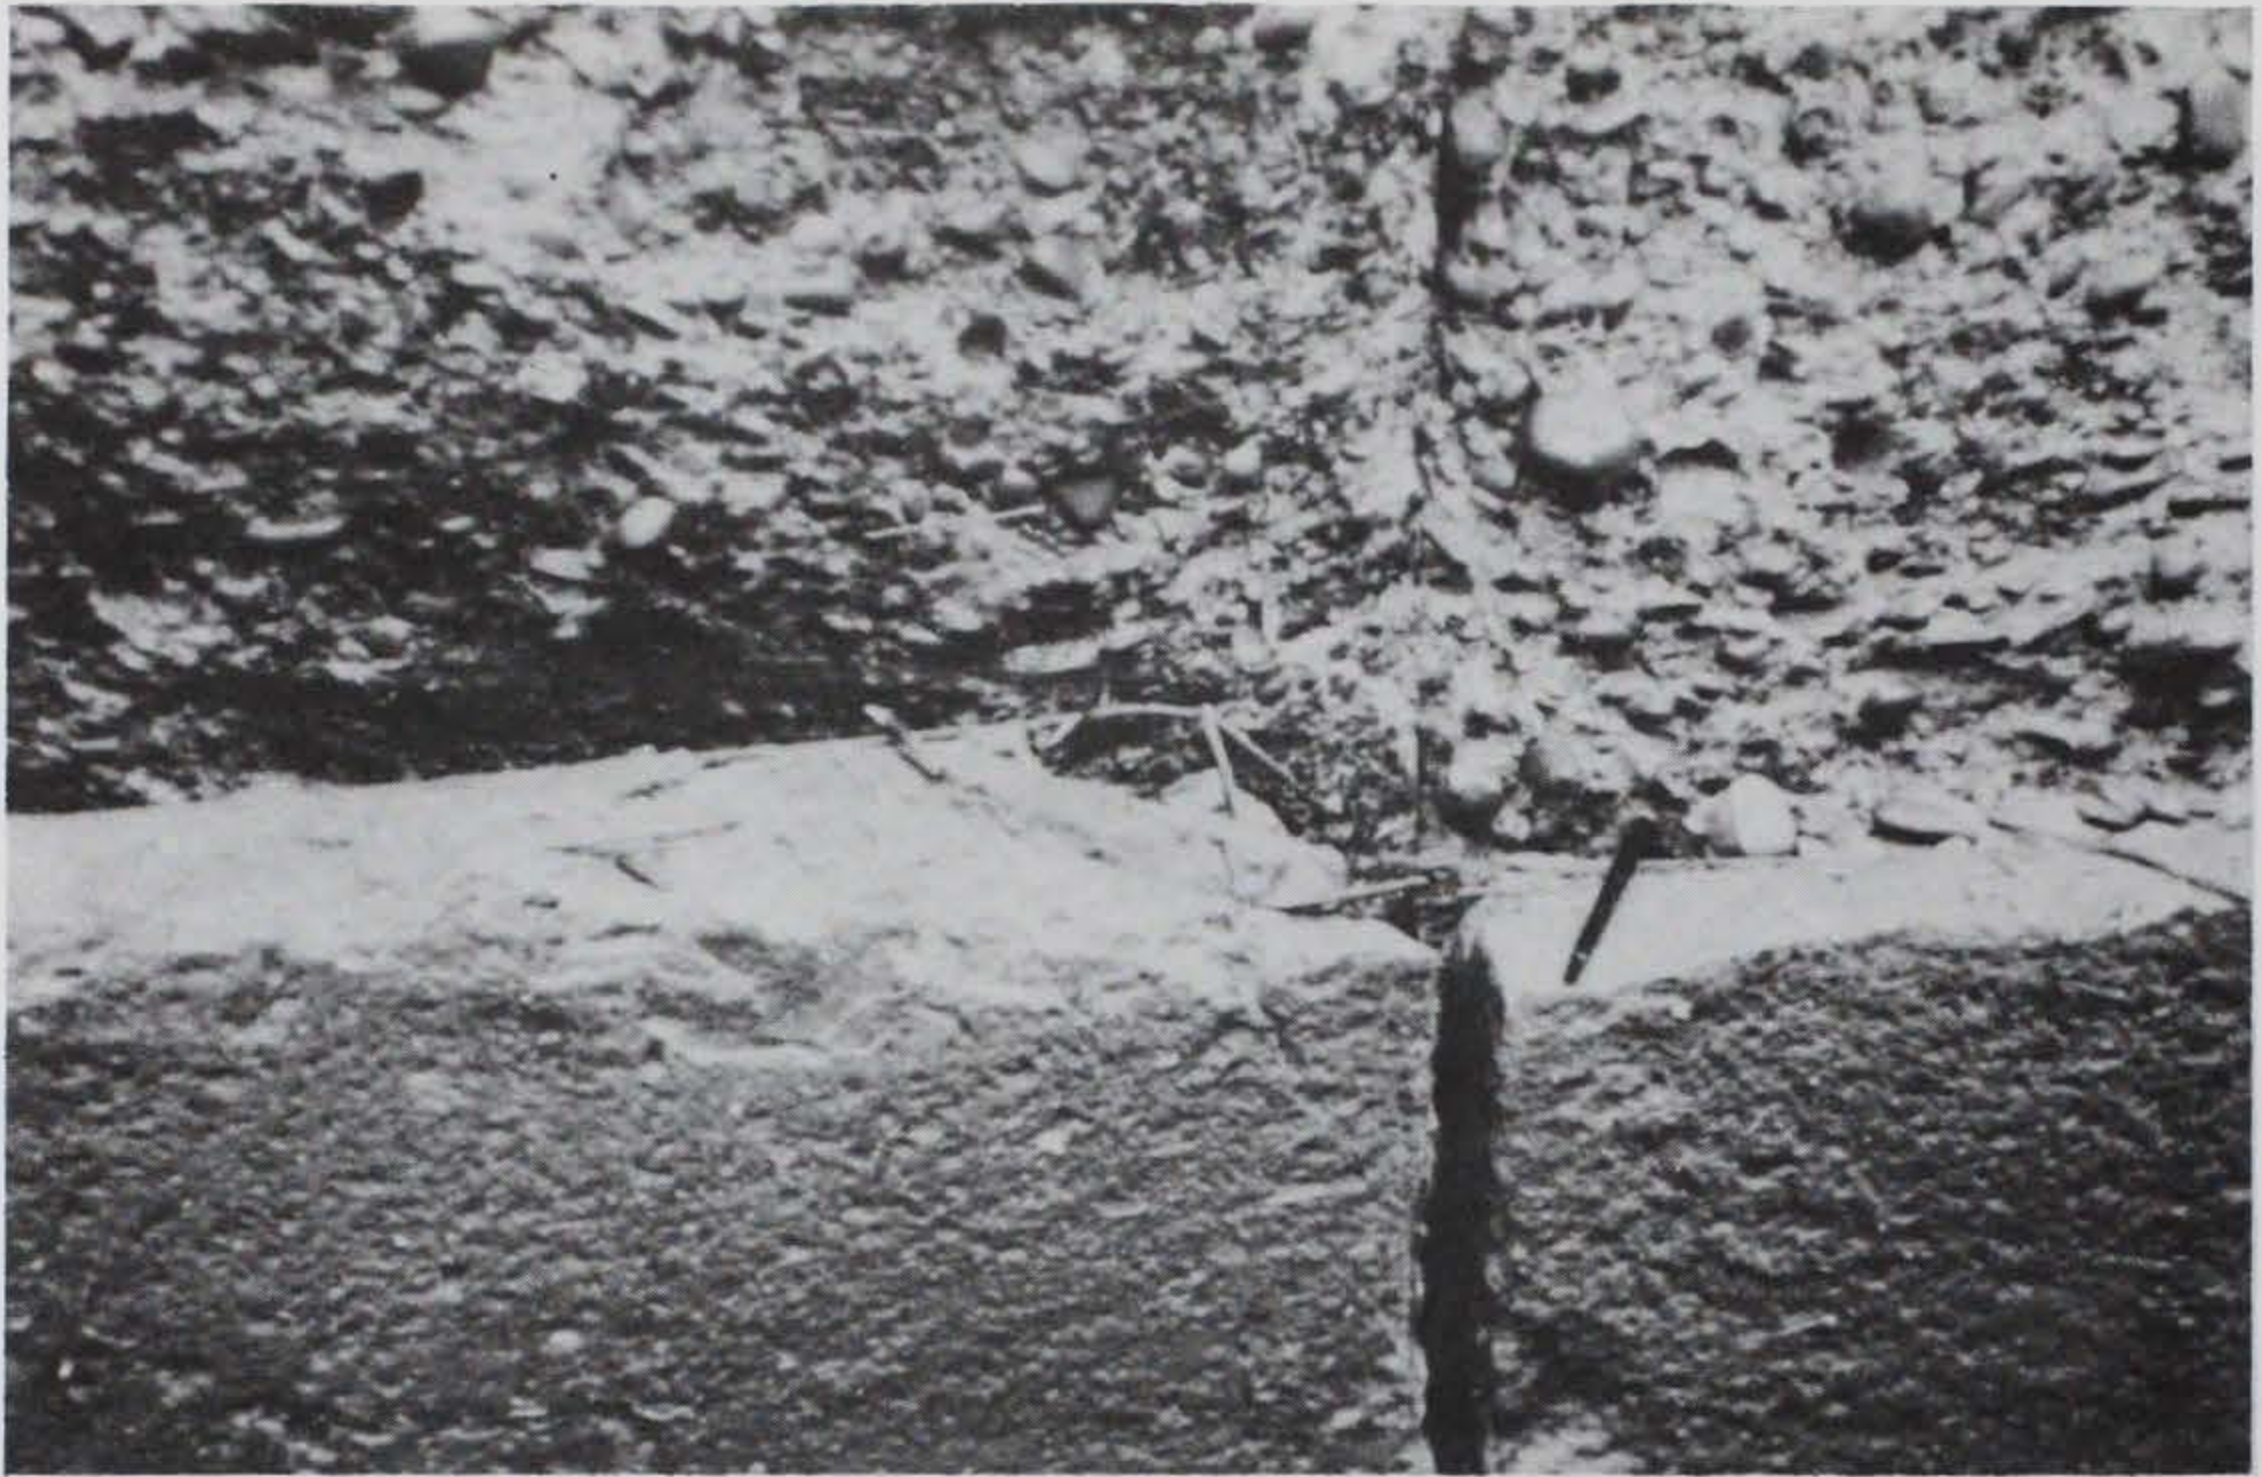
Figure 128. Anchored and reinforced shotcrete remains on the river lock land wall although it was not bonded to the original concrete in several cases, 1981, Emsworth Locks
