Evaluation of Cedar Tree Revetments for Bank Stabilization at the Locust Creek Conservation Area, Missouri

Quantifying Bank Erosion Volumes from Preproject to Postfailure

November 2022

Technical Report (TR)

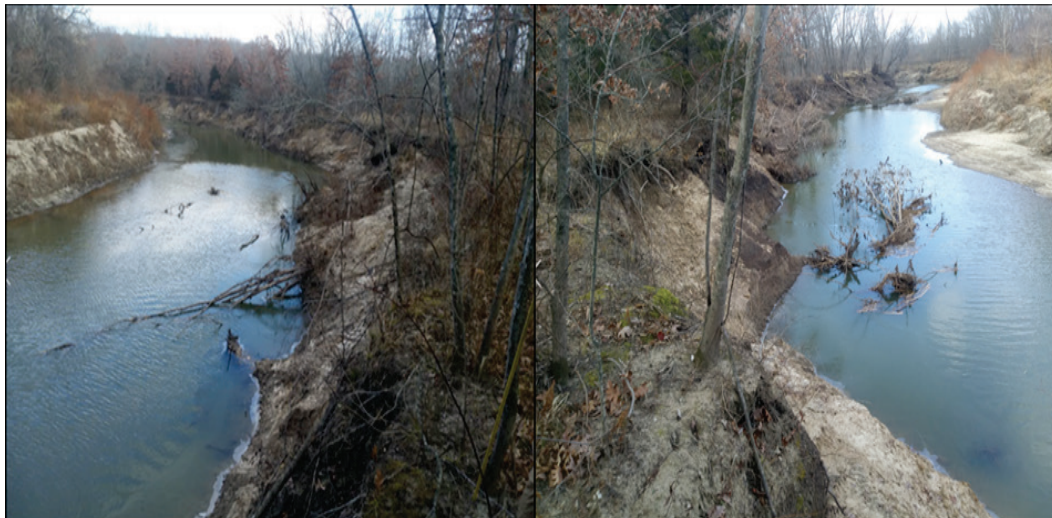
During the December 2019 survey (Figure 4), Site 3 had nearly vertical banks and no evidence of any remaining revetment. Some recently collapsed trees protruded into the creek, and only sparse vegetation grew along the bank.

Figure 4. Site 3 in December of 2019. *Left* photo is looking upstream, and *right* photo is looking downstream.

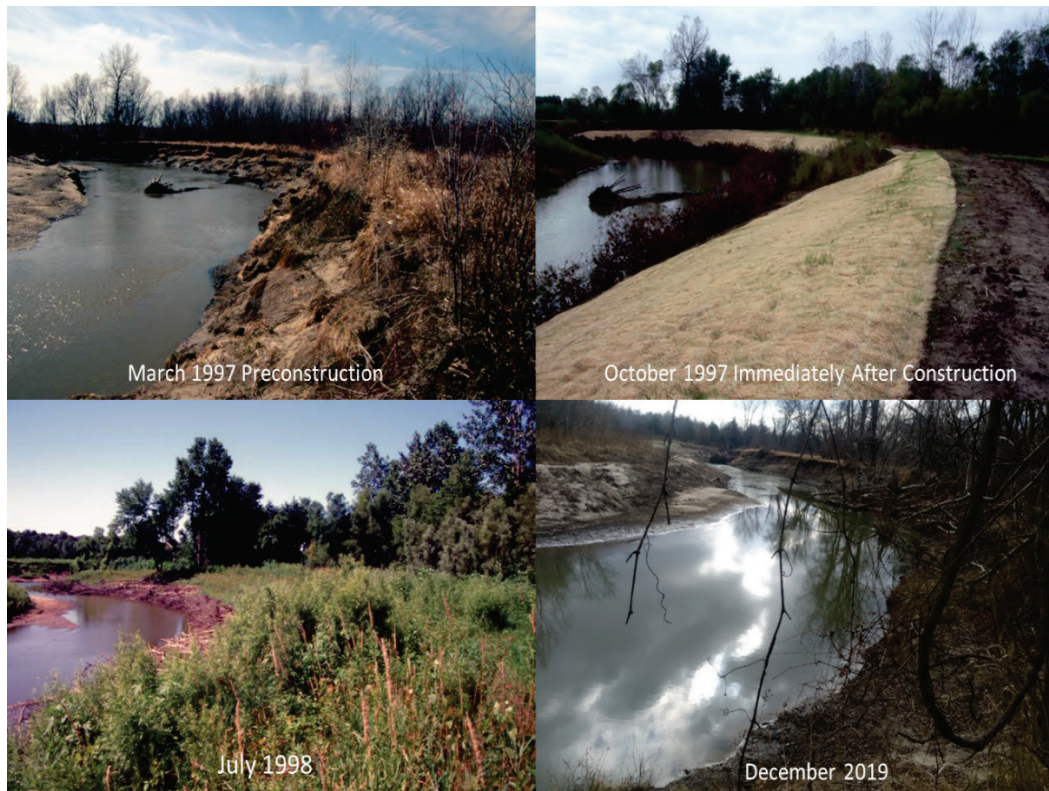
The revetment was initially successful in establishing vegetation along the bank, as seen in the 1998 photo that was taken a little less than a year after construction (Figure 5). However, the banks were nearly vertical and had little vegetation by December of 2019. None of the revetment was found during the 2019 survey.

Figure 5. Site 4, looking downstream. The *top left* photo was taken in 1997, before construction of the revetment. The *top right* photo was taken in 1997, immediately after construction. The *bottom left* and *bottom right* photos were taken in 1998 and 2019, respectively.

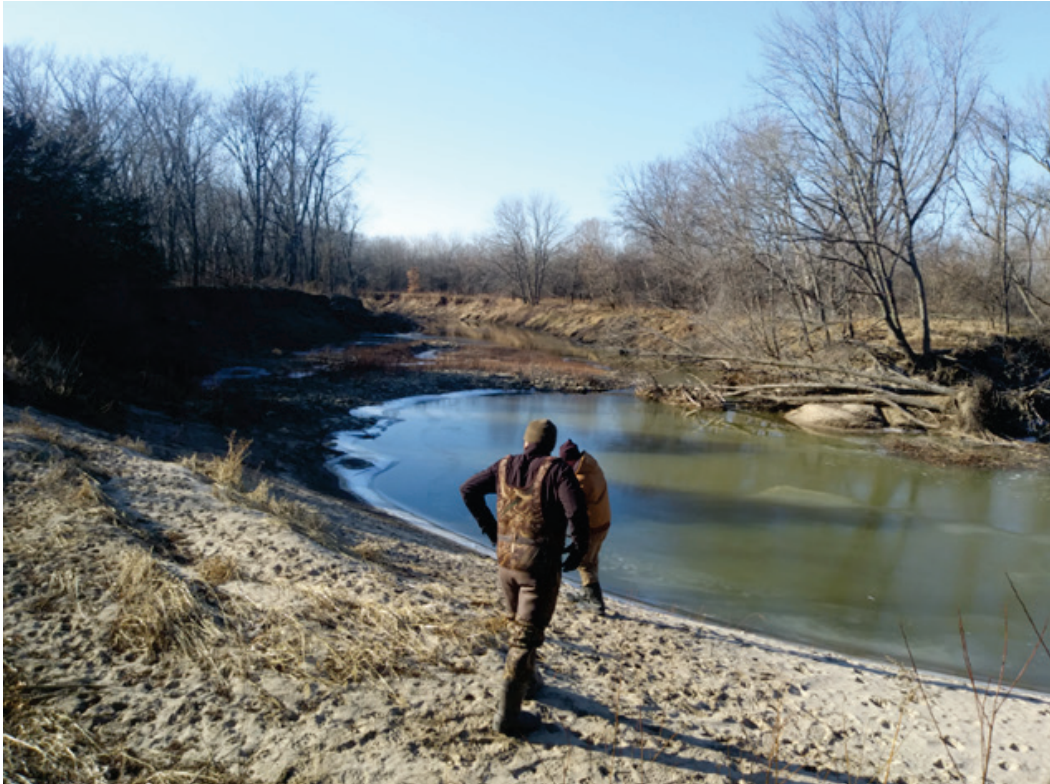
A willow pole revetment was constructed at Site 5 in February of 1992. No revetment remained as of the December 2019 survey. A sandbar had formed on the outside of the bend (Figure 6), presumably during the 2019 flood flows.

Figure 6. Site 5 in December of 2019.

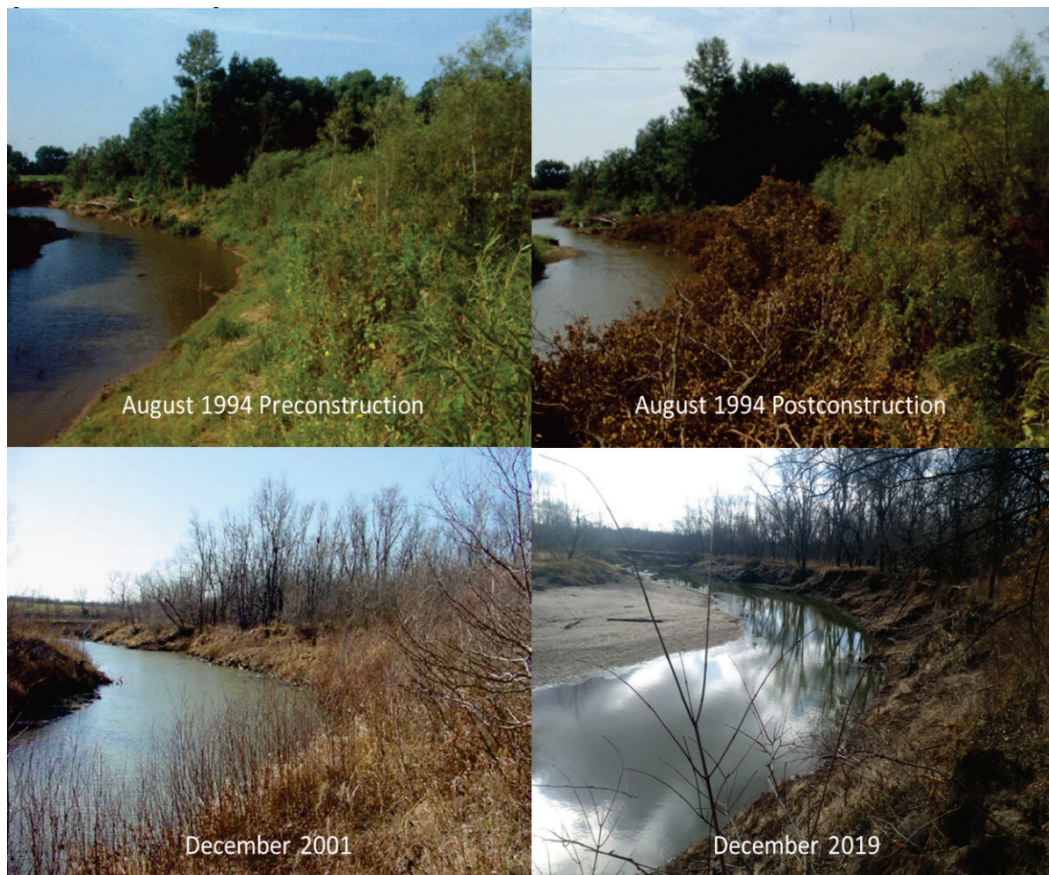
The double-row hardwood tree revetment at Site 6 (Figure 7) was constructed in 1994 from 35 shingle oak trees that were 20–35 feet long. Lost trees were replaced in 1996 and 2000. At the December 2019 visit, none of the revetment remained; the banks were nearly vertical and had only sparse vegetation growing on them.

Figure 7. Site 6. The *top left* photo was taken in 1994, just before construction began. The *top right* photo was taken just after construction was completed. The *bottom left* and *bottom right* photos were taken in 2001 and 2019, respectively.

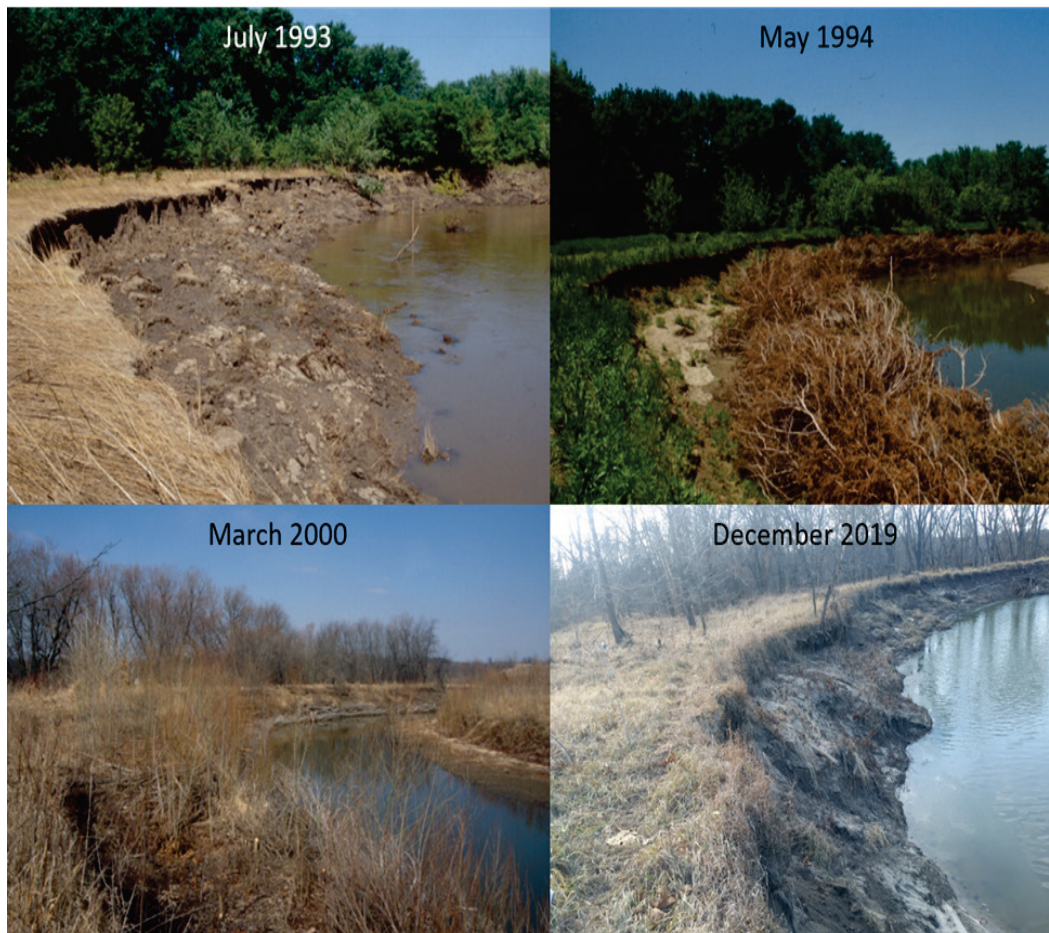
The streambank was actively eroding in 1993, prior to installation (Figure 8). However, after the revetment was installed in May of 1994, the bank remained stable until at least 2004. In December of 2019, the banks were steep and eroding, vegetation had been completely removed, and no revetment remained.

Figure 8. Site 7, looking downstream. The *top left* photo was taken in 1993, before construction of the revetment. The *top right* photo was taken in 1994, just after construction. The *bottom left* and *bottom right* photos were taken in 2000 and 2019, respectively.

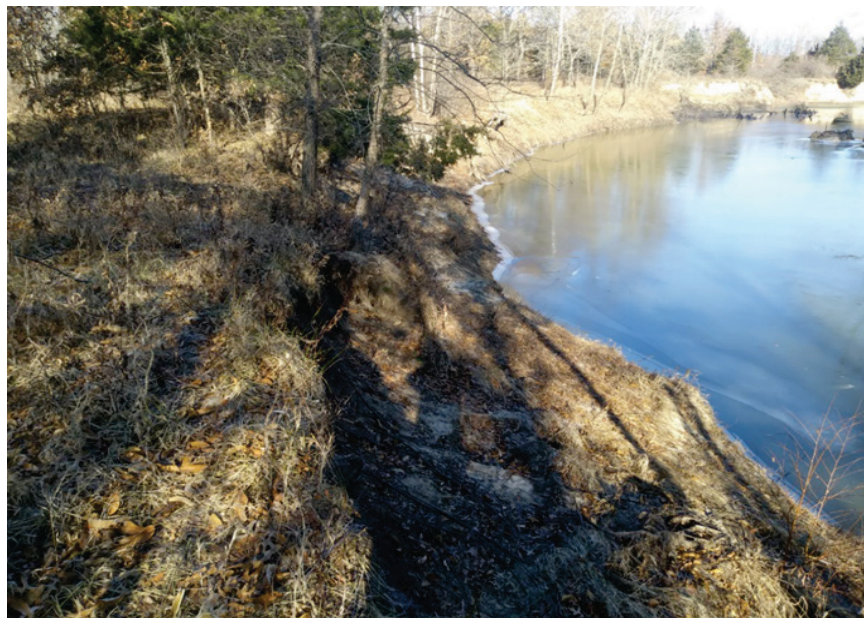
As of the December 2019 visit, the bank at Site 9 was not as steep as those of the other sites, and the riparian corridor was better developed with mature trees (Figure 11). This was most likely the influence of the grade-control structure.

Figure 11. Site 9 in December of 2019, looking upstream.

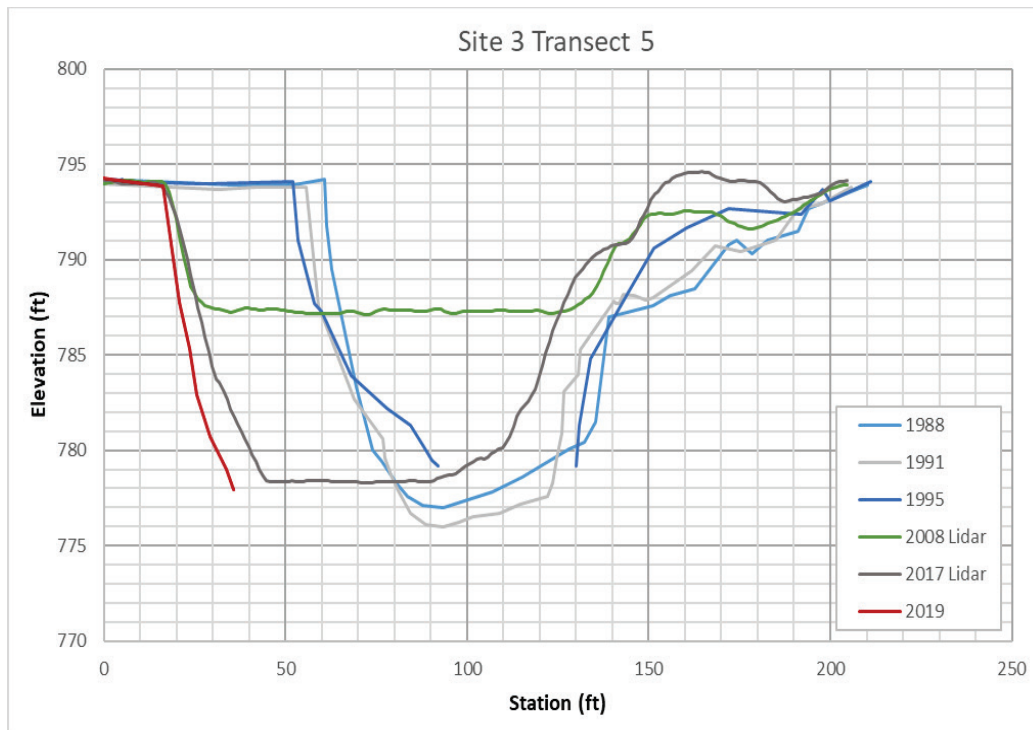
Figure 14. Site 3 transect 5. Lidar transects indicate water surface rather than channel bottom.

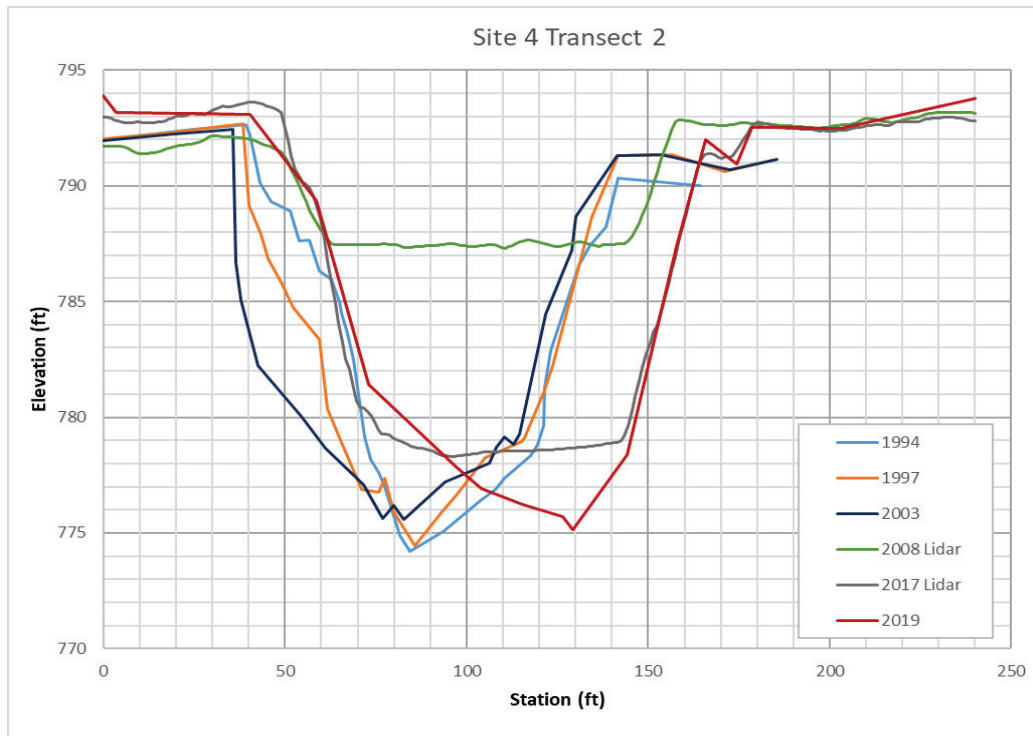
Figure 15. Site 4 transect 2. Lidar transects indicate water surface rather than channel bottom.

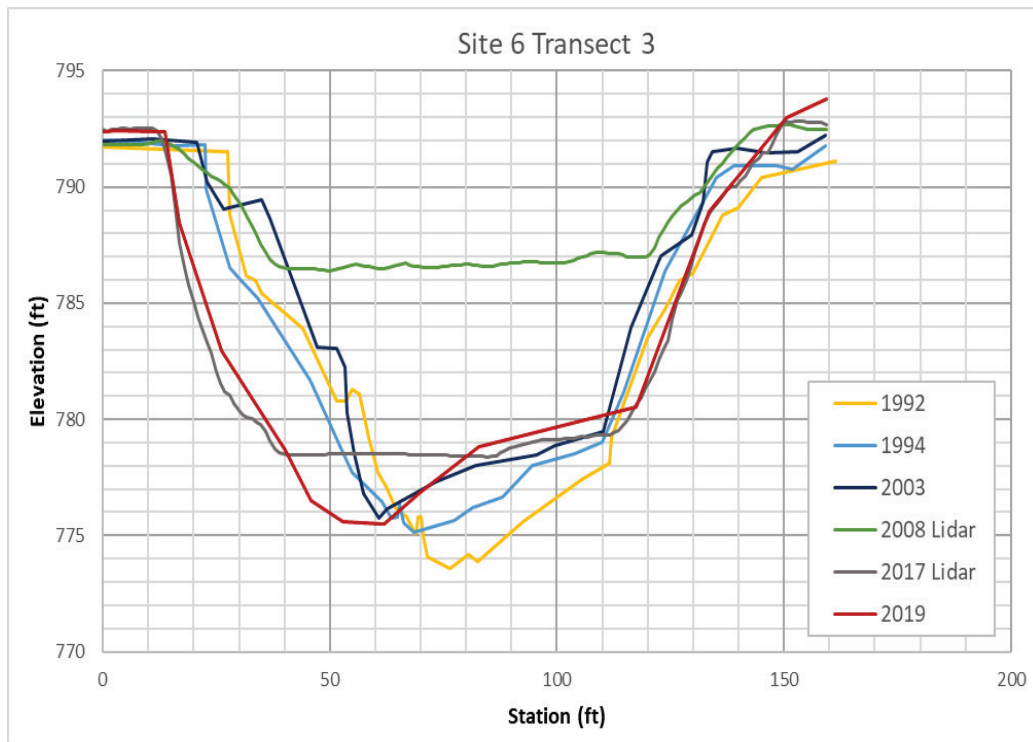
Figure 16. Site 6 transect 3. Lidar transects indicate water surface rather than channel bottom.

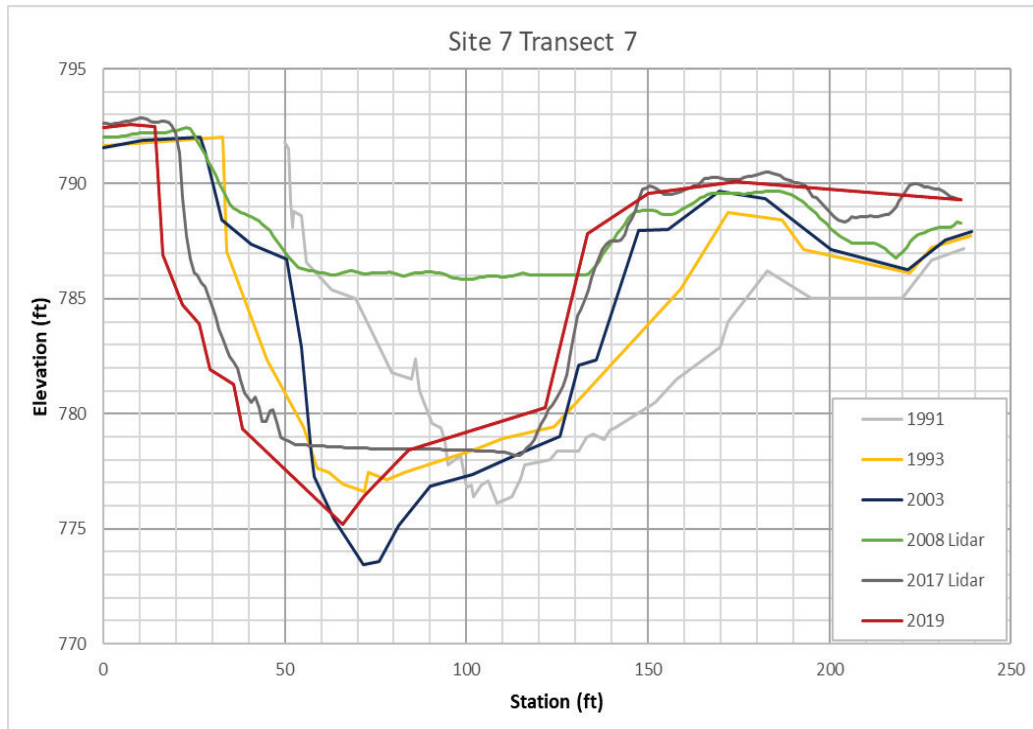
Figure 17. Site 7 transect 7. Lidar transects indicate water surface rather than channel bottom.

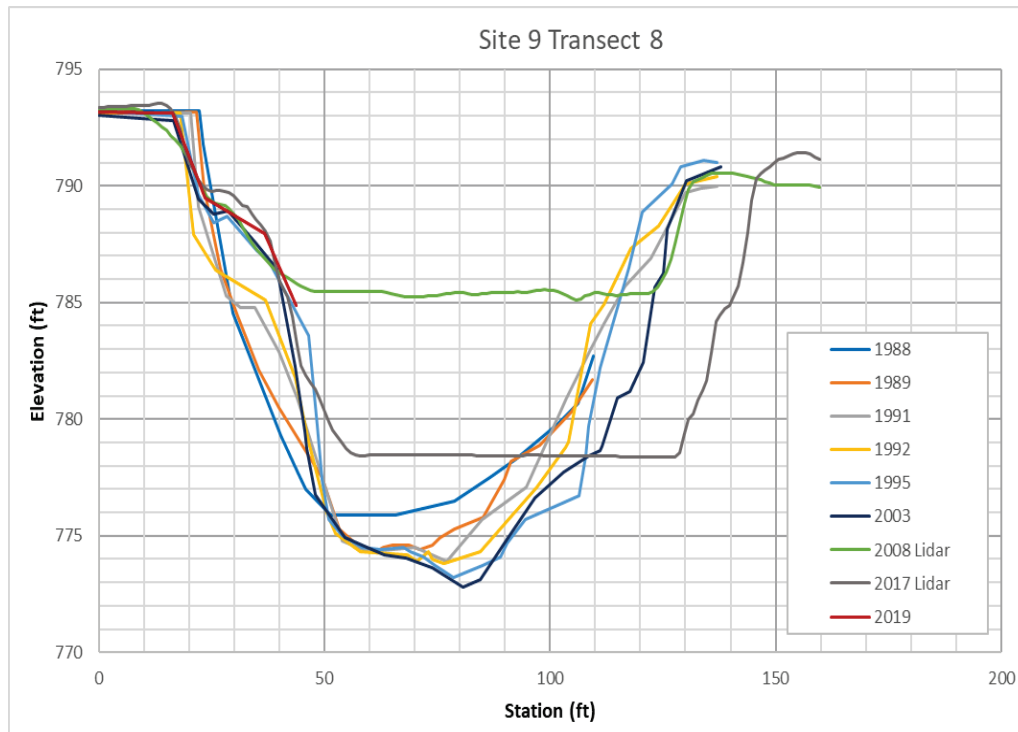
Figure 20. Site 9 transect 8. Note that the 2019 survey collected data on the left bank, but the revetment was installed on the right bank. Lidar transects indicate water surface rather than channel bottom.

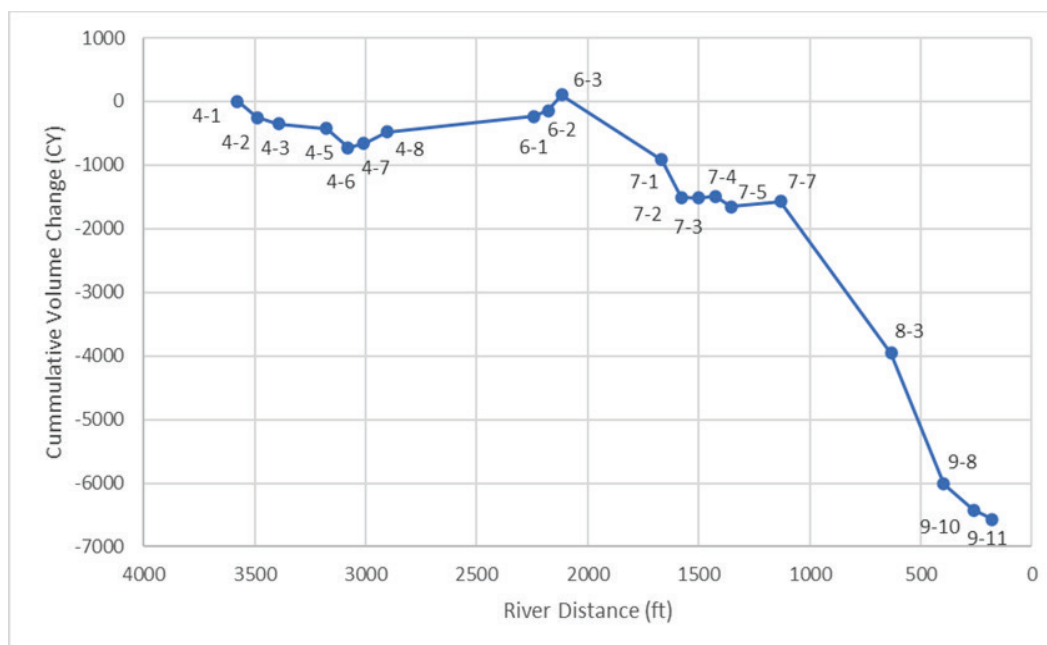
The cross-section analysis indicated 6,567 cubic yards of degradation from the 1994 to 2003 data sets. This equates to an average of 730 cubic yards per year. Figure 22 provides the longitudinal cumulative volume change.

Figure 22. Longitudinal volume change, approximately 1994–2003. Labels give the site and downstream cross section number.
