## **Character-Defining Features of the Buffalo South Mole (South Pier), NY**

Adam D. Smith and Megan W. Tooker

April 2023

Final Technical Report (TR)

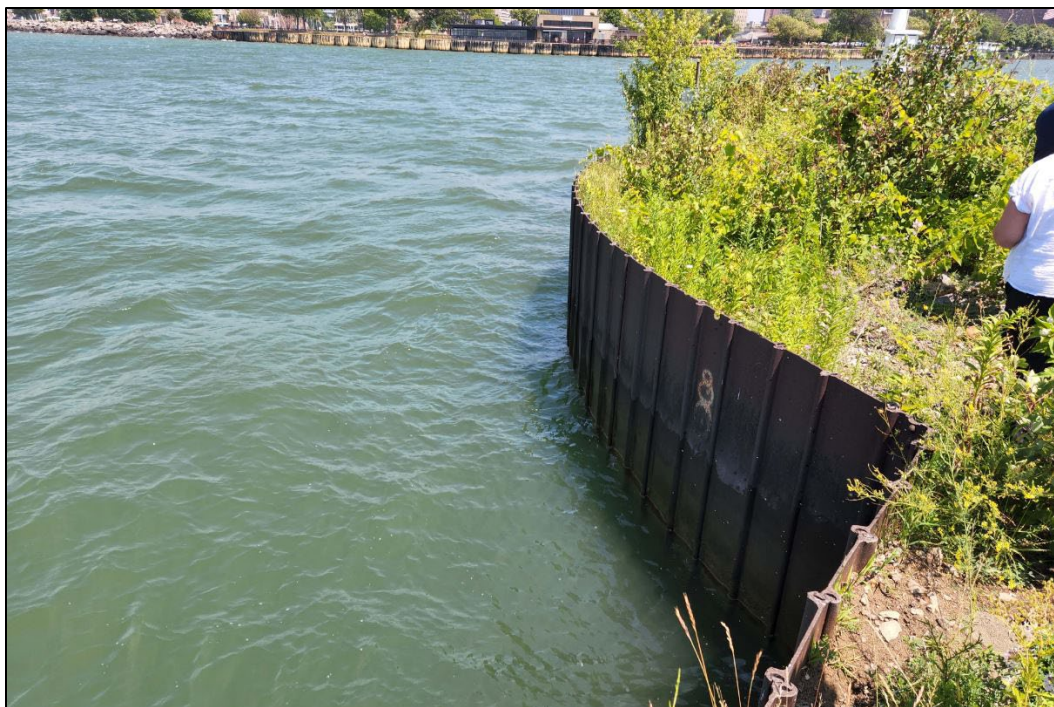
Figure 65. Detail of the 1959 steel bulkhead on the western end (photo by ERDC-CERL researchers, 2022).

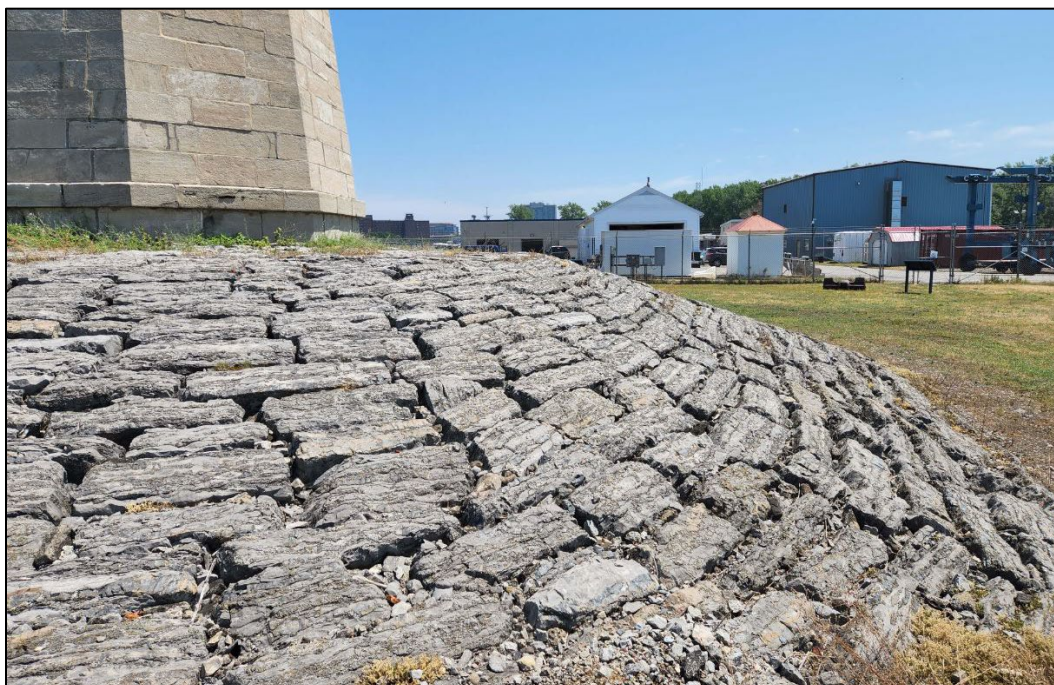
Figure 66. The 1833 stone talus at the base of the 1833 lighthouse on the western end (photo by ERDC-CERL researchers, 2022).<sup>10</sup>

<sup>10</sup> The talus extends beneath the surface, and the presence of the wooden dock beneath the surface as suggested by MASW and GPR surveys performed by LRB in April 2020.

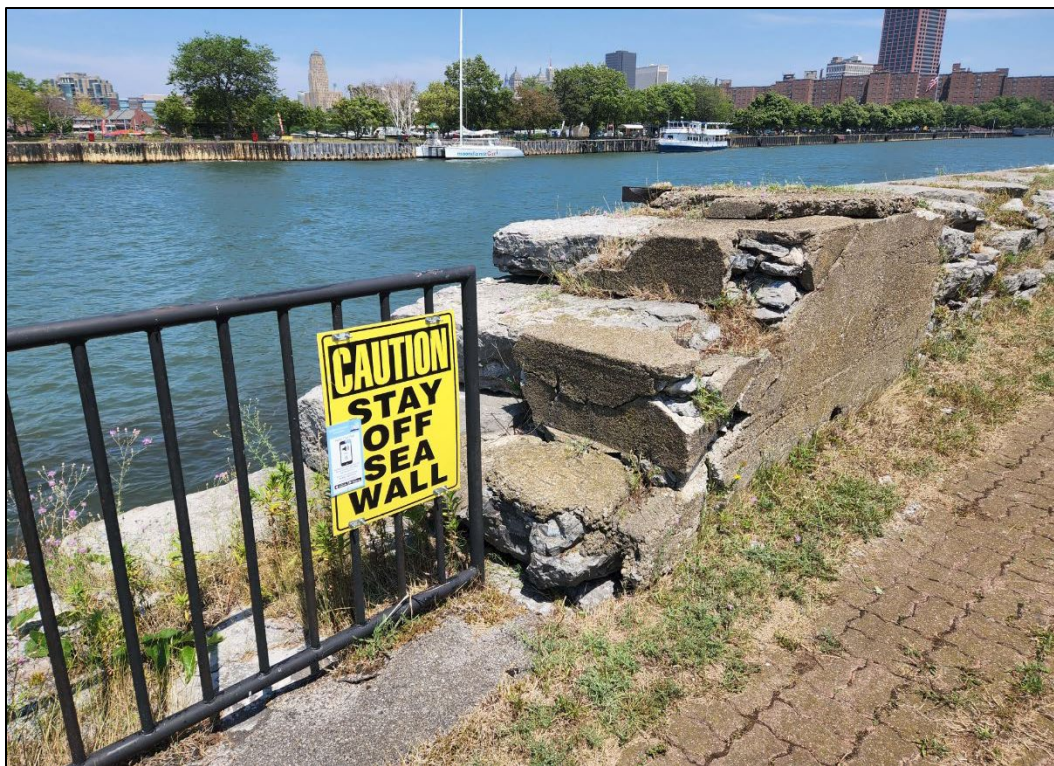
Figure 71. Middle of the 1820s stone wall showing how the wall was lowered in 1898 (photo by ERDC-CERL researchers, 2022).

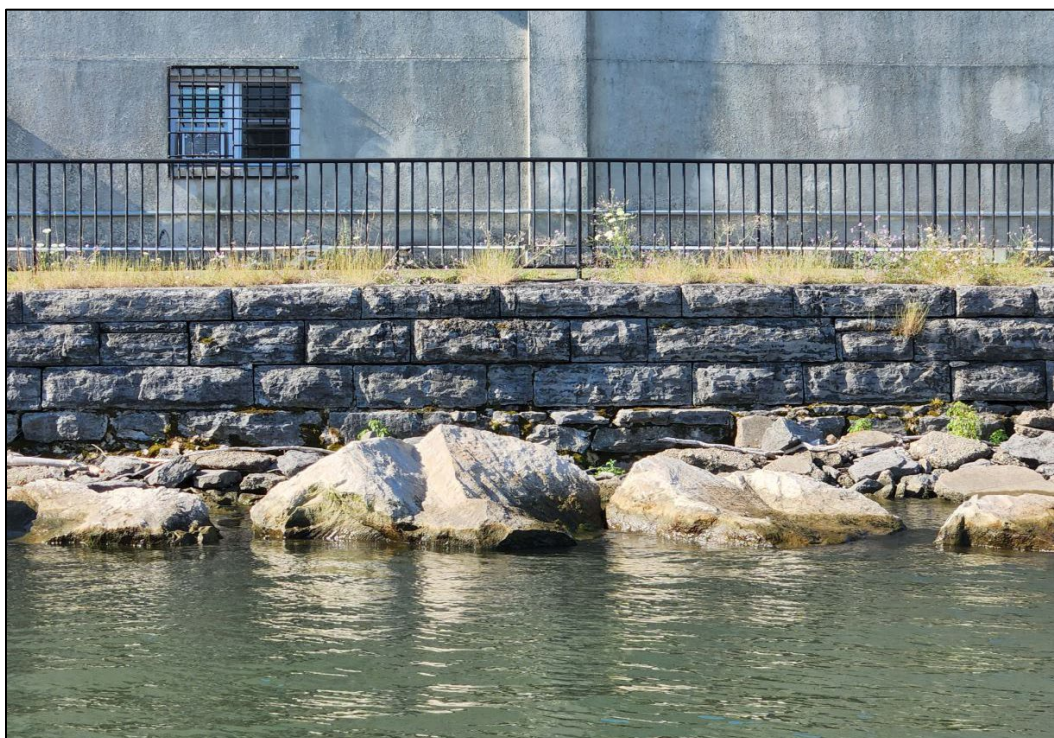
Figure 72. Looking south at the 1820s stone wall showing how it was lowered in the 1898–1903 period (photo by ERDC-CERL researchers, 2022).

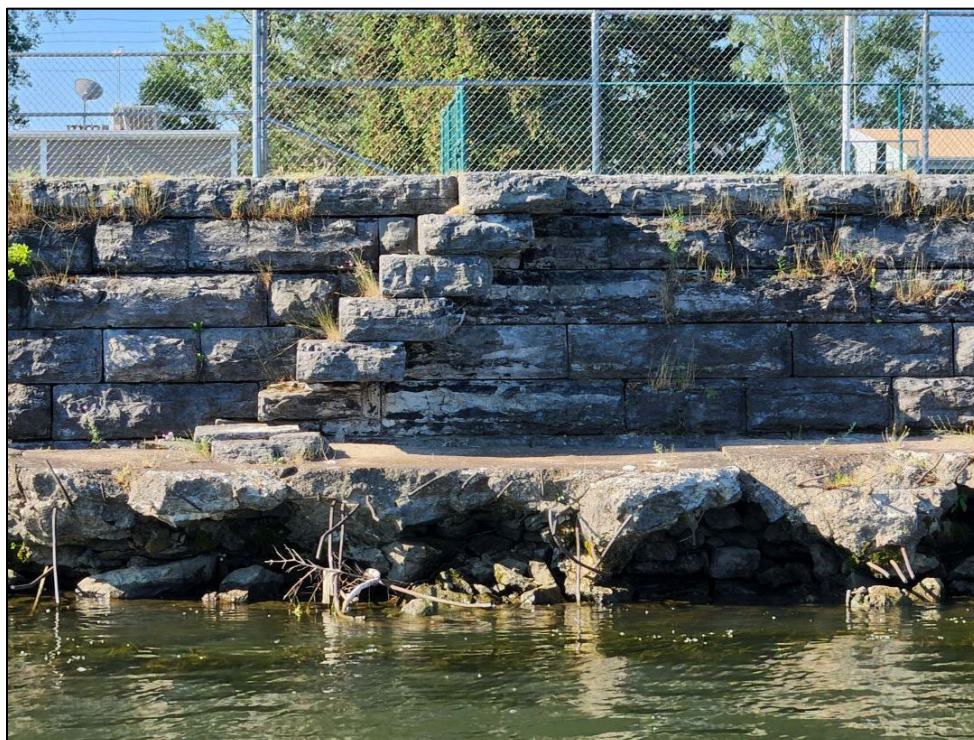
Figure 74. Looking south at the 1820s stone wall with 1820s stone stairs leading to a remnant of the 1933 concrete banquette (photo by ERDC-CERL researchers, 2022).

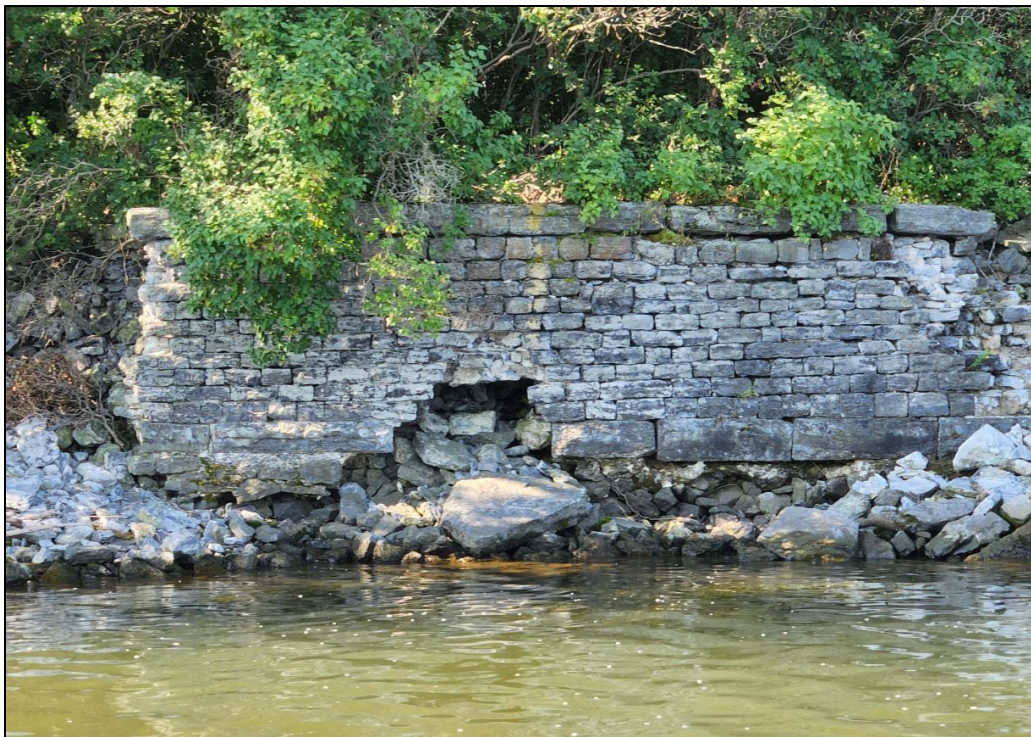
Figure 82. Looking east at the 1833 stone wall at the eastern end of the mole, note that the old lifeboat saving slip would have been to the left of this wall (photo by ERDC-CERL researchers, 2022)

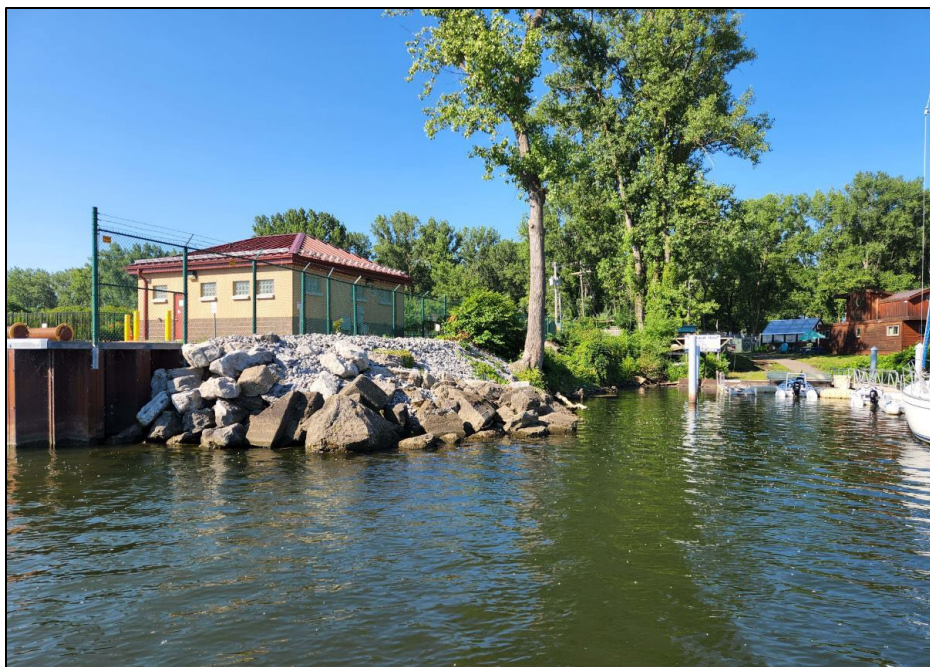
Figure 84. Looking southwest at the former lighthouse tender slip which is now used by the Sail Buffalo sailing school (photo by ERDC-CERL researchers, 2022).<sup>13</sup>

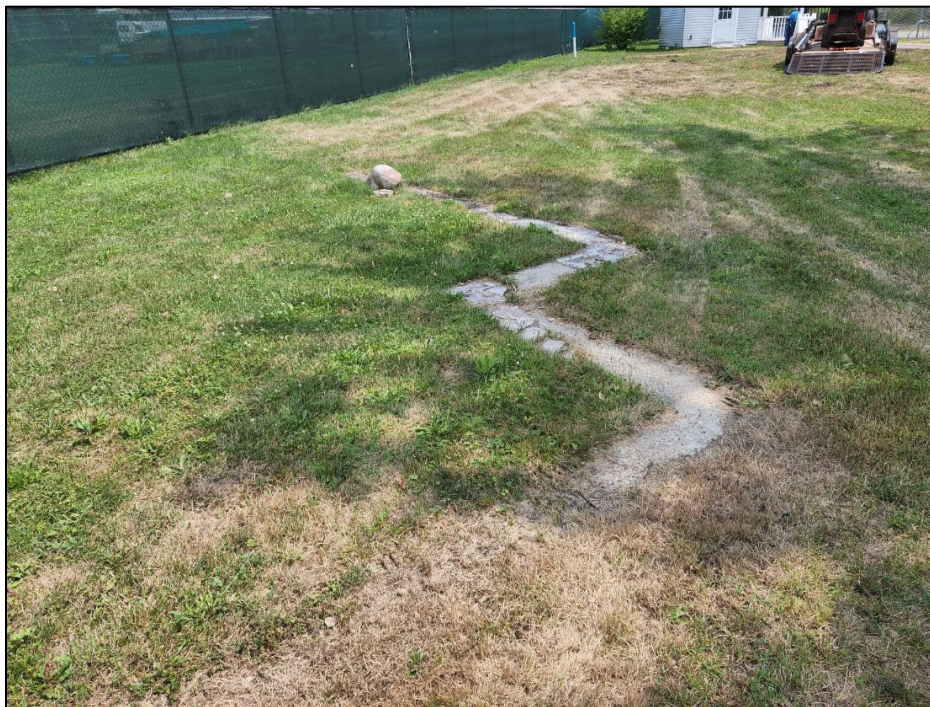
Figure 85. Foundation remnant, consistent with period georeferenced drawings, on the eastern side of the mole area (photo by ERDC-CERL researchers, 2022).

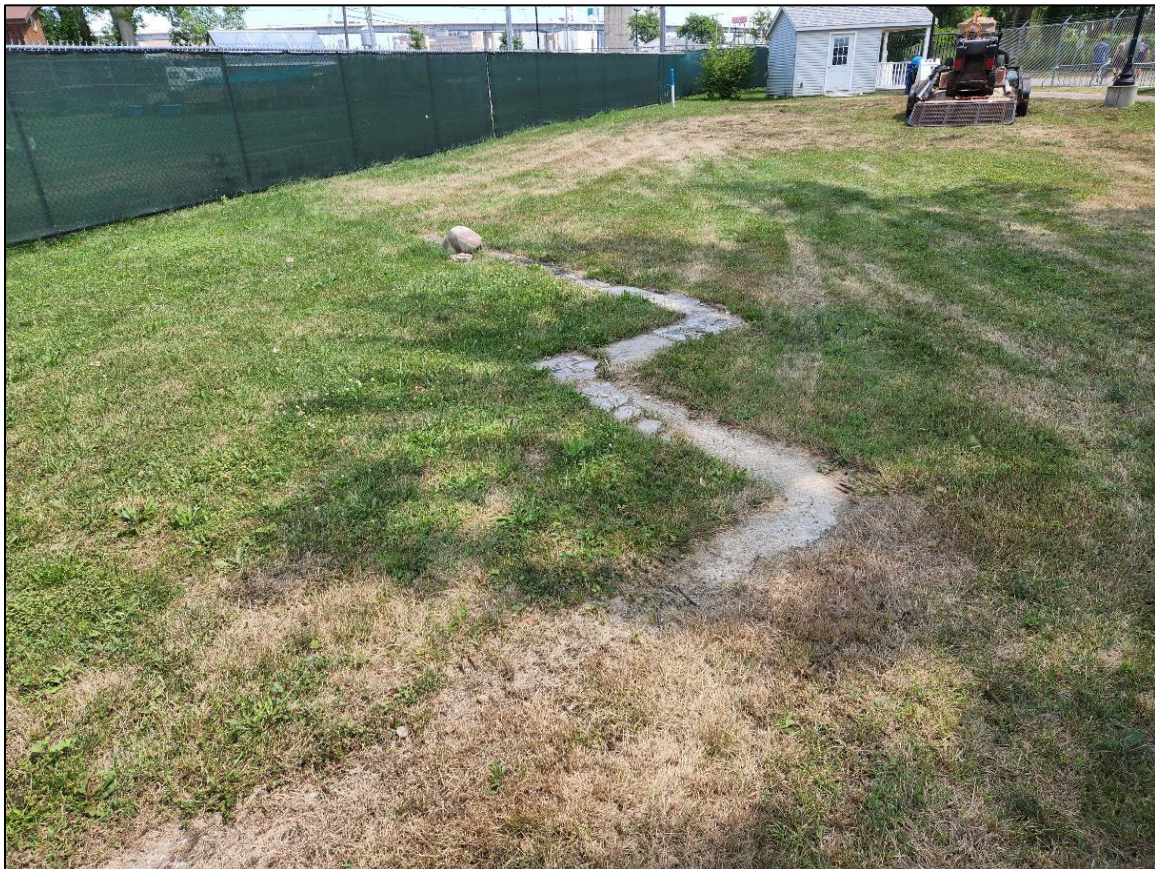
Figure 92. Foundation remains on eastern portion of site (photo by ERDC-CERL researchers, 2022).
