# Regional Sediment Management (RSM) Principles in Flood Recovery: Incorporating RSM after the 2011 Missouri River Flood

by Paul M. Boyd

**PURPOSE.** This Coastal and Hydraulics Engineering Technical Note (CHETN) summarizes actions undertaken during 2011 and 2012 to incorporate US Army Corps of Engineers (USACE) Regional Sediment Management (RSM) principles into a wide variety of projects as part of flood recovery and reconstruction on the Missouri River. Significant damage was caused by the 2011 Missouri River flood, and mitigation of sediment impacts and repair of infrastructure were given a high priority in an effort to return the flood protection system to acceptable flood protection levels.

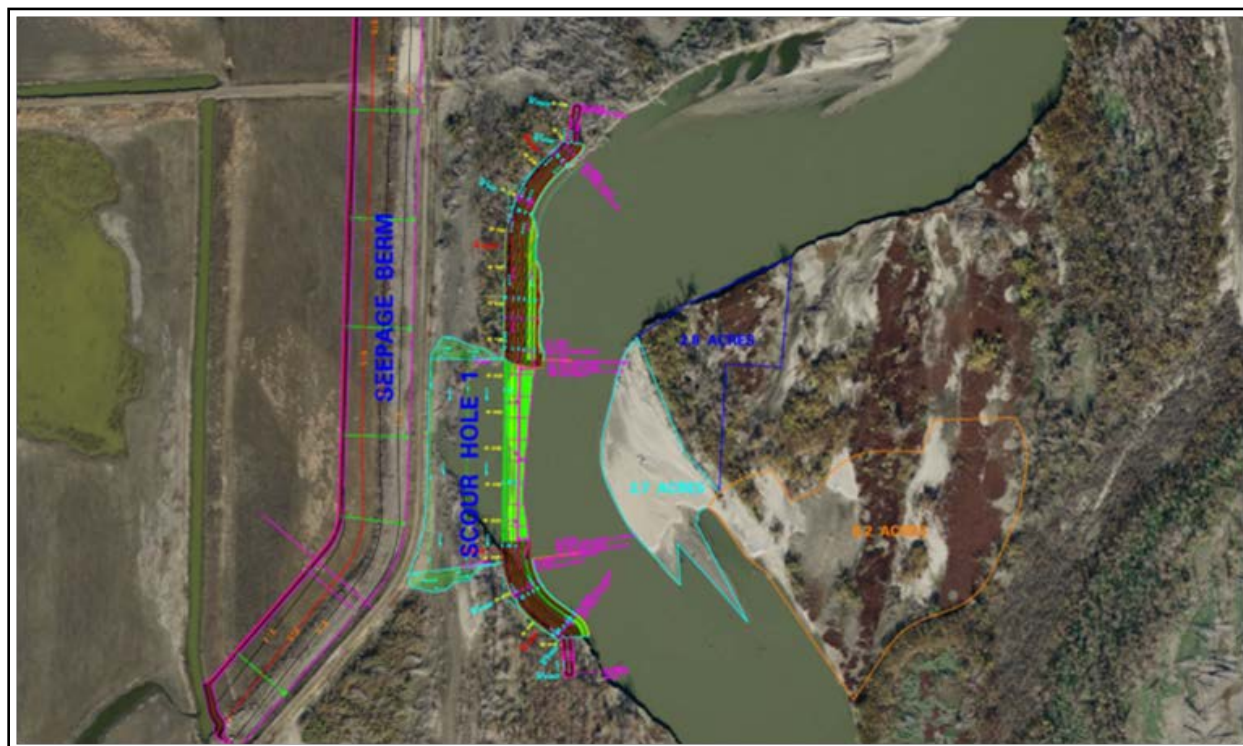
At a large bend centered within the chute, significant erosion along the outer bank threatened a Federal levee that protects adjacent homes and farmland. The eroded chute bank approached the toe of the levee causing considerable concern regarding stability. In addition to the erosion on the outer bank, a point bar formed as the channel migrated. Figure 3 shows the design drawing for repairing the levee toe.

Figure 3. Upper Hamburg Bend Chute, Missouri River, repair plan.

Approximately 30,000 tons of riprap were placed to re-establish the bank in front of the scour hole. Sediment was needed to fill and stabilize the scour hole between the riprap bank and the toe of the levee. The volume required to fill the scour hole exceeded the material available in the point bar that was to be dredged to provide fill and open up the chute channel. Therefore, an additional sediment source was required. Trucking and dredging were both considered; dredging was the more economical and timely option.

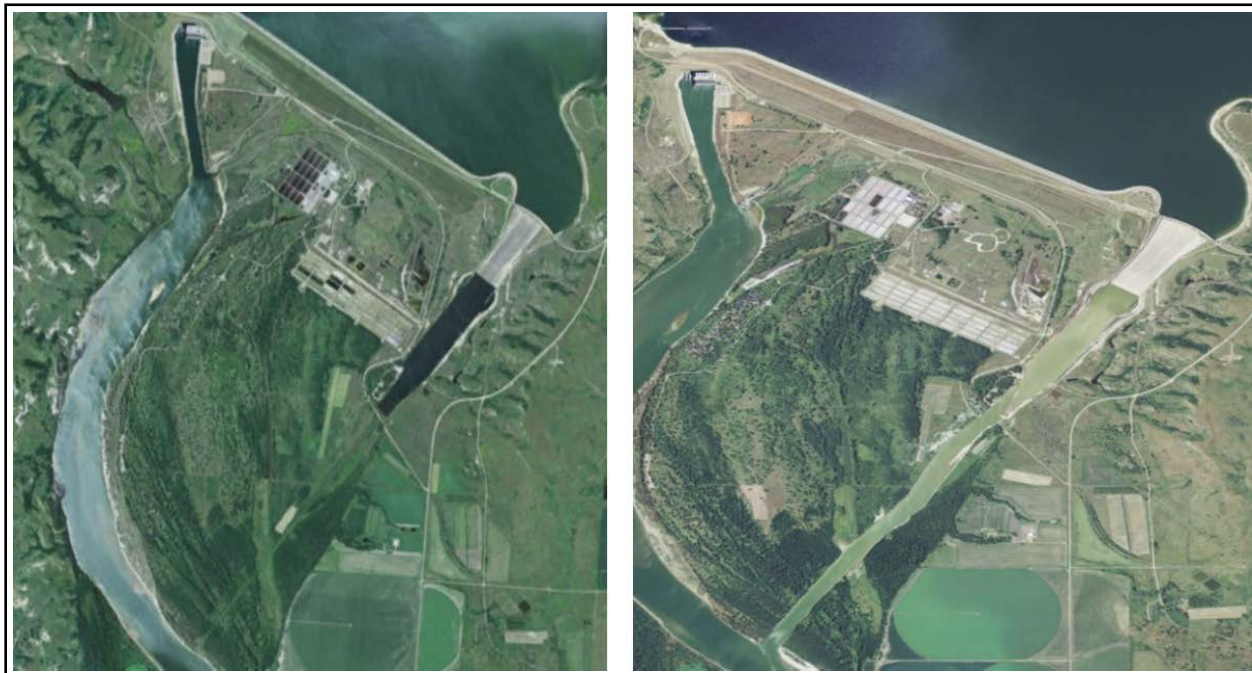
While the spillway was in use, the discharge passed through a pond at the foot of the spillway, and then through an earthen pilot channel that directed flow back to the Missouri River. Due to the magnitude and duration of the flood, the earthen channel experienced major erosion, resulting in a channel 300-ft wide and 10- to 15-ft deep. The flow also eroded the earthen embankment that served as the downstream shore of the spillway pond. The pond is part of a recreation area and serves as a water intake for the Garrison fish hatchery.

Figure 6. Garrison Dam spillway channel before (left) and after (right) the 2011 flood.

Surveys of the spillway channel indicated that approximately 900,000 cubic yards (cu yd) of material would need to be removed from the channel to regain full capacity. Approximately 100,000 cu yd of that material was attributed to 2011 flood deposits. Construction of settling ponds for the material would require hundreds of acres in an area with rolling hills and steep gullies. This solution was determined to be impractical. Two other proposed discharge locations were identified with sufficient volume: (1) disposal of the dredge material upstream of the dam on the lake bottom, and (2) filling the downstream spillway channel.

A pilot channel at the bottom of the lake used during the construction of the dam provides an easy path for escape of cold water through the powerhouse at low lake levels. To reduce this impact, it was proposed to discharge the dredge material into the submerged channel to block this flow. Water quality concern expressed by permitting agencies forced consideration of other methodologies. The washed out spillway channel was the next logical site for deposition. The dredged material would serve to help rebuild the pond embankment, and could then fill the channel below. Plans were made to vary the dredge discharge location in the channel to create shallow water habitat and wetlands. This site became the preferred alternative. However, as of December 2012, funding limitations have prevented execution of the project.

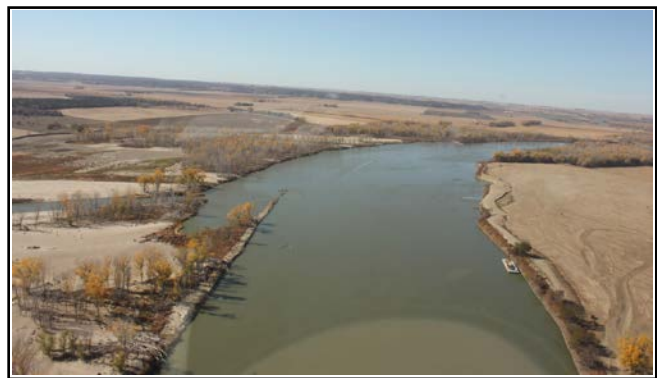
Lower Decatur Bend is located on the navigation channel of the Missouri River at RM 687. This site included a revetment lowering project to create shallow water habitat constructed in 2008. During the 2011 flood, sustained high flows scoured a floodplain flow path, damaged significant sections of revetment, and scoured a deep flow path behind the revetment. The widening of the river in the area also caused shoaling in the navigation channel crossover adjacent to the revetment overtopping area. Post flood surveys indicated that the authorized 9-ft-deep navigation channel was not fully supported in the crossover due to the shoaling. The primary goal of the post flood repair was to restore the navigation channel. Figure 7 shows the bend with the area eroded behind the revetment. Figure 8 shows the river depths at the flow used to assess the navigation channel depth.

Figure 7. Lower Decatur Bend, Missouri River, revetment erosion.

Dredging was considered to be a fast solution to regain the channel capacity; in turn, the dredge material could be used to re-establish the bank behind the revetment. However, the shallow area scoured behind the revetment was useful habitat for the endangered Pallid Sturgeon.
