Beach Erosion and Sediment Processes Study, North East Marina, Erie County, Pennsylvania

Andrew Morang and Jeffrey Melton

June 2001

Final report

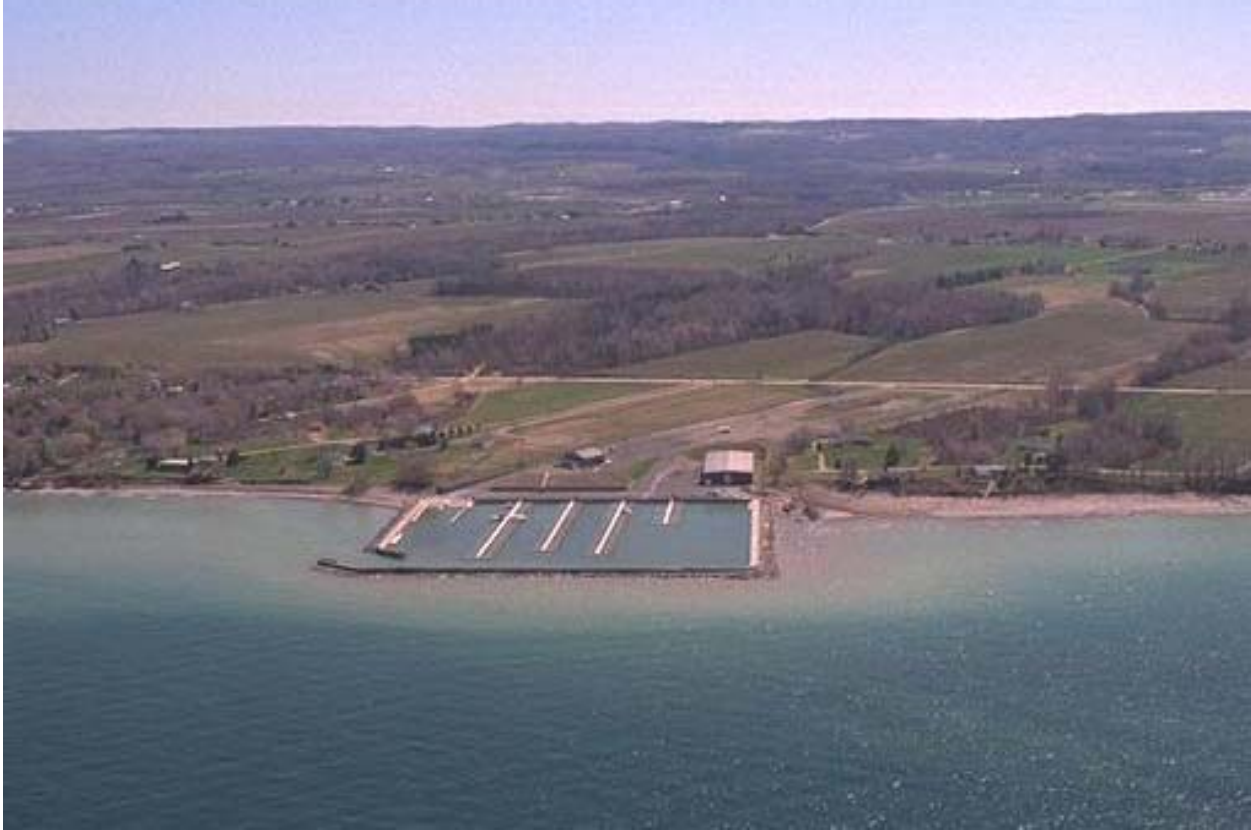
Figure 6. Oblique aerial photograph of marina looking southeast, April 1999. PFBC's spring bypassing operation is in progress, and a backhoe and truck are in the fillet on the right side of the marina. Photograph courtesy Buffalo District

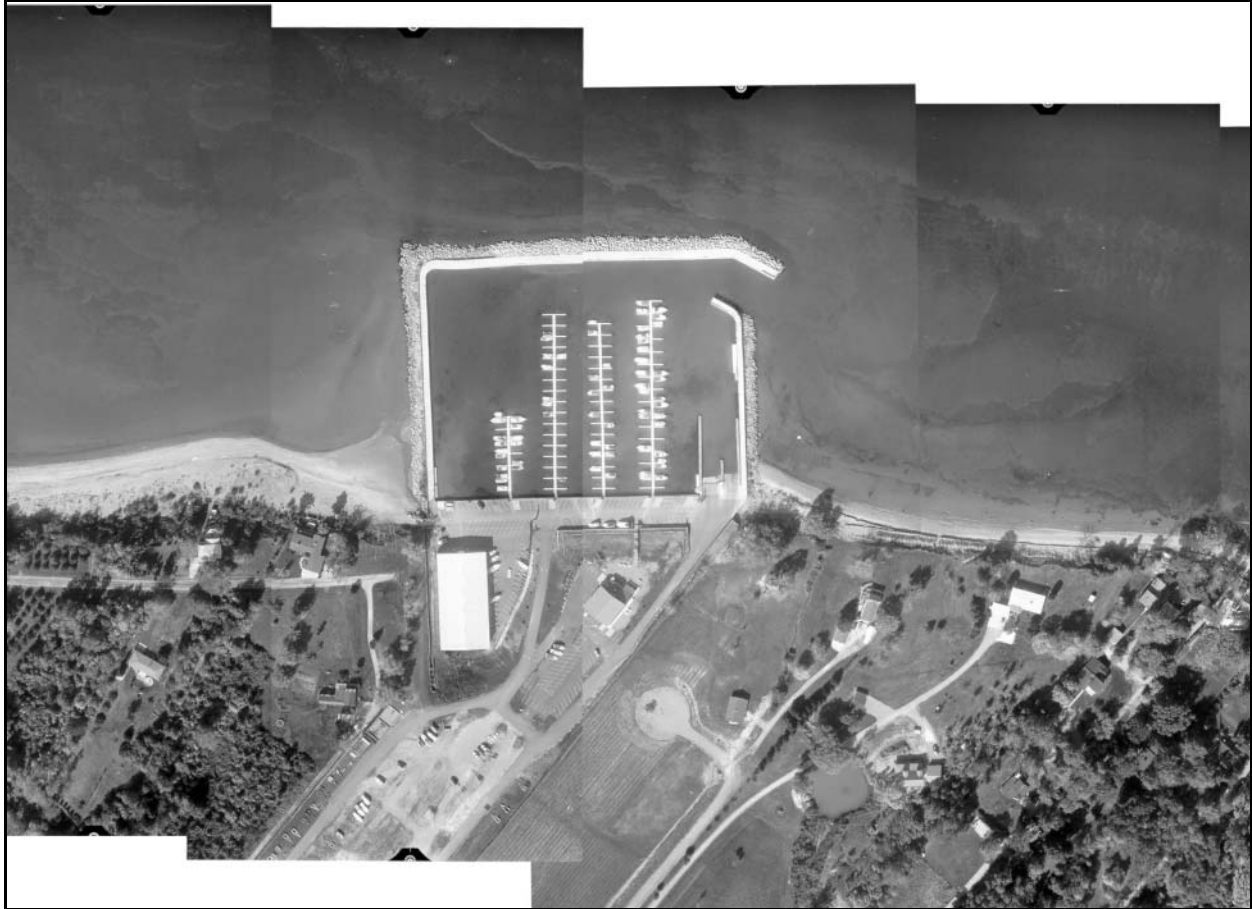
Figure 7. Vertical aerial photograph, October 15, 1999. Shale ledges can be seen through water east (to the right) and lakeward of marina. Bulge in shore west (left) of the marina is accretion on private property that PFBC is unable to mine during biannual bypassing operations

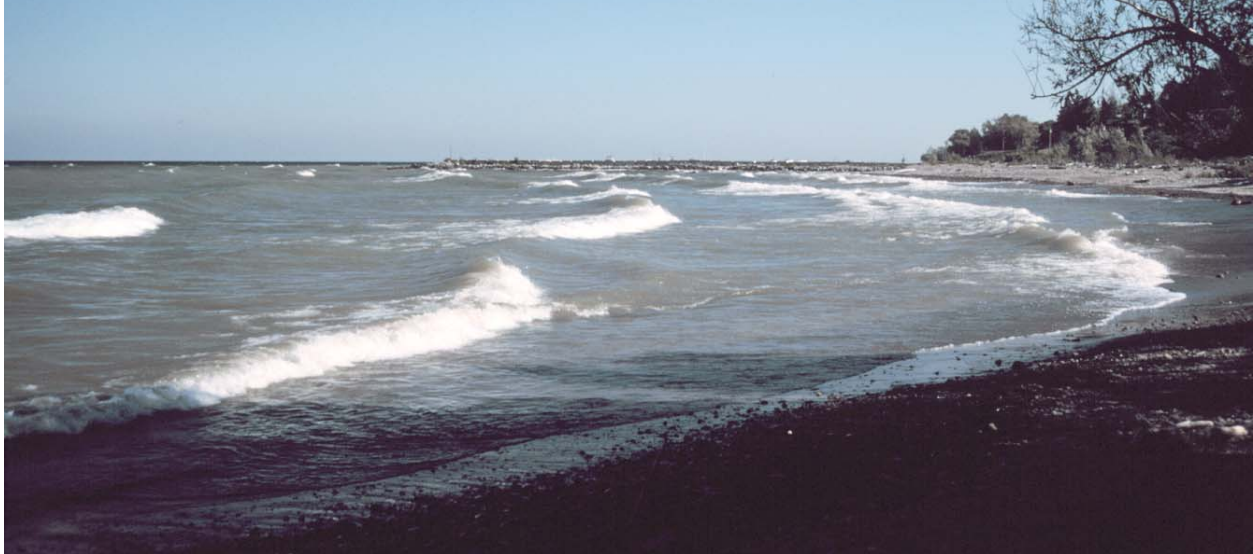
Figure 8. Spilling waves on west side of North East Marina, 22 September 1999. Surf zone was 20-40 m wide, and outer line of breakers formed approximately along a line extending from marina outer wall to west headland

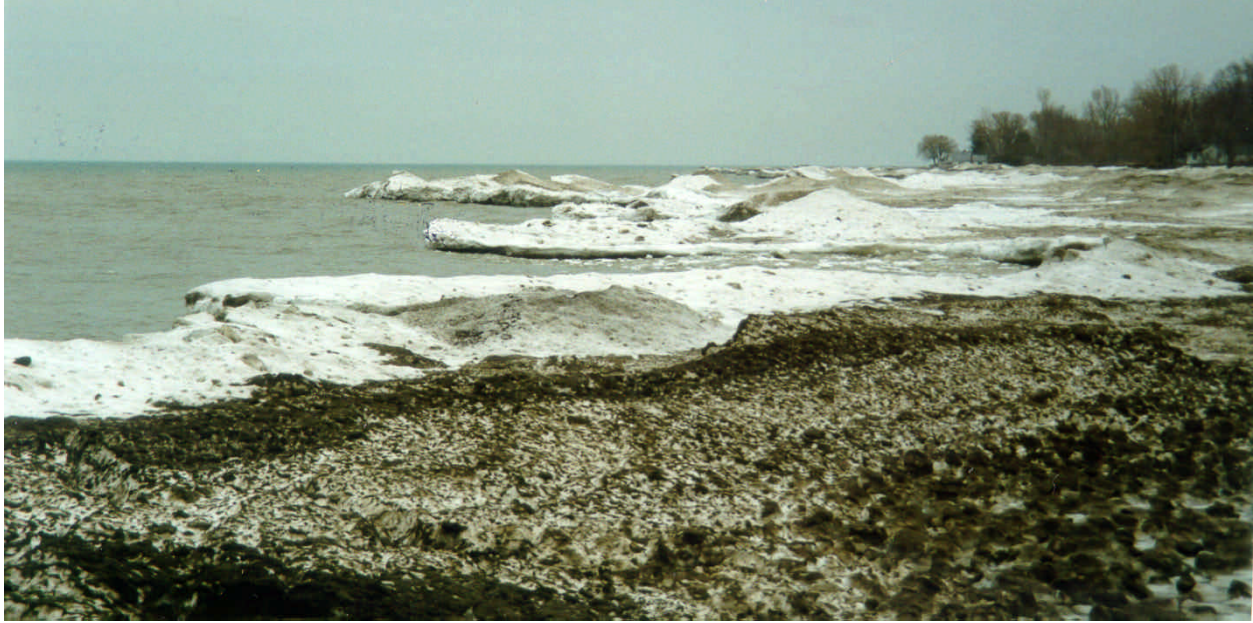
Figure 9. Ice armor along beach, 29 January 1999. During winter, ice protects shore from direct wave attack, but during spring thaw, ice blocks overturn, picking up masses of sand and gravel. View northeast towards Twentymile Creek. Photograph from Buffalo District archives

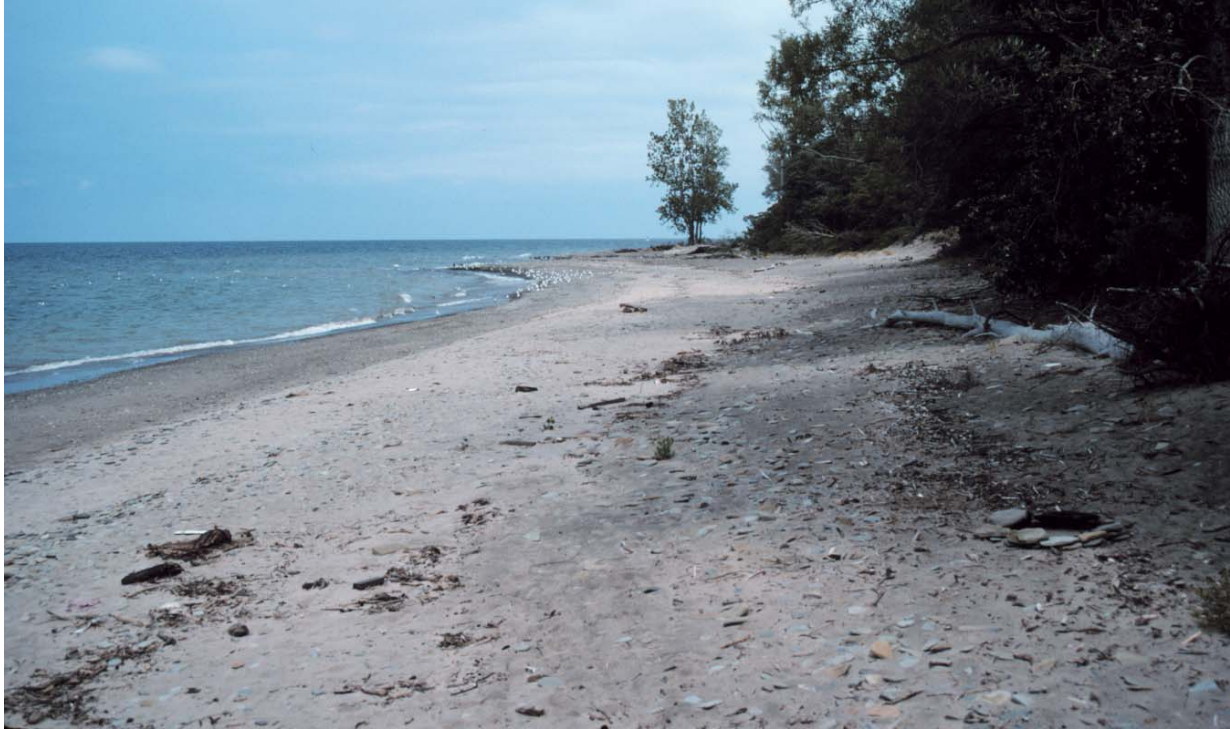
Figure 13. Sand beach west of Twentymile Creek, 1 August 1999. The expanse of sand demonstrates the beneficial effect of falling lake level. This section of beach is fine sand with scattered cobble, but becomes completely cobble at the mouth of creek. Lone tree in distance is at bank of creek. PFBC employees reported that beach was widest they could recall in years

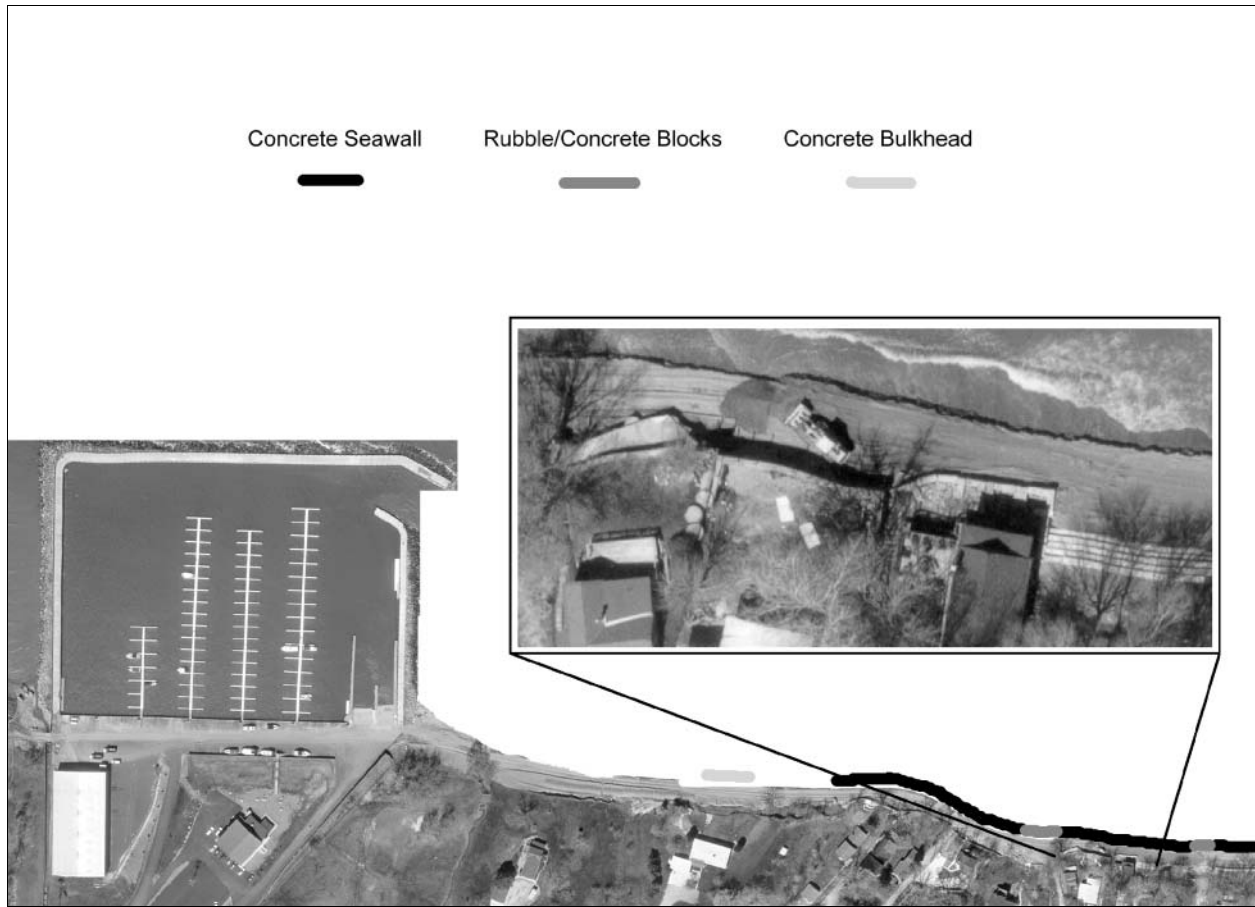
Figure 16. Armoring structures along the shore east of North East Marina (28 April 1999). All of these structures predate the marina. Insert shows a grader moving sand near one of the seawalls that project out from the bluff line

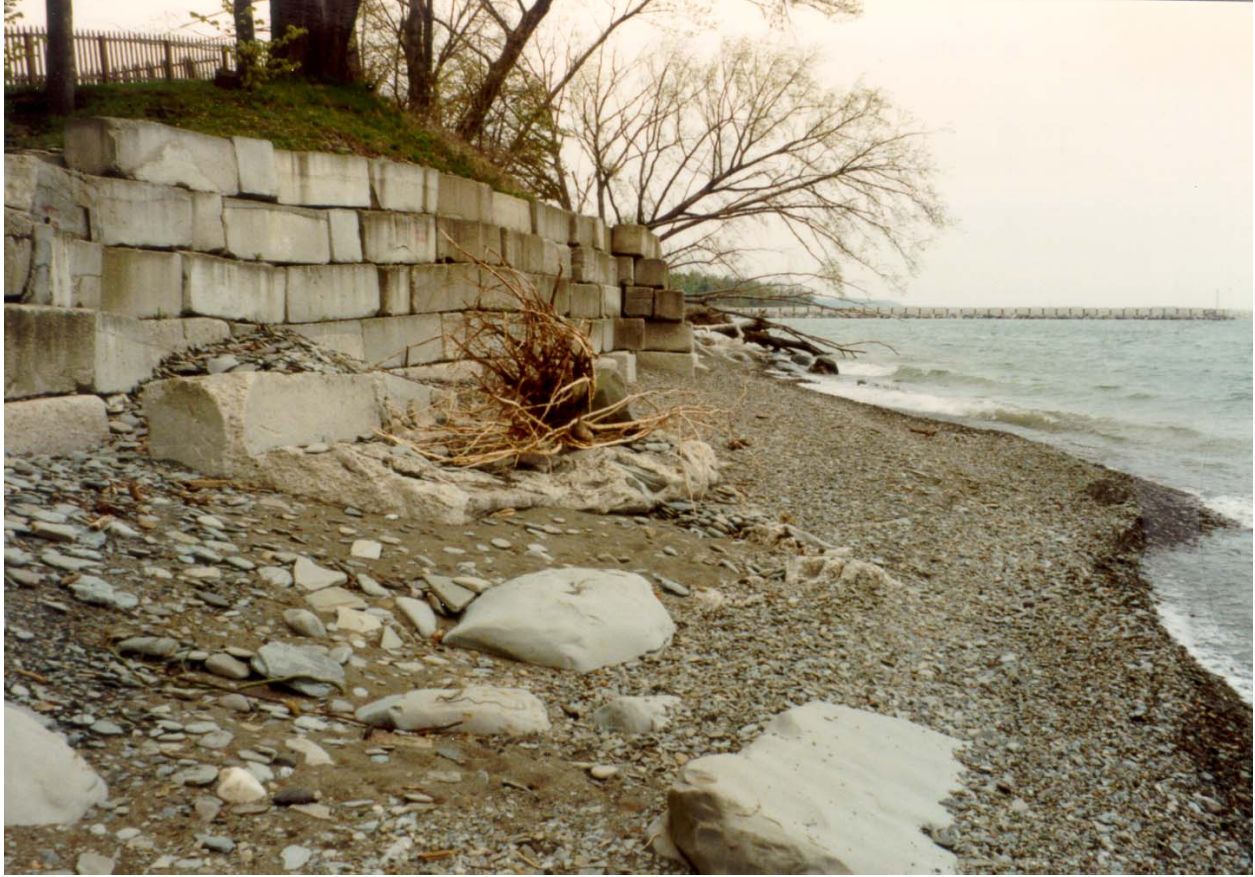
Figure 17. Concrete block wall about 200 m east of marina, 17 May 1991. Leaning tree is seen in subsequent figures

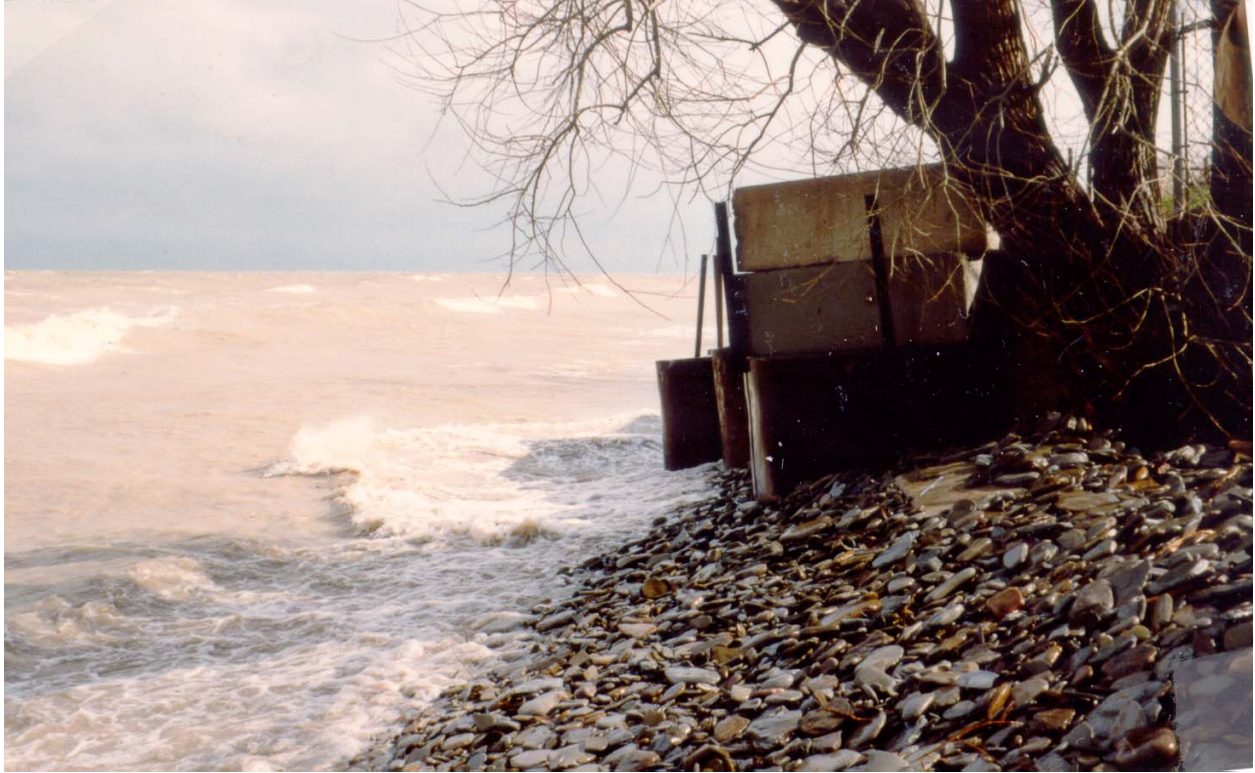
Figure 18. Exposed seawall March 1991, view east. Original photograph label states, "High water from storm just east of Kelley property" (Buffalo District archives)

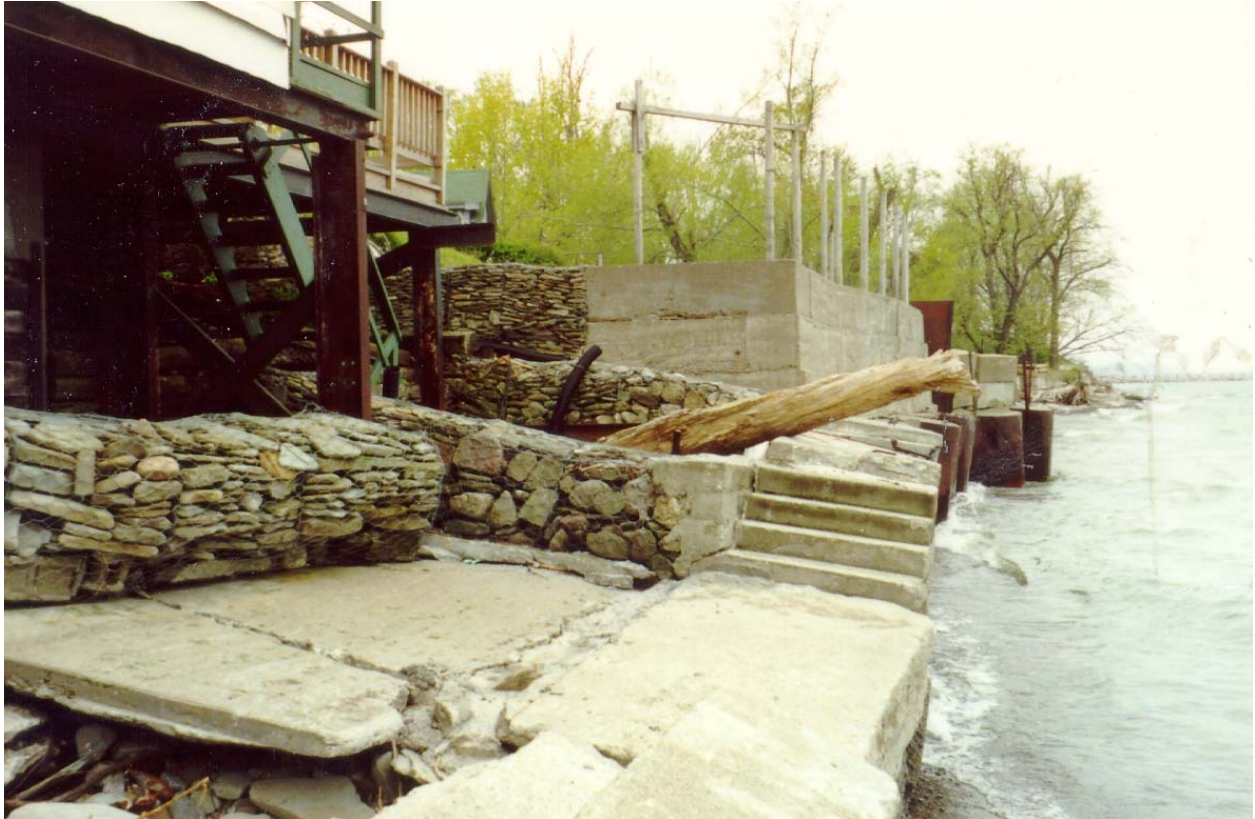
Figure 19. House protected with gabions, concrete, and concrete-filled tanks, May 1991. These structures are about 500 m east of marina's east wall (visible in right side of photograph). Notice tree trunk resting on wall next to steps, evidence of power of storm waves. When this photograph was taken, there was no beach at base of concrete slabs. Photograph from Buffalo District archives

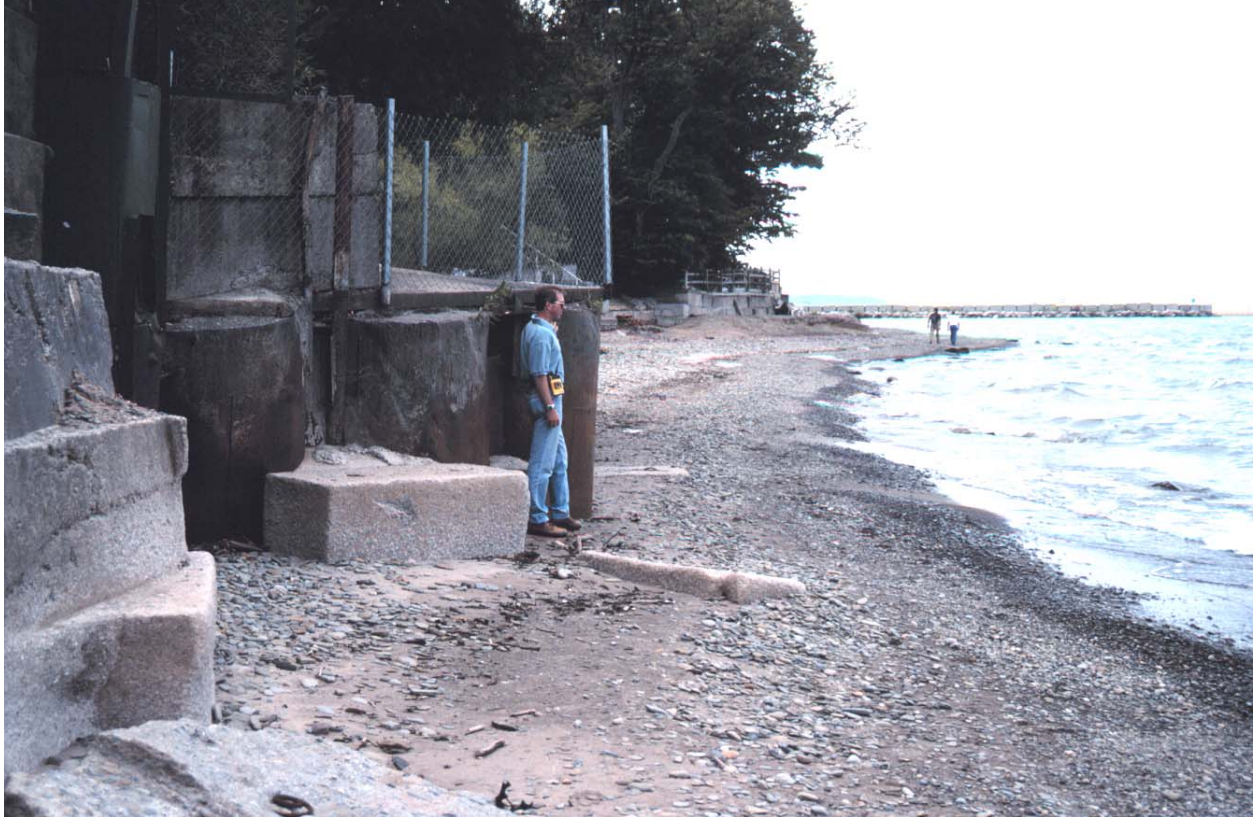
Figure 20. Gravel and sand beach below same structures shown in Figure 19. Beach is about 4 m wide. North East Marina east wall is in distance to right. Photograph taken 11 August 1999, before the autumn bypassing

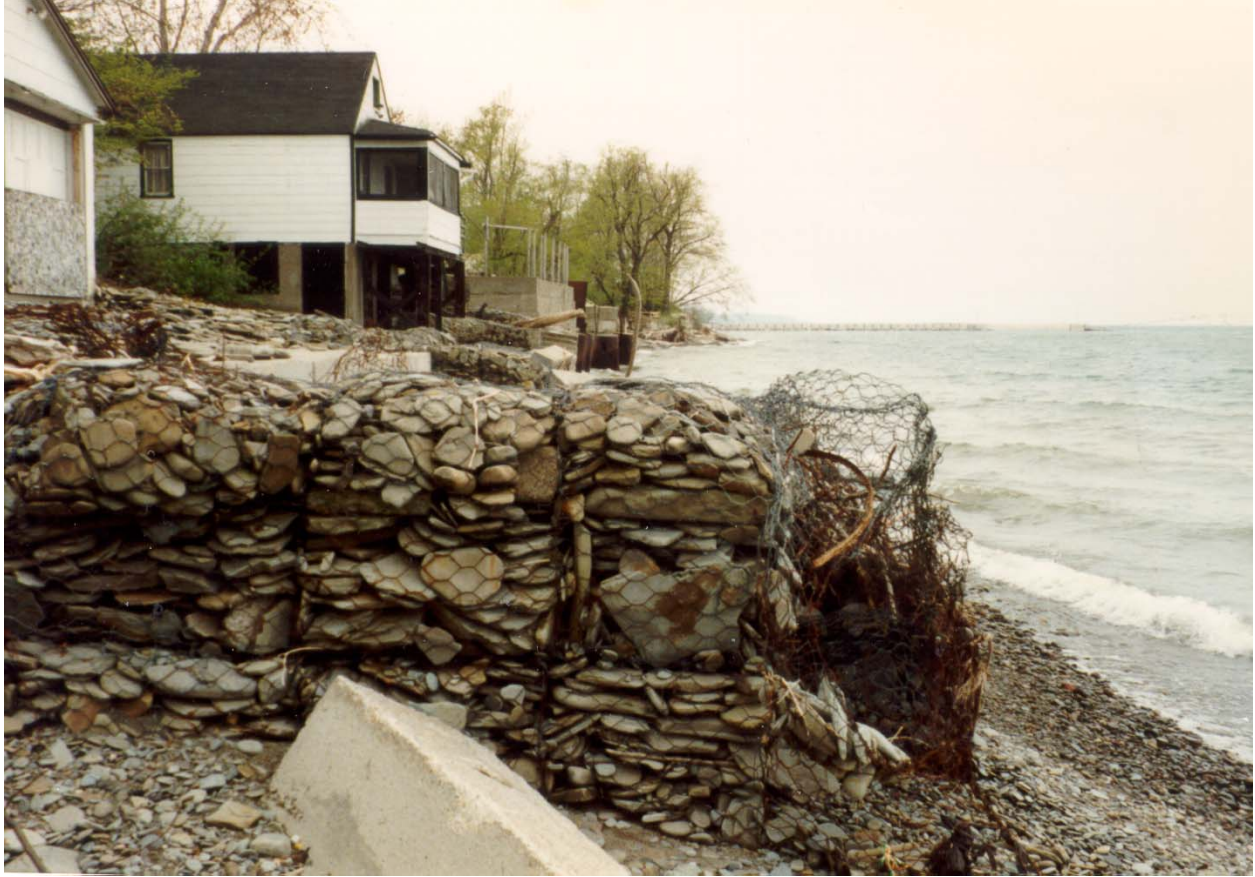
Figure 21. Gabion wall east of property shown in previous photographs, 17 May 1991. Leaning tree where concrete block walls are found is in distance. Photograph from Buffalo District archives

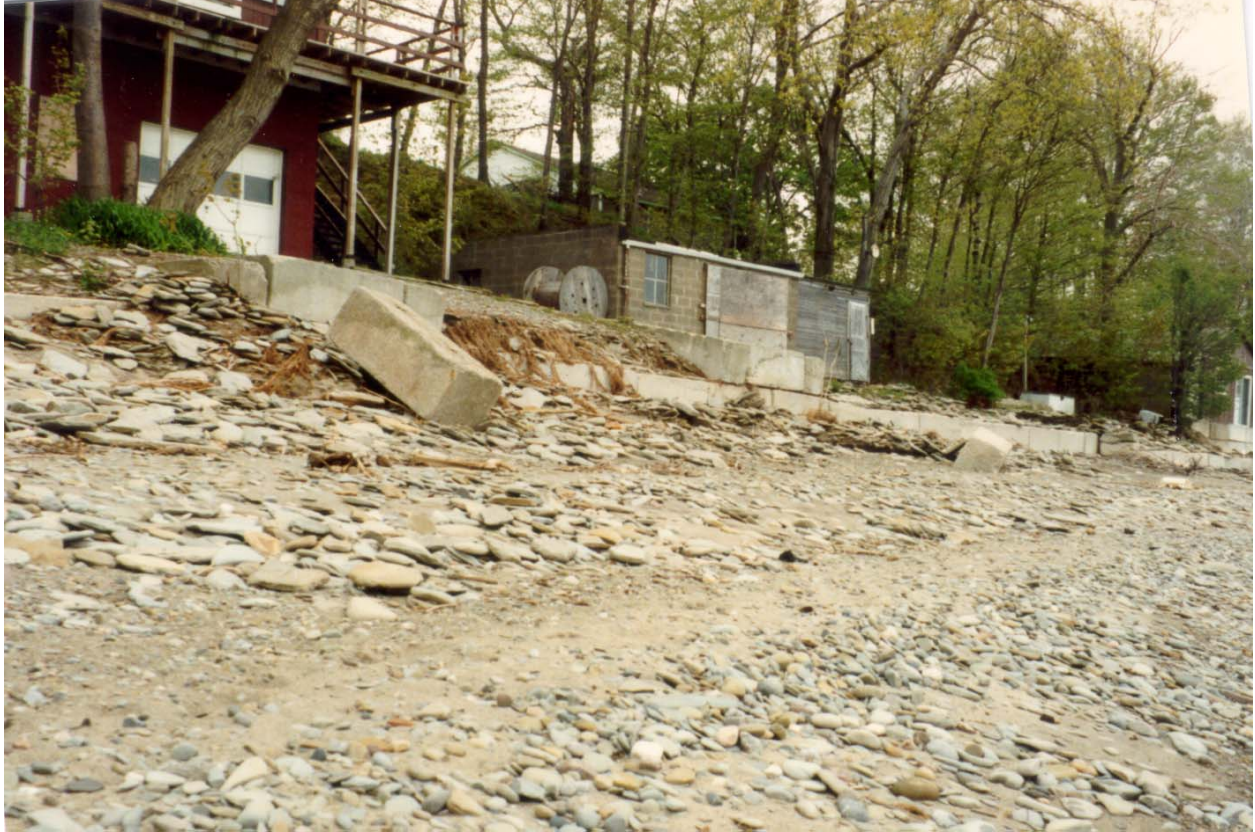
Figure 22. Cottage with protective concrete blocks east of the location shown in previous figures, 17 May 1991. Note the block that has been moved by storm waves. The three properties in the foreground are vulnerable to storm waves because they were built on the beach rather than up on the bluff like the house in the background. Photograph from Buffalo District archives

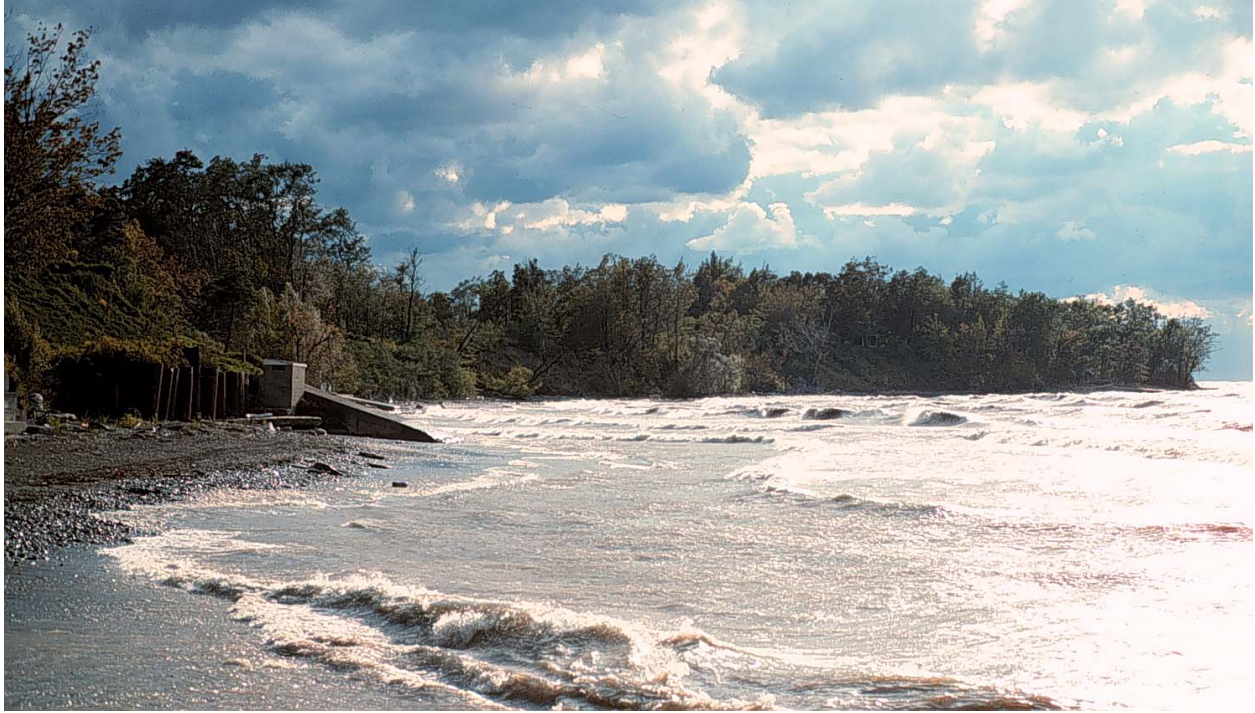
Figure 23. Seawall made of concrete-filled tanks west of North East Marina, November 1991. Most of the ramp and over two thirds of wall are now covered with sand and gravel. In 1991, beyond the walls, there was essentially no beach and waves broke directly at base of bluffs

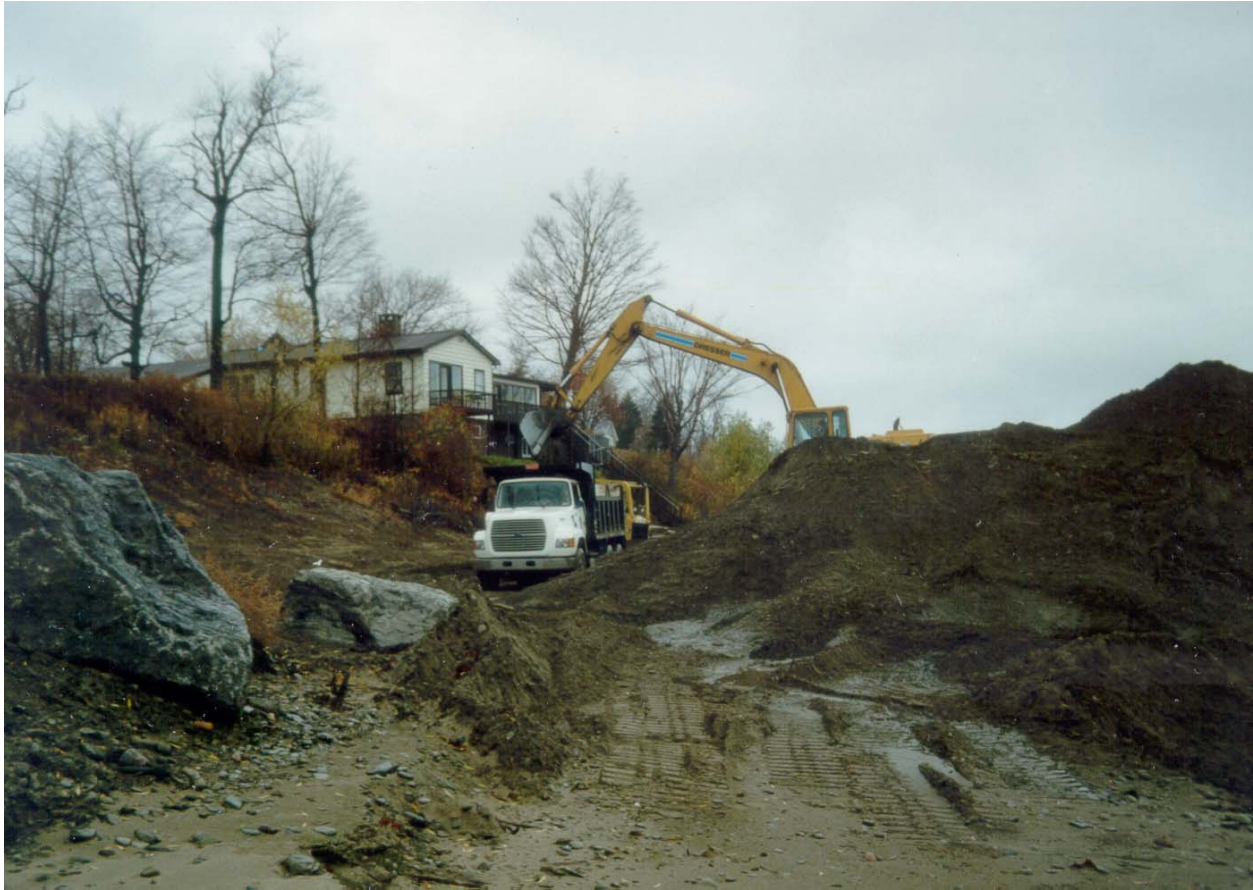
Figure 25. West fillet sediment being loaded into dump trucks, 17 November 1998

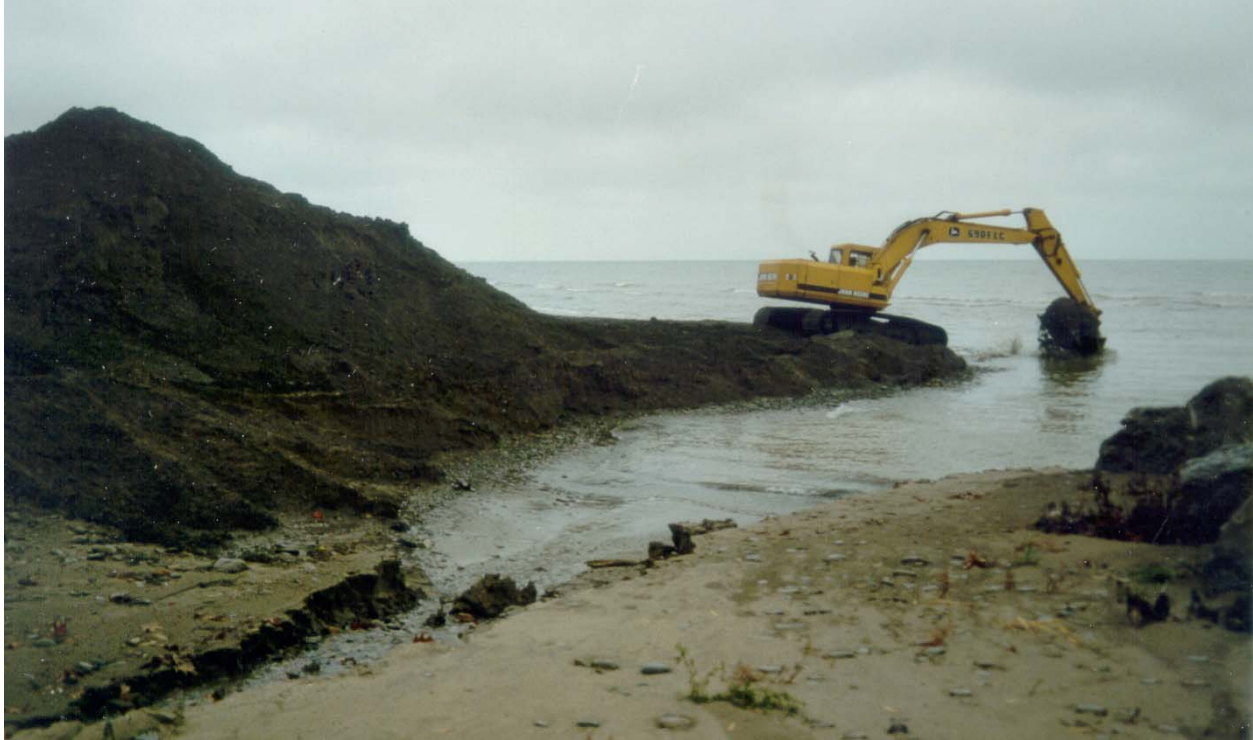
Figure 26. Backhoe removing sand and gravel from updrift fillet, 17 November 1998. A temporary road allows backhoe to proceed out into lake over 30 m

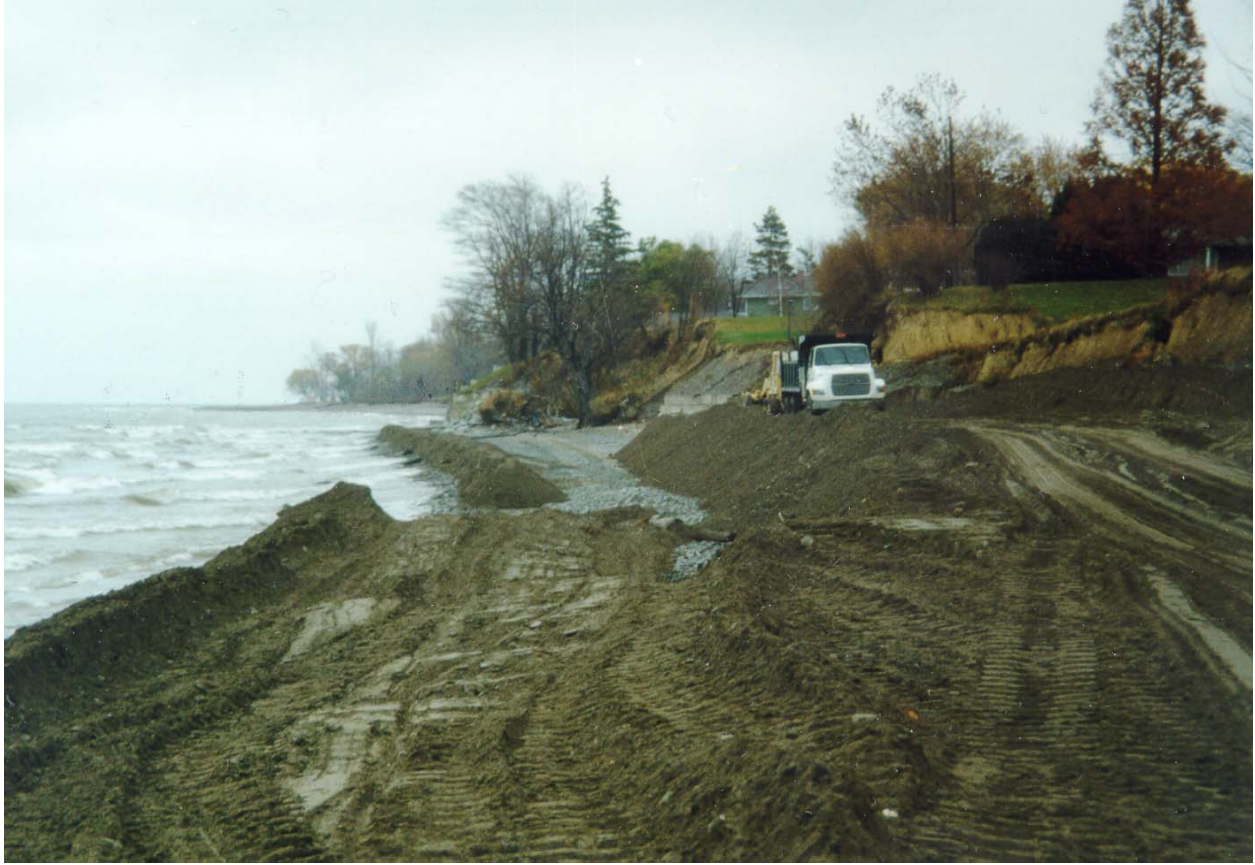
Figure 27. Temporary road along base of bluffs east of marina, 17 November 1998. Sediment is spread across beach and into water by a bulldozer

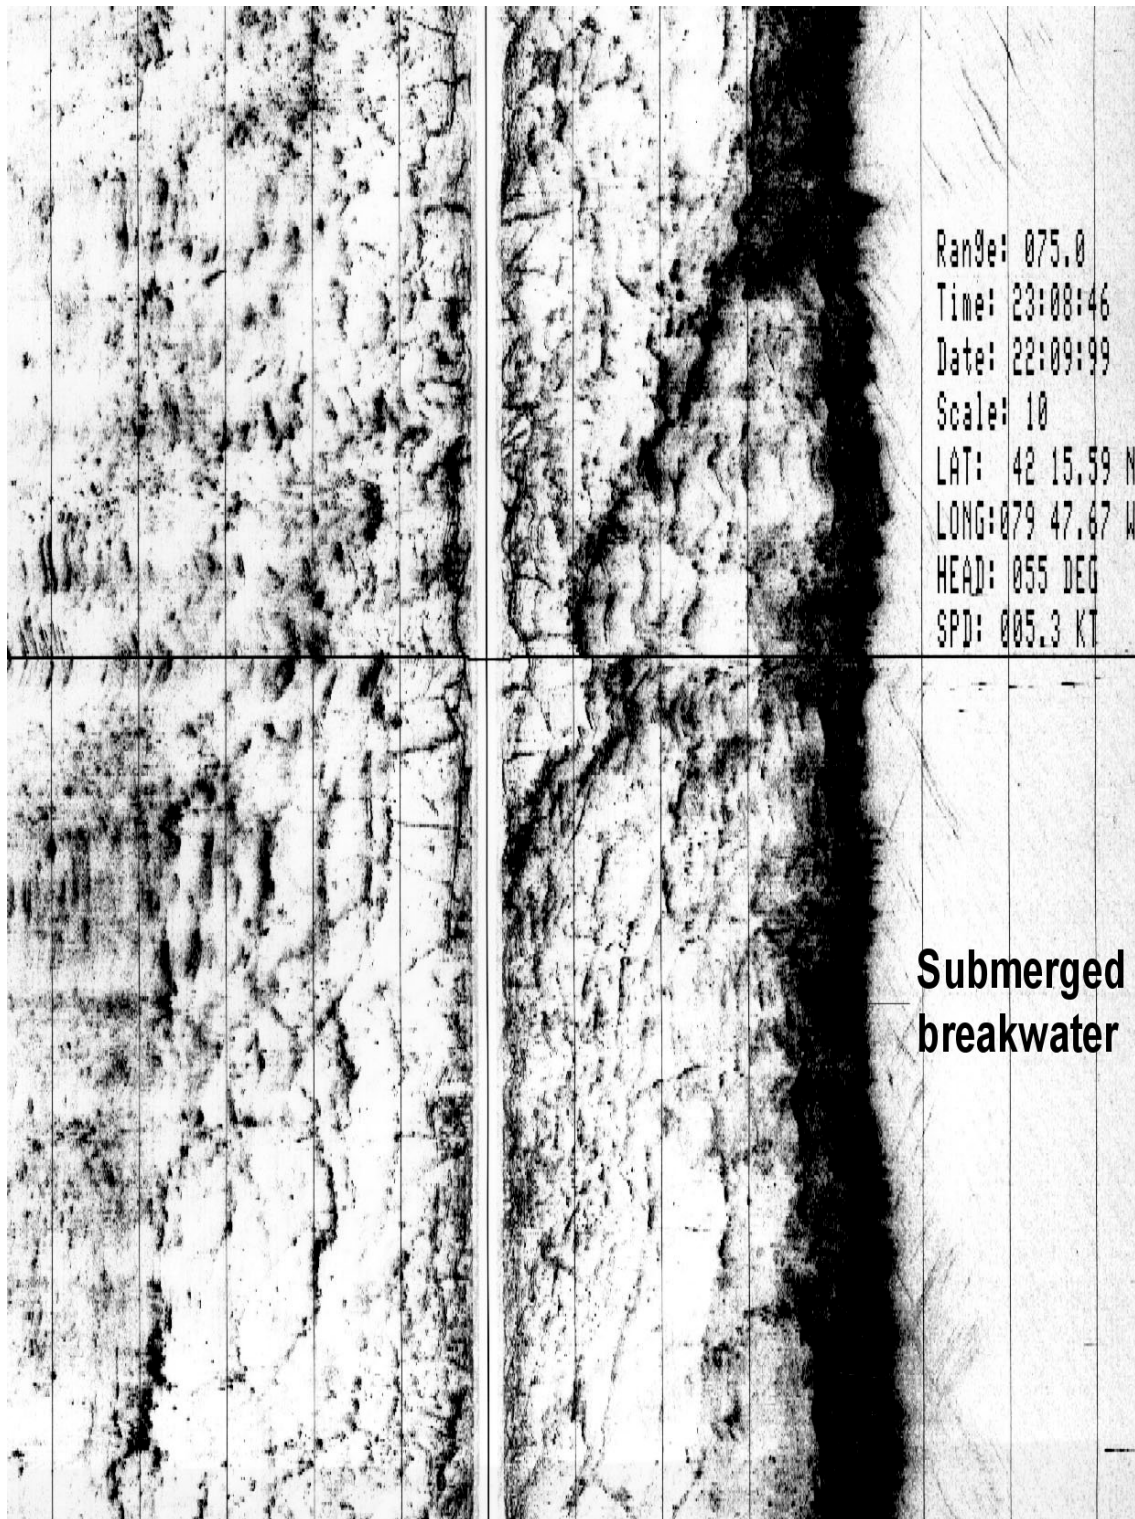
Figure 28. Sonograph immediately off marina wall, approximately halfway between east and west corners. Ship was heading NE paralleling wall. Scale between vertical lines is 10 m, and northeast is to top of page. Dark area to right is highly-reflective submerged portion of breakwater. Bedrock jointing and bedding and lack of sand is clearly shown on record

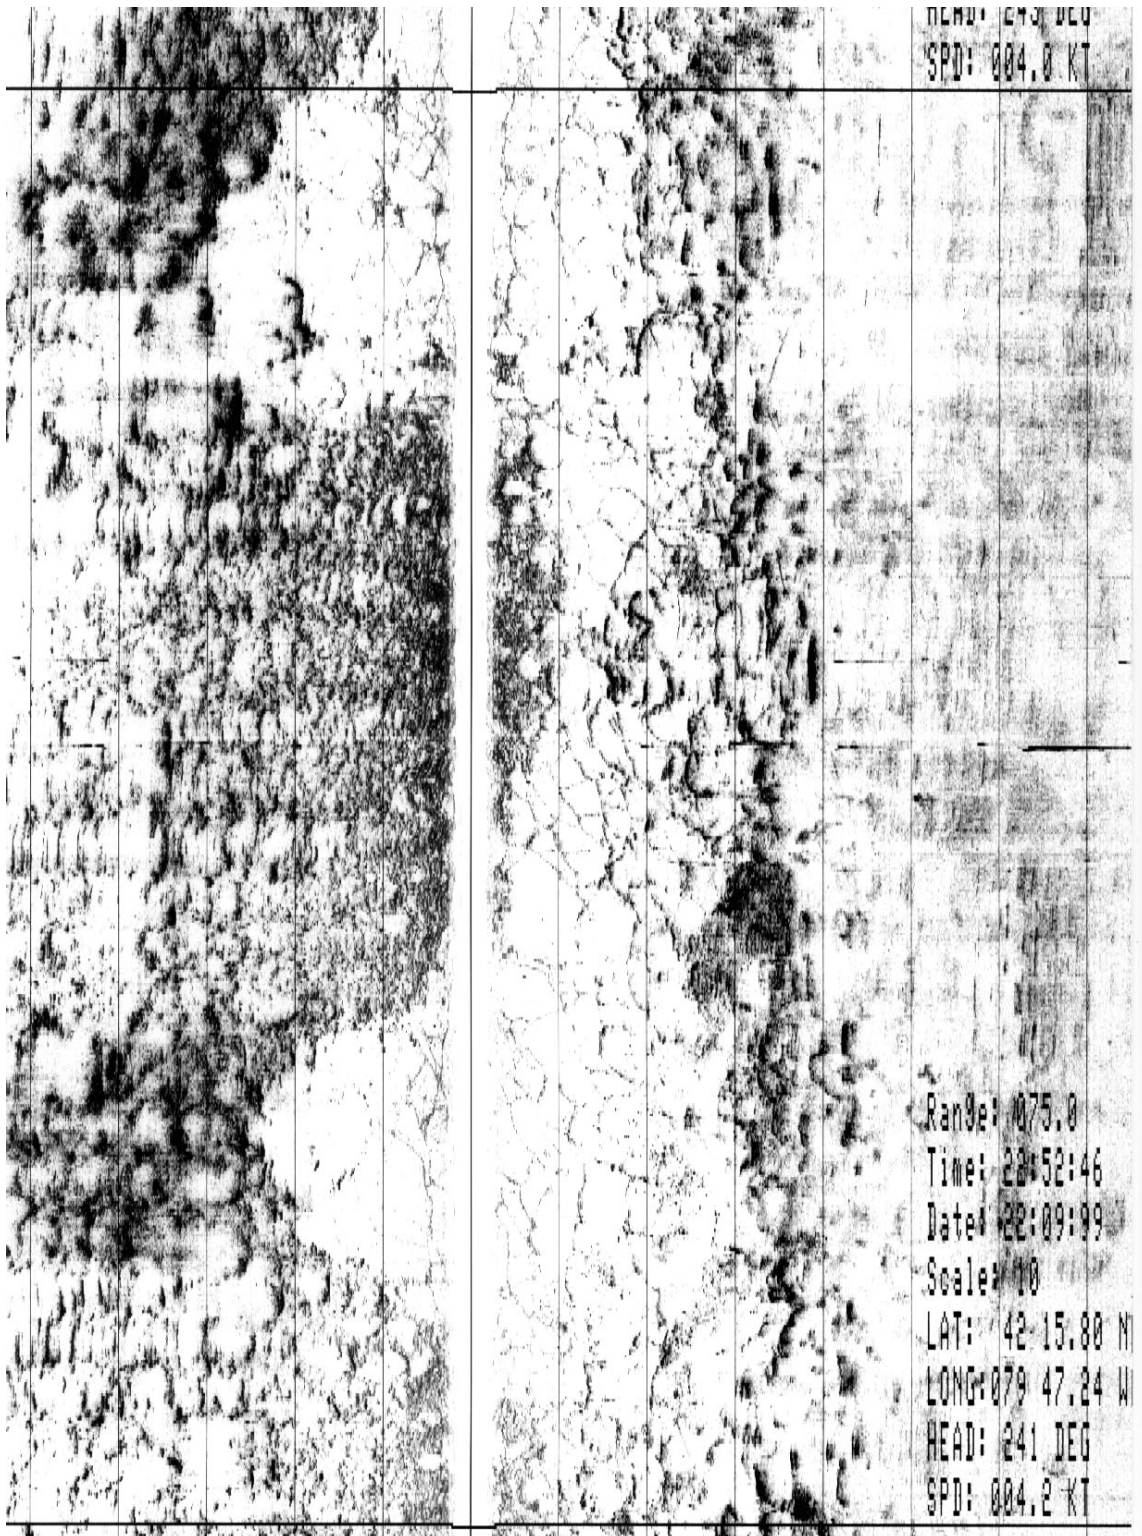
Figure 29. Sonograph, SW of the marina wall, shows additional bedrock jointing and bedding exposed on lake bed, with no evidence of sand. Ship heading was SW and distance from shore was approximately 250 m

- c. Off the marina wall and west of the marina, the bottom consisted of shale slabs with fractures and some rubble. No sand could be seen in the sonographs made off the north rubble wall of the marina (Figure 29).
