## **Detection and Evaluation of Scour Protection for Navigation Dams**

John E. Hite, Jr.

August 2008

Final report

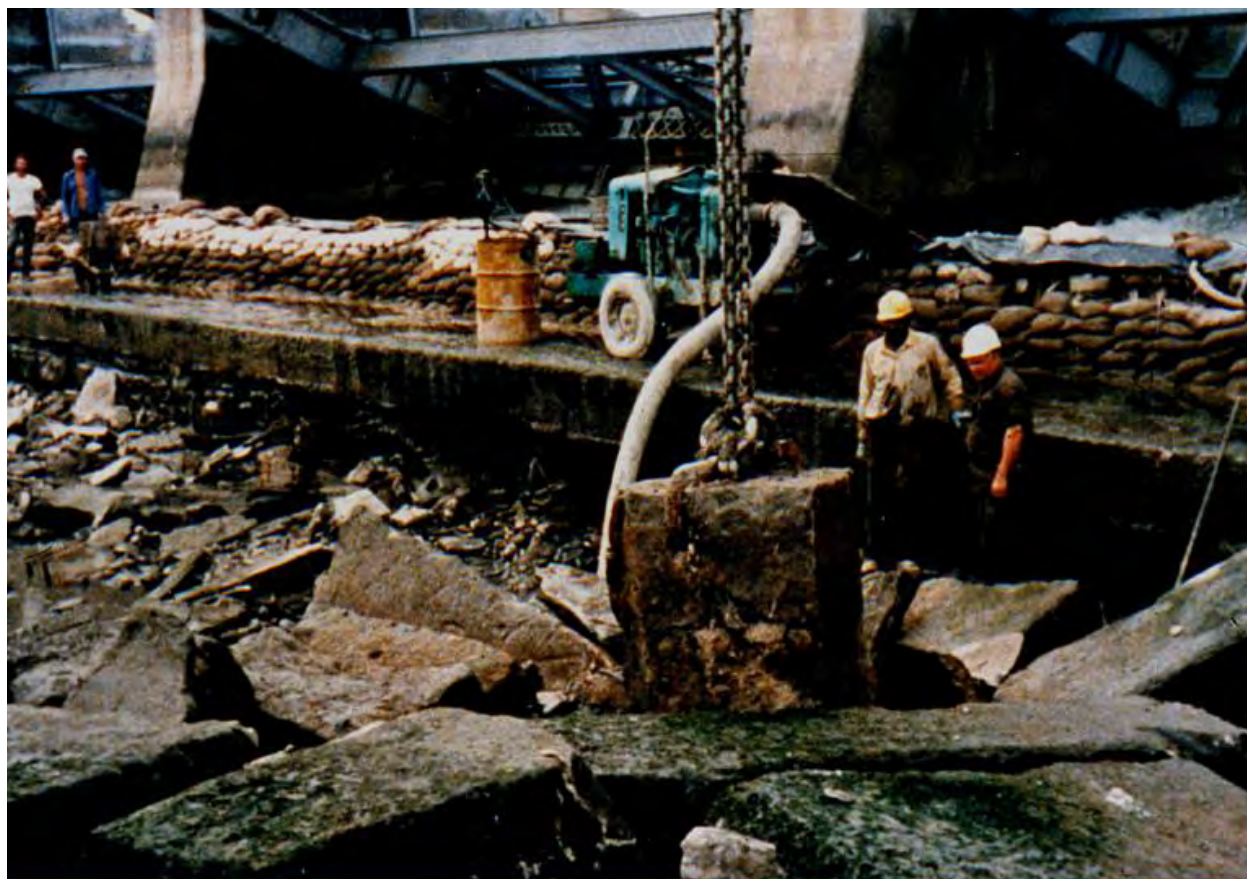
Figure 2. Scour below stilling basin at navigation dam on Illinois Waterway.

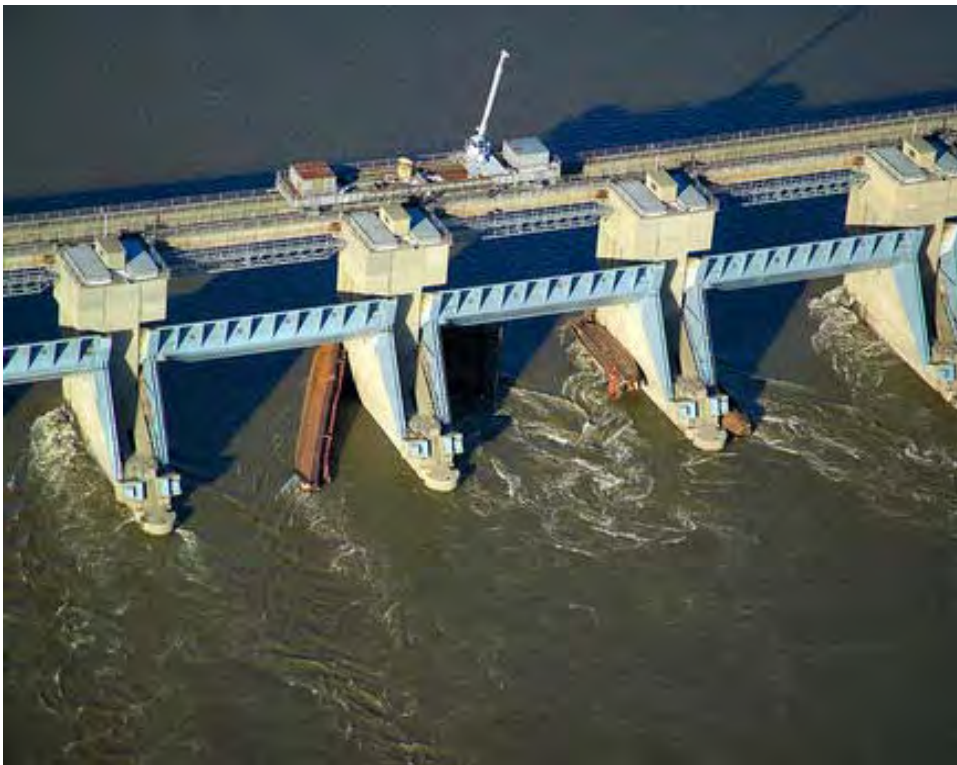
Riprap displacement from a navigation accident can be rapid and severe. The probability of failure can be high if the vessel or barges impact the riprap protection or sink and rest on the protection. Several accidents have occurred where both loaded and unloaded barges have impacted the navigation dam with the barges either passing through the structure or becoming lodged against the structure. Several situations can result from a barge accident. The gates can be damaged and normal operations are not possible. If the head becomes greater than normal and the tailwater drops below normal from insufficient discharge through the gates, scour can occur. Barges that have sunk and lodged against the upstream side of the dam can concentrate flow and cause extreme scour locally, as illustrated in Figures 3 and 4. The accident shown in Figure 3 caused significant scour both upstream and downstream from the dam. Following the accident, a secondary stilling basin was constructed from sunken barges filled with riprap and grout to prevent loss of the dam should an accident similar to this one occur again. The accident shown in Figure 4 resulted in loss of the navigation pool, with significant economic impacts.

Figure 4. Barge accident at Belleville Dam, Ohio River.

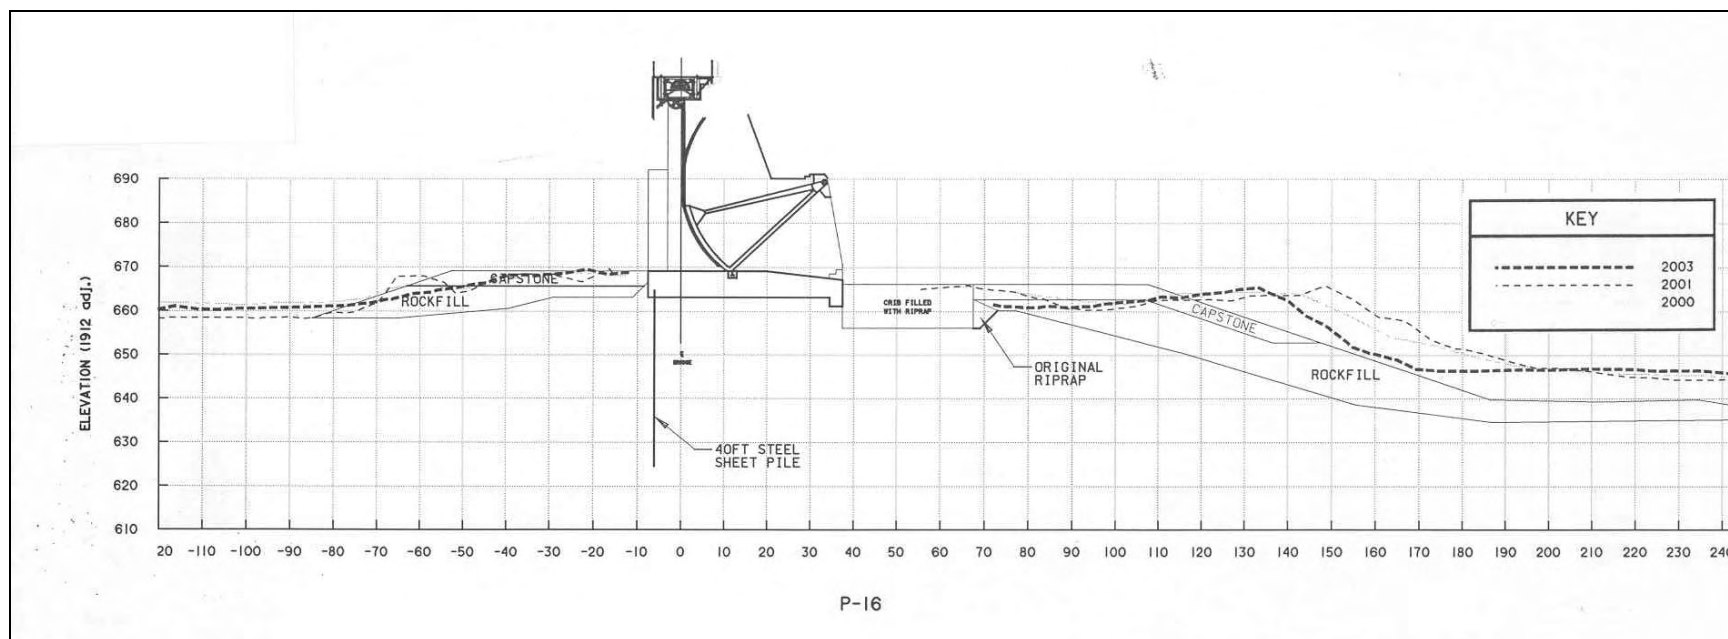
Figure 6. Example of streamwise longitudinal profile sounding data (P-16) for Dam 2 on the Mississippi River (positive distances are downstream from axis of dam)

Two of the significant damage assessment profiles were adjacent to one another (P-16 and P-17). This area will need immediate reconnaissance to verify that damage exists. If the damage is verified, a decision to repair or not will need to be made. The risks of not repairing will need to be determined. The displacement of the riprap downstream from the structure appears to have been caused by the flow. There are areas downstream from where the riprap has been displaced in which the original riprap appears to have settled. This indicates the riprap has been displaced from its original placement and has been washed downstream. The riprap size appears to have been inadequate. The multi-beam sonar could be used to map the areas in need of repair.

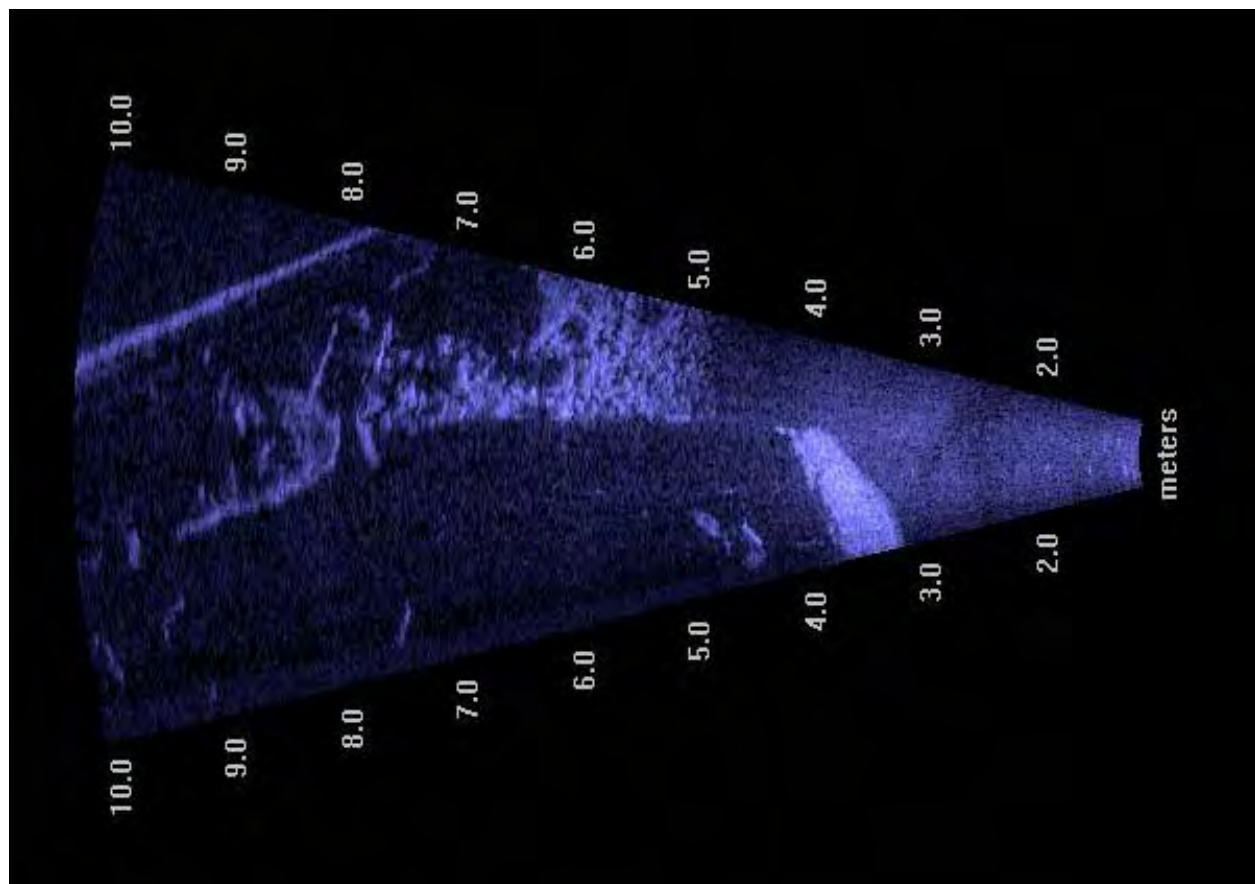
Figure 19. Area at middle to south side of gate bay 10 (Test 1).

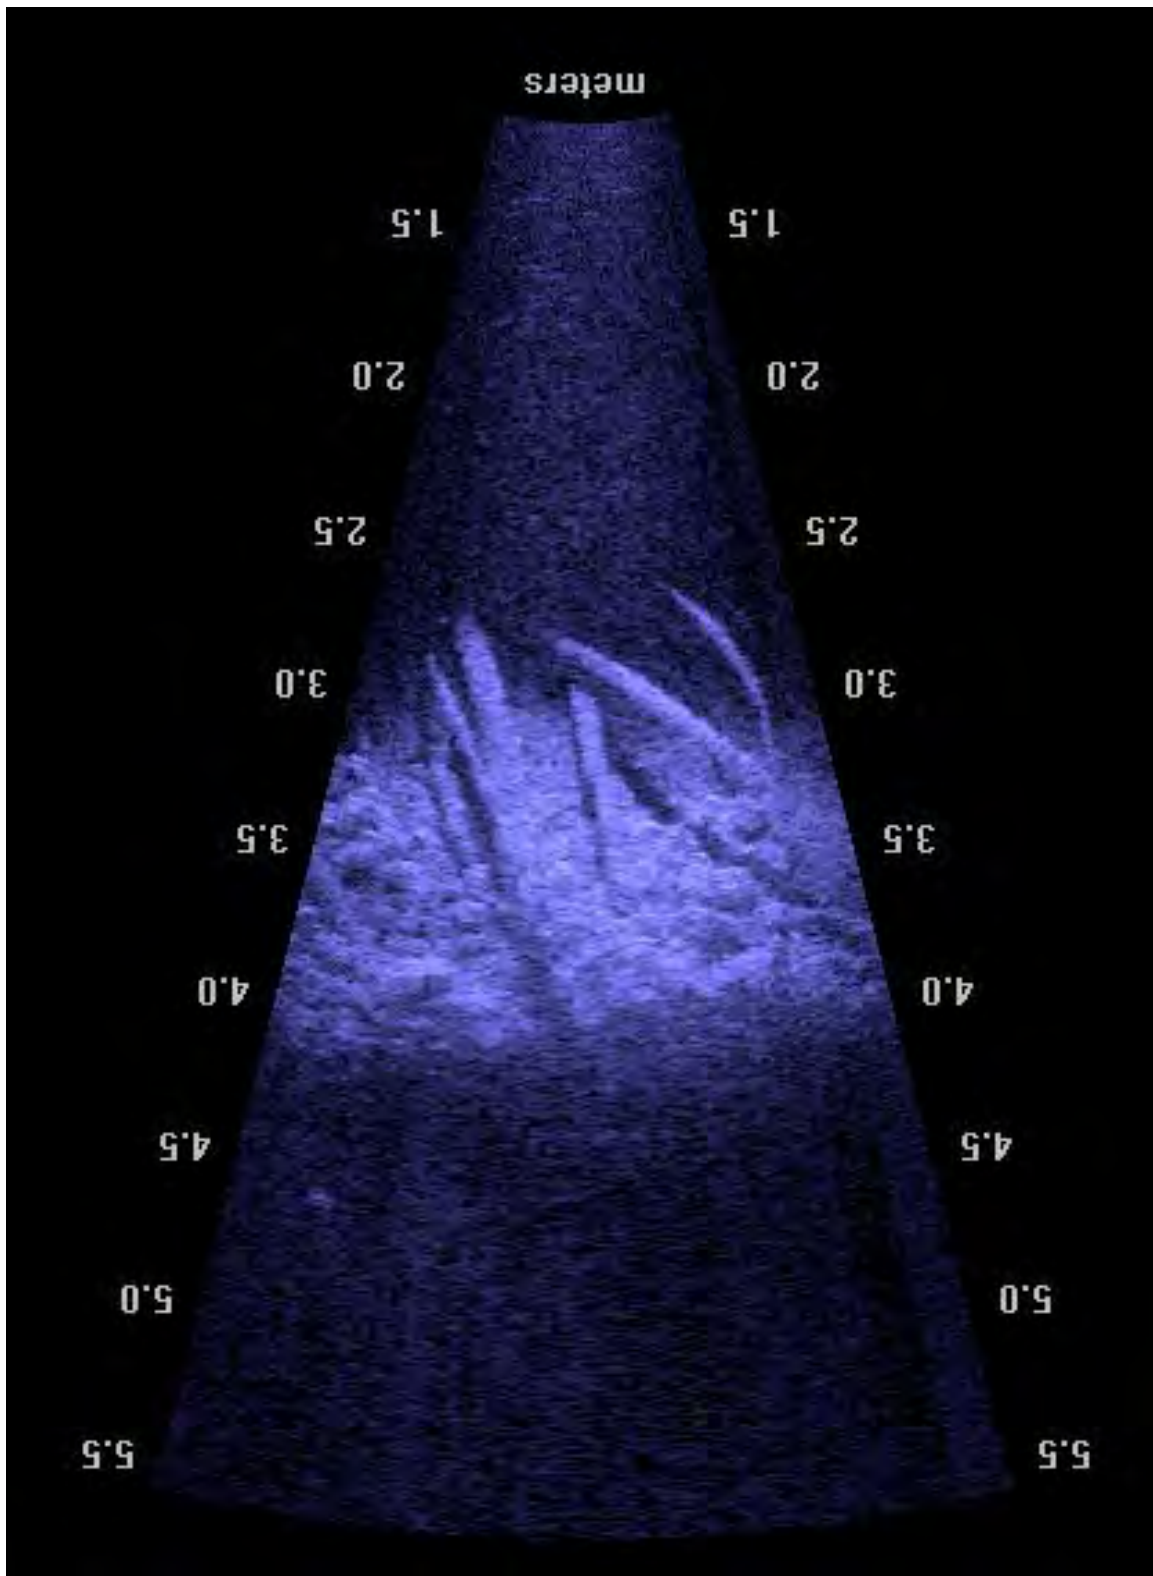
Figure 23. View of sunken drift below gate bay 9 (Test 2).

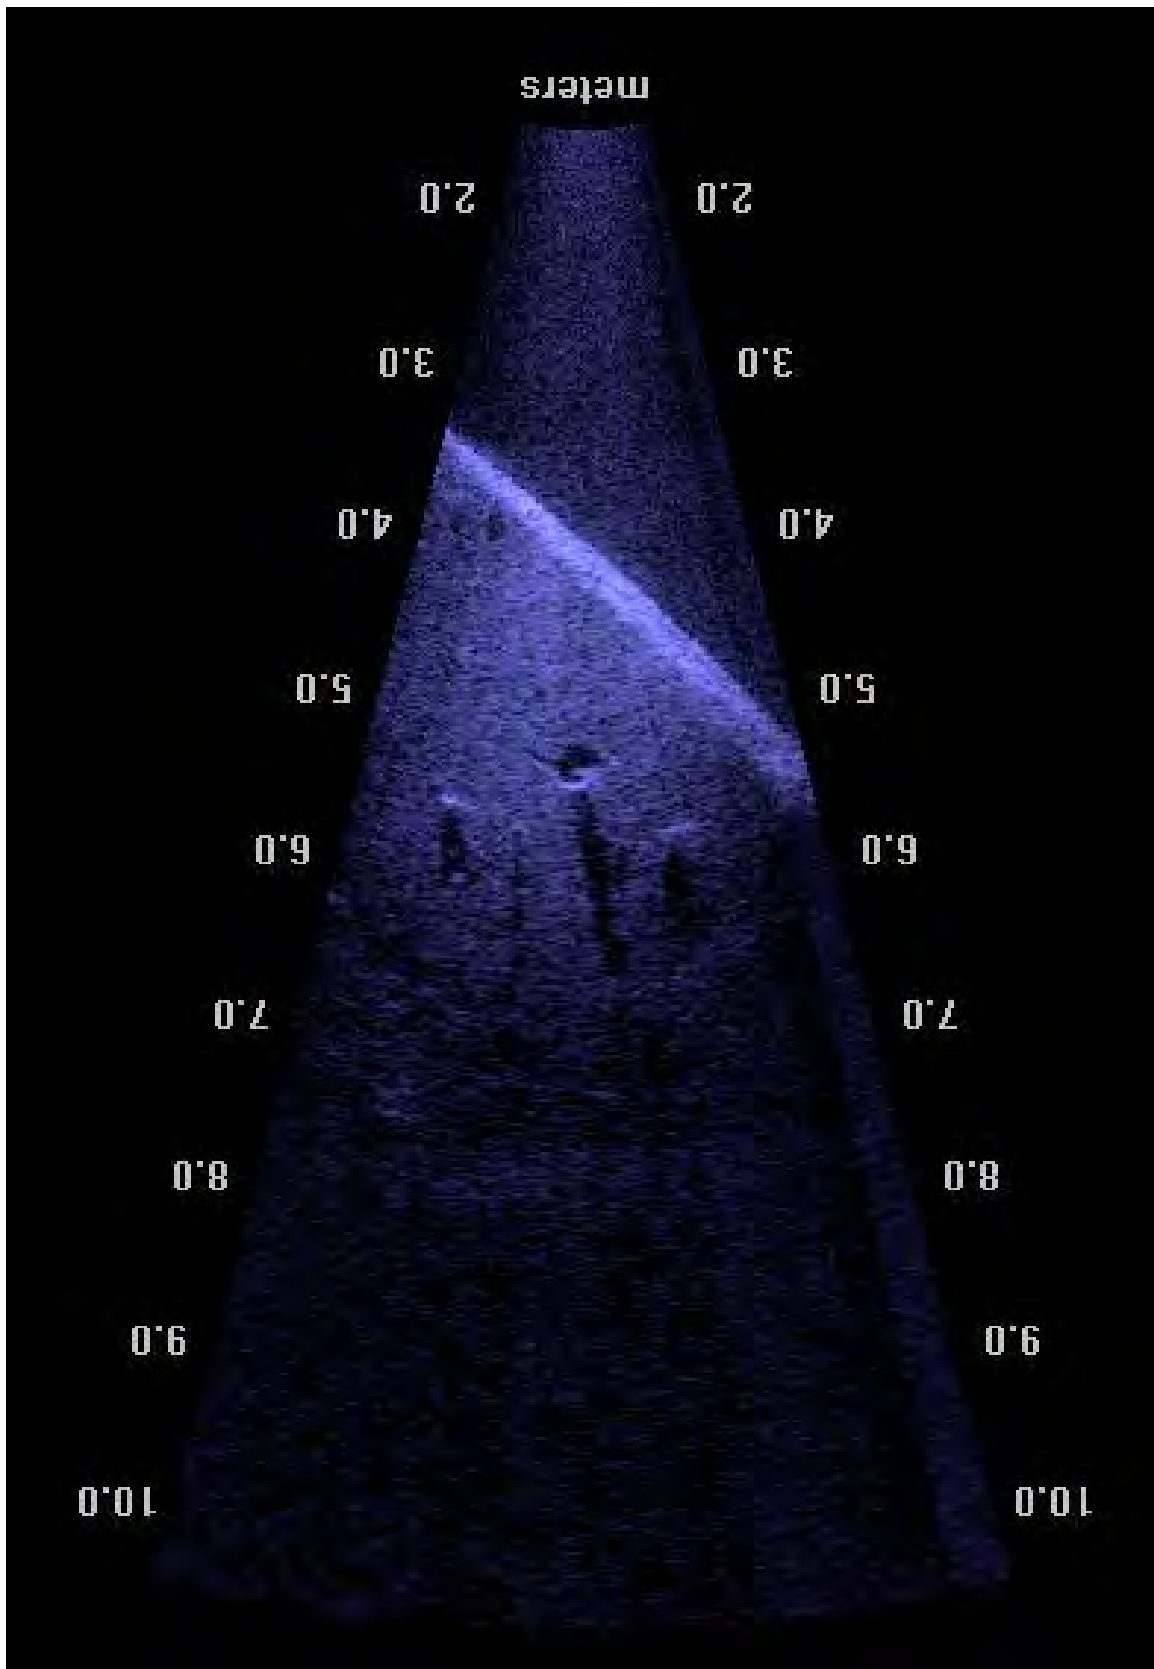
For Test 5, the boat was nosed on the north side of the pier between gate bays 8 and 9. The boat location is shown as the cyan colored area in Figure 25. The DIDSON remained 8 ft below the water surface. A small hole was observed on the dam apron just north (4 to 6 ft) from the pier between gate bays 8 and 9 as seen in Figure 28. This may be a former coring or possibly a weep hole. The area north of the pier between gate bays 8 and 9 is shown in Figure 29. No undermining of the apron was observed in this area. The boat position is shown in Figure 25.

Figure 28. Small hole on dam apron on north side of pier 8-9 (Test 5).

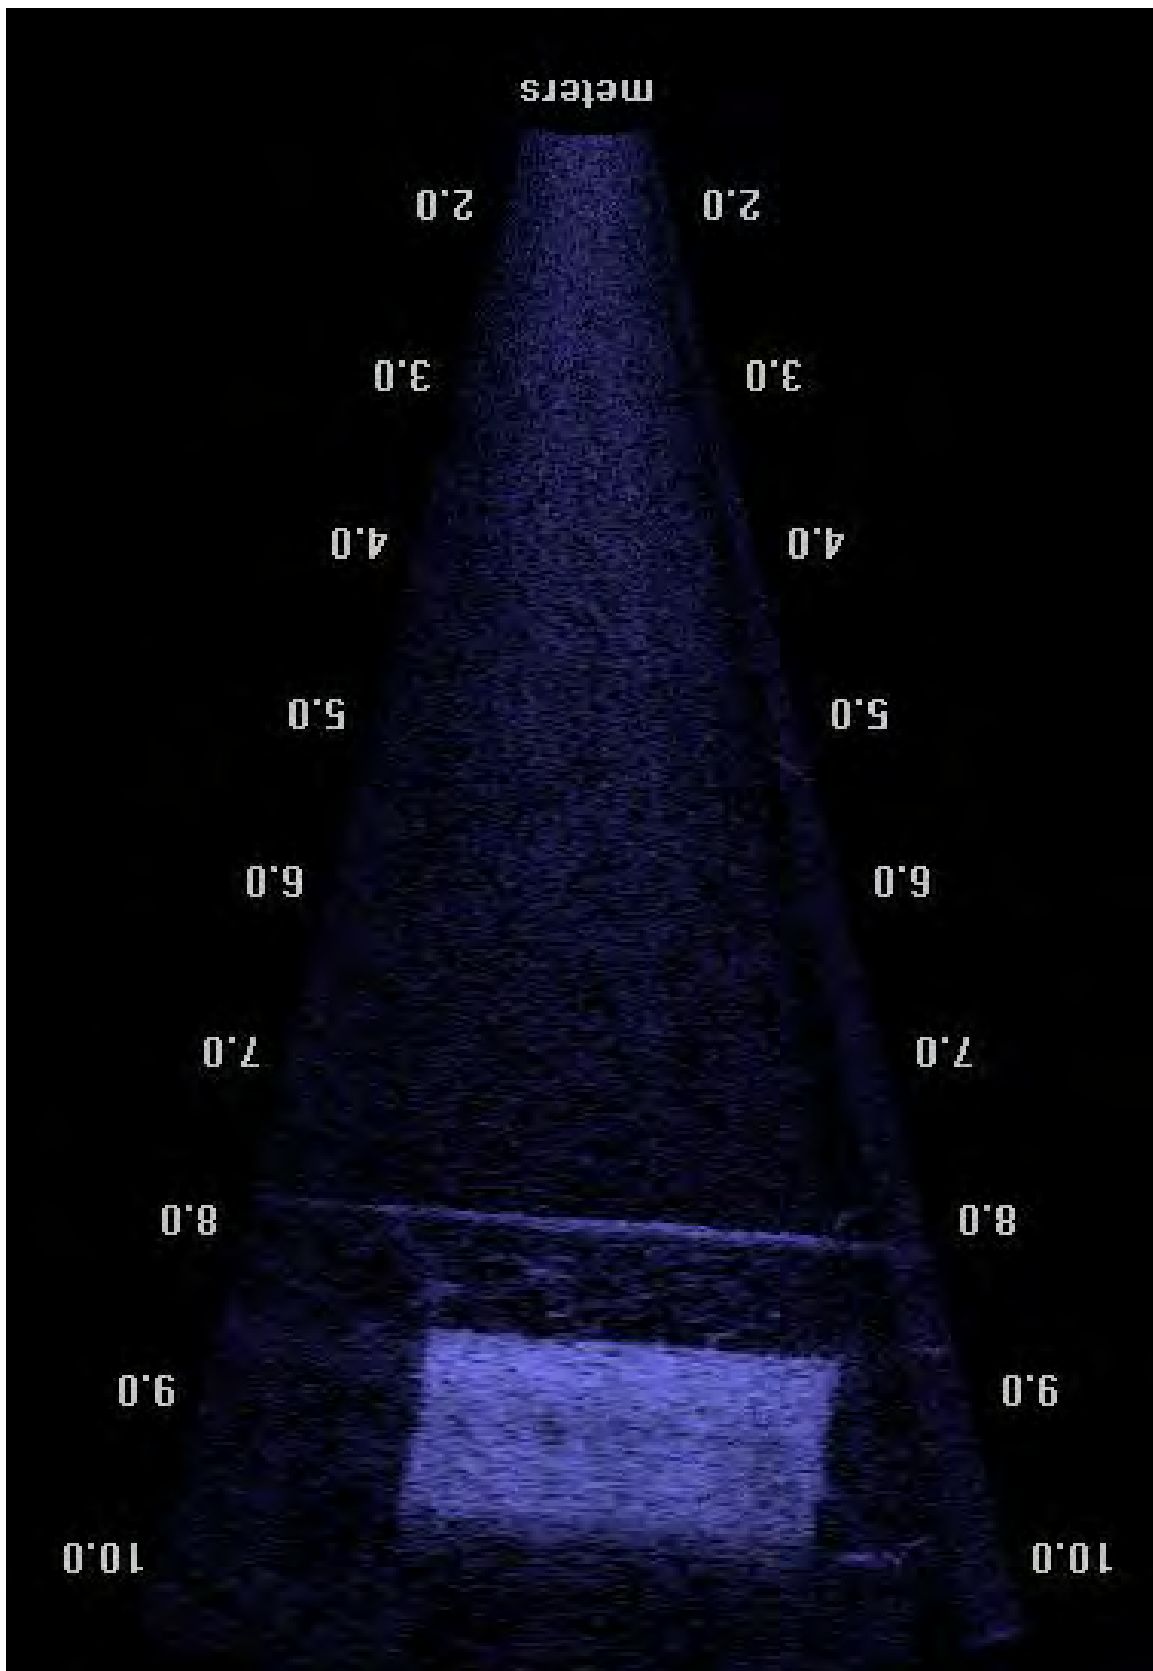
Figure 32. Pier 9-10 and area below apron.

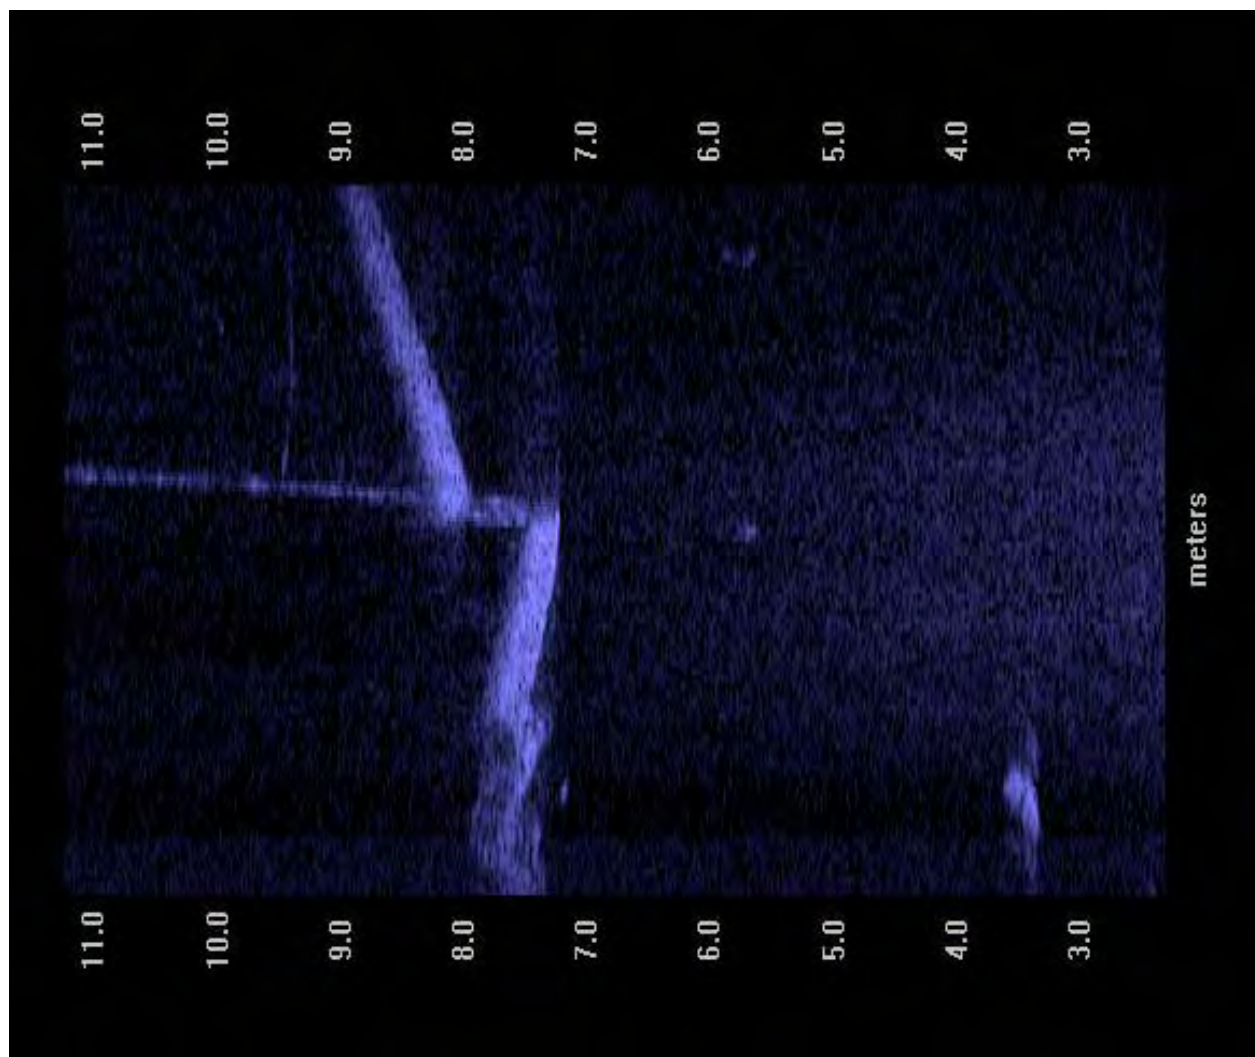
The downstream face of the dam apron is a vertical concrete wall that appears to be about 6 ft thick. The area underneath the apron appears to be rock and also has a vertical face to the intersection with the bottom. On the north side of the pier between gate bays 8 and 9, the apron is about the same elevation as the bottom for a distance of about 15 ft from the pier. In this area, the bottom begins to drop off from the apron elevation around 10 ft downstream from the dam apron. Moving south toward the pier, the vertical distance from the top of the apron to the river bottom appears to be between 11 and 12 ft. This distance increases to over 16 ft on the north side of gate bay 9 and then the distance decreases moving to the south toward gate bay 10. This distance between the top of the apron and the bottom reaches about 6 ft near the middle of gate bay 10.

Figure 36. View of pier 8-9 and area below dam apron.

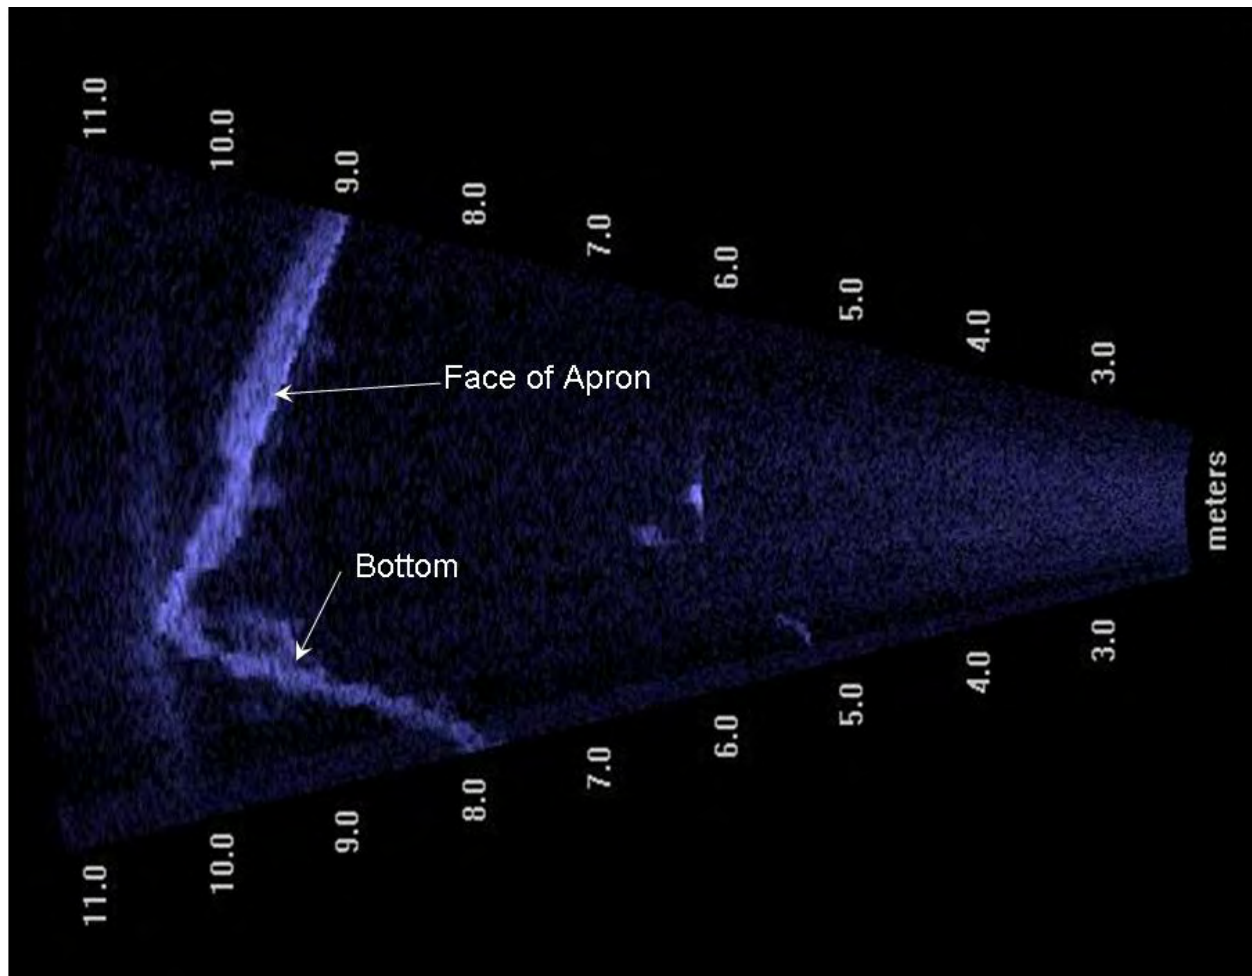
The images from the DIDSON show that a deeper area is present downstream from gate bay 9 and about halfway into gate bay 10. No evidence exists of the dam apron being undermined or undergoing any significant cracking of the apron. The demonstration showed that the DIDSON could be used to identify scoured areas suspected underneath a dam apron or stilling basin. Improvements to identify the location of the DIDSON could be made more quickly if additional funding were available. A GPS system could be better utilized to track boat location and a depth sounder may help locate the camera position.

Figure 37. Intersection of dam apron and bottom behind pier 8-9.

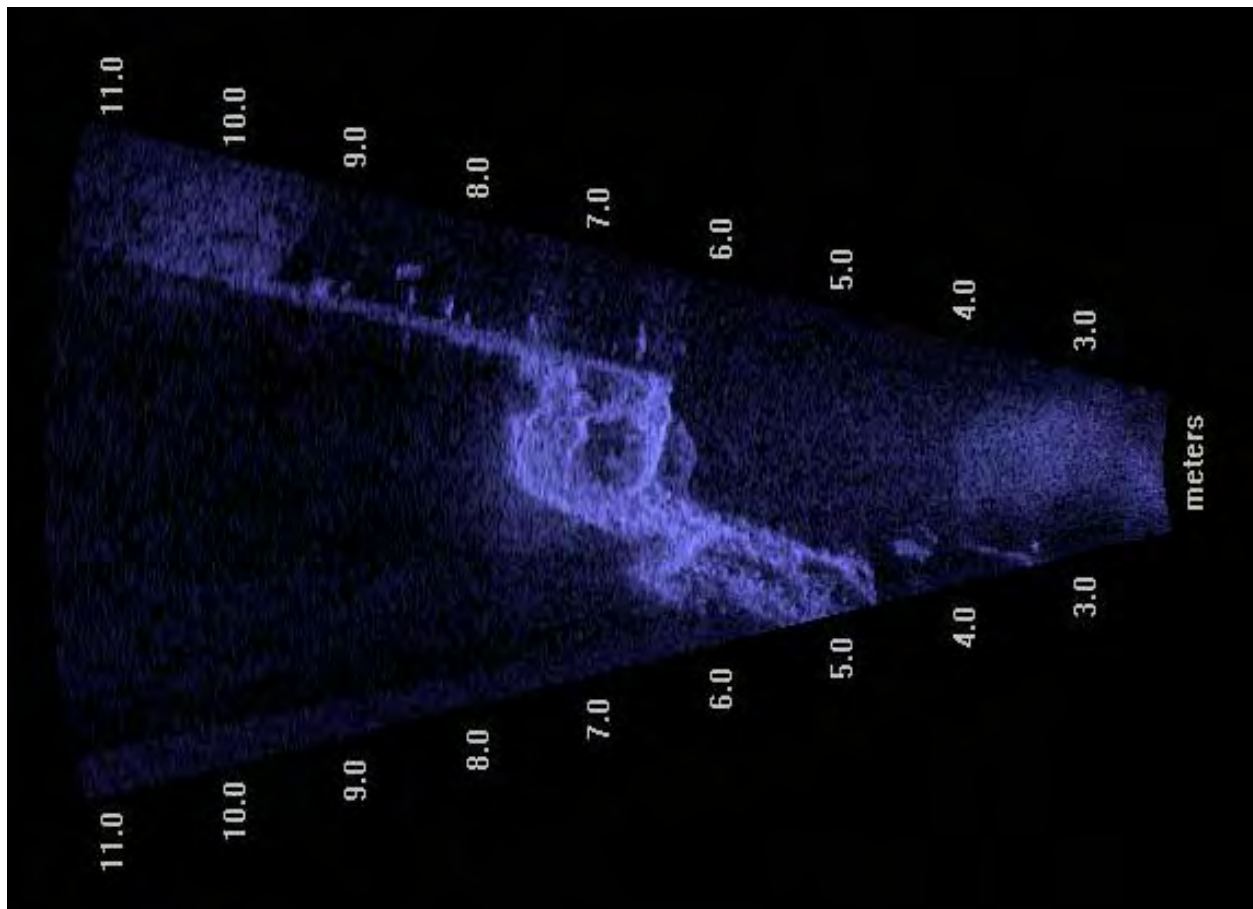
Figure 38. View of downstream face of apron on south side of gate bay 10 (Test 11).
