Performance of Insulated Pavements at Newton Field, Jackman, Maine

Maureen A. Kestler and Richard L. Berg

May 1992

Prepared for
FEDERAL AVIATION ADMINISTRATION
DOT/FAA/RD-92/8

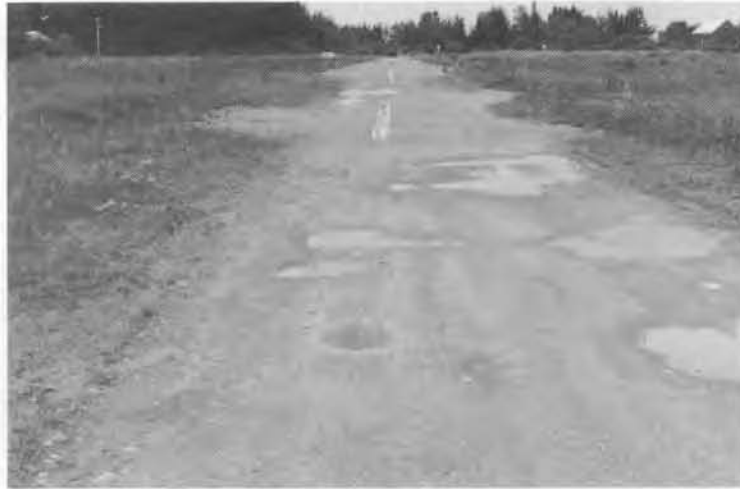
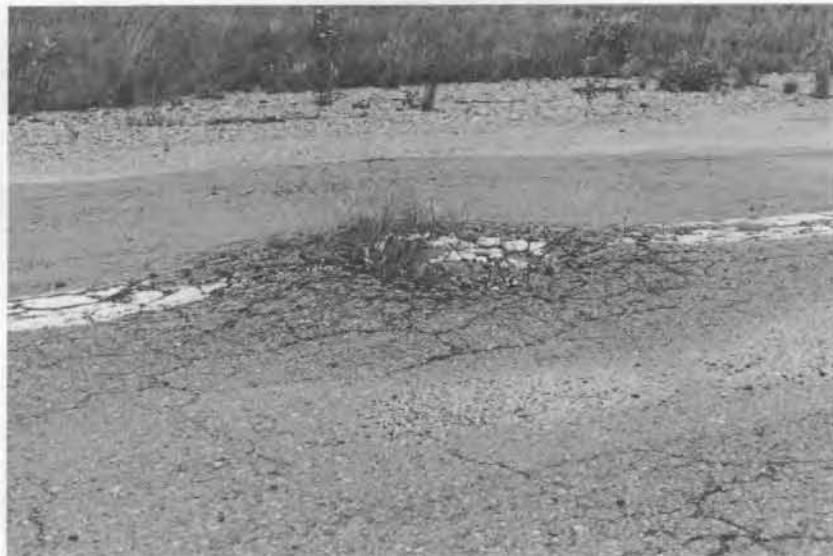
Figure 2. The Newton Field runway before 1986.

The runway at Newton Field was reconstructed in 1986. The old runway was in extremely poor condition, as is shown in Figure 2. The longitudinal and transverse pavement surface was highly irregular and was disintegrating as a result of moisture entering the large number of cracks. Although located in the same vicinity as the old runway, the new 2900- × 60-ft runway is longer, wider, and at a slightly different orientation than the old runway.

a. Looking northwest.

b. Boulder heave.

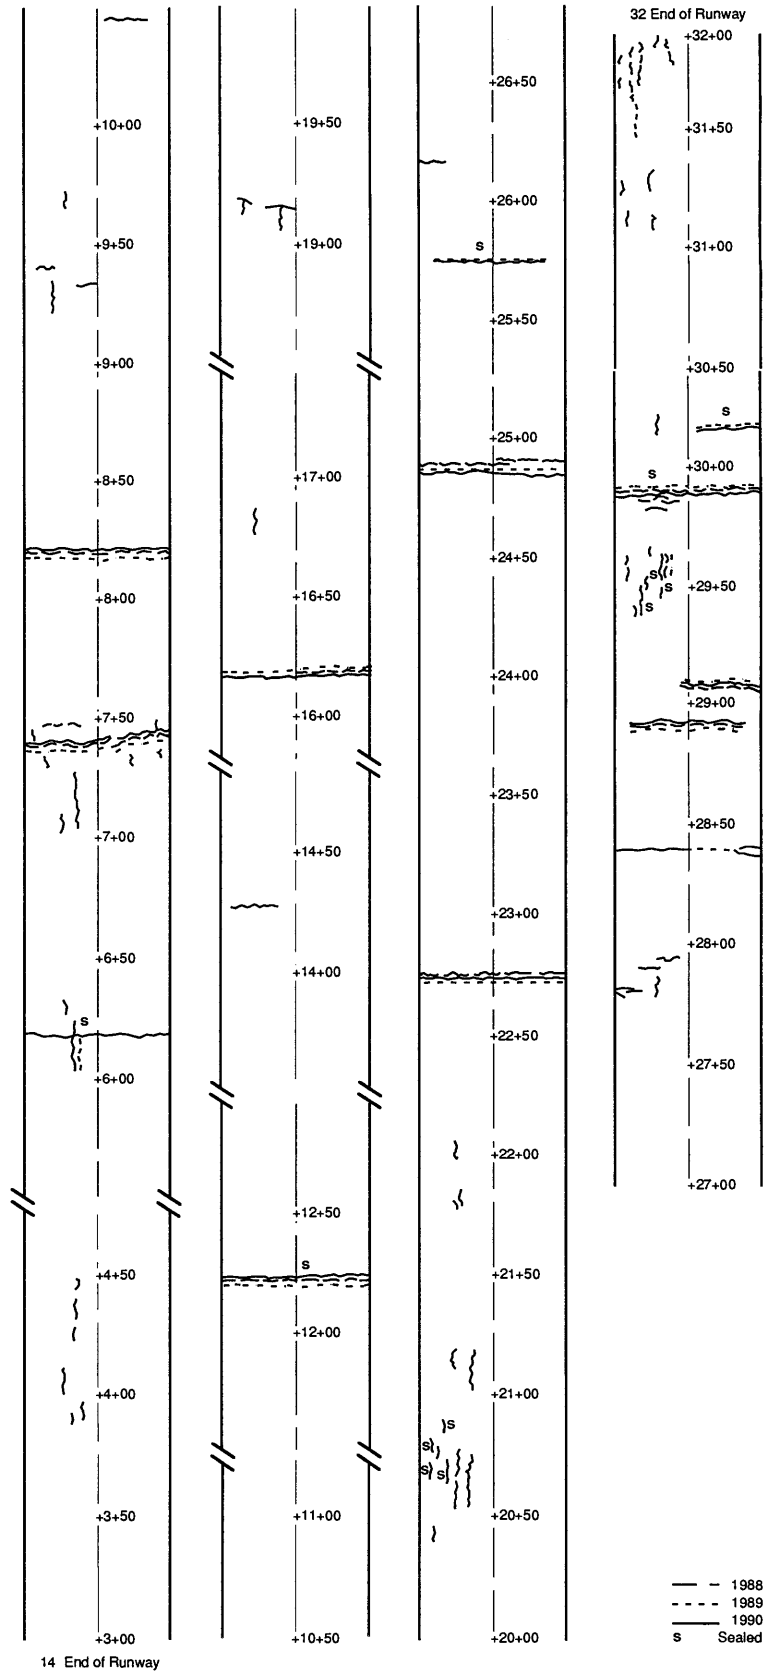
Figure 9. Newton Field pavement crack map.

The progression of crack development following placement of the final 1 1/4-in. asphalt concrete lift in 1987 is shown in Figure 9. Although the cracks had been sealed in September 1989 with a rubberized crack sealer and polyfiber, nearly all cracks have since reopened. In all instances, the failure occurred due to a loss of adhesion between the asphalt pavement and the sealing agent. The crack shown in Figure 10a was unsuccessfully sealed with silicone shortly before being resealed with the rubberized crack sealer.

Generally, the cracks have manifested themselves in two varieties: small longitudinal cracks typically occurring in localized groups, and individual long, wide, transverse cracks. Elev-

en transverse cracks extend across, or nearly across, the entire runway, and two transverse cracks extend across the taxiway. Crack density is particularly high at the southeast (32) end of the runway; elsewhere, cracks are fairly evenly distributed.

The asphalt concrete is beginning to exhibit signs of secondary cracking. One possibility is that the base course has eroded from beneath some of the larger cracks; however, no evidence of removed material has been observed at the edges of the runway. Figure 10b illustrates a crack at least 9 in. deep at station 16+15, and Figure 10c shows the results of the secondary cracking and ensuing settlement of approximately 3 in. at station 29+95. While Figures 10b and c represent the most extreme of the crack-related failures exhibited by the four-year-old pavement, progressive deterioration is inevitable unless the cracks are successfully sealed.

2. Extreme pavement distress is exhibited by cracks up to 9 in. deep and by severe secondary cracking. It is recommended that both the pavement surface and the underlying insulation be monitored for horizontal displacement. From this it could be determined whether the extreme crack-related failures are due to differential movement caused by the extreme temperature fluctuations experienced by insulated pavements, movement of the asphalt concrete and frozen base, or shrinkage of the asphalt concrete due to accelerated aging.

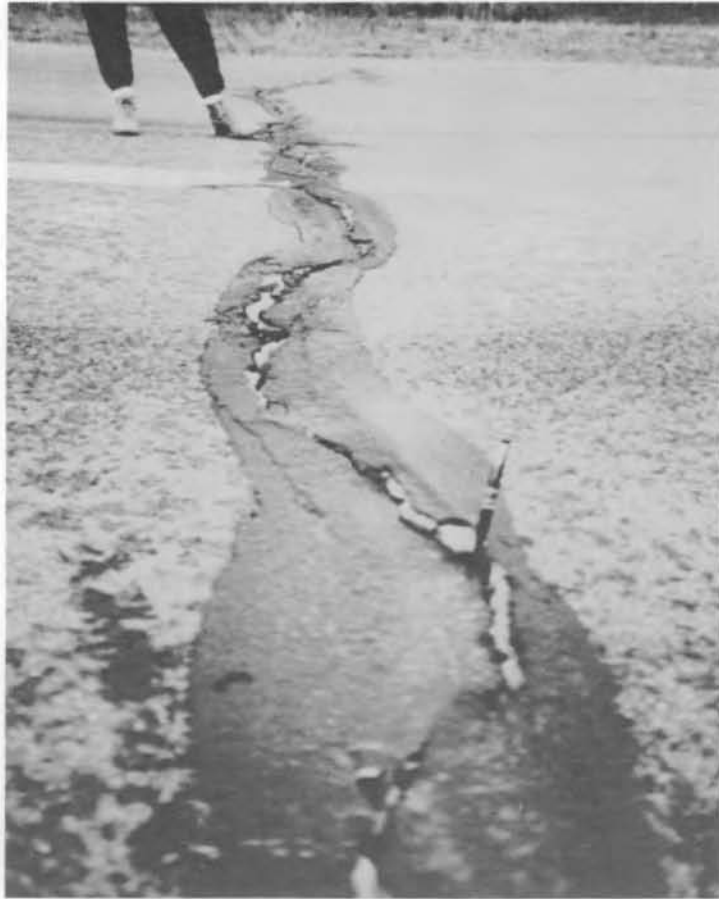
a. Crack at station 8+22 initially sealed with silicone, then with a rubberized crack sealer.

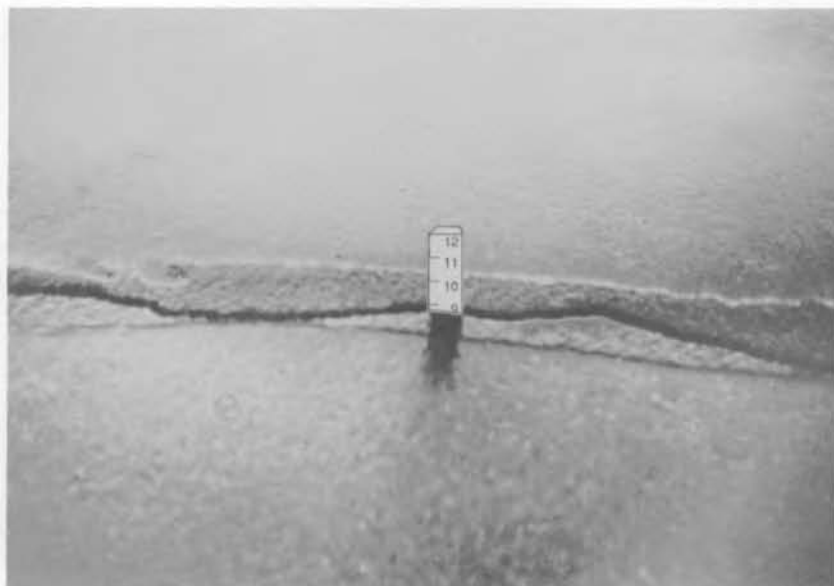
b. Crack at station 16+15.

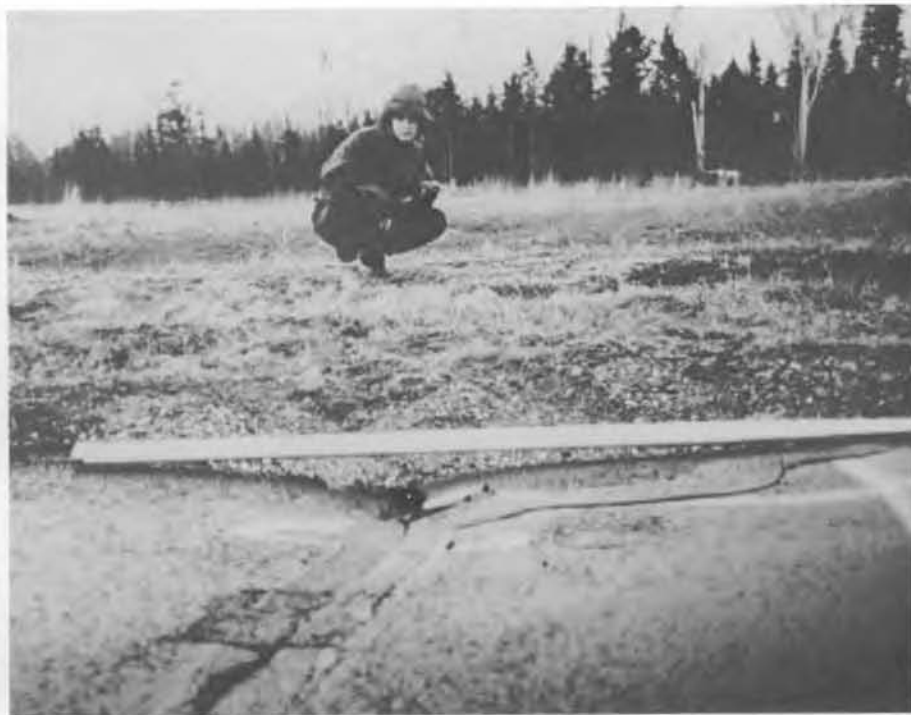
c. Settlement of pavement at station 29+95

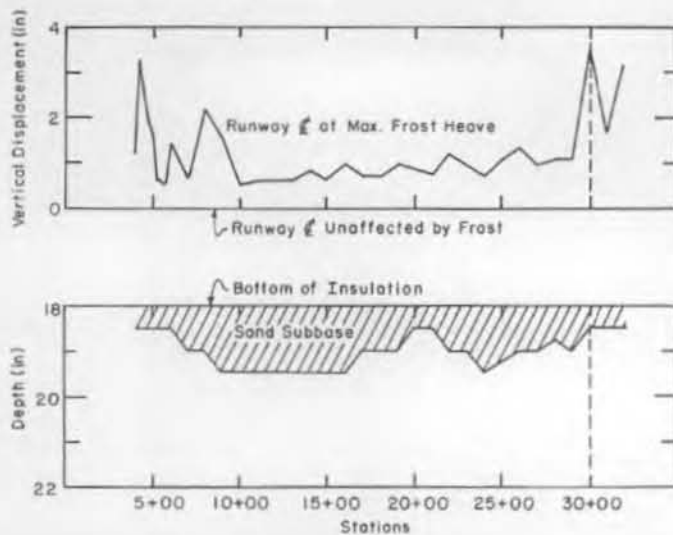
Figure 11. Profile of frost-heaved centerline and corresponding depth of sand subbase, March 1990.

32+00, approximately 3 in. Figure 11 shows both the March 1990 centerline profile and the depth of sand subbase along the length of the runway. The areas that experienced appreciable frost heave generally correspond to the two ends of the runway that were excavated to a lesser depth. In addition, both ends of the runway were particularly spongy during construction.

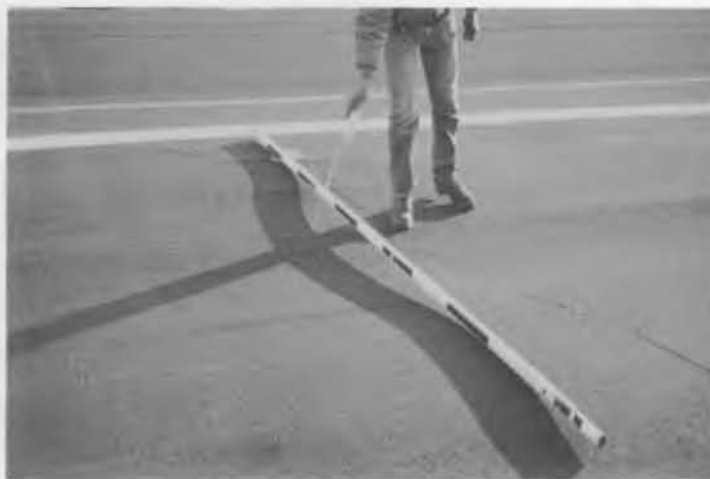
Figure 12. Differential frost heave near station 8+00. The "valley" is about 6 in. below the "ridges."

Localized differential heave was exhibited each spring in the vicinity of station 8+00 and between stations 29+00 and 32+00. Figure 12 depicts the irregular pavement surface near station 8+00 in early April 1988; in this area the differential movement was about 6 in. A variety of methods have been employed to investigate the causes of the localized differential frost heaving; the methods and observations are discussed later in this report.

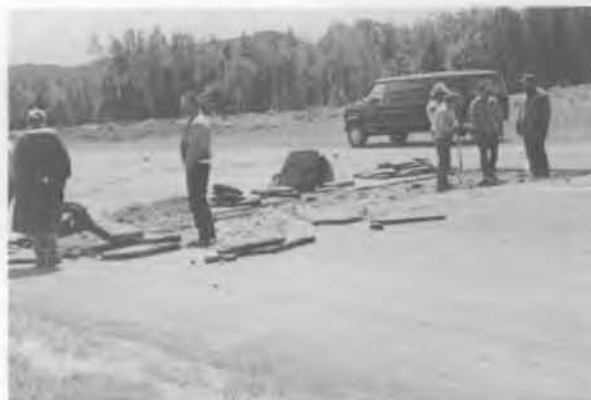
ized settlement (Fig. 16). Figure 17 shows the overlapping and damaged insulation that was removed and replaced. The damaged insulation at this particular location had been attributed by the consulting/design firm to settlement of the backfill above the 10-in. PVC sewer line that crosses the runway at a depth of approximately 8 to 9 ft beneath finished grade. It is probable, however, that similar insulation damage or separation of adjacent panels caused the temperature anomaly at station 4+50. Similar problems also are probably responsible for the substantial differential frost heave at both ends of the runway. These areas were undoubtedly more unstable during construction than areas with a thicker layer of granular material beneath the insulation. Since the subgrade possessed very low strength during construction, movement of the insulation panels due to construction traffic probably caused the individual boards to move, resulting in gaps in some locations and overlap in others.

Figure 16. 1987 removal of pavement at station 30+00.

direction of the resident engineer, the insulation was removed, the subgrade was removed to the desired depth, and the geotextile, insulation, and base course were all replaced.

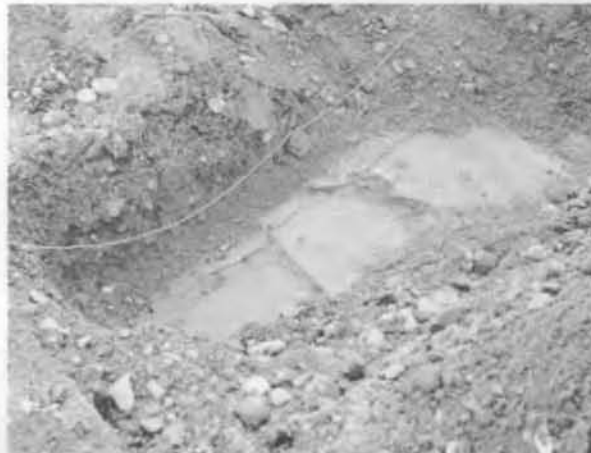
Figure 17. Overlapping and damaged insulation.

- Damaged and overlapped insulation was uncovered and replaced when a section of the pavement at station 30+00 was removed in July 1987.
- Data from the thermocouple assemblies at station 4+50 show a distinct temperature discontinuity immediately beneath the insulation.
- Each winter, both ends of the runway exhibited substantial frost heave with localized areas of substantial differential frost heave.
- Ground-penetrating radar results showed an extremely irregular insulation surface with an apparent range in depth to the insulation/subbase interface of approximately 5 to 24 in. Depths to the top

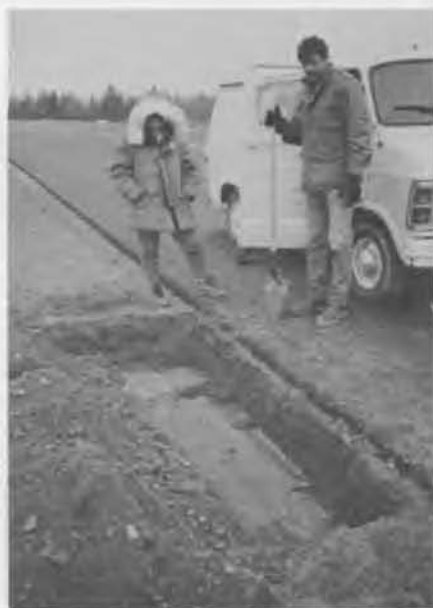
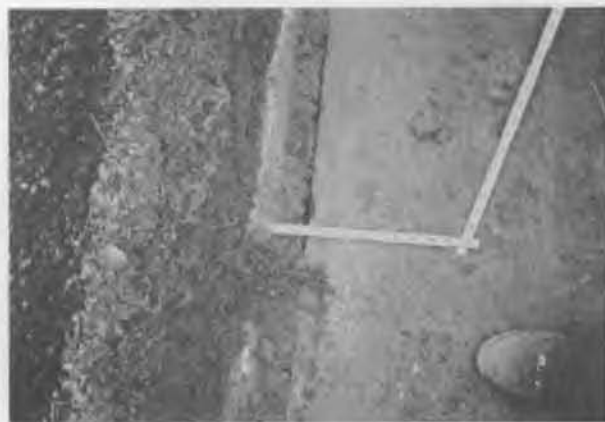
Figure 18. Station 7+75, south edge of Newton Field runway.

In April 1988, a 2- × 5-ft trench was hand-excavated immediately adjacent to the north edge of the runway at station 4+25. The insulation proved to be intact, with only a 1/4-in. gap between panels. A similar 2- × 8-ft trench at station 7+75 on the south edge of the runway again yielded intact insulation; however, a 2 1/2-in. gap was observed between insulation panels (Fig. 18). A third trench was started at station 4+75 on the south edge of the runway, but was abandoned when insulation was not encountered at the excavated depth of 18 in.

a. Trench excavation.

b. Gap between insulation panels

1. Field investigations confirm that gaps in excess of 2 in. have developed between the buried insulation panels in the shoulder area immediately adjacent to the asphalt pavement, indicating that similar discontinuities have probably developed beneath the asphalt pavement itself. Further studies are recommended to assess the thermal effects of panel spacing on both the thermal regime and frost heaving of insulated pavements.

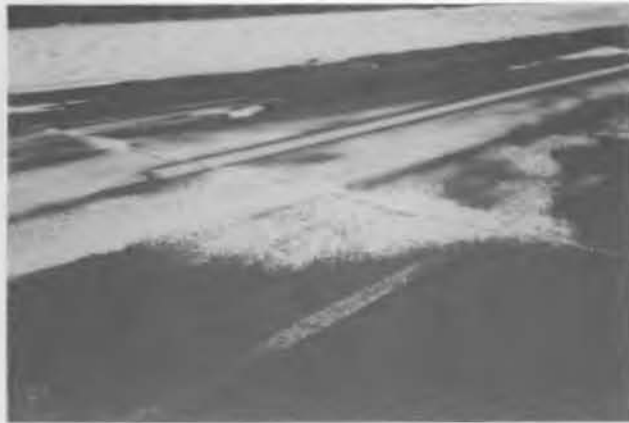
Figure 19 illustrates the variation in pavement surface temperatures in the immediate vicinity of a crack. In an attempt to record similar surface manifestations of the temperature variations caused by underlying gaps between panels or by damaged insulation, an infrared camera was used by CRREL personnel during the spring of 1988 to photograph the pavement surface (Fig. 20). The equipment records the infrared image on video tape, and the corresponding surface temperature of the object is indicated on the screen. Due to equipment problems, the

Figure 19. Variation in pavement surface temperature due to the presence of a crack.
