REPORT 82-11

*Shoreline conditions and bank recession
along the U.S. shorelines of the St. Marys,
St. Clair, Detroit and St. Lawrence rivers*

May 1982

Lawrence W. Gatto

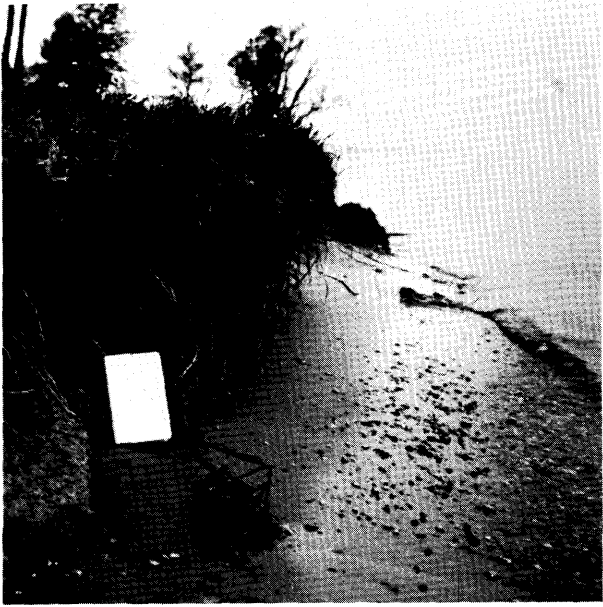
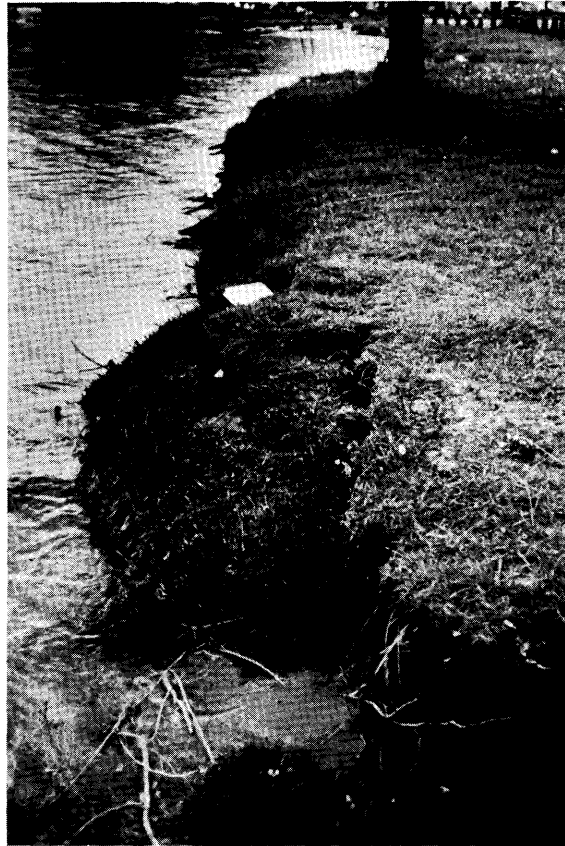
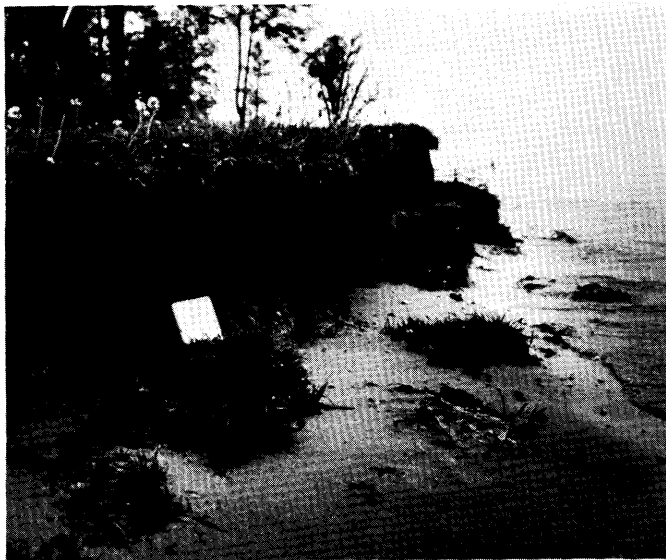
a. Undercutting.

b. Collapse of overlying sediments.

c. Removal of slumped material.

Figure 2. Typical erosion sequence (St. Clair River Reach 17).

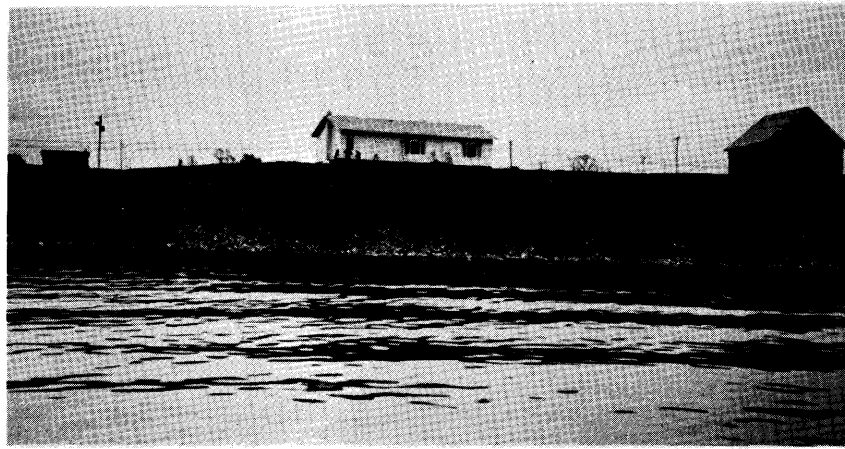
Figure 3. Gullies and rills along the bank crest and face (St. Lawrence River reach 12).

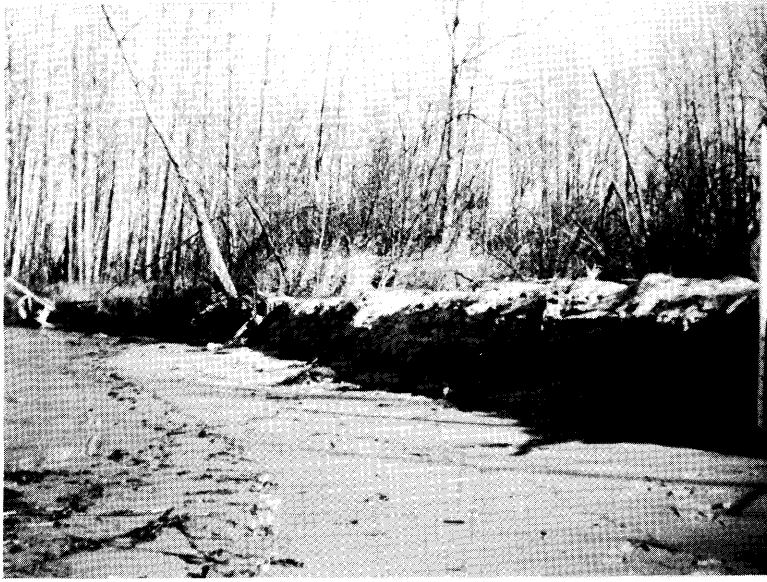
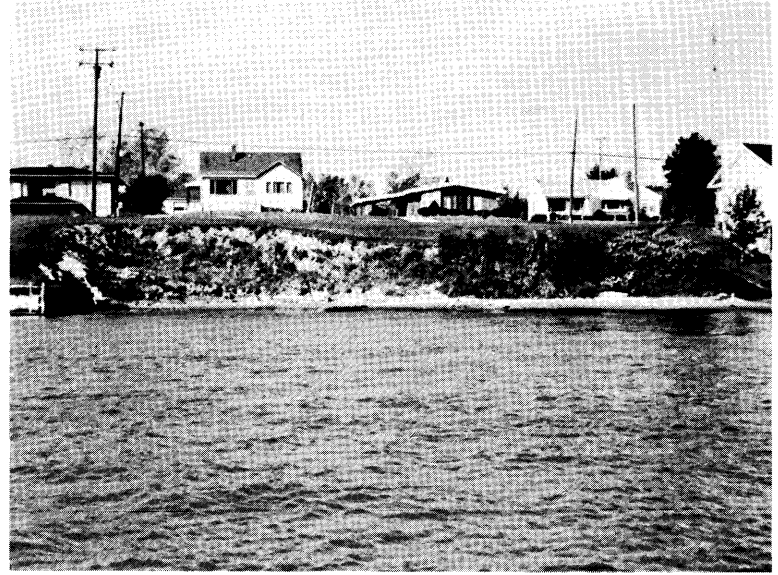
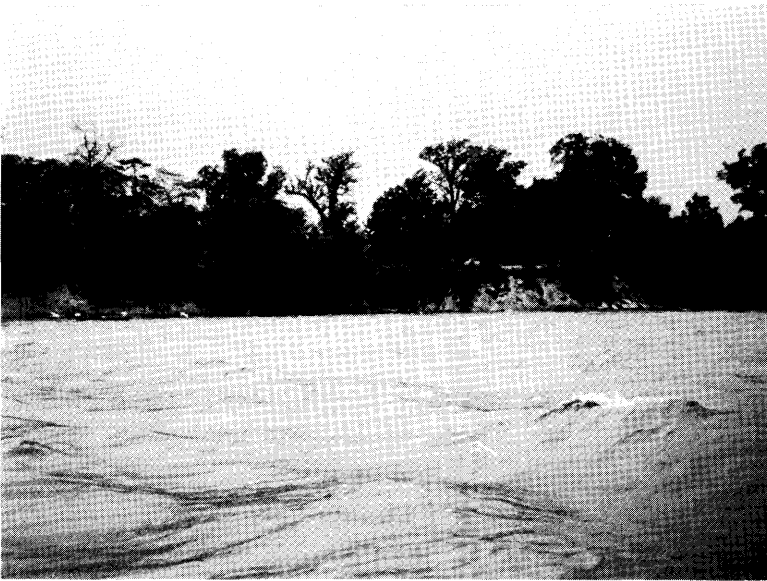
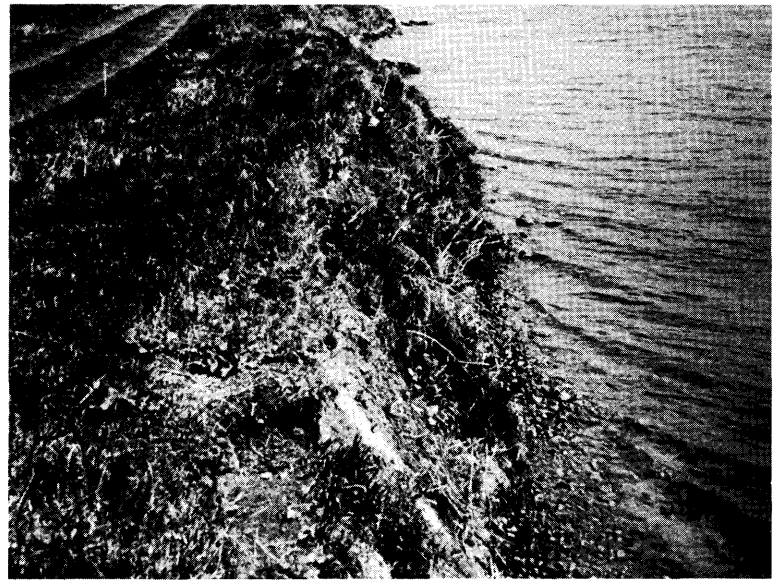
a. St. Marys River reach 16b.

b. St. Clair River reach 4a.

c. Detroit River reach 21b.

d. St. Lawrence River reach 38.

Figure 4. Partially vegetated and bare riverbanks typical of those mapped during the initial survey.

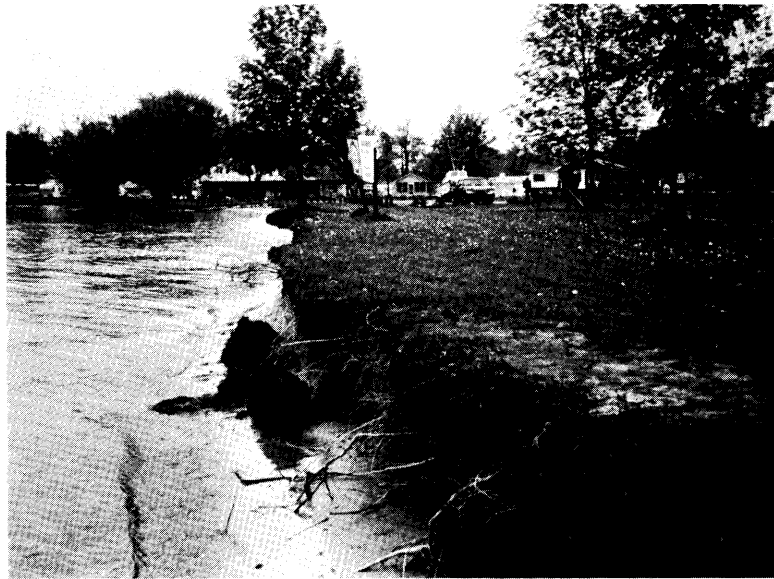
a. Slumped soil blocks (St. Clair River reach 17).

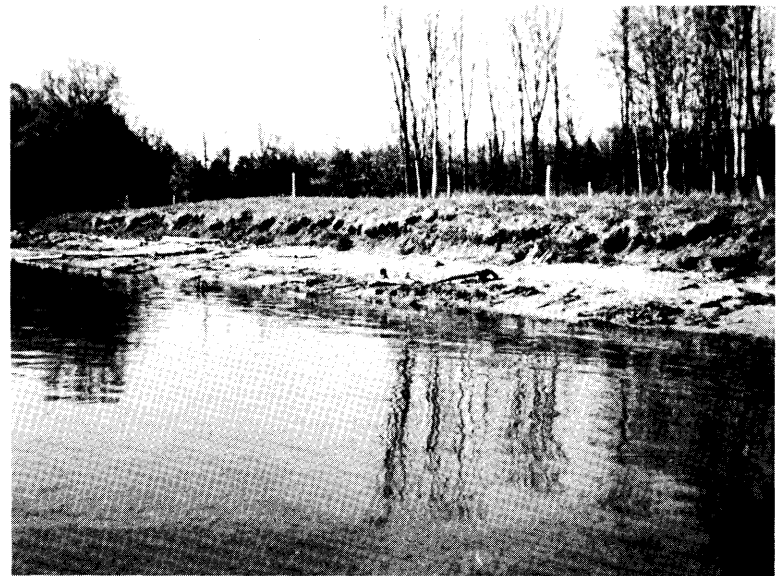
b. Newly exposed, unvegetated bank face surfaces (St. Marys reach 6c).

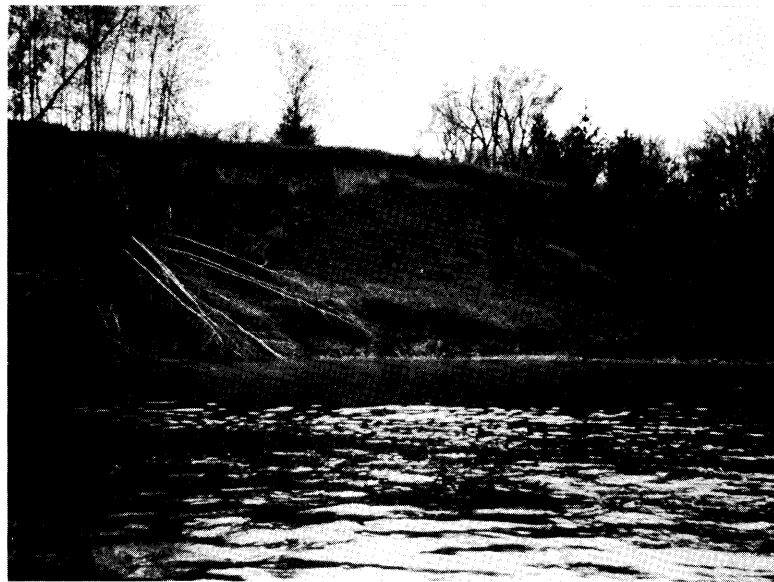
c. Fallen trees, brush and grass clumps (St. Lawrence River reach 20f).

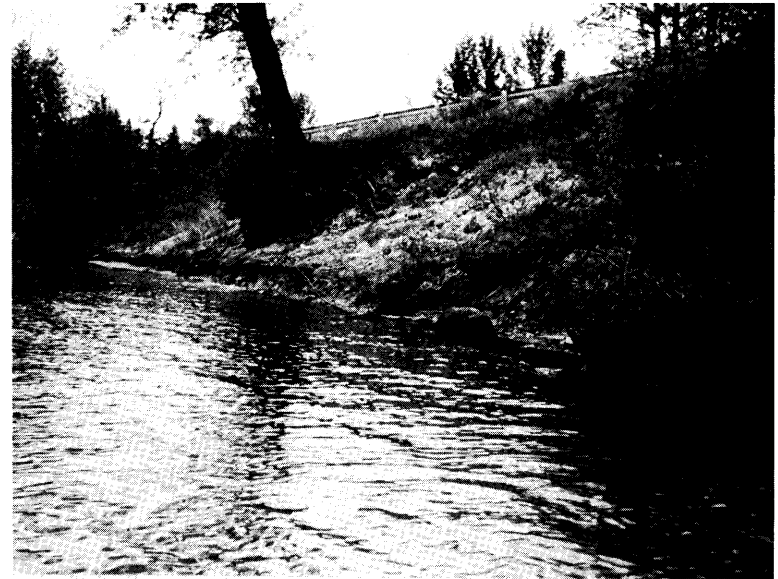
d. Newly formed small scarps (St. Clair River reach 5a).

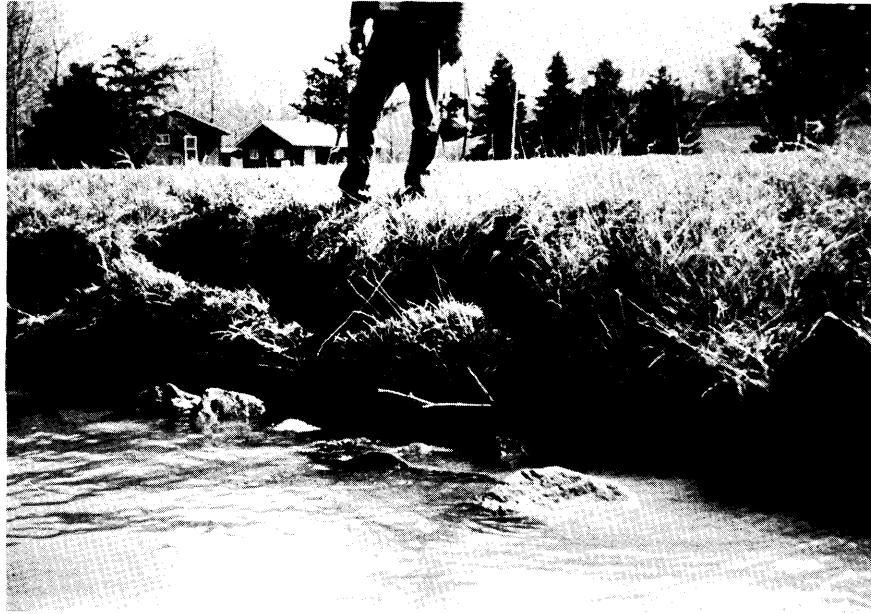
The types of bank failure along most of the eroding reaches were soil falls and slides (Fig. 7) (Code 1973). Soil falls generally result from extreme undercutting at the toe of a bank, and they usually produce vertical bank faces. Slides are due to shear failures, which result in relatively undeformed masses of soil moving along a single slide plane. These are common, especially where banks are composed of massive lake sediments or fine-grained tills. The slides along the St. Marys River are also due to the loss of support at the bank toe resulting from undercutting and material removal by river water. A few reaches show rotational slumping, and some show evidence of surface erosion (i.e. rills and gullies).

a. Soil fall (St. Marys River reach 27b).

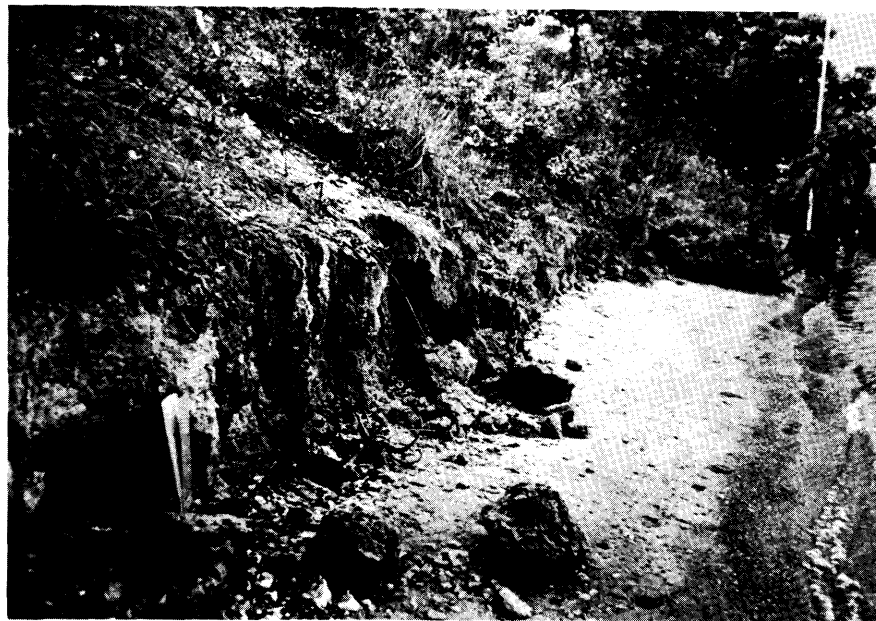
b. Soil fall (St. Clair River reach 5a).

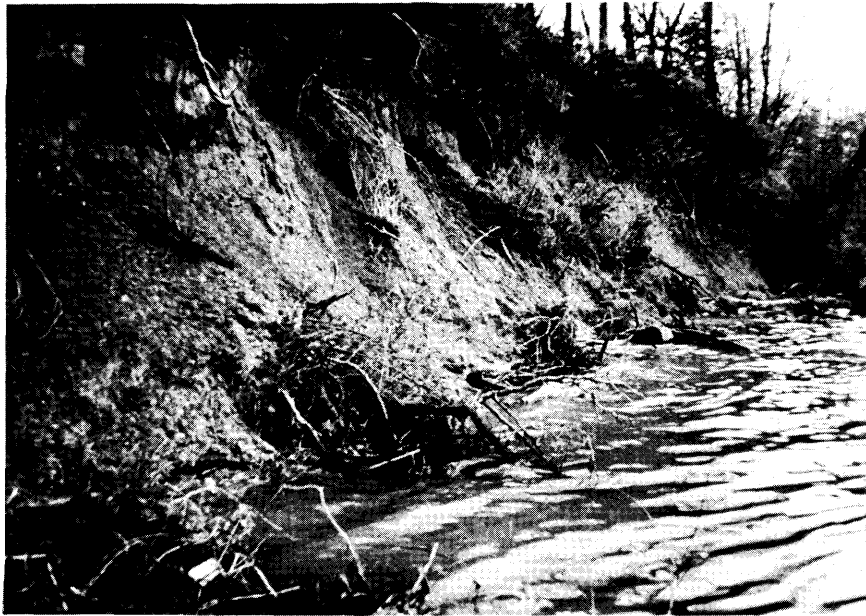
c. Soil fall (Detroit River reach 18).

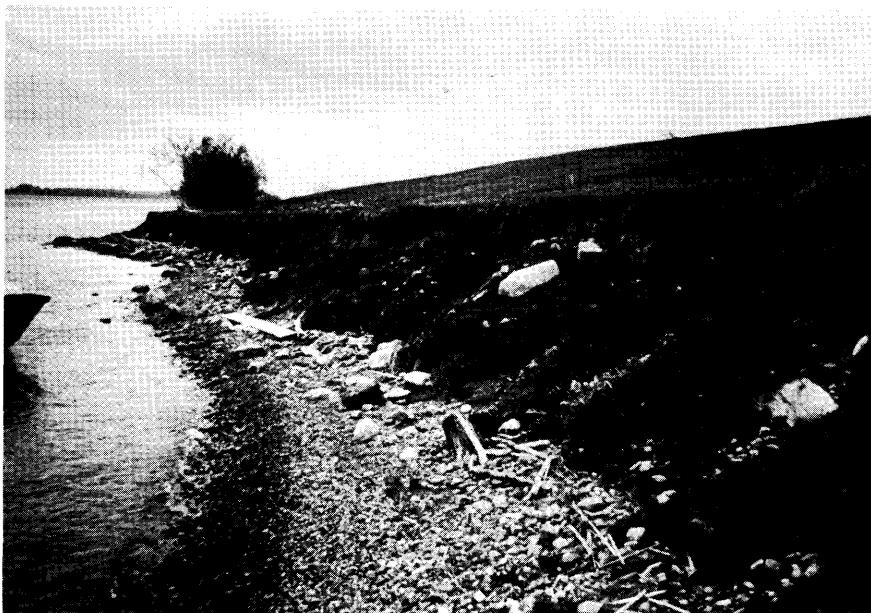
d. Soil slide (St. Lawrence River reach 26).

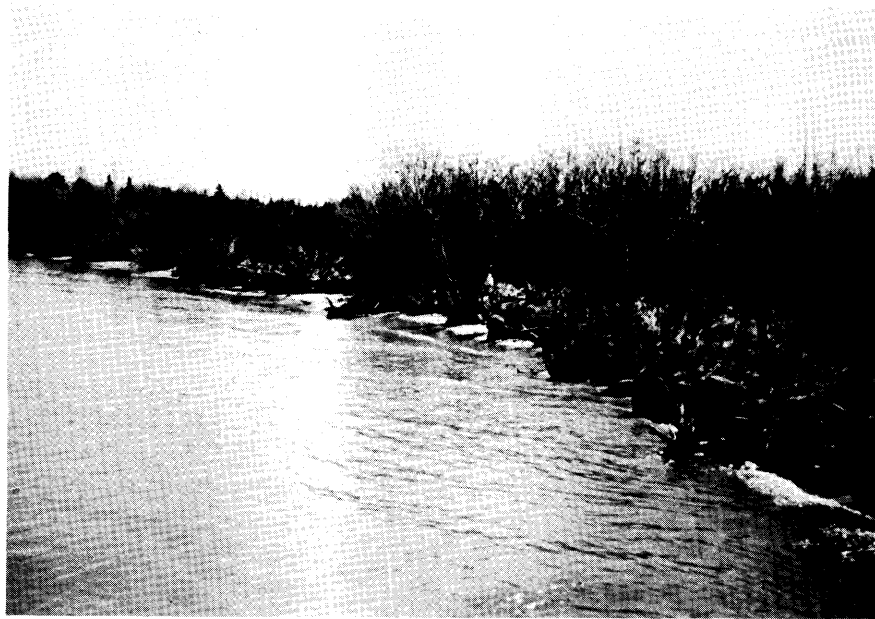
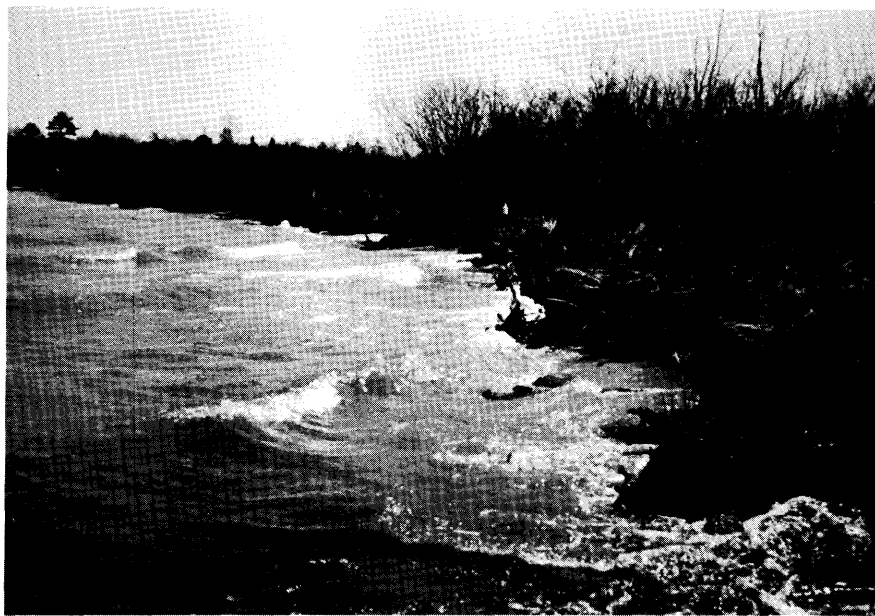
fects of ship passage. The weather was clear with a mild breeze, and there were no breaking waves along the shore (Fig. 8a). Two ships, the *Mesabi Miner* (downbound) and the *Canadian Olympic* (upbound), passed Brush Point simultaneously. The water level was drawn down, the river currents reversed, and water flowed upstream at a

noticeably higher velocity than the normal currents. Shortly after the sterns of the ships passed, the water surface rose rapidly behind an 8-inch wave to a level higher than the pre-passage level, and nearshore currents returned to a downstream flow. The velocity was still higher than

that of the pre-passage downstream currents and 6- to 8-inch waves broke while the water was at this higher level (Fig. 8b). This sequence of changes also occurred when the *A.H. Ferbert* (downbound) passed Brush Point a half hour later, but the changes were much less pronounced.

a. Nearshore conditions prior to ship passage.

b. Ship-induced changes in waves.

Figure 8. Hydraulic effects of ship passage (St. Marys River reach 4b, 22 May 1978).

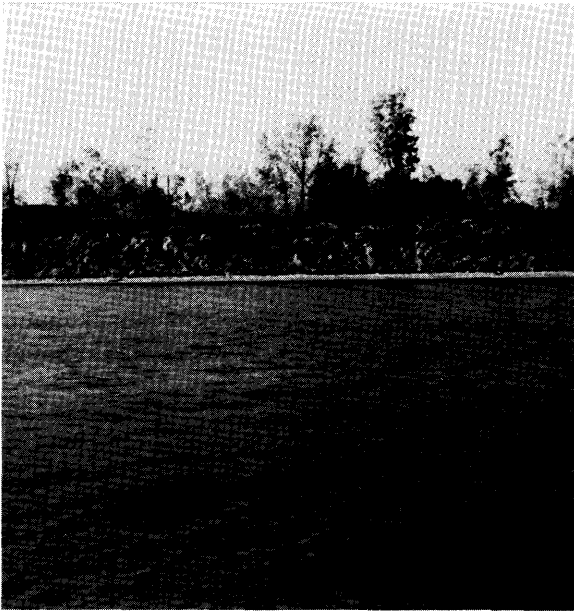
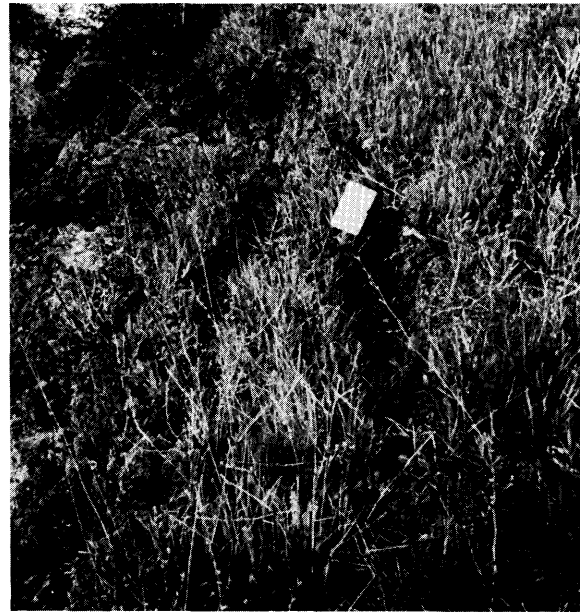
The types of bank failure along most of the banks were soil slides and falls along the face of the bank. These were caused by undercutting at the water line, loss of support for overlying sediment, and subsequent collapse. Rotational slumping occurred at reach 11b only (Fig. 10).

a. Viewed from the river.

b. Crack formed on top of the ground surface delineating a future slump block.

Figure 10. Rotational slumping (St. Clair River reach 11b).

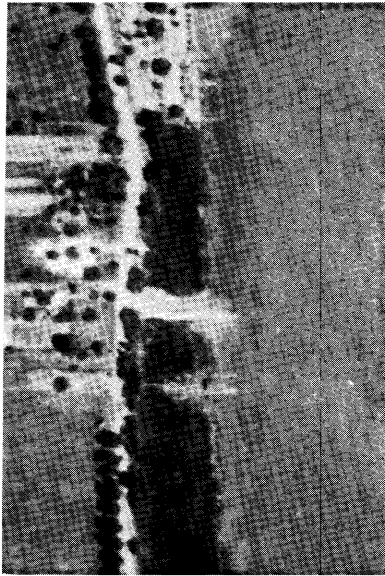
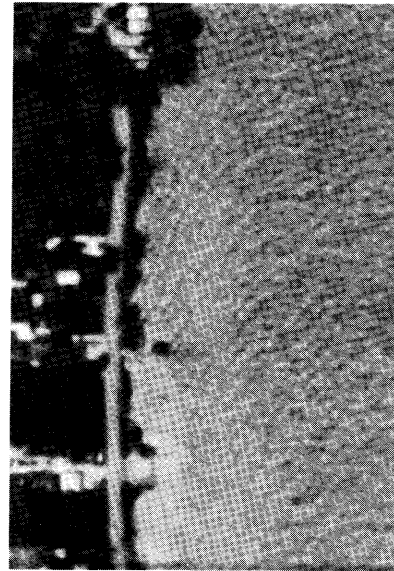
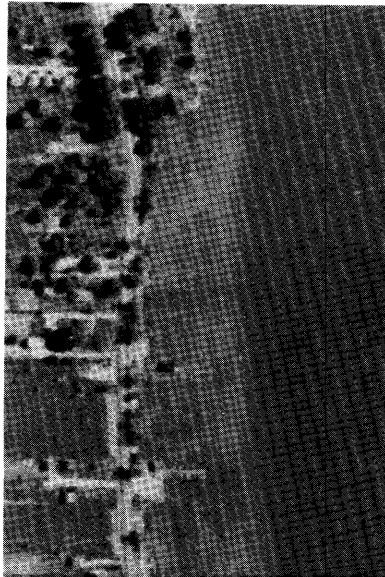
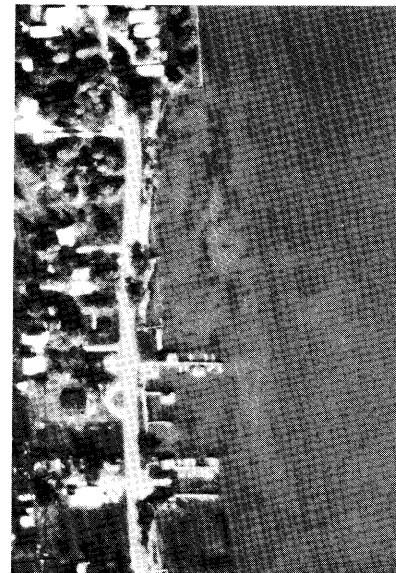
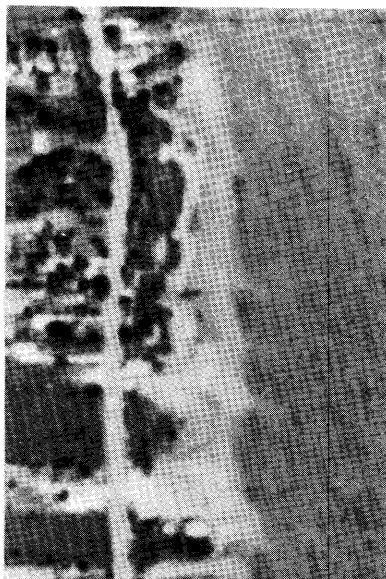
Using the observations made during the spring and fall surveys, I selected seven eroding reaches to estimate pre-winter-navigation bankline recession (Table A3). Between 1941 and 1977 recession varied from 40 feet at reach 5a to 139 feet at 12b. The amounts of recession from 1941 to 1970 at reach 12b appear to be extremely high, and the photographs clearly show that large-scale changes in the bankline have occurred along this reach (Fig. 11). In 1941 the crest of the riverbank was at the position shown in Figure 11a. The crest had receded to the position shown in Figure 11e by 1977. It appears that the water level had increased enough between 1941 (Fig. 11a) and 1957 (Fig. 11b) to inundate the low area shown in Figure 11a.

Most of the recession that occurred between 1941 and 1970 (Fig. 11) appears to have occurred between 1941 and 1957 due to this rise in water level. NOAA-NOS (1975) hydrographs for this period show high water levels on Lake Michigan and Lake St. Clair from 1943 to 1949 and from

Figure 11. Shoreline changes and recession at St. Clair River reach 12b.

1951 to 1956. Record high water occurred in 1973 and 1974, which could account for the high recession between 1970 and 1977.

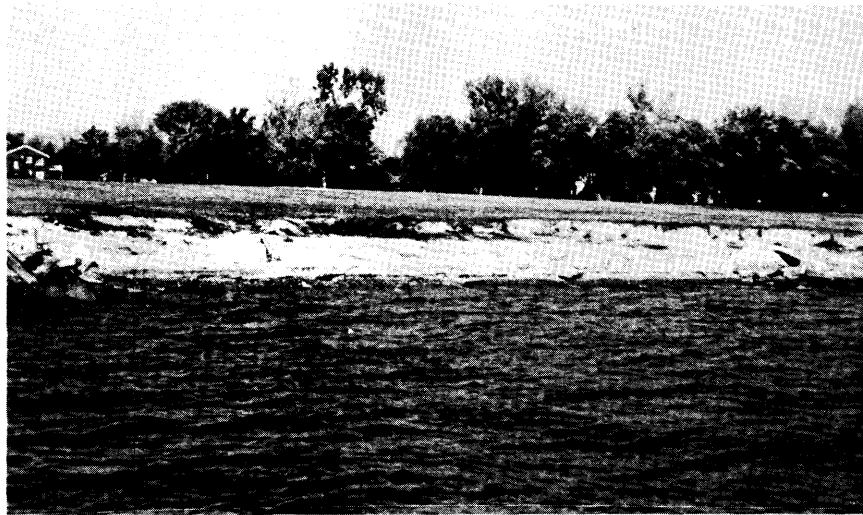
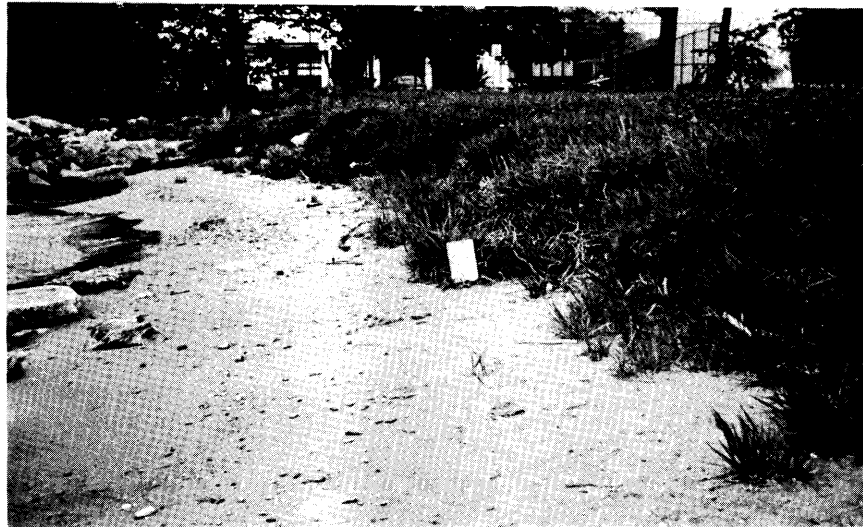
a. Detroit River reach 1a.

b. Detroit River reach 2a.

Figure 13. Slumped vegetation covering the low bank face.

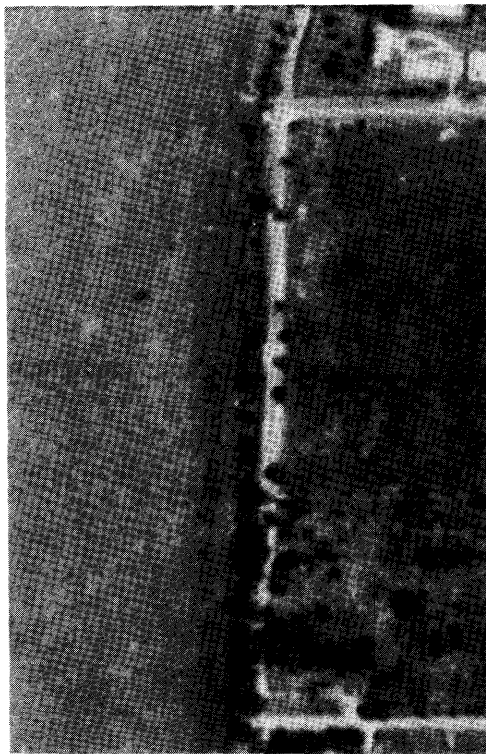
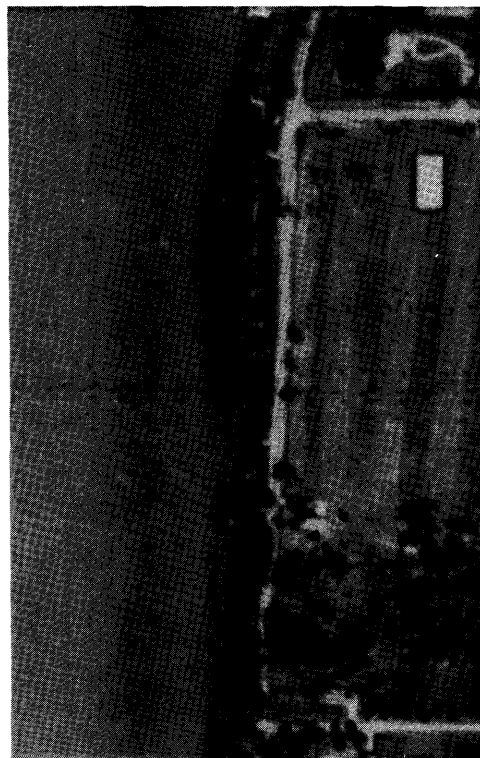
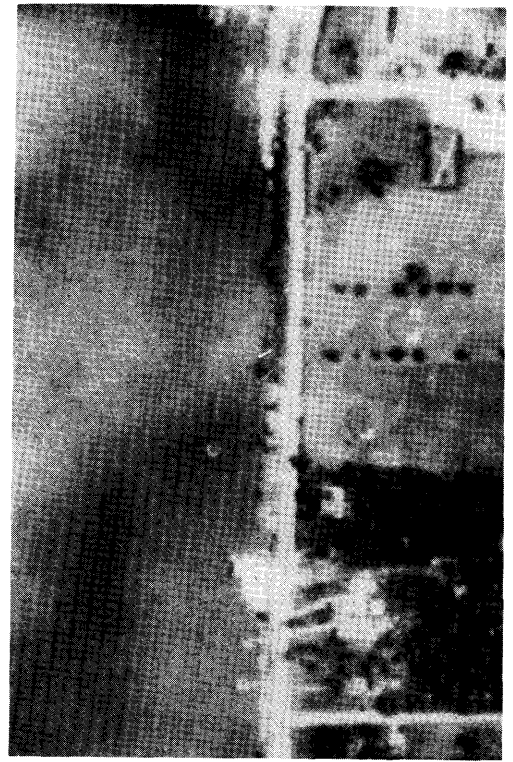
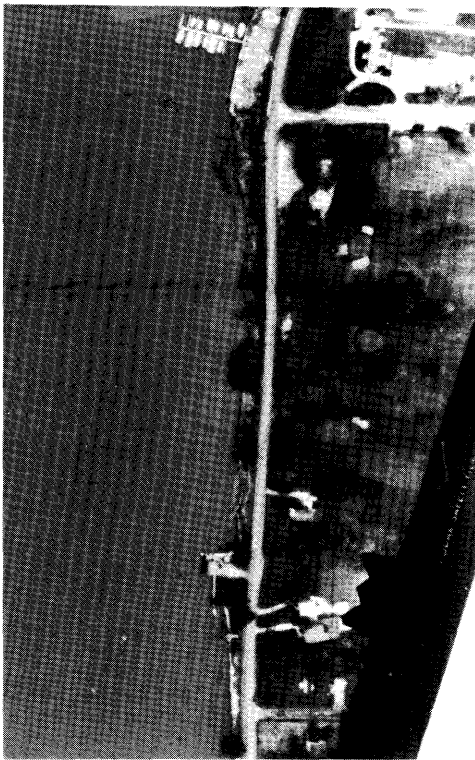
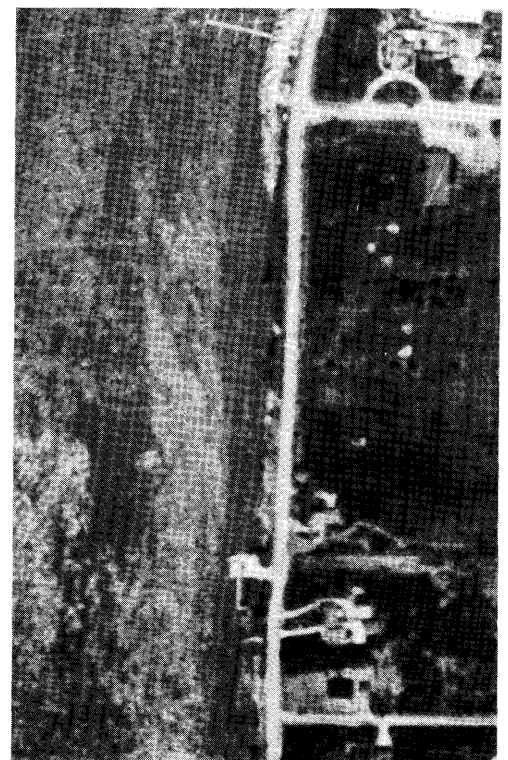
Major changes along site 18 occurred between 1937 and 1977 (Fig. 14). The amount of recession was 26 feet from 1937 to 1970 and less than 10 feet from 1970 to 1977. Figures 14 a and b show a band of land along the river in 1937 and 1940.

Figure 14. Shoreline changes and recession at Detroit River reach 18.

This land had been inundated or eroded by 1957; this probably occurred during the 1941–1957 high water period. I observed little change between 1966 and 1977.

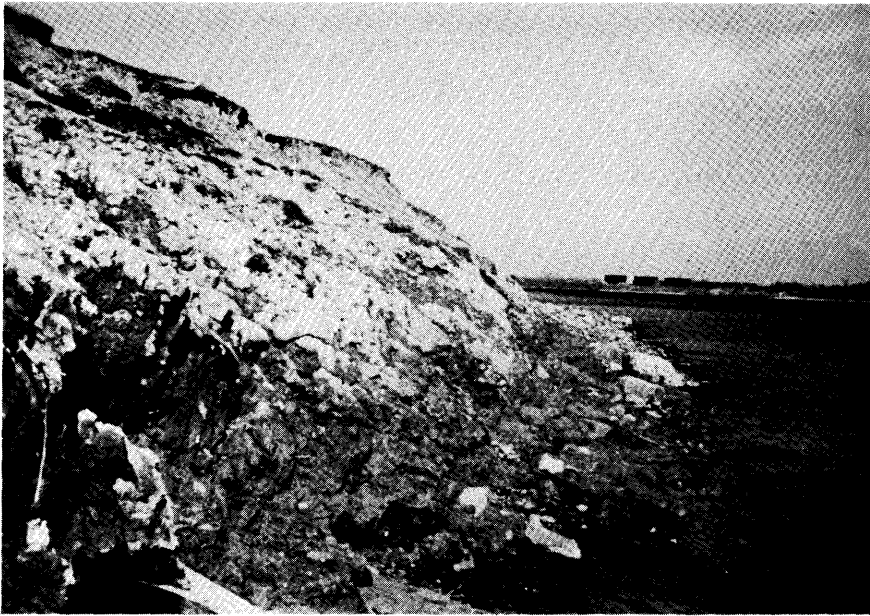
Figure 16. Localized slumps and mudflows along St. Lawrence River reach 35c.
