REPORT 86-17

Atmospheric icing on communication masts in New England

December 1986

Nathan D. Mulherin

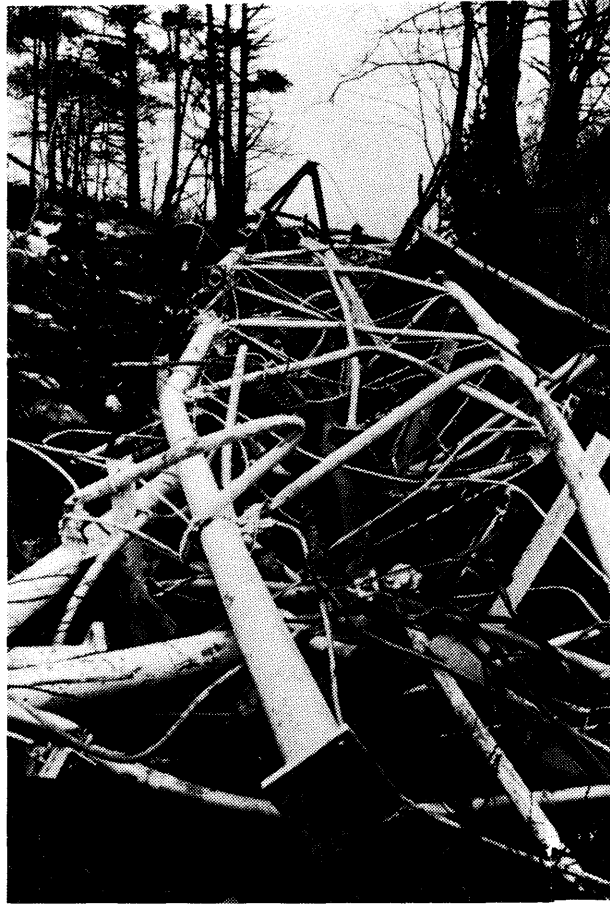
Figure 1. Wreckage of WCSH-TV's (Portland, Maine) 1300-foot tower felled by severe icing on 9 March 1983.

Portland, Maine's WCSH-TV (station 59) topped the list, having both severe icing conditions and high maintenance/repair costs. They have the tallest mast of all the responding mountaintop installations. Their annual cost for maintenance of protective equipment is reportedly \$5,000-10,000, with annual damage expenses (due mainly to falling ice) of over \$10,000. A severe buildup of rime and glaze in March 1983 toppled their 400-m mast, causing approximately \$34,000 in damages and days of lost airtime before a temporary, less powerful system could be put on-line. It was many months before a new tower was erected and operations returned to normal. The tremendous size of their tower, its high base elevation, and its northerly location are factors contributing to their severe icing problems.

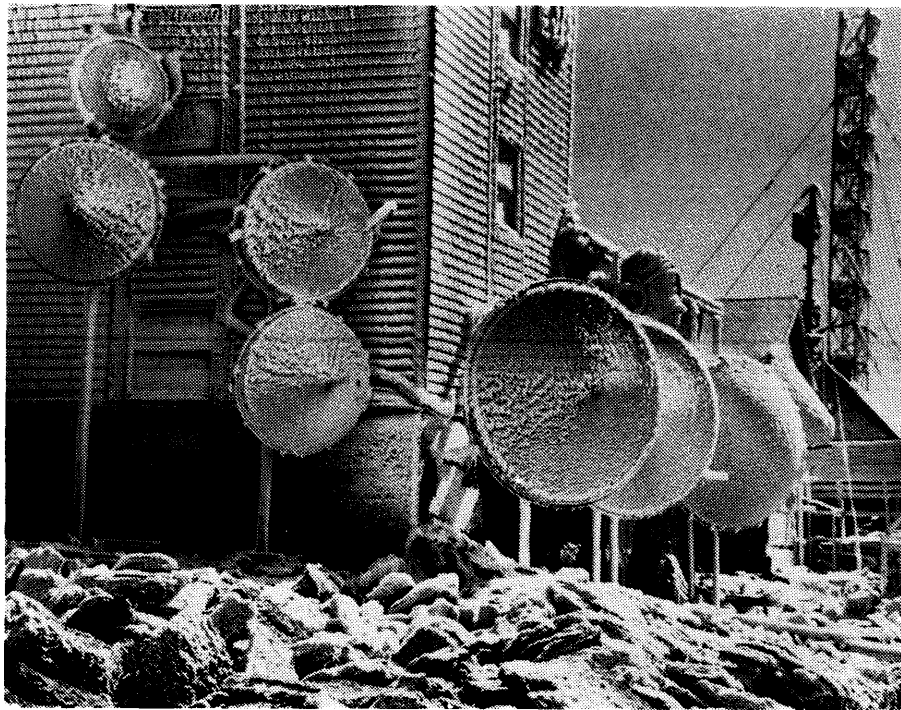
Radomes are an example of the use of this principle. These are rigid covers constructed of polyurethane, fiberglass, or sheet metal which enclose the radiating elements of an antenna or the reflecting surfaces of a receiver. Although they improve the system's capabilities during an icing event, severe conditions can still present a problem as seen in Figure 2. The WMTW-TV tower at the summit

Figure 2. Radomes over microwave relays following a riming event on the summit of Mt. Washington. Manual deicing of the radomes by on-site personnel using ordinary hand tools is often necessary.

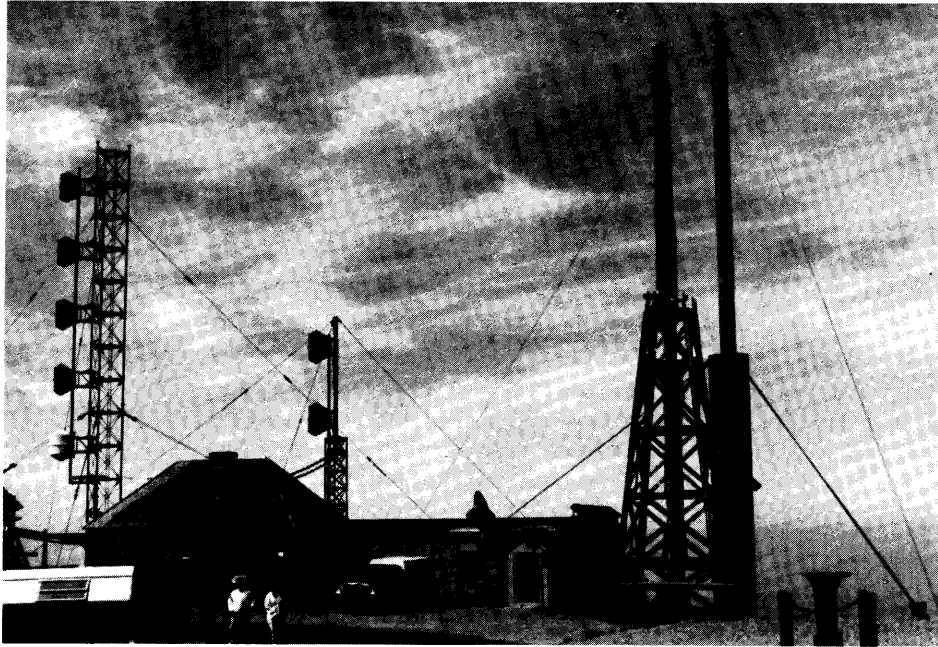
of Mount Washington is an example of a tower radome (Fig. 3). Today, their primary antenna is mounted atop a 120-foot tower completely inside a steel tubular enclosure. The old tower, with steel framework exposed, now supports only their emergency backup antenna. During an icing event, the two adjacent towers provide a clear illustration of the new tower's diminished propensity to icing. In addition, outfitting radomes or exposed elements with a flexible sheathing has been successful at some installations. Flexure is caused either passively by wind and vibratory action, or by an active pneumatic system (Hartranft 1972, Ackley et al. 1973). In some cases the entire tower structure has been enclosed, but only after the danger of increased wind loading has been carefully considered. In general, only the radiating elements are enclosed.

Figure 3. Radio and TV towers at the summit of Mt. Washington. WMTW-TV's tower, shown at extreme right, is radome-enclosed and less prone to icing than their old tower with exposed framework.

One might expect the summit of Mt. Washington to have the greatest icing severity due to its elevation, exposure and fierce weather conditions. Personnel at WMTW-TV (station 58) there report that icing occurs during 8-9 months of the year. It is interesting that WMTW's maintenance/repair costs tie it with seven other stations in fifth place on our list, lower than was expected. They do not use conventional antenna heaters but instead successfully employ radomes, short towers, and manual deicing techniques. Their station-to-transmit-
