## REPORT 76-29

### *Failure of an ice bridge*

S.L. DenHartog, T. McFadden and L. Crook

August 1976

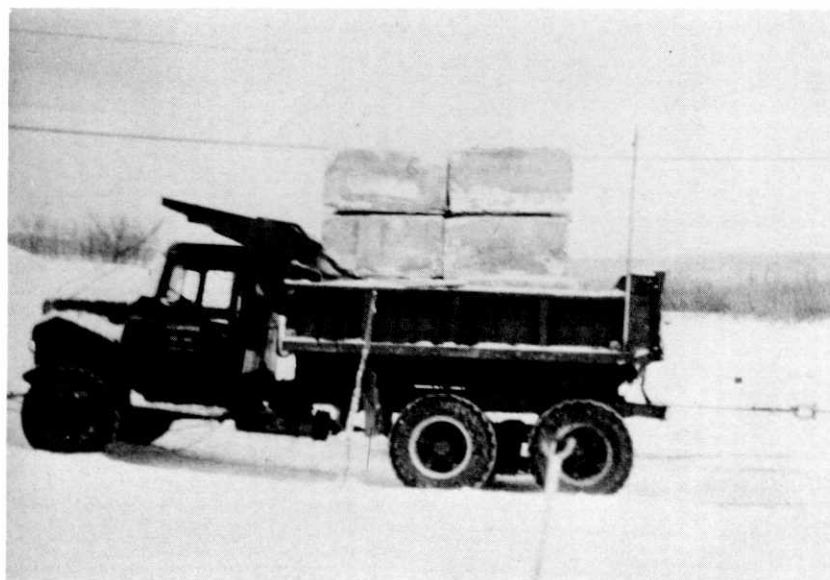
*Figure 3. Fully loaded truck.*
