Investigation of Mechanical Processes for Removing Lead-Based Paint (LBP) from Wood Siding

Robert H. Falk, John Janowiak, Richard G. Lampo, Thomas R. Napier, Stephen D. Cosper, Susan A. Drozdz, Steven Larson, and Edgar D. Smith September 2006

Final report

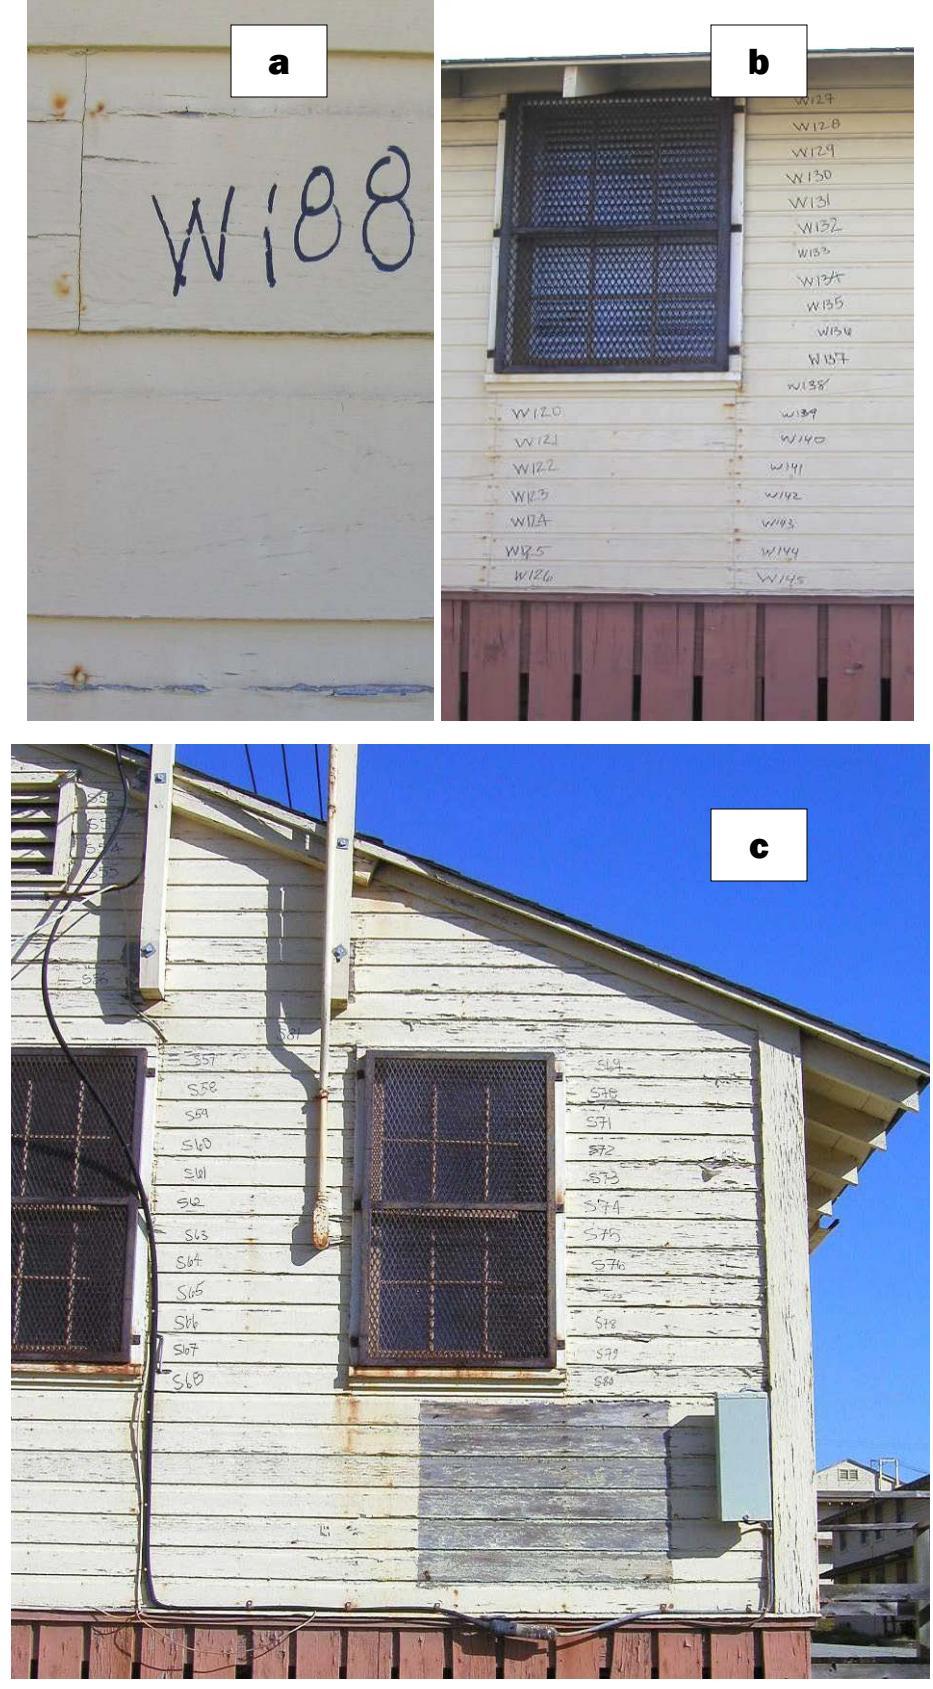
In Figure 2a, note double nail pattern at left, indicated by rust spots. Also, note the difference in siding condition in Figures 2b (west wall) and 2c (south wall), which is apparently a result of differences in weathering and exposure.

Figure 2. Typical ID numbering of individual siding pieces at Fort Ord.

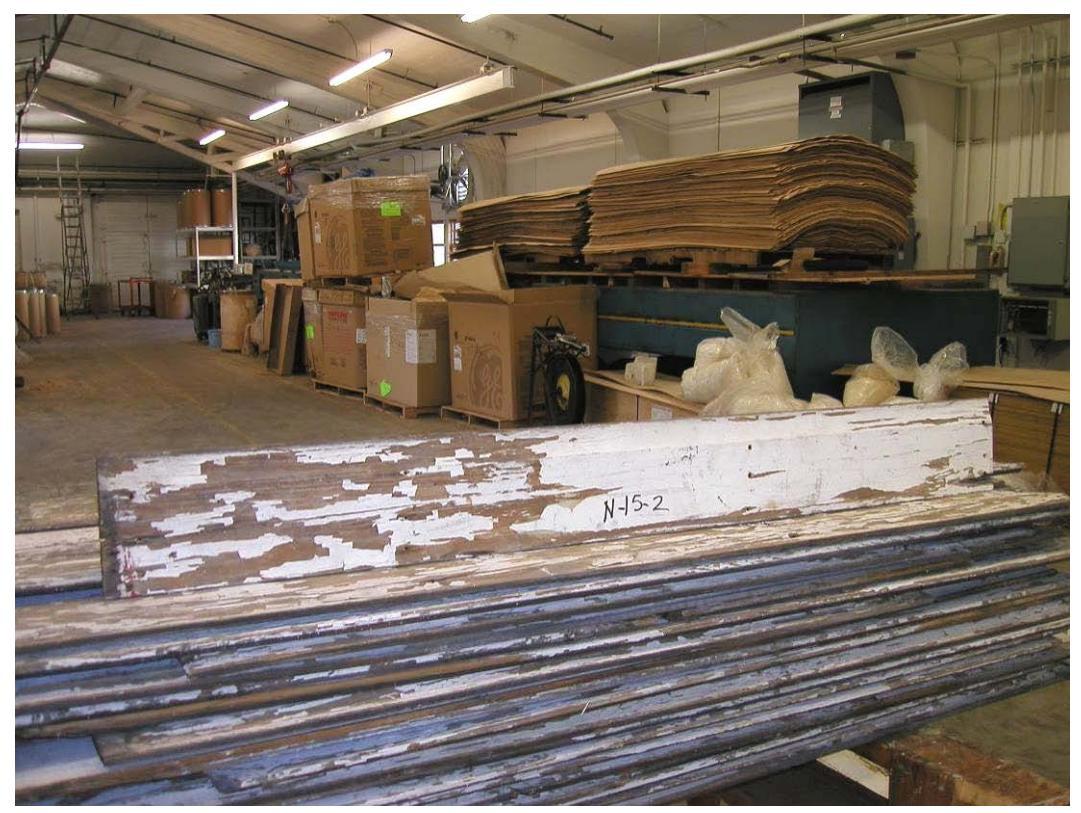
A visual assessment of the siding specimens from Fort Campbell indicated that it had been painted several times, but the paint surface was in poor condition. Surface quality varied considerably, and paint film separation and flaking were evident in most pieces (Figure 5). This paint failure was problematic because many siding pieces lost the hand-marked ID numbers during handling and transportation. This problem limited the ability to accurately account for and track all the siding back to its original building position.

Figure 5. Salvaged siding from Fort Campbell.

The siding from Fort Campbell showed more deterioration than the Fort Ord siding. One explanation for the difference may be that the Fort Campbell wood siding had been overlain with vinyl siding, which can trap moisture and accelerate paint failure. More importantly, this trapping of moisture may have maintained high moisture content in the wood, promoting decay fungi growth. Wood decay and associated discoloration from staining fungi and molds were prevalent on a large number of siding pieces.

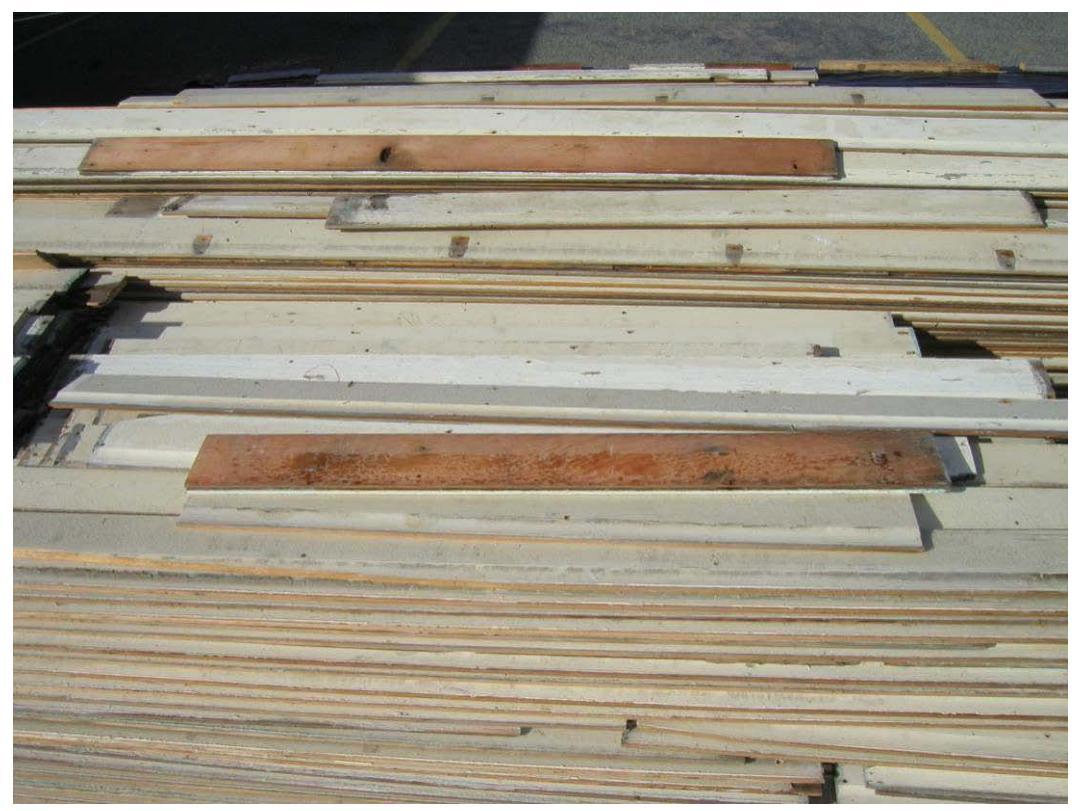
The siding salvaged from Fort Ord (Figure 6) was generally in much better condition than the Fort Campbell siding. In general, the same defects as described for Fort Campbell were found in the Fort Ord siding, but with much less frequency. The paint loss and wood weathering of the Fort Ord siding was more location-specific; the most severe degree of weathering and checking were found on pieces from the south sides of the building, where solar exposure was highest. Figure 2c shows a typical southern exposure and Figure 2b shows a typical western exposure.

Figure 6. Douglas fir siding salvaged from Fort Ord.

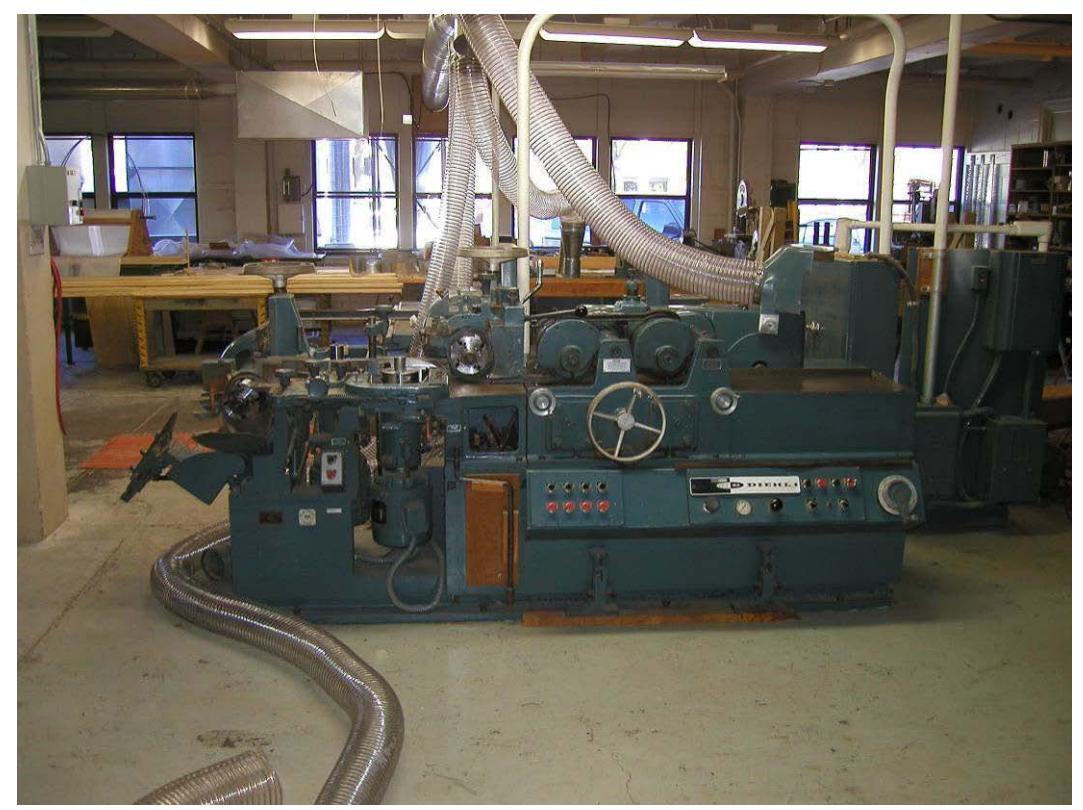
Figure 12. FPL's Diehl S4S molder.

Inspection of the molder indicated that the cutter heads and arbor assemblies needed to be replaced. The existing rotor-style cutter heads with hub lockdowns for constant axial setup were replaced with precision chamber pressure sleeve cylinder cutter heads. This substitution was made to as-

sure accuracy, uniformity, and concentricity for quality processing performance. These replacement parts are shown in Figure 13.

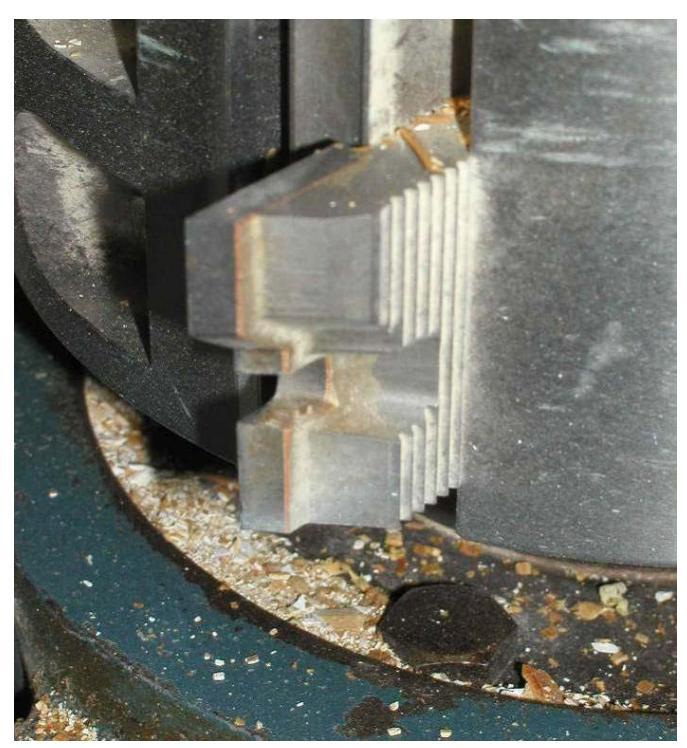
The excessive wear of HSS knives witnessed in early machining trials suggested that carbide knives could be a logical alternative. In addition to the abrasive nature of the paint, the Southern Pine siding from Fort Campbell had a larger number of knots, which also tends to rapidly dull knives, also shown in Figure 14.

Figure 14. Carbide knife used to machine southern pine, showing corrugation on back.

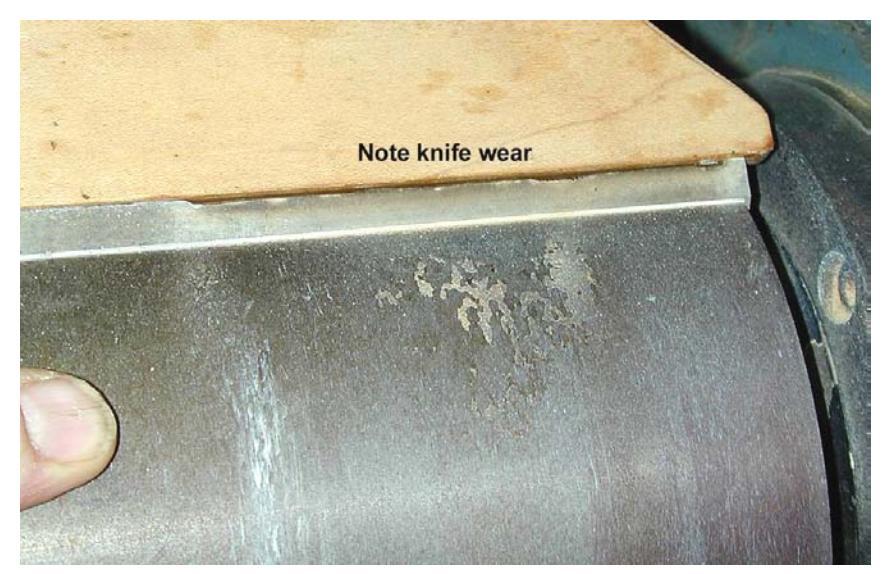
As shown in Figure 35, the machining of the LBP siding was very abrasive to HSS knives; the knife was razor sharp when installed but dulled dramatically after machining less than 1,000 lf of siding. This dulling in turn degraded the surface quality of the machined wood, as shown in Figure 36.

Figure 35. HSS knife edge showing wear after machining Fort Ord siding.

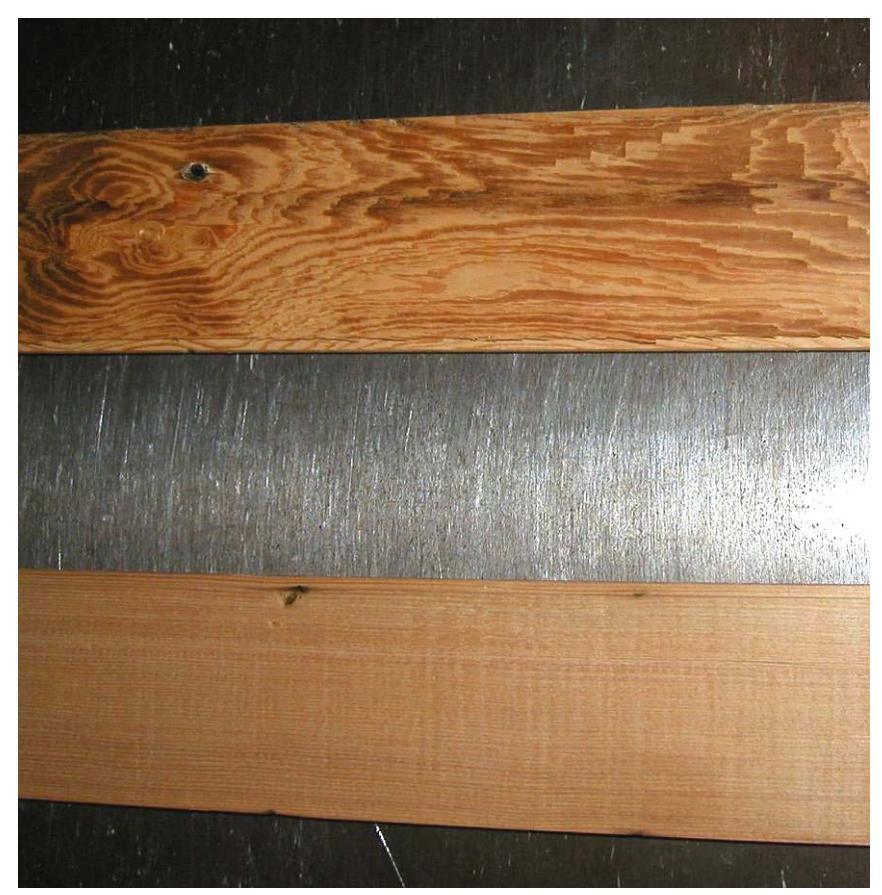
Figure 36. Degradation of wood surface quality (top) due to dulling of HSS knives.

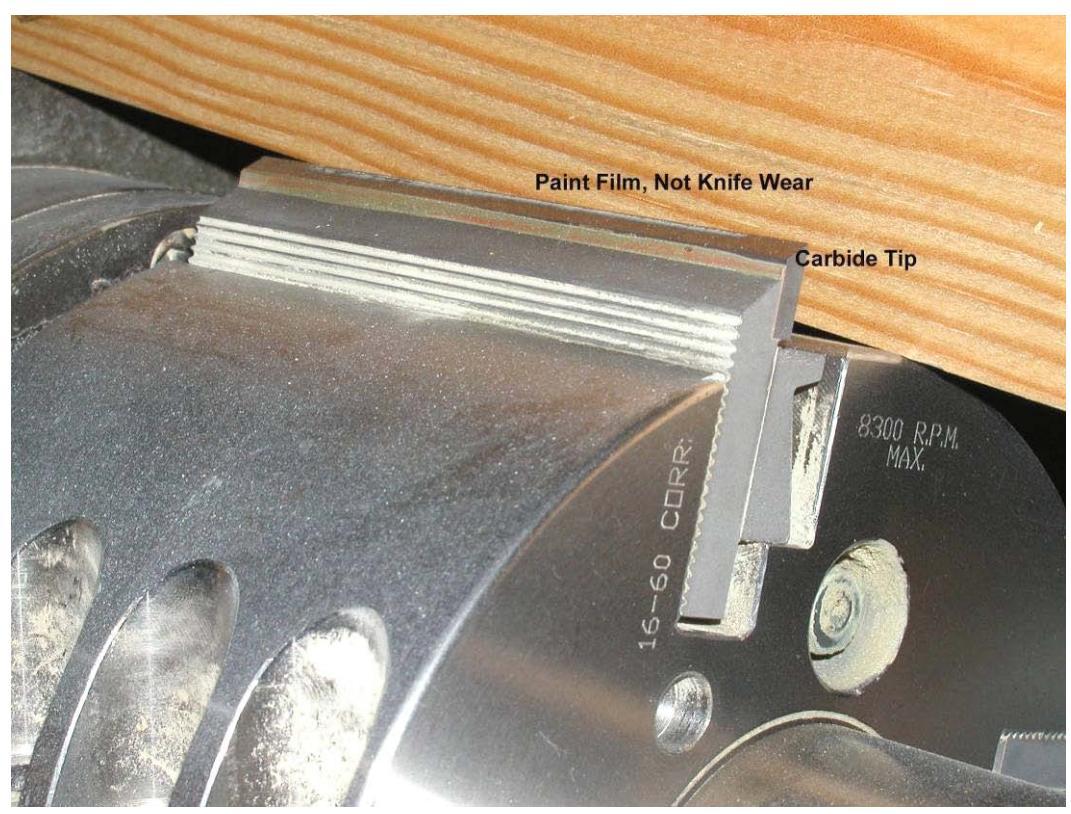
Figure 37. Carbide knife after machining, showing sharp edge with traces of paint residue.
