US Army Corps  
of Engineers®  
Engineer Research and  
Development Center

# Membrane and Flashing Condition Indexes for Modified Bitumen Roofs

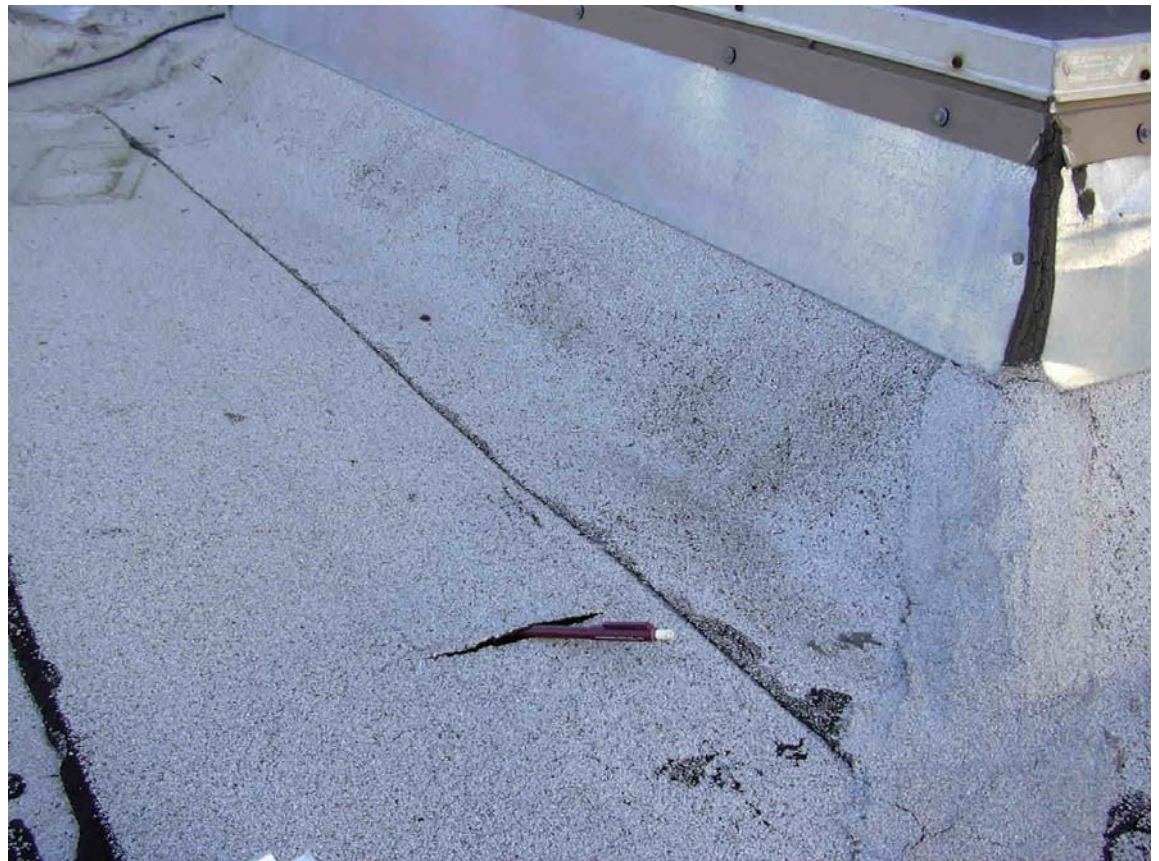
# **Membrane and Flashing Condition Indexes for Modified Bitumen Roofs**

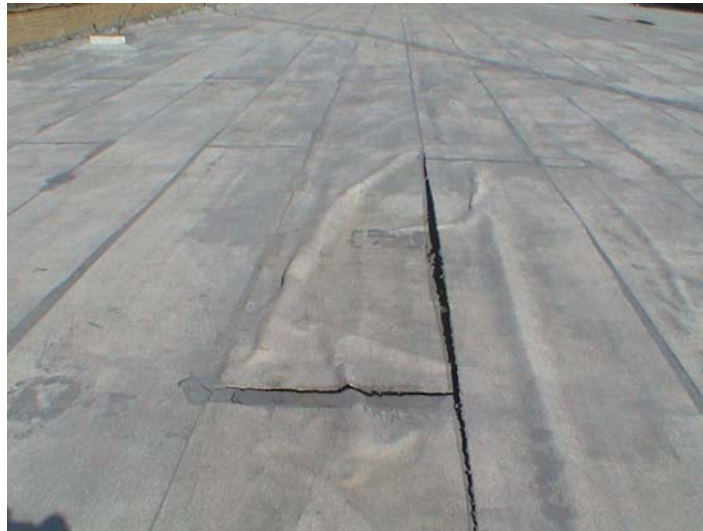
Step 1. Inspect roof. Determine distress types, severity levels and defects. Determine quantities and calculate densities.

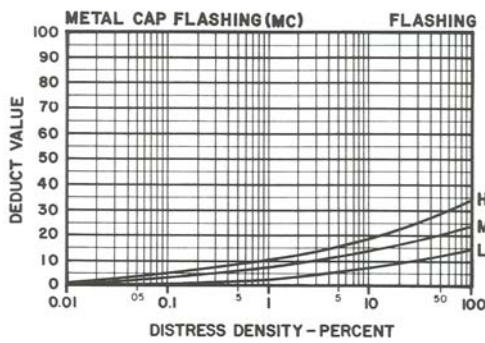
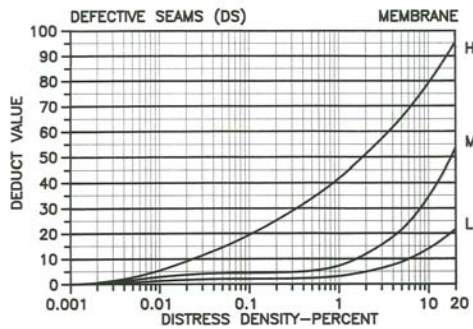
Step 2. Determine deduct values.

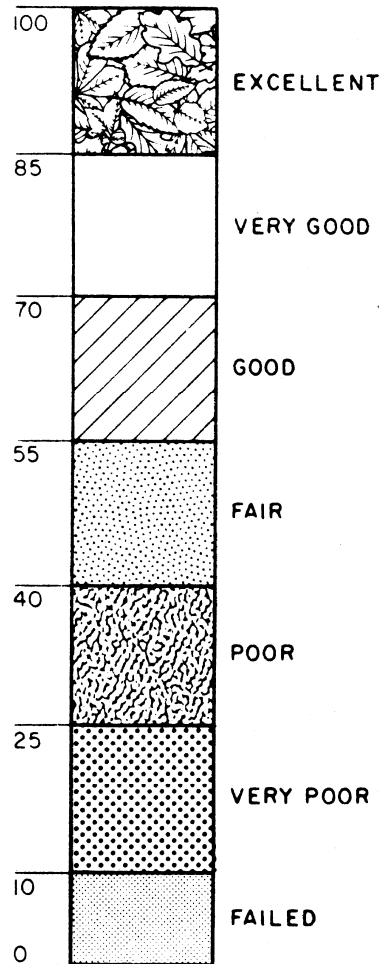
Figure 6. Flashing and membrane condition indexes (FCI and MCI) and ratings.

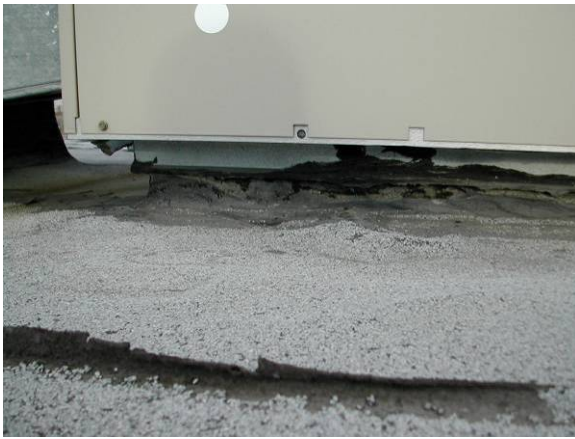
**BF-L-2:** Top of base flashing is less than 6 in. above the roof surface.

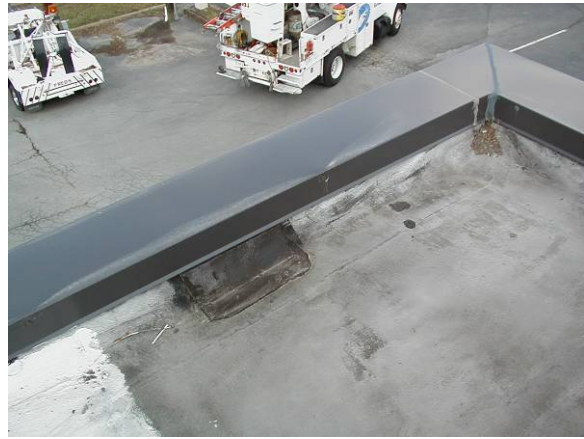
**BF-L-3:** Flashing has permanent repairs.

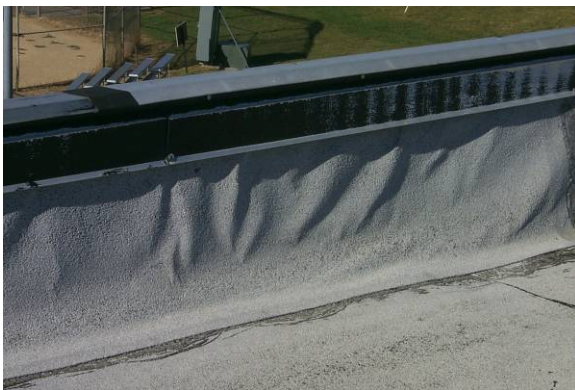
**BF-M-1:** Slippage, wrinkling, blistering, or pulling of base flashing material.

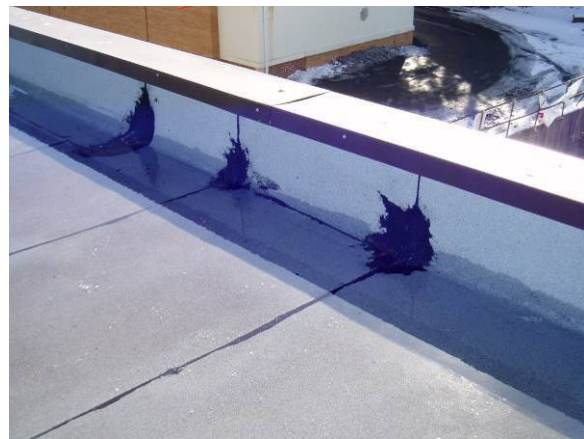
**BF-M-4:** Flashing has temporary repairs.

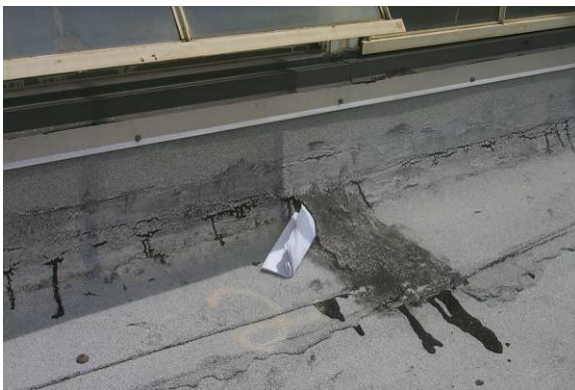
**BF-H-1:** Holes, splits, or tears in flashing caused by deterioration or physical damage.

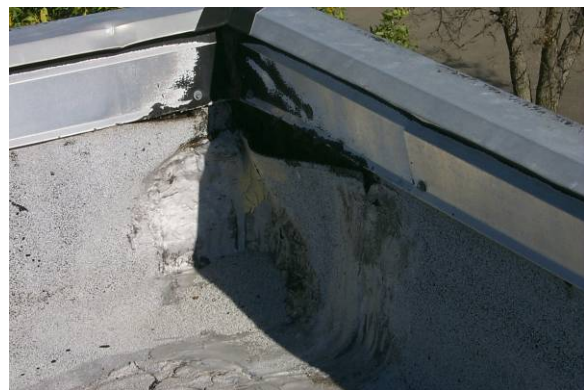
**BF-H-2:** Exposed gaps at the top of the base flashing that are not covered by counterflashing or open side laps in the flashing.

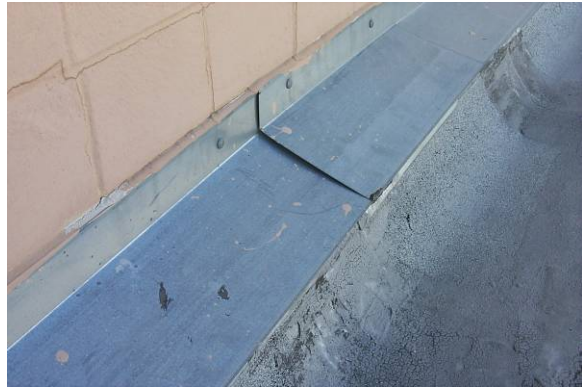
**MC-M-2:** Metal coping cap has loose fasteners, failure of soldered or sealed joints, open joints, or loss of attachment.

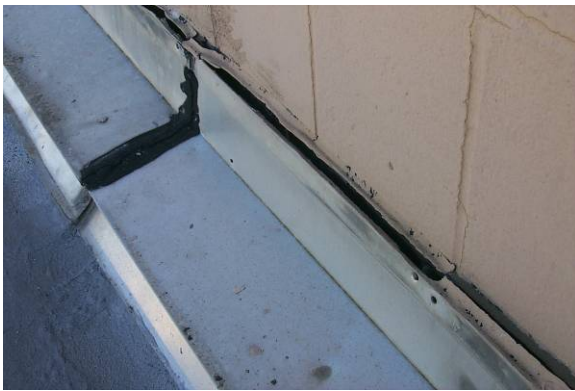
**MC-M-3:** Sealant at reglet or top of counterflashing is missing or no longer functioning, allowing water to channel behind.

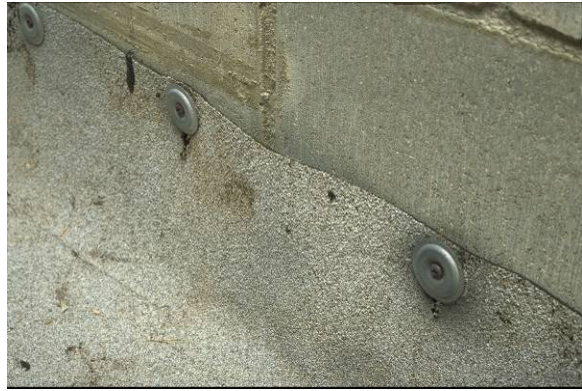
**MC-H-1 :** Metal coping cap or counterflashing is missing or displaced from its original position.

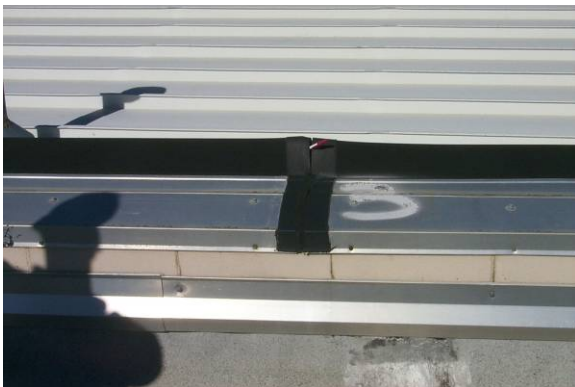
**MC-H-2:** Corrosion holes penetrating metal on horizontal surface or rubber bellows of an expansion joint cover.

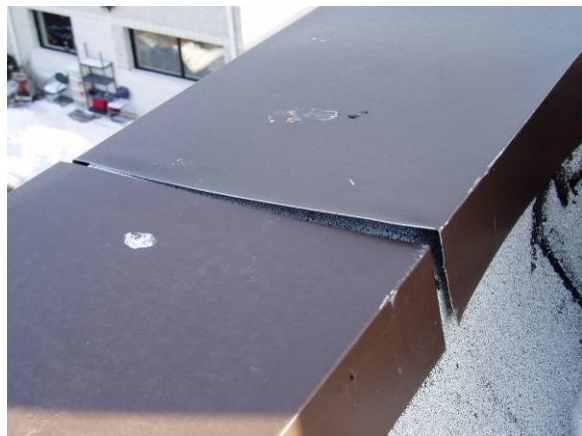
**MC-H-3:** Metal coping cap has missing joint covers where joint covers were originally installed.

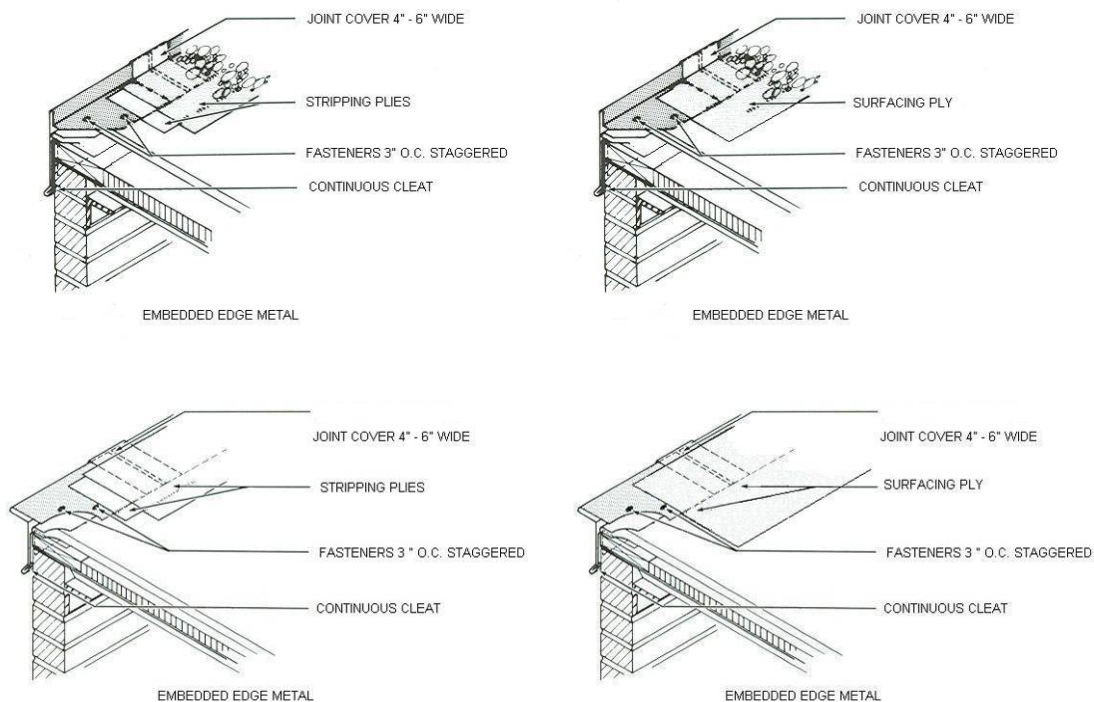
Embedded edge metal details.

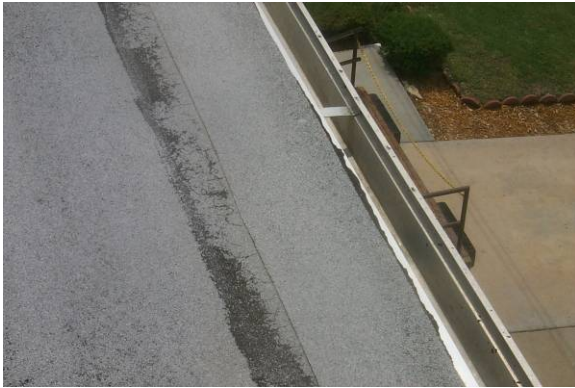
**EM-L-1:** The entire length of embedded edge metal flashings is rated low severity at minimum due to the maintenance problems.

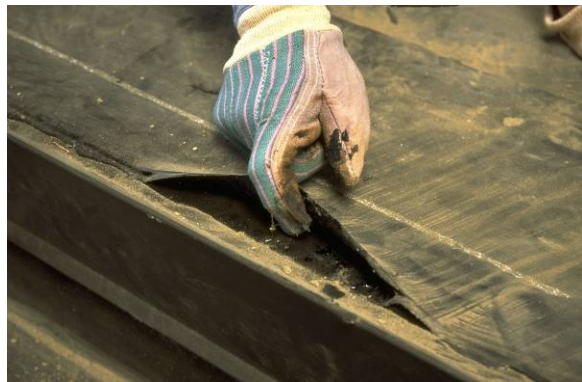
**EM-H-1:** Surfacing plies are missing or loose.

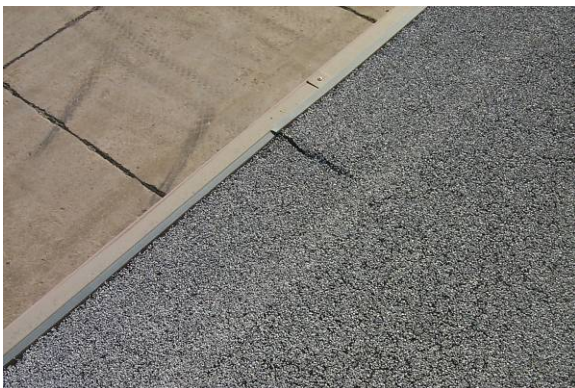
**EM-H-2:** Splits in the surfacing plies above the metal joints.

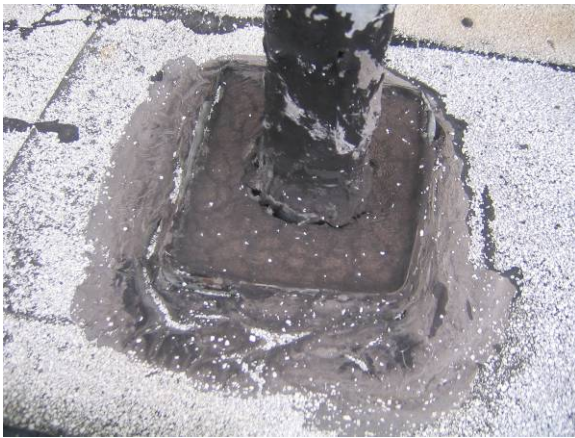
PP-H-4 : Sealing material has cracked or separated from pan or penetration.

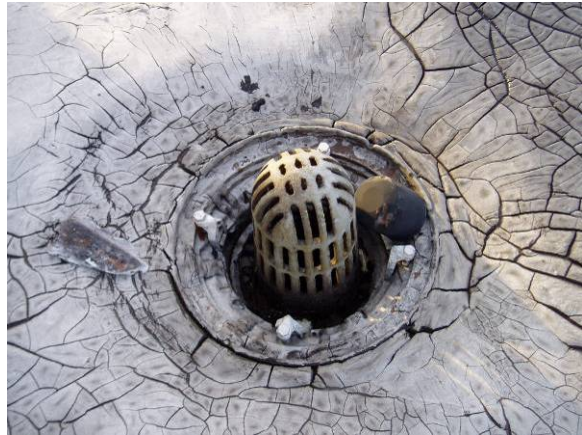
**DR-M-1:** Loss of granules or coating or delamination of foil surfacing and some deterioration of surfacing/stripping ply.

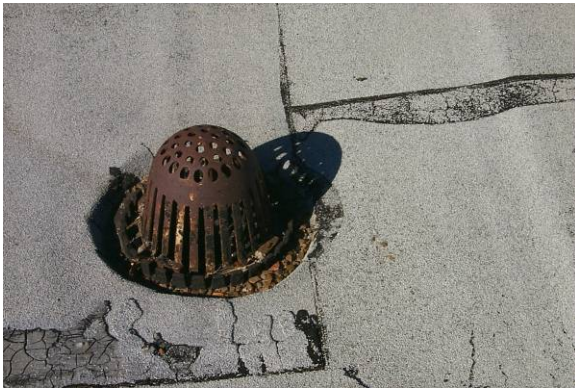
**DR-M-4:** Field seam exists under clamping ring.

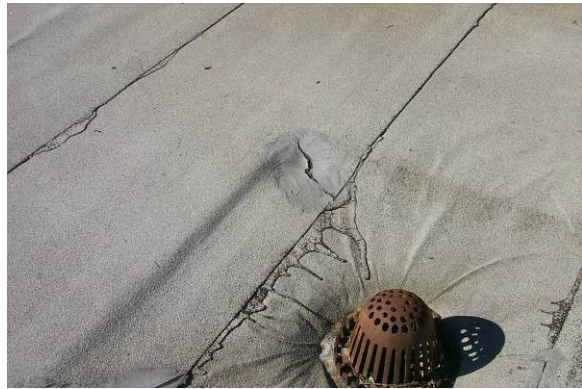
**DR-H-1:** Holes, splits, or tears in stripping ply caused by deterioration or physical damage.

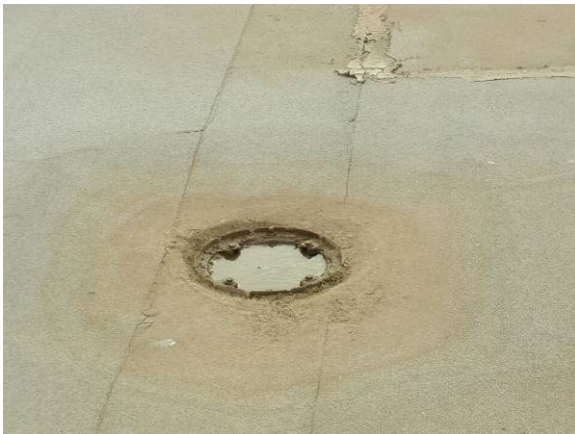
**DR-H-3:** Drain is clogged.

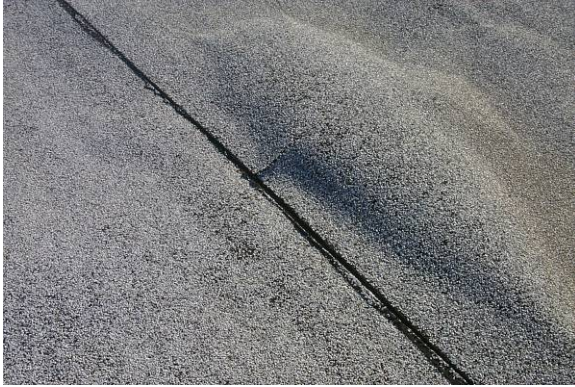
**BL-L-1:** The raised areas are noticeable by vision or touch. The surfacing is still in place and there is no membrane deterioration.

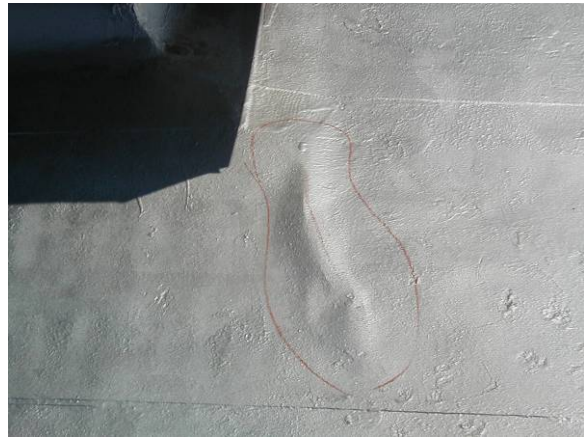
**BL-L-1:** The raised areas are noticeable by vision or feel. The surfacing is still in place and there is no membrane deterioration.

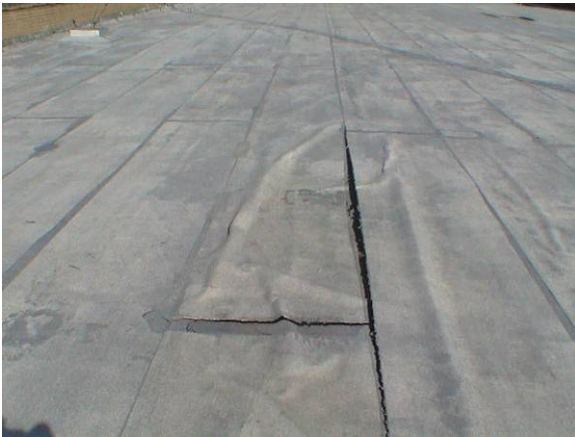
**BL-M-2:** Blister is beneath a seam, which has exposed unsurfaced membrane along the seam.

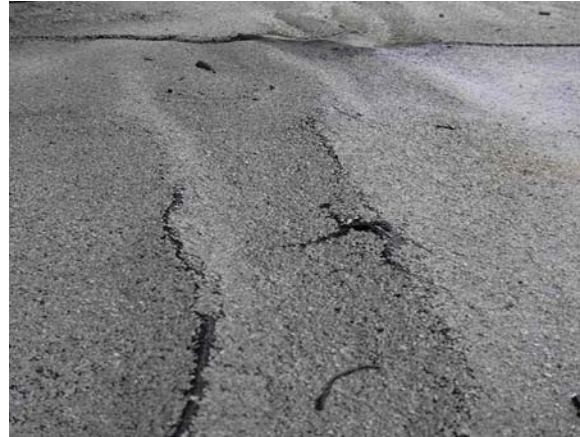
**BL-H-1:** The blisters are broken; there are holes, splits or tears.

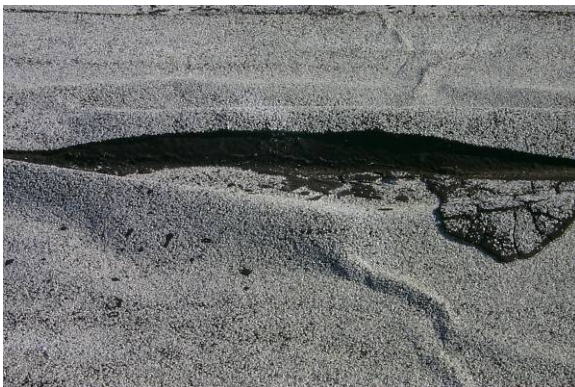
**BL-H-1:** The blisters are broken; there are holes, splits or tears.

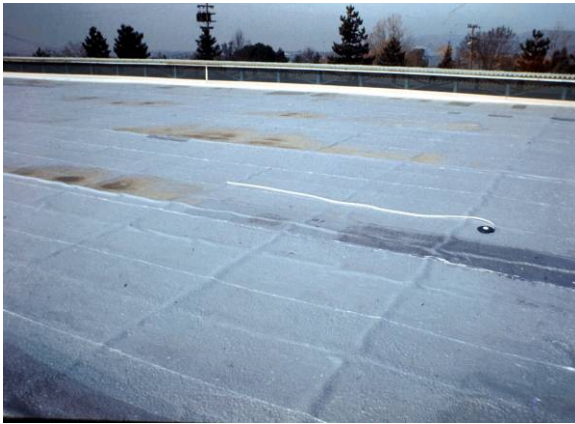
RG-L-1: The ridges are noticeable but the surfacing is still in place and there is no membrane deterioration.

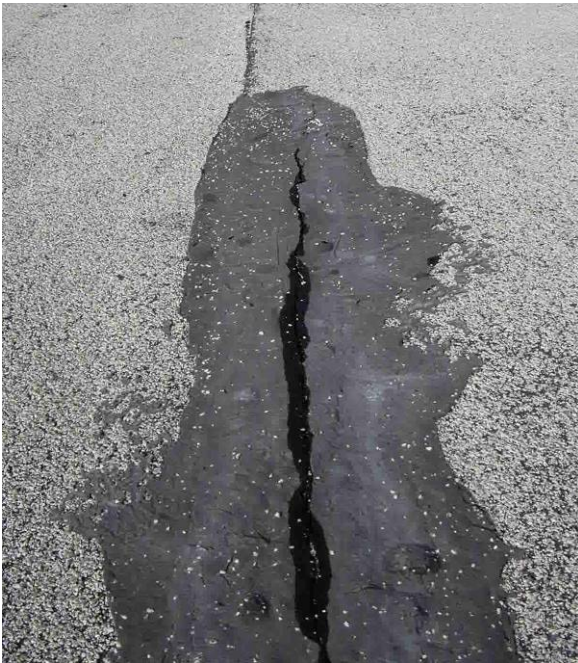
SP-H-1: An unrepaired split or a repaired split which has started to reopen.

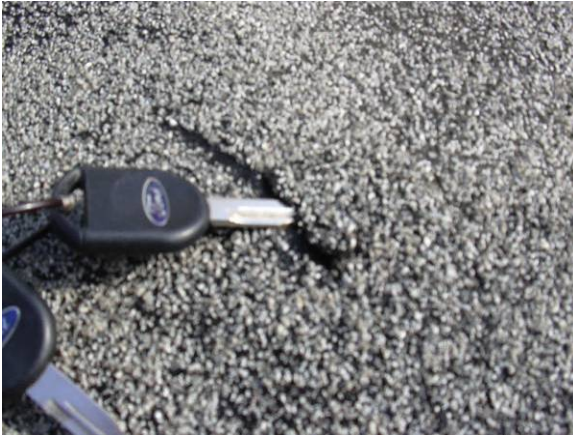
HL-H-1: All holes are considered high severity due to their high leak potential.

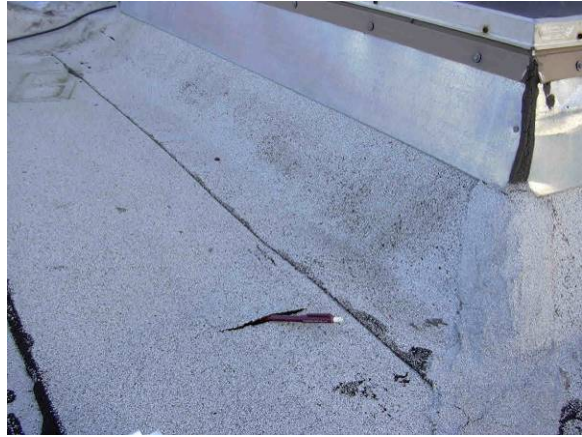
HL-H-1: All holes are considered high severity due to their high leak potential.

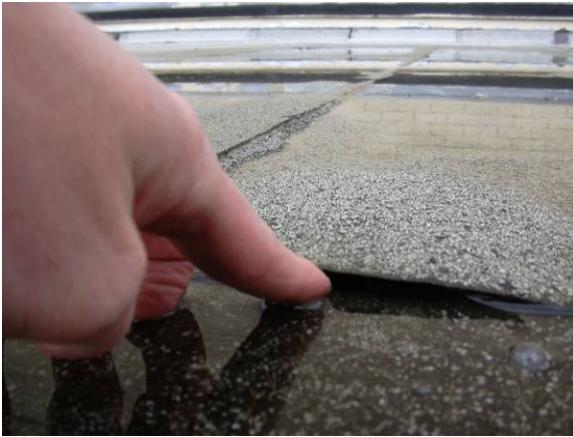
DS-L-1: Seam is open less than 1/2 inch.

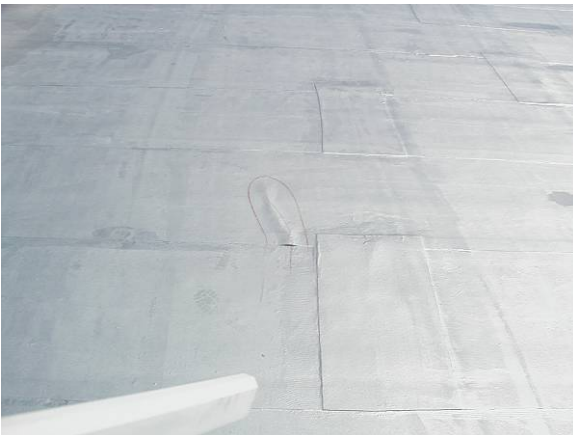
DS-H-2: Fishmouths, wrinkling, blistering or ridging at the seams that allow water to penetrate.

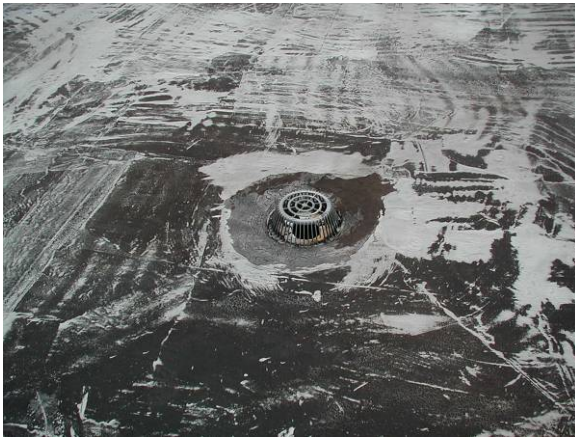
SR-L-2: On smooth liquid applied surfacing, there is loss of coating but no visible deterioration of surfacing ply.

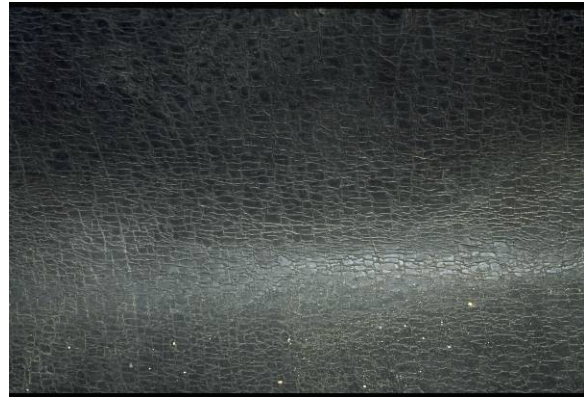
SR-L-3: On smooth liquid applied surfacing, there is evidence of crazing of top surface with hairline cracks (alligatoring).

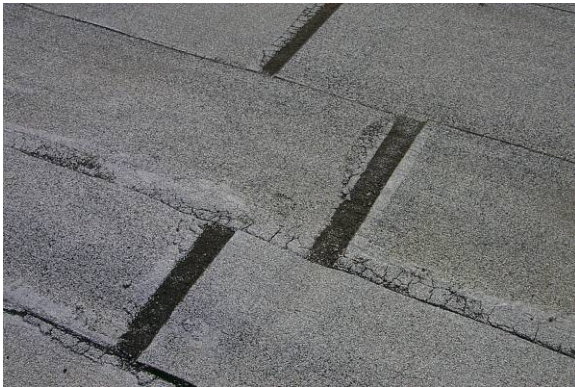
SR-M-2: On mineral surfaced capsheet surfacing, there is loss of granules, exposing the surfacing ply.

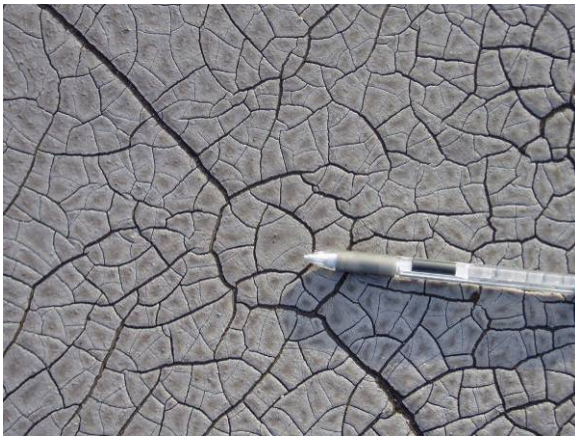
SR-M-4: On smooth liquid-applied surfacing, alligator cracks extend down through coating to the surfacing ply.

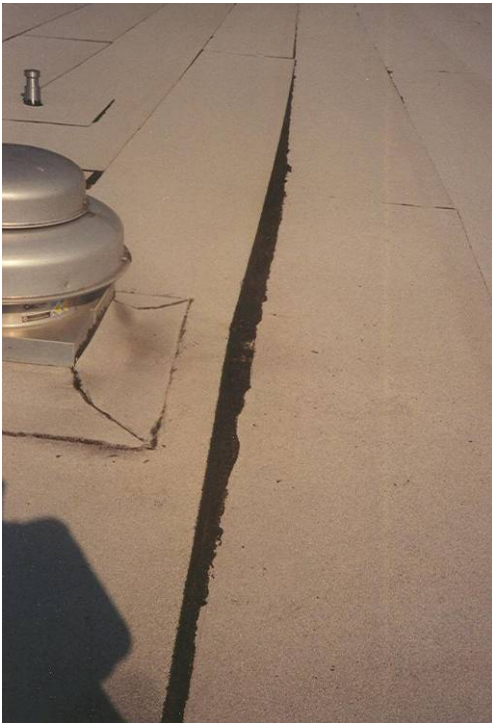
SL-H-1: More than 2 in. of slippage has occurred or the exposed bitumen has shown deterioration. There may be evidence of humping and wrinkling.

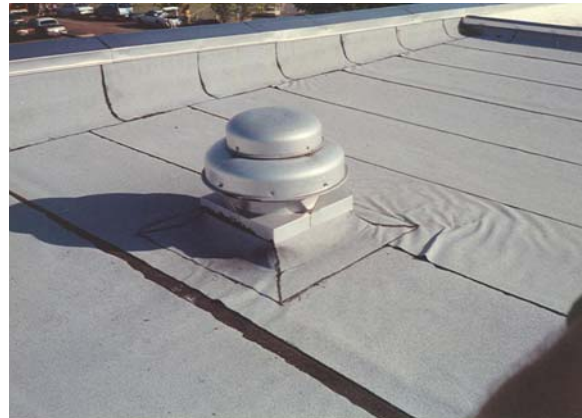
SL-H-1: More than 2 in. of slippage has occurred or the exposed bitumen has shown deterioration. There may be evidence of humping and wrinkling.

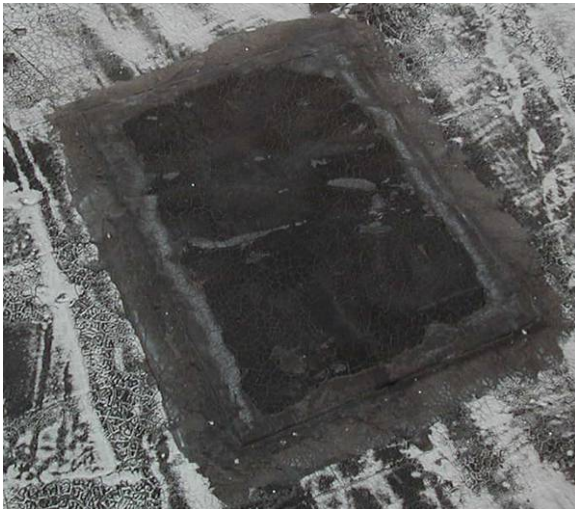
PA-H-1: Ruptures or other membrane distresses of at least medium severity are present within the patched area.

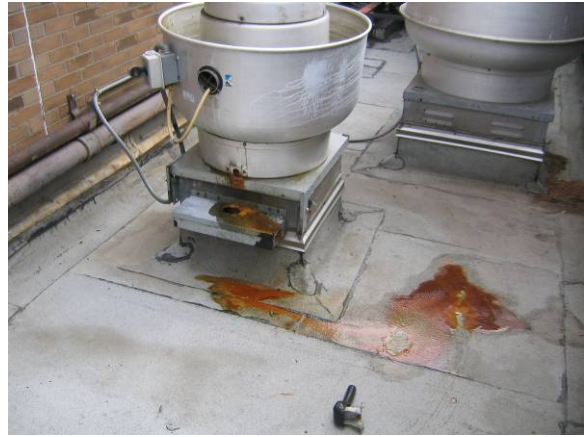
DV-M-2: Grease, solvent, or oil drippings on the roof which show no degradation of the roof membrane.

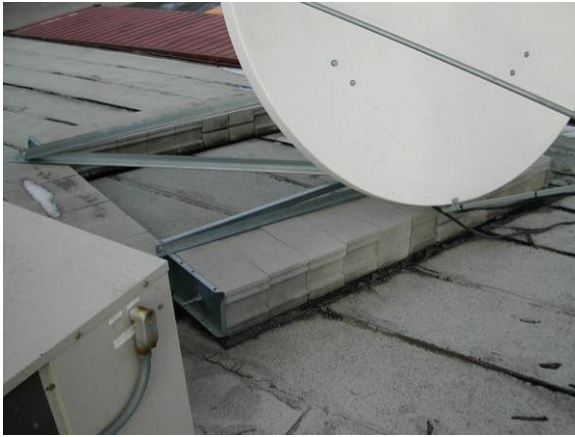
EQ-L-1: All improper equipment supports are rated low severity as a minimum due to the maintenance problems.

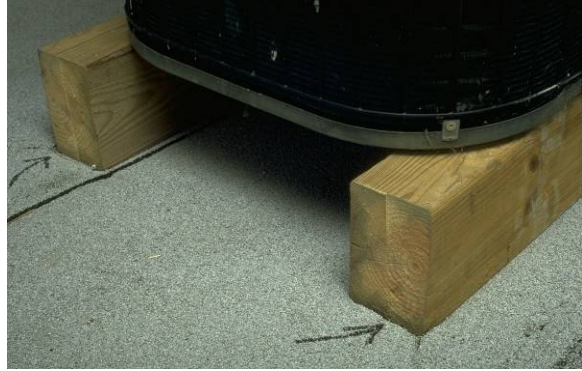
EQ-L-1: All improper equipment supports are rated low severity as a minimum due to the maintenance problems.

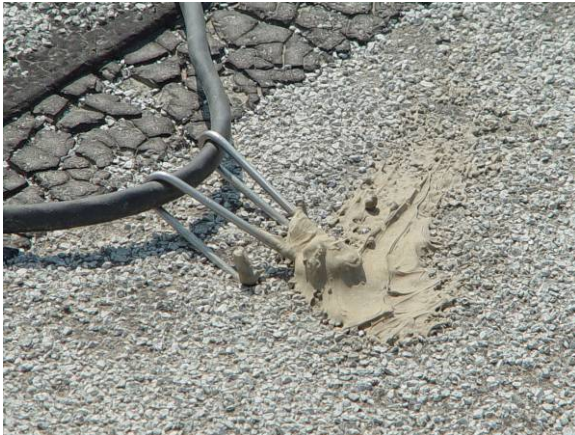
EQ-M-2: The equipment is bolted through the membrane but the bolts appear to be sealed.

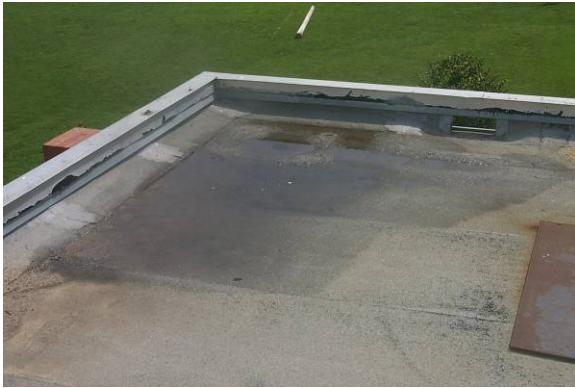
PD-L-1: Ponding is rated low severity due to the maintenance problems associated with it.

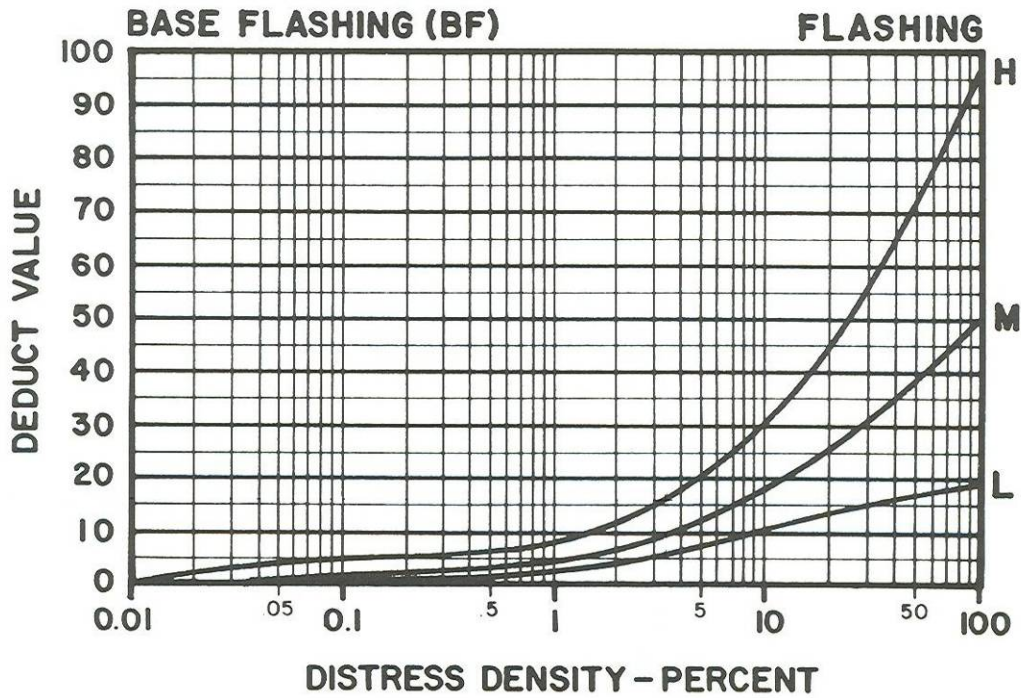
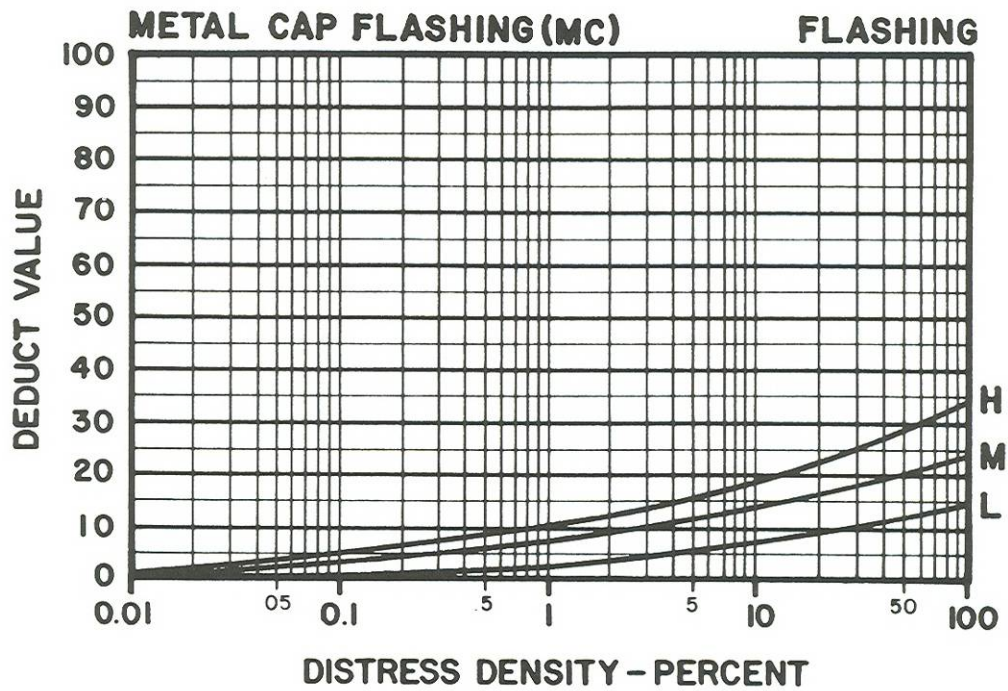
## Appendix A: Deduct Value Curves
