Coastal and Hydraulics Laboratory

Monitoring of Dolos Armor Units at Crescent City, California

September 2005

Final report

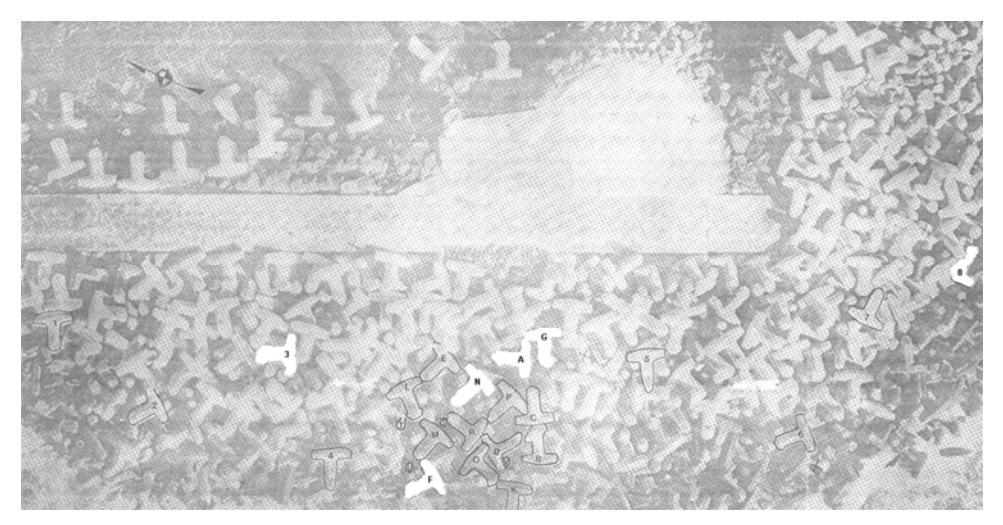
Of the 26 targeted dolos units and remaining non-targeted unbroken units, six had movement that exceeded the observation thresholds of 0.15 m (0.5 ft) cumulatively since 1986. Only dolos A had exceeded the thresholds since 1999. Details of significant movements can be seen in Figures 8-14 and in Table 1.

Figure 8. Location of dolosse with significant movement

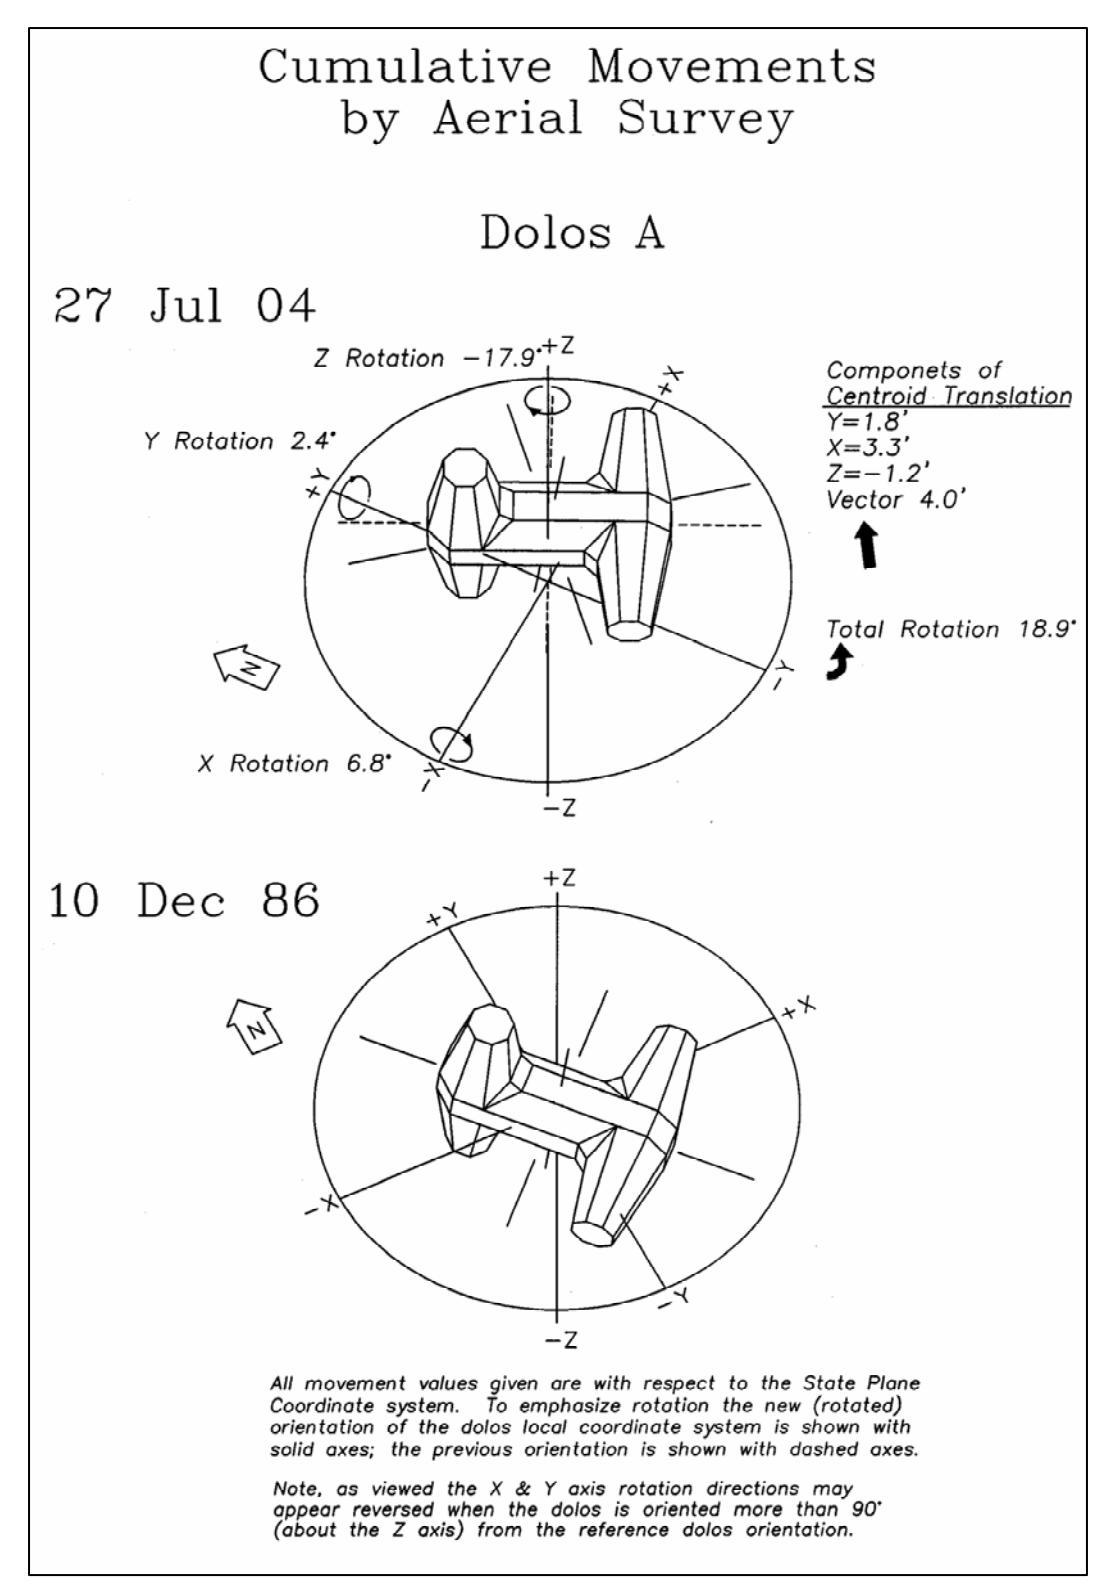
However, dolosse A, C, E, and G were recently moved using a crane to verify operation of internal instrumentation (Melby 2002). As such, the movement of these dolosse is not considered significant. Of the remaining dolosse with motion, none had significant movement since 1999.

Figure 9. Details of cumulative movement of dolos A through 2004

| Table 1Significant Movements of Targeted Dolosse Relative to 1999 and Cumulative from 1986 | | | | | | | | | | |
|--|---|---|---|---|---|---|---|---|---|--|
| Dolos A | Relative | 0.030 (-0.10) | 0.23 (0.74) | 0.02 (0.06) | 0.23 (0.75) | -3.3 | 3.0 | 1.8 | 4.8 | |
| | Cumulative | 0.56 (1.84) | 1.02 (3.34) | -0.37 (-1.17) | 1.22 (3.99) | 2.4 | 6.8 | -17.9 | 18.9 | |

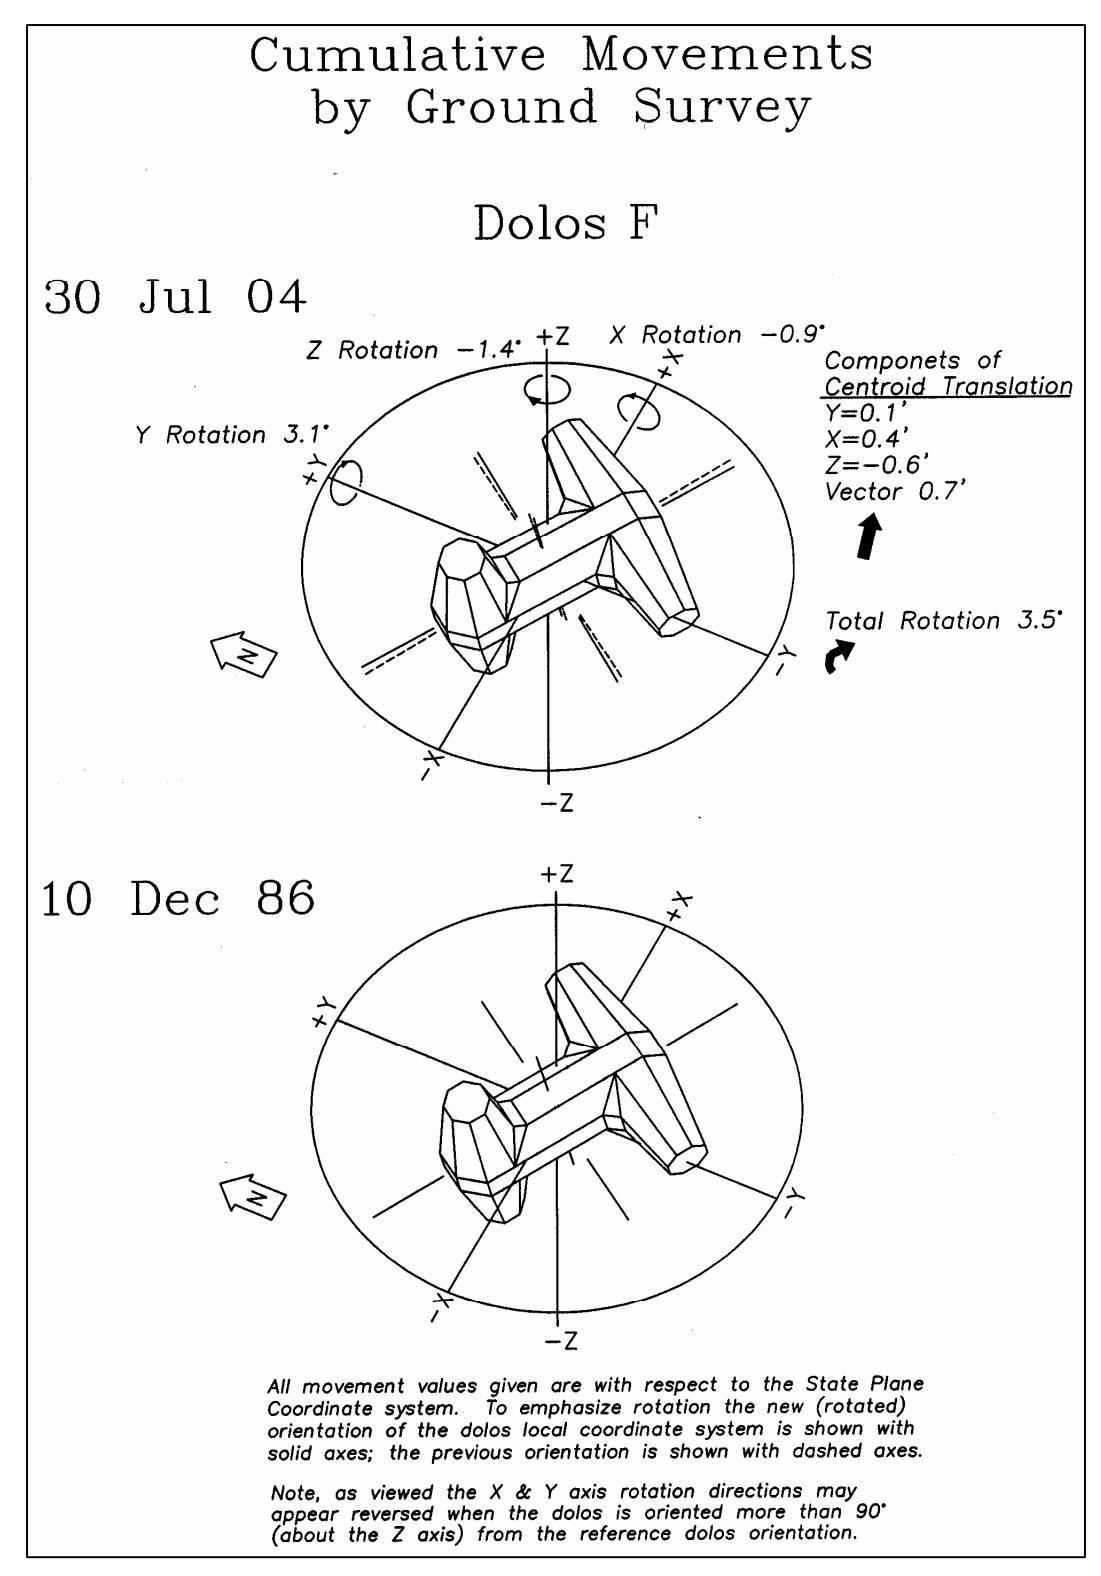
Figure 10. Details of cumulative movement of dolos F through 2004

| Table 1Significant Movements of Targeted Dolosse Relative to 1999 and Cumulative from 1986 | | | | | | | | | | |
|--|---|---|---|---|---|---|---|---|---|--|
| Dolos F | Relative | 0.003 (0.01) | 0.02 (0.05) | -0.05 (-0.16) | 0.05 (0.17) | 1.0 | -0.7 | -0.3 | 1.3 | |
| | Cumulative | 0.03 (0.10) | 0.13 (0.42) | -0.17 (-0.55) | 0.21 (0.70) | 3.1 | -0.9 | -1.4 | 3.5 | |

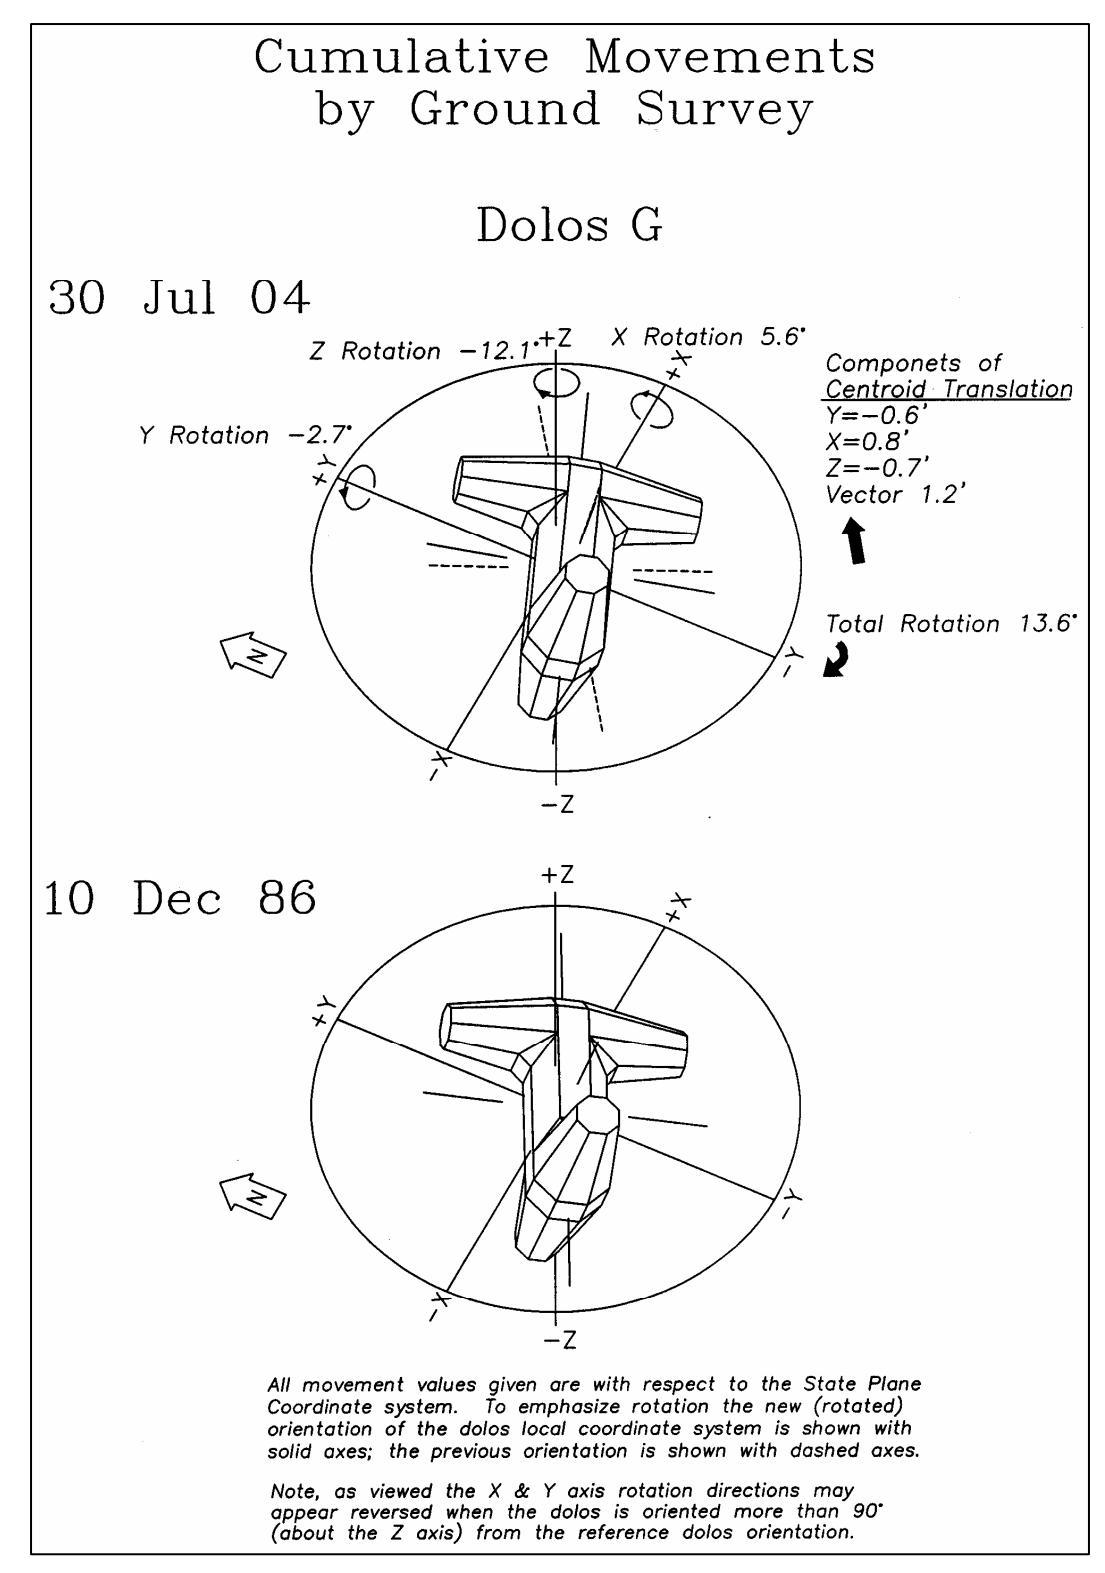
Figure 11. Details of cumulative movement of dolos G through 2004

| Table 1Significant Movements of Targeted Dolosse Relative to 1999 and Cumulative from 1986 | | | | | | | | | | |
|--|---|---|---|---|---|---|---|---|---|--|
| Dolos G | Relative | -0.07 (-0.24) | 0.05 (0.17) | -0.05 (-0.15) | 0.10 (0.33) | -3.3 | -0.3 | -5.8 | 6.7 | |
| | Cumulative | -0.19 (-0.62) | 0.23 (0.76) | -0.22 (-0.71) | 0.37 (1.21) | 2.7 | 5.6 | -12.1 | 13.6 | |

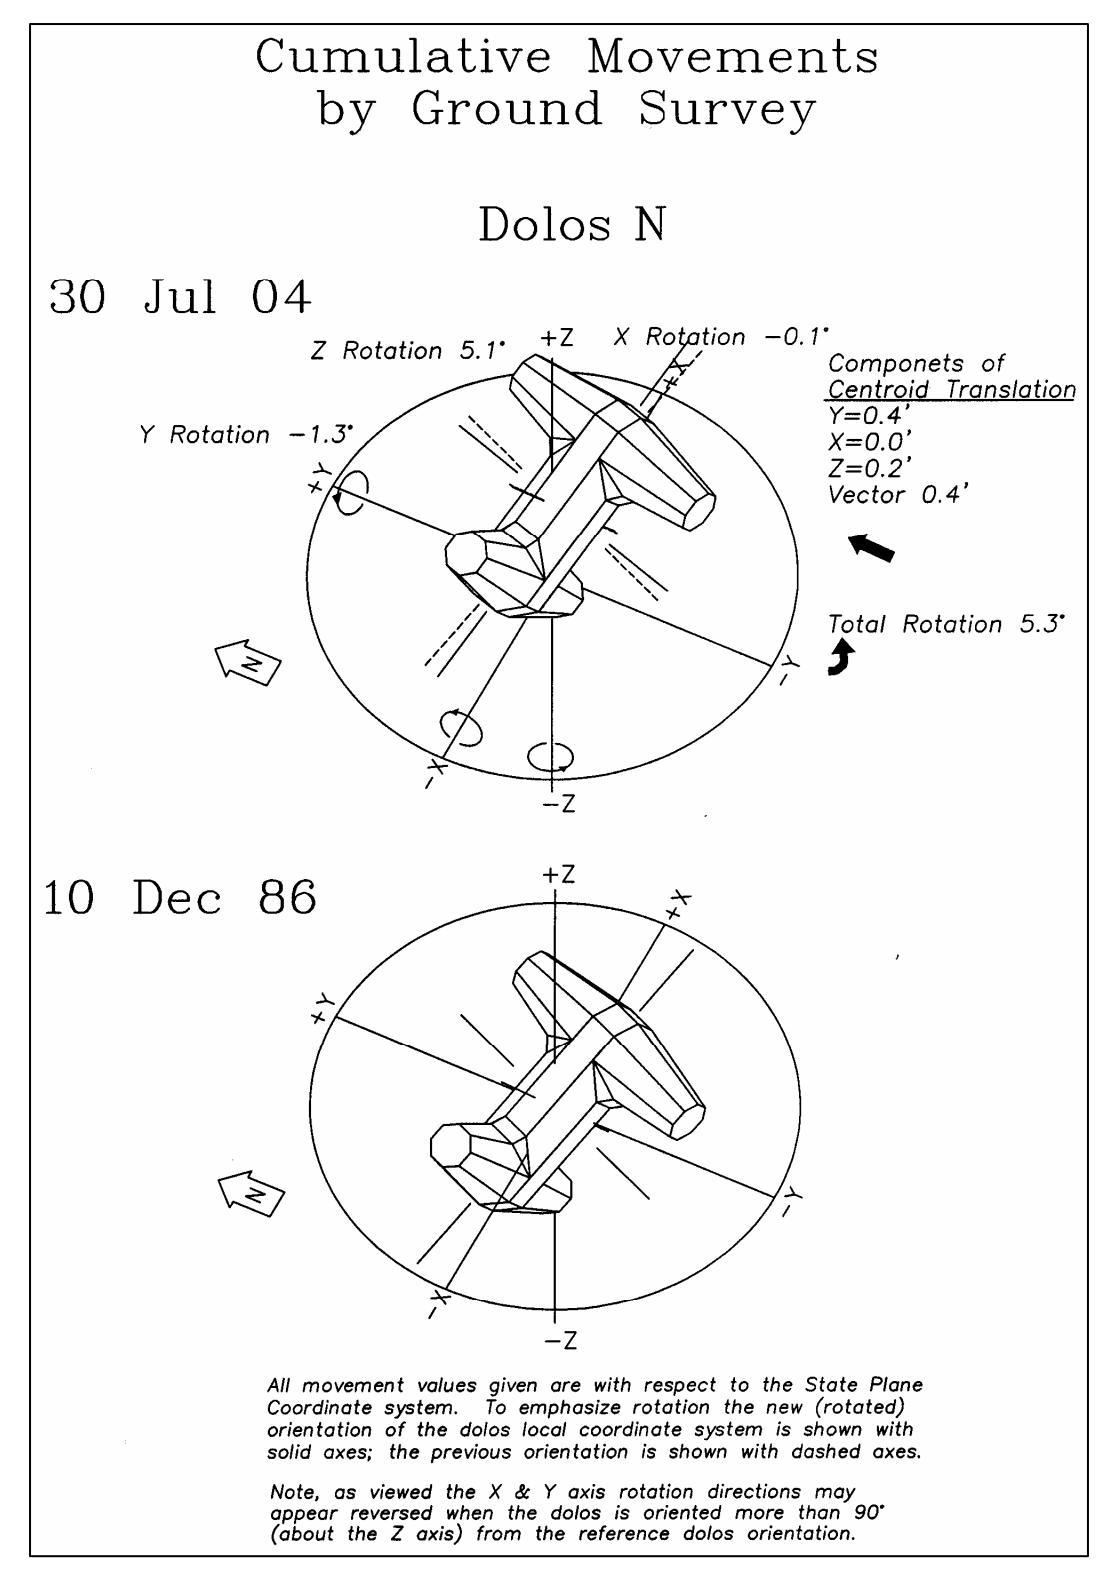
Figure 12. Details of cumulative movement of dolos N through 2004

| Table 1Significant Movements of Targeted Dolosse Relative to 1999 and Cumulative from 1986 | | | | | | | | | | |
|--|---|---|---|---|---|---|---|---|---|--|
| Dolos N | Relative | 0.01 (0.03) | 0.003 (0.01) | -0.01 (-0.04) | 0.02 (0.05) | -0.3 | -0.1 | 0.6 | 0.7 | |
| | Cumulative | 0.11 (0.35) | 0.003 (0.01) | 0.05 (0.15) | 0.12 (0.38) | -1.3 | -0.1 | 5.1 | 5.3 | |

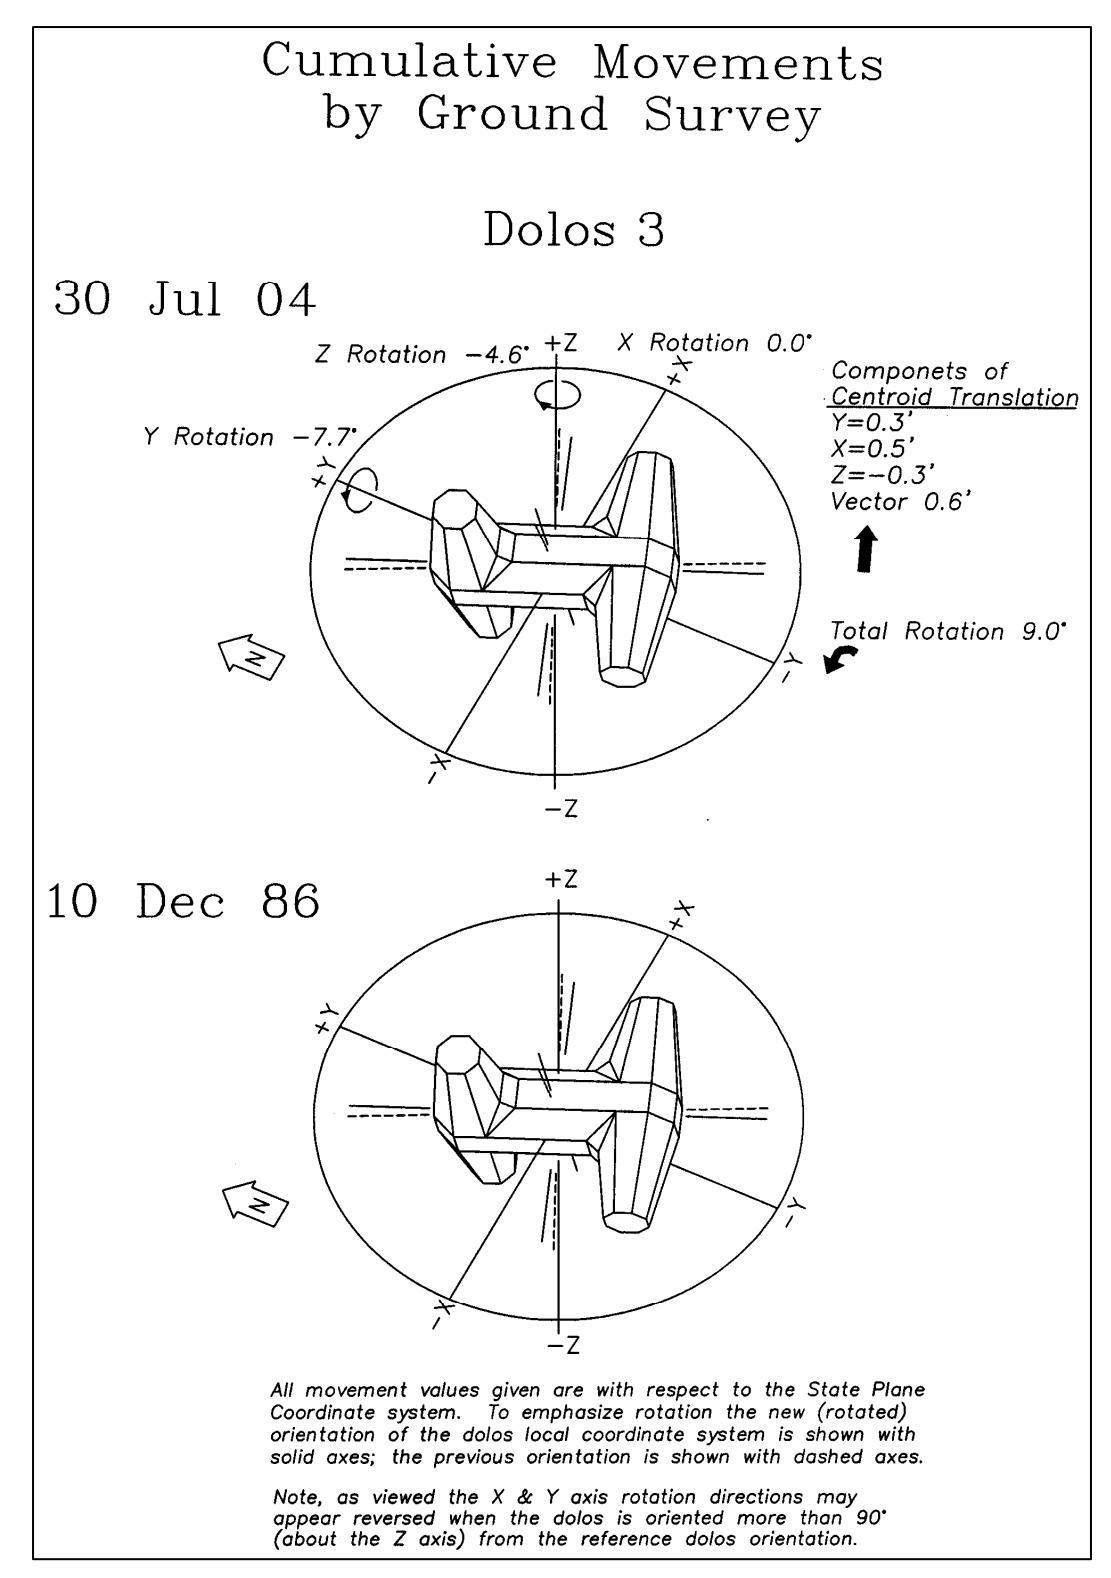
Figure 13. Details of cumulative movement of dolos 3 through 2004

| Table 1Significant Movements of Targeted Dolosse Relative to 1999 and Cumulative from 1986 | | | | | | | | | | |
|--|---|---|---|---|---|---|---|---|---|--|
| Dolos 3 | Relative | -0.003 (-0.01) | 0.02 (0.08) | -0.03 (-0.09) | 0.04 (0.12) | -1.8 | 0.1 | -1.4 | 2.3 | |
| | Cumulative | 0.09 (0.28) | 0.14 (0.46) | -0.08 (-0.25) | 0.18 (0.59) | -7.7 | 0.0 | -4.6 | 9.0 | |

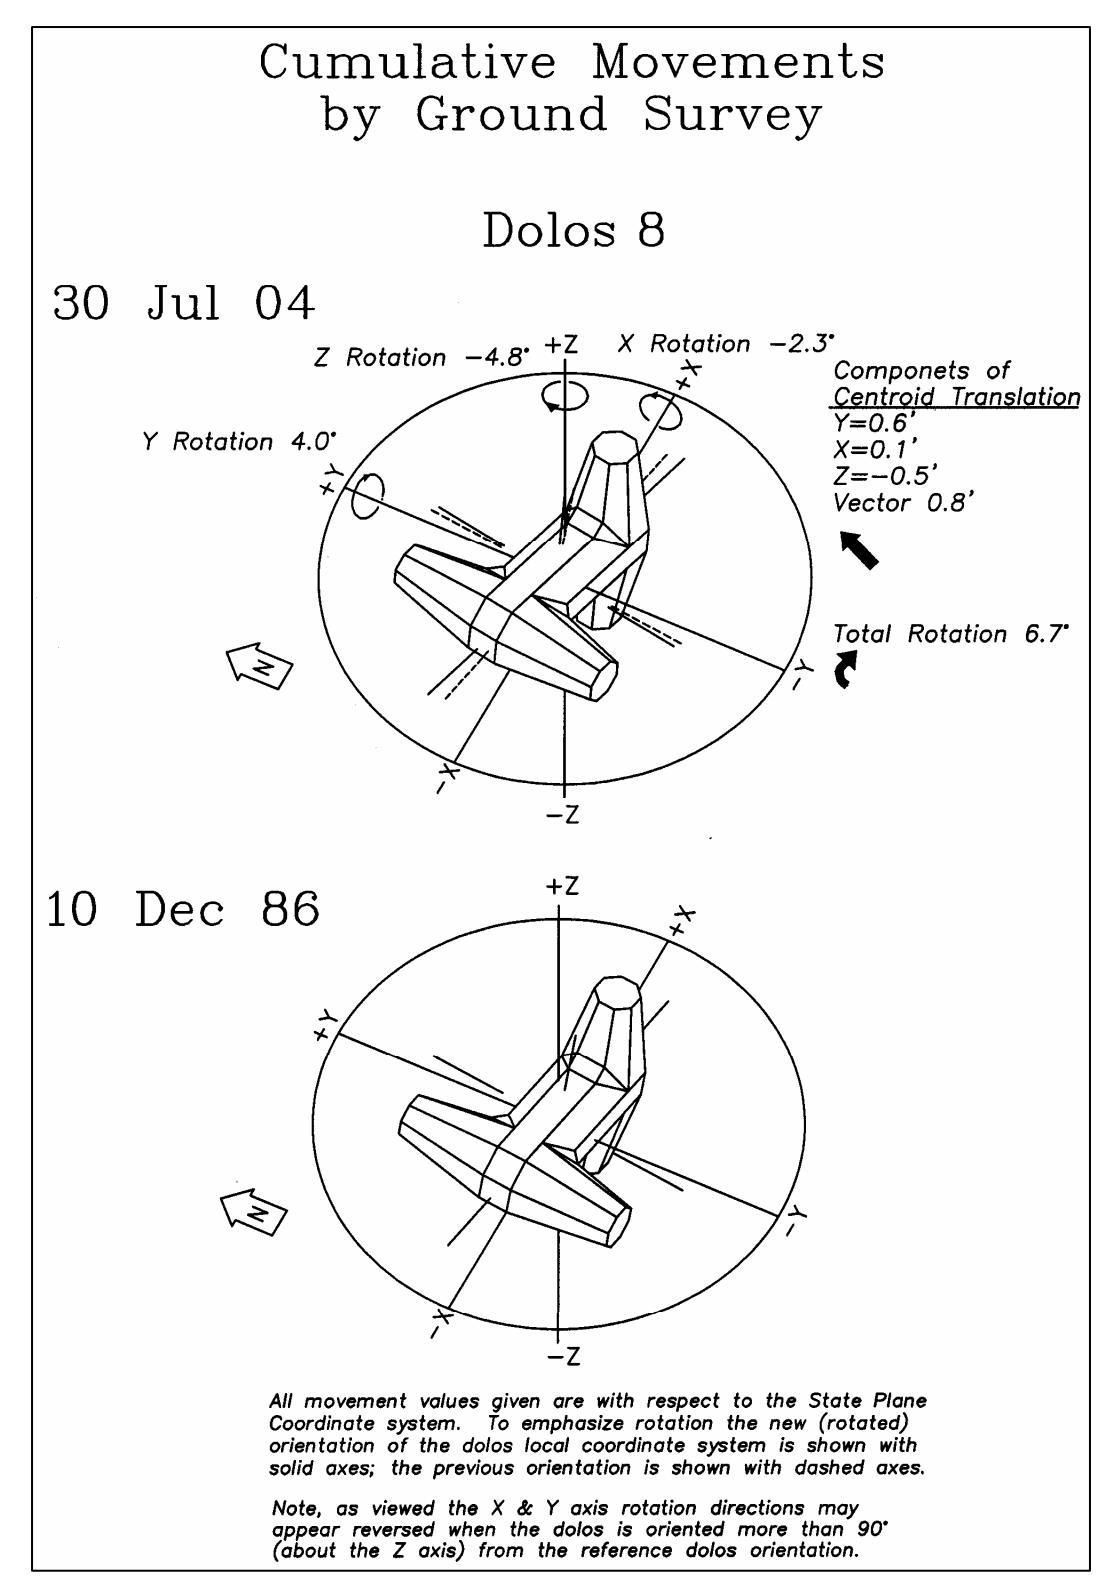
Figure 14. Details of cumulative movement of dolos 8 through 2004

| Table 1Significant Movements of Targeted Dolosse Relative to 1999 and Cumulative from 1986 | | | | | | | | | | |
|--|---|---|---|---|---|---|---|---|---|--|
| Dolos 8 | Relative | 0.07 (0.22) | 0.01 (0.04) | -0.06 (-0.19) | 0.09 (0.29) | 1.4 | -0.9 | -1.4 | 2.2 | |
| | Cumulative | 0.19 (0.62) | 0.04 (0.13) | -0.16 (-0.53) | 0.25 (0.83) | 4.0 | -2.3 | -4.8 | 6.7 | |

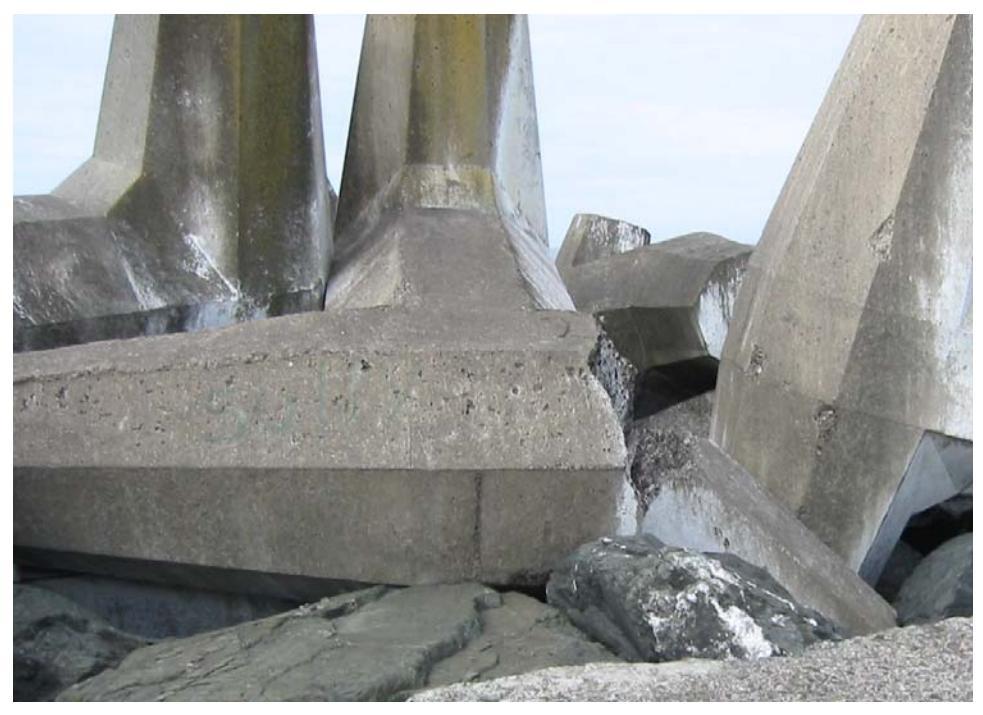
Figure 15. Example of a straight fluke-shank dolos break

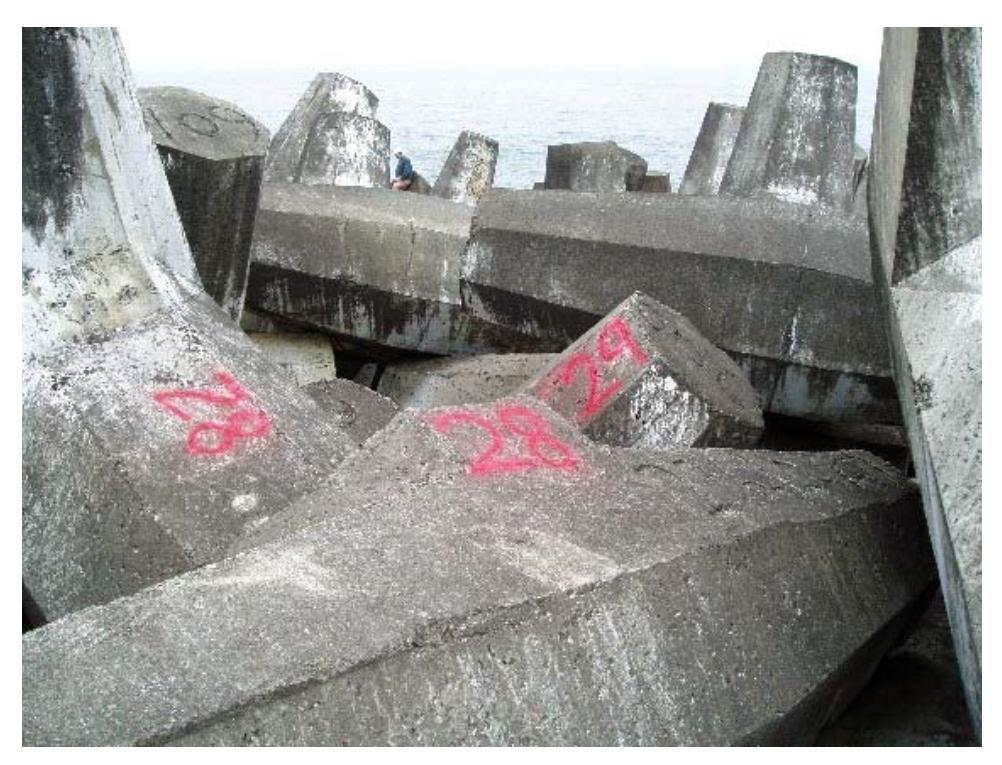
Figure 16. Example of shank-fluke dolos break

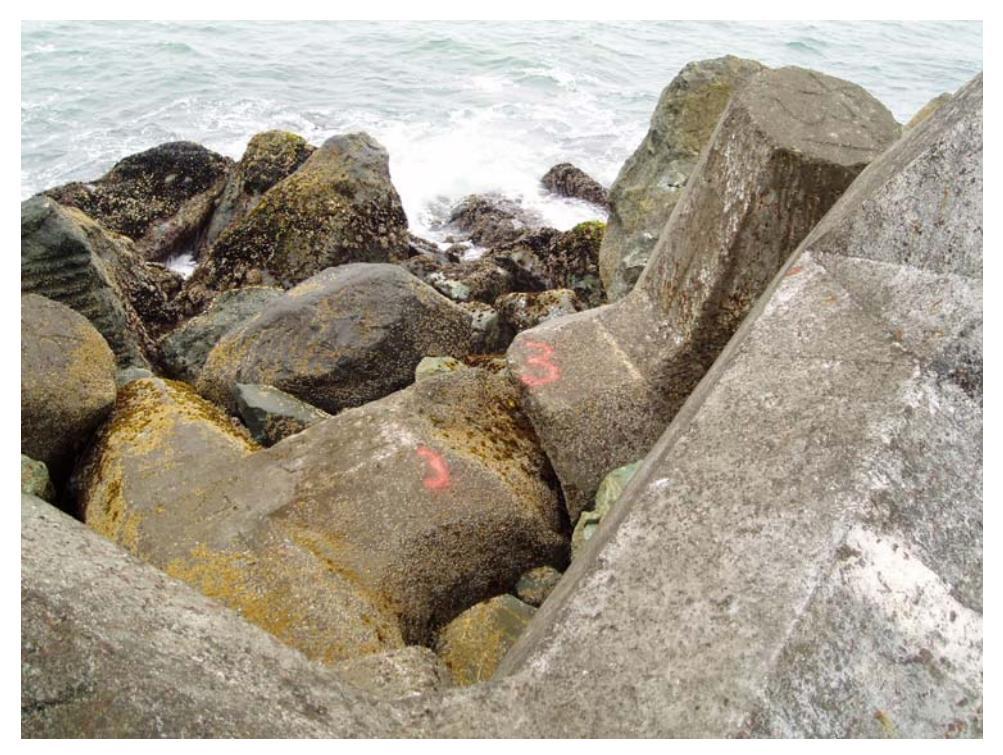
Figure 17. Example of mid-shank dolos break

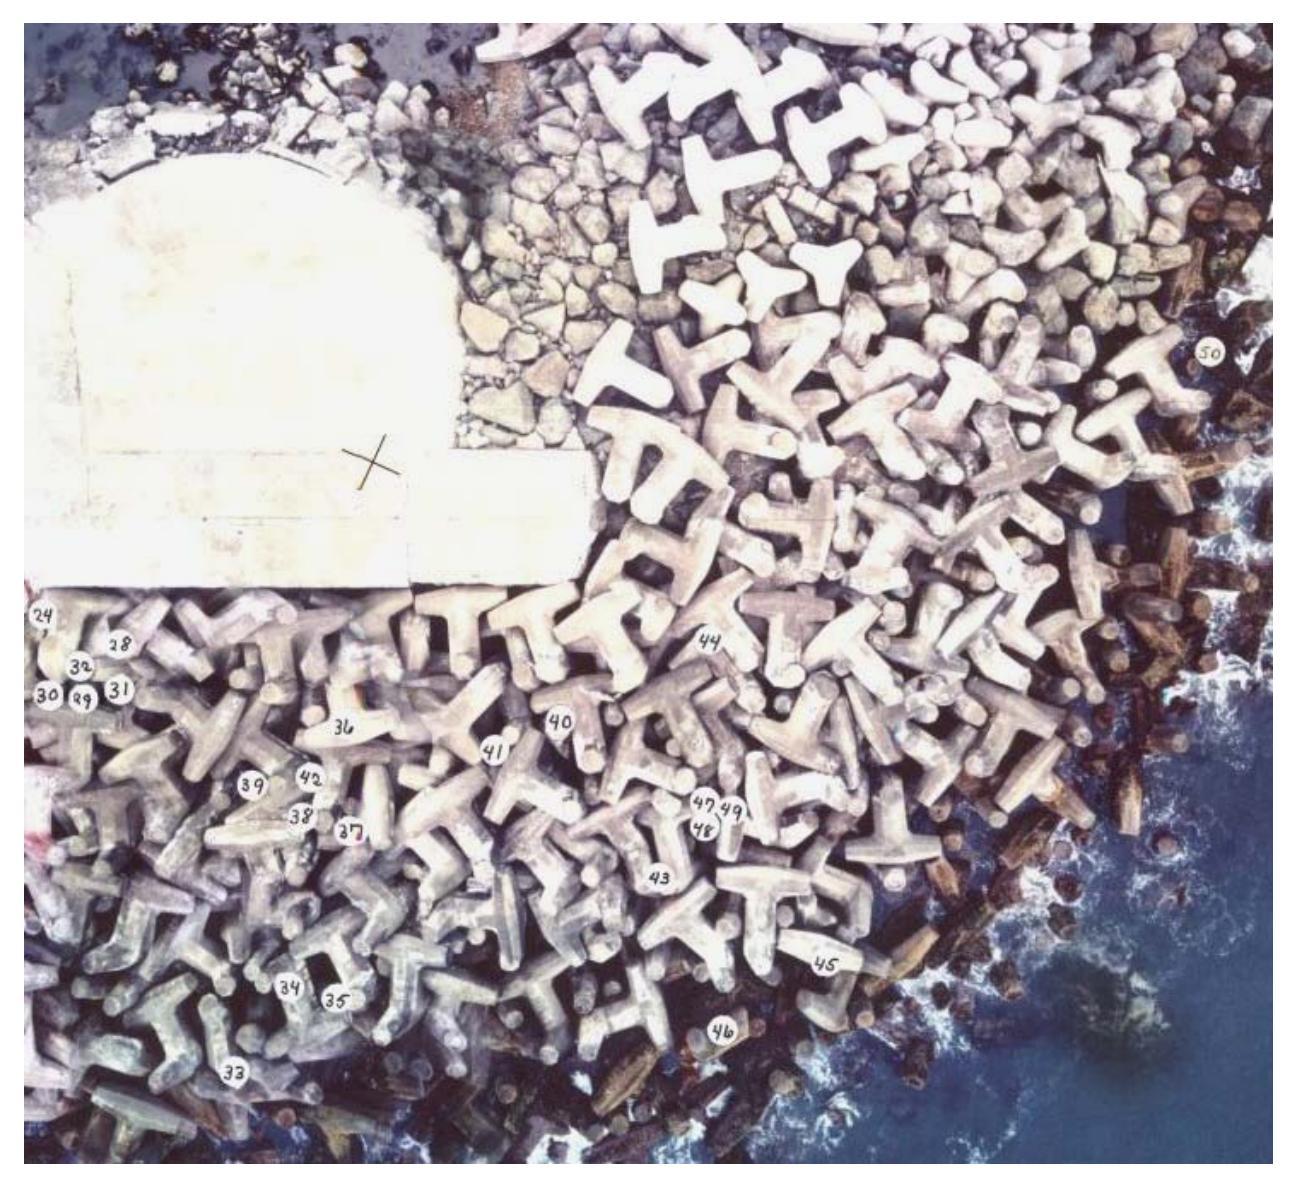
A comprehensive broken armor unit survey of above water dolosse was conducted on August 11, 2004, by Messrs. Myrick and Tolliver and Dr. Melby. This inventory revealed a total of 50 visible broken dolosse of which 14 were cast in 1986 and 36 were cast in 1974. Overall, 33 dolosse were broken at the shankfluke interfaces (Figures 15 and 16), seven along the shank (Figure 17), two in the fluke, and eight dolosse were broken into 2 or more pieces. The break descriptions of *fluke-shank* and *shank-fluke* are intended to differentiate between a break that is primarily in the fluke from one that is primarily in the shank, respectively. The broken dolos inventory, along with the location of broken dolosse and detailed types of breaks are listed in Table 2 and Figures 18-20. The results of the survey show that there has been no additional breakage since the last detailed comprehensive armor unit survey in 1993 by Melby and Turk.

Figure 19. Locations of broken/cracked dolosse along the southerly portion of elbow

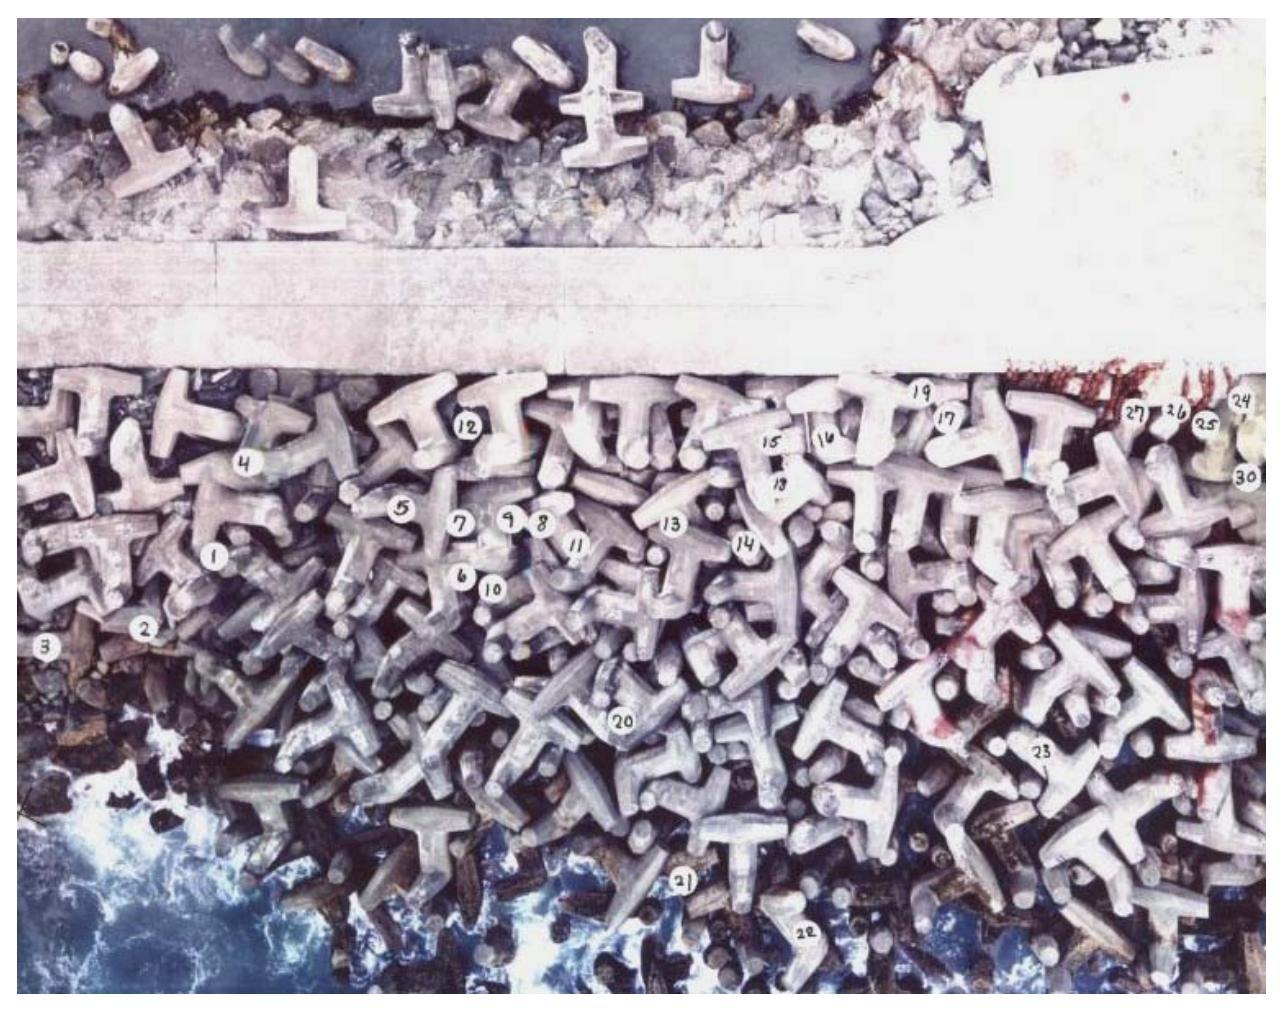
Figure 20. Locations of broken/cracked dolosse along the notherly portion of the elbow

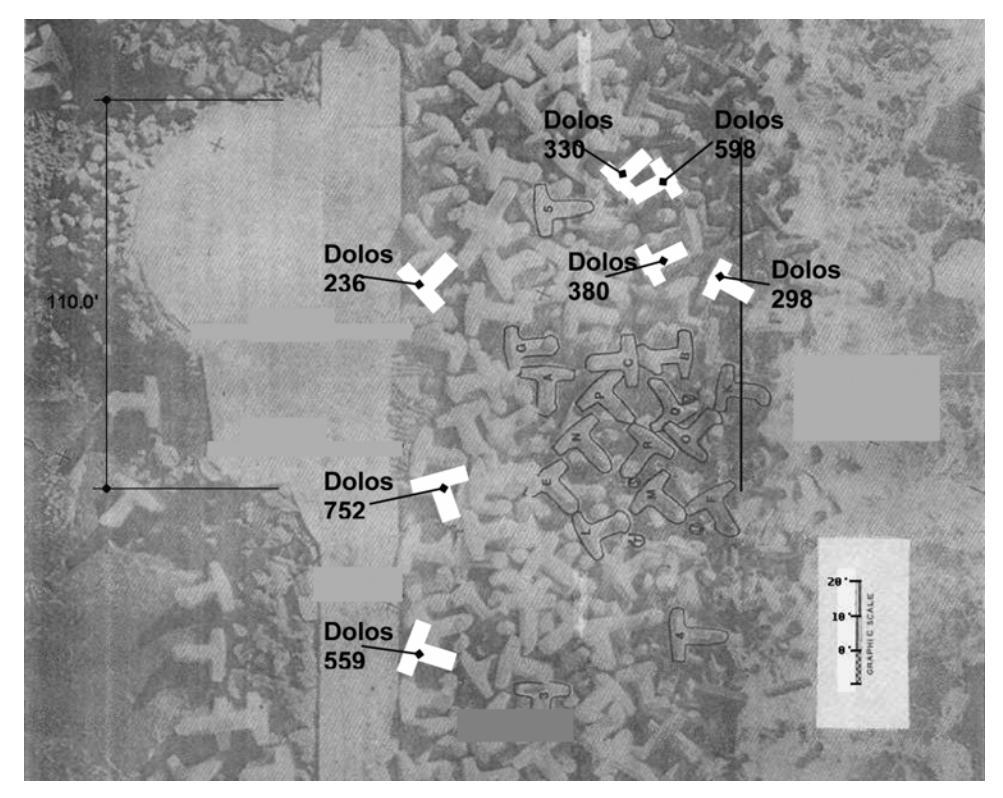
In August 1995, core samples were obtained from two 1986 dolosse near the cap to determine how the concrete strength had changed as the dolosse aged under repeated loading during the ten years since construction. Core samples were also obtained from one 1974 dolos for comparison of strengths. The 1974 dolos used for coring was a broken unit near the cap and two cores were taken very near the break. In August 1999, core samples were obtained from dolosse just above the still water level. The locations of cored units are shown Figure 21.

Figure 21. Location of cored dolosse

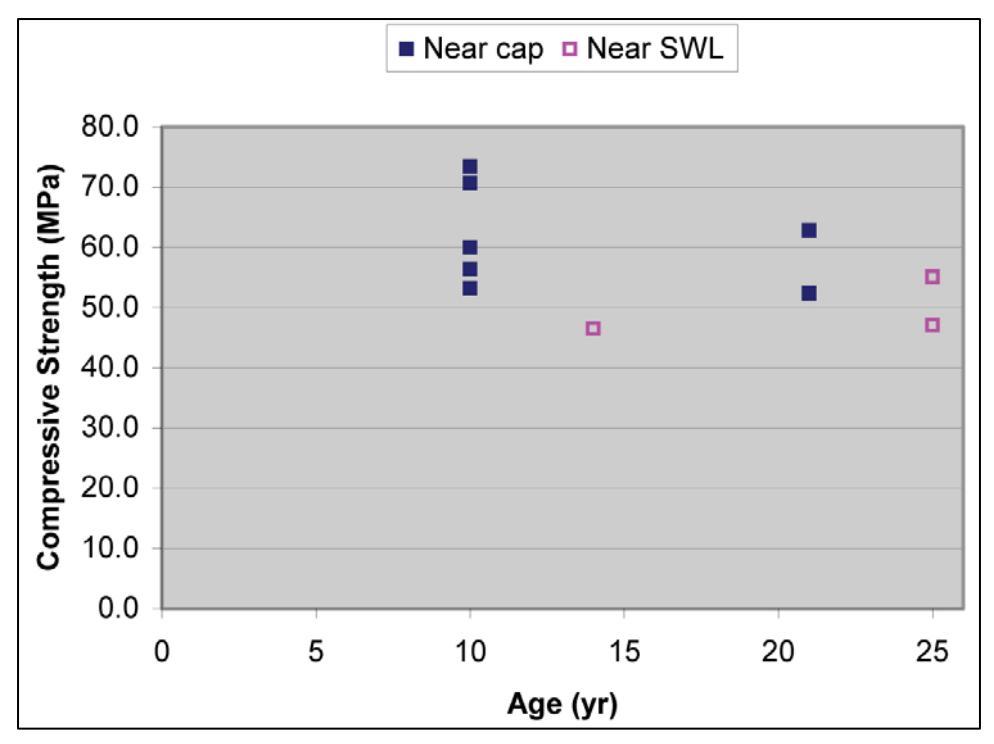
To illustrate the increase in strength, Figures 22 and 23 show the compressive and tensile strengths for all dolosse, respectively. Figure 22 shows the compressive strength results as a function of age for dolosse near the cap and near the still water level. Figure 23 shows the flexural tensile strength results as a function of age for dolosse near the cap, near the still water level, and for all 1986 dolosse at casting time (dashed line). Here, age is used on the horizontal axis to separate the 1986 dolosse from the 1974 units and not to show a general trend. Figures 22 and 23 highlight several interesting points concerning the Crescent City dolos concrete. First, the concrete strength in these units was very high. Typically, concrete armor units are specified to have minimum 28-day compressive and flexural tensile strengths of approximately 35 Mpa and 3.5 Mpa, respectively. The measured strengths were more than double this specification. All 1986 dolosse tested show increased strengths over the as-built average value of 6.8 Mpa. The range of increase is from 9 percent to 76 percent, with the lowest increase being in the most heavily loaded units near the low water level. The mean strength increase of the cap units corresponds crudely to the theoretical increase in strength with time. The units near the low water level show significantly lower strength levels than the units near the cap. This lower strength level could be due to fatigue. A crude theoretical estimate showed that this was the most likely cause; but the reduced strength levels are still greater than the 28-day strength levels.

Figure 22. Compressive strength as a function of age

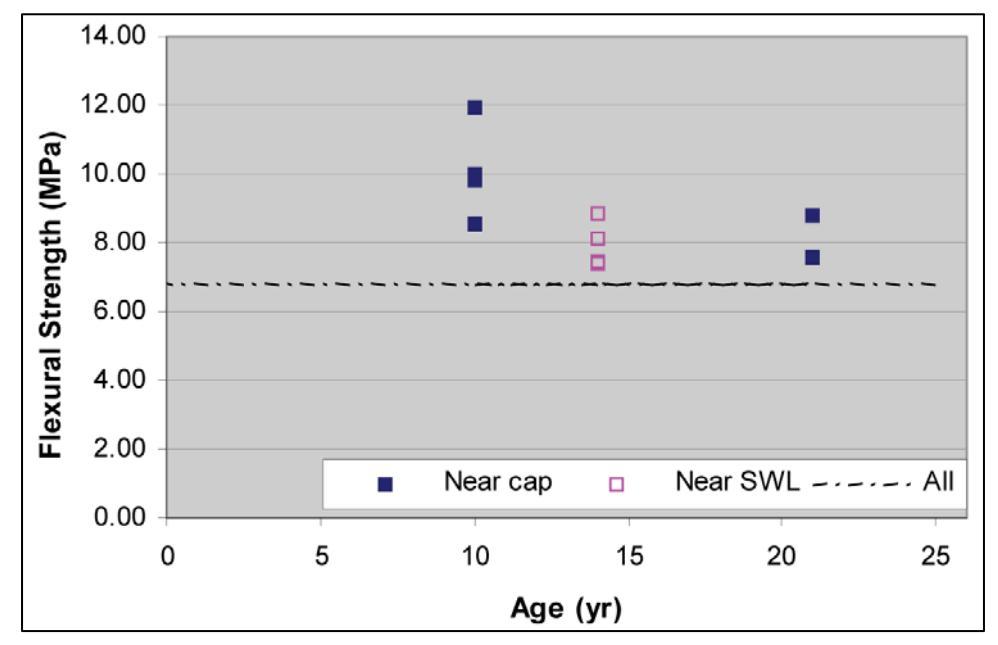
Figure 23. Flexural tensile strength as a function of age
